Progress of Geo-Disaster Mitigation Technology in Asia

Environmental Science and Engineering

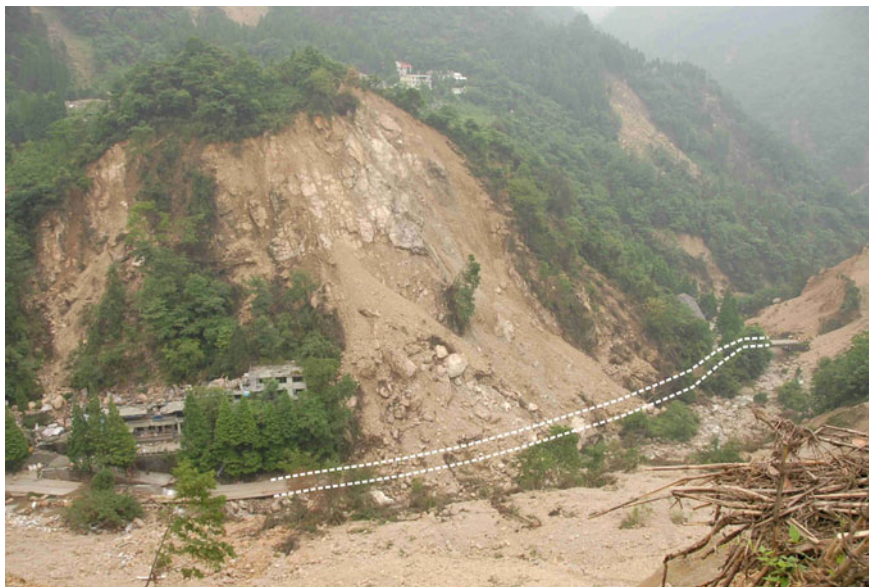
Fig. 2 This rockfall occurred in Hongyan Resort Village, located on an old landslide dam. The *dashed white line* shows where the road existed before the landslide

scale development was conducted and a large resort village was constructed here. During the Wenchuan earthquake, rockfalls occurred at the roadside, killed about 40 persons, and totally blocked the road, effectively cutting off the transportation route to the area (Fig. 2). From field observations, it was found that the road was built along the erosional path of a torrent which passed through the old landslide dam area (it is a local road constructed of concrete).

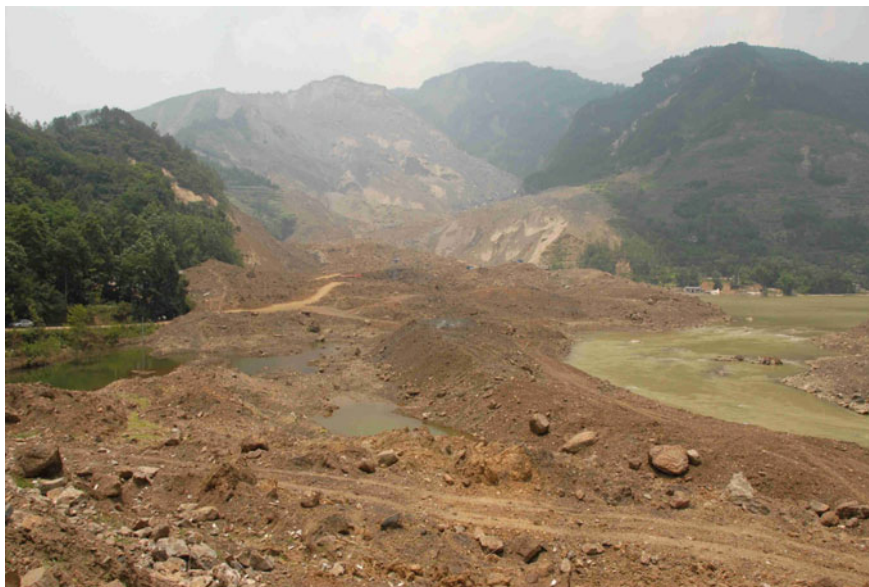
Fig. 4 The rockslide—debris flow in Donghekou Village (the photo was taken in July 2008, 2 months after the earthquake). The flow-path was considered to be fully saturated

A large-scale rockslide occurred on the mountain in back of Donghekou Village. Movement was triggered by the earthquake, and the initial rockslide became a debris flow as it moved down the mountain. Seven villages were destroyed and more than 400 people were killed. The photo in Fig. 4 shows the Donghekou rockslide/debris flow. The source area of the landslide looks dry, while the travel path is full of water. When the sliding mass entered the valley bottom, the deposit was estimated to be in a fully saturated state, based on the post-earthquake investigation and information in a photo showing the village before the earthquake.

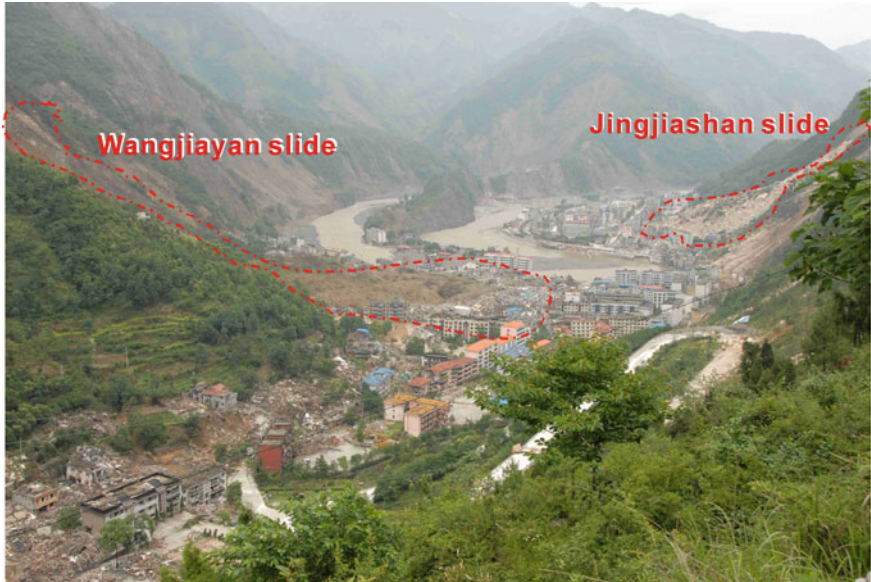
Fig. 5 The Wangjiayan earth fall/slide (*left*) and the Jingjiashan rockfall (*right*) in Beichuan county town. The Wangjiayan landslide killed 1,600 people and the Jingjiashan landslide killed 400 people. The *dashed lines* show the travel path and the extent of each landslide

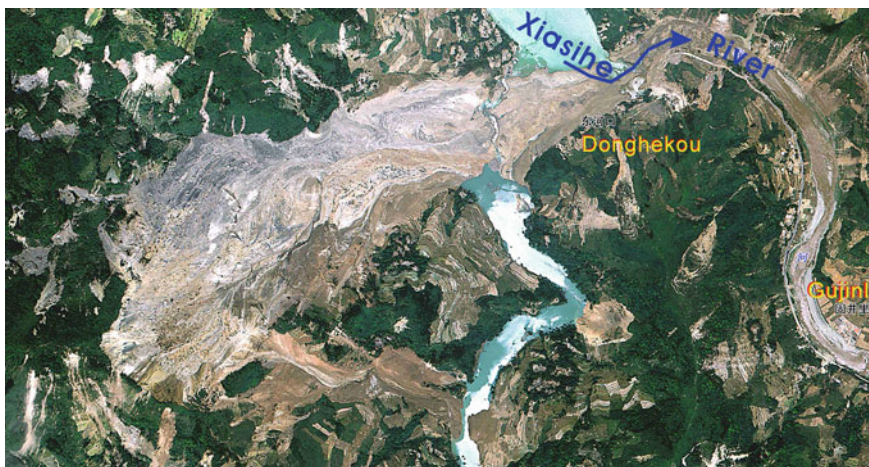
Fig. 6 Air photo of the Donghekou landslide. Refer to Figs. 7 and 8 for scale

Figures 6 and 7 are an air photo and topographic map of the Donghekou rockslide—debris flow, respectively. The debris flow dammed the Xiasihe River

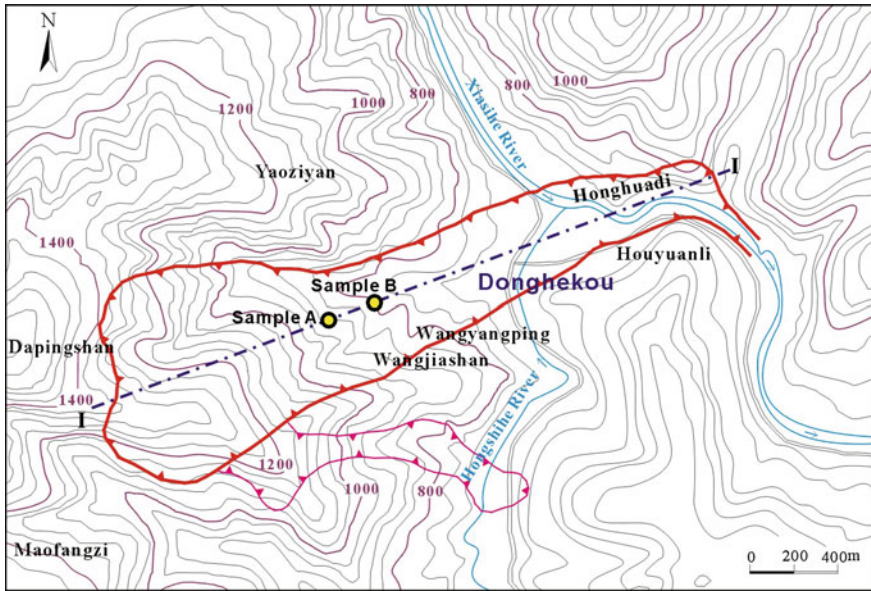
Fig. 7 Topographic map of the Donghekou rockslide—debris flow showing towns, rivers, and areas where samples A and B were taken (landslide boundaries are outlined in lines with triangle marks)

and its tributary, and formed two landslide lakes, and part of the displaced slide mass entered the Xiasihe River, and flowed down the stream. Fortunately, the landslide dam in the main stream of the Xiasihe River is not very thick. Because of the long travel distance, the debris flow deposits became wide and thin. The Donghekou Town is located at the junction of the tributary and the Xiasihe River, and it is reasonable to consider that the surrounding deposits were fully saturated before the earthquake, a situation that can occur, even in dry season. From Fig. 7, it can be seen that the scale of the rockslide can be estimated. In the source area, the average length is about 1 km, and the width is about 1 km, and the total length of the rockslide and debris flow reached about 3 km.

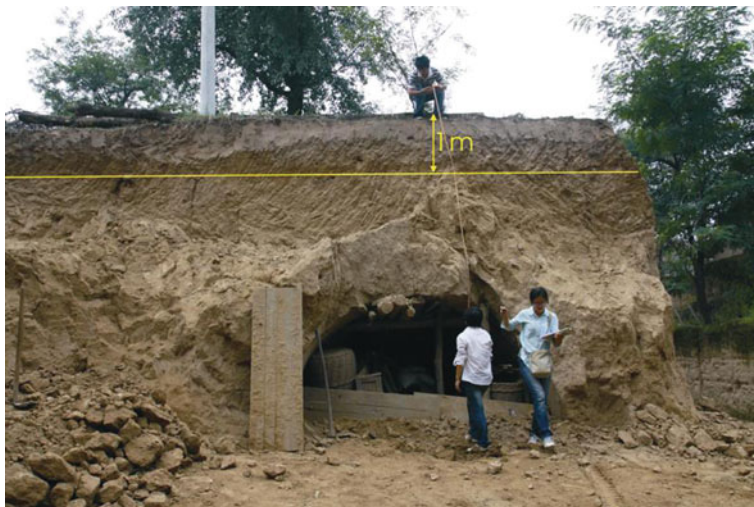
Fig. 17 Ground saturated zone after decades of intermittent rainfall, the observed site is located in Ganquan County, Shaanxi Province

permeability. The coefficient of permeability of loess is generally lower than 10^{-4} cm/s. In situ observation and test indicates that the depth of the saturated zone at the loess ground generally no more than 1 m even after a long term of raining, as Fig. 17 shows. However, the vertical joints on the tops of loess slopes are the main for the rainfall down moving. Erosion along the joints forms sink holes and opened fissures to permit much rain water flowing in (Fig. 18). As the water encountering a relative impermeable bed, such as paleosol, Tertiary red clay or bed rock, it would accumulate on the bed to soften the soil and induce landslide.

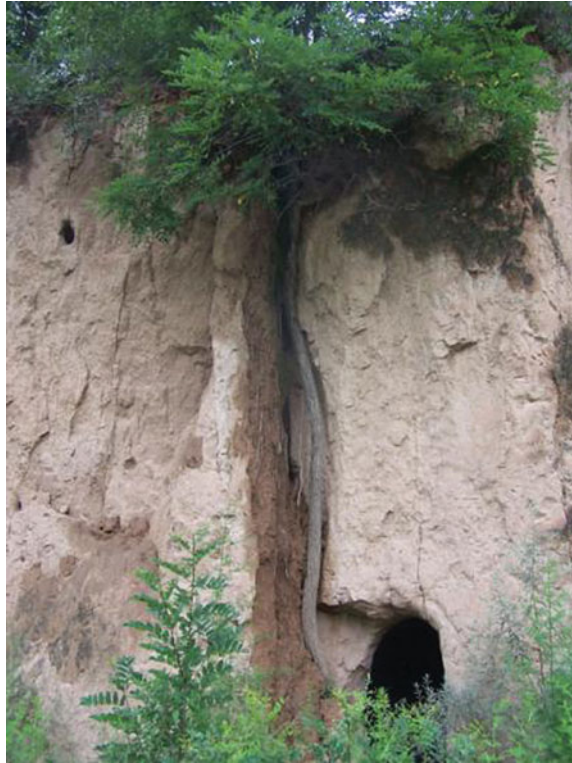
Fig. 18 The flow of rain water along vertical joint in the loess, root also grows along the joint

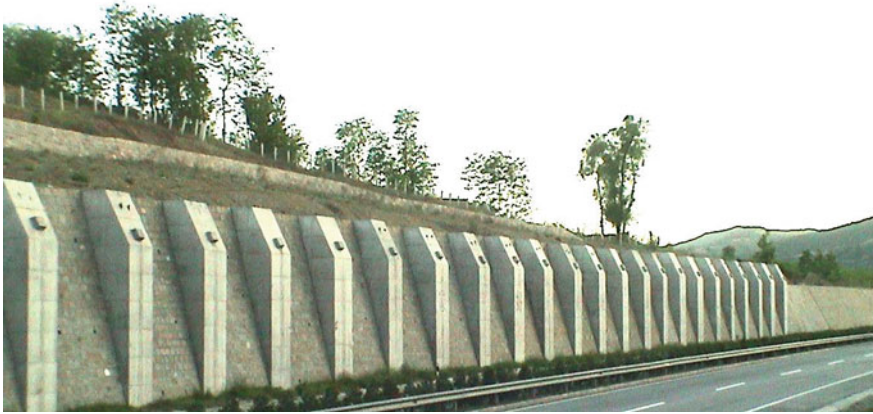
Fig. 21 The piles applied to stabilizing a landslide on the Tongchuan-Huanglin highway

the country. Construction of the roads induced a large number of landslides and caused a huge loss. Tongchuan-Huanglin highway is the first high grade road constructed on the Loess Plateau. In the period of design, the landslide problem was far low estimated; only 3 landslides were designed to stabilize. While the highway being constructing, there were 27 landslides occurred actually. More than 200 million yuan RMB was added to control the landslides. Almost all kinds of measures, such as piles, pile-anchors, block-anchors, frame-anchors, beam-anchors and retaining walls, were practiced in the landslides (Fig. 21).

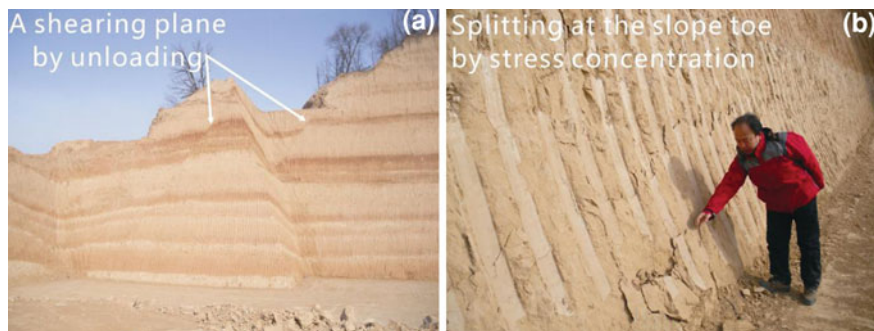
Fig. 23 A new excavated building site located in Longshou village, Huanglin County, Shaanxi. The west side has a shearing plane at the top by unloading (a); the toe of the north side was spited to slices by the concentrated stress (b)

Our investigation revealed that about 380 were killed and 70 injured in the collapse of 400 living caves during 1985 to 2010. Figure 23 shows a new excavated site for digging living caves. It can be seen that the toe of the north side has been split to slices by the concentrated stress, the west side has a shearing plane at the top by unloading, and the east side has dug caves at the toe. All the traces imply that the slope close to equilibrium state, digging of the caves would cause damage without reinforcement.

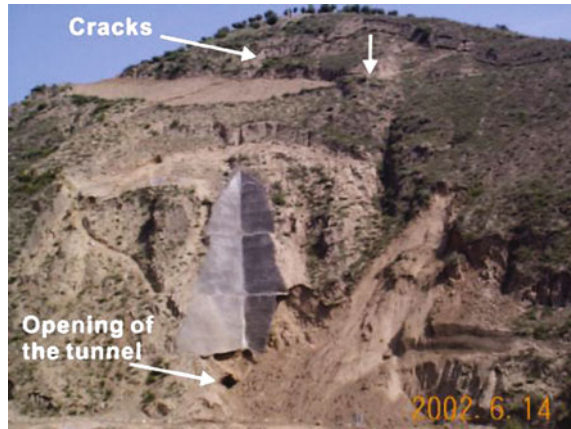
Fig. 24 Collapse and slide occurred in the opening as the tunnel being driven after a heavy rain

Figure 24 shows a tunnel crossing a loess ridge in the West-east Gas Transfer Route. As the tunnel was driving in June 2002, after 30 h continuously raining of 60 mm rain fall from June 8 to 9, a collapse fell down to cover half of the opening of the tunnel, further more, a 60 m high, 100 m width slide was appeared on the slope. The cracks bordering the slide opened 10–30 cm, and the top part of the sliding mass fell down 60–80 cm. The steel supports and the inner line were seriously twisted (Fig. 25). At last, the tunnel was abandoned; instead of entombing along the river valley beside, more than 10 millions Yuan RMB was added for the revision.

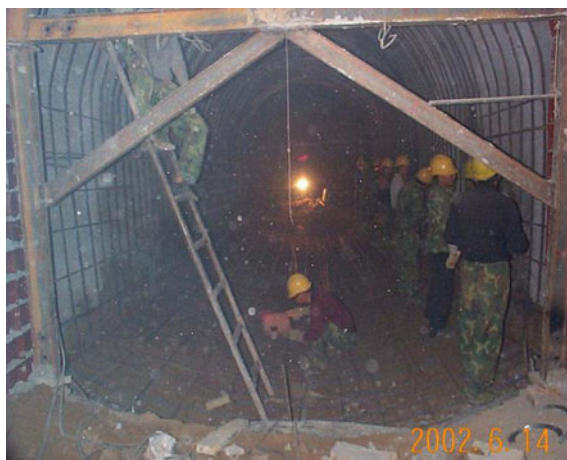
Fig. 25 Steel supports were twisted by deformation of the inner wall of the tunnel

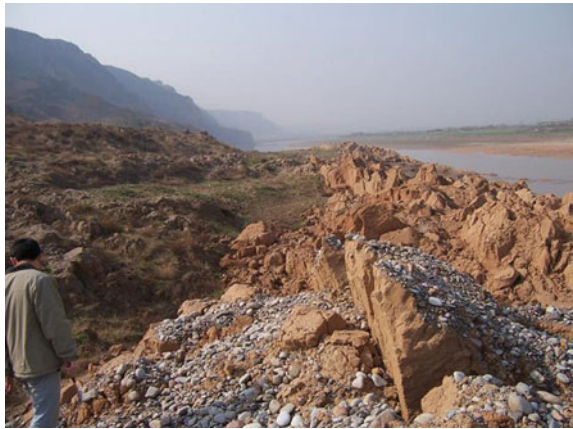
Fig. 27 The Jinghe river bed was squeezed up by the landslide

Jinghe River and then climbing up a 90 m high slope which is the north side of Jingyang Platform. A series of linear distributed sinkholes and cracks developing on the top of the slope told us a potential huge landslide was there. Then we persuaded the designer move the route a kilometer away on a stable old landslide, even though the route should be elongated 3 km and costs 6 millions Yuan additional money. The oil route was completed and put into work in the beginning of year 2002 (Fig. 26), while the slope slipped in March 2002, with irrigating on the top of the platform. The slide not only fell 50 m down, but also squeezed the Jinghe River bed to thrust up (Fig. 27). It would be a disaster as the oil route was entombed on the original site.

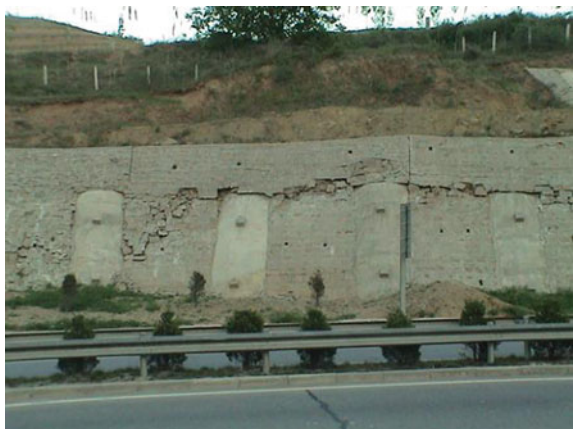
Fig. 28 The damaged beam-anchors for stabilizing the landslide

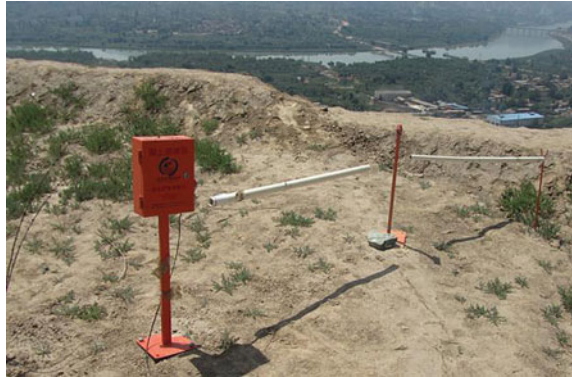
Fig. 32 An extensometer installed at a landslide in Heifangtai, Gansu province

data were obtained on real time with remote controlled unit from the field. Figures 32 and 33 shows the monitoring system of surface extensometer and borehole inclinometer installed at the landslides in Heifangtai, Gansu province.

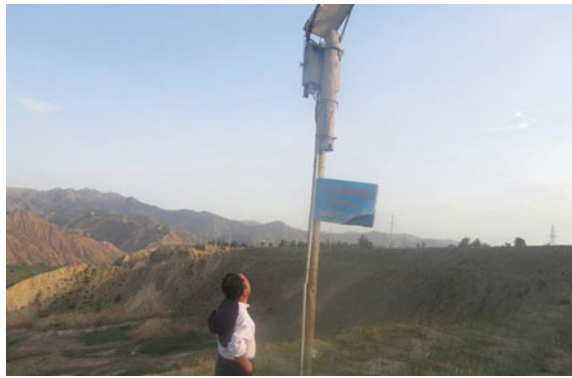
Fig. 33 A borehole inclinometer installed at a landslide in Heifangtai, Gansu province

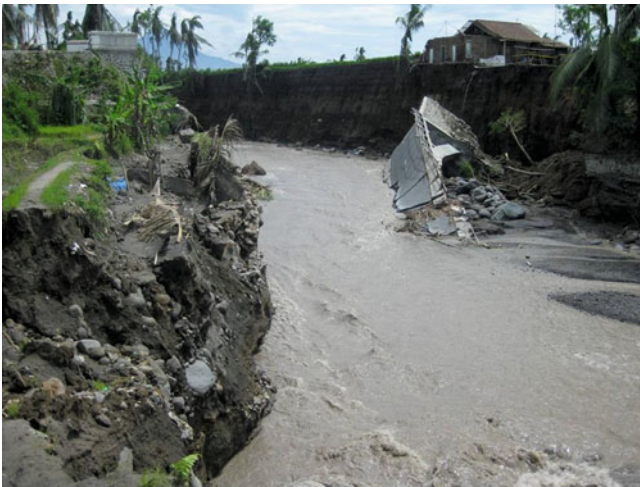
Fig. 2 Collapsed bridge due to the destructive power of rainfall-induced debris flow

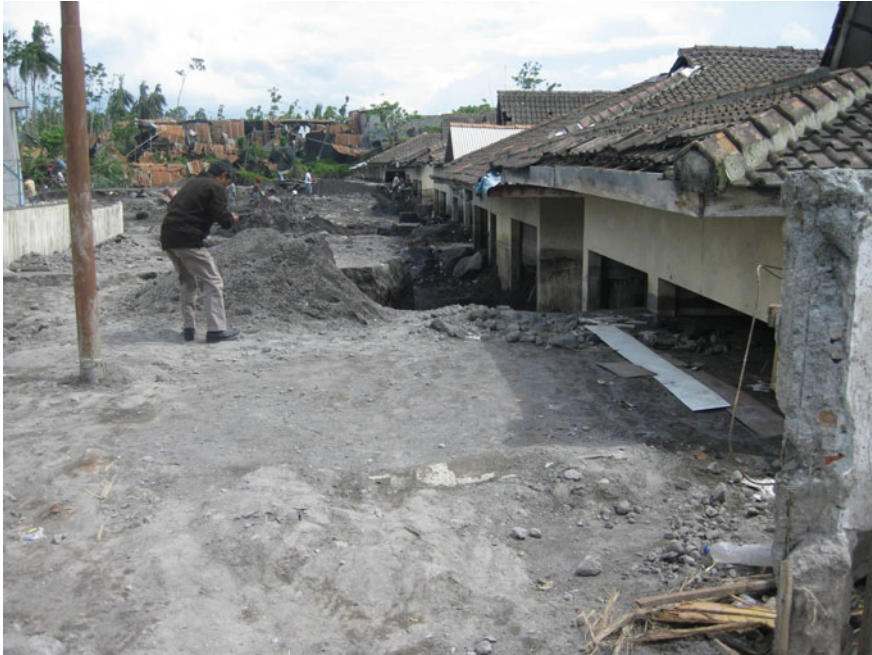
Fig. 3 Damage on houses near the volcanic river

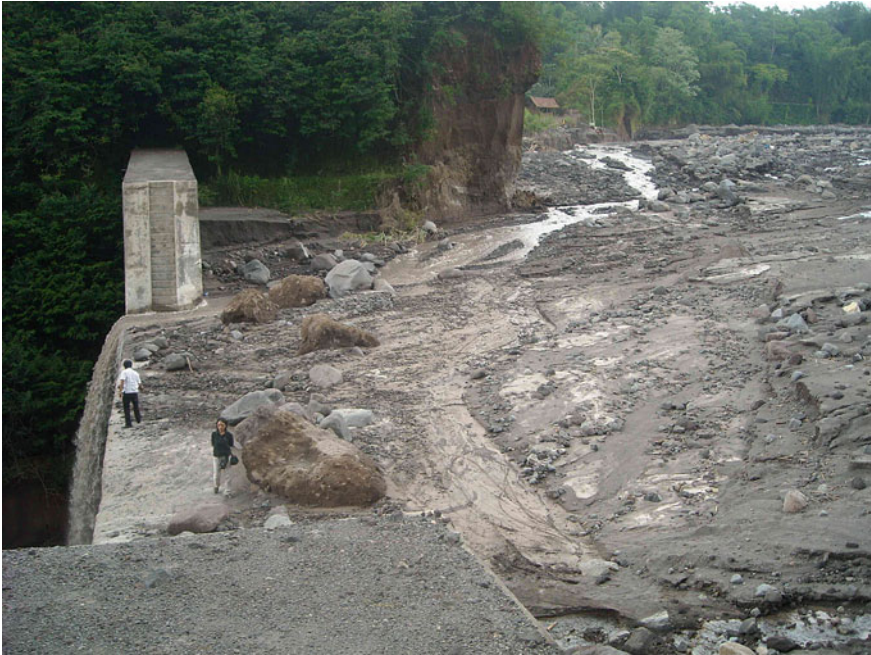
Fig. 5 Upstream condition of Boyong River: Sabo dam BOD4 on 14 January 2011

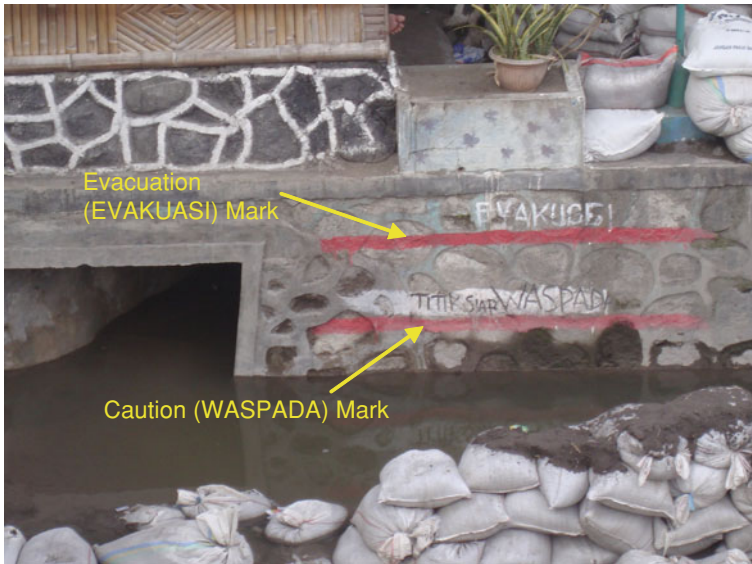
Fig. 9 Existing community warning alert in anticipating debris flow

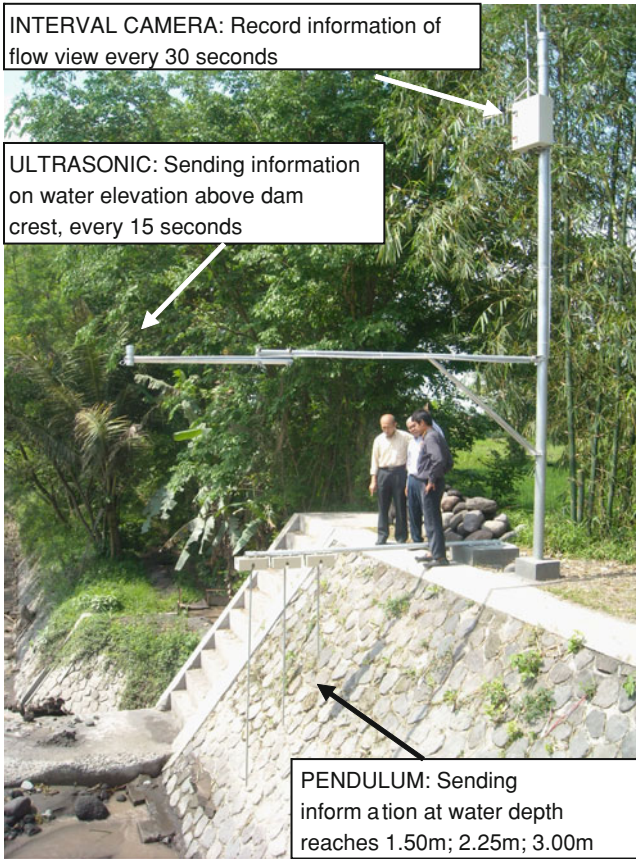
Figure 12 shows the cross-sectional monitoring system at Rejodani. Ultrasonic monitoring equipment, interval camera, and three different levels of pendulum are

Fig. 12 Cross-sectional monitoring system at Rejodani

placed in one river cross-section. This system transfers the monitoring results regularly to the central station. The whole system was built by prioritizing most adaptive and least cost technology. Through this system, a debris flow monitoring system of Boyong/Code River for community at Yogyakarta City is implemented. This monitoring system is easy to replicate for rivers threatened by debris flow disaster at the surrounding of Mt. Merapi area.

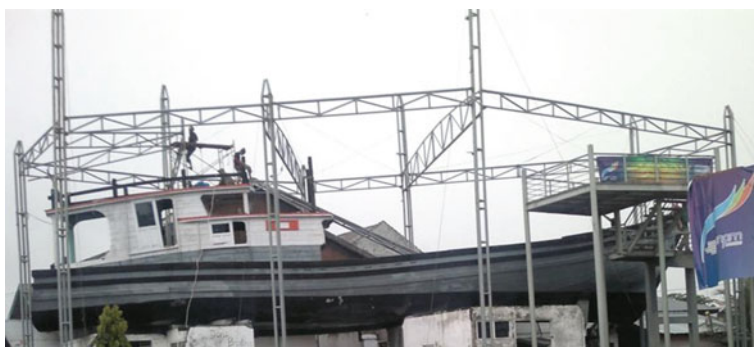
Fig. 2 Current situation of a ship on top of a building as a monumental sign

Currently the daily life of people in Aceh has been back to normal and almost no sign of damages and ruins can be seen. Some monuments of damaged infrastructures have been preserved as shown in Fig. 2 as memorial signs to keep reminding the people about the big earthquake and tsunami that might come again one day in the same place or in other places in other time. A tsunami research centre like TDMRC (Tsunami and Disaster Mitigation Research Centre) has been established by the local Syiah Kuala University in Aceh. Its building has vertical evacuation facilities, as shown in Fig. 3. However, it is felt that much more works must be carried out in Aceh to minimise the impact of future earthquake and tsunami, especially when it is learnt from 2011 Japan earthquake and tsunami discussed below.

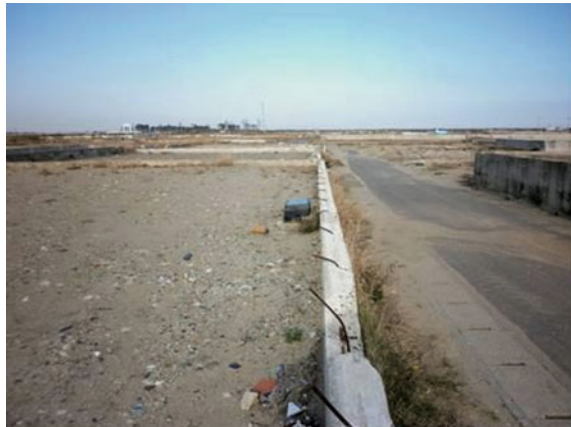
Fig. 4 Washed out community houses in Yuriage

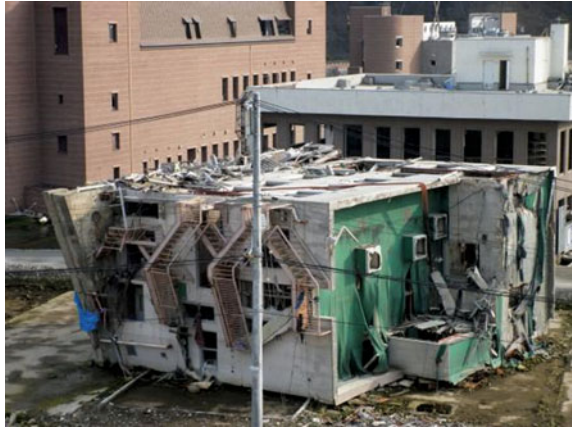
Fig. 5 Overturned building caused by tsunami hydrostatic and hydrodynamic forces in Onagawa

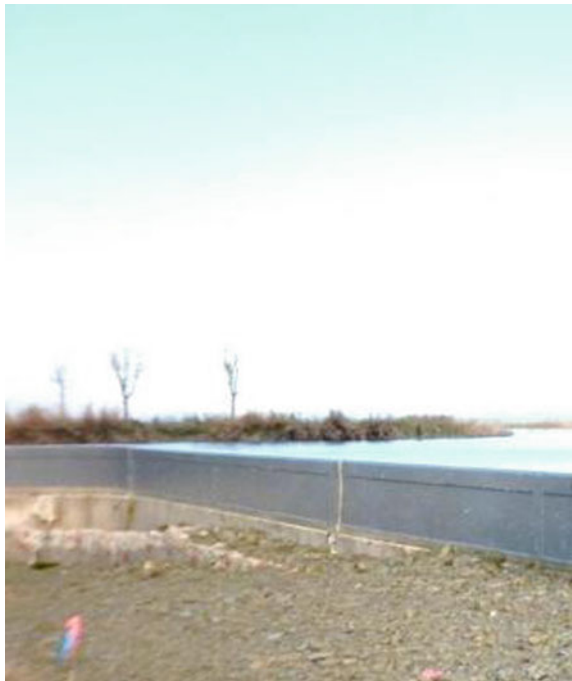
Fig. 6 Fixed tsunami seawall that have been overtopped during March 11, 2011 tsunami

1. Tsunami seawalls, as wall or curved barriers that block waves from inundating coastal areas and redirect wave energy back towards the sea, see Fig. 6.
2. Watergates, see Fig. 7 as constructions to protect against tsunami waves that can be closed manually or can begin to automatically close within second after earthquake shaking triggers its seismic sensors.

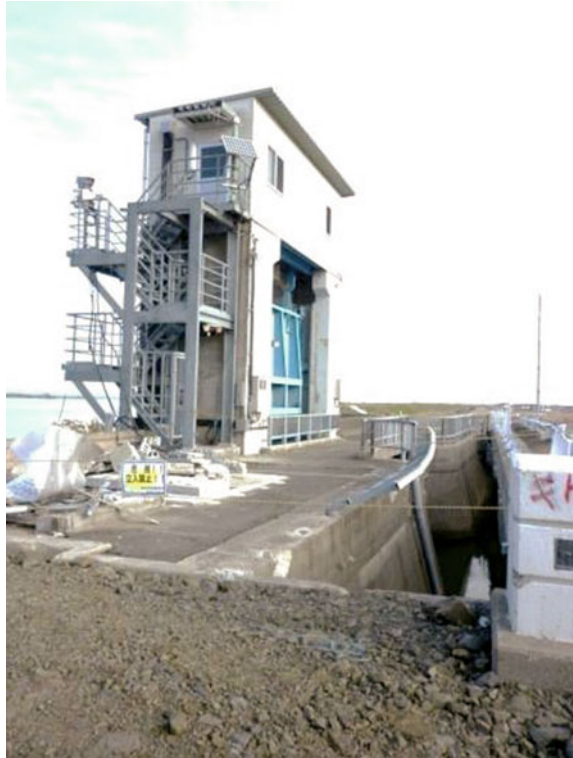
Fig. 7 Watergate that manually or automatically closed during tsunami warning

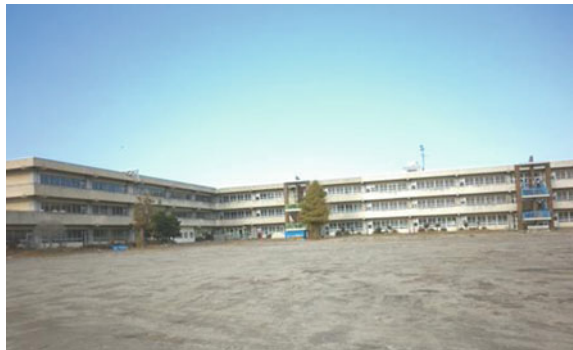
Fig. 8 School buildings are commonly taken as vertical evacuation structures but some of them have been overtopped during tsunami inundation on March 11, 2011

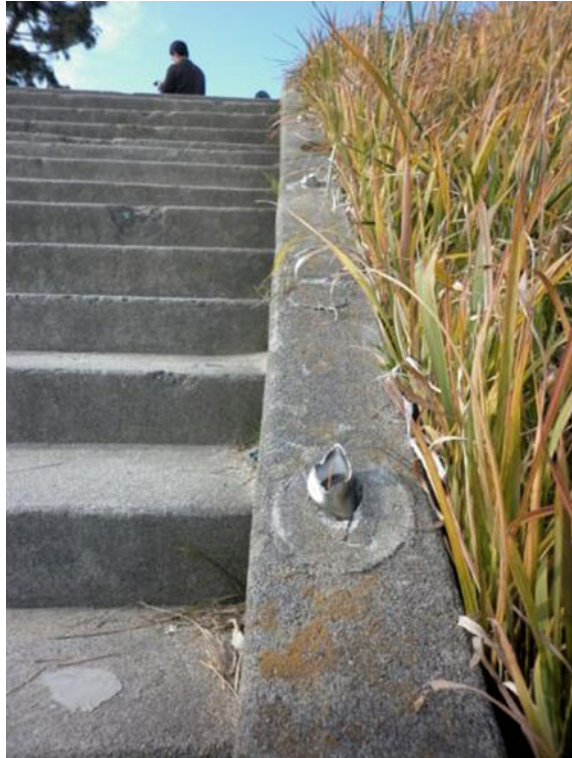
Fig. 9 The broken handrail remains in the footsteps of the overtopped high ground level designed for vertical evacuation facilities due to the March 11, 2011 tsunami

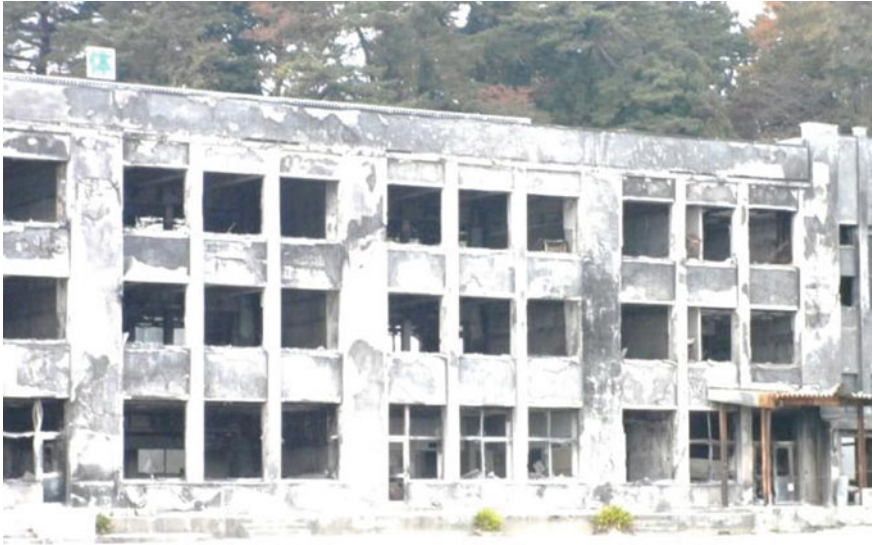
Fig. 10 Three storey school building that was set on fire spread by probably floating debris and combustible liquids

Among the above factors that made several tsunami countermeasure structures in general did not work well during the March 11, 2011 Japan tsunami are mostly the inadequate level (EERI 2011). However the structural damages caused by direct hydrostatic and hydrodynamic forces from water inundation and or impact forces from water-borne debris was possible as shown in Fig. 5. The ones caused by fire probably spread by floating debris and combustible liquids are also noted as can be seen in Fig. 10, while significant scour phenomena is found as can be seen in Fig. 11.

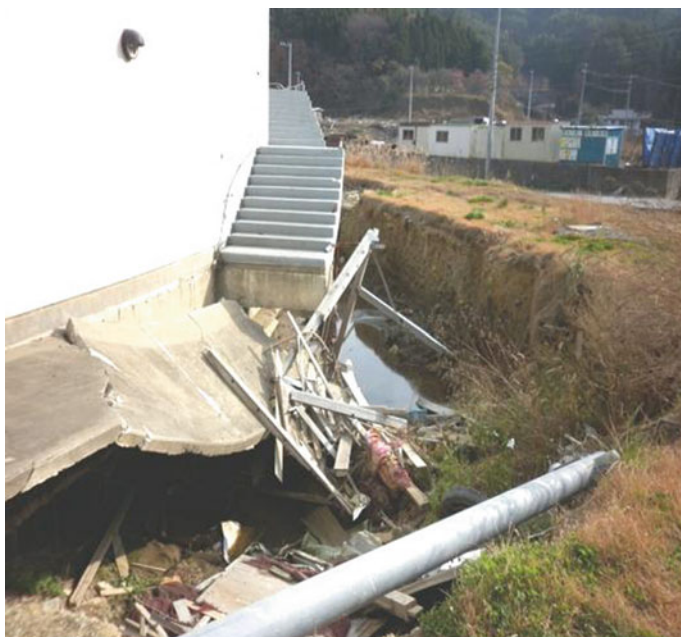
Fig. 11 Scour phenomena around a structure's foundation in a coastal are due to tsunami

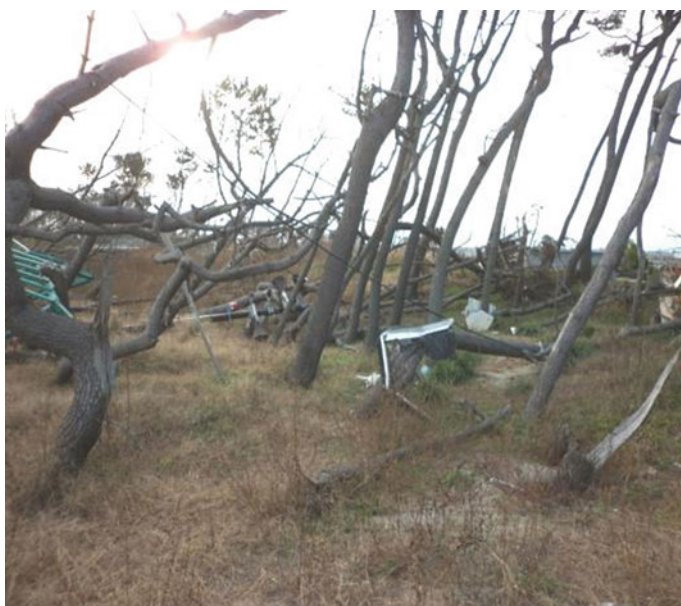
Fig. 12 Remains of coastal vegetations that did not effectively protect the area from tsunami hit

It is a common perception in Indonesia and may also be the same in other countries that coastal vegetations like mangrove forest can effectively protect or reduce an area from tsunami impact. However, Bate (2005) noted that mangrove forest was completely destroyed and did not reduce the impact during the December 26, 2004 Aceh tsunami. The same finding can also be noted during the March 11, 2011 Tohoku tsunami. Figure 12 shows the remains of the coastal vegetations that could not really protect the area from tsunami impact. EERI (2011) noted that tsunami mitigation forest planted along the coastline of Natori and Minamisanriku appeared to be ineffectual given the depth and velocity of the tsunami inundation. Moreover, even it was found that the tree trunks were snapped off or uprooted and became large wooden debris missiles brought inland by the tsunami that make higher hydrodynamic forces on structures.

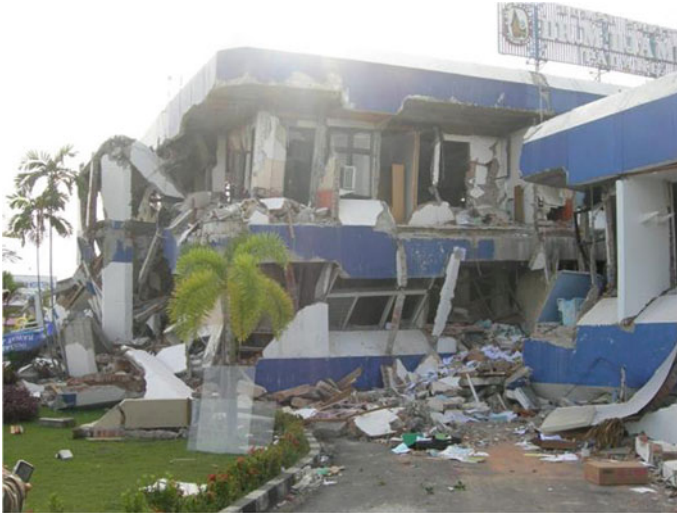
Fig. 13 An example of a vulnerable building during September 30, 2009 Padang earthquake that shall not be assigned as tsunami vertical evacuation structures

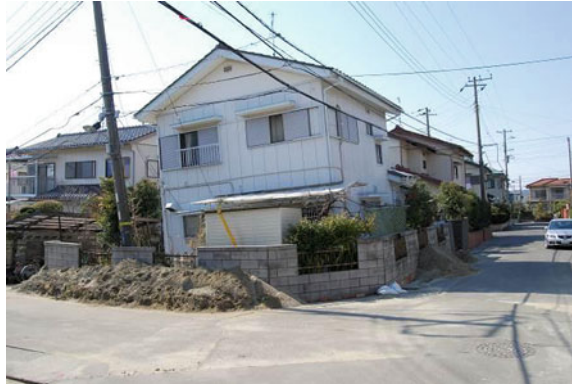
Photo 1 Settlement and tilt of residential house in Chiba city

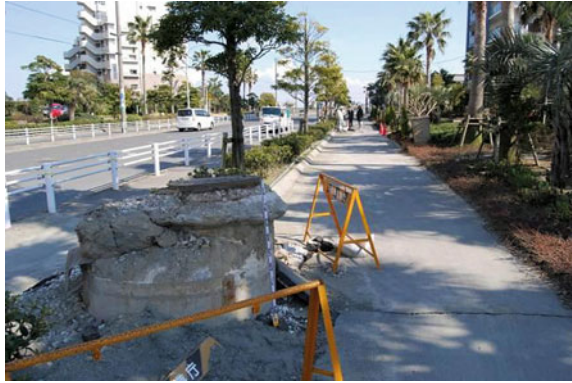
Photo 2 Uplift of manhole and settlement of pavement in Urayasu city

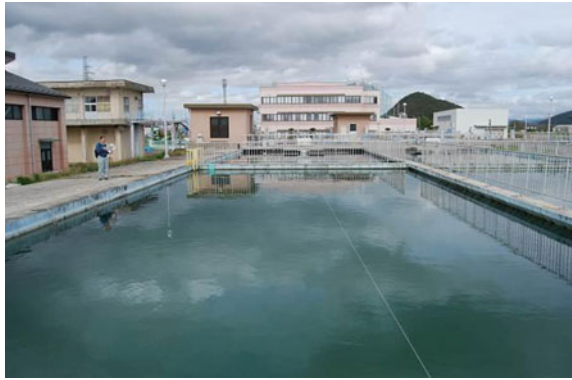
Photo 3 Sedimentation basin of the Hebita purification plant in Ishinomaki city

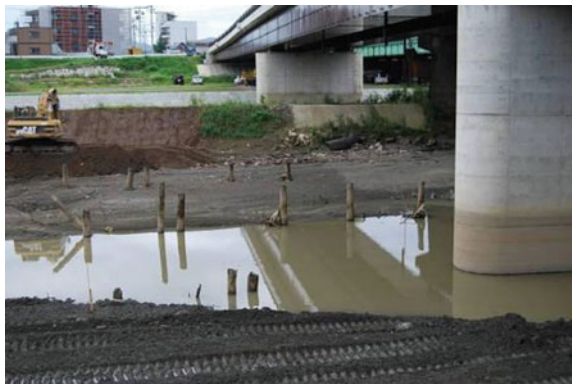
Photo 4 shows Kida Bridge across the Asuwa River that flows in Fukui city, Japan. The bridge was completed in December, 2008. It can be seen that there are a lot of head of piles made of wood in the riverbed near piers. These wood piles were used

Photo 4 Former wood pile foundations near Kida Bridge

as foundations of the former Kida Bridge which was completed in 1949. It is assumed that they were placed underneath the riverbed through 59 years (Yoshida et al. 2009).

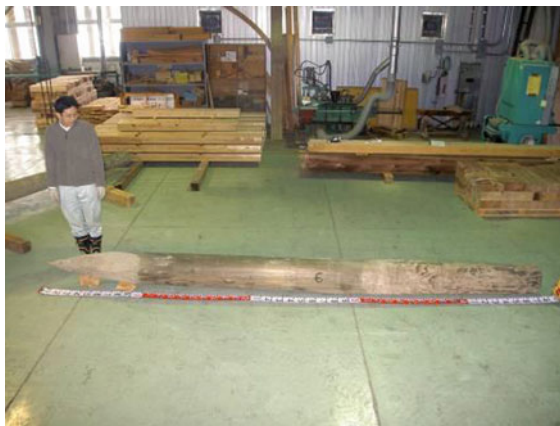
Photo 5 shows the wood pile which was retrieved from Kida Bridge. The length and diameter of the pile was about 3.5 m and 30 cm, respectively. By using optical

Photo 5 Wood pile retrieved from Kida Bridge

microscope, it was clarified that the species of wood pile is Japanese cedar (*cryptomeria*). According to the visual observation, it is assumed that the top of the pile was stuck up out about 1 m from the riverbed, because the area between about 1 m from the top had a mark that water scraped the surface of the wood pile. The wood pile was in the gravelly sand and clay layer, and the bottom of the pile was assumed to reach sandy silt layer or sand layer by referring to a borehole data near this site.

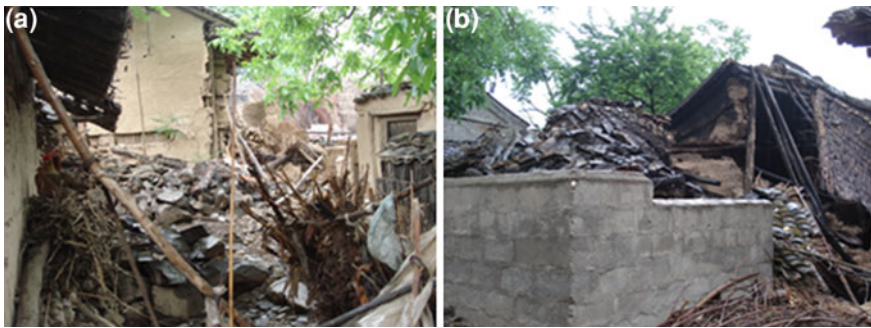
Fig. 3 The collapsed timberwork buildings

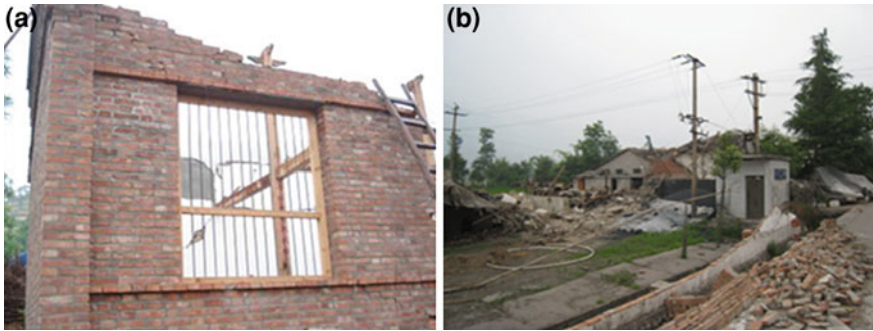
Fig. 4 The destroyed masonry timber buildings

Besides the raw-soil structure buildings and bricks timberwork buildings, masonry timber buildings are also another common type of local dwellings. The main support wall were mostly brick walls with thickness 120, 180 or 240 mm, and the roof were triangular wooden frames. Some masonry timber buildings were designed without seismic measures, lack of connection components, and roof trusses were installed directly on the brick wall, so these types of buildings are always of poor integrity. Figure 4a shows the masonry timber buildings under construction. Under vertical loads, the structures are relatively stable, but subject to horizontal earthquake, the maintenance walls were easily tilt, which leads to severe earthquake damages such as local collapse or overall collapse. In the earthquake, most masonry timber buildings were damaged seriously and some of the buildings built relatively earlier completely collapsed as shown in Fig. 4b. The masonry timber structures have the same problems with the raw-soil structure buildings, such as the purlins put directly on the brick walls. The improper constructions and connections made the masonry timber structures lose the aseismic ability.

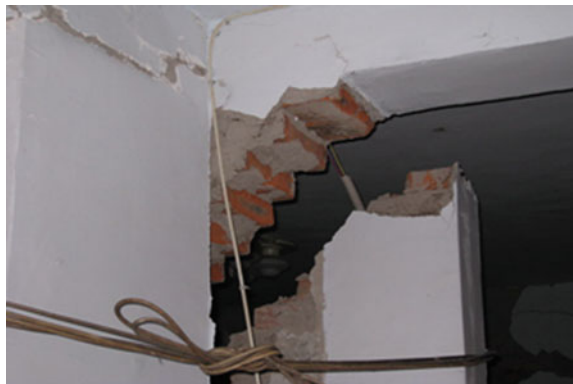
Fig. 7 The damaged buildings without aseismic joints

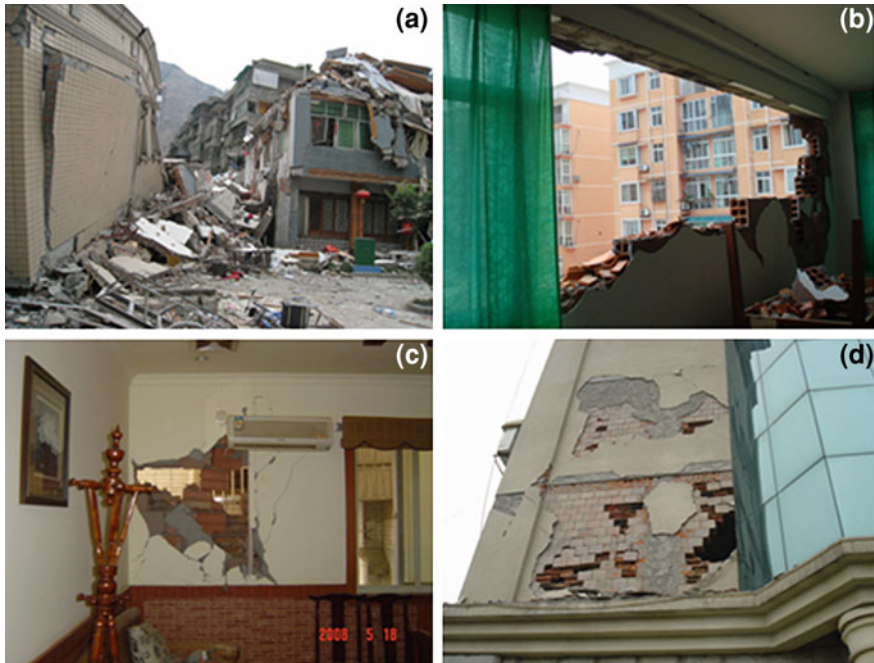
Fig. 8 The damaged infilled walls

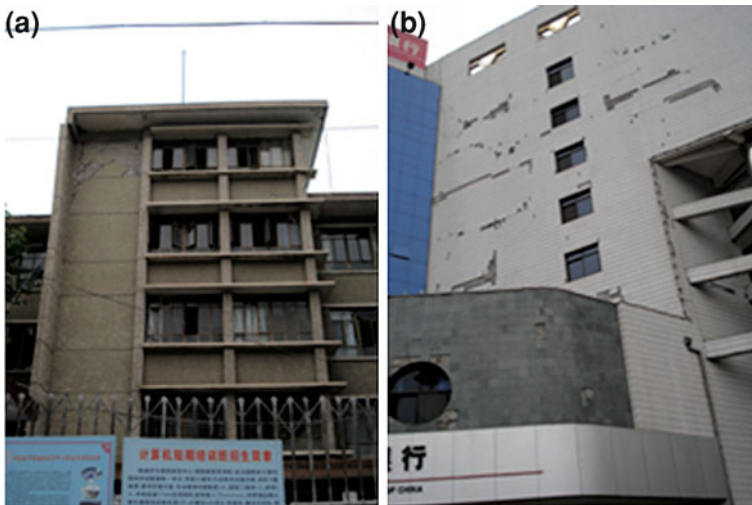
Fig. 11 The damaged irregular buildings, a irregular building in planar direction, b irregular building in planar direction and facade

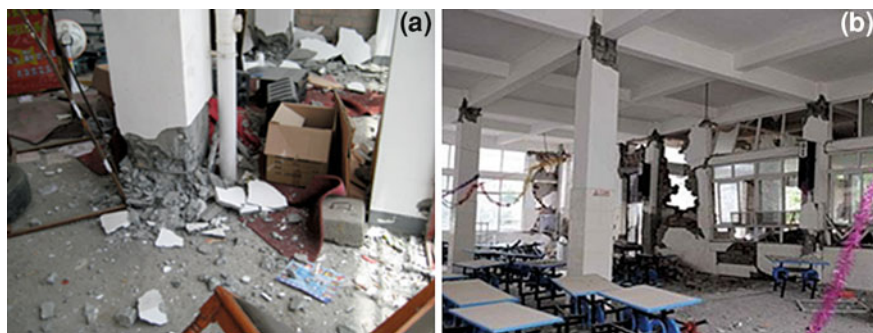
Fig. 12 The phenomenon of ‘strong beam-weak column’

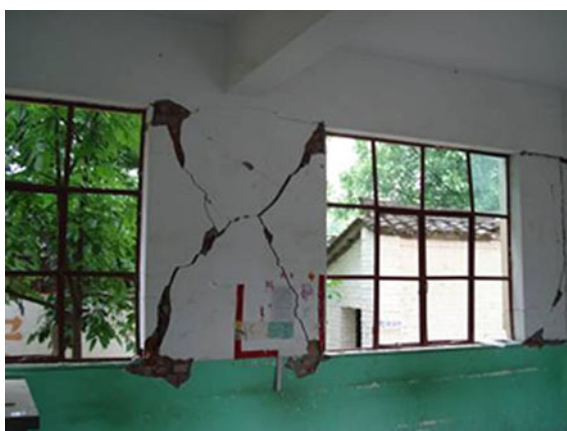
Fig. 14 The diagonal cracks of cross wall

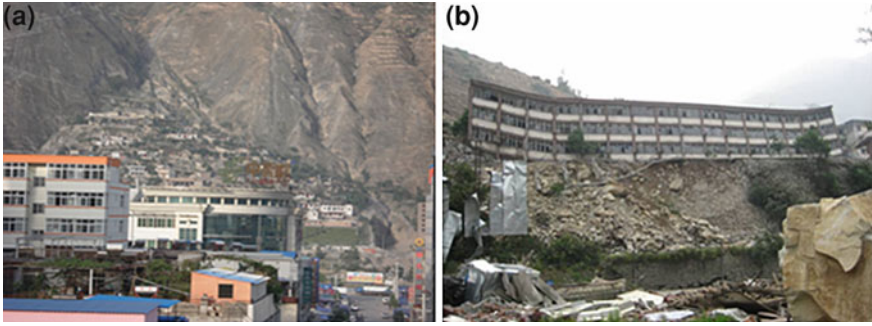
Fig. 16 The buildings built on improper location

Site investigation also showed that improper location was a main reason for building damages in the earthquake. Some buildings were built in bad geological location, such as slope surface area formed by landslide and debris flow as shown in Fig. 16.

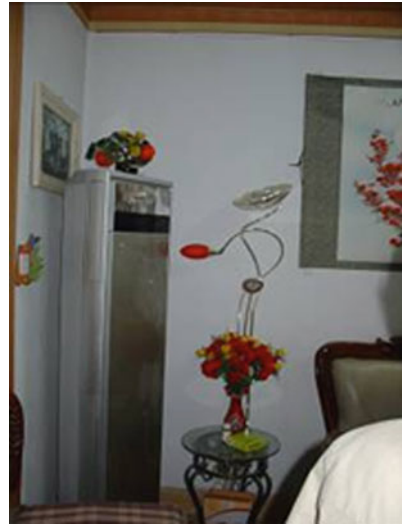
Fig. 17 The building with rubber bearing

In the earthquake, some buildings were seldom damaged since they had adopted seismic measures. The Fig. 17 provided by Gansu civil engineering science research institute shows an apartment building which adopts rubber bearing shown in Fig. 18. There were no cracks in the apartment building, and also the vase on the air conditioner did not fall. It showed that proper isolation measures are an effective way to improve the aseismic ability of buildings.

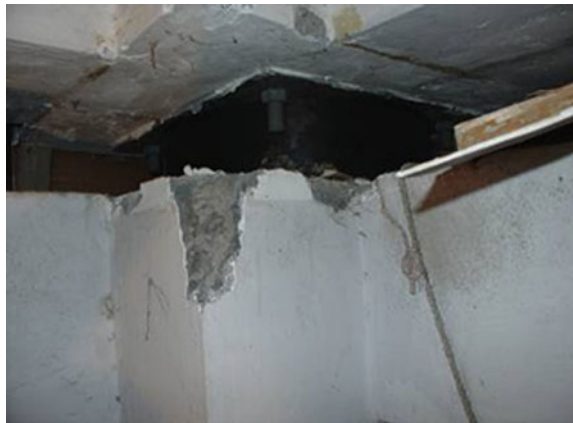
Fig. 18 The rubber bearing

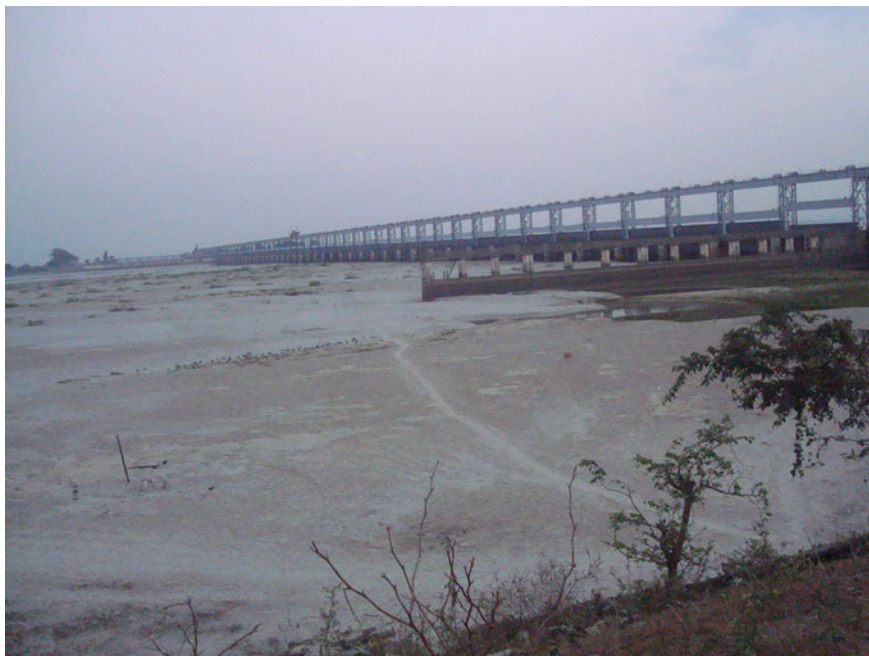
Fig. 5 Dry Kosi barrage (Pun 2009)

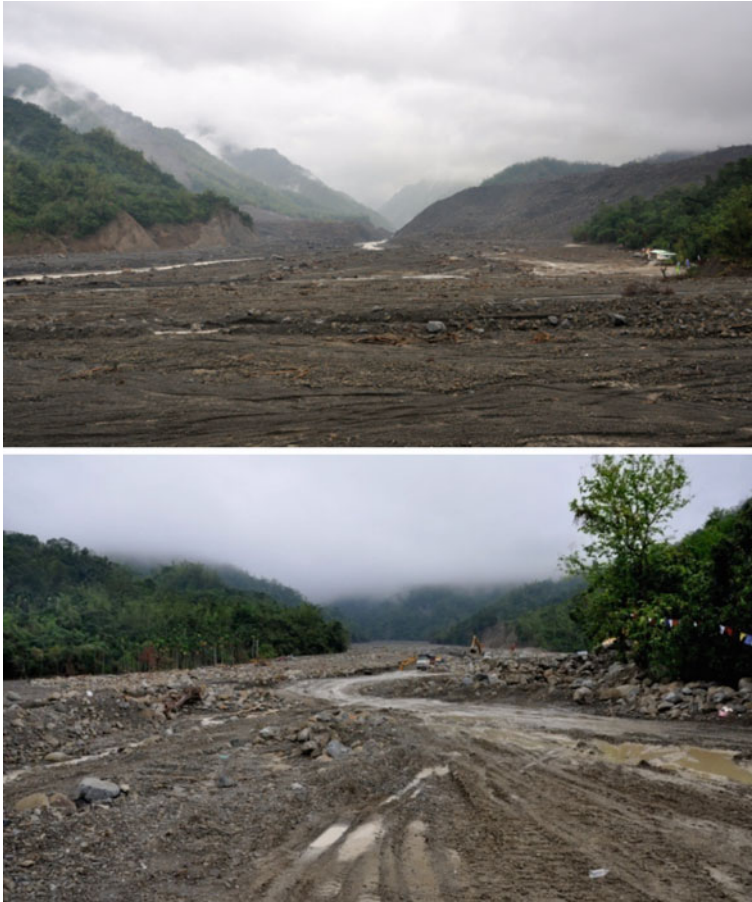
Fig. 5 Xiaolin Village after disaster. *Top* photo is taken from Chishan River and looking upstream while the *lower* photo is looking downstream. The only house survived is the one in the top photo on the *right*

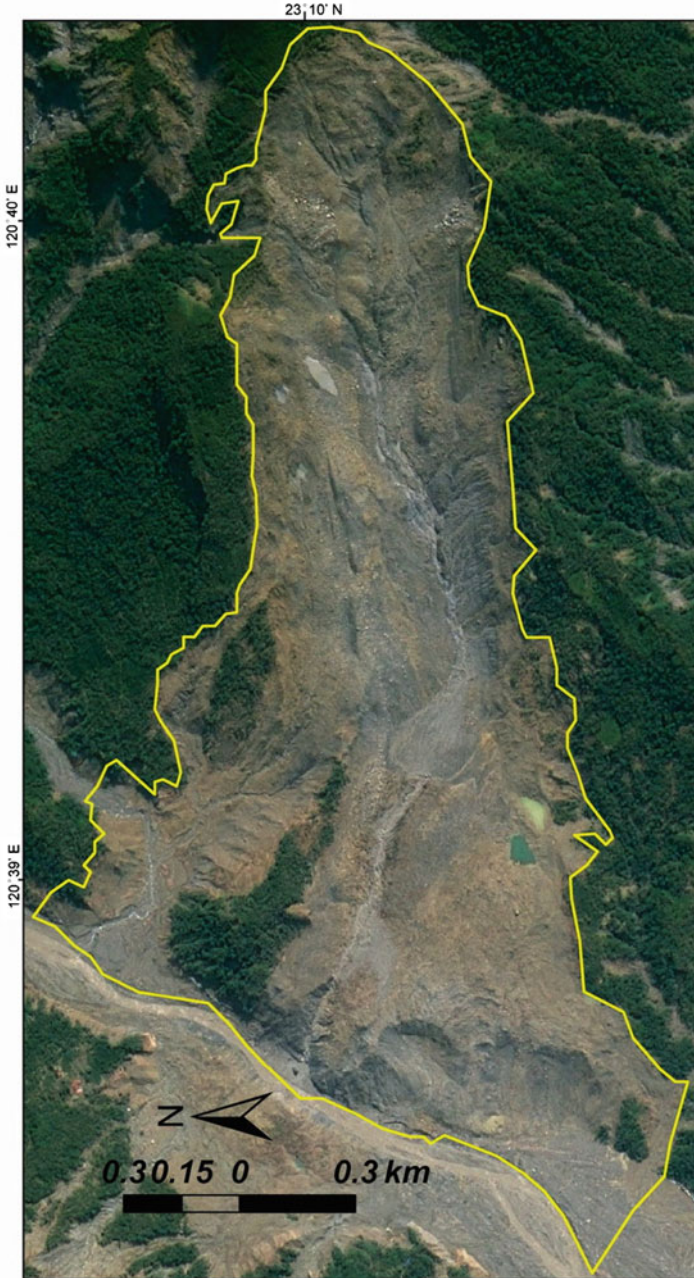
Fig. 6 a A satellite photo of the Xiaolin landslides. All later figures are based on this photo (Date of the photo: August 17, 2009; photo source: Formosat-2 Satellite Image). b Aero photo of Xiaolin Landslide (from Water Resource Agency, Taiwan)

- (11) 7:00 August 9th: Rainfall started to decrease to hourly intensity of 18 mm. Accumulated rainfall was 1,770 mm. Sanlin Bridge water level decreased to its lowest 118.1 m at 7 a.m. This shows the natural dam had blocked the upstream flow.
- (12) Around 7:40 August 9th: Hourly rainfall intensity was 13 mm and accumulated rainfall was 1,802 mm. The water level at Sanlin Bridge increased from 118.2 to 123.1 m in 20 min. This indicated the breach of natural dam had occurred. Remaining part of Xiaolin Village was buried by debris flows (Fig. 5). Estimating from the flow velocity, the breaching should occur around 6:40–6:60. An aerial photo of Xiaolin Village is shown in Fig. 6.
