Progress of Geo-Disaster Mitigation Technology in Asia

Environmental Science and Engineering

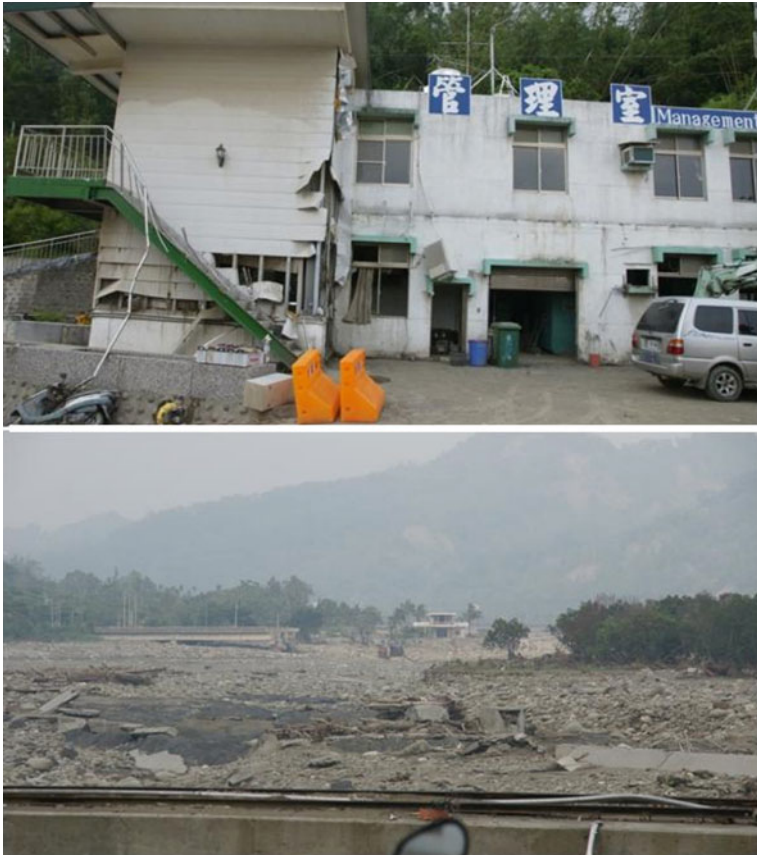
Fig. 7 Flood destroyed Chiahsien dam operation center (*top*) and nearby bridges (*bottom*)

- (13) 9:00 August 9th: Hourly rainfall intensity was 8 mm and accumulated rainfall was 1,822 mm. Water level at Sanlin Bridge decreased from 123 m to 121.5 m in 30 min and decreased to 120.4 m in 2 hours. Debris flows also destroyed Chiahsien dam operation center and all nearby bridges 25 km downstream (Fig. 7). The effect of the Xiaolin landslide had already propagated more than 80 km downstream.

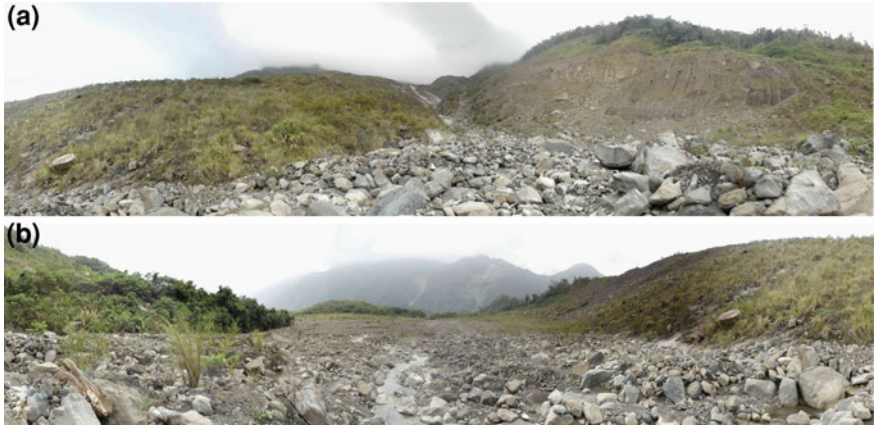
Fig. 13 Field survey of the Xiaolin landslides. Photo taken from central platform at Section 10. The sliding surface around here dipped to S50°W, and the dip angle was 23°; **a** uphill source area, **b** downhill view

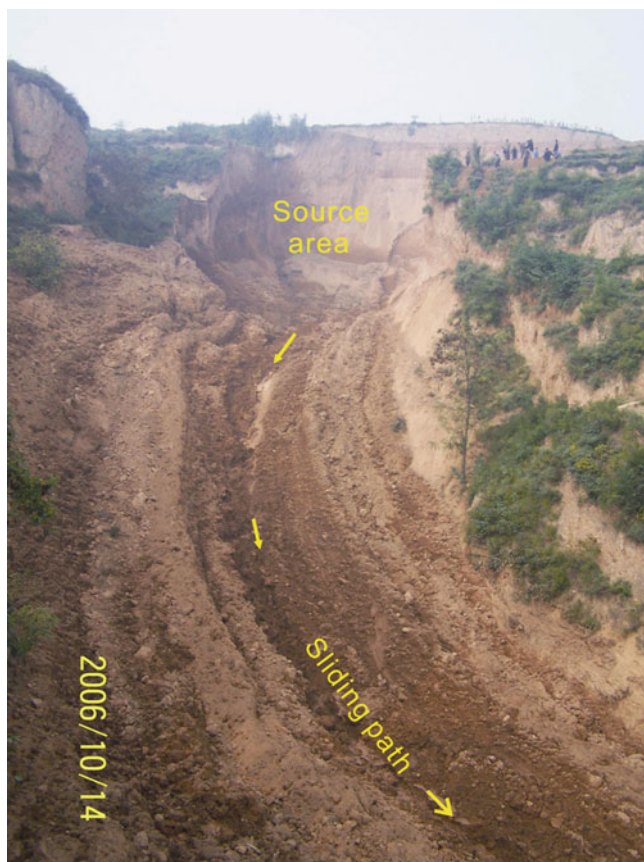
Fig. 3 The flow path of the Gaolu flowslide

rising of the water table as well as increasing of the pore pressure, the slope failed. Zhang et al. (2008) described the landslide movement as three phases according to the witnesses' description, the first phase occurred when very soft "mud" flew down quickly and was followed immediately by the second phase when "dry" soils descended, destroying the houses and burying 11 people. As the residents rushed to rescue the buried people, soon the third phase occurred when they saw the debris coming down. Two of them could not escape in time and were caught by the debris. The movement process implies that there is a lot of water taken in the displaced mass and the gully. As the slope fails, fluidization occurs first in the lower part of the saturated loess, then the dry loess of the upper part "floating" on the fluidized loess rushed down. The water in the loess and in the gully was pushed ahead to form mud flow down first, then the main sliding mass arrived. There were some saturated soils remained in the source area and on the path after while they flew down as debris.

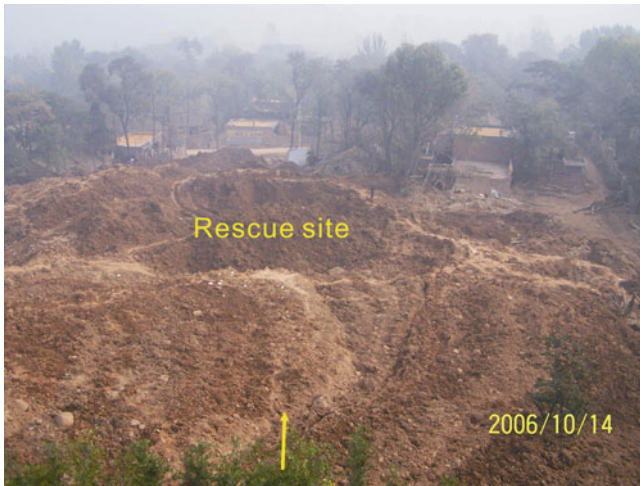
Fig. 4 The deposit of the Gaolu flowslide

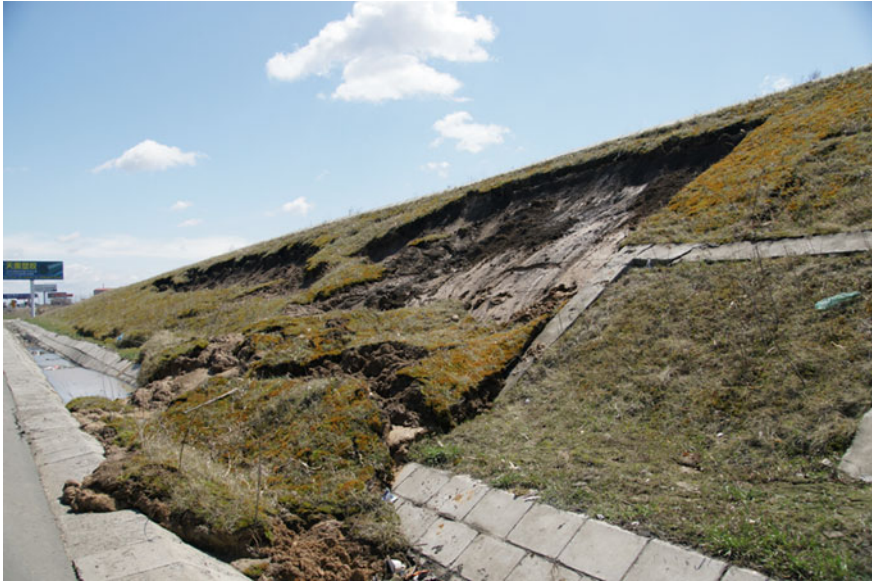
Fig. 1 Shallow slope failure occurred along the Jia-Ha highway

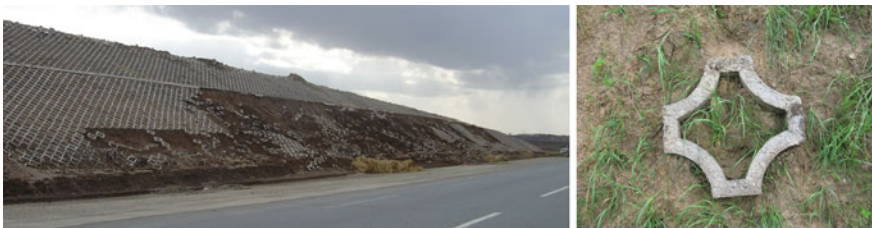
Fig. 3 Slope failure in Jia-Ha highway protected by hollow blocks

Figure 3 shows another type of geotechnical countermeasure approach. The hollow blocks were used to stabilize the surficial soil. The purpose of the empty hollow space was for growing grass. However, as seen in Fig. 3, these blocks were ineffective for the slope protection. Because the root of the grass is too short, it cannot supply enough resistance to stop the surficial soil deformation. The weight of the block is also too weak to keep it on the deformed slope. As a result, this kind of discrete stiff countermeasure work is also not suitable for slope stabilization in the frozen area.

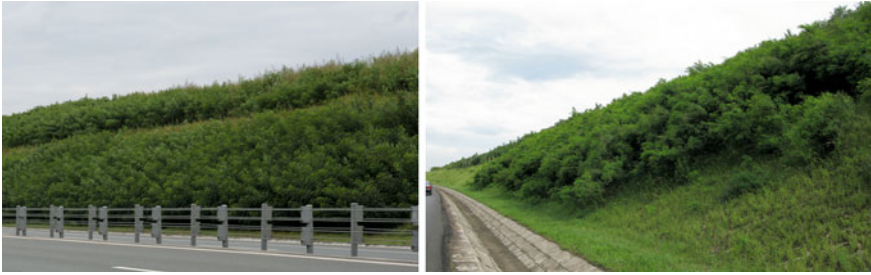
Fig. 4 Highway slope covering with *Amorpha fruticosa* (AF) (*left*) and *Lespedeza* (LP) (*right*)

Conversely, the countermeasure work applied through a biotechnical approach with the plants known as *Amorpha fruitcosa* (abbreviated as AF) and *Lespedeza* (abbreviated as LP) achieved great success. As shown in Fig. 4, AF and LP have performed well for slope protection in this area. They have made not only an

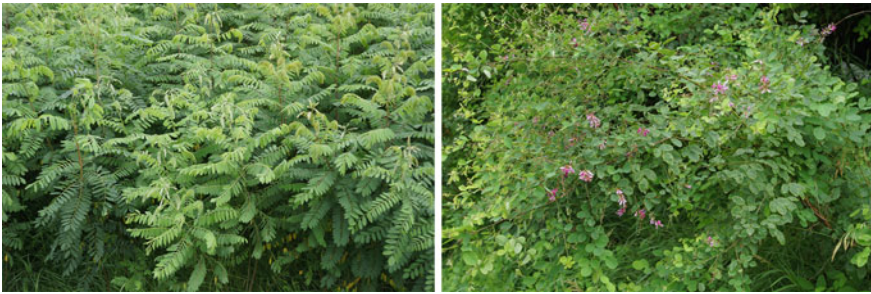
Fig. 5 Rich leaves of *Amorpha fruticosa* (AF) (*left*) and *Lespedeza* (LP)

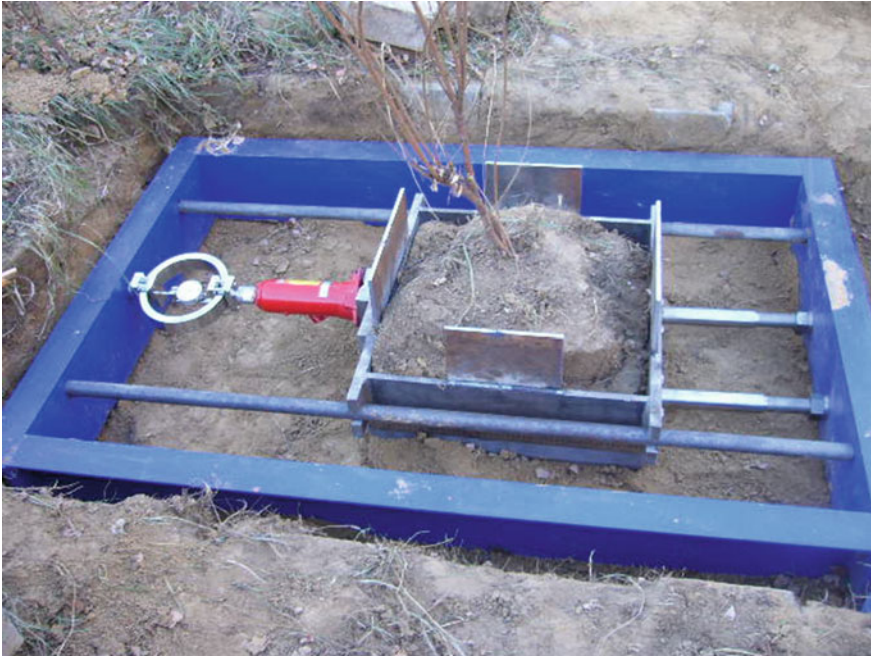
Fig. 18 Photo of the in situ direct shear equipment with a small AF within

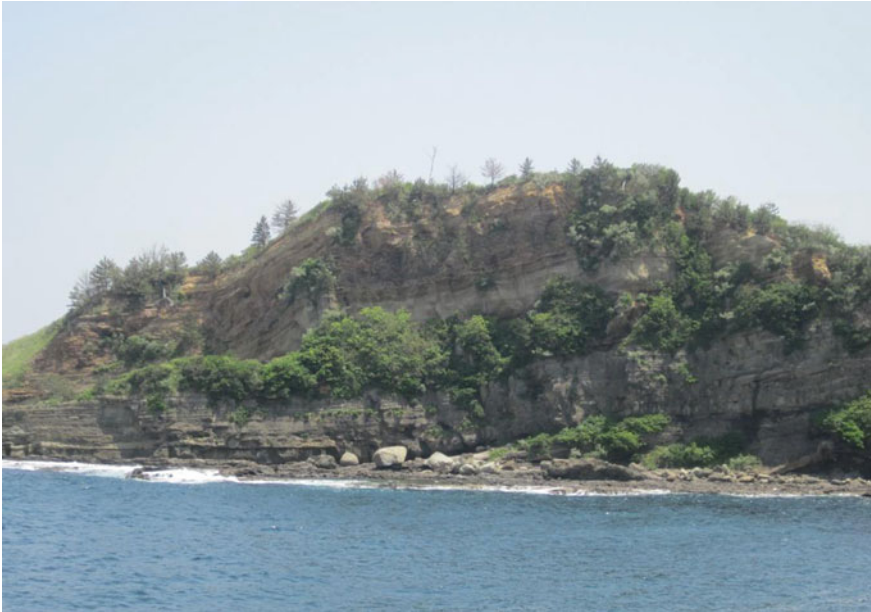
Fig. 3 Slope with alternately distributed shale layers and tuff layers

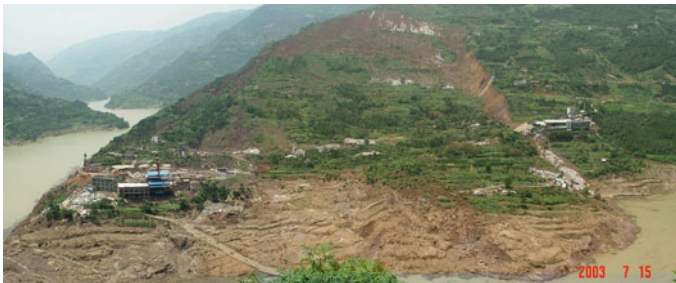
Fig. 2 Front-on view of the Qianjiangping landslide (Taken by Zhang, July 15, 2003)

The Qianjiangping landslide has a characteristic tongue-like shape with slope length of 1,200 m and maximum width of 600 m (Figs. 2 and 3). After the slope

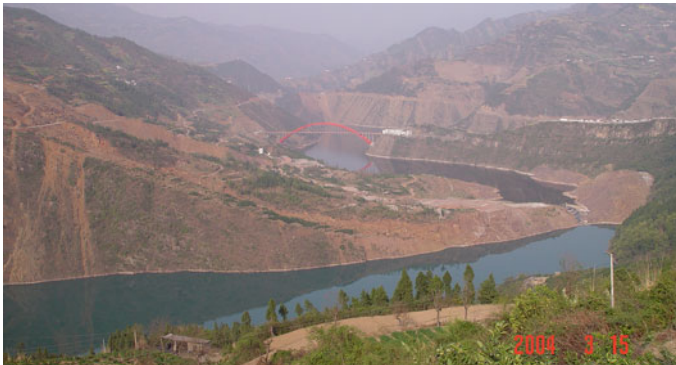
Fig. 3 View of the Qianjiangping landslide from the upstream side of the Qinggan-he River (Taken by Wang, March 15, 2004)

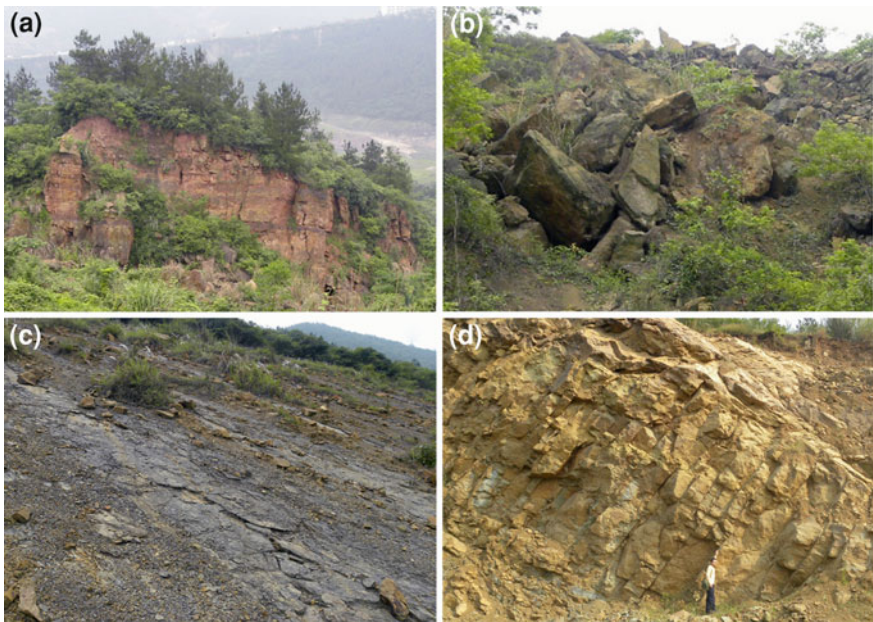
Fig. 8 Photos of **a** blocky rock mass at the middle-upper part of sliding mass; **b** disjointed rocky blocks at the upper part of sliding mass; **c** carbonaceous shale on the main scarp; **d** bedrock near the main scarp. Locations of these photos are shown in Fig. 4

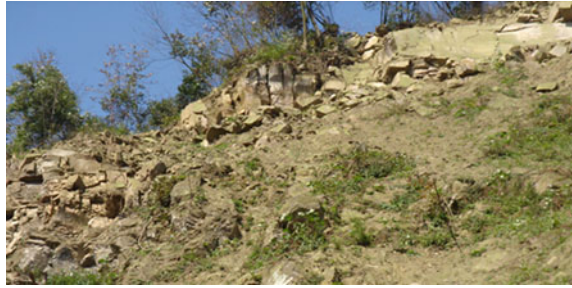
Fig. 1 Unstable rock No. 1

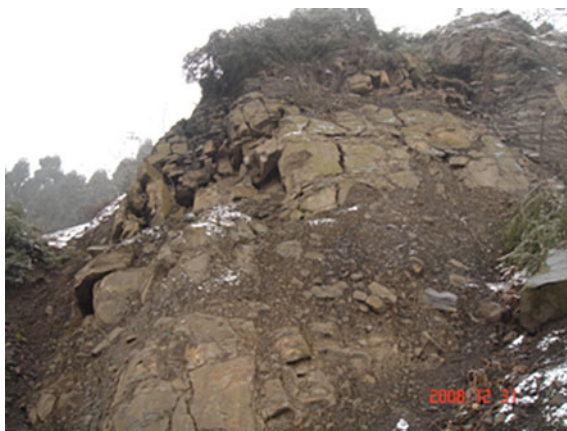
Fig. 2 Unstable rock No. 2

Analysis of the unstable rock form, development scale, basement and bottom layer characteristics, and spatial distribution characteristics shows that the rocks may fail by sliding while No. 1 and 2 unstable rock may fail by toppling.

No. 1 and 2 unstable rock is cut seriously by multiple sets of fractures. Lots of dangerous blocks of rocks are shown in Figs. 1 and 2. The toppling evaluation model of the unstable blocks is shown in Fig. 6. As the blocks fails by toppling, they will rotate around the C axis. Then the coefficient of stability will be calculated using the following equation:

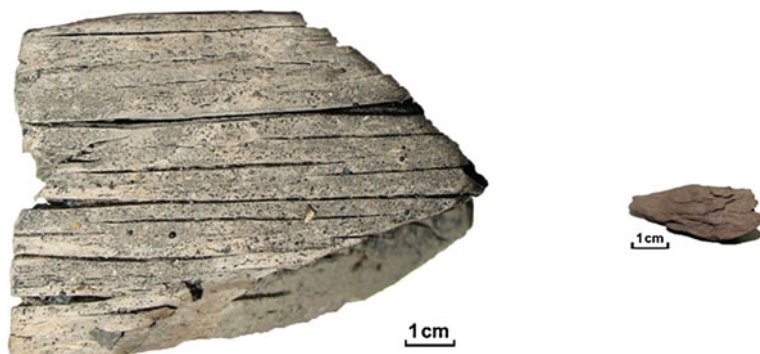
Three different sizes of oil shale were chosen to take experiments. In which the physical dimension of the small size of oil shale was 3–5 cm (right in Fig. 2). The one of the large size of oil shale was 10 cm (left in Fig. 2). There was a medium

Fig. 2 The physical figure of the large size and the small size of oil shale

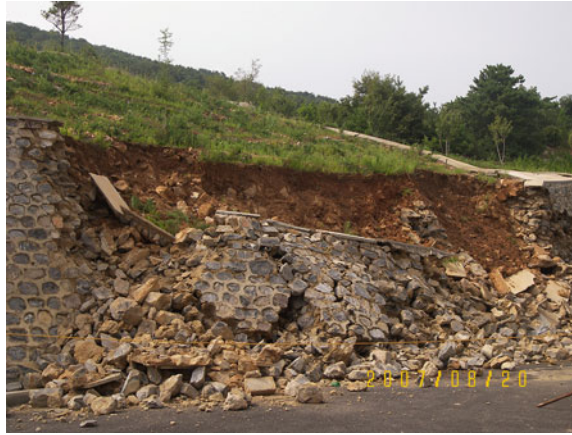
Fig. 1 Loose accretion at the front of the slope

The physiognomy type of slope is low hilly area of tectonic denudation whose hill top is rounded. The hill slope is lumpy and the terrain is relatively steep with a total slope gradient of 22–35°. There is vegetation growing on the slope and the bed rock of part ground that is composed by thick quartzite splint rock of Sinian bridge group is naked. The total terrain is high in the west and low in the east and undulating. The ground elevation is 87.56–157.81 m while the ground weight difference is 70.25 m. The photograph of loose accretion at the front of the slope is shown in Fig. 1.

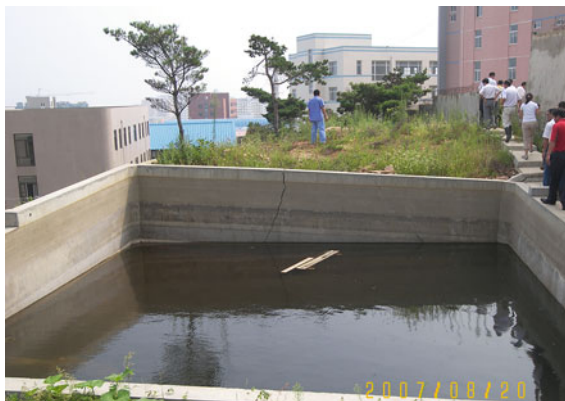
Fig. 2 Incline deformation of impounding reservoir at the end of the slope

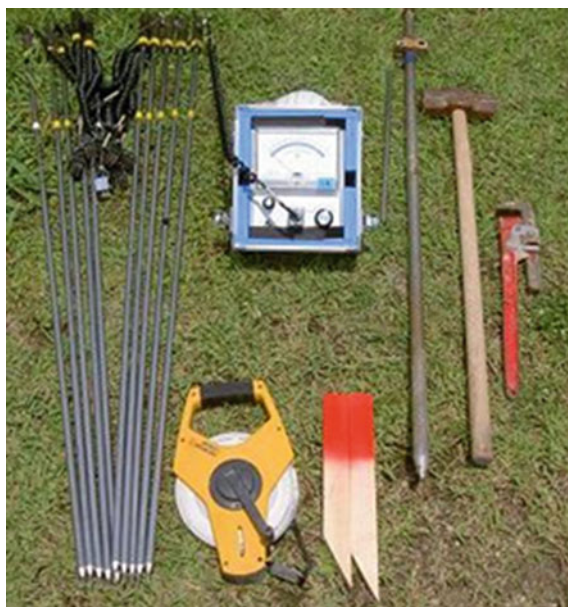
Fig. 4 Equipment of one-meter depth temperature method

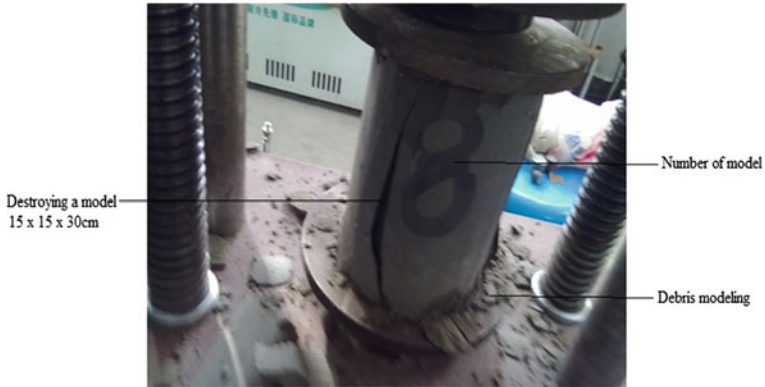
Fig. 4 Typical compression to failure using compression testing machine
