Loess Deposit and Loess Landslides on the Chinese Loess Plateau

Tonglu Li, Changye Wang and Ping Li

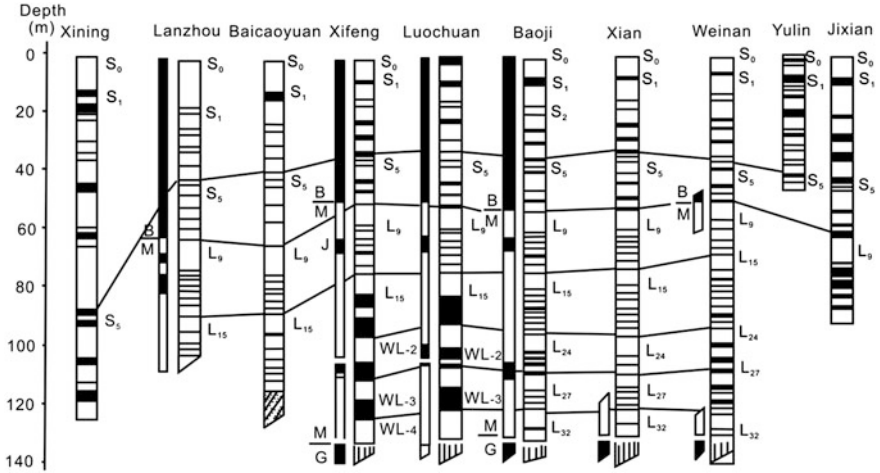
Fig. 4 Correlation of the loess stratigraphy on the Loess Plateau (After Liu 1996)

Since 1980, a detailed age dating of the loess strata has been recorded through the combined application of radioactive (C^{14}) and paleo-magnetic dating methods, and the correlation of isotope curves along the oceanic bore holes and loess sections. From the result, loess in the Quaternary are divided into Holocene (Q_4), Upper Pleistocene (Q_3), Middle Pleistocene (Q_2) and Lower Pleistocene (Q_1) series. The boundary of the Holocene and Upper Pleistocene is located at the basal section of the black loam, dating more than 11,000 years ago. The Upper and Middle Pleistocene are located at the lower part of the first paleosol (S_1), with ages dating more than 128,000 years ago. Also, the Middle and Lower Pleistocene are located in the eighth loess (L_8), with ages dating more than 730,000 years ago which corresponds to the B/M boundary of paleo-magnetism. The Lower Pleistocene boundary and the Upper Pliocene is located at the lower part of the loess, a little higher than the M/G boundary of paleo-magnetism. The age of the M/G boundary is about 2.47 million years, therefore, the boundary of the Quaternary and Tertiary is considered as 2.50 million years or so. It can be observed that there is a wide difference between the early lithologic units and the present chronostratigraphic units. The stratigraphic profile of the Luochuan loess is shown in Table 1. The profile also shows that the loess-paleosol sequences from different parts of the Loess Plateau are spatially correlative, as shown in Fig. 4 (Liu 1996).

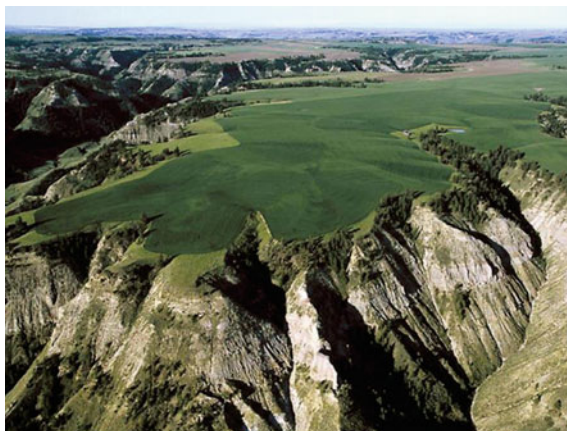
Fig. 6 Loess platform

Loess mainly forms three characteristic types of geomorphic structures. These are loess platform, loess ridge and loess dome, as showing in Figs. 6, 7, 8. Another form of geomorphic structure, loess Karst is not common.

It could be seen that on the sides of the platforms, ridges and domes are the steep slopes which could easily slide in favorable conditions, such as infiltration of rain water, irrigation water and earthquake effects. Generally, loess landslides occur on the slopes steeper than 35° and higher than 40 m. Our investigation in the northern Shaanxi Province shows that 80 % of loess landslides occurred in slopes with dip angles exceeding 35° . As the slope angle becomes greater than 50° , failure style is normally collapse-sliding or purely collapse; the slopes are stable for slope angles lower or close to 35° . The sliding is more preferable to occur in concaves slopes. The landslides are often continuously distributed on the sides of the loess valleys as the side being the rims of loess platforms, ridges and domes, hence forms the so-called “slide-skirts” or “slide-zone”. The loess slides on the southern part of the valley with strike direction trending East–West are more than those on the north because of its less sunshine effect and higher moisture content.

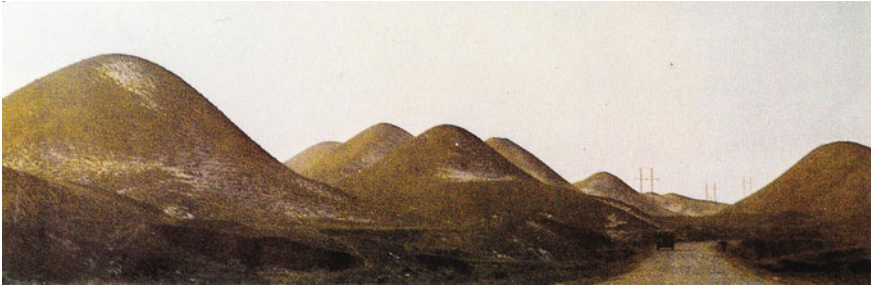
Fig. 8 Loess domes

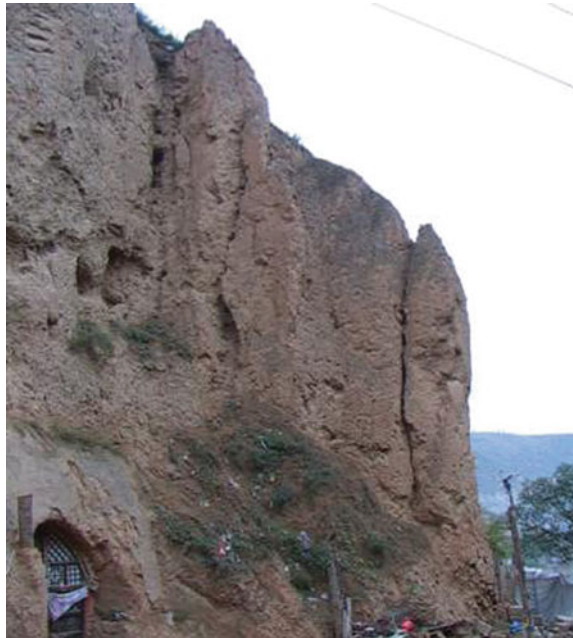
Fig. 9 Loess joints

One unique structural feature of the Loess Plateau is the existence of vertical joints (Fig. 9), which is both primary in origin due to loess formation by wind-blown processes and tectonic in origin due to neo-tectonic movement (Wang 1985). Vertical joints in the loess deposits constitute weak planes along which rainfall easily infiltrate into the loess. The joints are the main erosion path in the loess slopes especially on the margins of the platforms and ridges; the joints generally connect the upper and the lower part of the slopes. Rainfall infiltrates into the slope through the joints and moves down along the joint planes as meet a relative impermeable bed as paleosol, the water would move horizontally out on the impermeable bed. As a result, a lot of sinkholes (Fig. 10) form on the slope surface with outlets appears on the slope toe (Fig. 11). The process enlarges the joints into wide fissures which allow more water to flow in and form temporary waterfall during rainy periods. Erosion along the joints not only affects the slopes, but also allows more water to flow into the slope which essentially affects the stability of the slope.

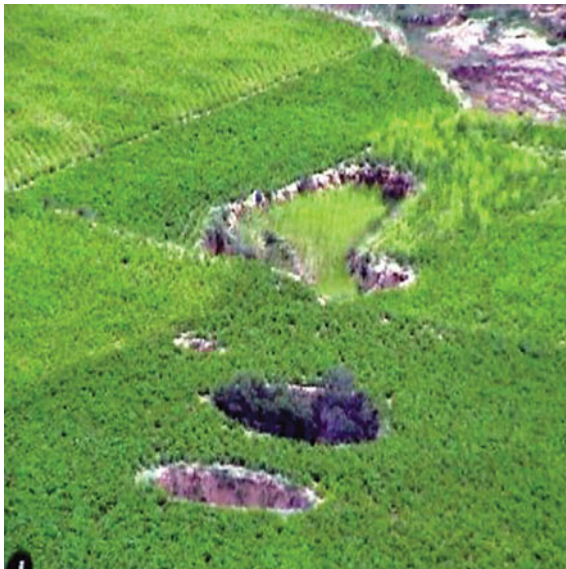
Fig. 10 Sinkholes on the ground

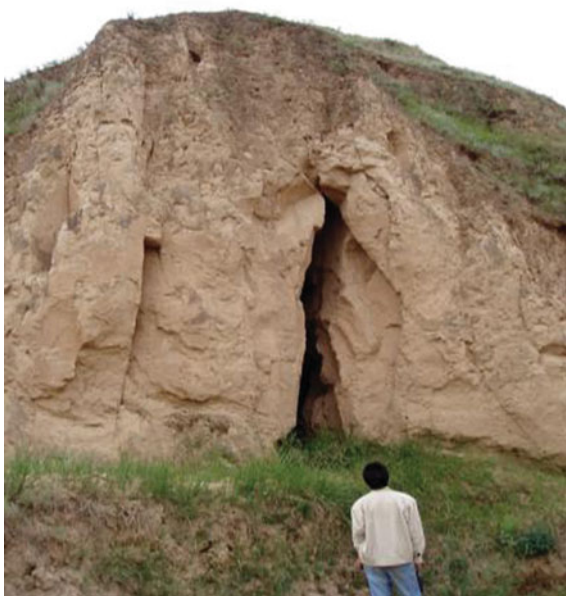
Fig. 11 Erosion along loess joints

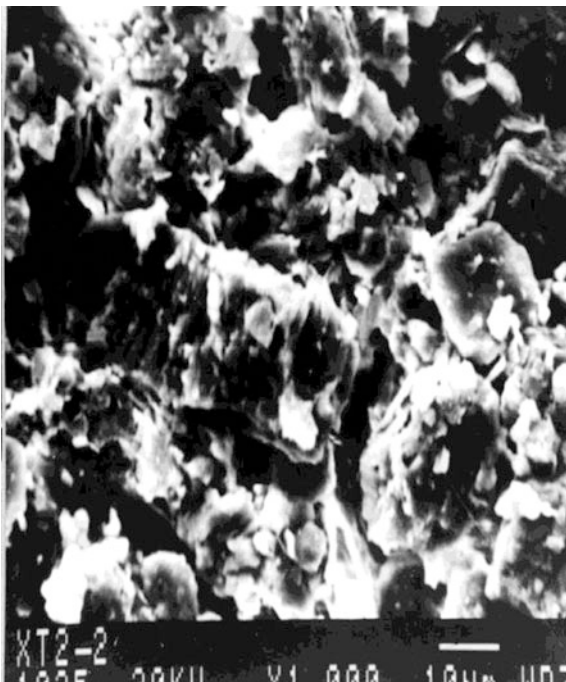
Fig. 14 Micro-texture after water soaked loess, the rounded aggregations disintegrate, parts of them fall in the pores

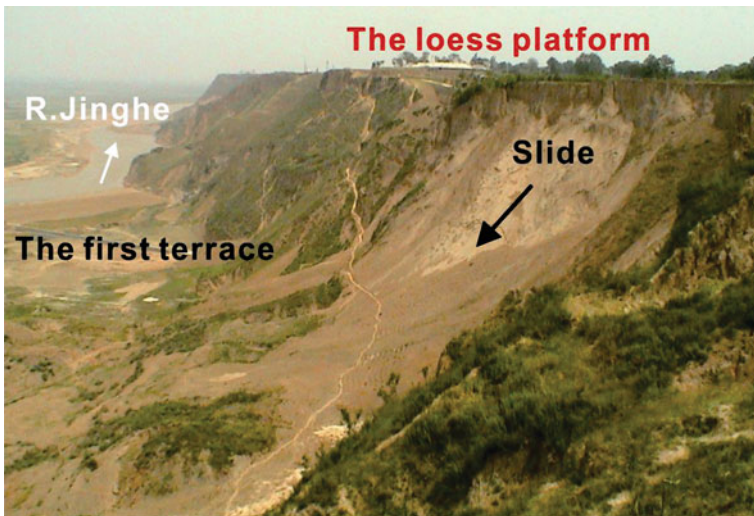
Fig. 20 The topography of the south bank of Jinghe River and the north side of a loess platform with the slope height of 70–90 m and slope angle of 50–70°. The top is an irrigation farmland, which often induces landslides at the side

In the Guanzhong irrigation area of central Shaanxi province, there is the same problems. Guanzhong irrigation area is accords with the Weihe rift area. There are many pieces of highlands among the branches and the trunk of the Weihe River in the rift area, those highlands are the dissected loess platforms. The surfaces of the most loess platforms are irrigating farmlands. The area has a long history of irrigation and now has a very dense canal system. Leakage of the canals and free-flow irrigations induced a large number of landslides at the side slopes of the loess platforms, such as the north sides of the loess platforms at the south of the Jinghe river (Fig. 20), Bahe river, and Weihe river.

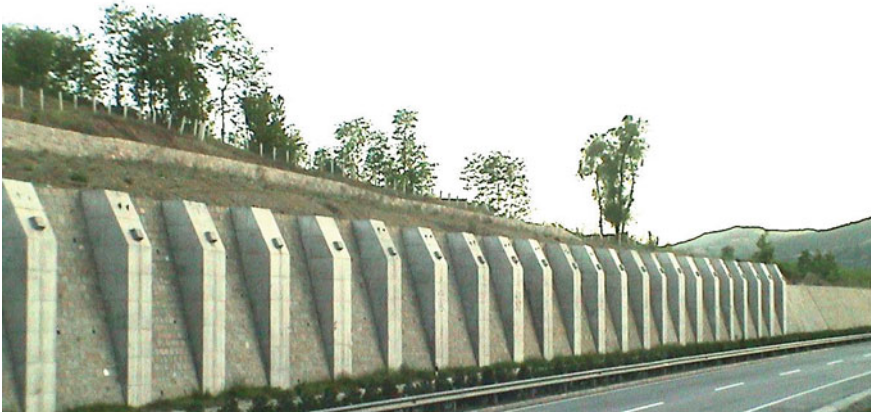
Fig. 21 The piles applied to stabilizing a landslide on the Tongchuan-Huanglin highway

the country. Construction of the roads induced a large number of landslides and caused a huge loss. Tongchuan-Huanglin highway is the first high grade road constructed on the Loess Plateau. In the period of design, the landslide problem was far low estimated; only 3 landslides were designed to stabilize. While the highway being constructing, there were 27 landslides occurred actually. More than 200 million yuan RMB was added to control the landslides. Almost all kinds of measures, such as piles, pile-anchors, block-anchors, frame-anchors, beam-anchors and retaining walls, were practiced in the landslides (Fig. 21).

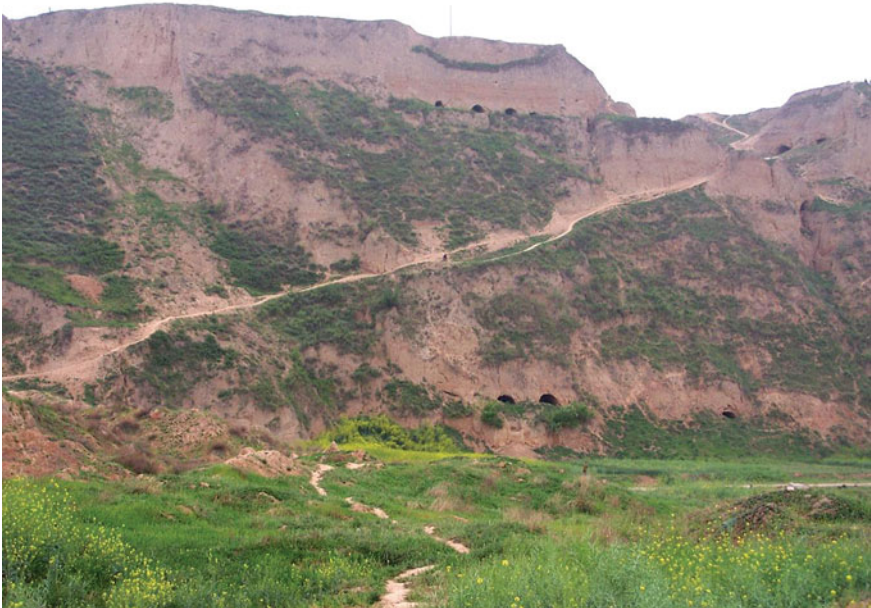
Fig. 22 The living caves (Abandoned) in the top and the foot of the loess slope

In addition, the people in the loess area have a tradition from ancient time to live in digging caves (Fig. 22), which also induced slides to cause a large number of casualties as not properly worked out. The living caves mostly dig either on the top or on the foot of a slope around platforms or ridges. As there are a good drainage ways around living caves to get rid of water penetration, and the thermos released by living activity to keep the soil of the inner wall always dry, the living caves are solid enough to living.

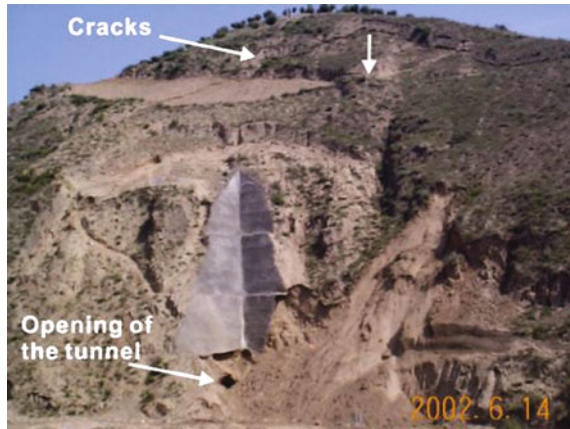
Fig. 24 Collapse and slide occurred in the opening as the tunnel being driven after a heavy rain

Figure 24 shows a tunnel crossing a loess ridge in the West-east Gas Transfer Route. As the tunnel was driving in June 2002, after 30 h continuously raining of 60 mm rain fall from June 8 to 9, a collapse fell down to cover half of the opening of the tunnel, further more, a 60 m high, 100 m width slide was appeared on the slope. The cracks bordering the slide opened 10–30 cm, and the top part of the sliding mass fell down 60–80 cm. The steel supports and the inner line were seriously twisted (Fig. 25). At last, the tunnel was abandoned; instead of entombing along the river valley beside, more than 10 millions Yuan RMB was added for the revision.

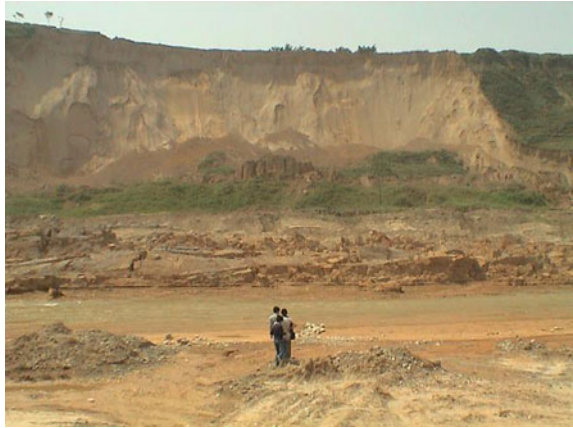
Fig. 26 The landslide on the north side of Jingyang loess platform occurred in March 2002

Jinghe River and then climbing up a 90 m high slope which is the north side of Jingyang Platform. A series of linear distributed sinkholes and cracks developing on the top of the slope told us a potential huge landslide was there. Then we persuaded the designer move the route a kilometer away on a stable old landslide, even though the route should be elongated 3 km and costs 6 millions Yuan additional money. The oil route was completed and put into work in the beginning of year 2002 (Fig. 26), while the slope slipped in March 2002, with irrigating on the top of the platform. The slide not only fell 50 m down, but also squeezed the Jinghe River bed to thrust up (Fig. 27). It would be a disaster as the oil route was entombed on the original site.

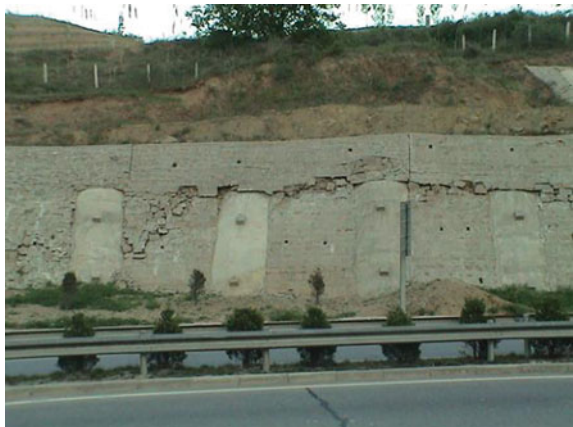
Fig. 28 The damaged beam-anchors for stabilizing the landslide

The Loess Plateau is located in the central of China. The 4 main national highways and the 3 railways of Long-Hai, Bao-Zhong and Xi-Tai connecting this region to others around the country. Because of the complicated landforms and rapid highway and railway development, construction of the road induced a large number of landslides and caused huge loss. On Tongchuan-Huanglin highway, there were 27 landslides occurred during construction in 1990 s. Almost all kinds of possible measures, such as piles, pile-anchors, block-anchors, frame-anchors, beam-anchors and walls for anti-sliding, were practiced in the slides. Unfortunately, part of the control structures was invalid at last. Since the road was completed to utilize on May 2001, it has troubles in every rain season, some of the piles were broken down, and some of the anchors were pulled out, and the slides were still moving forward. The reason of the failures is that drainage system is not sufficiently available, both ground and underground. In any cases, drainage of water is the most necessary, but simple and less cost measure in loess sliding control because of its sensibility to water. After of all, all the roads passing the Loess Plateau face the problems of landslides which either large or small (Figs. 28, 29).

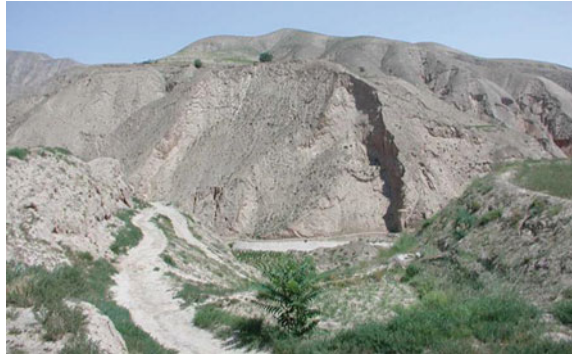
Fig. 29 A loess slide in No.309 National Road (K2075 + 100)

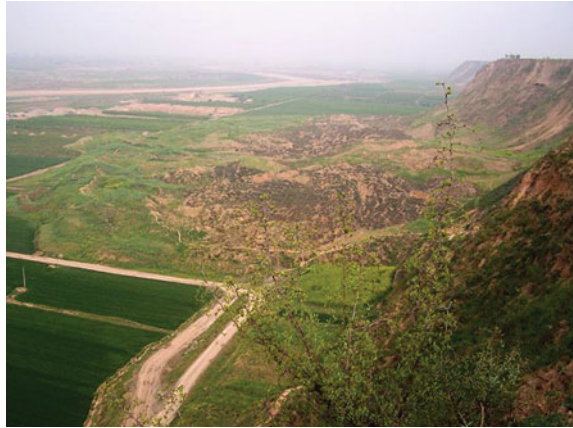
Fig. 30 A loess slide in South bank of Jinghe River sliding on May, 2003. Slipped away 80 mu, and covered 200 mu farmland

Now there are still 20 potential landslides creeping in dangerous state. Because local government pays much attention to the slide zone and set ones on duty to observe the change of the slope. They gave alarm to the villagers on time, so relative few people dead in the slipping along this zone. In recent years, Large slides almost happens every year in the fall, the follow photos (Figs. 30, 31) shows the ones in 2002 and 2006.

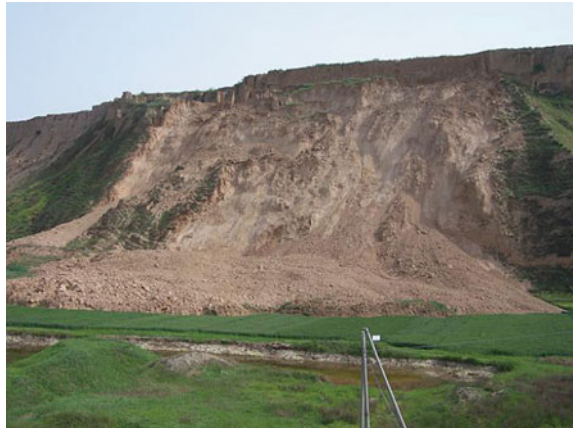
Fig. 31 A loess slide in South bank of Jinghe River sliding on April, 2006. Covered 5 mu farmland
