# The Back Wall of the Niches: Preliminary Considerations

Claudio Margottini

## Introduction

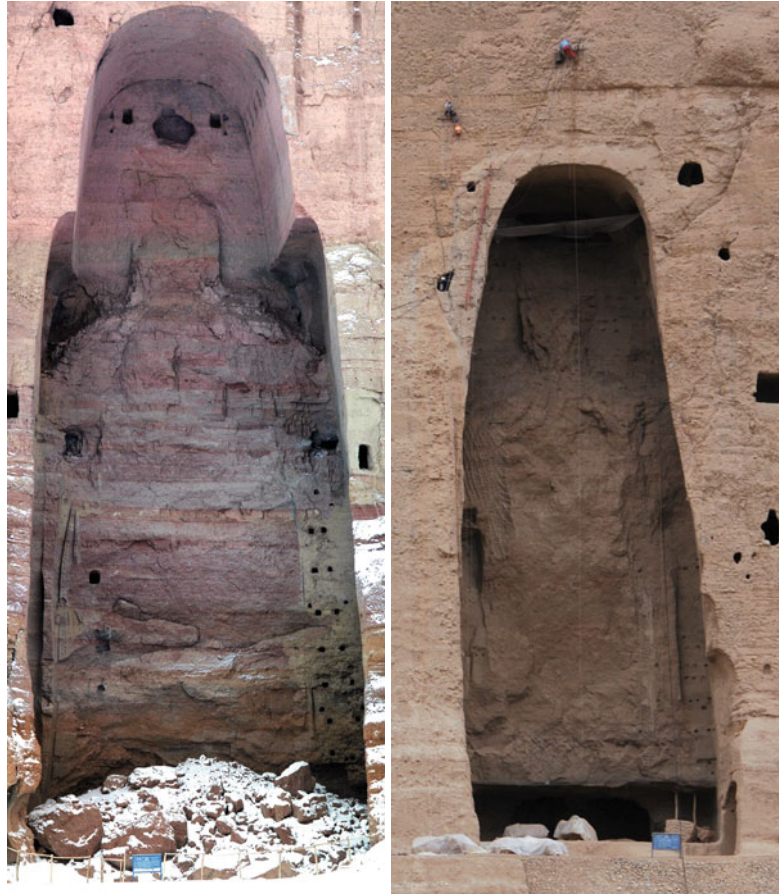
**Fig. 12.1** The silhouette of statues on the back side of both niches (Western on *left* and Eastern on *right*). At the ground of Western Buddha are the remains of the March 2001 explosion. Note the height of the western niche (*left*) is about 55 m and the eastern niche (*right*) is about 41 m (From PASCO 2003b)

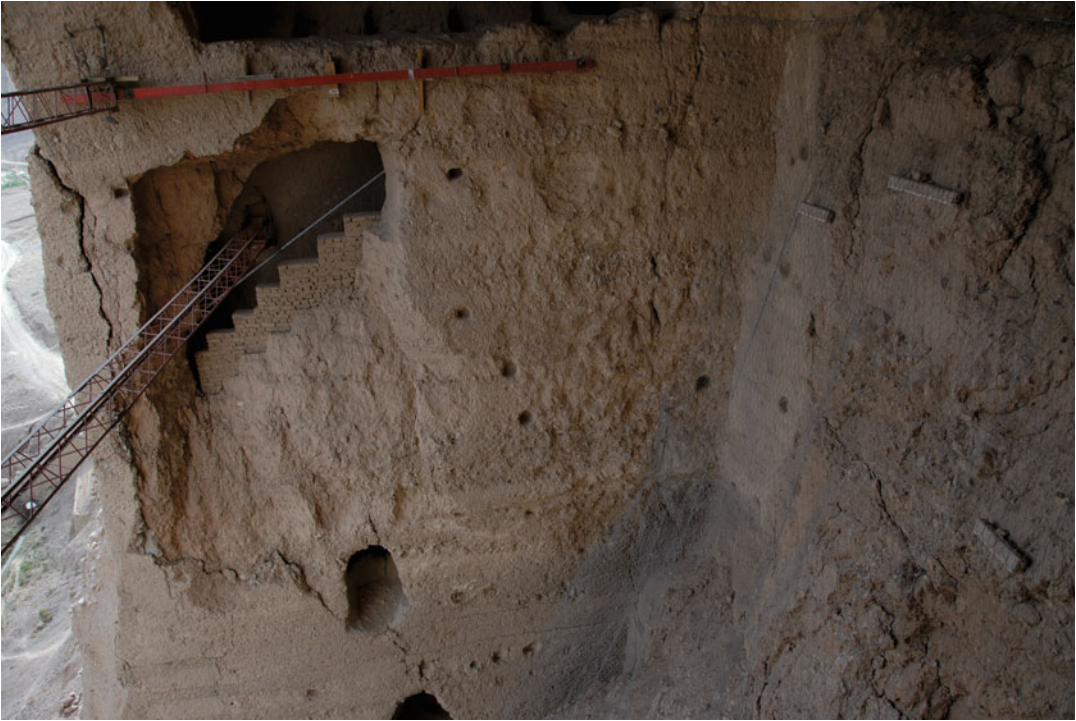
**Fig. 12.3** The metallic net protecting from the detachment of small rocks from the shear band of destroyed statue. The photo also shows the wooden spacers, covered

by nonwoven fabrics, placed on the niche to avoid any direct contact between the net and the remainder of the statue

1. *Temporary support for the unstable blocks including the vault in the ground level.* The existing net is certainly operating properly (Fig. 12.3), even if a better fixation at the underneath of the back side of the niche is required. This is to allow the safety of workers at the ground level. Presently the net is not completely fixed to the cliff and some falling rock may reach the ground. In the execution of a possible consolidation of the back side by means of scaffolding, the installation of more temporary steel cables, horizontally placed, is required.
2. *Damage assessment, in terms of surficial degradation and crack pattern distribution.* The back side is heavily damaged, because the six contemporary dynamite explosions of March 2001 produced the total detachment of the rock, originating a typical “shear band” (e.g., a thickness of rock deformed by the laying

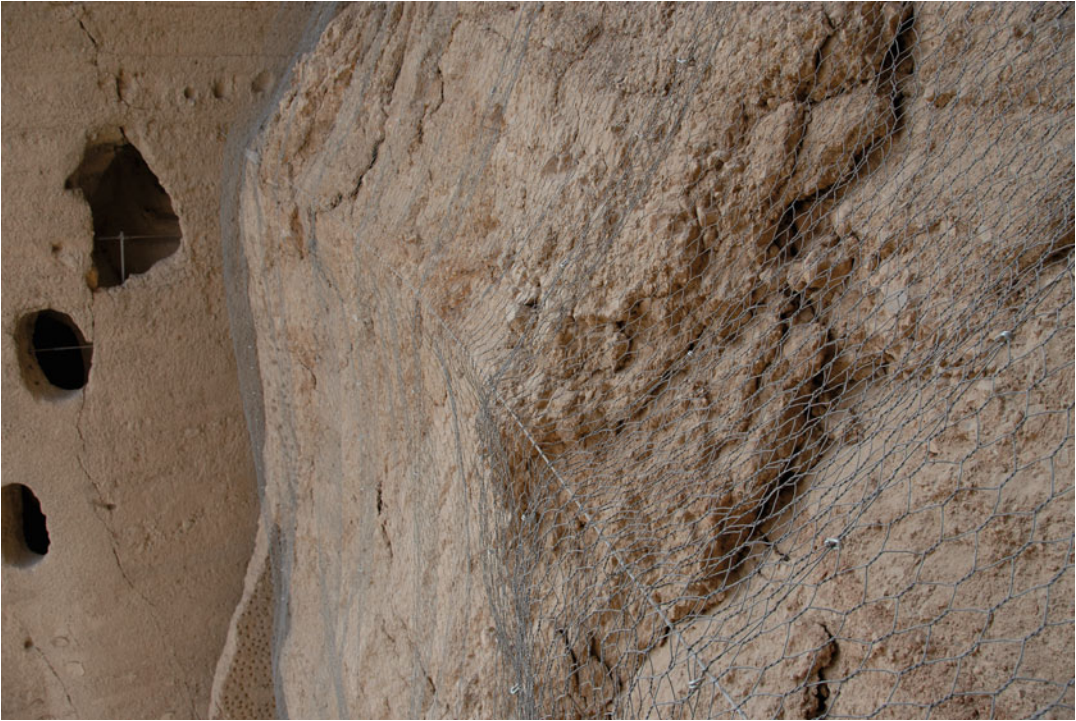
**Fig. 12.4** Detail of temporary net and of the shear zone on the back side of Eastern Giant Buddha niche

this can result in a large underestimation of the real situation. Figures 12.4, 12.5, 12.6, 12.7, 12.8, 12.9, and 12.10 provide an overview of the current status.

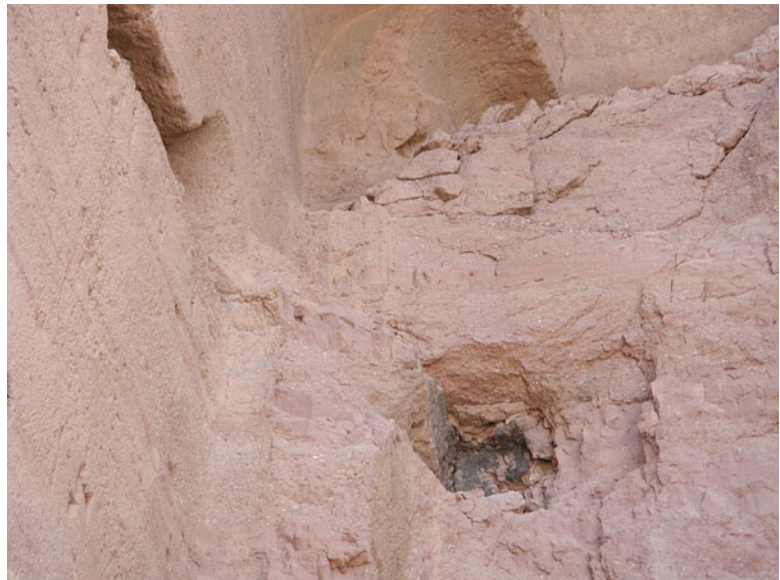
**Fig. 12.5** The shoulders of the Western Giant Buddha

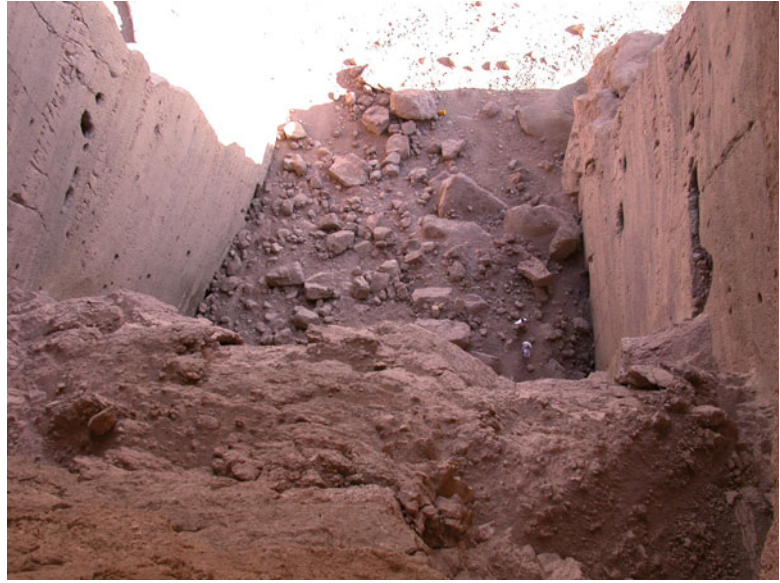
**Fig. 12.6** (*Top on the right*)  
The shoulders of the  
Western Giant Buddha from  
the top

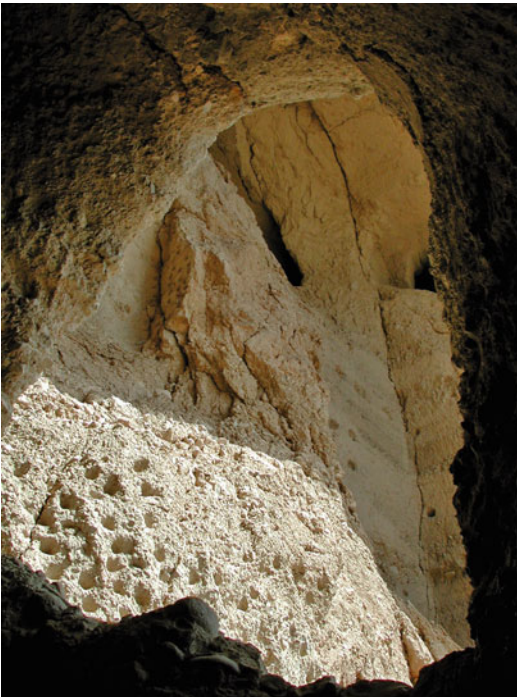
**Fig. 12.10** (Low to right) Detail of the detachment in the Eastern Giant Buddha

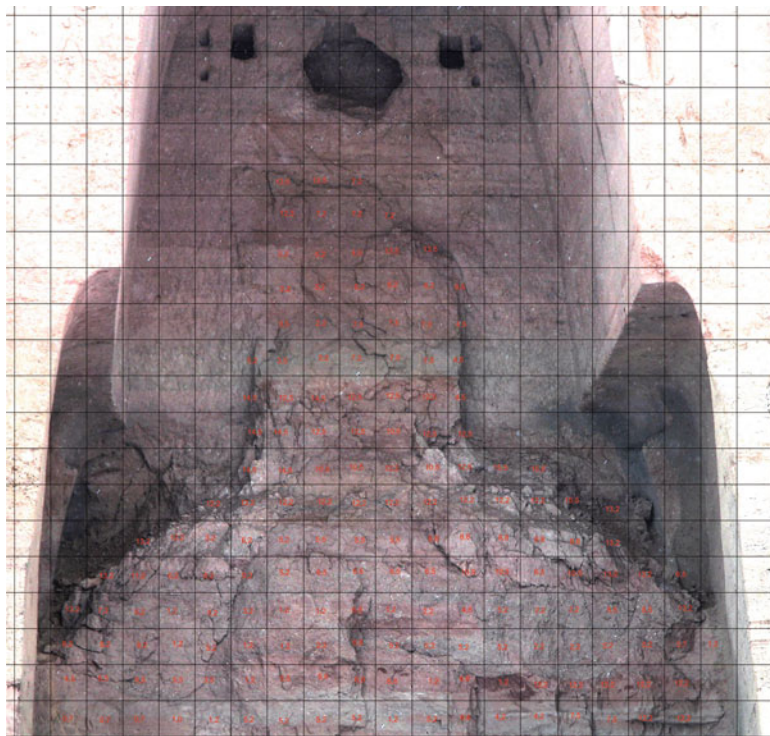
**Fig. 12.11** Distribution of the volumetric joint count ( $J_v$ ) in a portion of the niche

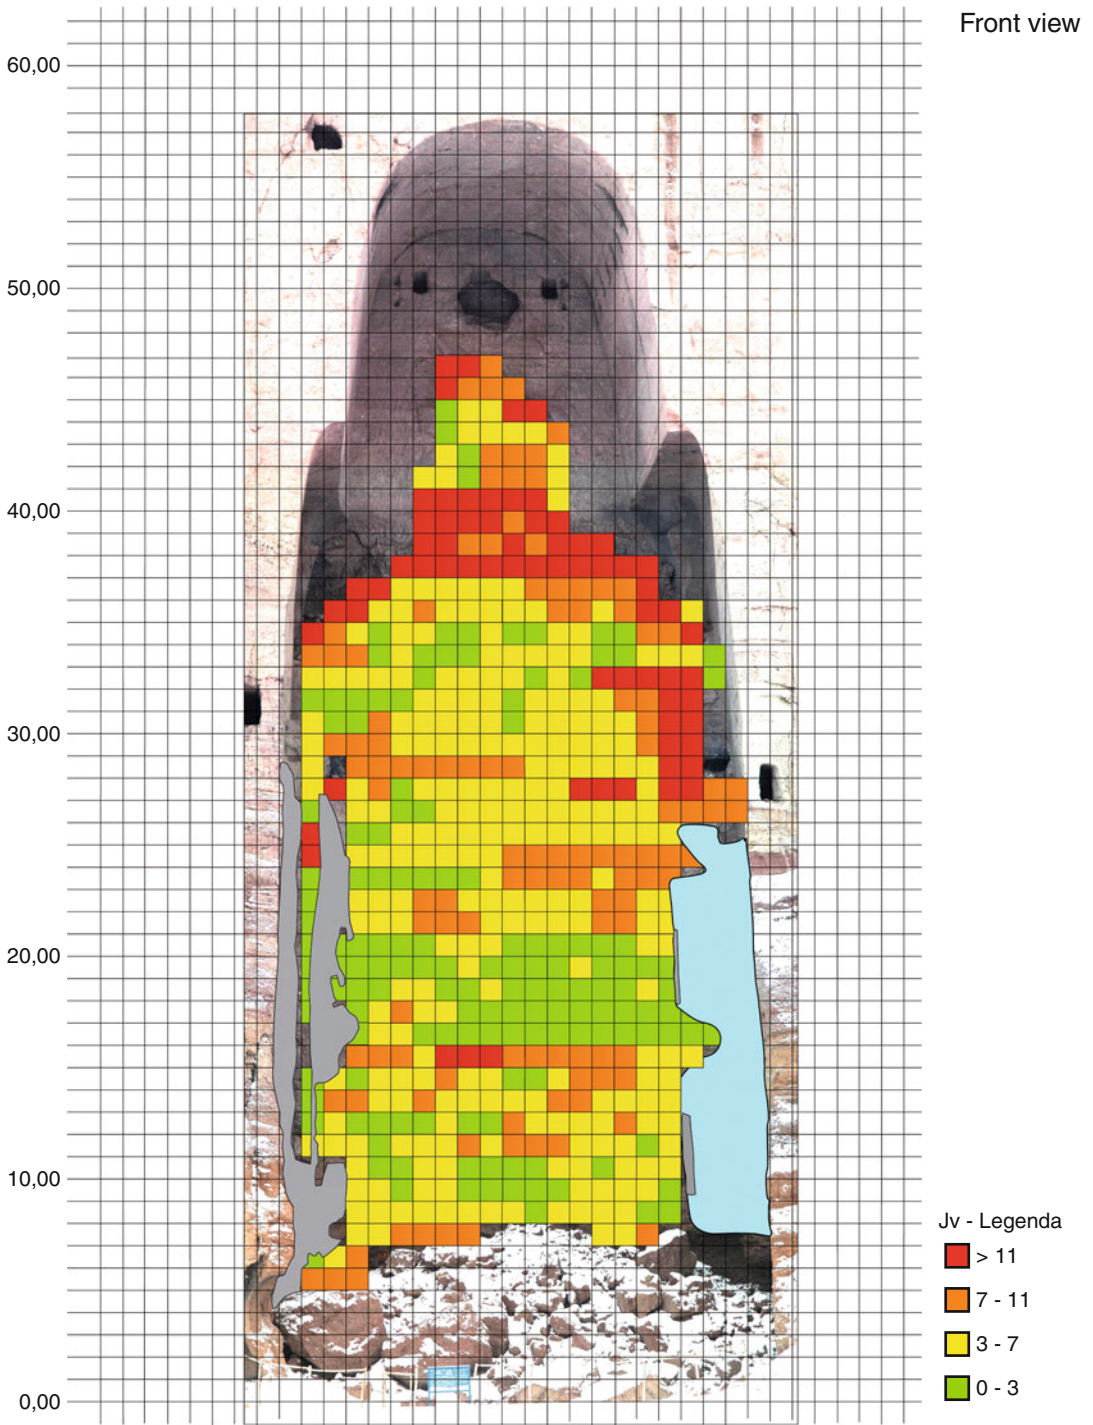
**Fig. 12.12** Joint volumetric count for the Western Giant Buddha niche. Legend has been readapted from traditional classification (Palmstrom 2005) to fit the available data.

In *grey* are original surfaces still preserved and in *sky* is the area resulting from the 1707 destruction

12 % of the surface exhibits block size smaller than 0.17 m<sup>3</sup>, 20 % exhibit block size between 0.17 and 0.6 m<sup>3</sup>, 43 % between 0.6 and 6.0 m<sup>3</sup>, and 25 % approximately less than 6.0 m<sup>3</sup>.

The above concept has been applied to the Western Giant Buddha niche, for selected 2-D areas of  $1 \text{ m}^2$ , where a rectified image is available. Given that the 3-D application is not possible to develop because the scaffolding is not yet installed, and the information on the propagation inside the rock of the effect of the explosion is not available, the result is only a first approximation. Figure 12.11 is a preliminary report of the distribution of the  $J_v$  for a detail of the Western Giant Buddha niche. In Fig. 12.12 all the niche is reported, showing the preliminary

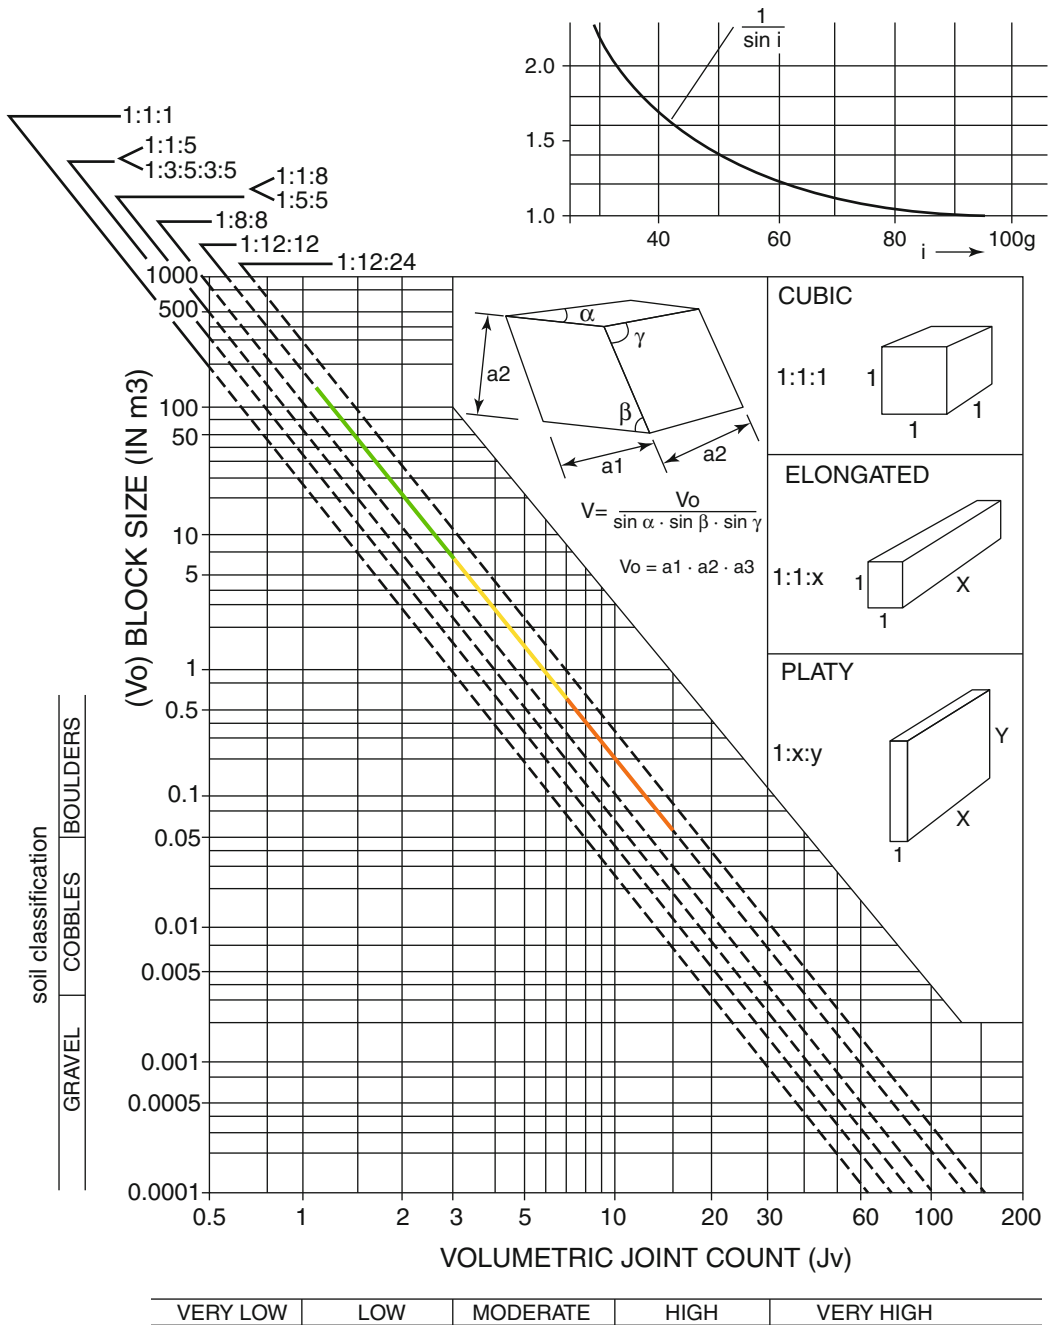
**Fig. 12.13** Comparison of average values of block size for the classes of volumetric joint count (J<sub>v</sub>) (Palmstrom 1982). In color are the classes selected in the present study, with the same legend as in Fig. 12.12

assessment of many areas of instability. Comparing these data with the chart of Fig. 12.13 in which the relationship between J<sub>v</sub> and block size is reported, it is possible to estimate that

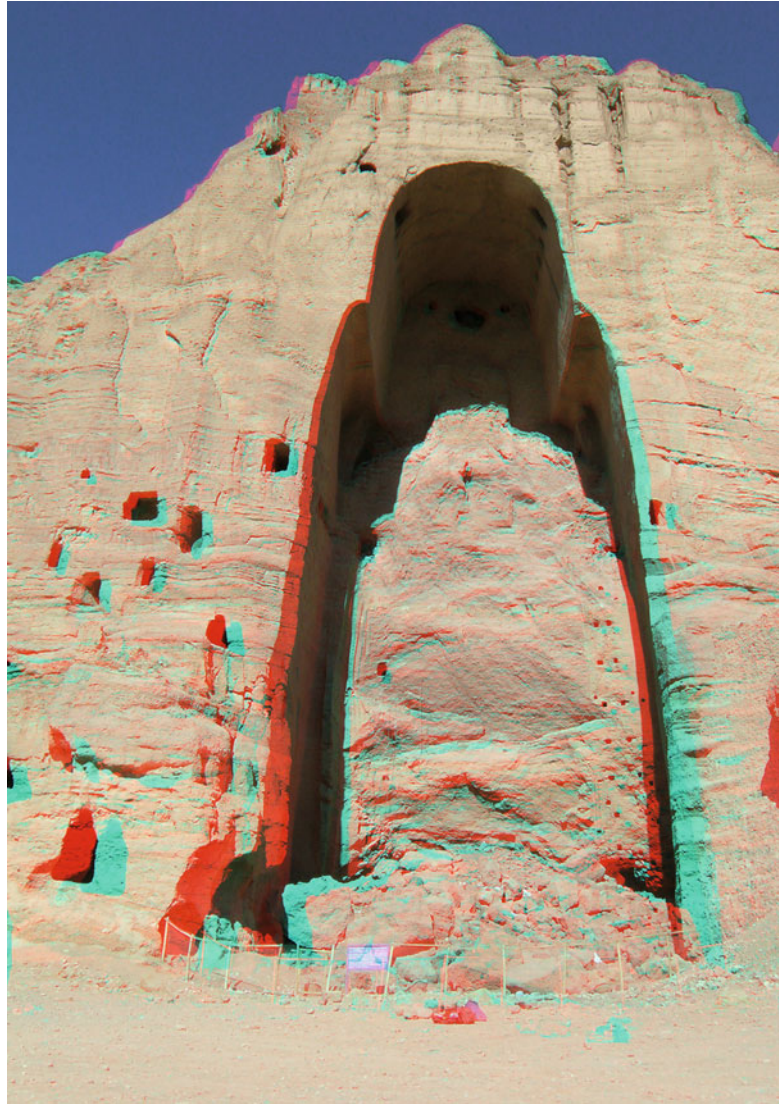
**Plate 12.1** The anaglyph image of the Western Giant Buddha niche. This technique is quite useful to display a static view of 3-D models. An anaglyph mixes into one image a stereoscopic view using the complementarity of colors in the RGB channels. With colored glasses, one can then filter the image and see the depth information of the model (Courtesy of Pierre Smars, ICOMOS)
