Andrea Bruno and Claudio Margottini

Typologies of Works

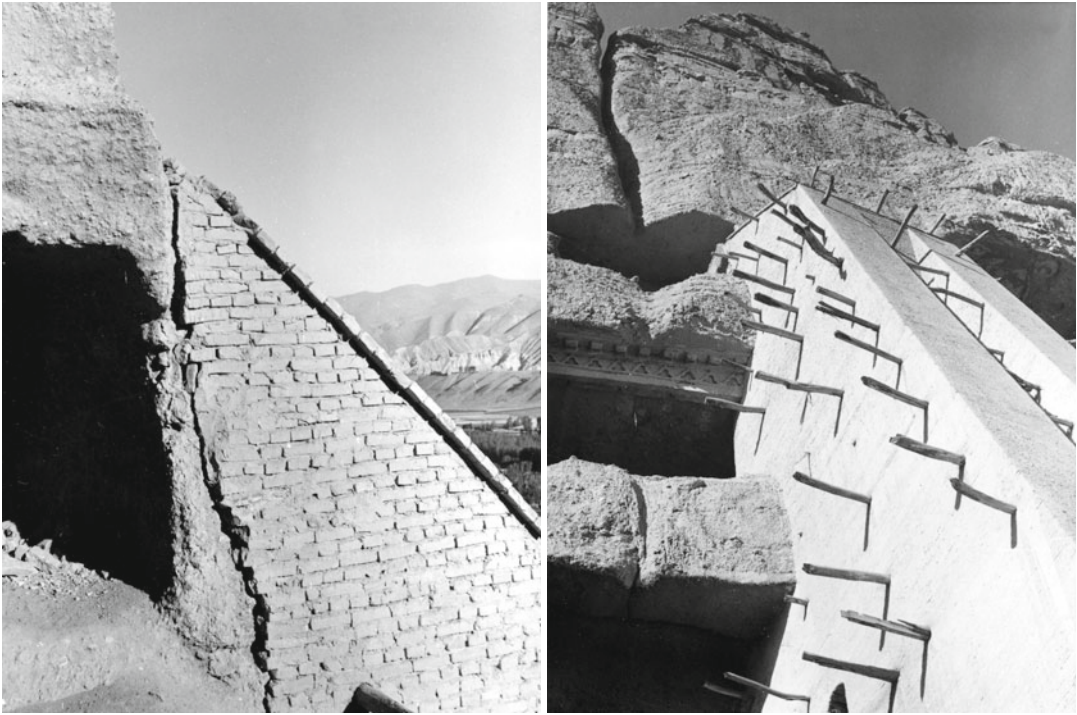
The construction was performed in brick, and the result, shown in Fig. 9.1, demonstrates the typical intervention of that period: to solve the problem with limited attention paid to the environmental and aesthetic impact of construction. On the other hand, this side of the niche did not suffer too much as a consequence of the explosion of March 2001, confirming the efficacy of this intervention.

Fig. 9.1 The top of the buttress constructed by the French Archaeological mission (Photos A. Bruno, Sept. 1960)

1. The major remaining feature of the work developed by the French Archaeological Mission is the buttress, constructed to sustain the western side of the Eastern Giant Buddha niche. This demonstrates that, at least since the middle of the last century, the cliff was in a precarious condition, and probably at the limit of equilibrium.

Unfortunately, the buttress was not well designed and the crack we would like to sustain started to re-open again. The reason is not clear even now, but there is a possibility that the soil foundation was not very well investigated, the buttress may be located over a cave, or the bearing capacity of the local soil may have been

underestimated. Even now, some evidences of deformation can be detected, suggesting the need for future intervention, at least to understand and recover the reason for such sinking. It is likely that the monitoring system of the main crack of the site did not reveal important widening in the period 2003–2007 in a small crack at the connection between the buttress and the cliff on the external side.

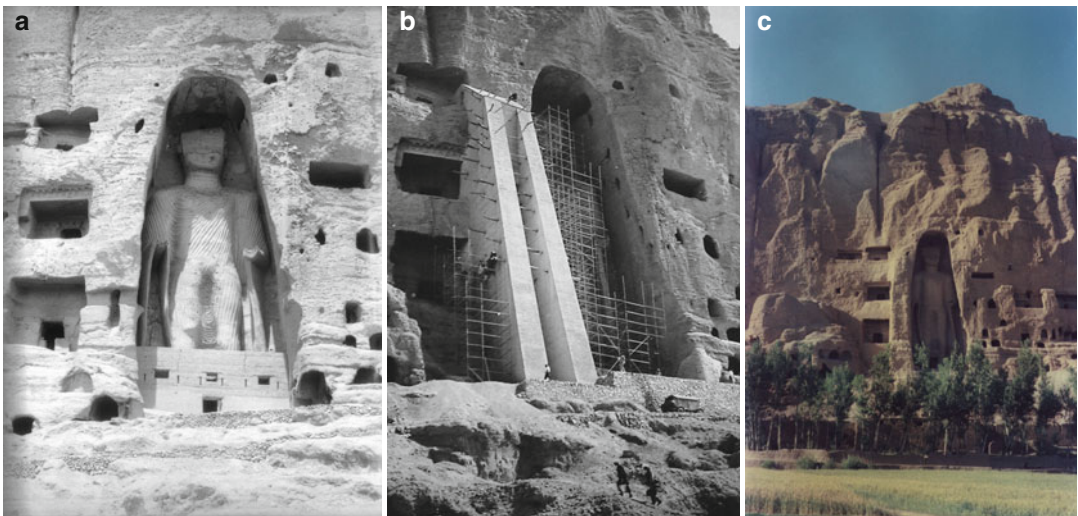
Fig. 9.3 The Eastern Giant Buddha before the French mission intervention, with the French buttress at the beginning of the Indian intervention (ca. 1968–1969)

(Courtesy M. Jansen) after restoration by the Archaeological Survey of India in 1975 (Photo G. Arduino), respectively (a), (b) and (c)

Finally, to overcome at least the heavy impact of the buttress, the Indian Archaeological Survey reshaped the structure and covered it with cement and natural earth, producing a camouflage not easy to recognize at first sight (Figs. 9.2 and 9.3).

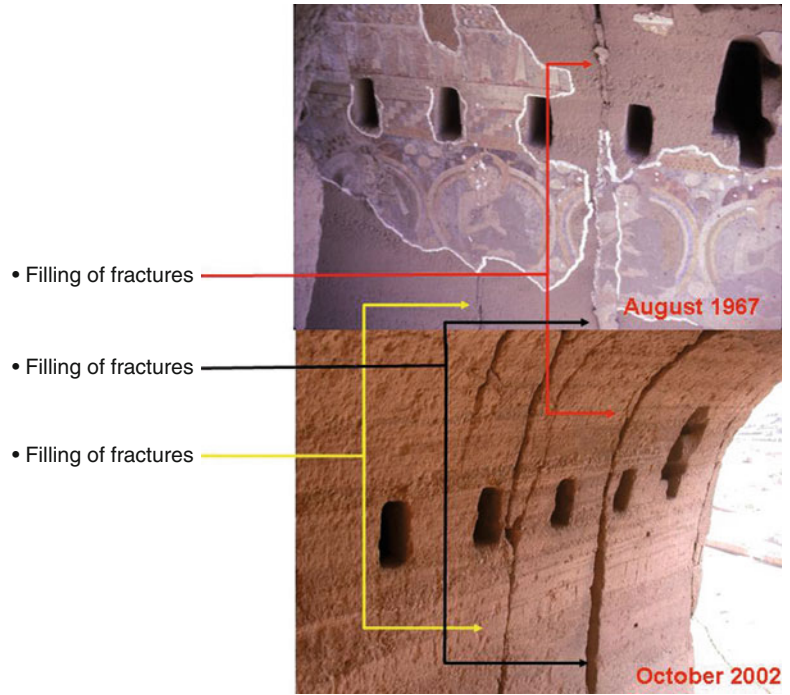
Fig. 9.4 Filling a fracture in the Western Giant Buddha with cement

2. Filling the fracture with concrete: A similar intervention was conducted, probably in 1960, in the Western Giant Buddha niche, as testified by K. Lambek's photos of August 1967, and likely aimed at avoiding water infiltration from the top of the cliff. Currently there is little evidence of this filling activity, suggesting a possible effect of the explosion or a natural enlargement of the fractures. This second hypothesis seems not to be

Cliff deformation of the Eastern Giant Buddha site produced many fractures inside the niche (Fig. 9.4).

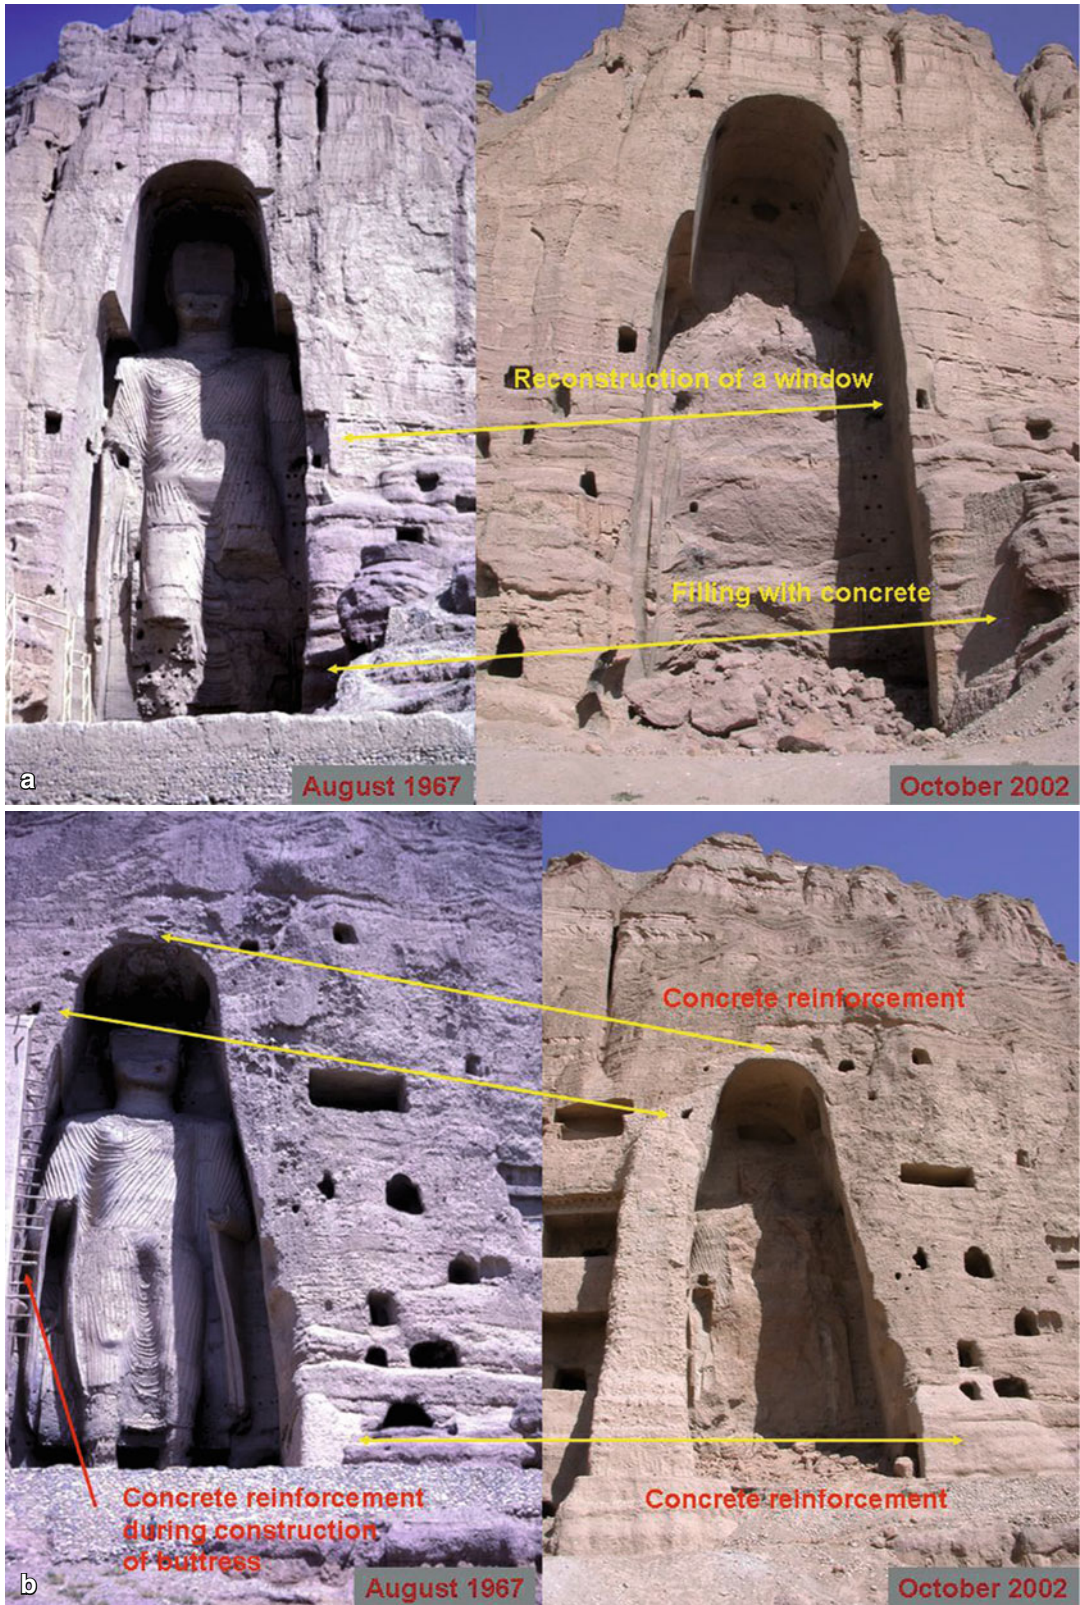
Fig. 9.6 Reshaping and consolidation of both Western and Eastern Giant Buddha niches with cement

Giant Buddha and the cliff has been filled with concrete. A similar intervention of reconstruction of weak or missing parts has also been done for the Eastern Giant Buddha niche with excellent results (Fig. 9.6).

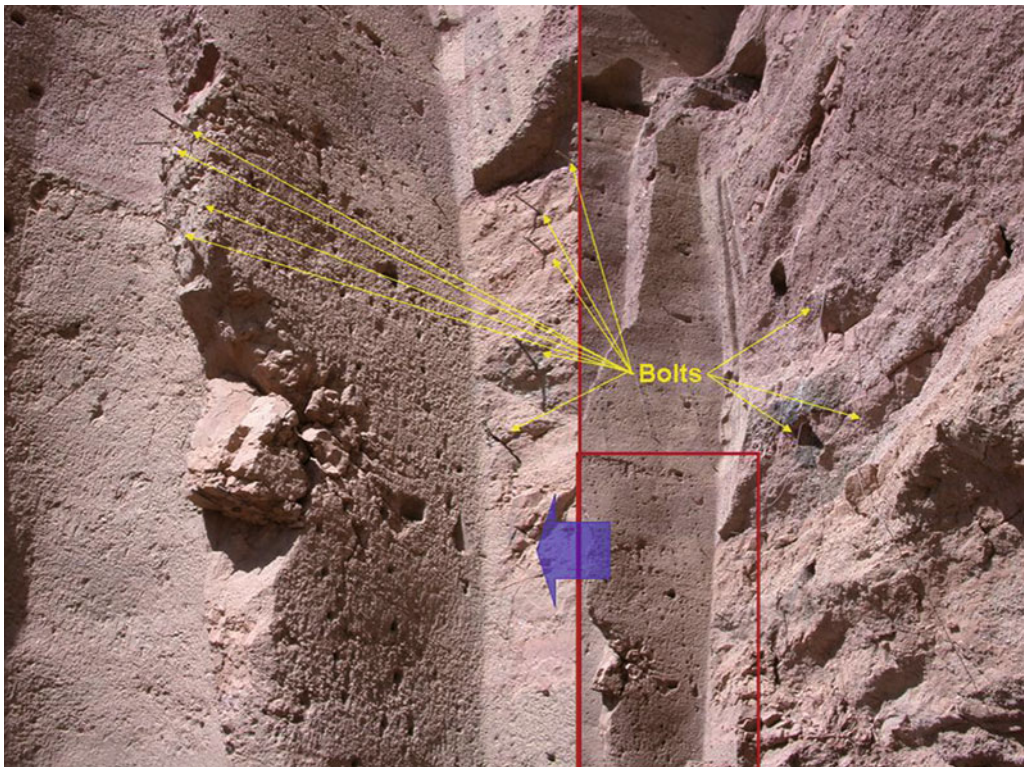
Fig. 9.8 Use of bolt for anchoring small pieces of the Western Giant Buddha

4. Protection from water runoff. This measure was considered extremely important in the past, and it still is. The Indian Archaeological Survey constructed two major protection channels above the Buddha niches. Their perfect maintenance and conservation is essential (Fig. 9.7).
5. Bolts have been used in the past to anchor small pieces of the statues to the cliff. The approach was correct and the result fully satisfactory until the blast occurred (Fig. 9.8).

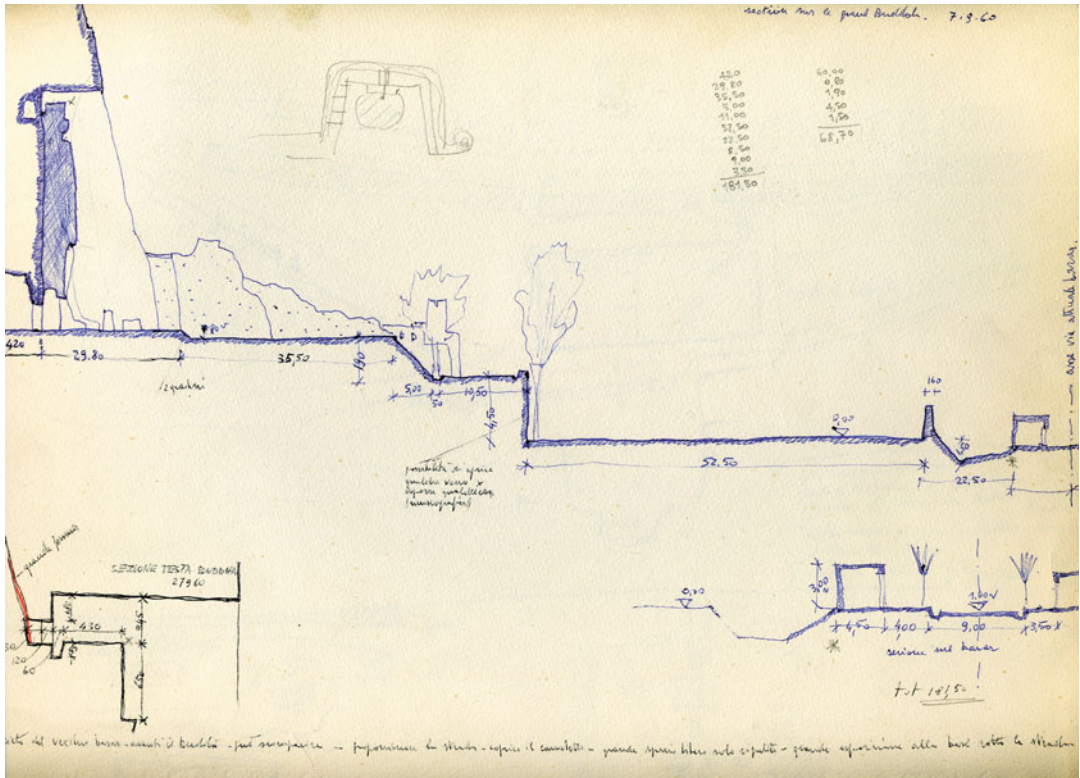
Fig. 9.9 Profile of the Western Giant Buddha niche and statue from the drawings of Andrea Bruno in 1960

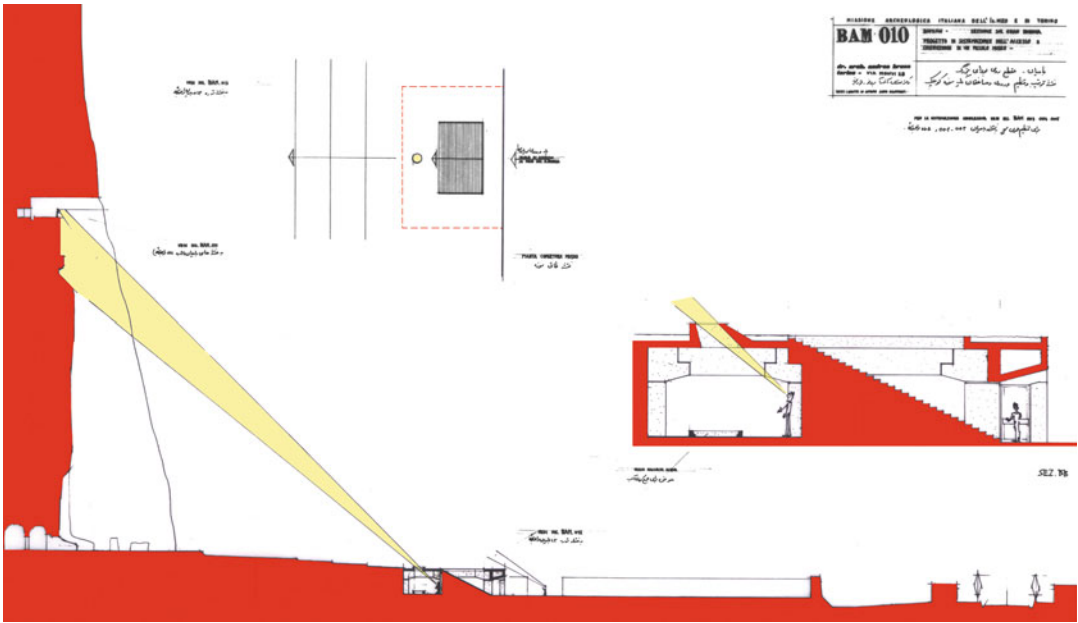
Fig. 9.12 The proposal of Andrea Bruno for the construction of a museum in front of the Western Giant Buddha niche in Bamiyan, 1960

The project of a museum located just under the ground level in front to the Western Giant Buddha niche, where one might look at the head of the statue is a stimulating and intriguing concept. The idea can be put on the table when the scientific community and UNESCO start to think about what to do with the fragments of the statues that were destroyed in 2001.

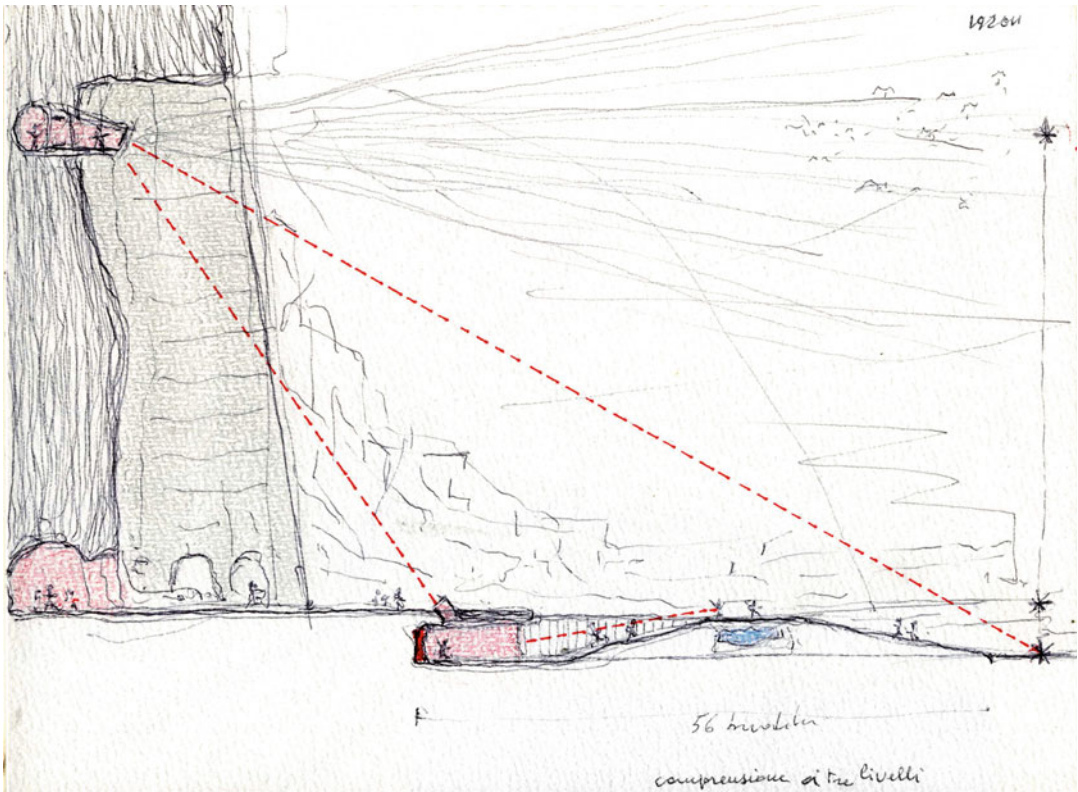
Fig. 9.13 The new project for the exploitation of the niche of the Great Buddha and the surrounding area, the observatory and the underground sanctuary-museum (Drawing by A. Bruno, 2010)

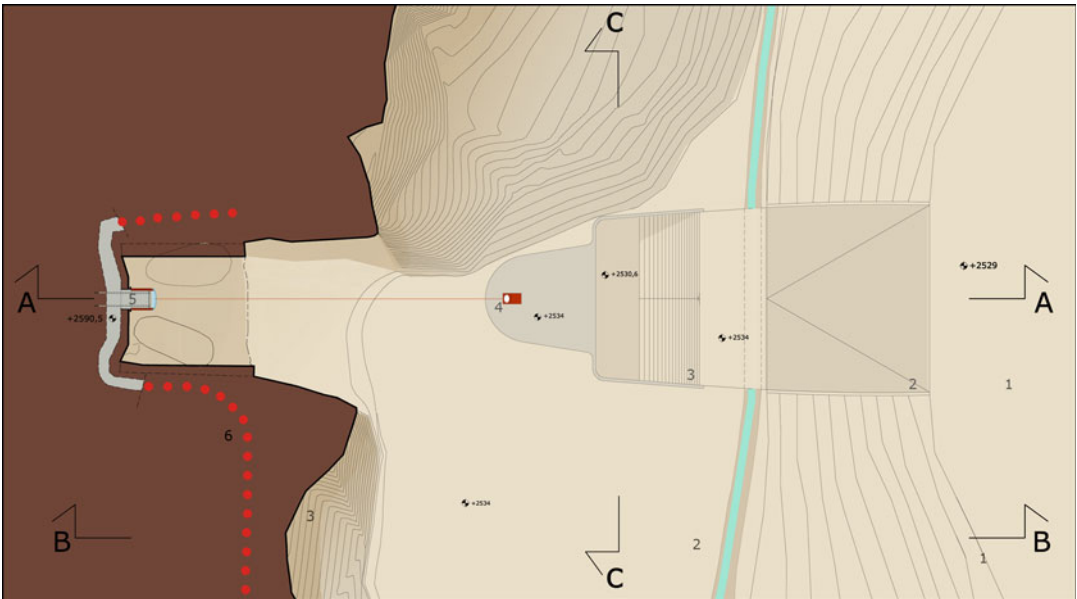
Fig. 9.15 General plan of the project at the level of the new Observatory (at approx. 65 m in height from the base of the Western Giant Buddha), 2010. Project by Andrea Bruno: Legend for plans and sections: (1) “Great

esplanade” - area in front of the niche. (2) Ramp. (3) Entrance to the new sanctuary. (4) Oculo. (5) Observatory. (6) Access to the tunnels of the wall

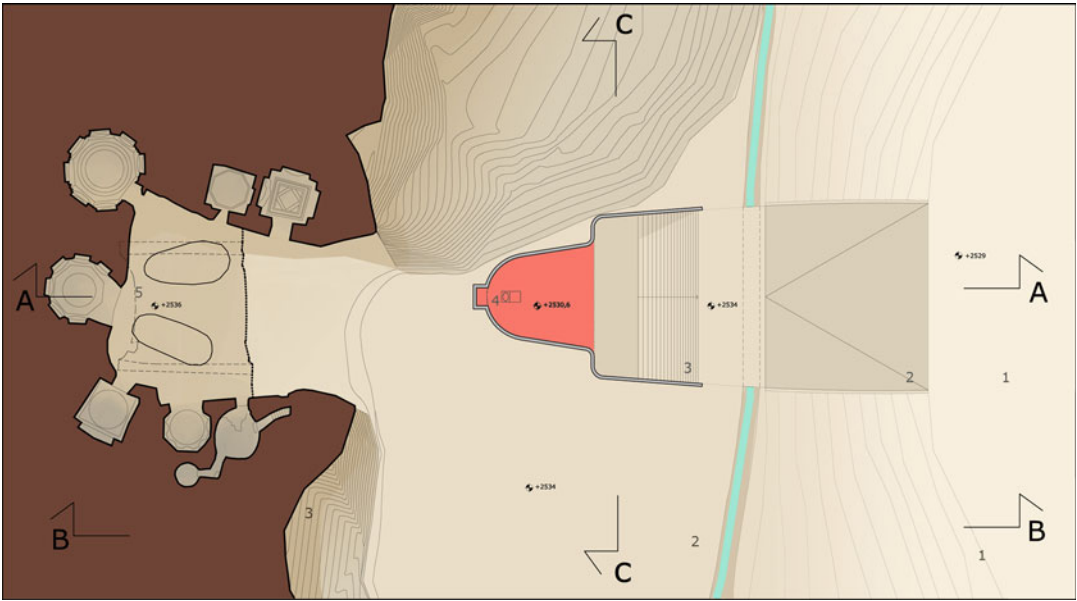
Fig. 9.16 General plan of the project at the level of the base of the Western Giant Buddha, 2010. Project by Andrea Bruno: Legend for plans and sections: (1) “Great esplanade” - area in front of the niche. (2) Ramp. (3)

Entrance to the new sanctuary. (4) Reproduction of the Western Giant Buddha on a small scale. (5) Sanctuaries carved into the rock surrounding the niche of the Western Giant Buddha
