## New Real-Time Landslide Monitoring System in Polish Carpathians

Zbigniew Bednarczyk

### Abstract

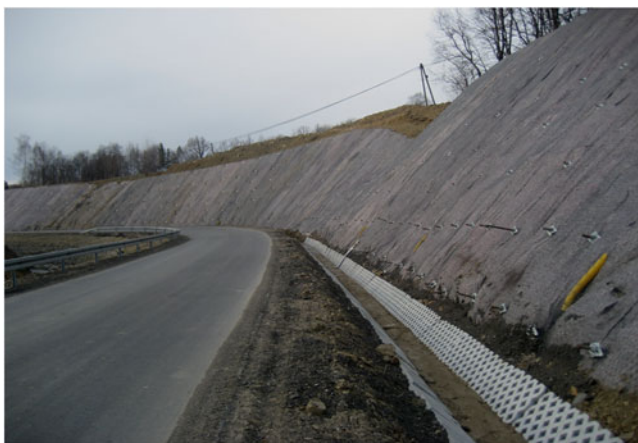
**Fig. 4** Partly stabilized part of the Szymbark-Szalowa public road

Geobrug high tensile wire mesh, gabion retaining walls along the river, internal and surface draining system. Anchors length of 6–15 m were drilled into the bedrock (Fig. 4). It helped to safeguard the road however full stabilization was not possible due to landslides size and activities. Some parts of the landslides located close to road, bridge and private buildings were still active in June 2010 after the record precipitations. They caused infiltrations of groundwater's in upper parts of the landslides and movements activation (Fig. 5). New cracks, high strains in Geobrug meshes, some destructions of drainage systems and a new cracks at buildings were observed. Previous movements depended mainly on precipitations and snow melting conditions. They were influenced by creeping processes, clayey flysch deposits strength parameters, slope inclination, infiltration processes (high pore pressure) and undercutting of landslide head during a road construction. It was confirmed by inclinometer measurements. Landslides were investigated by Poltegor-Institute in Bednarczyk (2006–2010) by the network of three standard monitoring points to the depth of 7.5, 15, and 18 m. These measurements showed that full landslide stabilization were not reached. That was caused by not fully effective landslide drainage system and difficulties in stabilization of Bystrzyca landslide lower part. Also some others landslides head parts were not stabilized due to limited financing. Displacements have accelerated mainly in periods after intensive rainfalls as in May-June 2010 (2 June 2010, 100 mm rainfall in 3 h time), when some parts of counteraction works were partly damaged (Figs. 6, 7, 8, 9, and 10). They were also intensive in some central parts of the landslides, where new ground movements and cracks occurred (Figs. 7 and 8).

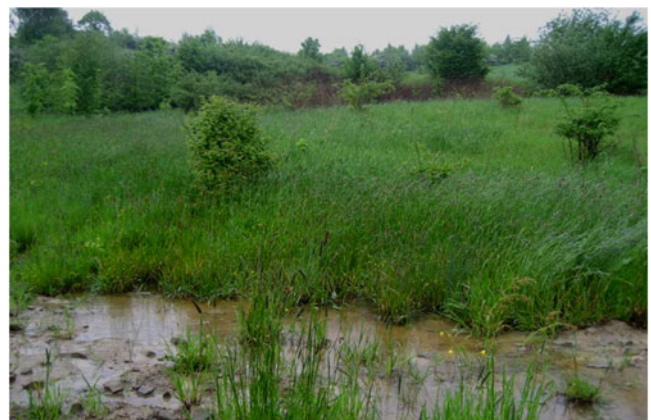
**Fig. 5** Groundwater reservoirs in upper part of landslide no 1

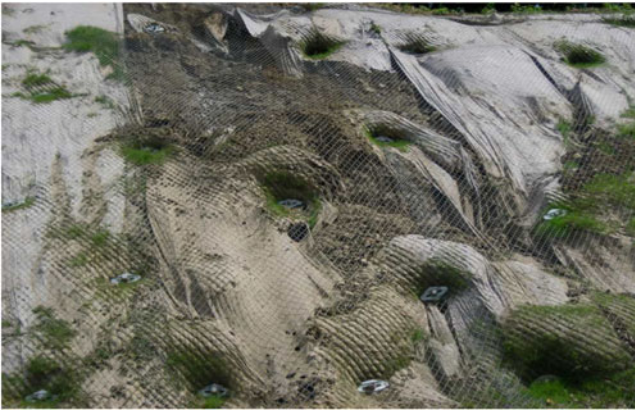
**Fig. 6** Damages in partly stabilized *lower part* of landslide no 1

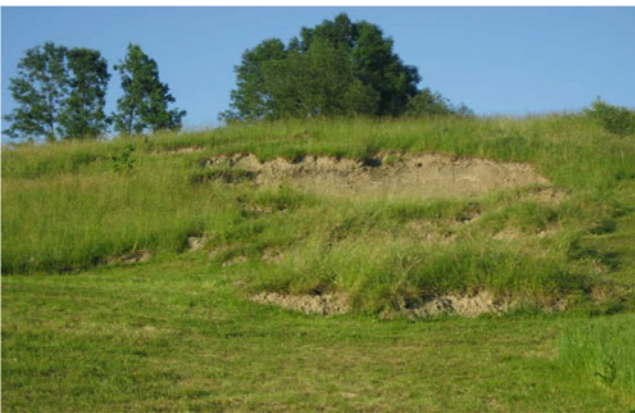
**Fig. 7** New cracks (May 2010) – *central part* of landslide no 5

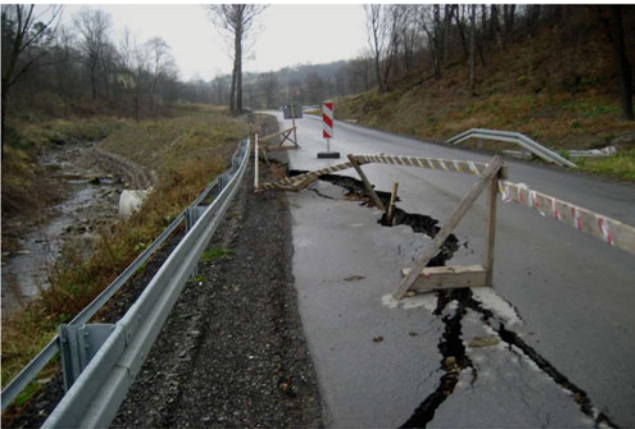
**Fig. 8** Destructions of a public road (erosion) landslide no 6

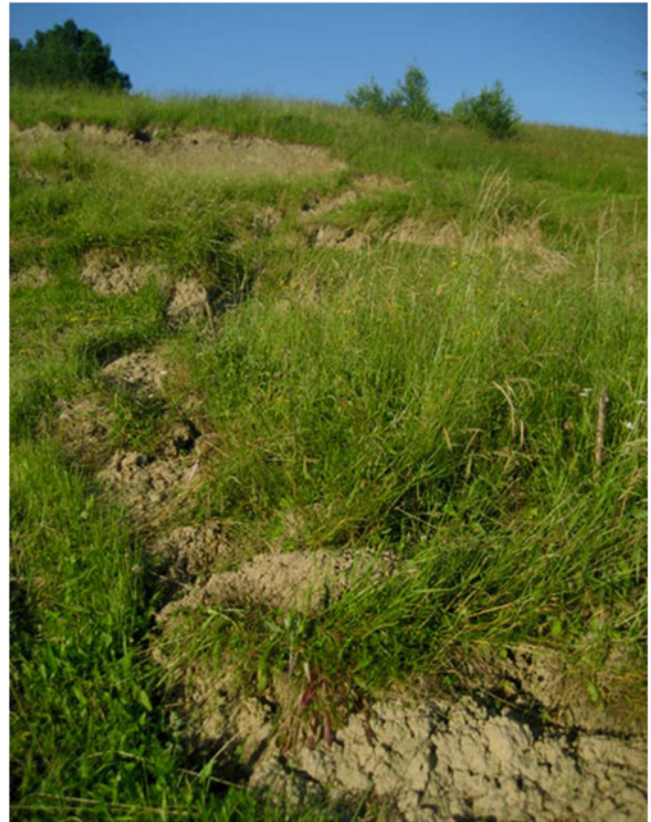
**Fig. 9** New cracks – land no 5

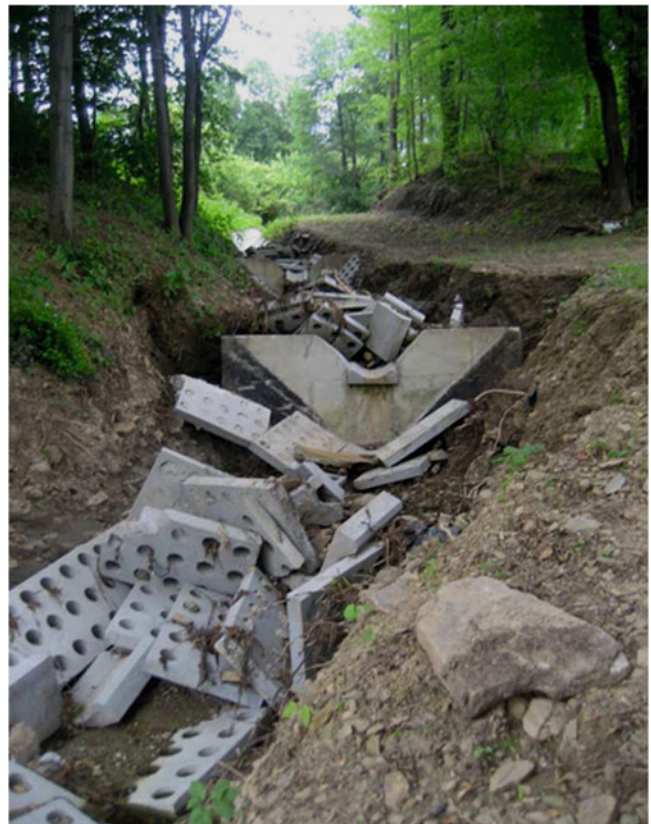
**Fig. 10** Damages of drainage system – landslide no 6

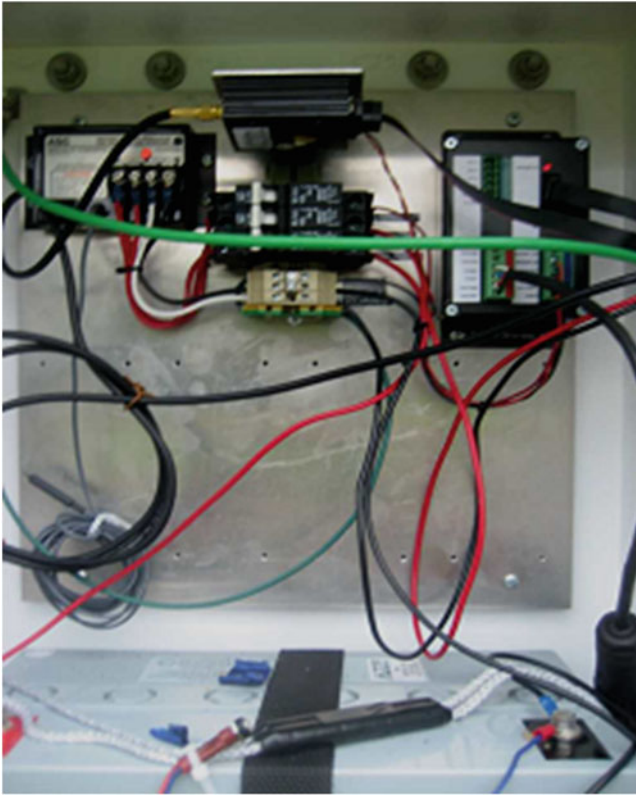
**Fig. 12** Interior of M2 Field Station

The instrumentation was proceeded by study of landslide data and input parameters. Depths of installation were chosen with respect to expected sliding surface depths and groundwater conditions. Standard inclinometer measurements and results of laboratory tests were included in the prediction. System is consisted of four stations. Three fully automated landslide monitoring field stations and the weather station. Data were stored in the loggers and transmitted using cellular GPRS network to the Internet. System was powered by batteries and solar panels (Figs. 11 and 12) (Figs. 13, 15, and 19).

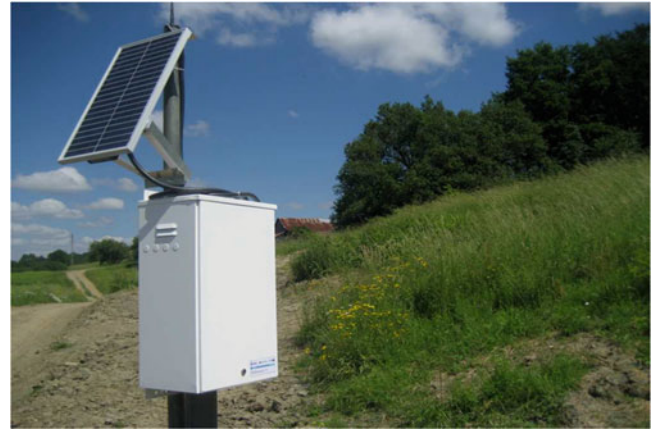
**Fig. 13** M2 Field Station on landslide no 5

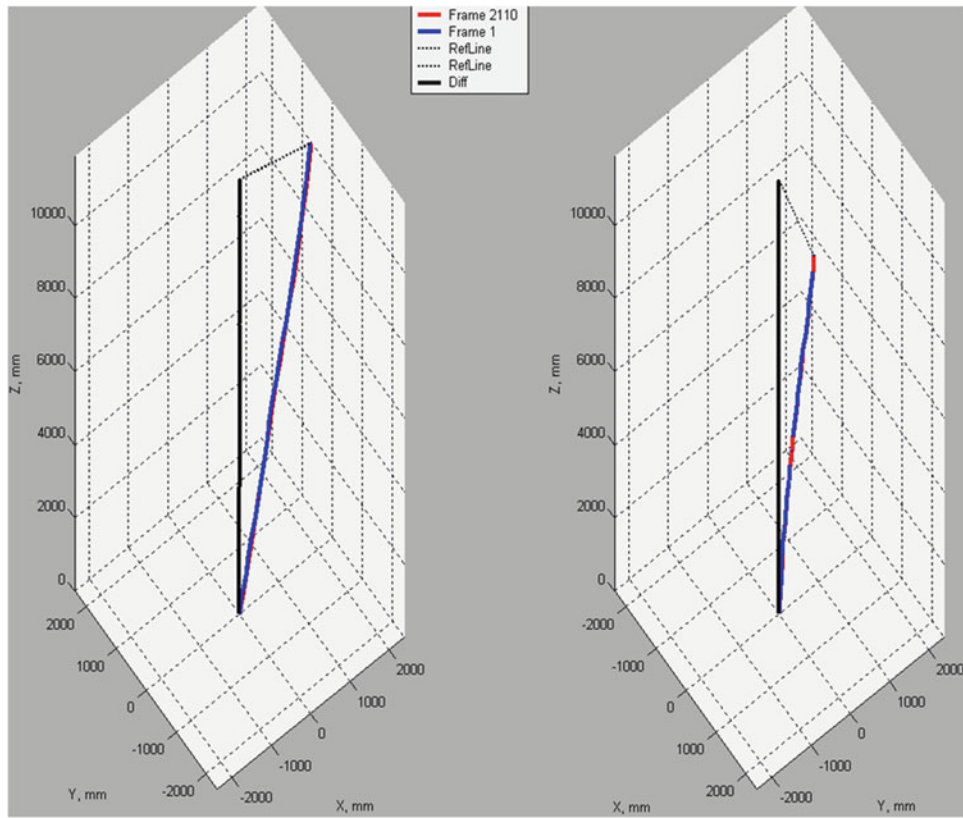
**Fig. 17** 3D displacements at M3 Field Station

Automatic monitoring measurements started in May/June 2010 and will be performed continuously till the end of 2012. Displacements will be compared with groundwater level, temperature and pore pressure readings. This measurements will be analyzed using whether station data including precipitations, temperature, air humidity and air pressure. Obtained correlations will be used for designing of early warning system and prediction of alarm stages. Preliminary results of monitoring measurements presented on Figs. 14, 16, 17, 18, 20 showed that variable displacements were registered up to 11–15 m. At M3 field station, between 24 May and 10 June 2010 displacements reached value of 1.3 cm. Sliding zone depth at that point was 12.4 m bellow natural terrain level. At M2 field station between 18 May till 7 September displacements reached 18 mm and were activated to 15 m depth, however, the largest were registered at depth of 2 m. The values of pore pressure at the landslides were very high 57–63.9 kPa. The interpretation software allowed 3D presentation of measured displacements (Figs. 17–20 and 22). It showed that displacements at M3 Field Station were rotated towards a new bridge on Bystrzanka River (Figs. 15–17).

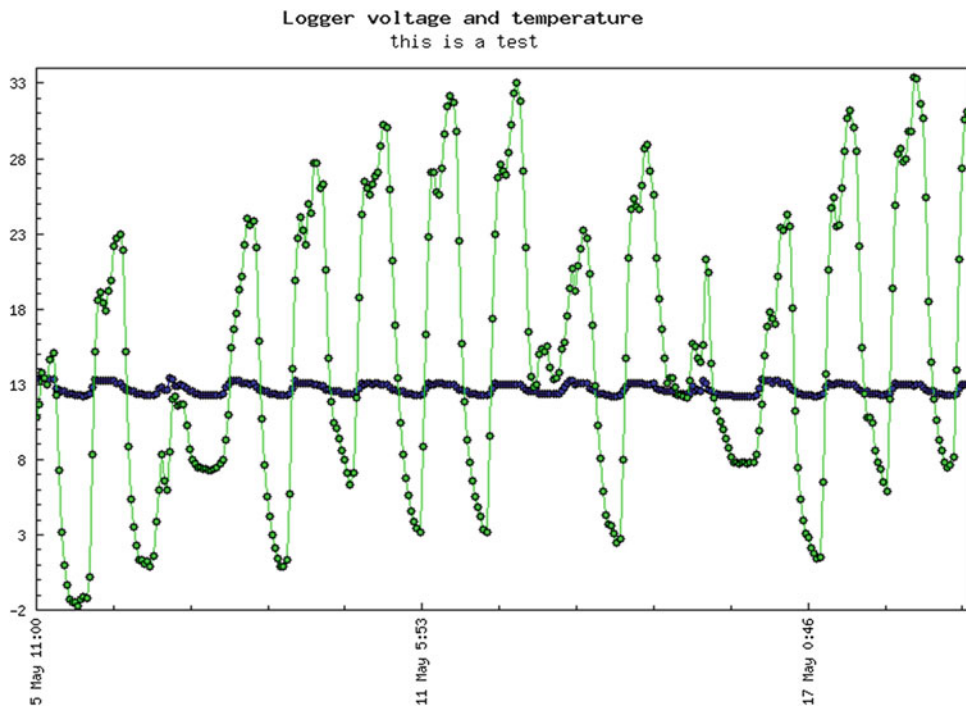
Fig. 19 M1 Field Station battery charge control

the server. Data could be edited for risk levels predictions and exported to others software's in "txt" format. Every device were calibrated for measurement depths, number of transducers and specific calibration values. Data access could be defined for various verified users. Alarms conditions could be generated by SMS messages or emails to defined users. Data stored in the loggers could be uploaded manually to a laptop PC. Earth stations were installed in waterproof enclosures and powered by high capacity battery charged additionally by solar panels in order to ensure maintains-free operation. It allows also to control power supplies (Fig. 19) and GSM signal strength. System contains:

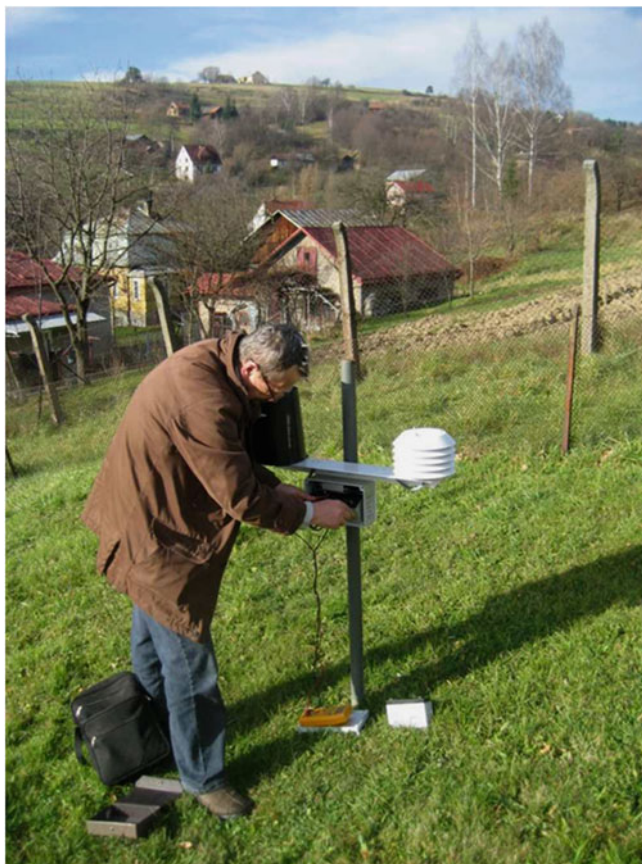
**Fig. 21** Automatic weather station

The weather conditions were investigated using automatic station installed near the border of landslide no 1 (Fig. 21). Measurements were stored in the logger and transmitted every 60 min to the Internet using GPRS network. Station enabled continuous observation of precipitations, air pressure, air temperature and air humidity values. The battery voltage and GSM signal level were also continuously controlled. This allowed prevention of data loosing. Obtained data could be exported as “txt” files or edited as a plots (Fig. 22). Since April 2011 the station is additionally powered by the solar panel.

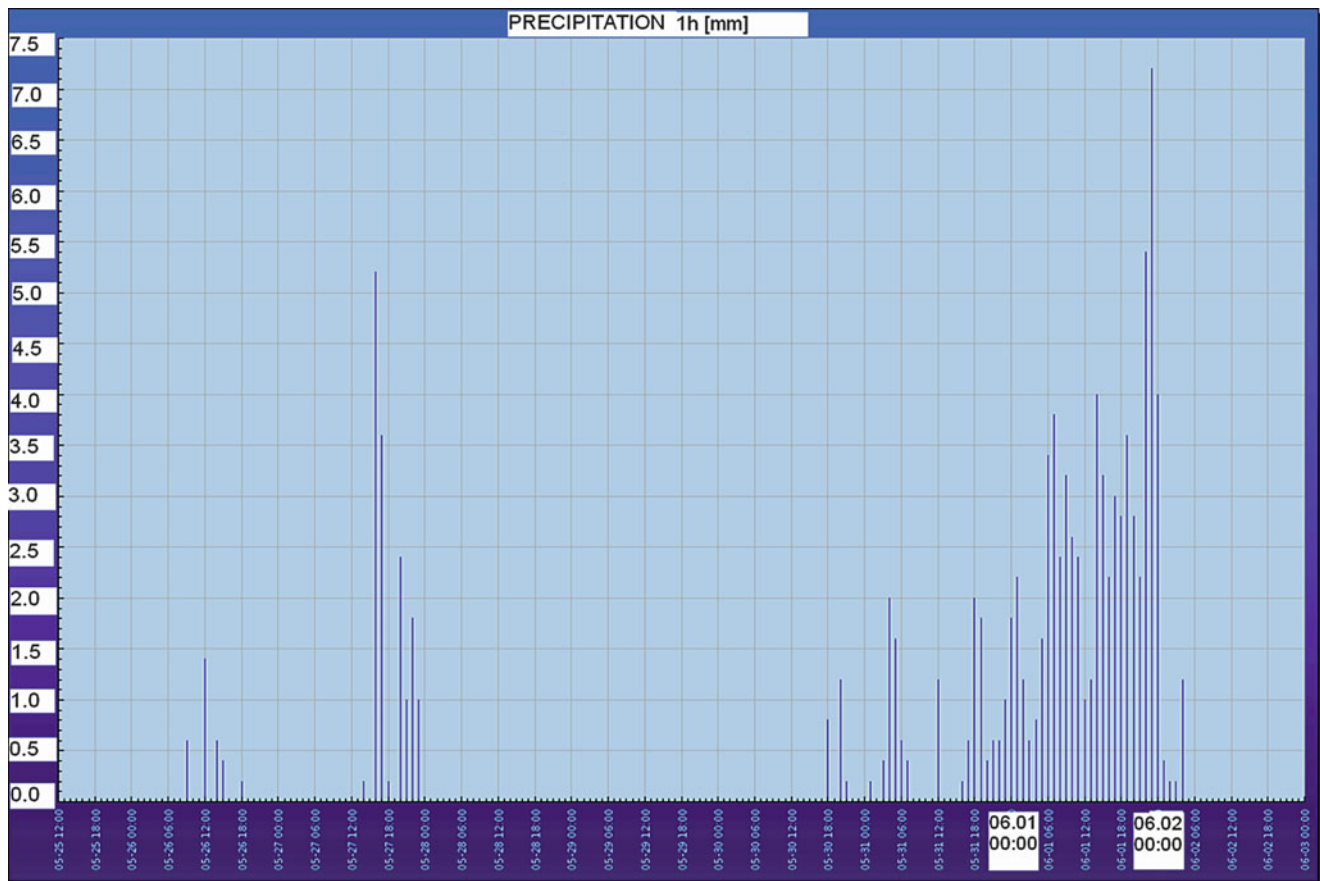
**Fig. 22** Precipitation values May/June2010

The meteorological parameters measurements has been started in May 2010 air pressure in August 2010. Exemplar daily values of precipitations are presented on Fig. 22. It allowed registration of record monthly precipitations in

May–June 2010. Detected record precipitations between June the 1 and June the 2 reached 100 mm (Fig. 22). Meteorological parameters will correlated with displacements and pore pressure data.
