Bhedetar Landslide, Eastern Nepal: Aftermath of the Sikkim Earthquake (18th September 2011)

Abstract

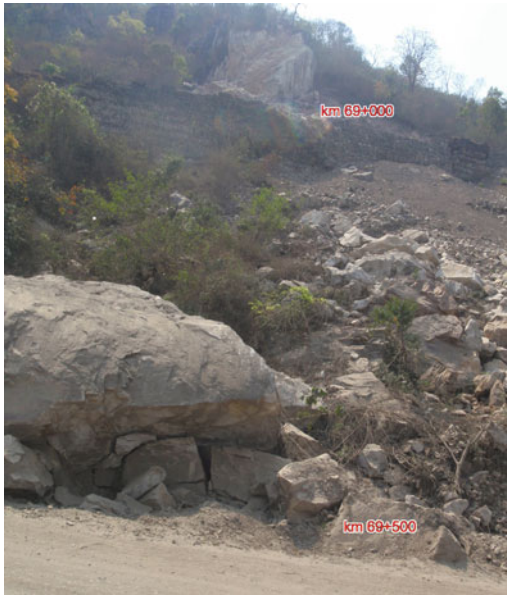
Fig. 4.2 An overview of Bhedetar landslide

The road sections at 69+000 and 69+500 chainages of the Koshi Highway is completely destroyed by the earthquake induced Bhedetar Landslide. The landslide is a rock avalanche type and is located at approximately 6 km from Bhedetar along the Koshi Highway (Fig. 4.1). Huge boulders were fallen down from the hill slope and rolled down hitting and sweeping the road surface at 69+000 chainage and damaging the road surface at 69+500 chainage located just below the 69+000 chainage (Fig. 4.2).

completely destroyed the road sections at 69+000 and 69+500 chainages of the Koshi Highway. Huge boulders were fallen down from the hill slope and rolled down hitting and sweeping the road surface at 69+000 chainage and damaging the road surface at 69+500 chainage located just below the 69+000 chainage.

The road was fully blocked for the traffic movement and pedestrians for two and half days. By concentrated efforts of the Department of Roads, District Administration Offices of Dhankuta and Sunsari, Nepal Army, Nepal Police, Armed police and all other concerned authorities, the highway was successful opened by 15:00 of 21st September, 2011. Due to various problems and emergency conditions, temporary tracks are made such that they are single lane with rough (earthen) surface. Original track at 69+000 chainage needs to be reconstructed by replacing the existing damaged retaining structures and that at 69+500 chainage is required to be rehabilitated by removing/

breaking the huge boulders on the road surface and maintaining it (DoR 2011).

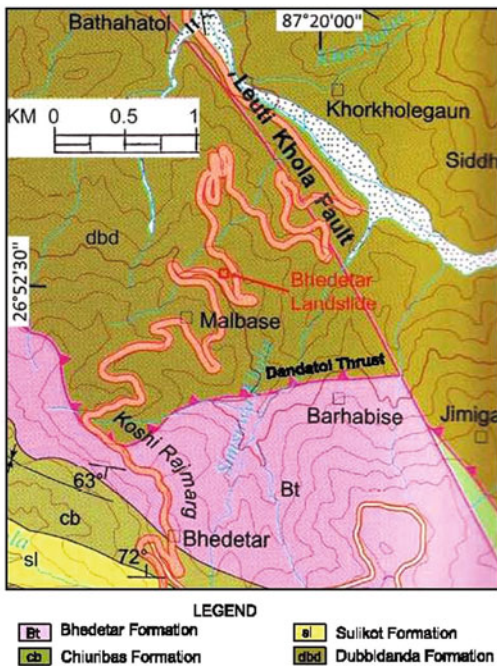
Fig. 4.3 Geological map of study area (modified after PEPP 2009)

The study area falls within the Lesser Himalayan region. Regionally, the area belongs to the Midland Group of Precambrian age (PEPP 2009), which is further subdivided into four formations, namely Dubbidanda Formation (Dbd), Sulikot Formation (Sl), Chiuribas Formation (Cb) and Bhedetar Formation (Bl). The Dubidanda Formation is represented by greenish grey quartzite with chloritic phyllite and augen gneiss. The Sulikot Formation (Sl) is composed of fine- to medium-grained grey quartzite and grey phyllite, whereas the Chiuribas Formation (Cb) contains green phyllite with grey, purple slate and grey quartzite. The Bhedetar Formation is made up of pink quartzite with purple slate and grey quartzite. The Bhedetar Landslide lies within the Dubbidanda Formation (Dbd).

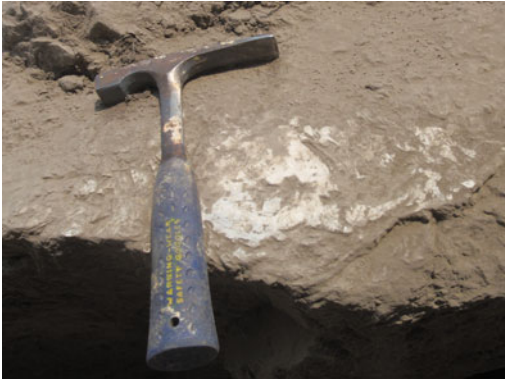
Fig. 4.5 Slicken side planes on quartzite with stations

The landslide zone from crown to toe is almost bare and is covered by debris. Around the landslide zone, the slopes are covered by small trees and bushes. Some of the boulders are fairly large (more than 8 m in length) with striation marks on slicken side planes (Fig. 4.5). The average size of boulders is 1.5 m.

The rock in the landslide zone is represented by light grey to white quartzite belonging to the Dubbidanda Formation (Dbd) of Precambrian Midland Group. The rock is massive, but with open cracks/joints. The discontinuity planes especially the foliation planes are iron stained indicating good water movement. They are slightly to moderately weathered.
