Genetic Types of Large-Scale Landslides Induced by the Wenchuan Earthquake

Q. Xu, S. Zhang and X. J. Dong

Abstract

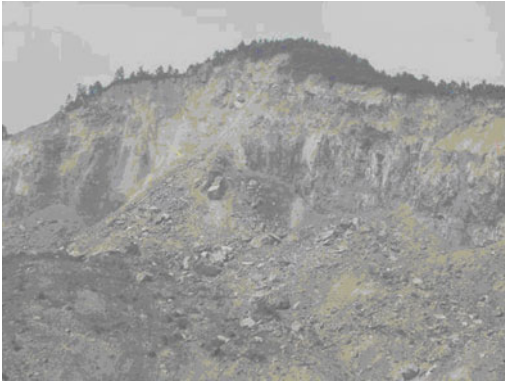
Fig. 54.1 Steep scarp with coarse cracks from Donghekou landslide, Qingchuan

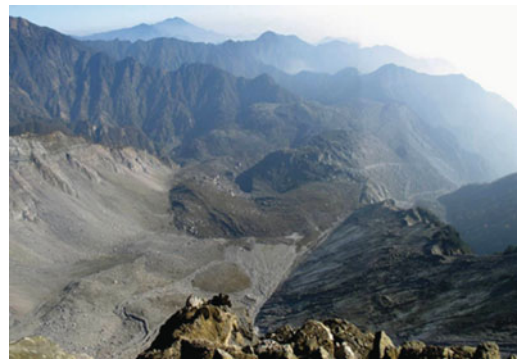
Fig. 54.6 Aerial view of Daguangbao landslide with main sliding direction of NE

The two structural surfaces combined with the free surface at E and S side can cut the rock mass into blocks (Huang et al. 2009). Under the dynamic role of the earthquake, the sliding mass is firstly depart from structure surface in the trailing edge of landslide in NW direction, then the landslide happened by taking the NE steep dip structure as the lateral crack surface and the sand soft layers as the slip surface (Figs. 54.5 and 54.6).

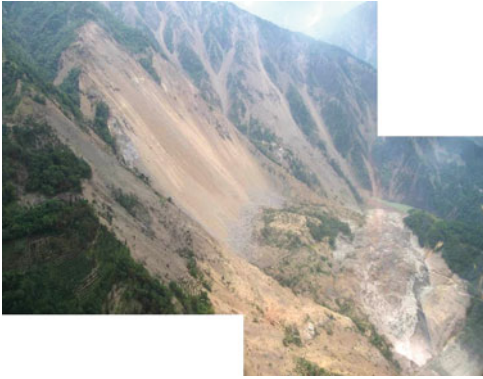
Fig. 54.7 Overview of the Tangjiashan landslide, Beichuan

Before the Wenchuan earthquake, the average slope gradient of Tangjiashan landslide is 40° , the elevation of Tangjiashan catchment is ranged from 665 to 1500 m, with a relative relief of 835 m. The landslide area is mainly underlain by mudstones and siliceous consisting the Qingping group, Cambrian. The outward bedding rock layer has the dip angle range from 50° to 85° . Weak layers of mudstone exist in the slope consist of the potential sliding surface. If the potential sliding surface was invisible, a cutting-bed surface will appear under the dynamic role of earthquake. Such phenomenon is more prone to happen in the soft rock slopes

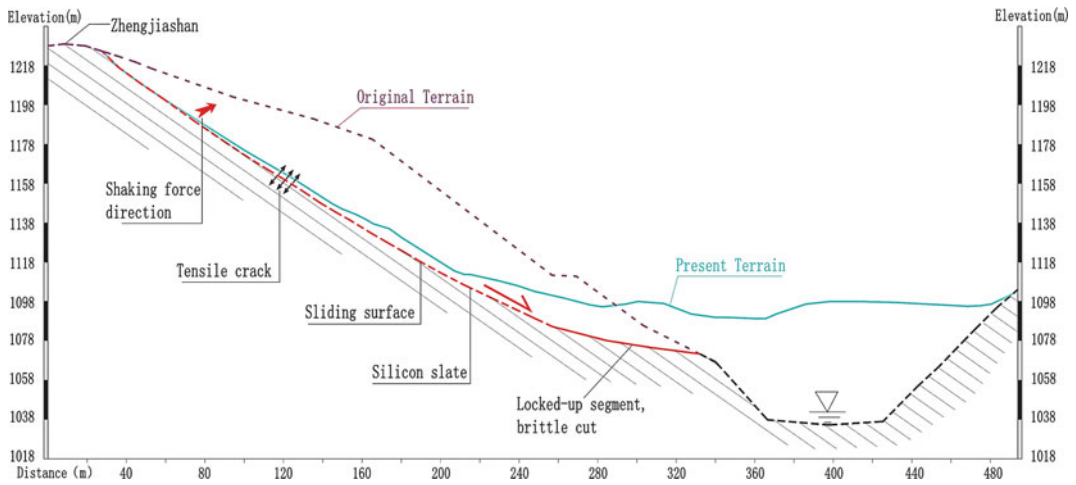
Fig. 54.8 Typical longitudinal section and genetic mode of No.1 landslide, Zhengjiashan

(Fig. 54.8), like Tangjiashan landslide and Zhengjiashan landslide in Pingwu County. If the potential sliding surface is visible at the front of the slope, landslide will happen along the direct linear sliding surface. Such phenomenon is prone to happen in hard rock slope. The occurrence of bedding slip is very common in the earthquake zone.

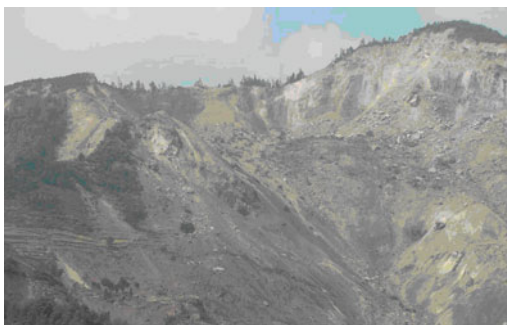
Fig. 54.10 Large scar left in the source area after Donghekou landslide

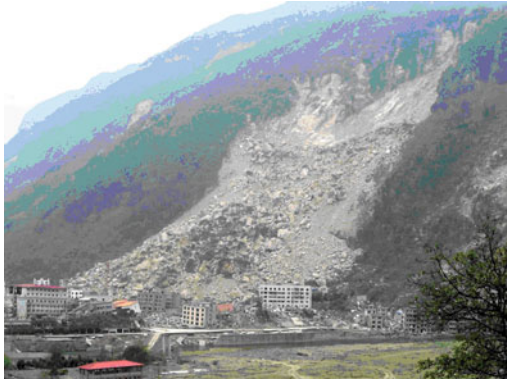
Fig. 54.11 Large blocks in the deposition zone of Beichuan new middle school landslide

A typical representative of tension-scattering sliding is Beichuan new middle school landslide (Fig. 54.11). This landslide located in the back of mountain of new district, Beichuan. Limestone of Carboniferous Yanguan group (C_{1y}) consists of the slope rock mass in the source area. Multi-group structural plane cut the slope rock into

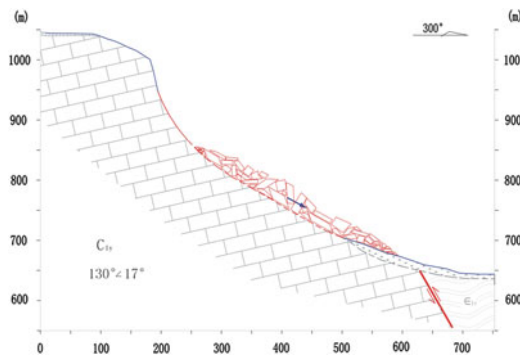
Fig. 54.12 Shattering-cracking

blocks. Therefore, numerous landslides or rock falls occurred in this area before. During the Wenchuan earthquake, the superficial rock mass of slope disintegrated and slip along one group of structural plane finally (Fig. 54.12). The accumulation zone of this type of landslide is mainly composed of granular boulder (Fig. 54.13).

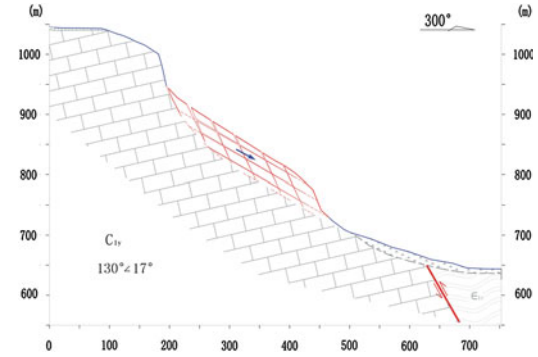
Fig. 54.13 Scattering-sliding

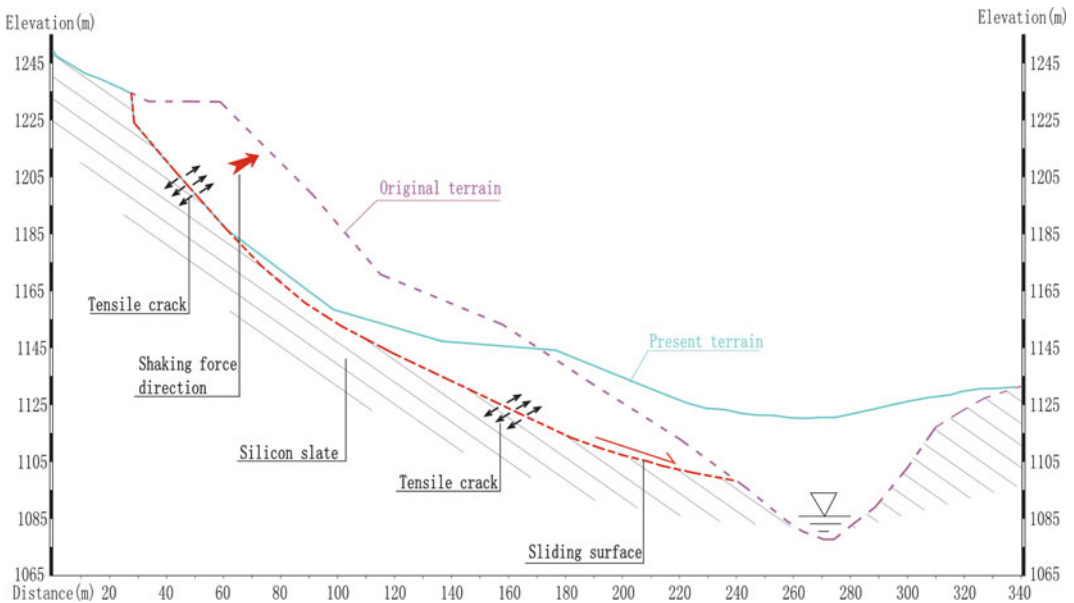
Fig. 54.15 Longitudinal section and deformation and failure mode of No. 2 landslide, Zhengjiashan
