Secondary Hazards Associated with Coseismic Landslide

Abstract

Activities in WG 3 of JLS-ELRP.

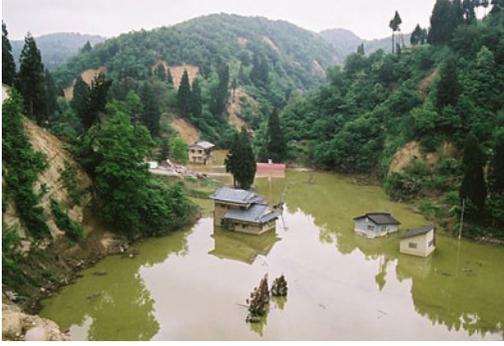
Photo 8.1 Submerged village and road by landslide dam caused by the Mid Niigata Prefecture Earthquake in 2004 (Higashi-Takezawa village, Niigata Pref., Japan) (Sakurai and Goto 2005)

In the Mid Niigata Prefecture Earthquake (2004), 55 landslide dams were formed along the Imo River. The largest dam at Higashi-Takezawa village was 30 m high and submerged upper villages and roads (Photo 8.1). As an emergency measure, the water was drained by pumps and a temporary channel, then the dam was stabilized by check dams and channel works (Ministry of Land, Infrastructure and Transport Yuzawa Office 2005).

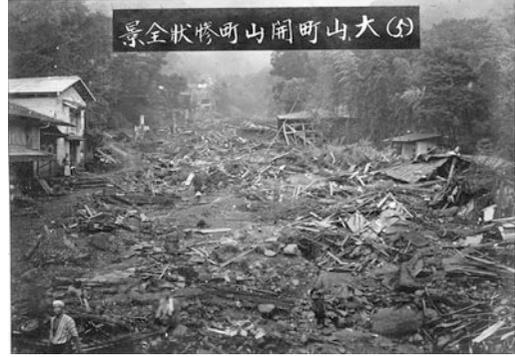
Photo 8.4 Debris flow disaster at Oyama village, Kanagawa Pref., Japan caused by heavy rain two weeks after the Kanto Earthquake (1923) (Editorial committee of Isehara municipal census 1963)

In the Kanto Earthquake on September 1 (1923), many landslides occurred in the Tanzawa mountainous district, and large amounts of debris were deposited on unstable slopes. Between September 12 and 15, heavy rains (200–300 mm in 4 days) during a typhoon induced many landslides including some serious debris flows. At Oyama village, one person was killed and 140 houses were destroyed by a large debris flow (Photo 8.4), and other villages were also damaged by other debris flows. Some post-seismic landslides also occurred in the Hakone volcanic mountainous area near Tanzawa (Nakamura et al. 2000). There was heavy rainfall throughout the Tanzawa district from north to south, including part of the Hakone area. These debris flows occur in the areas with strong ground shaking by the Kanto Earthquake.

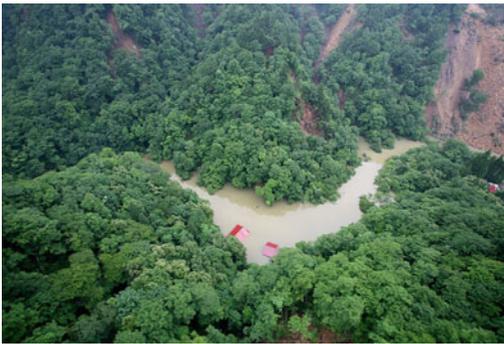
Photo 8.2 Submerged houses by landslide dam caused by the Iwate-Miyagi Nairiku Earthquake in 2008 (Yunokura village, Miyagi Pref., Japan) (taken by Okamoto T.)

In the Iwate-Miyagi Nairiku Earthquake (2008), some landslide dams submerged a hot spring hotel and some houses along the river (Photo 8.2). Many landslide dams were also formed by the Wenchuan Earthquake (2008): the largest dam created a lake more than 6 km long

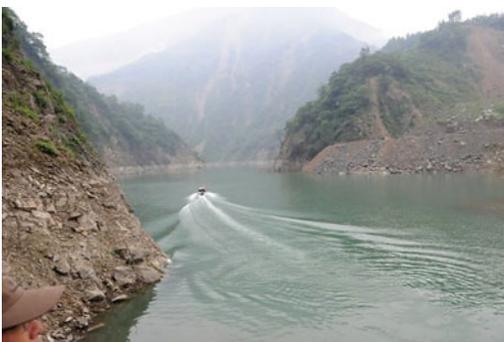
Photo 8.3 Landslide dam caused by the Wenchuan Earthquake (2008) in China (taken by Sakurai M.)

along the river (Photo 8.3) (Chigira et al. 2010). Although channel works have been constructed, long-term sediment discharge is still a concern.

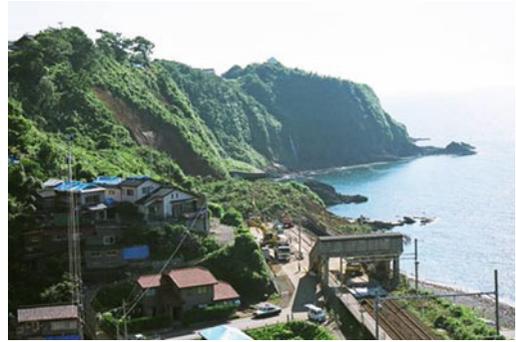
Photo 8.5 Landslide close to the Omigawa railway Station caused by the Niigata-ken Chuetsu-oki Earthquake (2007) (Niigata Pref., Japan) (taken by Sakurai M.)

In the Niigata-ken Chuetsu-oki Earthquake (2007), a landslide of 20 m width, 40 m height and 5 m depth occurred, blocking the railway track close to Omigawa Station (Photo 8.5) (JSEG Research Mission of the Niigataken Chuetsu-oki Earthquake Disaster 2007). As a result, a section of the railroad was closed for 2 months.
