# Exploitation of Thermal Imagery for the Detection of Pathologies in Monuments

Dafni Sidiropoulou-Velidou<sup>1</sup>, Andreas Georgopoulos<sup>1</sup>, and José Luis Lerma<sup>2</sup>

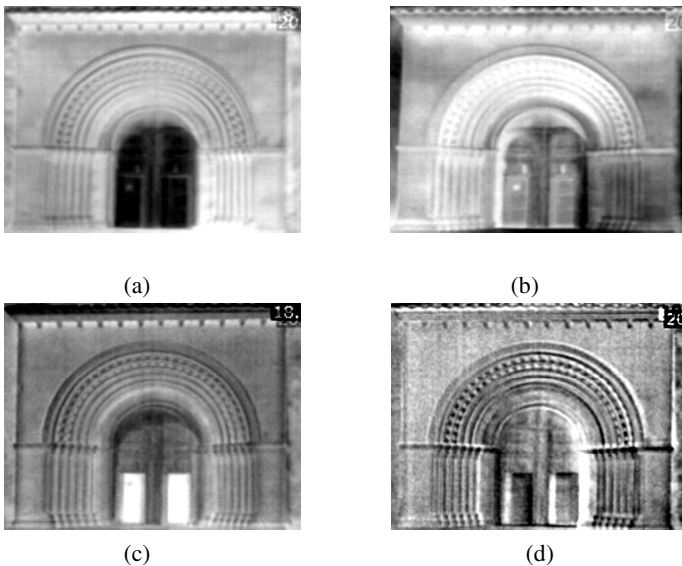
**Fig. 5.** Principal Component Analysis of the four thermal band images: a) PC1, b) PC2, c) PC3, d) PC4

The outputs (components) of the first PCA are presented in Fig. 5. In the first component, PC 1, an area on the left upper side of the wall is portrayed in different tones in comparison to the total wall structure. The same phenomenon is observed above the right horizontal cornice. Furthermore, the difference among the interior and the internal part of the door is obvious. The same areas of the stone wall and the door are distinguished in the second component, PC2, with reverse colors. However, more emphasis on differences can be found regarding alterations. The third and fourth images do not produce exploitable results: the third component yields a flat image (Fig. 5c), while the fourth component yields significant noise (Fig. 5d).

In general, equivalent phenomena stood out in both PCAs, whilst the second one provided more detailed information concerning the limits of the problematic areas.

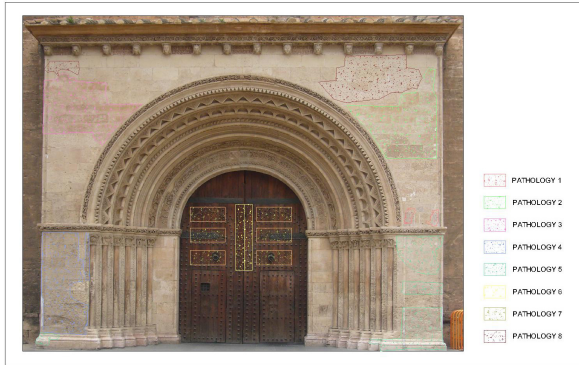
Fig. 11. Pathology information overlaid onto a visible orthoimage

The identification of the pathologies detected is reliable and their position and shape are clearly defined after the results of all previous processing steps. In derivative images, where alterations are noticed in the display of the object, the borders of problematic areas are described either clearly or more blurred, depending on the type of processing. When one problematic area appears in more than one image, then it is more likely to represent an alteration or pathology. In the step of temperature measurements, measures in various spots of these areas either confirm or reject the possibility of an existing problem. Finally, the latter results are taken into account and the areas we are interested in are defined. The limits are digitized, each time, with the help of the derivative image (PCA, classification or pseudo color image), where they are more clearly represented. This means that, different borders may be digitized on different images. All variety of polygons with pathologies and alterations are integrated and overlaid onto a visible orthoimage (Fig. 11). Thus, the position and extension of the phenomena can be easily recognized.

The results extracted from the analysis, and mostly image-based pathology plans, could form a useful tool for building technicians in restoration and reconstruction works, as well as in their inspection. Further work could be expanded with the addition of information concerning the materials found in the object. Elements such as thermal properties could help the interpretation of their responses.
