Michael M. Morlock, Gerd Huber, and Nick Bishop

1.1 Ceramic Implants for Joint Arthroplasty: Where Do We Stand?

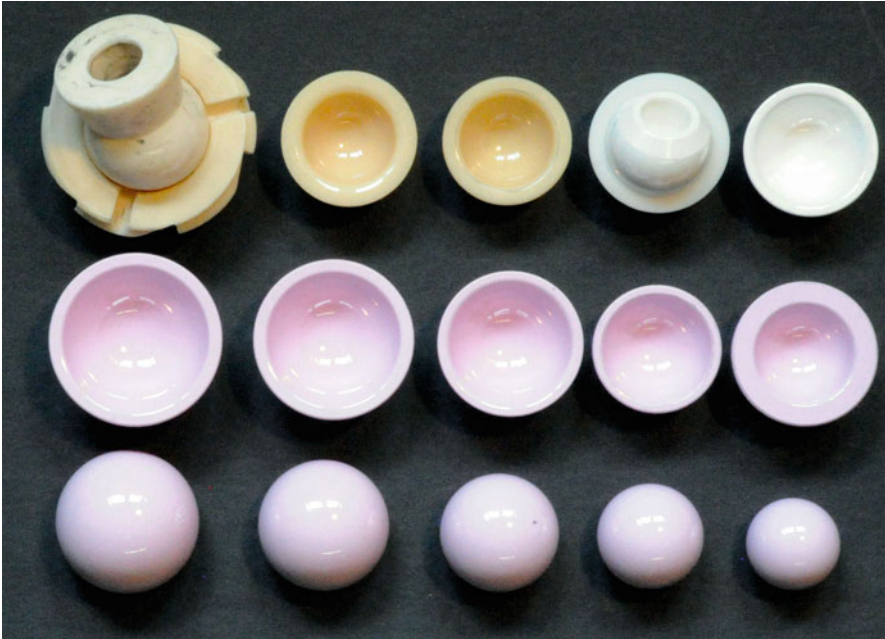
Fig. 1.1 The three generations of ceramics used in hip arthroplasty as bearing materials: (*top left to bottom right*) first-generation BIOLOX® threaded cup Ø 38 mm, second-generation BIOLOX® forte Ø 28 mm (*thick and thin inlay*), third-generation ceramys® Ø 28 mm (*thick and thin inlay*), BIOLOX® delta Ø 44, 40, 36, 32, 28 mm

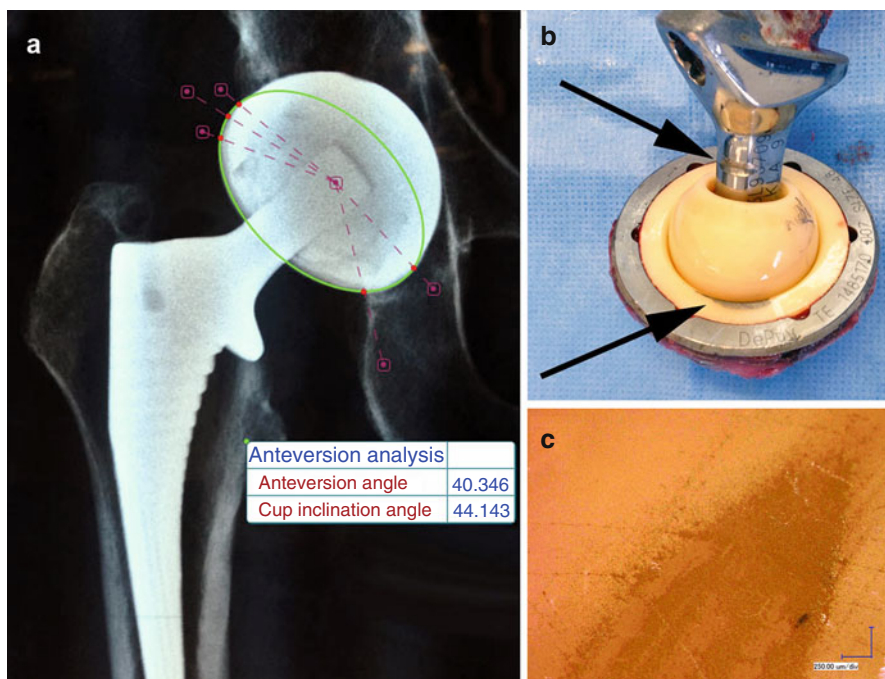
Fig. 1.7 Impingement situation. (a) The X-ray shows a large cup anteversion (estimated with the IMATRI.org software). (b) Due to the large anteversion of the cup, the neck of the prosthesis stem impinges on the inferior edge of the ceramic inlay during full extension. This causes metal transfer to the insert (*bottom arrow*) and damage to the stem (*top arrow*). (c) Stripe wear (grain breakout) on the bearing surface on the top of the ceramic head caused by the subluxation due to the impingement between stem and cup (Courtesy of Tarik Ait Si Selmi)

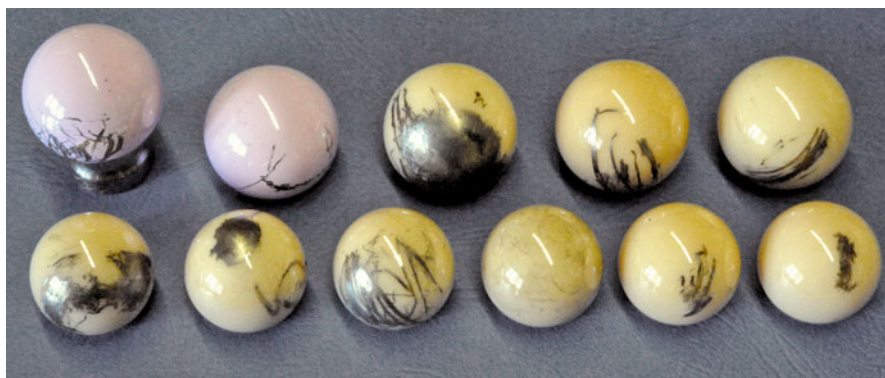
Fig. 1.8 Examples for metal transfer to ceramic heads (Courtesy of Hartmut Kiefer)

Another issue related to component positioning is metal transfer from the cup to the ceramic head (Fig. 1.8). Insert designs with an elevated rim, or ceramic insert
