# Infrared Thermography Application in Buildings Diagnosis: A Proposal for Test Procedures

E. Barreira, S. S. de Freitas, V. P. de Freitas and J. M. P. Q. Delgado

**Keywords** Infrared thermography · Building materials · Building envelopes · Test procedures

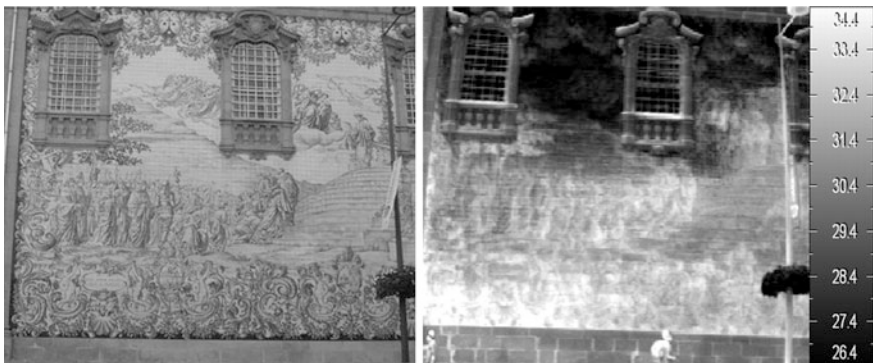
**Fig. 1** Visible image and thermogram of the Carmo Church's façade covered with "azulejos" (ceramic tile) in Porto, Portugal

Infrared thermography (IRT) can be defined as the science of acquisition and analysis of data from non-contact thermal imaging devices. The process of thermal imaging was simplified over the years with the availability of efficient, high resolution infrared cameras that convert the infrared radiation emitted from bodies into thermal images [1], the thermograms, showing the body's superficial temperature distribution [2]. In this process, each shade expresses a specific temperature range (see Fig. 1).

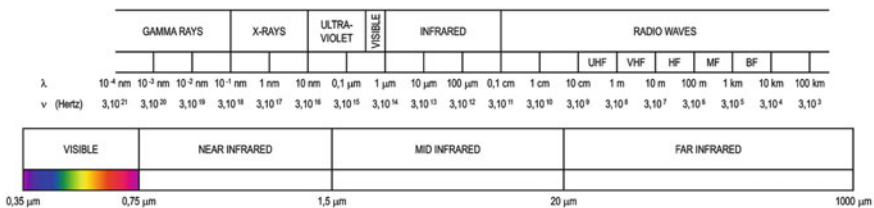
Fig. 2 Electromagnetic spectrum

Infrared energy is part of the electromagnetic spectrum. It travels through space at the speed of light and can be reflected, absorbed and emitted. The wavelength ( $\lambda$ ) of infrared energy is between 0.75 and 1,000  $\mu\text{m}$ . It can be divided into three parts: near-infrared, from 0.75 to 1.5  $\mu\text{m}$ , mid-infrared, from 1.5 to 20  $\mu\text{m}$  and far-infrared, from 20 to 1,000  $\mu\text{m}$  (see Fig. 2).

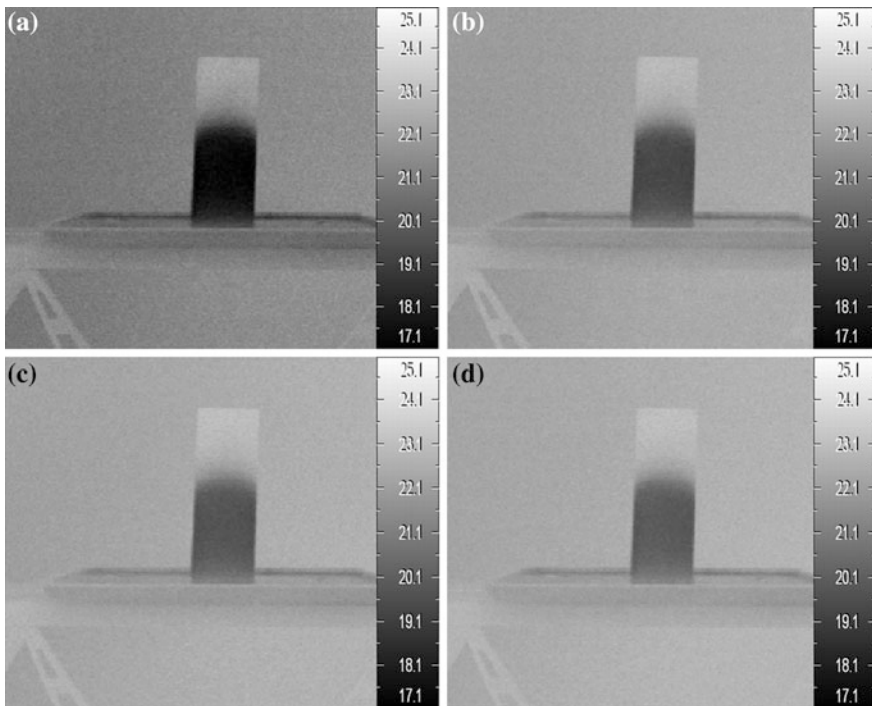
**Fig. 3** Thermograms of a cellular concrete specimen during absorption phase obtained with different emissivities: **a**  $\varepsilon = 0.62$ . **b**  $\varepsilon = 0.85$ . **c**  $\varepsilon = 0.91$ . **d**  $\varepsilon = 0.95$

One of the laboratory test consisted of partially immersing a specimen of cellular concrete in water followed by a drying period. The test was performed under steady state conditions, inside a climatic chamber. Thermal images were obtained using four different values of emissivity: 0.62, 0.85, 0.91 and 0.95.

As expected [3, 9–11], the results showed that emissivity variation induced changes in the thermal images, during absorption (see Fig. 3). By looking at the thermal images it was possible to say that the images obtained with emissivity 0.62 were quite different from the remaining ones. The differences between the other thermograms (emissivity's 0.85, 0.91 and 0.95) were not very significant [12].

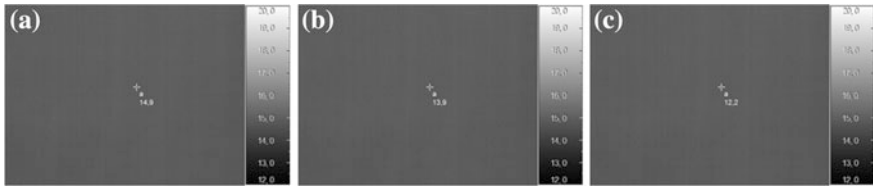
**Fig. 4** Thermograms of lime stone specimen obtained with different emissivities: **a**  $\epsilon = 1.00$ ,  $T_{\text{measured}} = 14.9 \text{ }^\circ\text{C}$ . **b**  $\epsilon = 0.80$ ,  $T_{\text{measured}} = 13.9 \text{ }^\circ\text{C}$ . **c**  $\epsilon = 0.60$ ,  $T_{\text{measured}} = 12.2 \text{ }^\circ\text{C}$

Another laboratory test consisted of measuring the surface temperature of a lime stone sample in hygrothermal equilibrium with the environment. Thermal images were obtained using three different values of emissivity: 0.60, 0.80 and 1.00. The surface temperatures measured at the same point on the specimen vary considerably according with the emissivity (see Fig. 4). For the lower values of emissivity, the changes in surface temperature of the lime stone specimen were greater than 1.5 °C: with emissivity of 0.60, the obtained surface temperature was 12.2 °C; with emissivity of 0.80, the surface temperature obtained was 13.9 °C and with emissivity of 1.00, the surface temperature obtained was 14.9 °C.

These tests showed that if a quantitative evaluation is intended, the emissivity values must be precisely determined. However, if the study aims for a qualitative evaluation of the results, the selected emissivity value is not very important. Nevertheless, a judiciously selected emissivity value may simplify the interpretation of the thermal image.

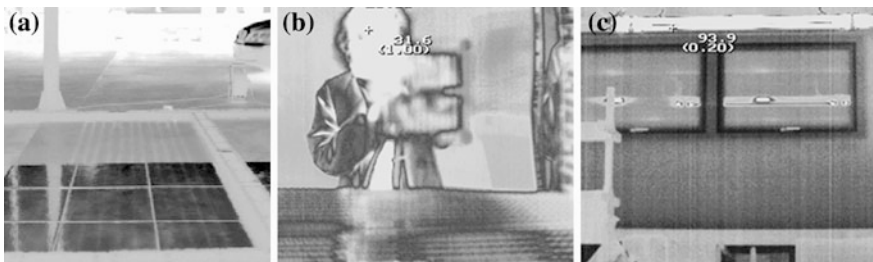
**Fig. 5** Importance of reflective surfaces on thermographic measurements: **a** effect of reflectivity on the thermal image of a ceramic floor. **b** reflection of the operator on a metallic surface. **c** reflection of a light bulb in a window

Several examples of reflection are presented in Fig. 5: (a) effect of reflectivity on the thermal image of a ceramic floor - the hotter area in the bottom left of the image results from the ceramic surface’s thermal reflection [13]; (b) reflection of the operator on a metallic surface; (c) reflection of a light bulb in a window.

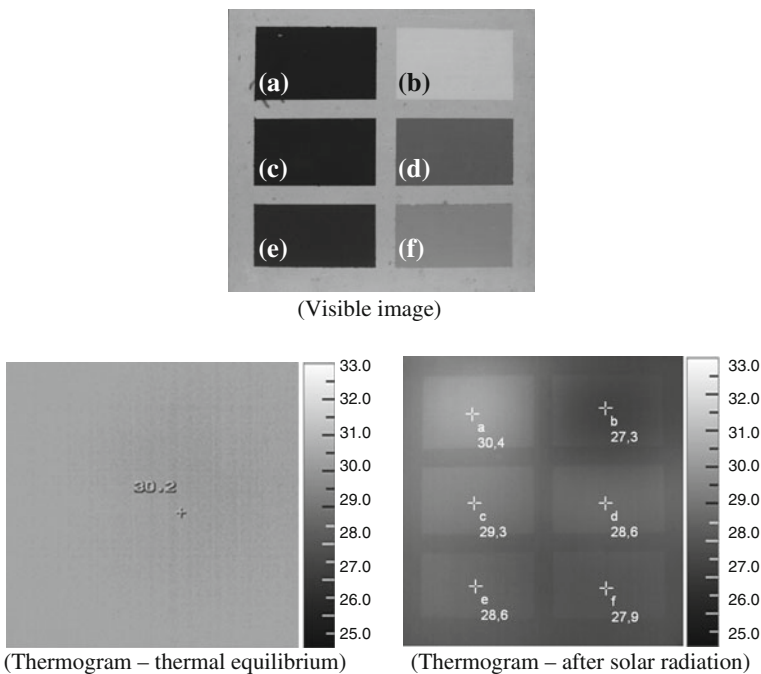
**Fig. 6** The effect of absorptance on different colours of the surface: **a** black, T(after solar radiation) = 30.4° C. **b** white, t(after solar radiation) = 27.3° C. **c** dark blue, T(after solar radiation) = 29.3° C. **d** green, T(after solar radiation) = 28.6° C. **e** red, T(after solar radiation) = 28.6° C. **f** yellow, T(after solar radiation) = 27.9° C

The other test that was performed consisted on painting a lime stone sample using different colours and assessing the effect of absorptance (see Fig. 6: (a) black (b) white, (c) dark blue, (d) green, (e) red, (f) yellow). Thermograms were taken with the sample in thermal equilibrium with the environment and no temperature differences were detected in the thermal image. However, after the exposure of the sample to solar radiation, the surface temperatures measured on different colours were quite different. Black and dark blue presented the highest temperatures, followed by green and red, yellow and, finally, white.

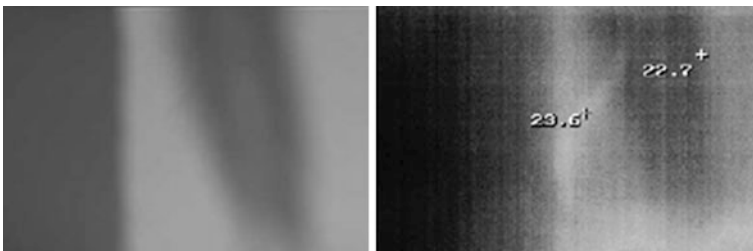
**Fig. 8** Influence of shadows (visible image and thermogram)

The existence of shadows on the building, resulting from the presence of other buildings, trees or other neighbouring elements can lead to wrong conclusions (see Fig. 8). Also moist surfaces, after rain fall, may affect the interpretation of the results if not taken into account (see Fig. 9). Moreover, thermography is hardly applied when objects are in thermal equilibrium and without any thermal gradient (see Fig. 10).

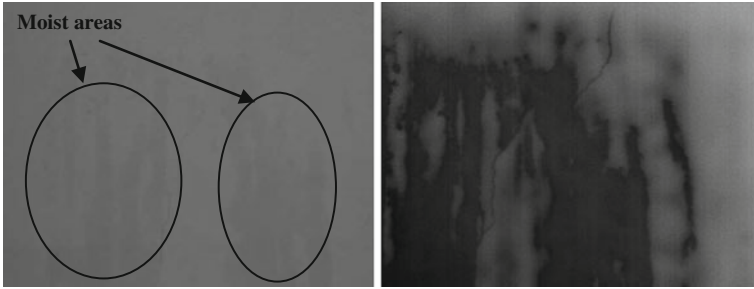
**Fig. 9** Influence of moist surfaces, after rain fall (visible image and thermogram)

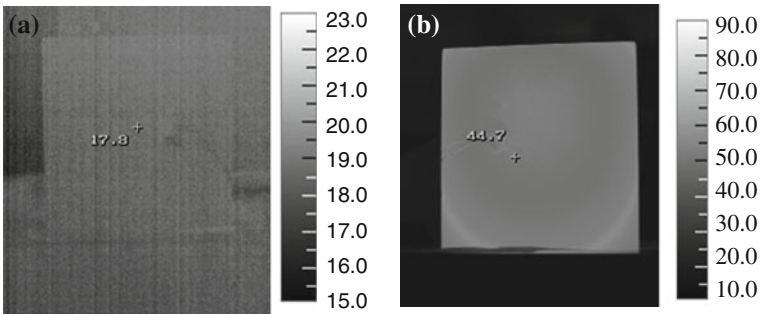
**Fig. 10** Influence of thermal gradient: **a** sample in equilibrium with the environment and **b** sample with higher temperature than the environment

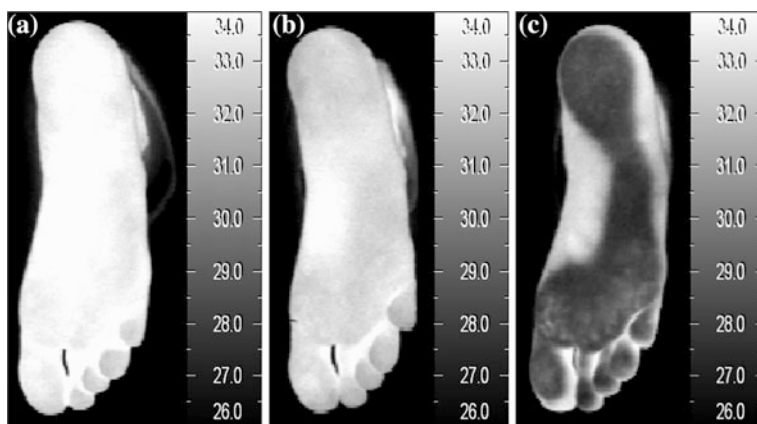
**Fig. 11** Assessment of comfort of interior floor coatings: **a** standard temperature. **b** after being in contact with carpet. **c** after being in contact with granite

The comfort of interior floor coatings is very important for the well-being of building users, especially in bedrooms and bathrooms where people commonly walk barefoot. Although comfort depends on floor and environmental temperatures, it is also determined by the material's thermal characteristics, namely, thermal diffusivity and effusivity. Infrared thermography can be used to evaluate the comfort of interior floor coatings by comparing effects from barefoot contact with different materials [12,15,16] (see Fig. 11).

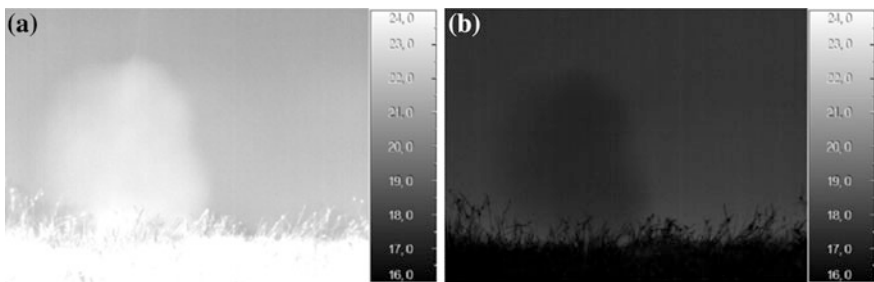
**Fig. 12** Detachments observed with sunlight falling on the façade at: **a** 4.30 pm and **b** 11.30 pm

The detection of detachments in real building façades is also possible using the solar radiation as a heat source (see Fig. 12).

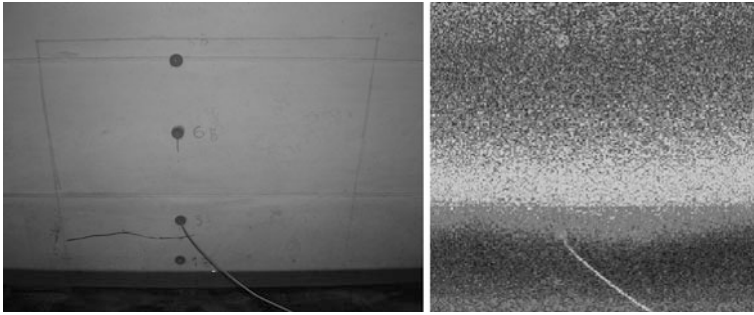
**Fig. 13** Moisture detection (rising damp—visible image and thermogram)

Rising damp on walls can also be detected by infrared thermography. The water level in the wall is detected due to superficial temperature variation, which is a result of evaporation at the wetted surface (see Fig. 13).

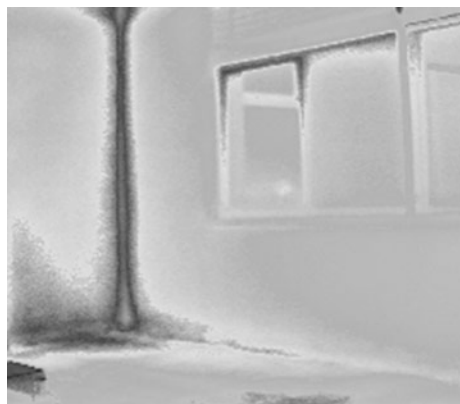
**Fig. 14** Thermal bridge in a building detected by IRT

significantly heat loss through buildings components, especially with higher insulation levels (see Fig. 14).

As showed by Balaras and Argiriou [22], taking an outdoor thermogram of the structural component during winter, thermal bridges appear as light coloured areas because the heat losses from the indoor heated space cause a temperature increase. An indoor thermogram of the component during summer will show a similar image as a result of the absorbed solar heat gains from the external surface that are conducted through the building materials.

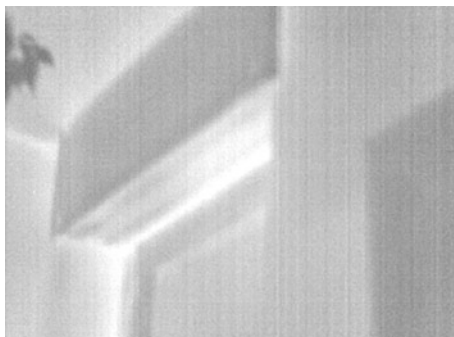
**Fig. 15** Air leakage through window detected by IRT

increases heat losses in winter and heat gains in summer, thus, increasing both heating and cooling loads. A common location for air infiltration is around a window or a door frame. Infrared thermography is commonly used with a blower door test running. The blower door helps exaggerate air leaking through defects in the building shell and such air leaks are detected by the infrared camera (see Fig. 15).

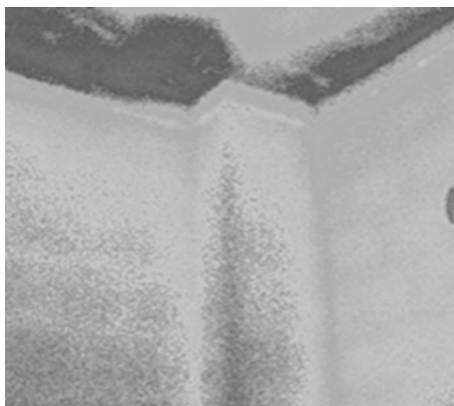
**Fig. 16** Missing insulation detected using IRT

Infrared thermography allows checking the effectiveness of insulation in a building [3,28]. Thermal insulation reduces heat losses by conduction through the building envelope (*i.e.* walls, roofs) during winter and heat gains during summer. Missing or damaged insulation can be located by infrared cameras (see Fig. 16). According to Balaras and Argiriou [22] when the thermogram indicates a temperature difference of about 11 °C between the internal and external surface temperature that could indicate problems with the thermal insulation.

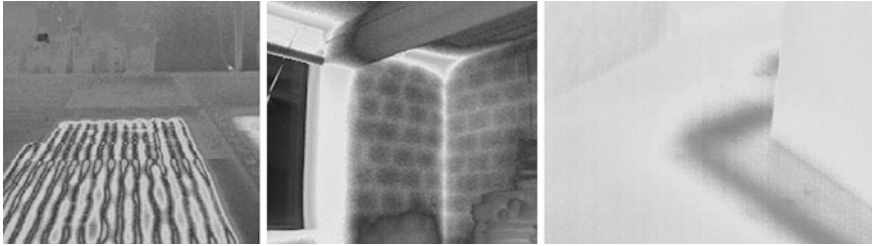
**Fig. 17** Detection of “hidden details” using IRT

Infrared thermography can be used to detect “hidden details”, as subsurface pips, ducts, wall ties, thermal resistances from radiant floors, etc. (see Fig. 17).

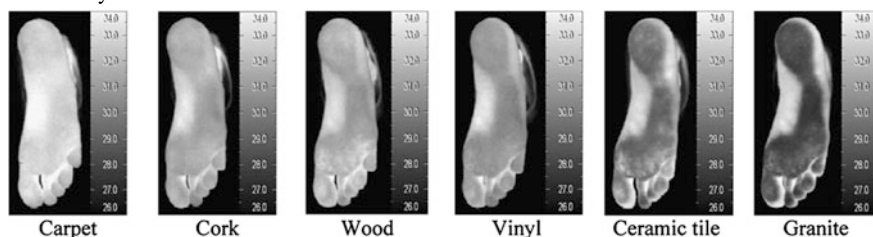
Thermograms after 1 min of contact

**Procedure** The comfort is evaluated qualitatively by comparing a reference thermogram of the foot surface temperature with two thermograms made after two contact times (1 min to assess initial discomfort and 2 min to study discomfort progress over time). Six samples of floor coatings (carpet, cork, vinyl, wood, ceramic tile and granite) were used

Comfort of floor coatings	
Results	<p>Different temperatures were obtained for the six samples that result from the different thermal characteristics of the materials related to the propagation of heat. These heat exchanges are a function of the thermal diffusivity (the higher its value, the quicker the propagation and greater the heat flow through the material) and the thermal effusivity (reflecting the ability to absorb or store heat). The heat transfer between the foot and the material will be faster with higher values of the effusivity and thermal diffusivity</p> <p>The surface temperature of the foot is always lower than the reference thermogram and it was observed that the initial contact is more comfortable with carpet followed by cork, wood, vinyl, ceramic and, finally, granite. With the increased contact time for 2 min, the thermal equilibrium is approaching and the discomfort is attenuated. An increase in the surface temperature of the foot is observed without significant differences for carpet, vinyl, wood and cork. For ceramic and granite the temperatures are lower</p>

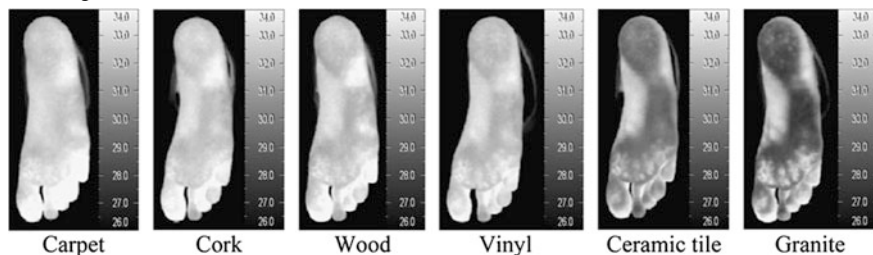
Thermograms after 2 min of contact

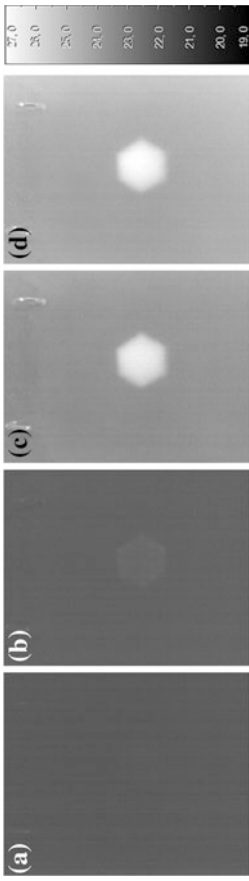
Thermograms in the heating phase: (a) without heating, (b) start of heating, (c) 10 min. after start of heating, (d) 30 min. after start of heating

<b>Detection of Detachments</b>	
Results	<p>Defects are generally identified by differences in surface temperature between areas with and without pathologies. The detachments create an air layer and thermal resistance to heat flows, which enables the temperature differential to be assessed</p> <p>Two phases can clearly be distinguished. In the heating phase, the thermal resistance caused by detachment impedes the absorbed heat from reaching the interior, which means that the surface temperature is higher in the detachment. In contrast, in the cooling phase, the heat absorbed by the façade is prevented from reaching the surface, which means that surface temperatures are lower in the detachment, due to the reduction in thermal capacity</p> <p>The following results were obtained:</p> <ul style="list-style-type: none"> <li>• Laboratory Tests—The physical model used for the laboratory tests enabled the qualitative assessment of the detachments artificially created in three samples when subjected to action from a heat source. It was found that the defect created was clearly visible through dynamic thermography. In the cooling phase, although the temperature difference between the detachment and zone without detachment was smaller, the detachment was also observable</li> <li>• “In situ” Tests—In the morning, when the sun does not heat the façade, the detachment is not visible. At around 3 pm, when solar radiation is at its peak, the detachment is perfectly visible, showing higher temperatures than those on the zone of the façade without detachments. On the other hand, when the façade is cooling, the detachment zone cools faster, and is therefore distinguished by lower temperatures</li> </ul> <p>The tests carried out “in situ” produced results that were consistent with those of the laboratory tests. These tests prove that the application of thermography in real situations leads to positive results in the diagnosis of the pathology in analysis</p> <p>Laboratory tests—Thermo tracer TH 7,800 (measurement accuracy: <math>\pm 2\%</math> or <math>\pm 2\text{ }^{\circ}\text{C}</math>; resolution: <math>0.05\text{ }^{\circ}\text{C}</math> to <math>0.1\text{ }^{\circ}\text{C}</math> for a range of <math>-20\text{ }^{\circ}\text{C}</math> to <math>100\text{ }^{\circ}\text{C}</math>; <math>752\text{ (H)} \times 480\text{ (V)}</math> pixels and a spectral band of <math>8\text{--}14\text{ }\mu\text{m}</math>)</p> <p>“In situ” tests—Thermo tracer TH 9,100 (measurement accuracy: <math>\pm 2\%</math> or <math>\pm 2\text{ }^{\circ}\text{C}</math>; resolution: <math>0.02\text{ }^{\circ}\text{C}</math> to <math>0.06\text{ }^{\circ}\text{C}</math> for a range of <math>-20\text{ }^{\circ}\text{C}</math> to <math>100\text{ }^{\circ}\text{C}</math>; <math>320\text{ (H)} \times 240\text{ (V)}</math> pixels, and a spectral band of <math>8\text{--}14\text{ }\mu\text{m}</math>)</p>

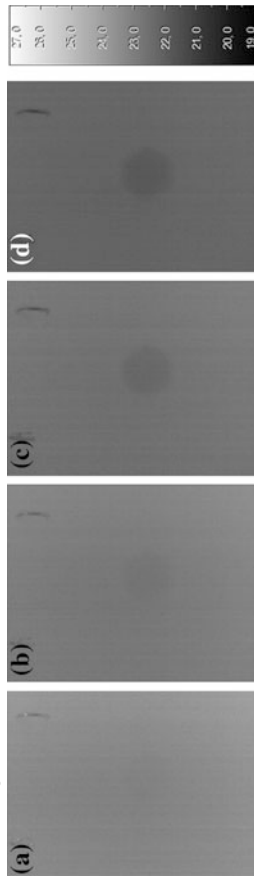
Thermograms in the cooling phase: (a) 10 min. after heating switched off, (b) 20 min. after heating switched off, (c) 40 min. after heating switched off, (d) 70 min. after heating switched off

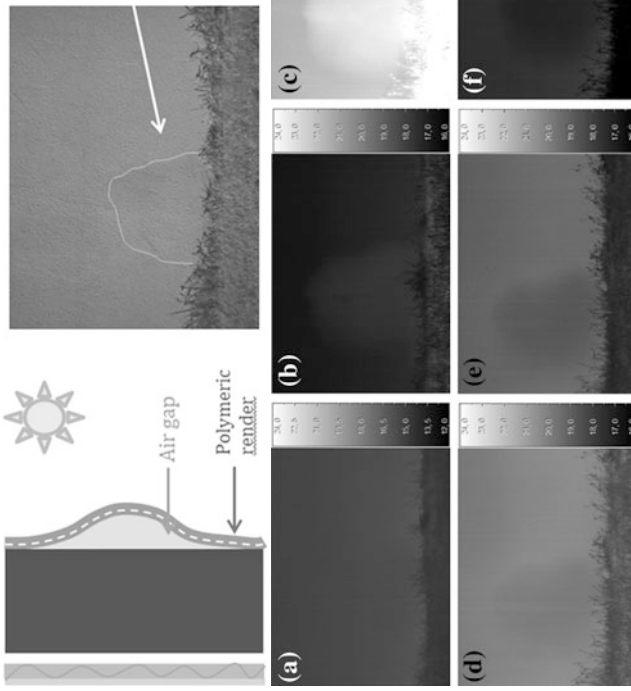
Thermograms taken “in situ” during an October day: (a) 9.30 am (b) 12.30 pm (c) 4.30 pm (d) 5.30 pm (e) 6.30 pm (f) 11.30 pm

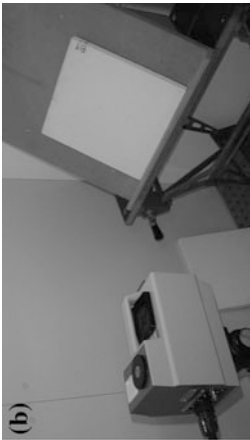
(A) Capillary absorption and (B) wetting and drying processes	
Laboratory tests—Results

(A)	The test carried out demonstrated that it was possible to visualize superficial temperature variations due to rising capillarity. Moreover, it was recorded faster drying at the top and vertical edges of the specimen. At the end of the test, the superficial temperature of the specimen was uniform and the moisture distribution was not perceptible

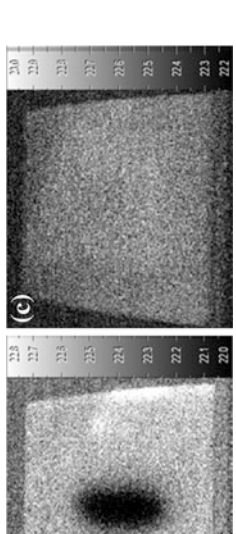
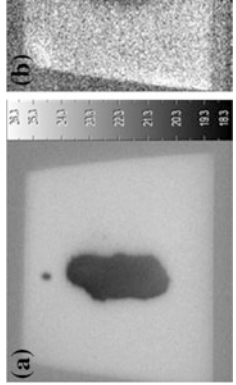
<p>(c)</p>
<p>(B) Wetting and drying processes: (a) Specimen after 48 h of drying and (c) Specimen at the end of the drying period</p>		
<p>Objective Detection of capillary absorption and wetting and drying processes</p>		
<p>References [15, 30, 31]</p>		
<p>Procedure Two experiments were carried out:</p>		
<p>(A) A cellular concrete specimen (<math>70 \times 70 \times 200 \text{ mm}^3</math>) was tested inside a climatic chamber under steady state conditions (<math>T = 20 \text{ }^\circ\text{C}</math> and <math>\text{RH} = 60 \%</math>). The emissivity value considered was 0.85 and the specimen was kept on water for 407 h after which the drying period started</p>		
<p>(B) Two cellular concrete specimens (<math>300 \times 300 \times 20 \text{ mm}^3</math>) were tested inside a climatic chamber with 4 different conditions:</p>		
<p>(1) <math>T = 20 \text{ }^\circ\text{C} + \text{RH} = 60 \%</math></p>

(B)	After one hour of wetting a stained area was clearly detected. At the end of 48 h of drying, the colder area decreased. During the drying phase the specimen achieved the thermal equilibrium with different drying periods. An approximation of the drying times was made but only for superficial moisture
Equipment	Thermo tracer TH1 101 (measurement accuracy: $\pm 0.5$ °C ; resolution: 0.1 °C and spectral band: 8–13 $\mu\text{m}$ )
Critical analysis	The damages caused by moisture are a common problem that affect buildings. The detection of moisture in building components using thermography underlies in the physical principle of evaporative cooling of the surface, as surface temperature variation due to the phase change of water is significant
	It is possible to evaluate the wetting and drying process of building materials. However, it may not always be reliable and a quantitative approach can be difficult to implement. The goal is to highlight on the surface the areas related to a certain range of the evaporation rate
