A Comparative Analysis of Detecting Bearing Fault, Using Infrared Thermography, Vibration Analysis and Air-Borne Sound

Nikolaos G. Athanasopoulos and Pantelis N. Botsaris

Abstract A comparative analysis has been performed as an effort to obtain a better idea of how the fault is appearing over a rolling bearing. In this paper are presented the results of this analysis between three methods of detecting faults on bearings: infrared thermography, vibration analysis and air-borne sound. Those methods are applied on a specific rolling bearing and developed on an experimental set up. The conducted experiment depicted that this comparison is feasible as the results of each method are relevant.

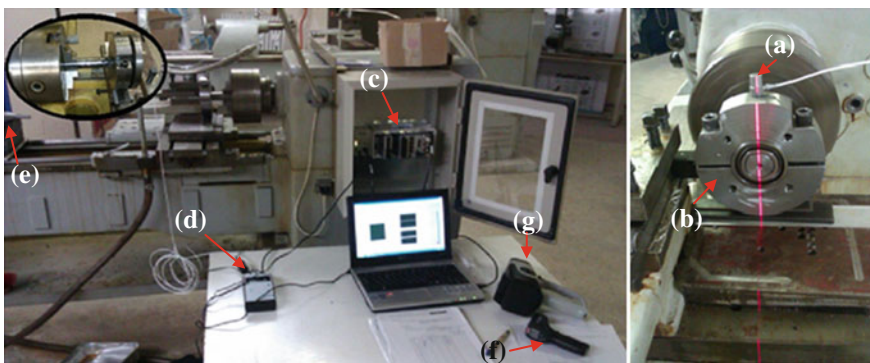
Fig. 1 Experimental setup: **a** One accelerometer (for vibration on the radial axis) (type 8702 B25 by Kistler), **b** A load device for the measurement of charge (constructed by a previous work in our laboratory (Fig.2) [2]), **c** A DAQ card for acquired data (type CompactDAQ—9172 by national instruments and the module NI 9233), **d** The coupling circuit for the accelerometer, **e** A microphone for the measurements of the acoustic emissions (Votcraft Digital Schallpegelmeßgerät 329), **f** An Infrared thermometer (type KIRAY 100 by KIMO), **g** A portable thermal imager (type IVN 780-P by IMPAC)

The instrumentation and experimental setup that was used for the needs of the present work is presented in Fig. 1.

The ball bearing that was used for charging was a common deep groove ball bearing with single mounting (type 6206 by Nachi). It was adapted in an axis and inside the load device (Fig. 1). The accelerometer was placed on the top of the load device. The bearing charged with a continuous radial load equal to 48,54 KN. The sensor signals were of altered tendency and with suitable conditioning circuitry leveled to the host computer, for storing and further processing with the LabView (National Instrument) program.

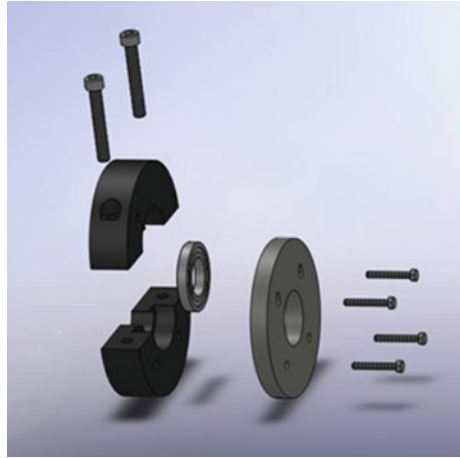
Fig. 2 Steel construction (Stall 37-2), with shear modulus G equal to 80 KN/mm^2

The load device for the applying of charge of the bearing was studied for both radial and axial stress. For radial stress, the surface growing tension is $\sigma_1 = 57.6 \text{ N/mm}^2$, while the yield point of steel St 37-2 is $R_e = 210 \text{ N/mm}^2$ (safety factor on the surface deformation = 3.6), while for axial the surface stress in the cap of the structure is equal to $\sigma_2 = 34.3 \text{ N/mm}^2$ ($E_2 = 728 \text{ mm}^2$) (safety factor on the surface deformation in the cap = 6.1) [2]. After studying the

strain-machine, there had to be calculated the load of the bearings, caused by the screw, and therefore had to be calculated the torque from the torque wrench that were used on the two radial screws, by using the equations of Mann :

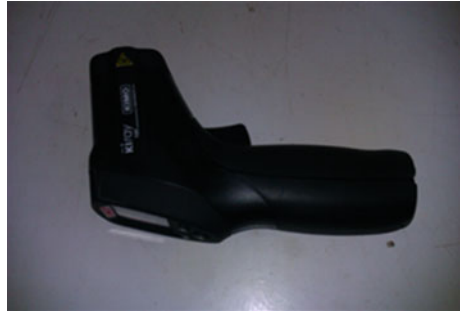
Fig. 3 Infrared thermometer

The measuring of the rolling bearing temperature has been done with the infrared thermometer (Fig. 3). After analyzing the increasing temperature, further details had to be added in order to specify which parts of the bearing exactly did the fault occurred. At this point were used the method of Infrared thermography. The thermographs were acquired by a fixed thermographic camera and were processed and recorded every 20 min . A study of machine tool spindle to obtain an assembly presenting a limited temperature increase at high speed monitored the fatigue life of bearings [8]. It showed by model and by experiment that a temperature rise between 16 and $34 \text{ }^\circ\text{C}$ was to be expected in normal working conditions. In the study of J.-S. and K.-W Chen, for bearing load for high speed spindle, it was clearly showed that the temperature of the bearing depend on the load and on the rotational speed [6].

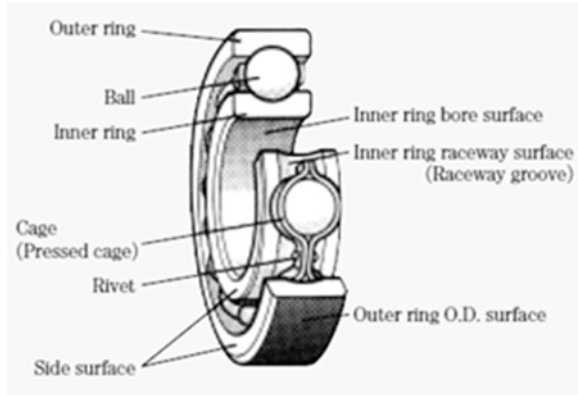
Fig. 4 Deep groove ball bearing

where f_s , B_d , P_d , ϕ and Z are the revolutions per second of the IR or the shaft, the ball diameter, the pitch diameter, the contact angle and the number of balls, respectively (Fig. 4). The contact angle for the ball bearings carrying no thrust load is assumed to be zero.

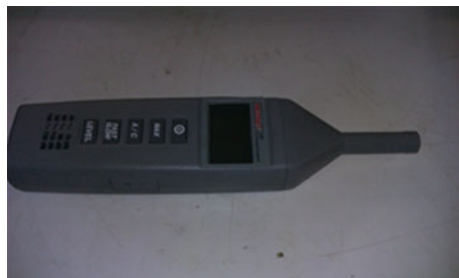
Fig. 5 Portable microphone

In this paper the air-borne sound were measured by the portable microphone (Fig. 5).

The microphone is a sensor that converts sound pressure into an electrical signal. Of great importance is how to load the microphone right. It should be placed always in the same place as the previous measurements so that the results

are comparable. The microphone should be placed at a distance greater than twice the length of the machine but not too far away from it as the received signal will permeate other sounds.

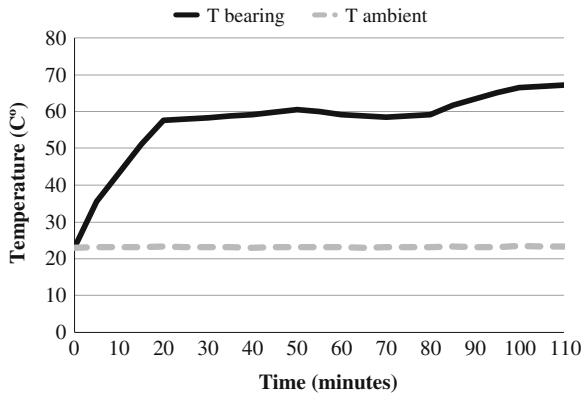
Fig. 6 The evolution of temperature over time diagram

In Fig. 6, it is presented the evolution of temperature over time measuring by the portable thermometer.

It is shown that at the beginning of the operation (the first 20 min) there was a high increase of the temperature. A steady low increasing temperature followed and at the end of the experiment a further increase had occurred depicting the fault of the bearing. Those temperatures were above the limit of normal working conditions of the bearing that is around 60 °C [11].

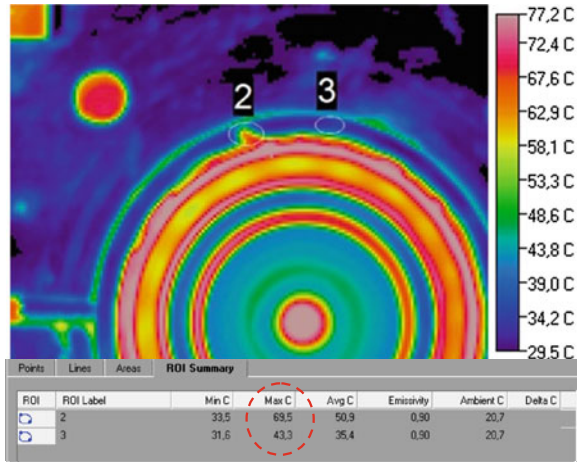
Fig. 7 Thermal image depicting a hot spot on the outer raceway

In the experiments that were conducted for the purpose of this paper there were depicted faults in two parts of the bearing, by the portable thermal imager. On the Fig. 7, it is shown that there was a hot spot with max temperature of 69.5 °C on one part of the outer ring, while the rest parts temperature were about 26 °C below.

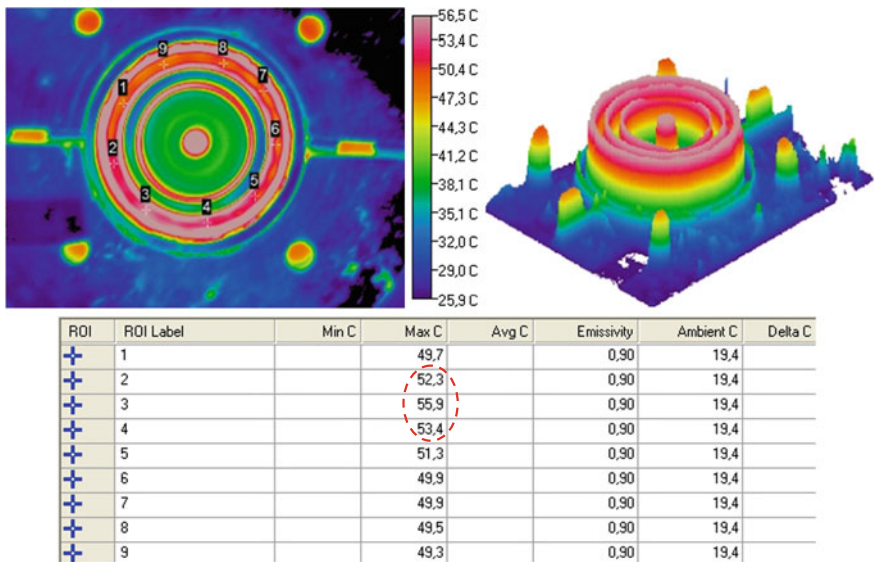
Fig. 8 Thermal image depicting a difference of temperature in the balls of the bearing and also the 3-D profile of it

The other part that an increased temperature was occurred is on the rolling elements (the balls), shown by Fig. 8.

At the Fig. 8 the numbers (1–9), represent the nine balls of the bearing, and at the ball number 3 there was an increased temperature, about 5 °C more than the others, declining a fault at this ball.

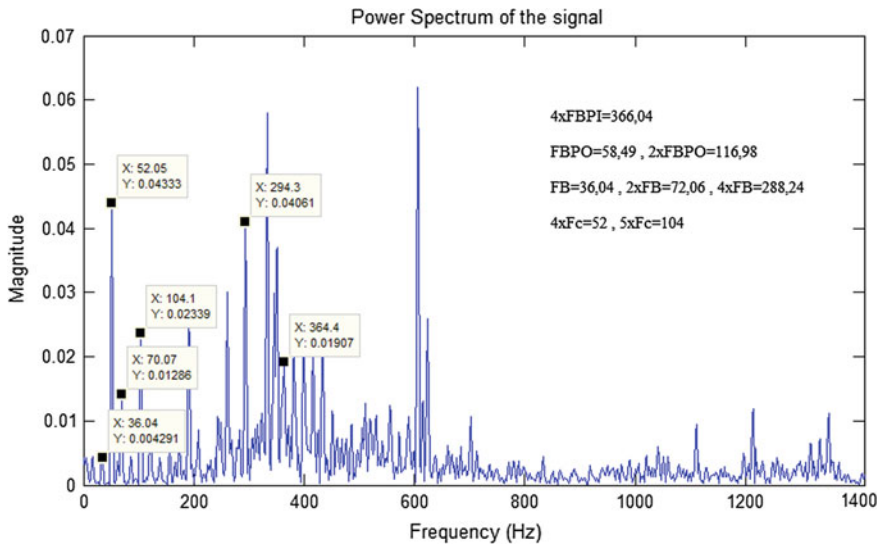
Fig. 9 The extracted plot from MatLab with the characteristics frequencies

The analysis of the signal by the use of the FFT is presented on the Fig. 9.

It is depicted the appearance of fault in various part of the rolling element, defined by the appearance of the characteristic frequencies and their harmonics.

More precisely, on the plot it is visible the first second and forth harmonics of the FB (FB = frequency when one point on a rolling element is damaged), declining fault on the rolling elements (the balls). Also the first and second harmonics of the FBPO (FBPO = frequency when one point on outer raceway is damaged), showing the fault on the outer raceway of the bearing. Some fault can also be seen at the parts of the cage (Fc) (fourth and fifth harmonics) and at the inner raceway (fourth harmonic).

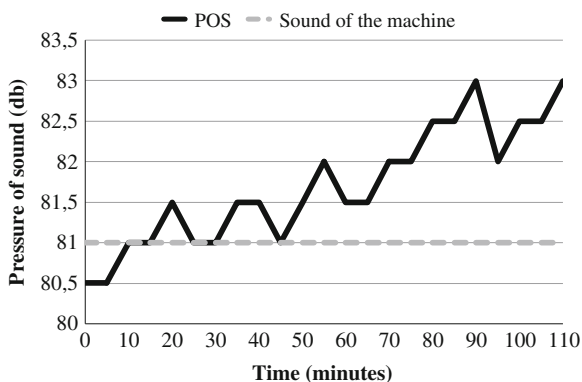
Fig. 10 The sound pressure evolution over time during the experiment

In the Fig. 10, it is presented the sound pressure evolution over the time of the conducted experiment. It is shown that over the time there was an increase of the sound pressure depicting extensive use of the machine as well increased stressing of the bearing element.
