# Structural Rehabilitation of Old Buildings

# **Building Pathology and Rehabilitation**

Volume 2

Aníbal Costa · João Miranda Guedes  
Humberto Varum  
Editors

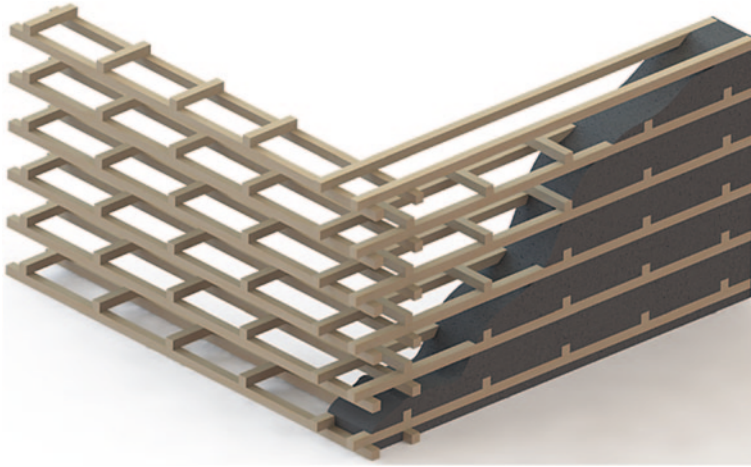
**Fig. 2** Greek laced masonry based on the work of Sakellaropoulou [30], without scale (credit A. Tavares)

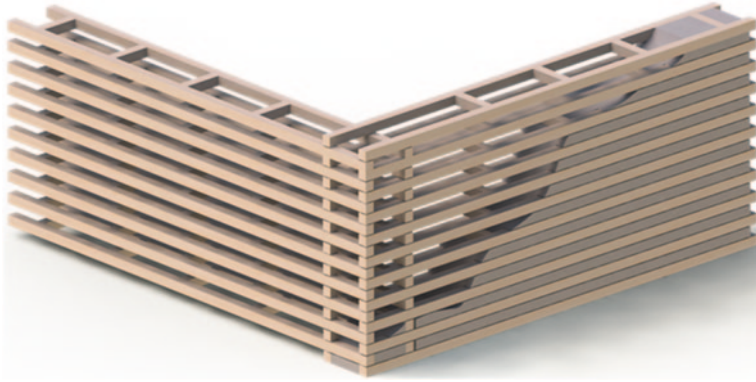
**Fig. 3** Scheme based on the work of Hughes R. [33] of an antique defensive tower wall, Pakistani *cator* and cribbage system, without scale (credit A. Tavares)

Hughes considers the Turkish *hatil* system related with the *cator* and cribbage systems (Fig. 3) of northern Pakistan [33], despite its difference in the number of timber elements, which can be much less in the *hatil*, the *hatil* also has the same type of timber longitudinal elements embedded on the walls. In the *cator* system Hughes explains that the timber elements have generally a square section of 50–120 mm and horizontal beams are placed on both sides of the wall, at vertical spacing of 0.30–1.30 m. “In better constructed walls the face timbers are tied together through the wall thickness with joined/nailed cross pieces at 1–4 intervals. Where the beam is of insufficient length for the whole length of the wall, two or more pieces are connected with tension resisting scarf joints. Breaks in the integrity of the ring beam may occur at doors and windows” [33, p.3]. The image of Alti Fort Tower in Hunza, Pakistan, presented by Hughes show a more dense use of horizontal timber elements given its

defensive use. The *cator* system shows also clear similarities with the Greek traditional system as, for example, the system found in Lesbos Island. Both of these systems use horizontal timber elements as beams facing both sides of the width of the wall. In addition to the function of confining the masonry infill, a more regular spacing of the horizontal elements and their larger dimensions makes at the walls corner more robust than for the Greek system.

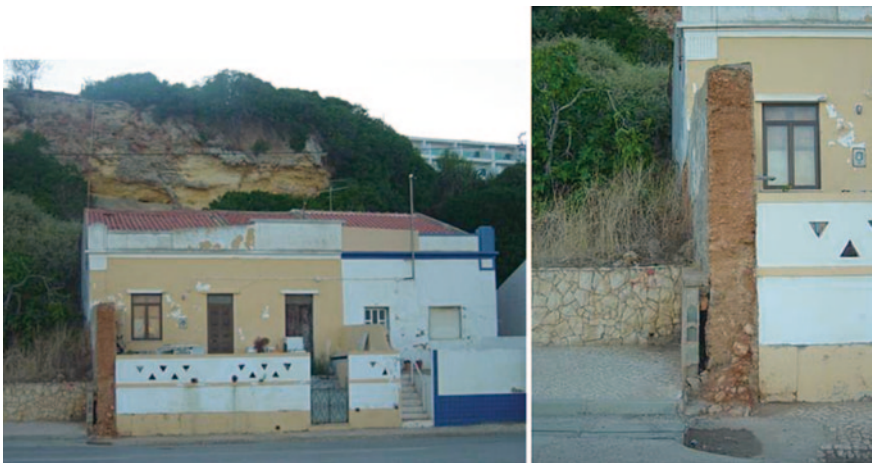
**Fig. 7** Rammed earth construction, Portugal (credit H. Varum)

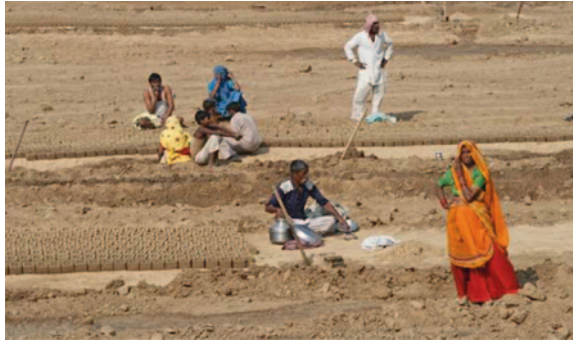
**Fig. 8** Adobe production, India (credit A. Costa)

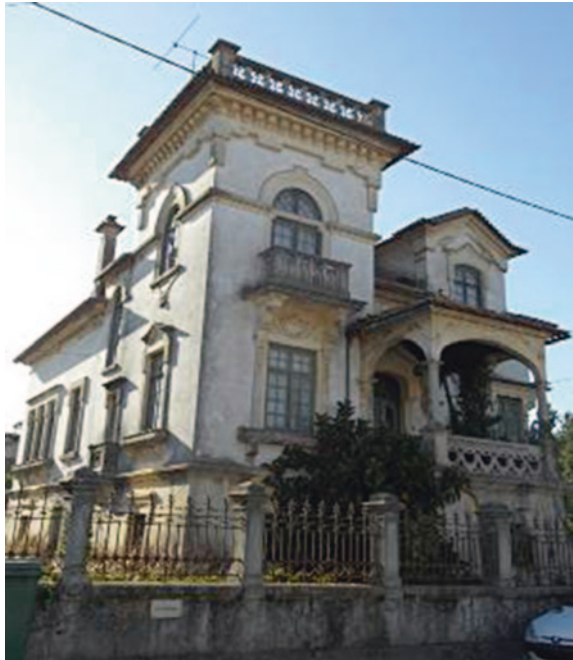
**Fig. 9** Adobe construction in Portugal (credit A. Tavares)

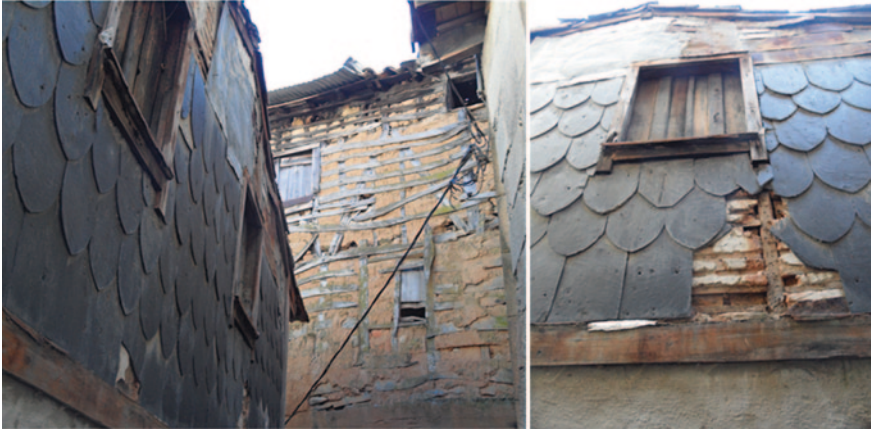
**Fig. 10** Traditional *tabique* construction in Portugal (credit A. Tavares)

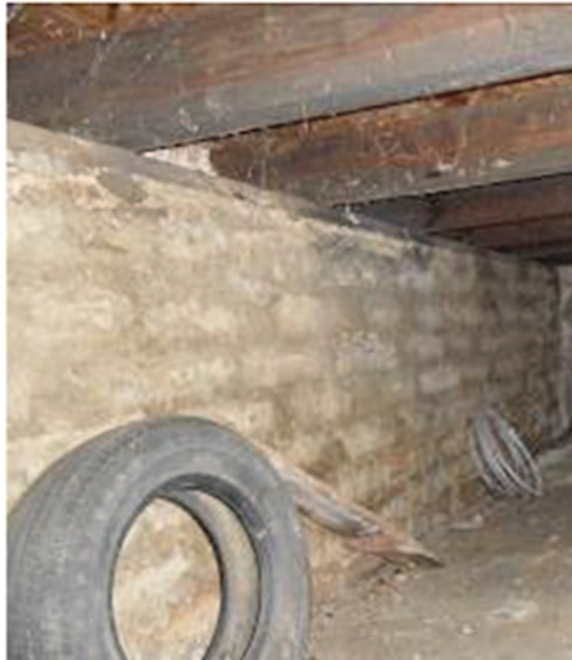
**Fig. 12** Ventilation space in the base of an adobe construction (credit A. Tavares)

In some regions as in Central region of Portugal or in Istanbul (Turkey), adobe constructions included a ventilation space between the level of the ground floor and the soil level, with holes in the foundation walls to allow air circulation (Figs. 11 and 12). This allows for better conservation of the timber and the permanent drying of the wall base [57]. As mentioned in Alberti's treatise (see Sect. 3), this is a very important issue that can also be observed in old stone masonry constructions. Another example is appointed by Sahin in relation to the base of traditional buildings in Turkey: a timber beam is placed on a stone platform inside the foundation walls and joists are set on this beam. Between the stone platform and

the pressed earth there is a minimum of 0.20–0.30 m of air space for ventilation [40]. In the central region of Portugal this ventilation space is usually more than 0.50 m in constructions from the end of the 19th century until the half of the 20th century.

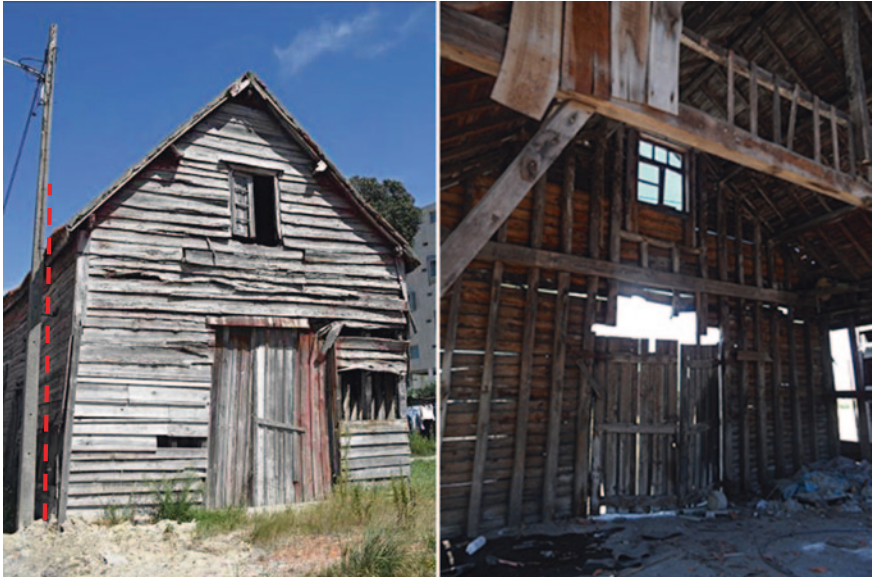
**Fig. 13** Traditional timber constructions—Portugal (credit A. Tavares)

Other types of earth construction such as wattle and daub can be seen to exhibit similar concerns with the stability of corners, namely by using diagonal timber elements placed in the corners connecting the timber columns to guarantee the stability of the structure. Diagonal elements are also important in timber constructions since the lack of these elements can totally damage the building, as can be observed in [Fig. 13](#) where the diagonal elements from an abandoned salt warehouse were removed. The damage of this traditional timber building resulted from the movement of the entire construction in one direction which may then lead to its collapse.

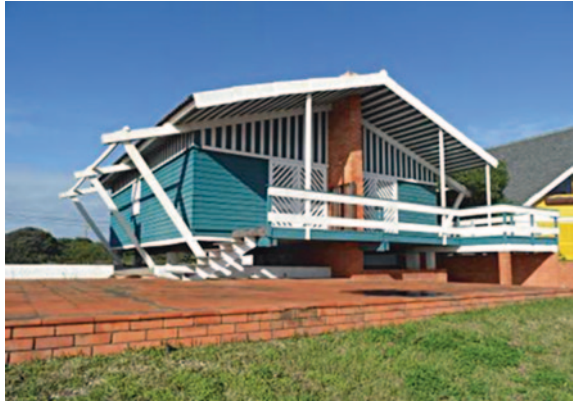
**Fig. 14** Timber building, modernism, Costa Nova, Ílhavo, Portugal (credit A. Tavares)

In Portugal, the introduction of the reinforced concrete was gradual in some regions until the 1940s. It was first used in some elements or short beams on the main façades. Then it became more common in beams and, finally, it was also used in columns and thin slabs despite the maintenance of the loadbearing walls of adobe or stone masonry in the construction. What in some regions of Italy was considered to be the preservation of links with traditional materials and architectural volumetric configurations in order the nationalism, was seen in Portugal as a continuity of the social structure and “natural” acceptance of the new material in old frameworks to “improve” traditional systems [45]. Regionalist proposals mixing tradition and restricted innovation were adopted in Portugal from the beginning of the 20th century. However, this period had also a high experimental purpose in terms of technique and architecture which led to interconnected proposals between these two factors. For this reason, buildings with Modernist aesthetic and traditional materials (Fig. 14) were seen to appear in almost the same

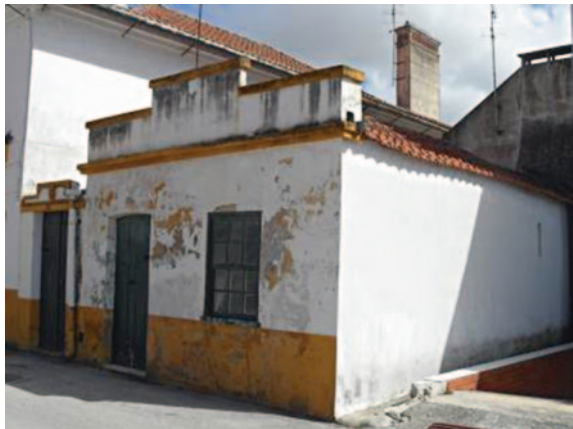
**Fig. 15** Old building with reinforced concrete elements (credit A. Tavares)

period as mixed systems with reinforced concrete in old and traditional aesthetic shapes (Fig. 15).

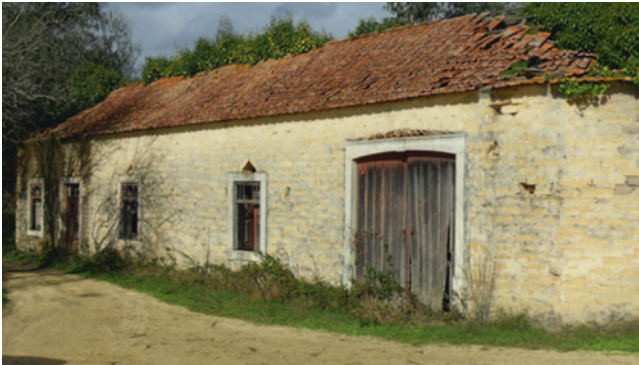
**Fig. 3** Typical rural house in Aveiro surroundings

In Portugal, earth construction dates back to several hundreds of years ago, located mainly in the centre and south coastline [8–10]. These buildings are examples of the vernacular architecture, part of the Portuguese built heritage. In the district of Aveiro, a particular type of adobe was produced and used in construction. In this region, adobe blocks were stabilized with lime, to improve its mechanical strength and durability. In this region, the use of adobe in the construction was widely applied until mid of the twentieth century. After, the reinforced concrete as being used as the main building material/solution. The typical adobe houses in urban areas are two or three storey buildings (Fig. 2), sometimes covered with high valued tiling. In the city of Aveiro, it can be found several examples of buildings influenced Art-Nouveau architectural style [11, 12]. The majority of the constructions in rural areas are simpler and with only one storey, as can be seen in Fig. 3.

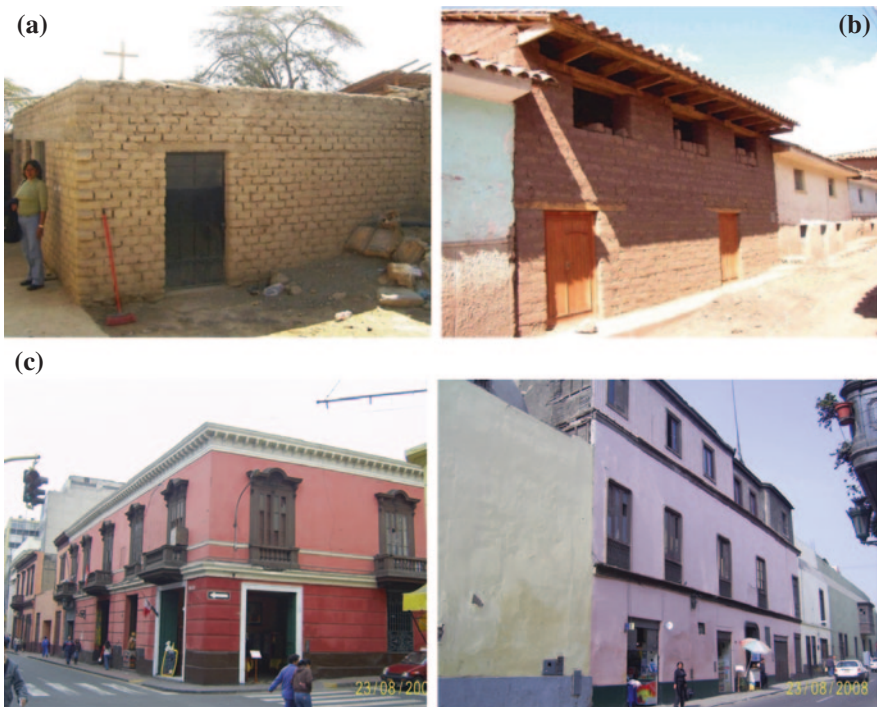
**Fig. 4** Typical Peruvian adobe houses. **a** Adobe house located at the peruvian coast. **b** Adobe house in peruvian highland. **c** Colonial adobe houses of two and three storeys in Lima, Peru

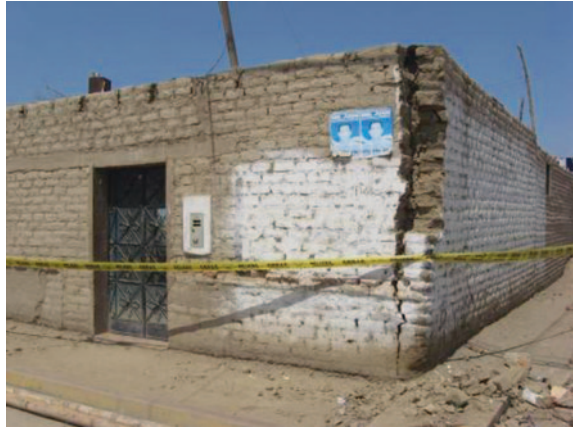
**Fig. 8** Collapse of adobe houses during the Pisco earthquake in 2007, Peru. **a** Roof supported on the facade walls. **b** Roof supported by transversal walls

connection between the roof's wooden joists and the top of the façade walls. When the roof joists were supported by the façade wall, its collapse affects the roof support conditions, and finally the roof to collapse as well (Fig. 8a). If, on the other hand, the joists were supported by the walls that were perpendicular to the façade wall, the roof didn't fall apart (Fig. 8b).

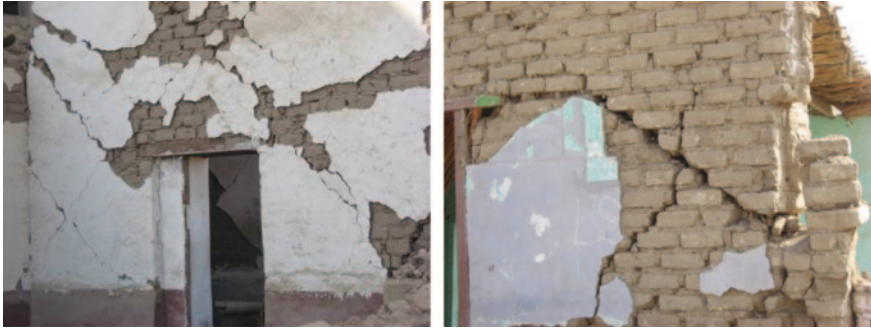
**Fig. 9** Typical X-cracks on adobe walls due to in-plane actions

Lateral seismic forces acting within the plane of the walls generate shear forces that produce diagonal cracks, which usually—but not always—follow stepped patterns along the mortar joints. The diagonal cracks often start at the corners of openings, such as doors and windows, due to the stress concentration at these locations (Fig. 9). If the seismic movement continues after the adobe walls have cracked, the wall breaks into separate pieces, which may collapse independently in an out-of-plane mode.

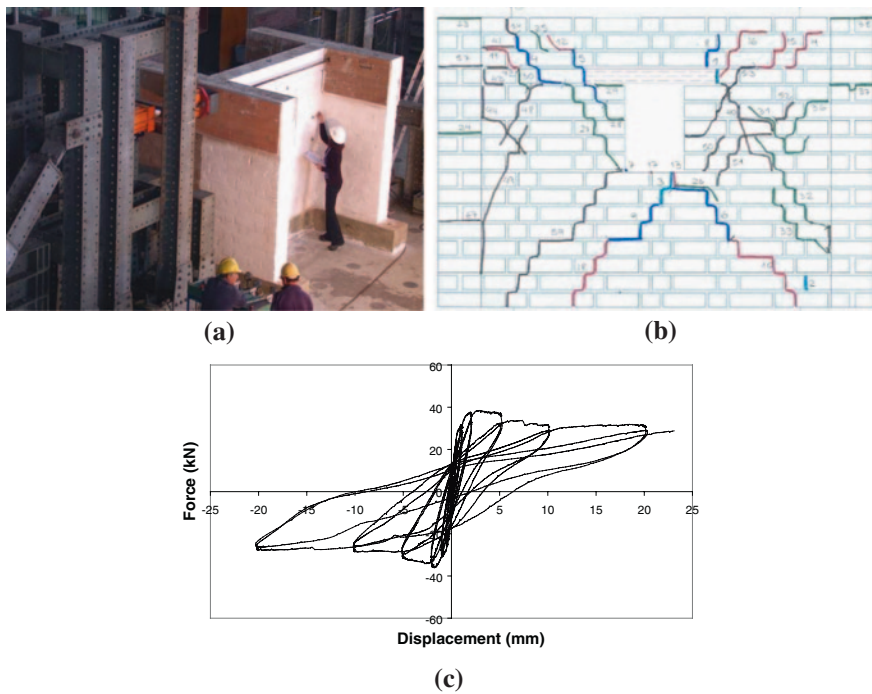
**Fig. 14** Cyclic test carried out on a double-T wall [27]. **a** Tested wall. **b** Damage pattern evolution during the cyclic test. **c** Cyclic test carried out on a double-T wall [27]

pattern evolution caused by in-plane forces. The wall presented a double-T shape in-plan view (Fig. 14a), and the main longitudinal wall (with a central window opening) was 3.06 m long, 1.93 m high and 0.30 m thick. The structure also included two 2.48 m long transverse walls that were intended to: (a) simulate the influence of the connection between transversal walls found in typical buildings; (b) avoid rocking due to in-plane actions. The specimen was built on a reinforced concrete continuous foundation beam. A reinforced concrete beam was built at the top of the adobe wall to provide gravity loads corresponding to a roof composed of wooden beams, canes, straw, mud and corrugated zinc sheet. The top beam also ensures a more uniform distribution of the horizontal forces applied to the wall. The window lintel was made of wood. The horizontal load was applied in a series of increasing load cycles. Loads and displacements were applied slowly in order to avoid dynamic effects. Each displacement cycle was repeated twice. During the test, the cracks started at the windows' corners and advanced diagonally up to the top and down to the base of the wall. During reversal loads, the cracks generated the typical X-shape crack due to in-plane forces. Figure 14b shows the crack patterns that settled in the adobe wall during the tests. Considering, as control displacement, the lateral displacement at the base of the top beam, the cracks observed after two consecutive cycles for the displacement levels of 1, 2, 5 and 10 mm are marked in

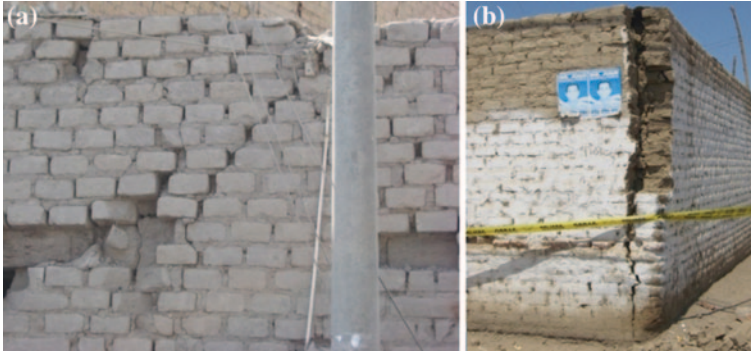
**Fig. 20** Typical crack patterns in adobe masonry walls. **a** Stair crack shape (concentrated on mortar). **b** Vertical crack (fracture of bricks)

In addition, the cracking pattern observed in adobe walls subjected to horizontal loading is quite complex and difficult to predict. Generally, the mortar is weaker and softer than the bricks and therefore cracking tends to follow the mortar joints (Fig. 20a). However, sometimes failure of masonry may involve crushing and tensile fracturing of masonry units [31], in particular in adobe walls where the mortar has the same material properties as the bricks.

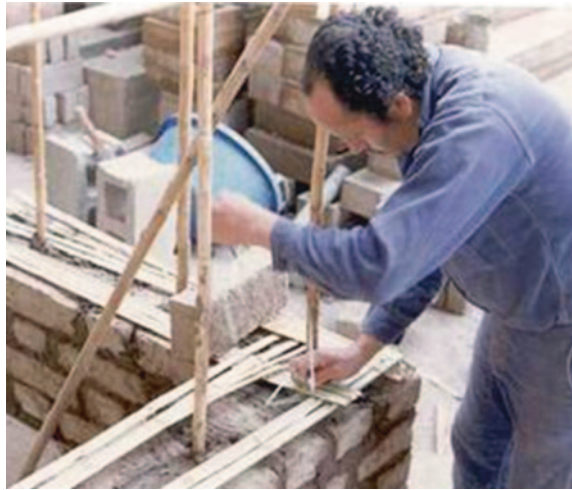
**Fig. 27** Internal cane mesh reinforcement [77]

This type of reinforcement consists of placing an internal grid, with vertical and horizontal elements, able to bond efficiently with the structure, improving its seismic performance (see example in Fig. 27). The vertical elements should be conveniently anchored to the foundation and to a ring beam on top of the walls. The spacing of the vertical or horizontal elements should be such to provide an efficient connection to the structure. Bamboo canes or eucalypt dry timber is

recommended for these reinforcements [76, 77]. It should be noted that this type of reinforcement can only be done in new constructions.

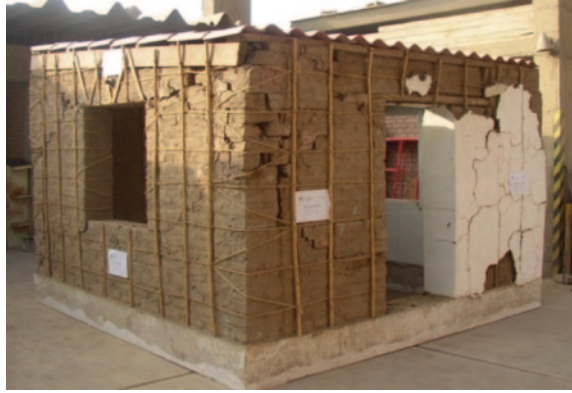
**Fig. 28** External cane-rope mesh reinforcement [80]

For repair or seismic retrofit of existing structures, an external reinforcement using a grid of canes and ropes can be a good solution. Canes are placed vertically and externally to the wall, on both sides, inside and outside. Ropes are then positioned horizontally tying the vertical canes along the walls and involving the structure. Different rows of horizontal ropes are placed along the height of the wall with a spacing of 30–40 cm. In order to connect the two grids—outside and inside grids—and thus confine the earthen structure, small extension lines are placed connecting the two grids, crossing the wall from one side to another through holes, made at each 30–40 cm. This reinforcement grid can then be covered with plaster for adequate finishing, providing at the same time more confinement to the earth structure.

Figure 28 shows an example of this type of reinforcement applied to a real-scale model tested at the PUCP, where only part of the structure was covered with plaster.

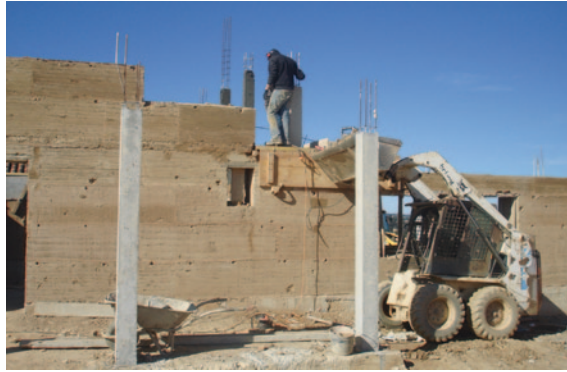
**Fig. 1** Construction of a new rammed earth house in Odemira, Portugal

Rammed earth, also known as “*taipa*”, “*taipa de pilão*”, “*tapial*”, “*pise de terre*”, “*pisé*” or “*stampflehm*”, consists in compacting layers of moist earth inside a removable formwork, therefore building monolithic walls (Fig. 1). In fact, the formwork constitutes a key feature, which differentiates this technique from the others. The conception and design of the formwork have been an evolving process, which resulted in several configurations. In order to grant the quality of the rammed earth wall, this element must present adequate strength and stability to support the dynamic loads of the compaction process, and adequate stiffness to mitigate the consequent deformations [4].

Another important feature that requires tight control is the weight of the formwork, which must be sufficiently low in order to make it easily handled by the workers (in the assembling and disassembling operations). Typically, the formwork is supported directly on the wall and is dislocated as the rammed earth blocks that form the wall are built, and whereby this is called crawling formwork [5].

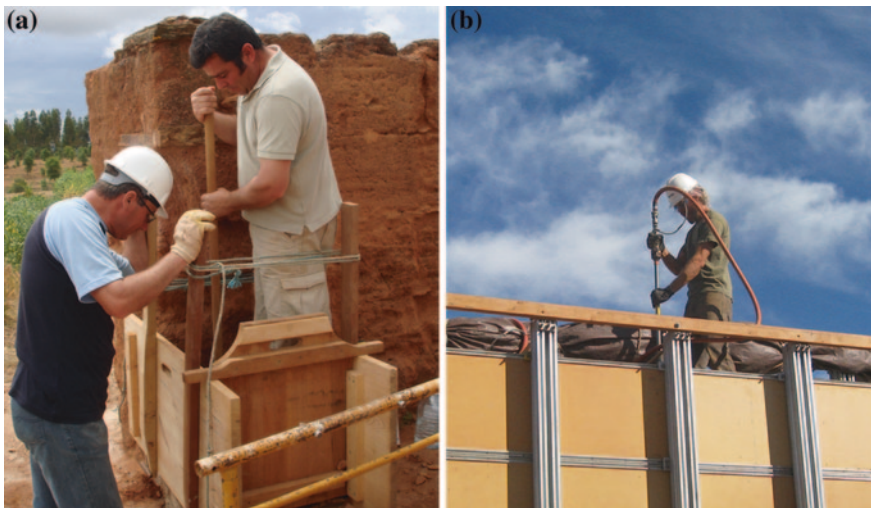
**Fig. 3** Rammers used to compact rammed earth: **a** manual rammer; **b** pneumatic rammer (courtesy of Bly Windstorm from Earthdwell)

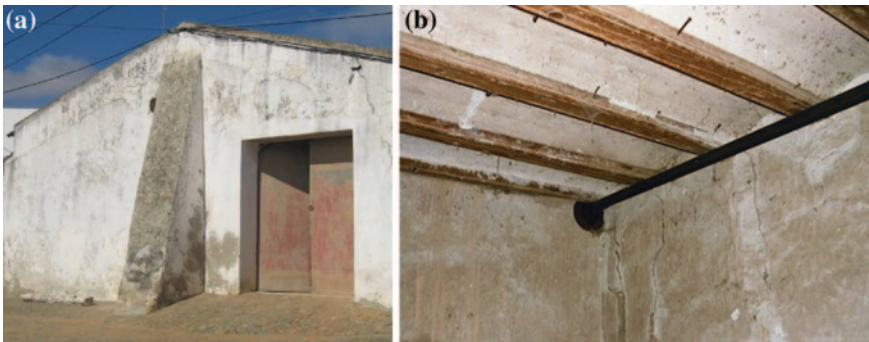
**Fig. 8** Strengthening of rammed earth walls by means of: **a** buttressing [20]; **b** tie bars [5]

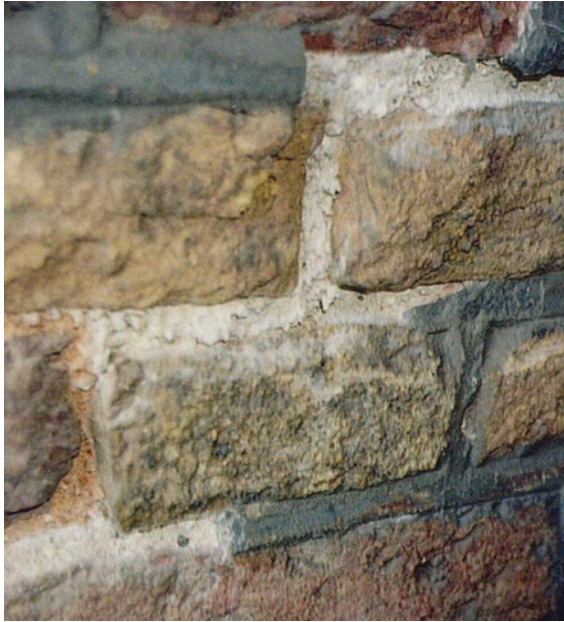
**Fig. 7** Push-out of cement re-pointing due to crystallization of salts at the interface of new pointing and old bedding mortar

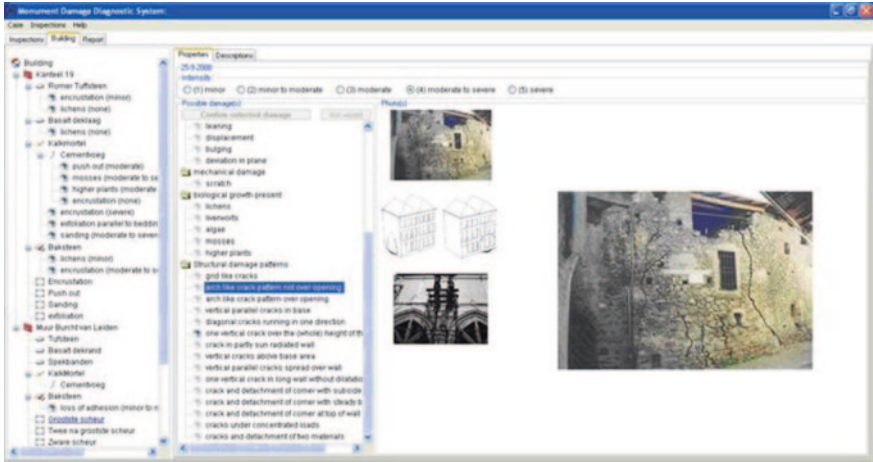
Fig. 11 Structural damage atlas, integrated in the diagnostic section of MDDS

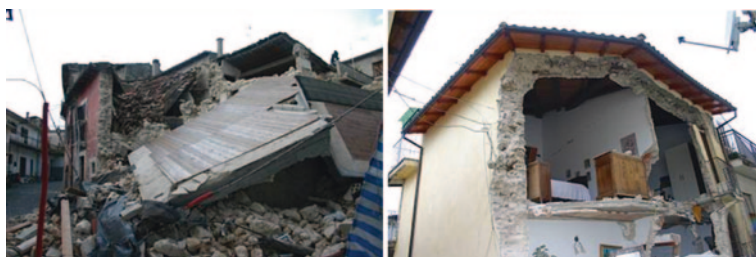
Fig. 7 Damage caused by past interventions, Abruzzo 2009

The observation of failures due to incompatibility between the original structure and the repair intervention, showed the need for developing new structural models for assessing the behaviour old stone masonry buildings, and code requirements for the intervention procedures [50, 65]. Formerly, the code requirements were oriented to the seismic adequacy of structures. In the case of cultural heritage constructions, namely those classified or protected by national or international directives, the new Italian seismic code moved from the imposition of “adequacy” to “improvement” [38–40, 66], which means more flexible, compatible and respectful interventions on existing structures. Such codes promote the improvement of the performance of old constructions through a series of intervention procedures, but without imposing the fulfilment of the (too demanding) code requirements for new constructions.

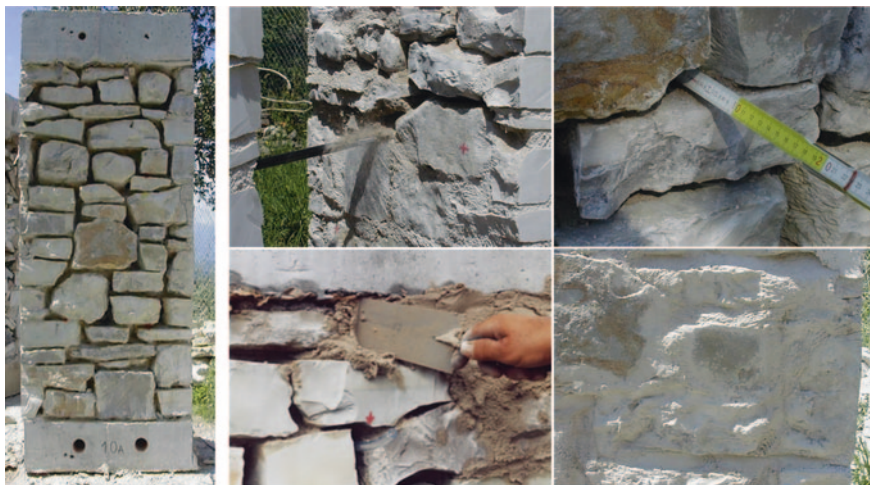
**Fig. 9** Deep re-pointing procedure [7]

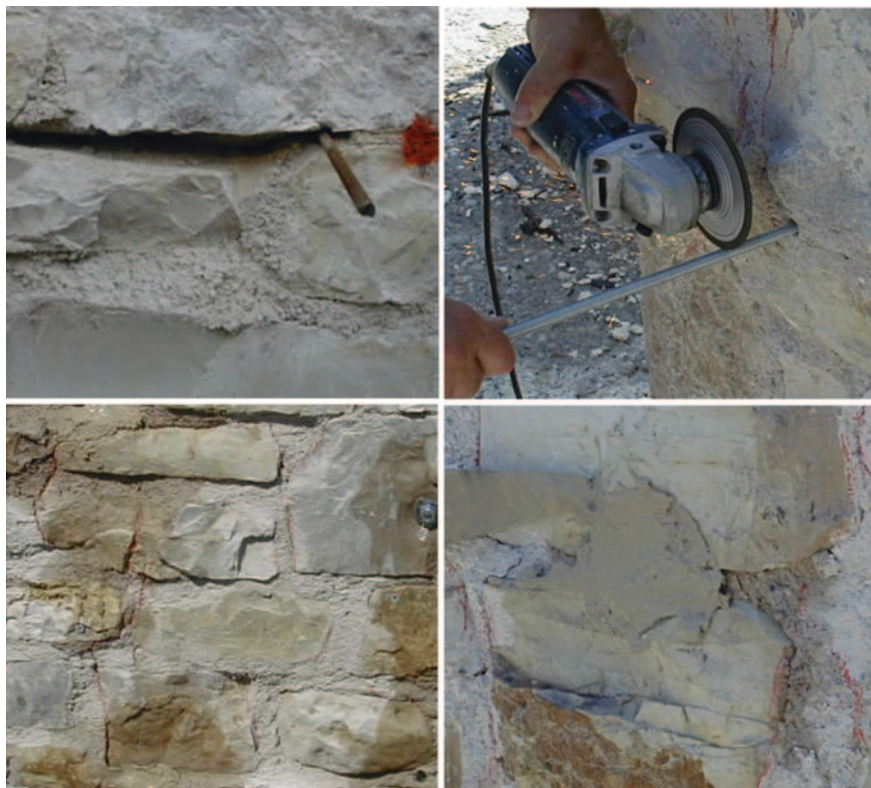
**Fig. 10** Application of transversal ties in multi-leaf stone masonry walls [7]

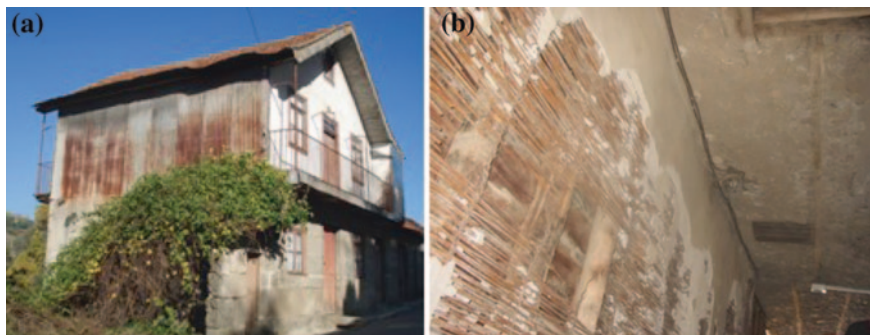
**Fig. 1** Examples of *tabique* dwellings. **a** Portuguese (*exterior view*). **b** Turkish (*interior view*)

In the Portuguese context, over three hundred *tabique* buildings have already been studied in this research work. In general, these buildings are dwellings [1], Fig. 1a. The most common featured scenarios are related to two (Fig. 1a) or three floors *tabique* buildings [2]. One floor or over three floors scenarios are rare. Perhaps, one floor *tabique* building solution is uncommon because the timber structure system of the vertical building components would be very vulnerable to the attack of insects due to its proximity to the ground and also rising damp related problems such as deterioration of the earthy render. Meanwhile, up to three floors solutions are rare because they are related to dwellings type typology and, probably, there

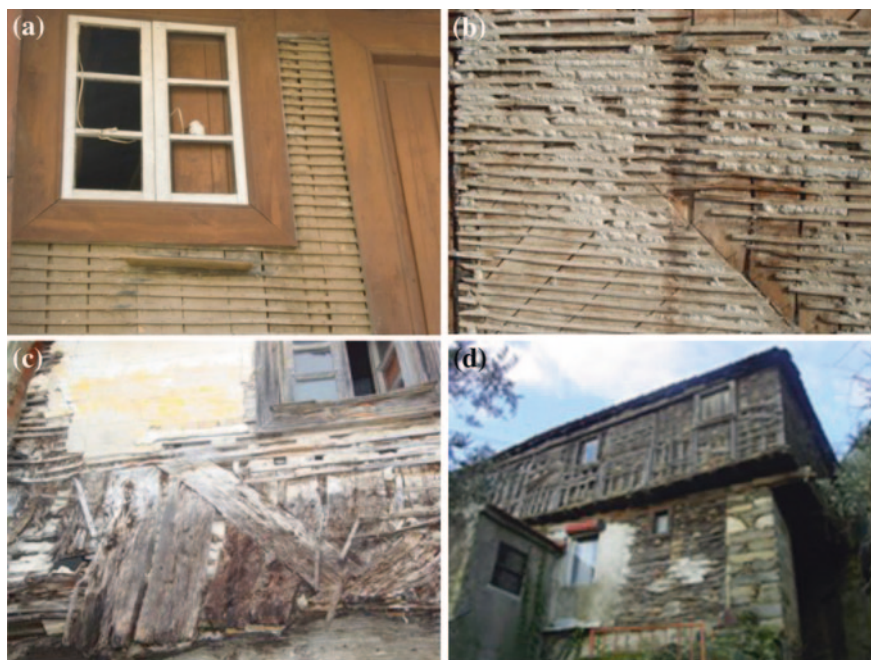
**Fig. 2** Timber structural system typologies of tabique walls. **a** Typology 1. **b** Typology 2. **c** Typology 3. **d** Typology 4

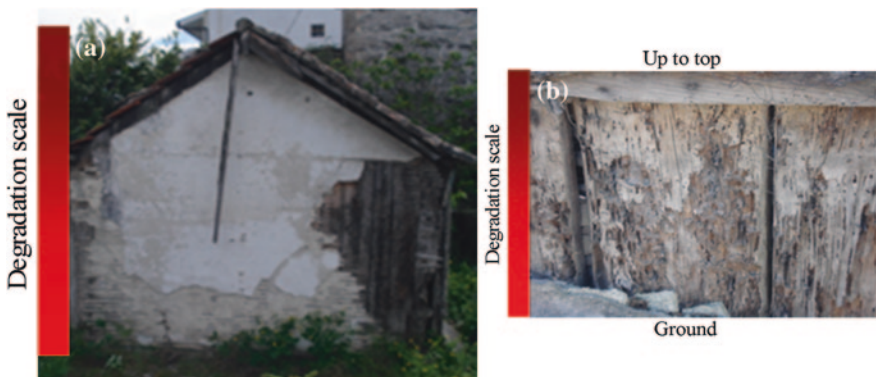
Fig. 12 Ground depending pathological effect. a Deteriorated façade. b Biological attack effect

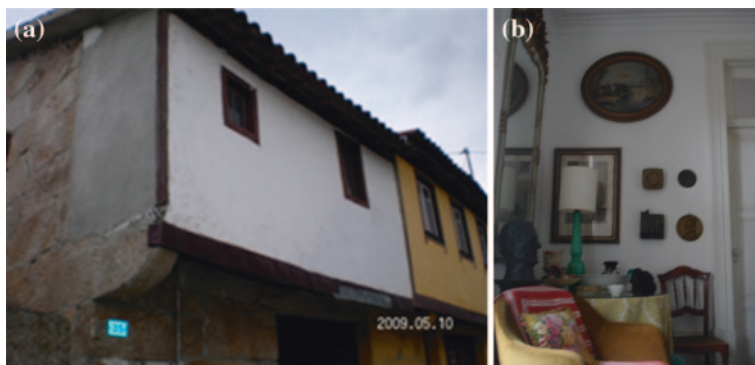
**Fig. 14** Two examples of regularly maintained *tabique* buildings. **a** Example 1 (*exterior view*). **b** Example 2 (*interior view*)

the material compatibility. Adequate compatibility between new and old materials has to be guaranteed in order to avoid additional deterioration and to assure durability of the intervention. The technical information delivered in Sect. 3 concerning the identification and characterization of the wood, the nails and the filling may help in this respect in future rehabilitation processes. Above all, we have to keep in mind that each *tabique* building has its specificities and, therefore, may also require a specific non-structural rehabilitation process. It is also important to highlight that the referred pathological technical aspects may not be specific to the *tabique* building technique. In fact, they may also be related to the other traditional Portuguese building techniques, including even the currently applied ones. However, a profound knowledge of a building is necessary before taking rehabilitation actions. Identifying pathology causes, understanding the pathologies, evaluating the level of degradation, finding measures of mitigation and adequate repairing solutions, are not straightforward tasks. Figure 14 presents two examples of *tabique* buildings which have been maintained regularly.

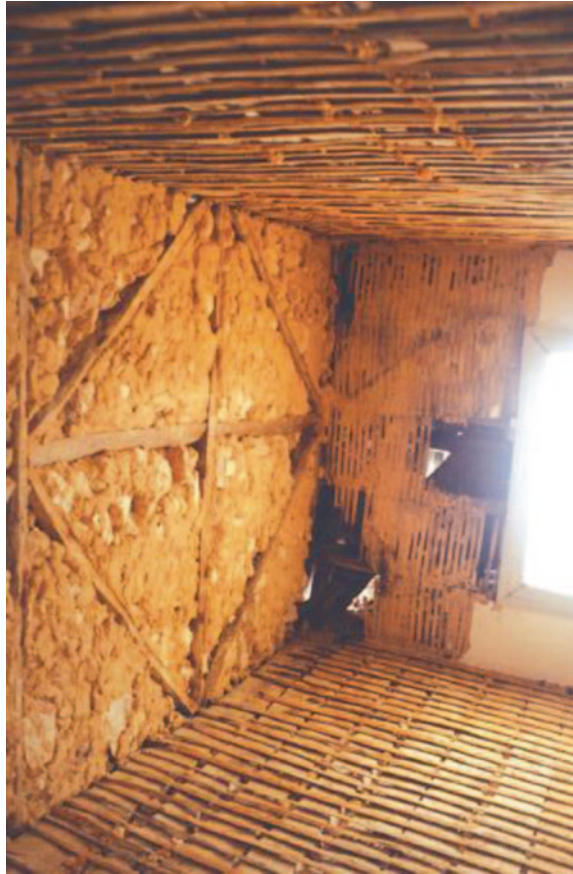
**Fig. 2** *Gaiola* wall with masonry filling [2]

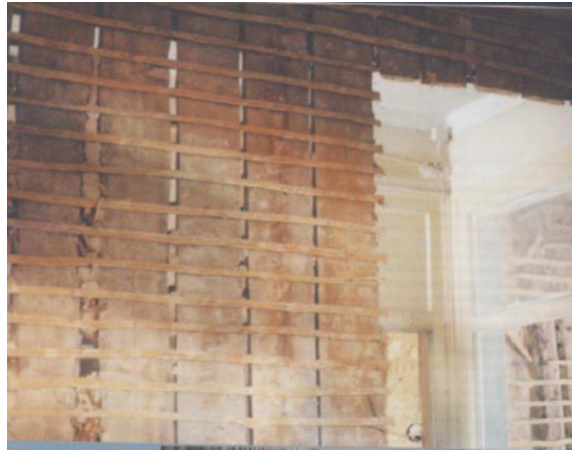
Fig. 4 Partition wall [3]

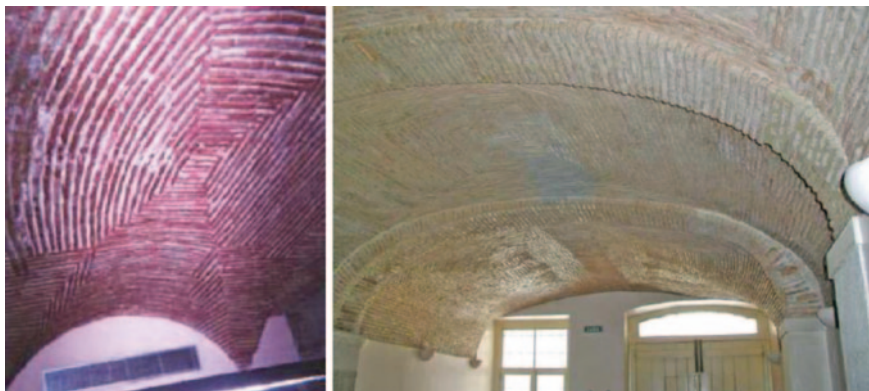
Fig. 6 Masonry arches and vaults at the ground floor ceiling [2, 5]

The pavements of the 1st floor (ceiling of ground floor) are usually constituted by masonry arches and vaults, as shown in Fig. 6, for two reasons: (i) create a barrier to fire, in order that possible fires on the ground floors do not spread to the upper floors, and (ii) to avoid that the soil humidity reaches the *Gaiola* wood structure above the 1st floor. At ground floor level, where the *Gaiola* structure does not exist, the arches and vaults are supported in the interior by masonry piers and walls and on the exterior by façades and gable walls.

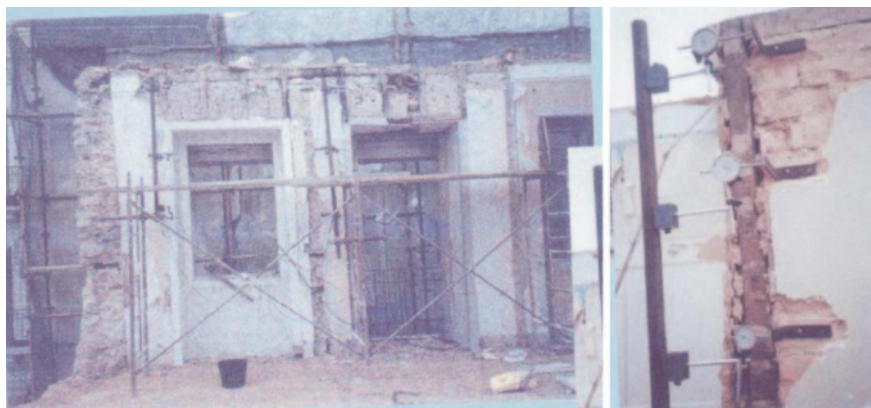
**Fig. 9** In-situ tests to rupture [8]

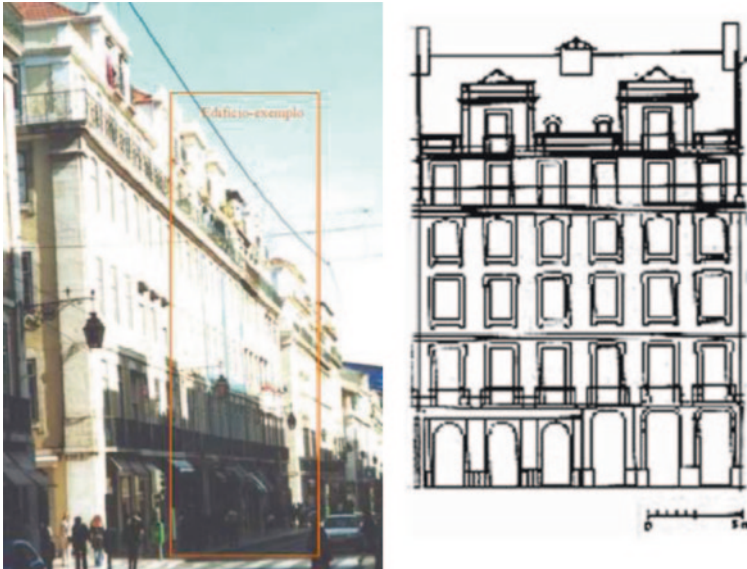
Fig. 10 Front façade of the building of Rua da Prata [5]

In the early years of the 2000 decade Rafaela Cardoso [5] analysed with detail the model of a *Pombalino* building with ground floor, 4 upper floors and attic, with the numbers 210–220 of *Rua da Prata*, whose front façade is shown in Fig. 10 and whose project was available for consultation. It is thought that this building is a late *Pombalino*, probably of the early nineteenth century period, due to the fact that it has one more floor than usual. At this time the memory of the 1755 earthquake was starting to fade away and the strict construction rules imposed after the earthquake were being relaxed due to pressure of urban developers.

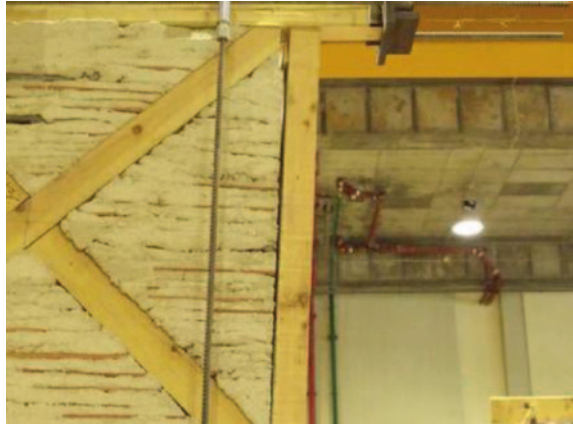
**Fig. 13** Detachment between the masonry filling and the *Gaiola* structure [12]

of the panels [5]. The comparison of the stiffness of the analytical models with the experimental stiffness, disregarding the low stiffness branch before closing of the gaps, led to the conclusion that the masonry and the tensile diagonal of the *frontal wall* should be disregarded (except at small displacement, of little relevance under strong seismic actions). From the range of values for the wood Young's modulus given at EC7 [13] (8000–12000 MPa), the one that yielded the best match with the experimental results was the lowest value that was chosen for the analysis.

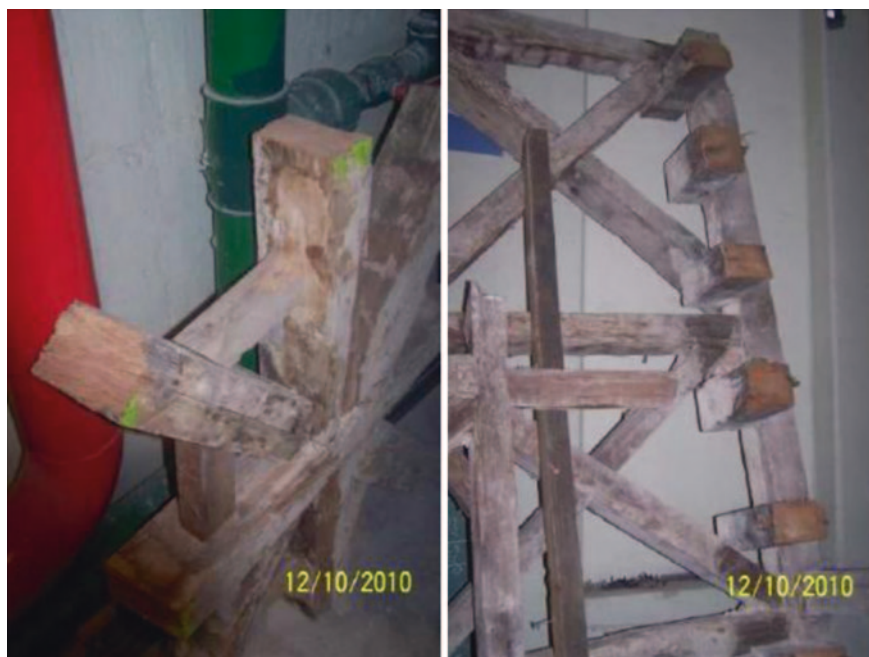
Fig. 19 Evidence of nowadays excellent conservation state of *frontal* walls

the original buildings. It is known, from works in those buildings, that the conservation state of the *Gaiola* is good in general. For instances Fig. 19 shows parts of *frontal* walls removed from a *Pombalino* building in 2010 in excellent conditions.

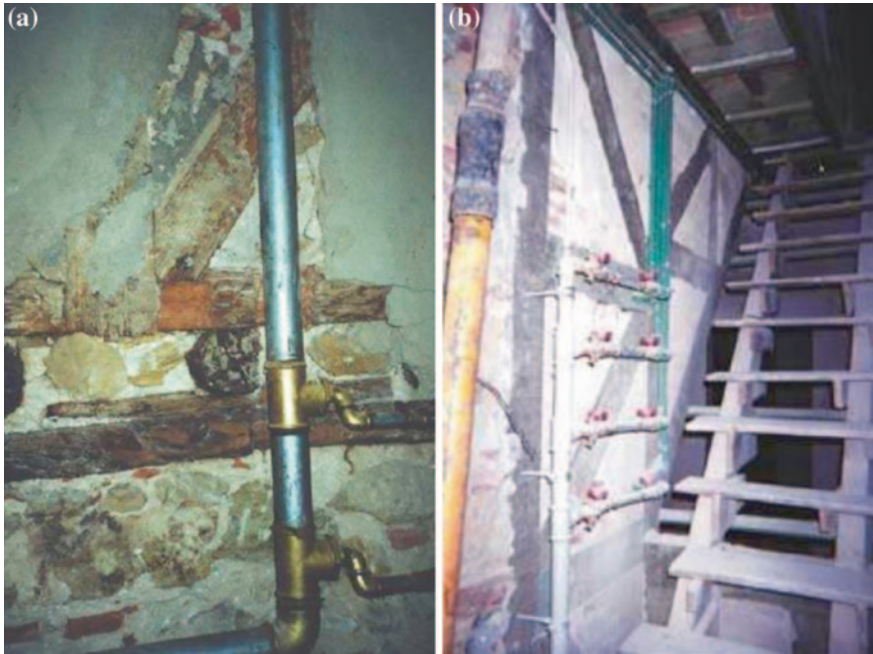
**Fig. 20** a Cut in frontal wall to introduce pipes and b pipes crossing wall in the perpendicular direction [20]

Figure 20a shows on the left hand side photo a case of water pipes introduced inside a *frontal* wall, probably during the twentieth century, cutting the wood bars of the *Gaiola* and strongly weakening the resistance of the frontal wall, specially under horizontal loads, and b) on the right hand side a photo of a case in which the pipes cross the wall in the perpendicular direction causing much less impact.

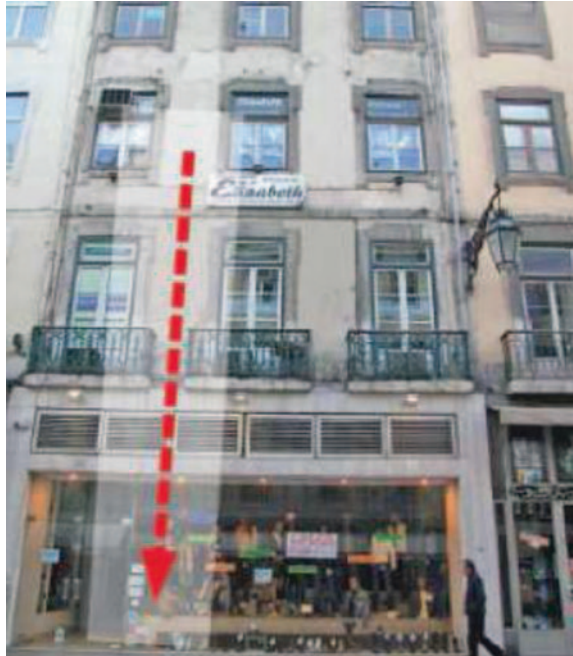
**Fig. 22** Cut of columns at ground floor level [21]

Figure 22 shows one of the many buildings in which apparently façade ground floor columns were cut to create a wider shop window, weakening the building where seismic effects are stronger. Usually this is done introducing a beam on top of the columns that are cut to transfer the vertical loads to adjacent columns. However, there are cases in which entire *Gaiola* panels (above ground floor) are removed without addition of strengthening beams and without collapse, showing the excellent performance of the *Gaiola* (in the upper floors) that allows the redistribution of vertical loads from the zone that is removed to the adjacent ones.

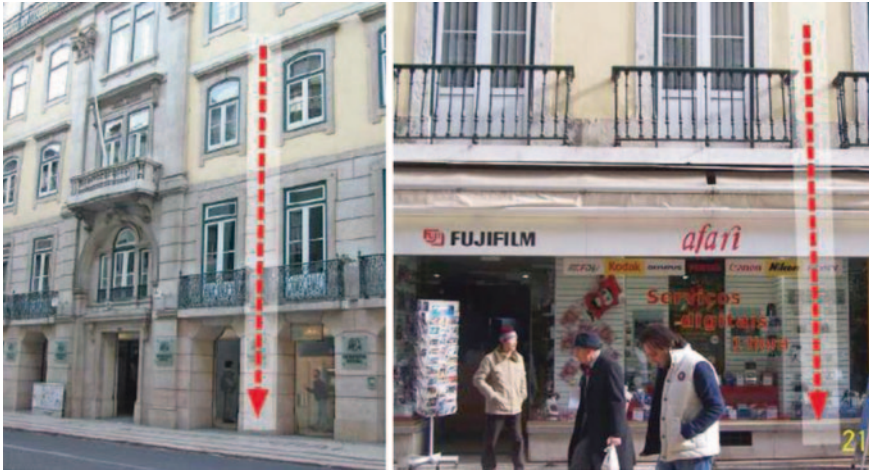
**Fig. 43** External accesses and window shops with integration of original columns [21]

A common problem that arises from the adaptation of old buildings to new functions is the cut of façade columns at ground floor levels aiming at creating larger spaces for shop windows. This is not acceptable, given the potential consequences. Therefore the actual and future owners of shops in zones and/or buildings of relevant cultural value should assume that if they want to keep or set-up a business in such zones they must accept some restrictions to the changes that can be done in those buildings, namely that cut ground floor columns is not acceptable. This does not seem to be a problem difficult to solve or that creates incompatibilities with most modern uses. There are in downtown Lisbon several good examples of integration of shop windows with ground floor columns, for instances by using the columns as supports for shelves or just leaving the columns between exterior accesses. Figure 43 shows two examples of compatibility between original structure and modern uses and functions.

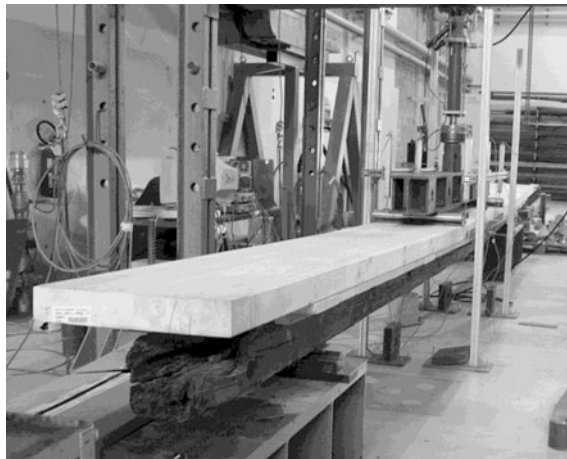
**Fig. 8** Four-points bending test setup (EN 408:2010 [15])

The calculated value of the experimental efficiency parameter was  $\eta = 0.74$ . This was determined using the values of the bending stiffness  $EJ_{ef}$  (reinforced beam),  $EJ_0$  (beam with unconnected board) derived from the test data carried out on the single elements, and  $EJ_\infty$  (rigid connection system) deduced from the experimental data adopting the “parallel axis theorem”.

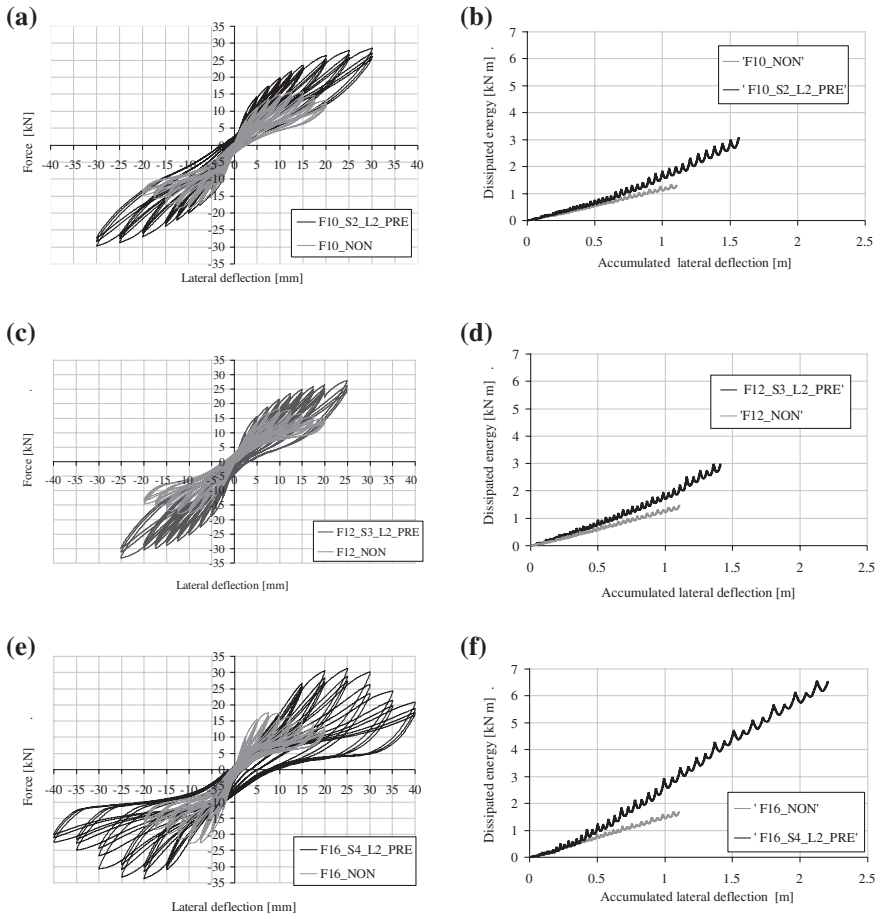
**Fig. 16** Force-lateral deflection and dissipated energy versus accumulated lateral deflection for: **a, b** F10\_NON and F10\_S2\_L2\_PRE columns; **c, d** F12\_NON and F12\_S3\_L2\_PRE columns; **e, f** F16\_NON and F16\_S4\_L2\_PRE columns

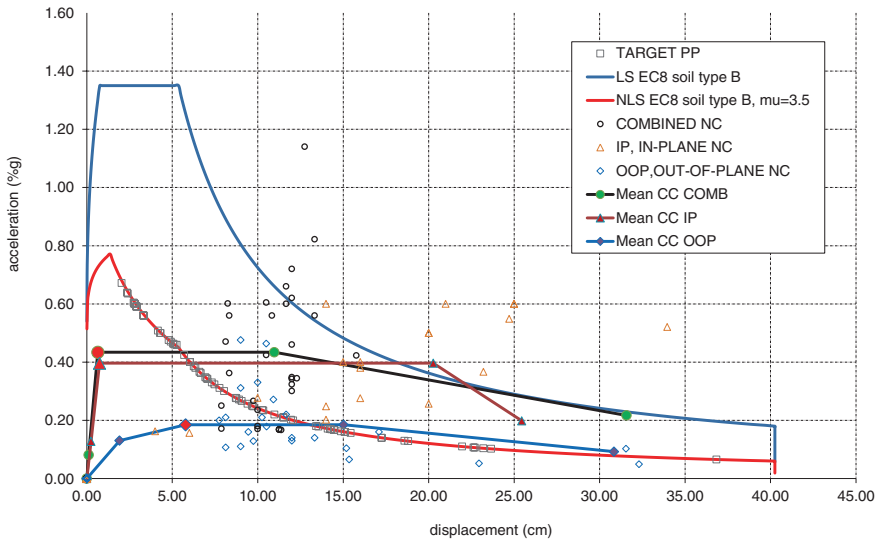
**Fig. 13** Representation of target performance points and damage thresholds for Near Collapse limit states in the acceleration/displacement space. The PGA is the value recorded for the 1997 Umbria Marche earthquake in Nocera Umbra. On the mean capacity curve for the three mechanism classes, the mean significant damage thresholds are marked in *red*
