# Structural Rehabilitation of Old Buildings

# **Building Pathology and Rehabilitation**

Volume 2

Aníbal Costa · João Miranda Guedes  
Humberto Varum  
Editors

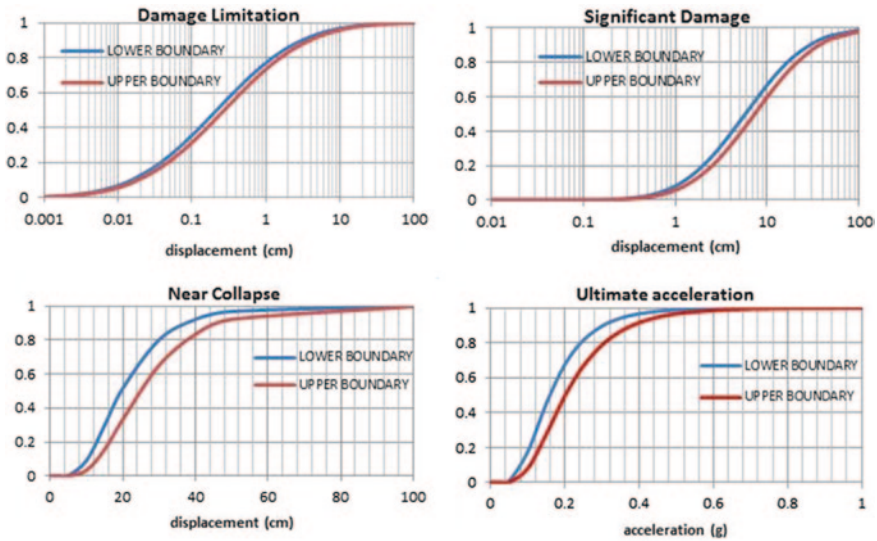
Fig. 18 Effect of epistemic uncertainty on fragility distribution for limit states

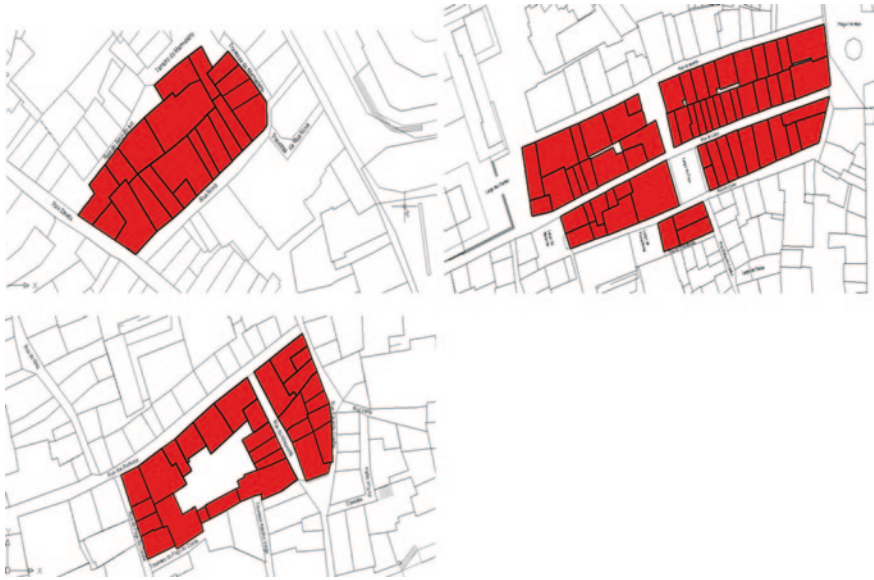
Fig. 20 Building aggregate shapes

Building aggregates can take a number of shapes, as shown in Fig. 20, although buildings in a row are very characteristic of the eighteenth century urban layout for many European historic city centres. Whatever the aggregate shape, the seismic behaviour is evaluated in two main directions: parallel to the building façades development and perpendicular to them. More complex aggregate shapes can be sub-divided in smaller aggregates of simpler shape.
