# Conservation and New Construction Solutions in Rammed Earth

Rui A. Silva, Paul Jaquin, Daniel V. Oliveira, Tiago F. Miranda,  
Luc Schueremans and Nuno Cristelo

**Keywords** Rammed earth • Damage • Repair • Conservation • Strengthening • Grout injection • Alkaline activation • Fly ash

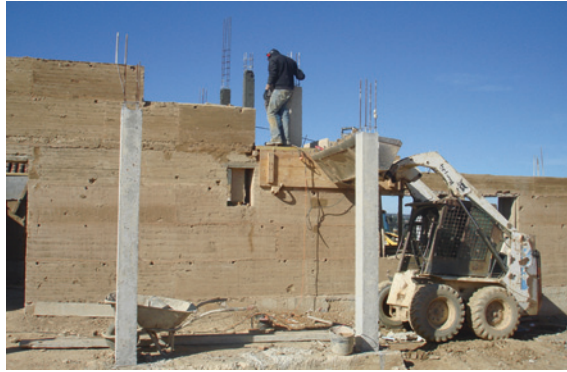
**Fig. 1** Construction of a new rammed earth house in Odemira, Portugal

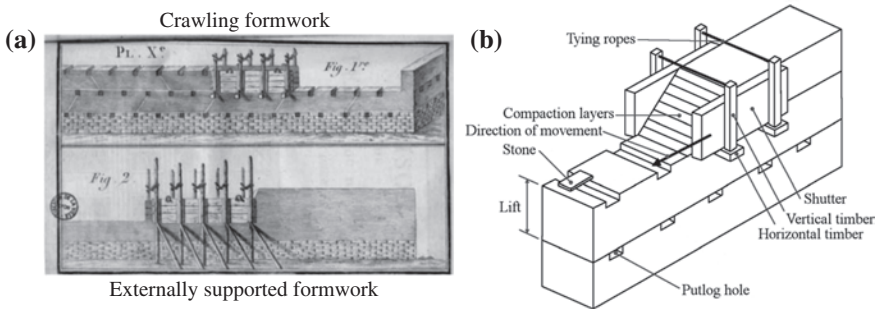
**Fig. 2** Rammed earth formworks: **a** Crawling and externally supported formwork [6]; **b** elements of a traditional crawling formwork

The elements of traditional formworks are made of timber, but not exclusively, as ropes and tying needles, for example, can be used for holding the shutters in place (Fig. 2b). Nowadays, the trend is to use the same metallic shutters used in concrete technology to constitute the formwork; a crawling formwork is composed by two metallic shutters or a self-supporting formwork is constituted by assembling the shutters in such way that they cover the entire wall.

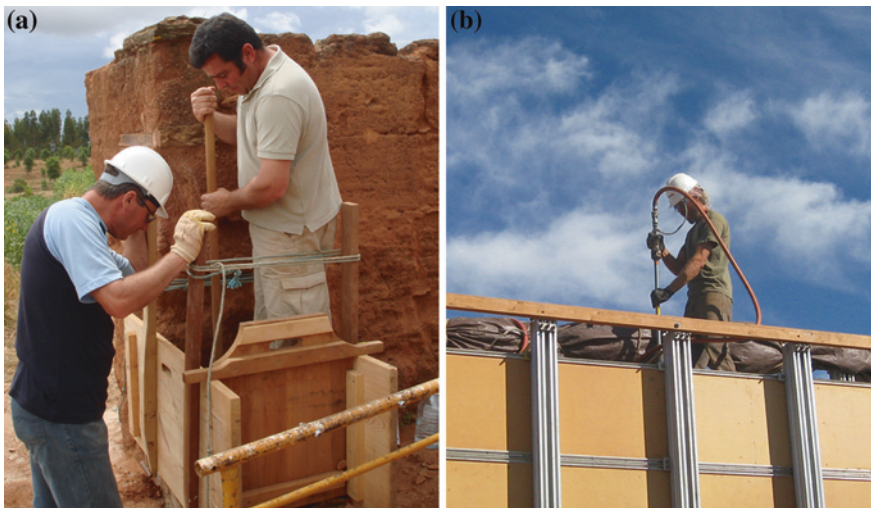
**Fig. 3** Rammers used to compact rammed earth: **a** manual rammer; **b** pneumatic rammer (courtesy of Bly Windstorm from Earthdwell)

The compaction of rammed earth blocks is traditionally carried out by manual means, resorting to rammers that in general are made of timber (Fig. 3a). Nowadays, the compaction process has been simplified by the introduction of mechanical apparatus such as pneumatic (Fig. 3b) and vibratory rammers, which comparatively reduce substantially the labour and time consumed in the construction. The dimensions of the rammed earth blocks are very variable from country to country, from region to region or even within the same region; for example in Alentejo (Portugal) the length of rammed earth blocks from typical dwellings may vary from 1.4 to 2.5 m, the height from 0.4 to 0.6 m and the thickness from 0.4 to 0.6 m [7].

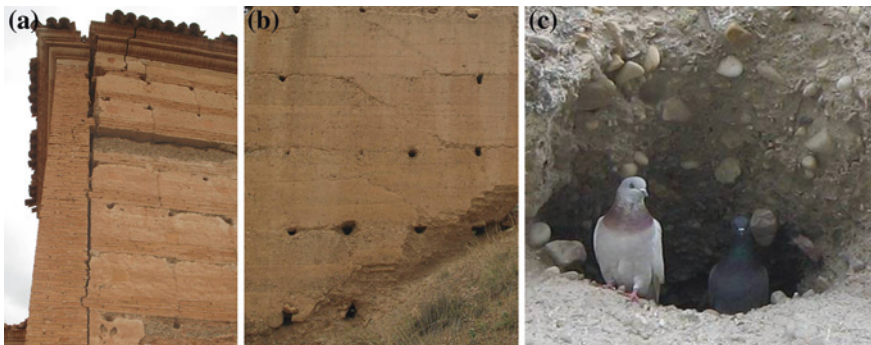
**Fig. 5** Damage in rammed earth constructions: **a** corner crack caused by settlements of the foundations or by horizontal thrust of the roof; **b** basal erosion caused by rainfall; **c** damage caused by nesting pigeons

Commonly to other types of structures, foundation deficiencies may result in terrible consequences to the structural integrity, such as severe cracking or even collapse (Fig. 5a). These problems are related to the capacity of the foundation soil to bear the loads transmitted by the massive rammed earth walls. Moreover, the poor tensile strength of rammed earth walls does not allow them to absorb differential settlements caused by seasonal variations of the water table or by the presence of different foundation soils along the length of the wall.

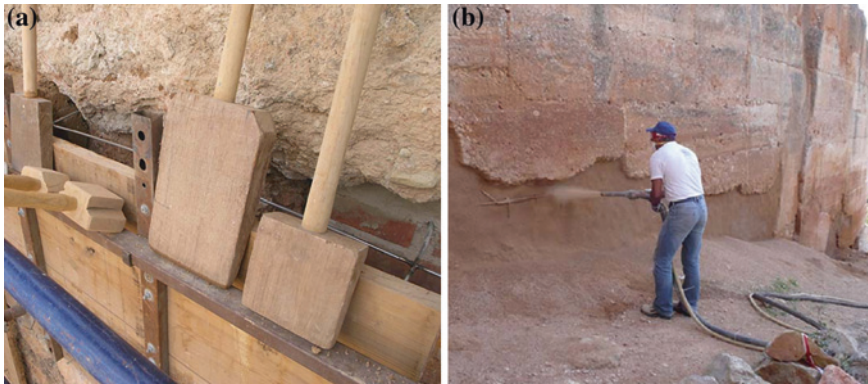
**Fig. 6** Repair of the basal erosion of Paderne's Castle [16]: **a** by compacting new rammed earth material in place; **b** by projecting earth at high speed

A common technique used to repair basal erosion consists in using a mix of soil (previously studied) similar to that of the rammed earth construction, which is compacted in place (Fig. 6a). First, the missing section is regularized and the loose material is removed. Then, a single-sided formwork partially covering the damaged section is assembled, and the earth mixture is compacted from the uncovered zone in horizontal layers. One of the main problems with this technique is associated to the difficulty in compacting adequately the last layers due to the limited

Projected earth (Fig. 6b) is a recent intervention technique used to repair basal erosion, which was applied successfully in the conservation of Paderne's Castle (Algarve, Portugal) [17] and in the Alhambra of Granada (Spain) [18]. This technique consists in projecting a mixture of moist earth at high speed against the damaged area, whereas the impact energy is supposed to grant a similar compaction to that of the original rammed earth. This technique has some aesthetical limitation, since the rammed earth layers are not recreated, and instead a much more homogenous surface texture is obtained. The shrinkage is another problem of this technique, since the projection of the earth is only adequately executed by the wet method [18], which requires high moisture content of the earth mixture in order to provide adequate flowability for the projection apparatus. It should be noted that this technique is recent and thus further investigation must be carried out.

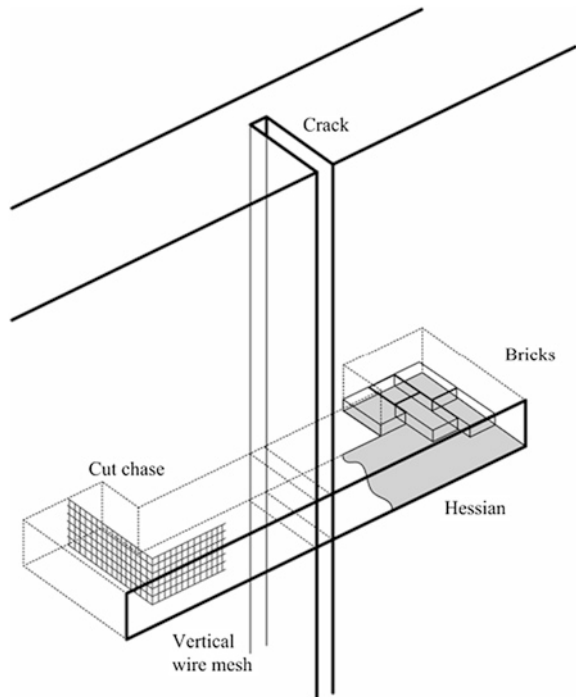
Fig. 7 Repair of cracks by stitching [5]

Stitching the crack is another solution to reconnect cracked parts, and consists in creating a mechanical connection between the two sides of the crack (“stapling” the crack), see Fig. 7. According to Keefe [12], this is carried out by cutting horizontal chases in the wall with a determined spacing along the crack, which are then filled with mud bricks and earth mortar prepared with a soil similar to that of the original rammed earth.

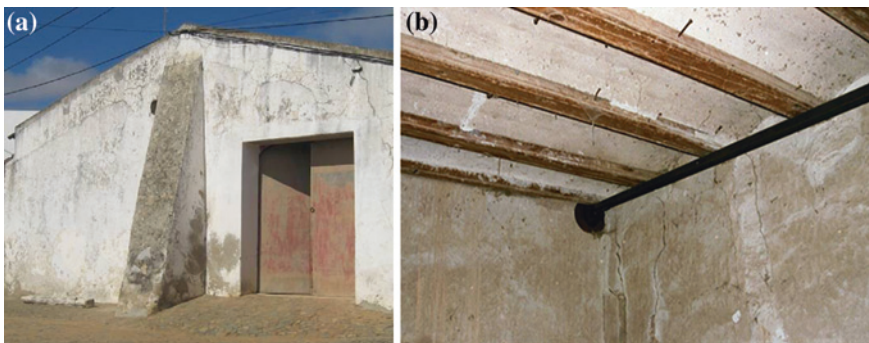
**Fig. 8** Strengthening of rammed earth walls by means of: **a** buttressing [20]; **b** tie bars [5]

The introduction of stone masonry buttresses (see Fig. 8a) is probably one of the most basic and ancient solutions for out-of-plane strengthening of rammed earth walls. This solution serves both as amendment for the seismic performance and as solution to solve the problem of leaning walls caused by horizontal thrusts transmitted by traditional timber roofs. The introduction of steel tie bars to connect opposed facades is another method to improve the out-of-plane behaviour of rammed earth walls, see Fig. 8b. The placement of external beams tied by wires on opposed walls is an alternative to the previous technique. This constitutes a more global strengthening, as the forces from the beams are transmitted along the walls. On the other hand, the forces in the tie bars are transmitted to the walls in localized points by anchorage plates [19], whose dimensions are designed accordingly.

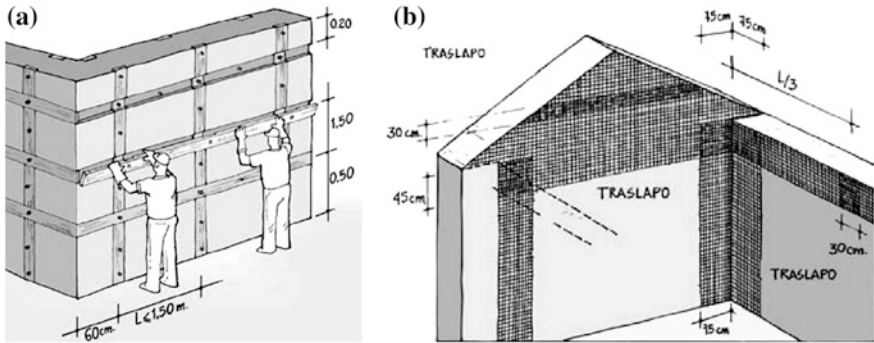
Fig. 9 Strengthening by fixation: a timber elements [22]; b metallic meshes [23]

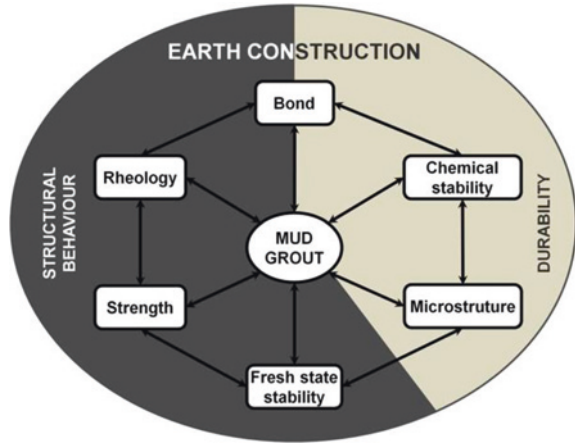
**Fig. 10** Design methodology of a mud grout [32]

As pointed out by Silva et al. [32], the design of a mud grout is a complex process. For instance, it must consider the construction demands, namely recovering the structural behaviour and granting durability, see Fig. 10, in a similar approach to that used in the conservation of historical masonry [24]. Then, the composition is defined such that the properties of the mud grout meet the demands. The complexity of the design lies in the interdependence between each of the grout properties, which becomes evident when the composition is adjusted. Therefore, it is essential

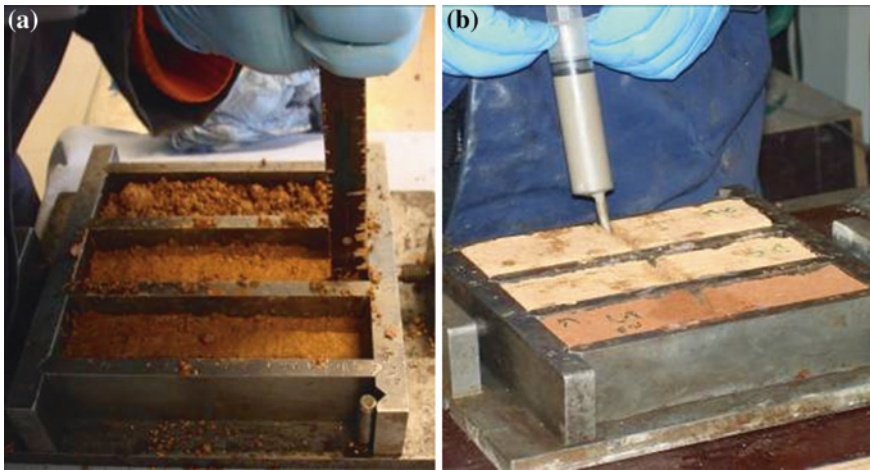
**Fig. 12** Preparation of the earthen beams: **a** for adhesion tests; **b** injection of the broken earthen beams after 3-point bending tests

particles larger than 2 mm, which resulted in the properties given in Table 2. The beams were tested under bending, being repaired afterwards by injecting selected KLH mixes (2 beams of each soil per mix) into the crack between the two parts of each beam, see Fig. 12b. After 15 days, the repaired beams were tested again under bending.

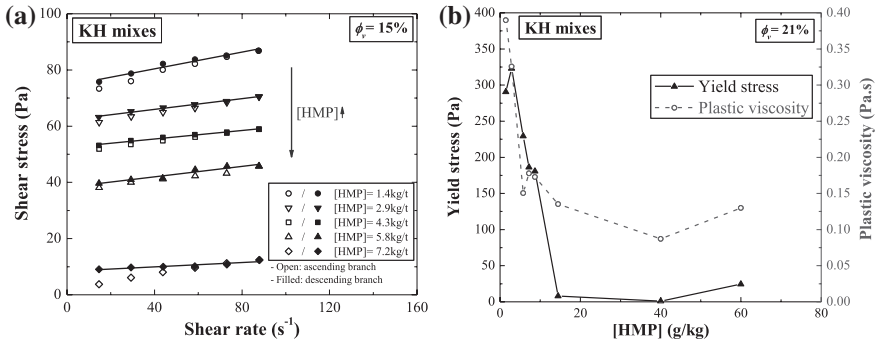
**Fig. 14** Flow curves: **a** KH mixes with  $\phi_v = 15\%$  (with Bingham’s model fitted to the descending branch); **b** Bingham’s parameters of KH mixes with  $\phi_v = 21\%$

Figure 14 shows that the shear stress required to shear the KH mixes decreases with increasing [HMP]. The addition of increasing amounts of HMP reduces substantially both Bingham’s parameters of the KH mixes (parameters obtained by linear fitting of the descending branch of the flow curves). However, the yield stress seems to have the greatest contribution to the flowing resistance, and furthermore this parameter is the main responsible for the failure registered with some Marsh funnel tests.

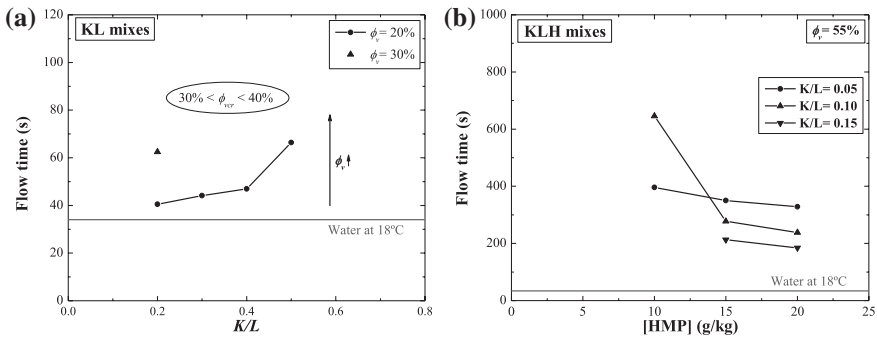
**Fig. 15** Flow time measurements: **a** KL mixes; **b** KLH mixes with  $\phi_v = 55$

The results of the Marsh’s funnel tests for the KL mixes (Fig. 15a) show that the increase in clay content (increase in  $K/L$ ) increases the flow time. Moreover, it is shown that substituting the clay content with a silt size material (limestone powder), significantly increases  $\phi_{vcr}$  when comparing to the K and KH mixes.

The KLH mixes showed the combined effect of the addition of HMP and the incorporation of limestone powder (Fig. 15b) by further increasing  $\phi_{ver}$ , since flowing suspensions with  $\phi_v$  between 55 and 60 % were obtained. However, the flow times increased substantially when compared with those of the K, KH and KL mixes. The addition of increasing amounts of HMP results in the reduction of the flow resistance of the KLH mixes (Fig. 16a), but it seems to have greater impact on the reduction of the yield stress than it has on the plastic viscosity (Fig. 16b). In fact, the addition of high quantities of HMP brings the yield stress to values close to zero, which is an important finding regarding the success of a grouting intervention [41]. This importance relies in the fact that if the injection pressure of a mud grout inside a crack is not sufficient to keep the shear stress at the head higher than the yield stress, the flow stops, which does not allow the complete filling of the crack by the grout.

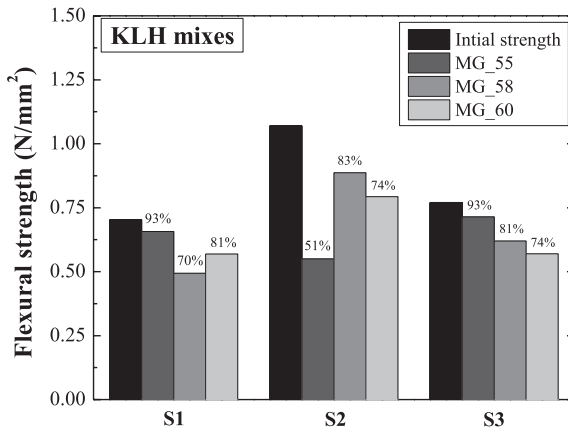
**Fig. 19** Adhesion capacity of the selected mud grouts for the three soil types

The results of the three-point bending tests performed on the repaired earthen beams, as well as the repair efficiency of the selected mud grouts, are presented

in Fig. 19. The grouts failed at re-establishing completely the original strength of the earthen beams. However, the repaired beams developed a flexural strength of at least 0.5 N/mm<sup>2</sup>, which is above the minimum flexural strength for adobes required by the New Mexico [42] and New Zealand [43] standards (0.35 and 0.25 N/mm<sup>2</sup>, respectively). The volumetric solid fraction  $\phi_v$  of the selected grouts does not seem to interfere significantly with the repair efficiency, which probably means that the water content of the mud grout may be further increased in order to favour its injectability properties, but accounting for the possible occurrence of excessive drying shrinkage.

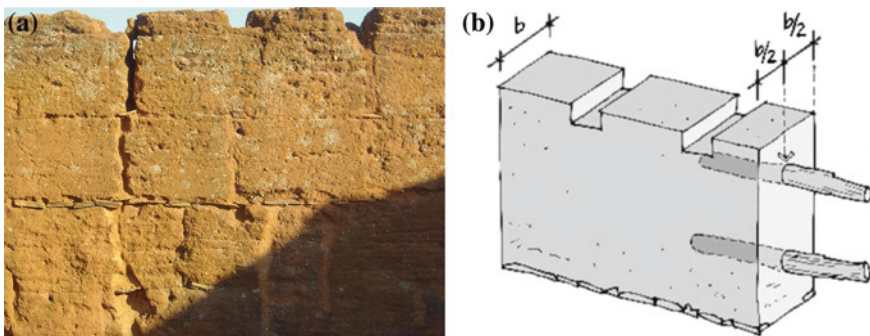
**Fig. 20** Strengthening of rammed earth joints: **a** inclusion of schist stones in the horizontal joints (abandoned dwelling); **b** reinforcement of the vertical joint by timber elements (based on [22])

The inclusion of hard materials, such as stones, bricks and tiles, in the horizontal joints is frequently observed in traditional rammed earth dwelling from the Iberian Peninsula (Fig. 20a). This is thought to improve the shear-bond behaviour between blocks and thus it can be adapted for new constructions. In a set of surveys carried out in Columbia, Lacouture et al. [22] found several cases of reinforcement of the vertical joints. These reinforcements consisted of timber elements that were embedded in the rammed earth to connect two contiguous blocks (Fig. 20b). The same principle can be applied in new rammed earth constructions to improve their structural behaviour.

The introduction of vertical reinforcements during the compaction of the walls, such as bamboo canes, can also result in the improvement of their shear and out-of-plane behaviours [49]. However, the presence of the reinforcements renders difficult the compaction process by making it more time consuming and by compromising the density of the material around the reinforcements.
