Chandur P.K. Wadhvani  
*Editor*

# Cementation in Dental Implantology

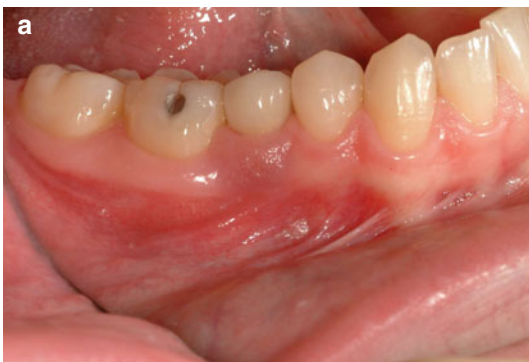
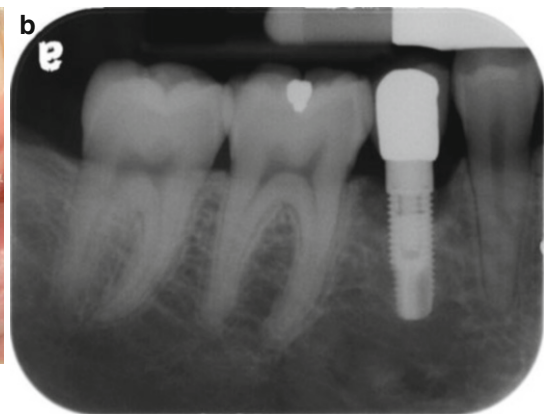
**Fig. 1.3** (a, b) This implant site developed peri-implant disease. Initial soft tissue findings were cyanotic tissue that was inflamed. Radiographic examination shows the

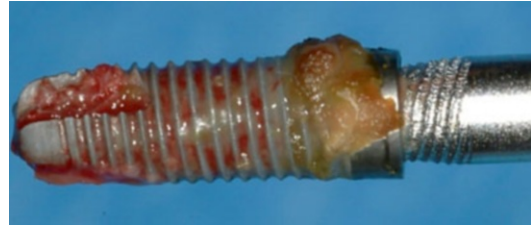
**Fig. 1.4** The crown removed and implant removed by reverse torque. Calculus was noted on top of luting cement. This case is more completely described in chapter 11—Patterns Characteristic to Cement Induced-Peri-implant Disease (Reprinted with permission by *Dentistry Today* (Wadhvani and Pineyro 2012))

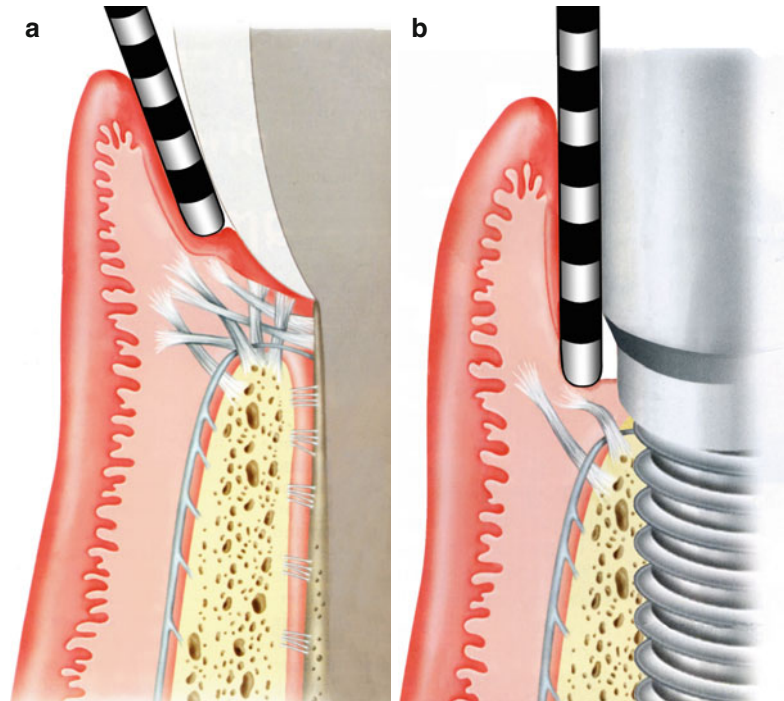
excess cement extrusion—A clinical report. Wadhvani and Ansong Reprinted with permission from *Implant Realities* 2012).

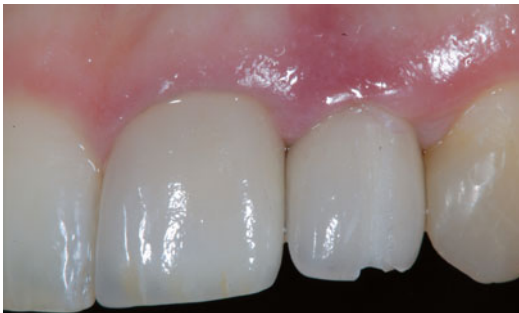
**Fig. 1.8** One week after cementing the restoration. Erythema is noted on the peri-implant soft tissues; the crown is being cut to facilitate removal

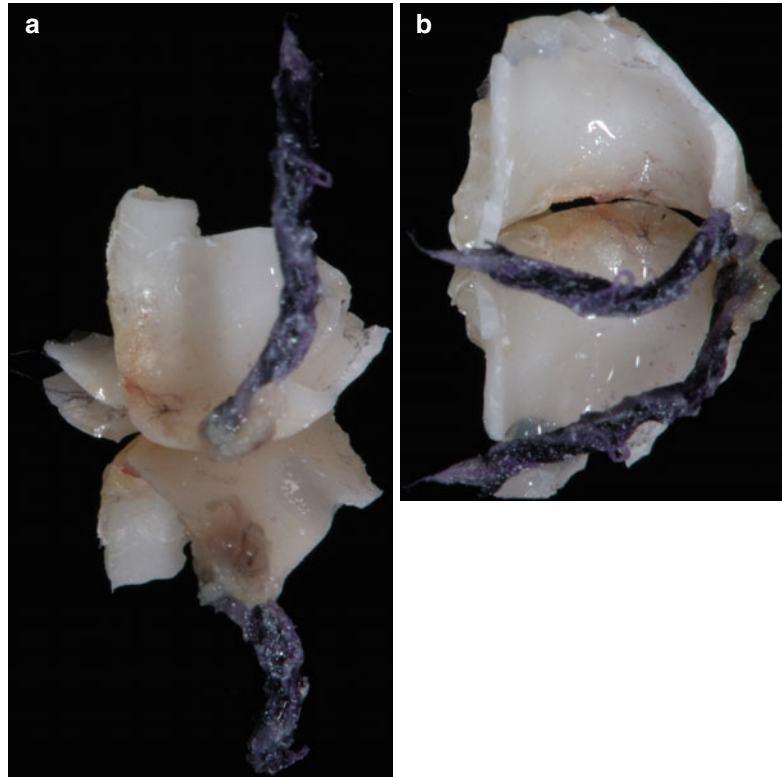
When considering the depth of the cemented margin with a tooth preparation, it is advisable to stay above the gingival sulcus where possible and, in esthetic sites, just beneath the free gingival margin. In contrast, implants are frequently placed 2–4 mm below the facial free gingival margin in esthetic sites. Where a natural tooth is adjacent to the implant, because of the tissue scalloping which rises at the papilla site, this may be 5–7 mm deep. This presents a significant difference again, which clearly places the peri-implant tissues at risk from insult with retraction cord.

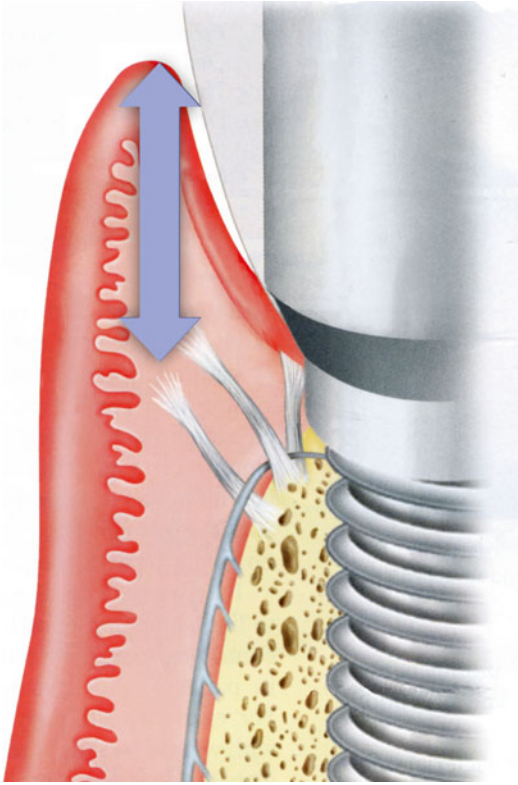
**Fig. 1.11** If the head of the implant is placed 3 mm below the free gingival margin of the facial tissue, then where a papilla exists, this may extend to depths of 6–7 mm (Modified from: Rose LF et al. *Periodontics: Medicine, Surgery and implants* (2004))

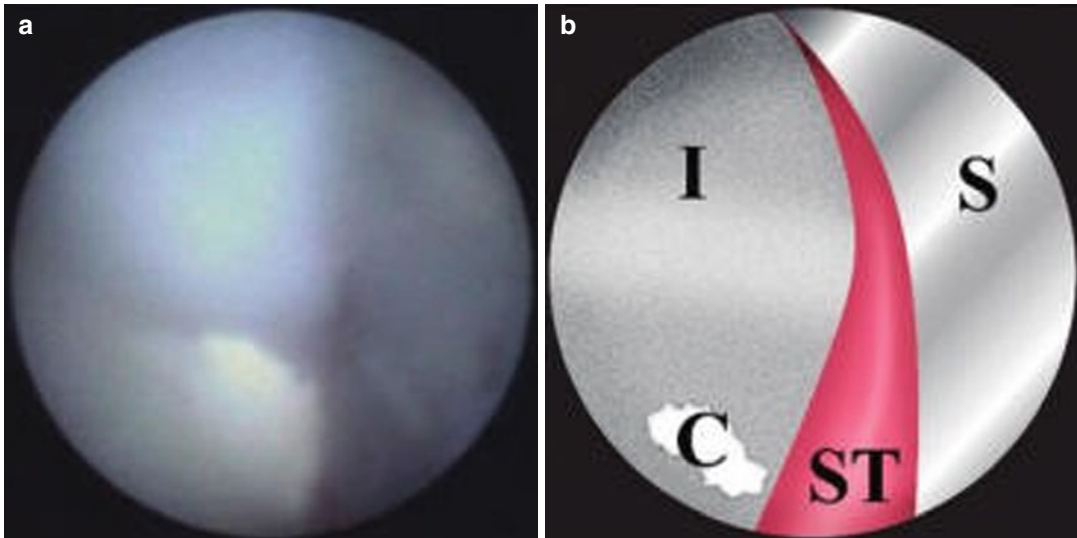
**Fig. 2.2** (a) A piece of cement, 0.5 mm in diameter, attached to the implant surface is seen in the lower left quadrant of the screen grab from the endoscope. (b) An

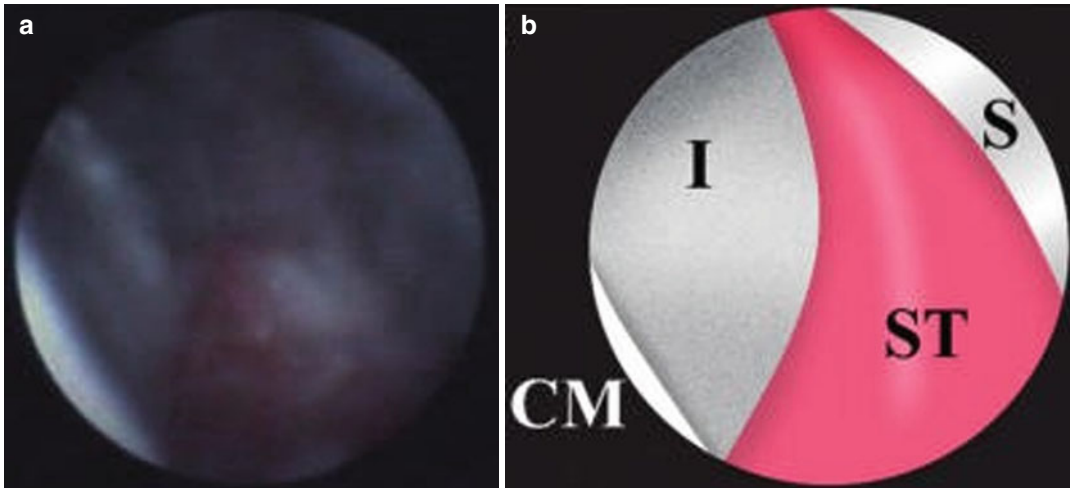
**Fig. 2.3** (a) An endoscopic view of the same implant seen in Fig. 2.1 after cement removal. (b) An illustration of (a). *I* implant, *S* shield, *CM* crown margin, *ST* soft tissue

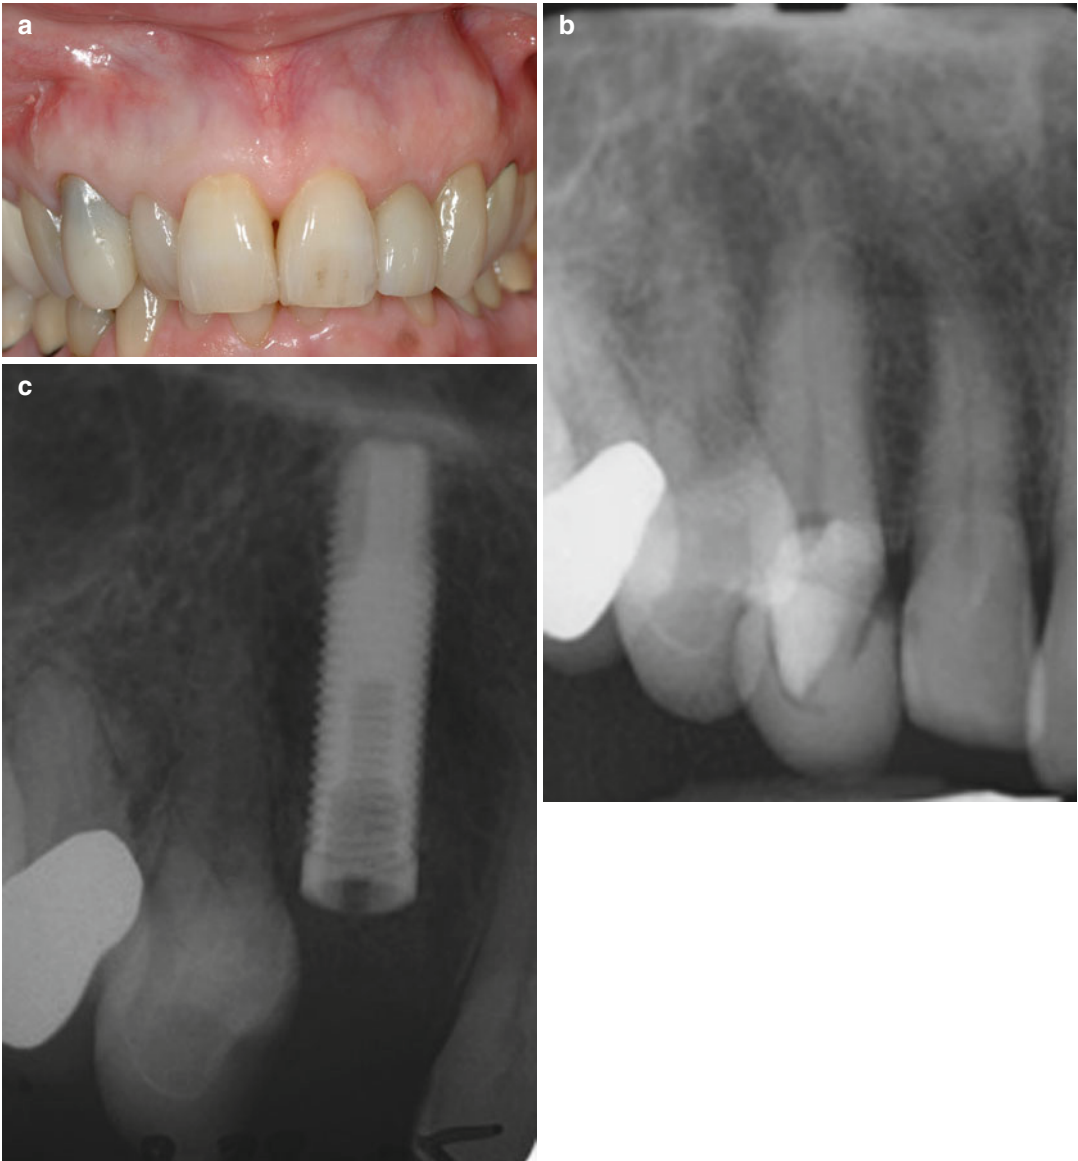
**Fig. 2.5** (a) This female patient presented with cervical resorption of the maxillary right canine with symptoms of irreversible pulpitis. (b) Radiograph is shown. Treatment of choice was extraction and implant placement. (c–e) Post extraction, the surgical site was carefully evaluated and bone thickness recorded. This was considered appropriate for immediate implant placement (Implant: Nobel

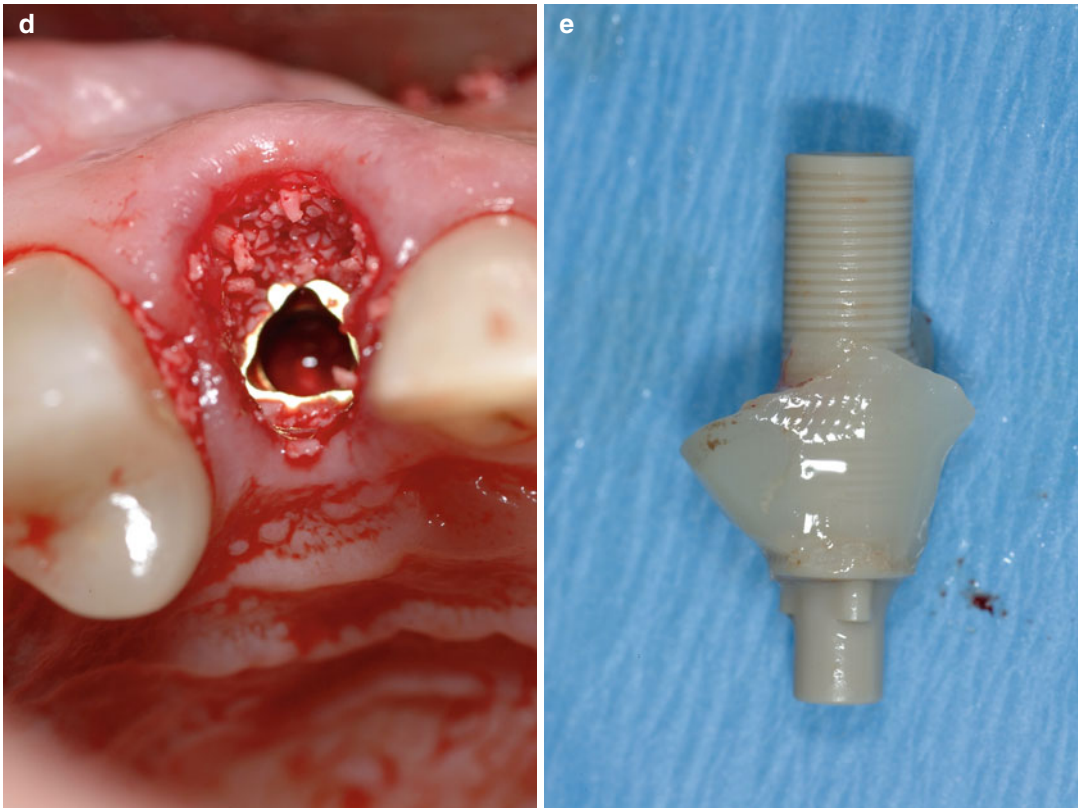
**Fig. 2.5** (continued)

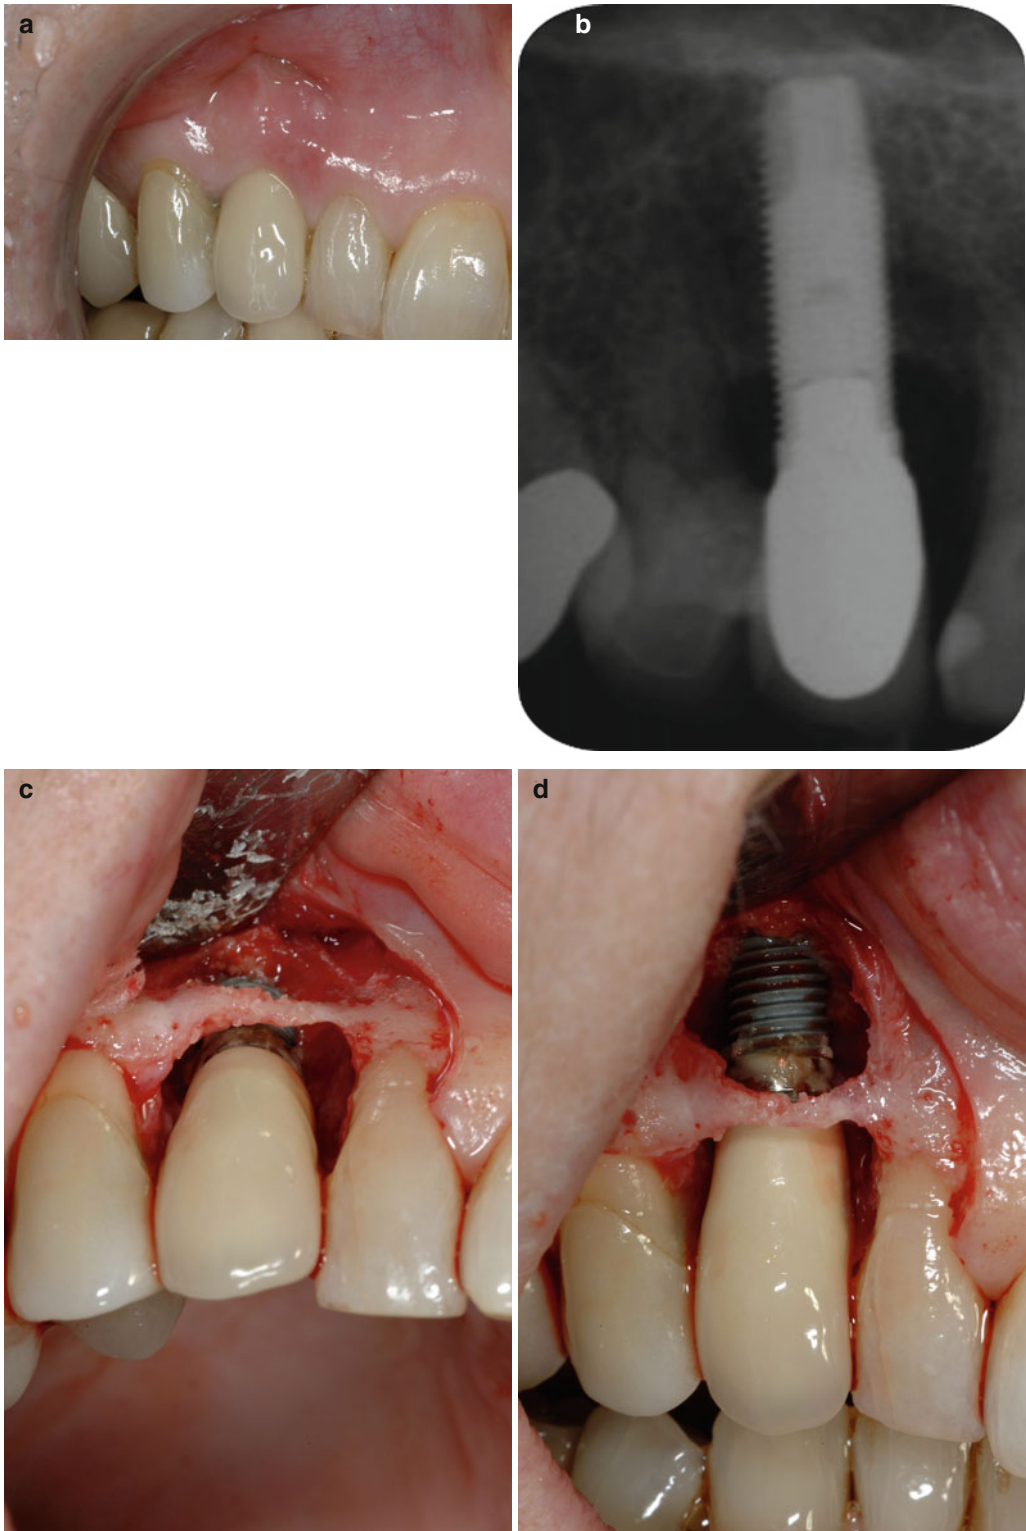
**Fig. 2.6** (a–d) Three years after implant restoration, the patient re-presented at the periodontist’s office complaining of pain. (a) Clinical photograph, note tissue changes

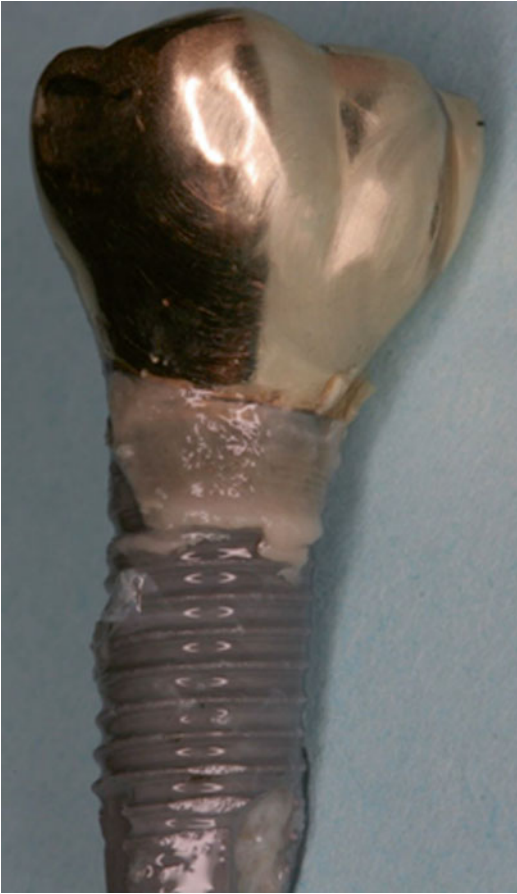
**Fig. 2.7** Example of a failed implant with residual excess cement. XRF analysis determined this as RelyX luting cement

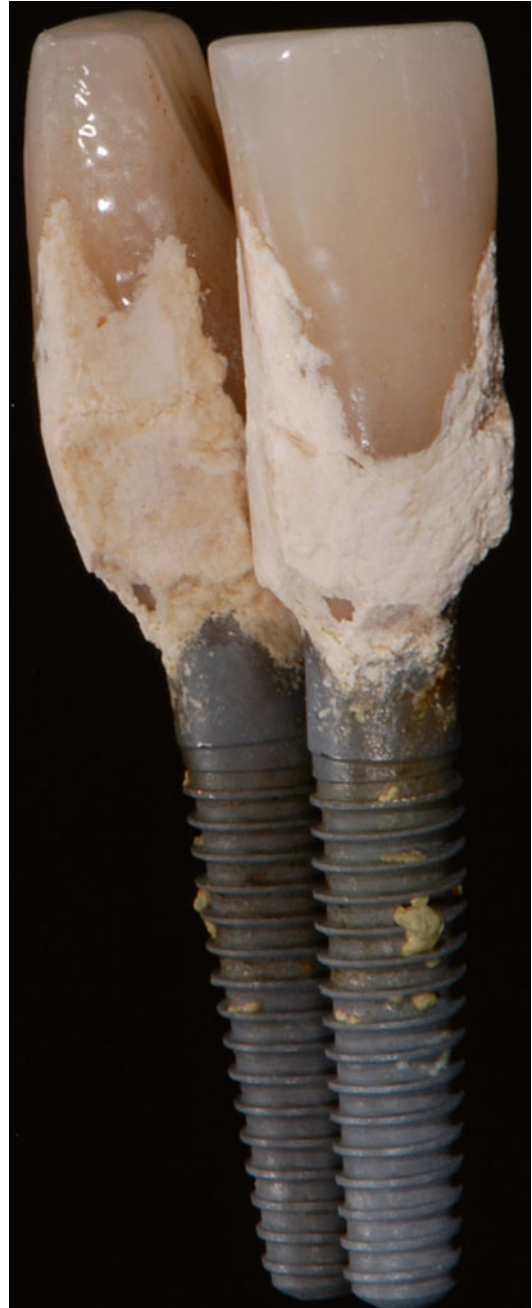
**Fig. 2.8** This failed implant (with mirror) had a note from the surgeon stating the patient was a smoker and that may have contributed to the implant failure. The material was examined and determined to be calculus on top of a resin-based cement

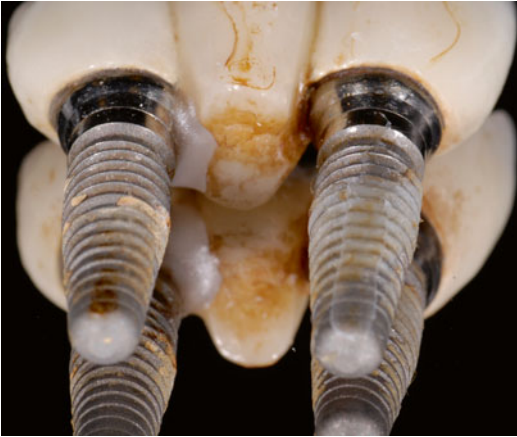
**Fig. 2.9** Failed implant bridge after 8 years of service. The implant documentation stated the implants were placed in October 2001, restored in April 2002, and removed in May 2010

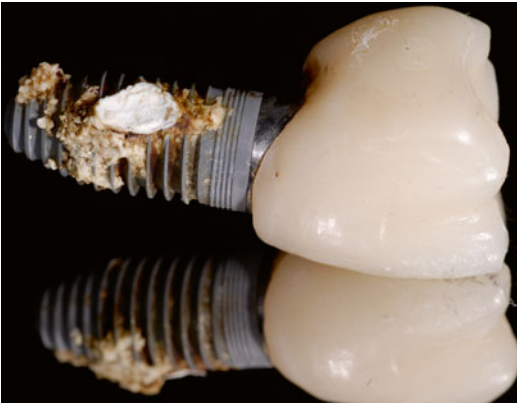
**Fig. 2.10** Another failed implant with residual excess cement noted all the way down onto the screw threads. It should be stated that cement may not be the cause of failure in some cases; however, the lack of control of the clinician with the cementing technique is clear

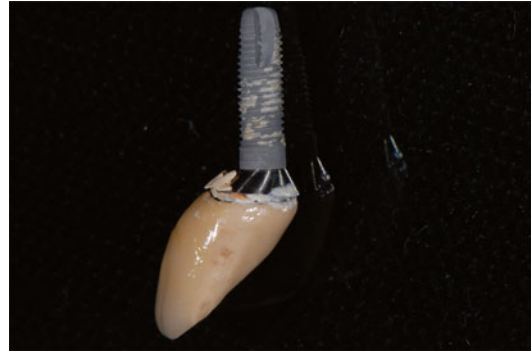
**Fig. 2.11** Cement is clearly visible at the margin of this specimen. It also extended halfway down the implant. The other materials noted were bone mineral deposits extending to the full length of the implant

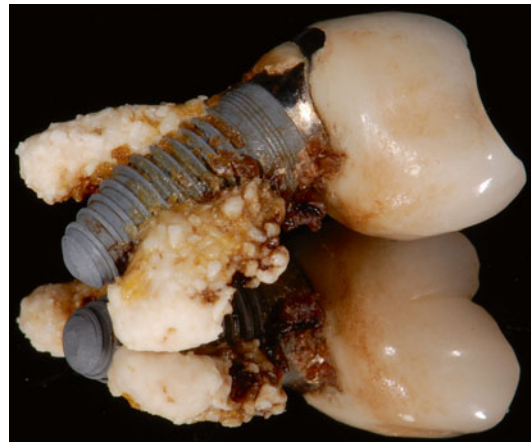
**Fig. 2.12** This example had cement, calculus, and bone mineral deposits the full length of the implant body. The size of defect on removal of this failed implant is unimaginable!

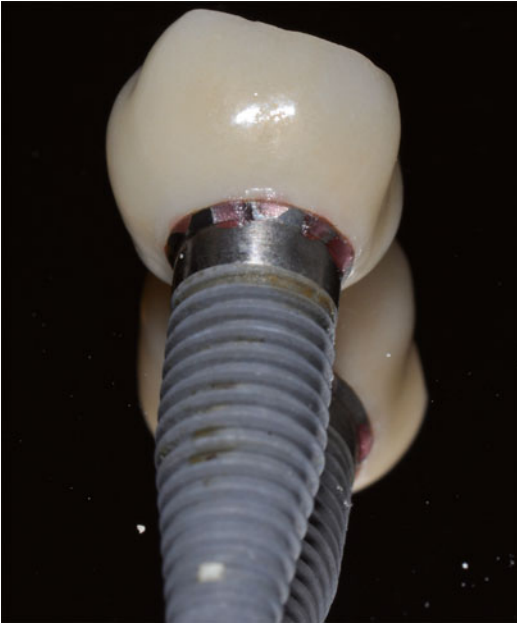
**Fig. 2.13** Some cements could be clearly identified by their physical characteristics; this pink cement was Premier implant cement

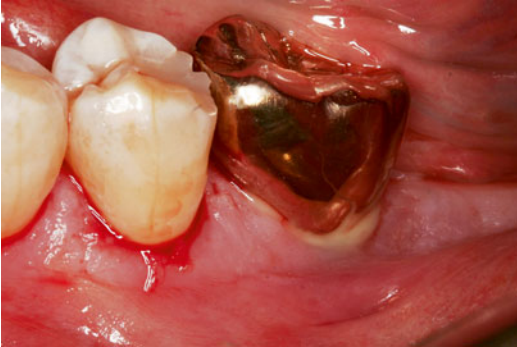
**Fig. 3.2** This case shows the effects of residual excess cement resulting in peri-implant disease with suppuration a common finding

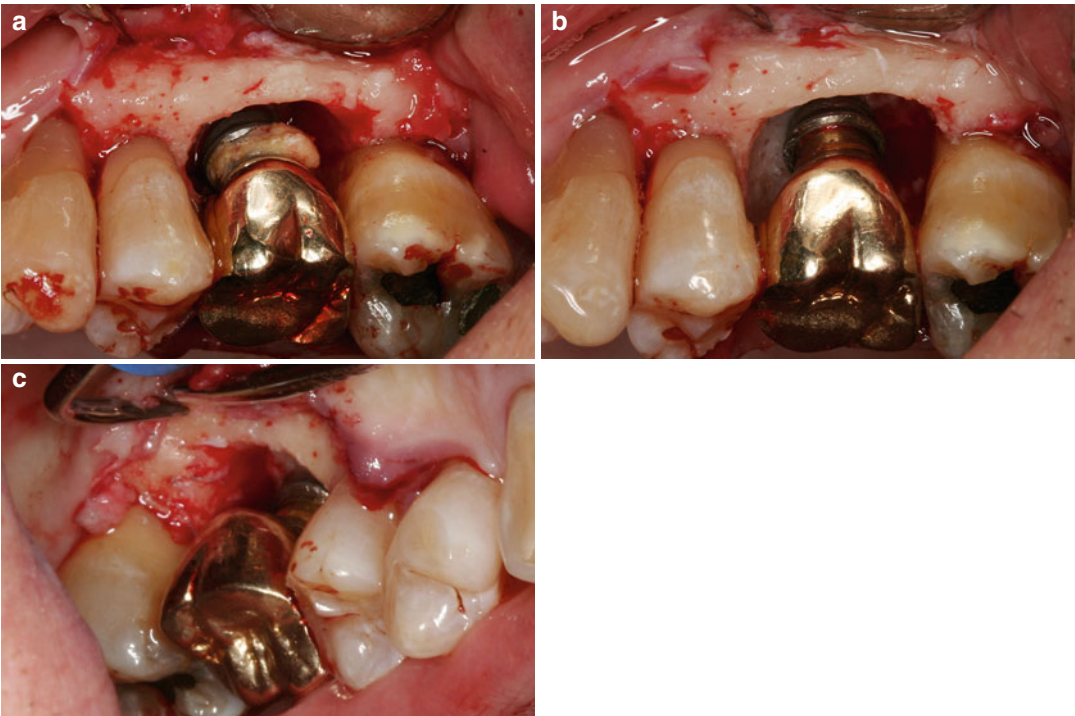
**Fig. 3.3** (a) Bone loss in a classic crater-type form; excess cement is noted on the implant body. (b, c) The crater is noted to extend 360°, with bone loss evident (Photos courtesy of Amy Fuller, DDS, and Brian Fuller, DDS)

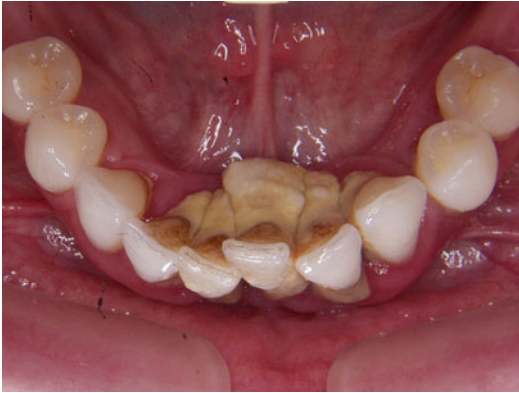
**Fig. 3.4** Calculus around these teeth presents an issue due to bacteria associated with it. In itself, it may be considered having more of a “passive” than “active” role in periodontal disease

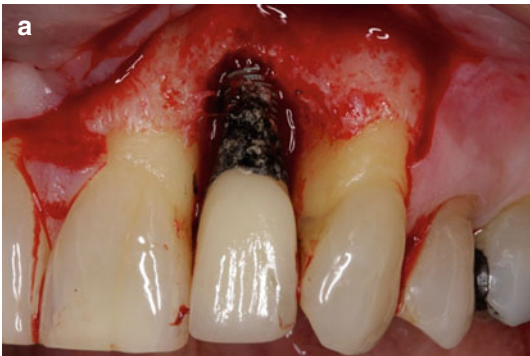
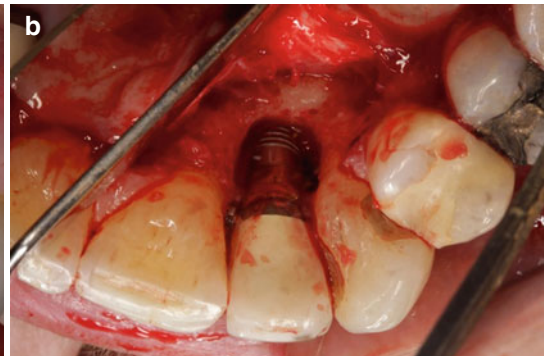
**Fig. 3.5** Facial (a) and palatal (b) photographs of a site affected by residual cement. The resultant disease process is clear. Can this response truly be considered passive like

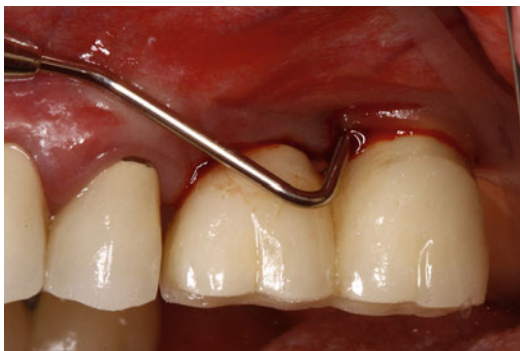
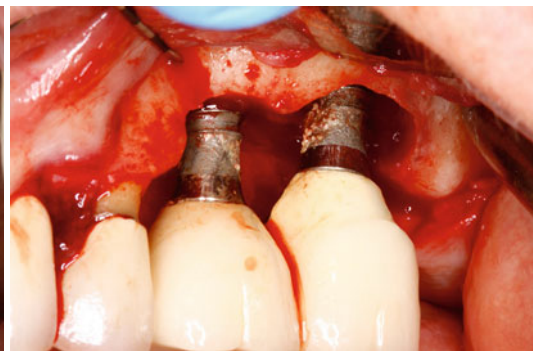
**Figs. 3.6 and 3.7** A deep probing noted around these implants. Surgical evaluation with remnants of excess cement noted on these two failing implants. Is it possible

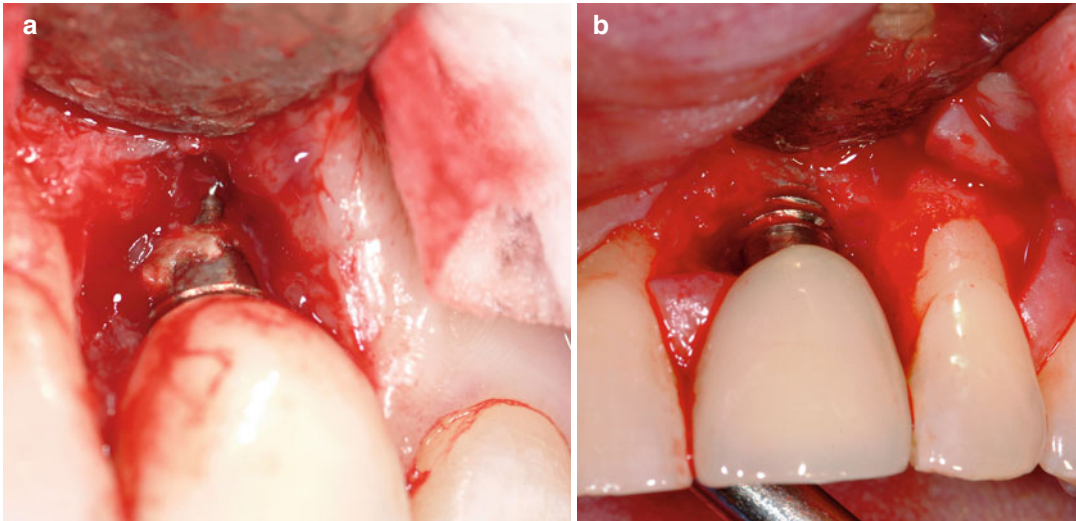
**Fig. 3.8** (a) Was there always going to be an issue with this implant and the cement is simply there as a result, or did the cement get into the site and cause the problem? (b) Debrided site

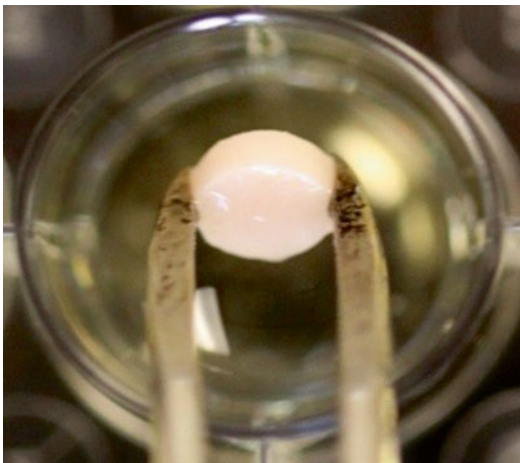
**Fig. 3.9** Planktonic growth: test cement disk being introduced into bacteria-containing media

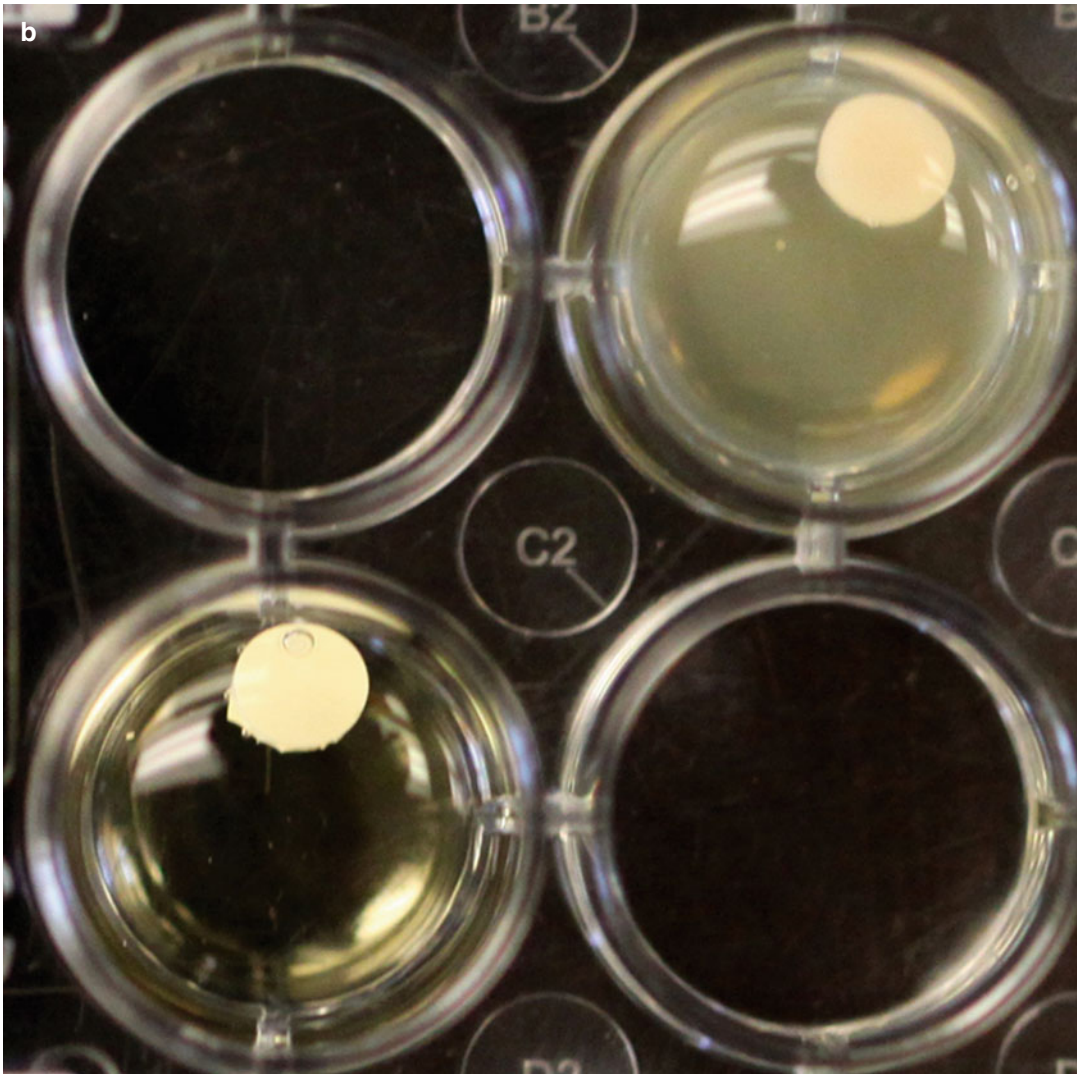
**Fig. 3.10** (continued)

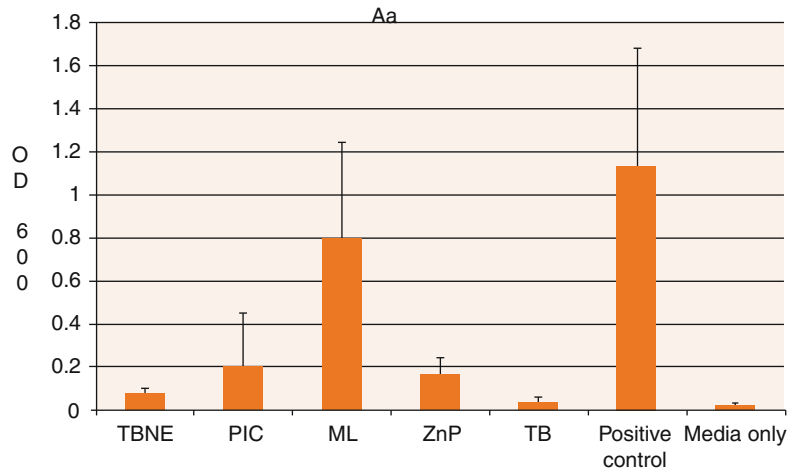
**Fig. 3.12** Graph showing mean and standard deviations relating planktonic growth of *Porphyromonas gingivalis* (*Pg*) with the test cements and controls (Reproduced with permission from John Wiley and Sons: Raval et al. (2014). © 2014 Wiley Periodicals, Inc)

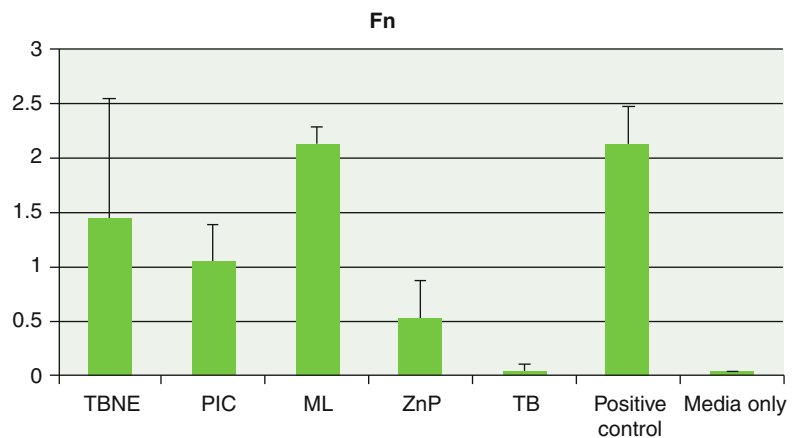
**Fig. 3.13** Graph showing mean and standard deviations relating planktonic growth of *Fusobacterium nucleatum* (*Fn*) with the test cements and controls (Reproduced with permission from John Wiley and Sons: Raval et al. (2014). © 2014 Wiley Periodicals, Inc.)

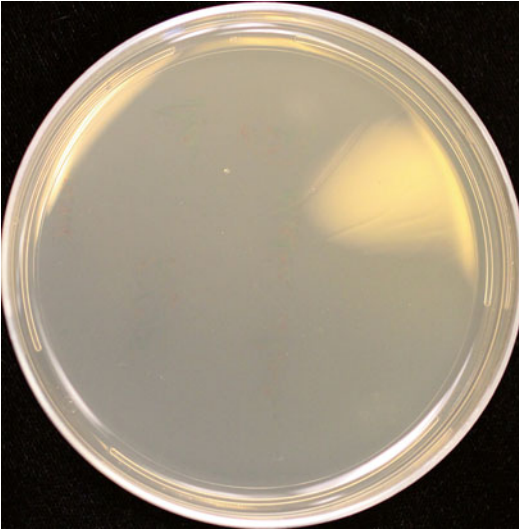
**Fig. 3.14** A typical example found with TB with no biofilm growth on the agar plates with *Aggregatibacter actinomycetemcomitans* (Aa) and *Fusobacterium nucleatum* (Fn)

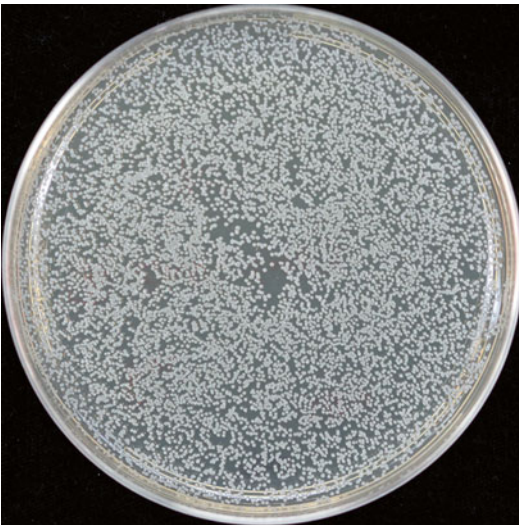
**Fig. 3.15** Typical example of biofilm growth found with ML on the agar plates with *Aggregatibacter actinomycetemcomitans* (Aa) and *Porphyromonas gingivalis* (Pg)

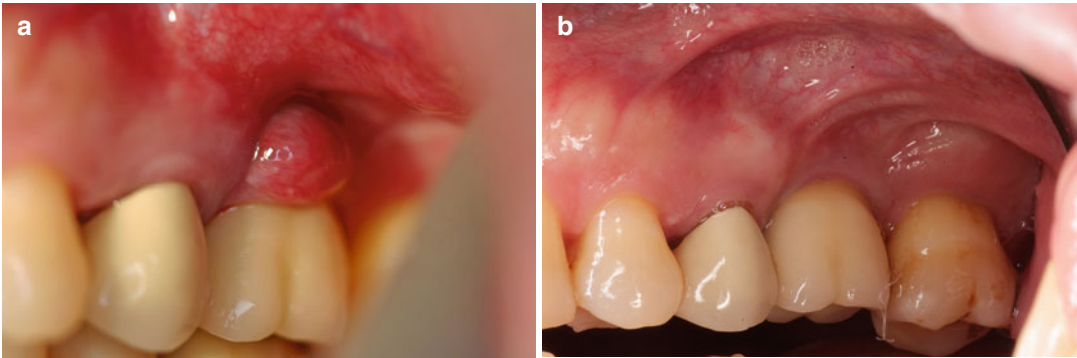
**Fig. 3.16** (a) Giant cell foreign body reaction associated with residual excess cement. Treatment involved crown removal, lesion excision with debridement, and removal

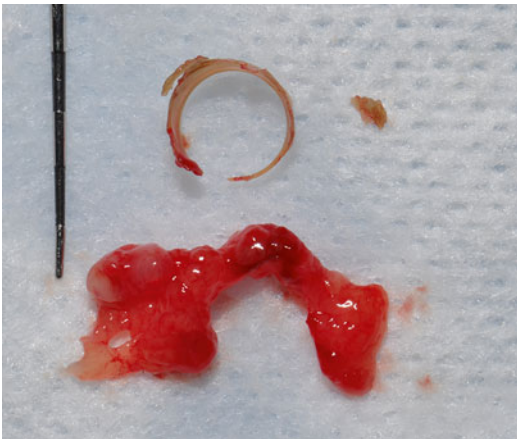
**Fig. 3.17** Residual excess cement along with soft tissue. The granulomatous tissue should be sent for histopathologic evaluation

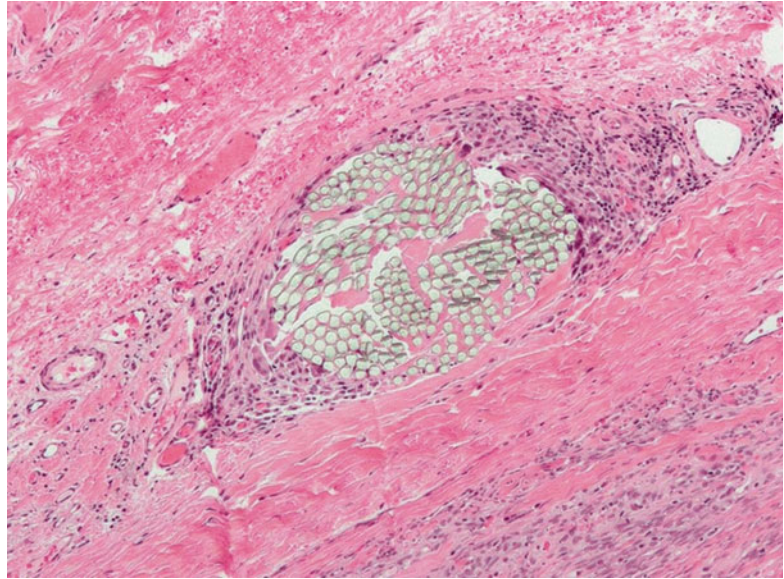
**Fig. 3.19** The dark spots are cement within this tissue mass of inflammatory tissue. It is possible they contributed to the mass destruction that occurred around this implant

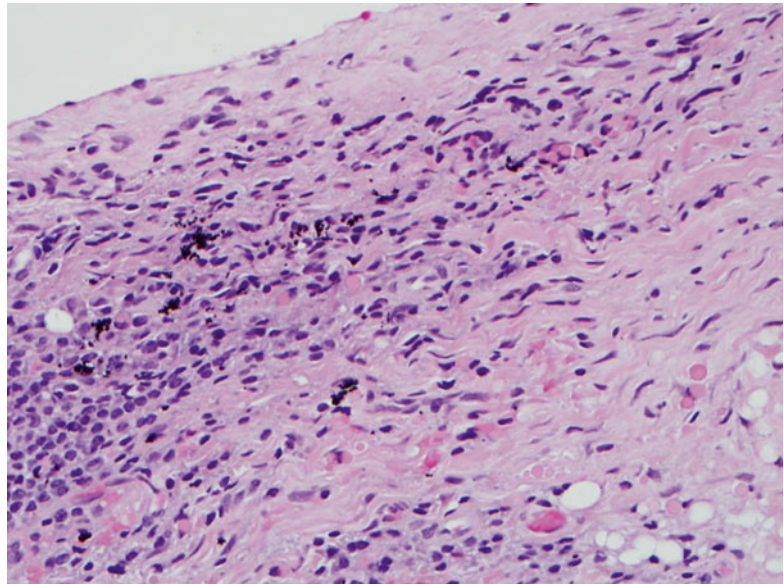
known to cause inflammation and breakdown of the surrounding tissues. Peri-implant disease is such a response. There is no justification for the use of this material where titanium products are used (Fig. 3.26).

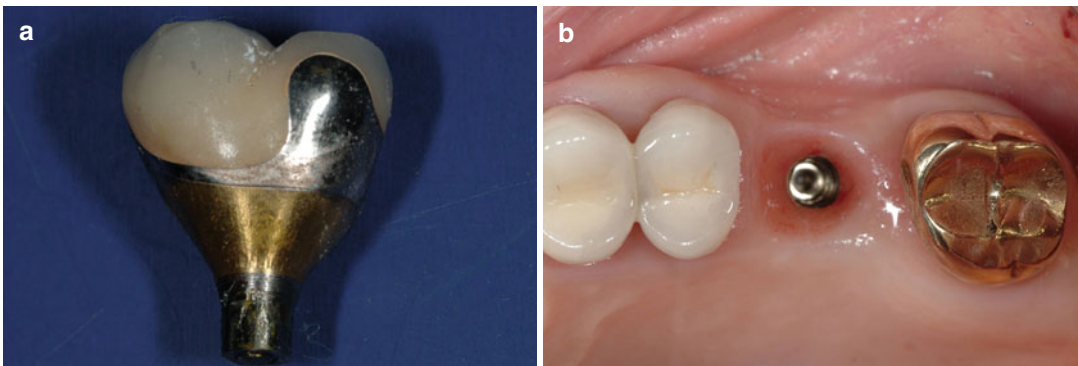
**Fig. 3.21** (a) The crown and implant abutment were removed by cutting through the occlusal surface to locate the screw. (b) The depth of the implant in relation to the size of the crown is shown

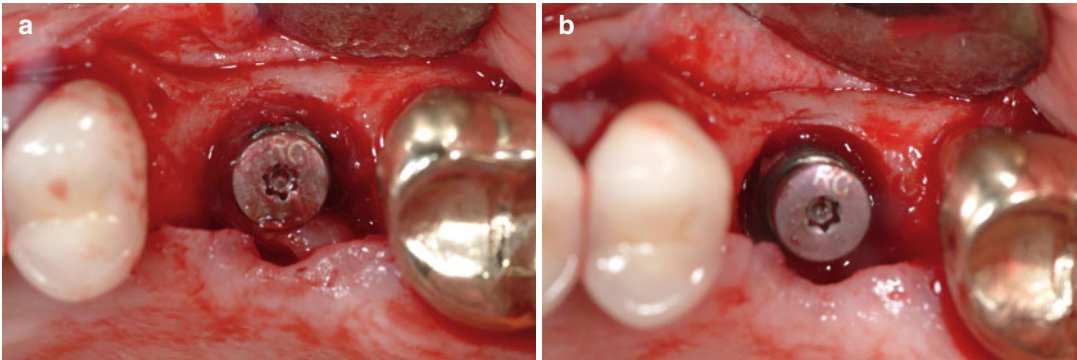
**Fig. 3.22** (a) Healing cap placed to prevent blood and debris contaminating the internal implant lumen and a full-thickness flap raised. (b) On the palatal aspect, a soft tissue mass was noted and removed, pink colored foreign material is seen attached to the mesial aspect of the implant

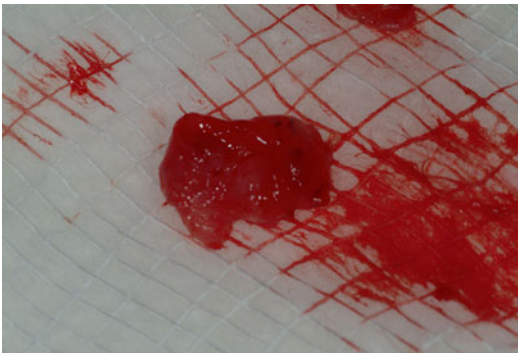
**Fig. 3.23** The soft tissue mass recovered from around the implant. Note the dark inclusions. This was sent for evaluation and oral pathology report case report courtesy of Dr. Goichi Shiotsu

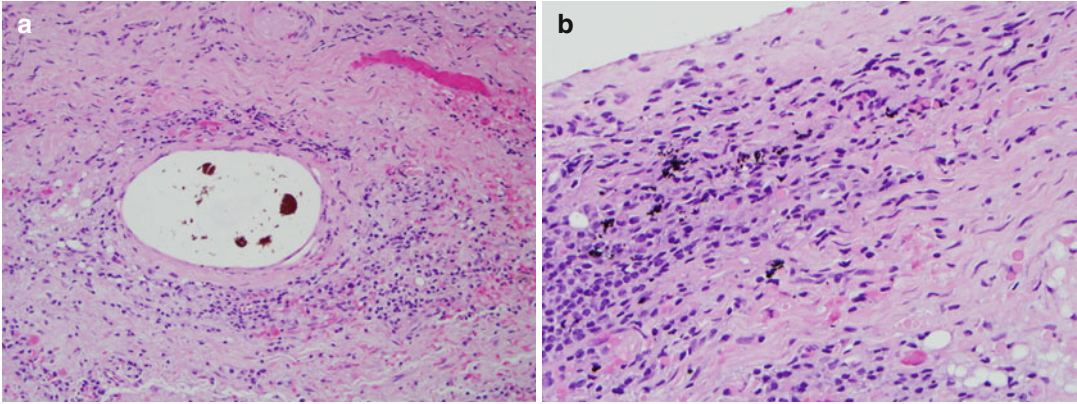
**Fig. 3.24** (a, b) Histological images. The brown-colored material is believed to be cement extrusion products. The pathology report noted “subacutely inflamed granulation tissue, abscess, squamous epithelium, and foreign material”

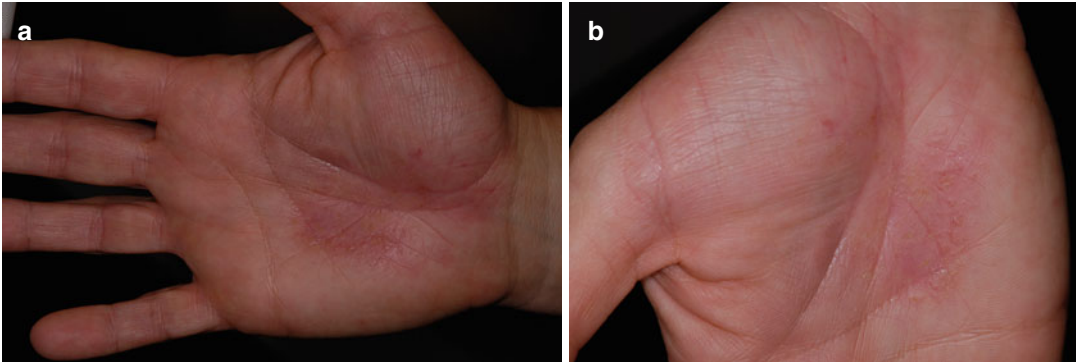
**Fig. 3.25** (a, b) The palm of a dental assistant with contact dermatitis, the result of allergic response to dental materials being handled without barrier protection, i.e., gloves

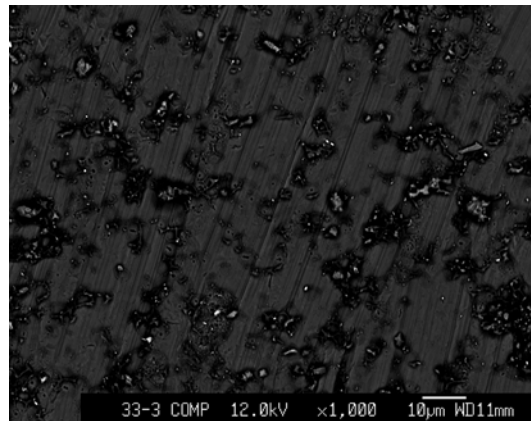
**Fig. 3.26** A scanning electron microscope image of titanium alloy used for implant components that has been subject to cementation with Durelon for 7 days. The pitting corrosion is evident. Micro-electro cells producing galvanic action will keep this process of corrosion active indefinitely

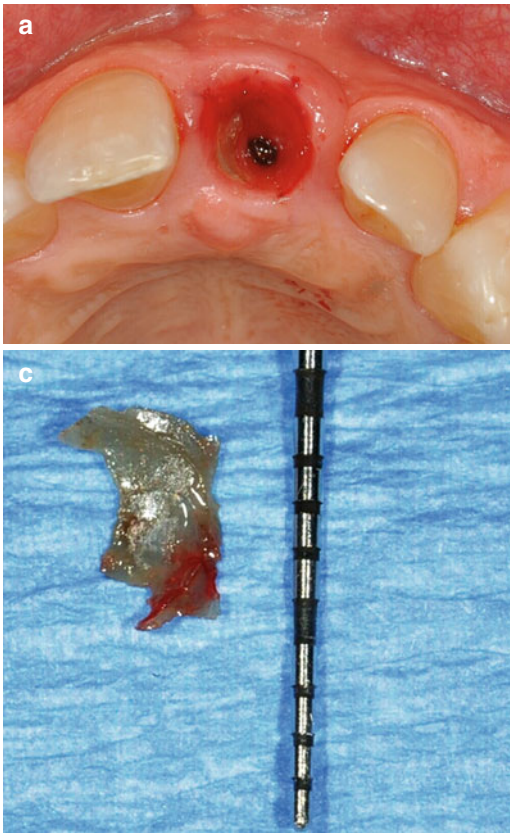
**Fig. 3.27** (a–c) The hemidesmosomal attachment can be readily detached from the implant by excess cement being forced beyond the margins of the abutment. (a) This case demonstrated cement displacement on the soft tissue sur-

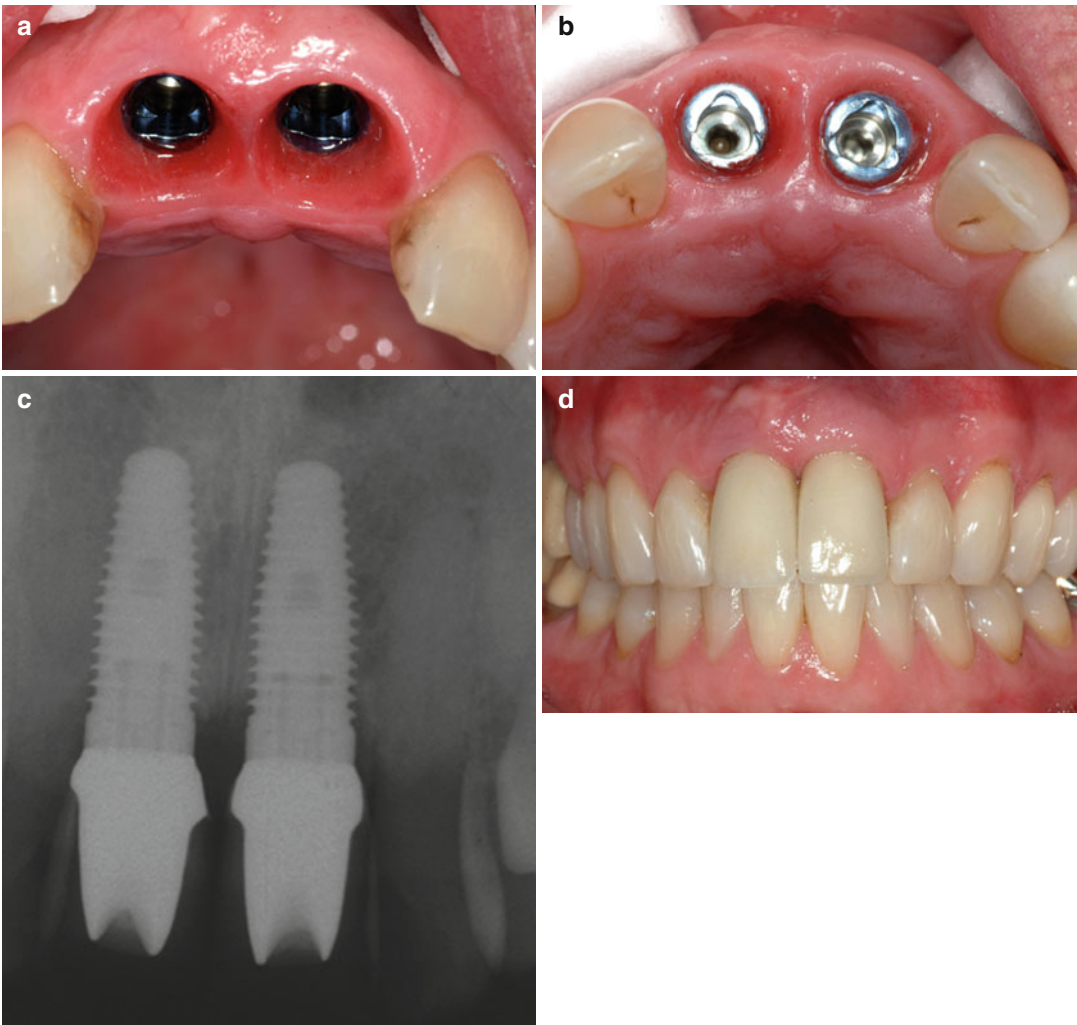
**Fig. 4.1** Dental implants provide an acceptable treatment, in this case replacing the central incisors. (a) The soft tissue emergence profile of the implants. (b) Occlusal view. (c) Radiograph of the final restorations. (d) Completed Restorations

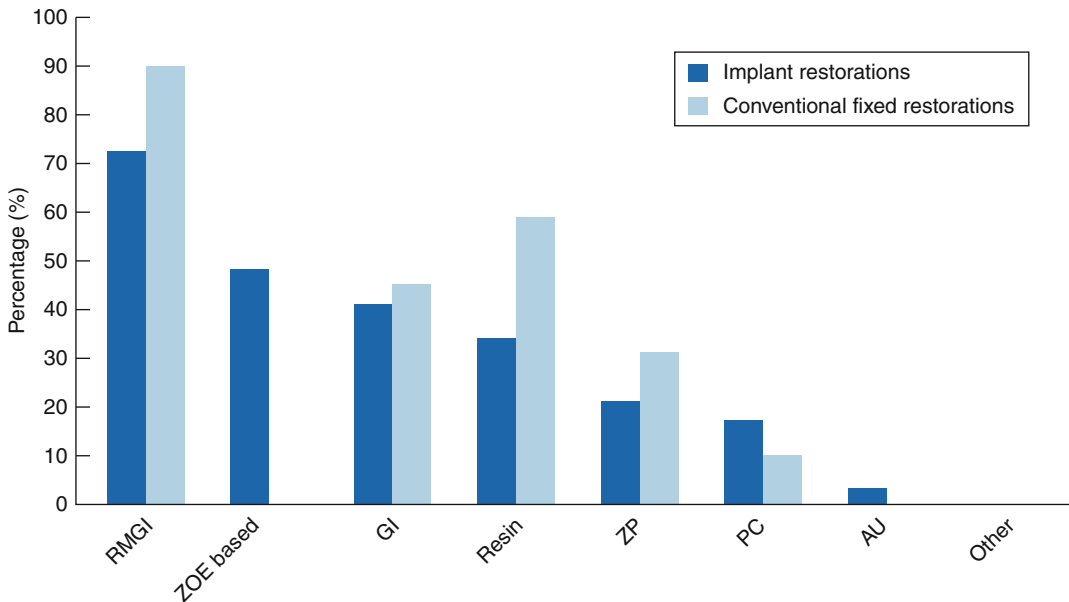
**Fig. 4.2** Definitive cements used for implant and conventional fixed restorations by prosthodontic residency directors in 2008. *RMGI* resin-modified glass ionomer, *ZOE* zinc oxide eugenol, *GI* glass ionomer, *ZP* zinc phosphate,
