Chandur P.K. Wadhvani  
*Editor*

# Cementation in Dental Implantology

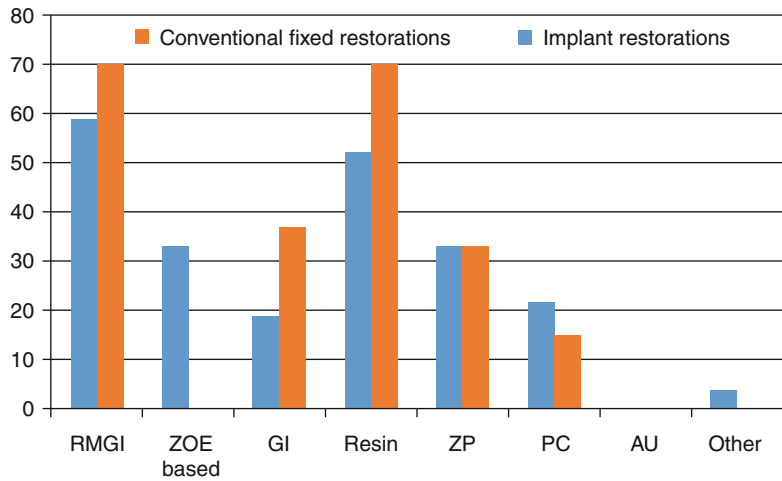
**Fig. 4.3** Definitive cements used for implant and conventional fixed restorations by prosthodontic residency directors in 2013. *RMGI* resin-modified glass ionomer, *ZOE* zinc oxide eugenol, *GI* glass ionomer, *ZP* zinc phosphate, *PC* polycarboxylate, *AU* acrylic urethane

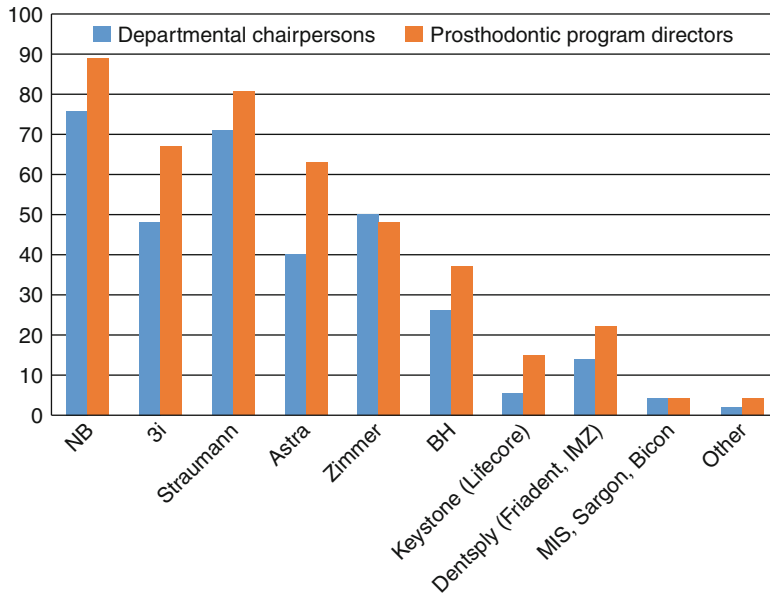
**Fig. 4.4** Implant manufacturers used at US dental institutions in 2013. *NB* Nobel Biocare AB (Gothenburg, Sweden), *3i* Biomet 3i Inc (Palm Beach Gardens), *Straumann* Institut Straumann AG (Basel, Switzerland), *Astra* Astra Tech Inc (Waltham, MA), *Zimmer* Zimmer Dental (Carlsbad, CA), *BH* BioHorizons (Birmingham, AL), *Keystone* Dentsply (Mannheim, Germany), *MIS* MIS

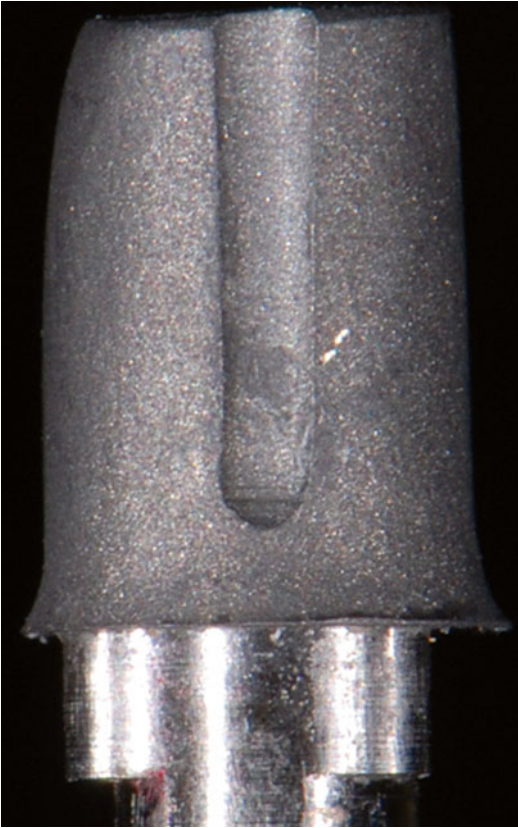
**Fig. 4.5** An example of abutment modifications. This abutment has been air abraded and also has an axial groove placed. This would represent two modifications

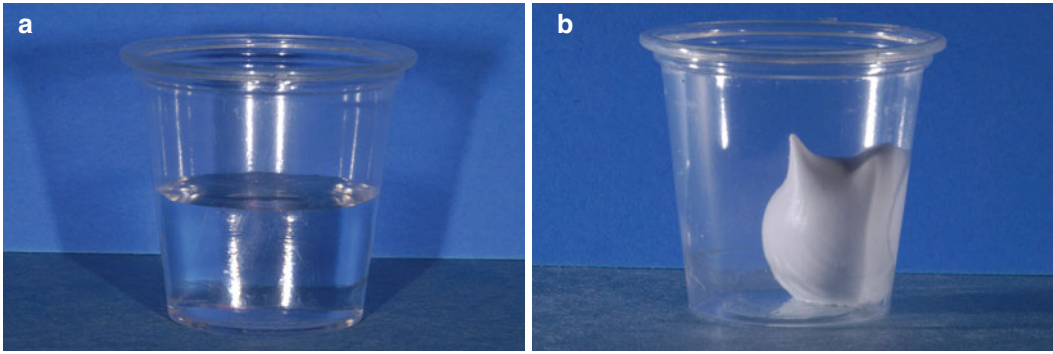
**Fig. 4.9** (a) This body of water has Newtonian properties; it fills this container and will flow according to Newtonian laws when a force is applied to it. (b) This

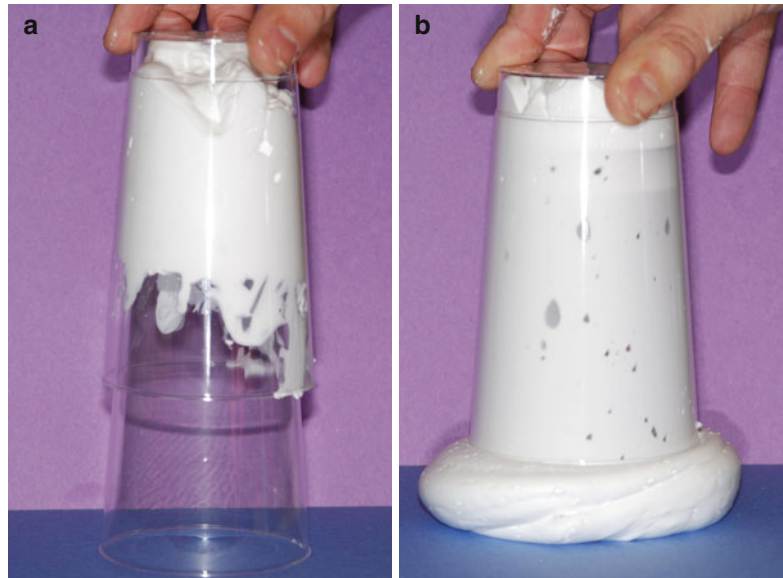
from the occlusal cement layer that traps between the two horizontal surfaces. Liquids (cements prior to setting) are resistant to compression, unlike gases. Once the applied force is great enough to overcome this compression, the cement flows down onto the axial walls of the “abutment” and the excess cement will eventually be extruded out of the crown/abutment

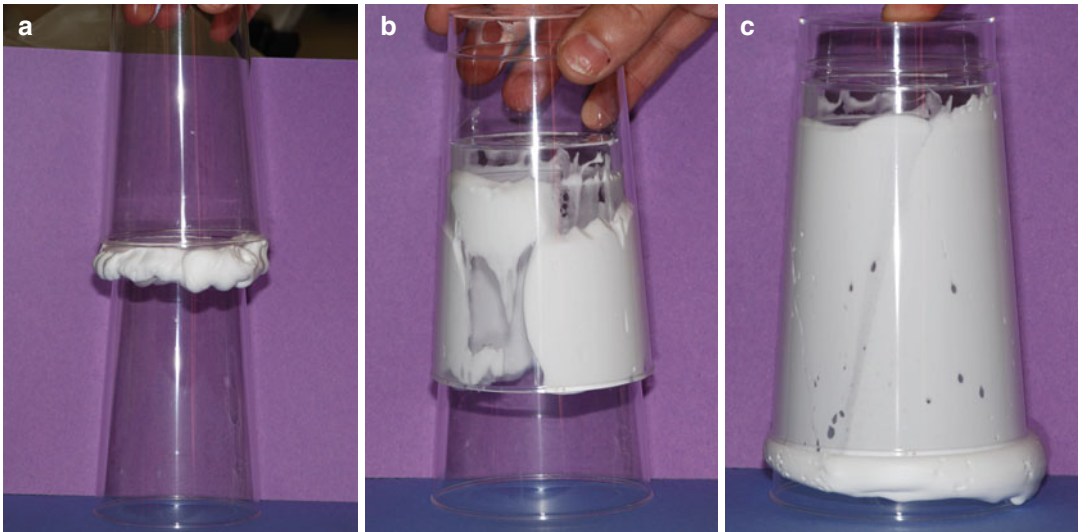
**Fig. 4.13** (a–c) Application of cement to the axial wall near but not on the occlusal surface results in the cement flowing in the same direction as the applied seating force.

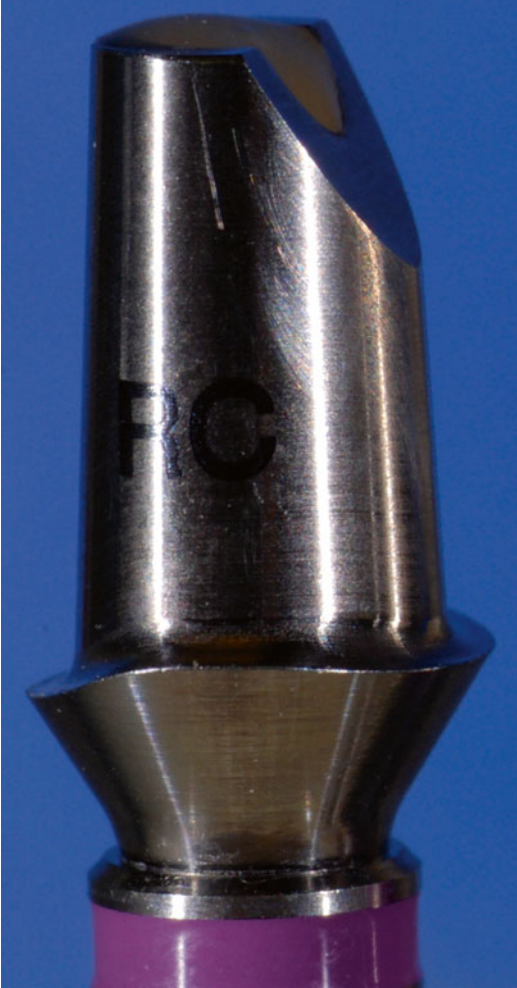
**Fig. 4.16** Example of abutment that has closed off abutment screw access holes, as advocated by US dental schools

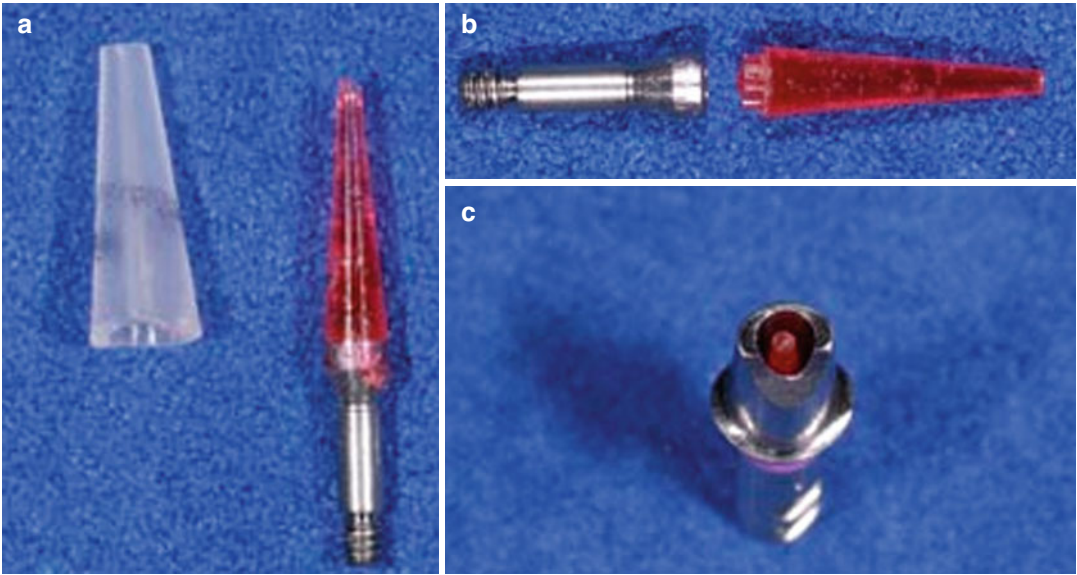
**Fig. 4.22** (a) Fabrication of an abutment cone insert using auto-curing acrylic within a syringe tip. (b) The acrylic indexes the screwhead, and (c) when placed, it projects within the center of the screw channel

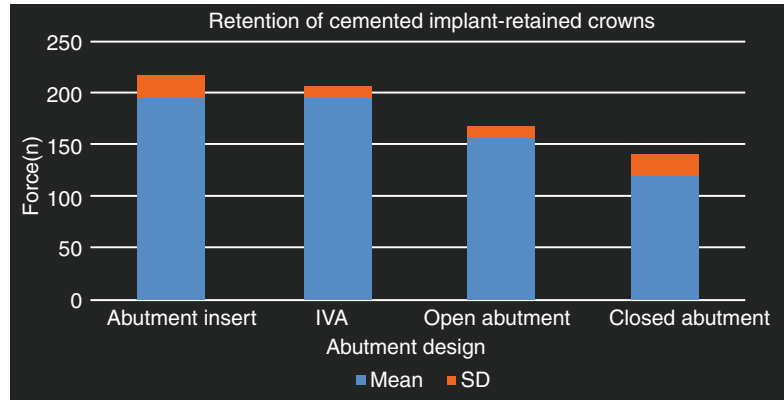
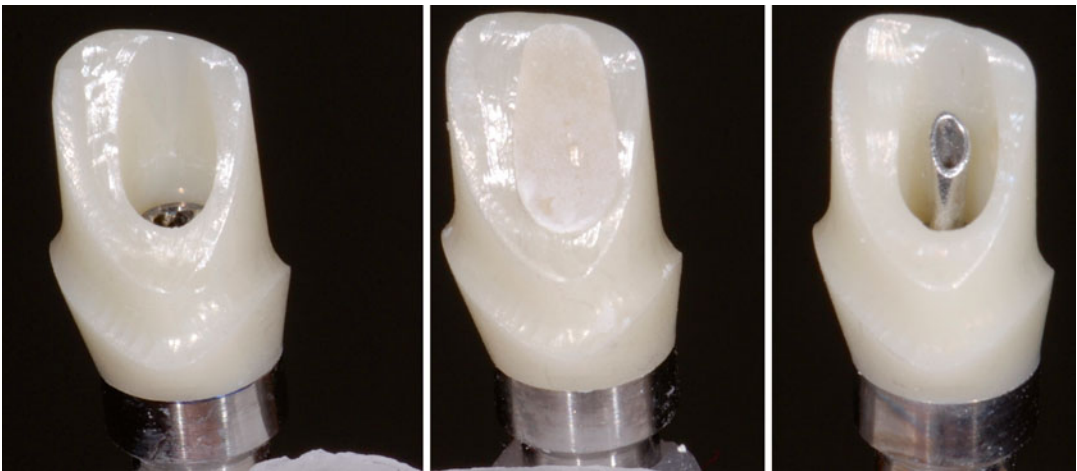
**Fig. 4.25** The three groups showing modifications of the screw access channel: open, closed, and abutment insert

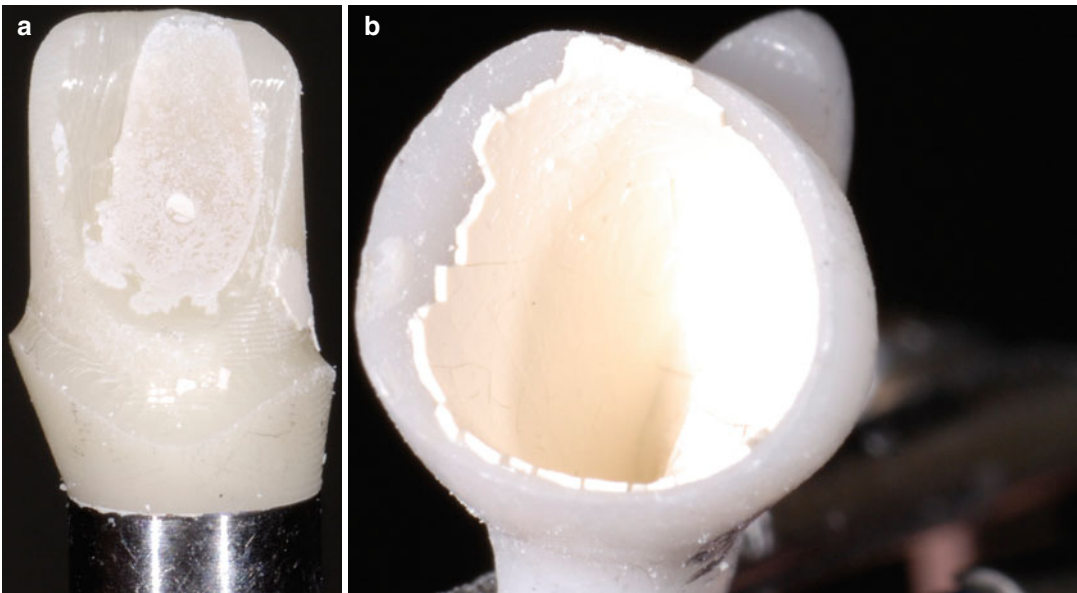
**Fig. 4.27** (a) Pattern of cement failure for the closed abutment that failed at the lowest force level. (b) All cement remnants are on the crown

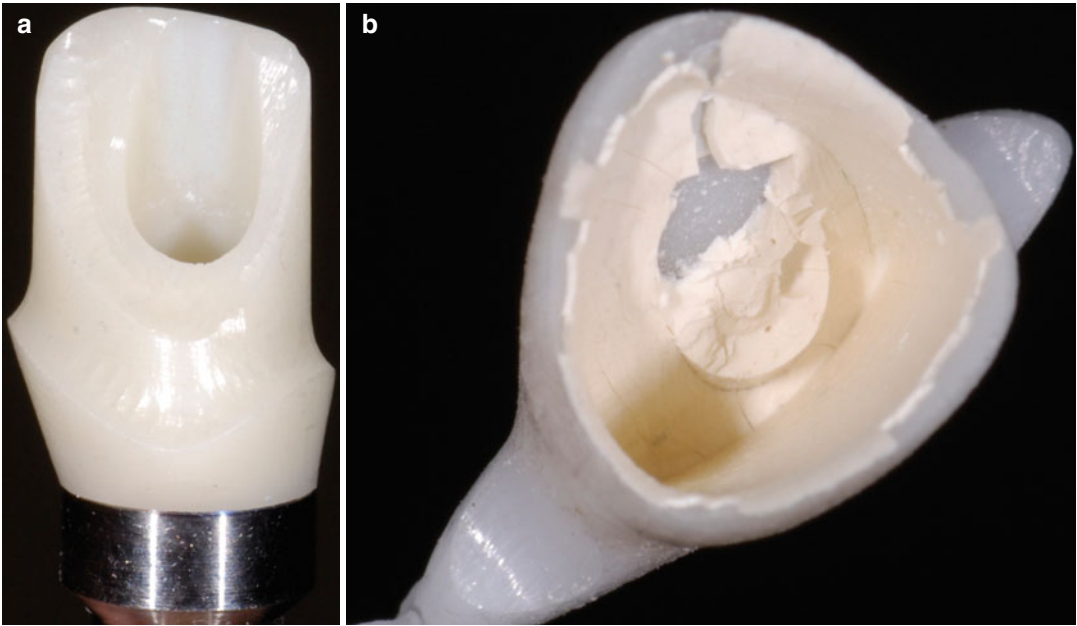
**Fig. 4.28** (a) Cement failure with the open abutment group. Some cement is seen remaining within the abutment, which gave a slightly higher force level to failure. (b) An incomplete fill of the internal screw access channel of the abutment is also noted (Used with permission from Wadhvani and Chung (2014). Copyright Elsevier Inc.)

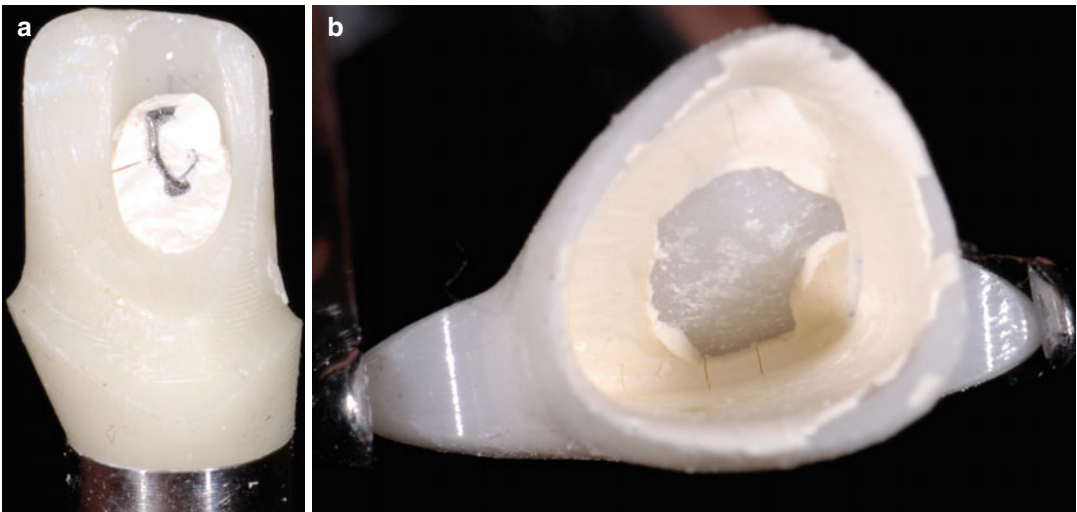
**Fig. 4.29** (a) The abutment insert group had the highest load to failure. The cement was seen to be forced internally, and (b) fracture pattern showed a very different failure site compared with the other groups

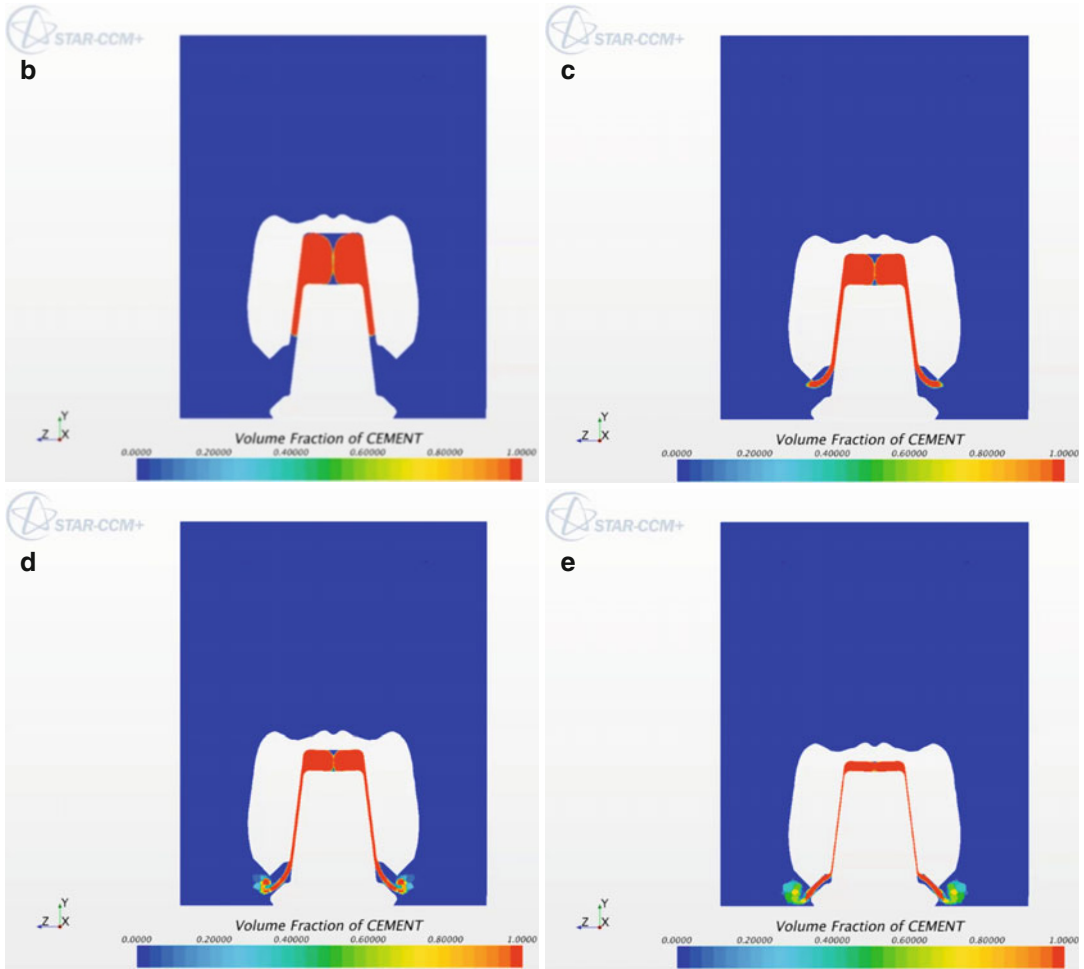
Fig. 4.41 (continued)

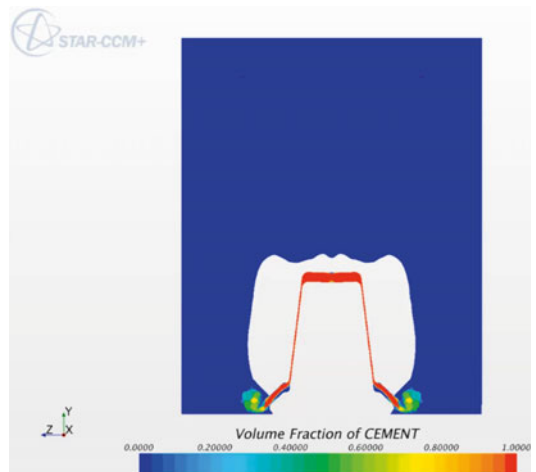
→  
Fig. 4.42 Compared with cement placed at the crown margin, cement seal is incomplete and more turbulence of cement is noted

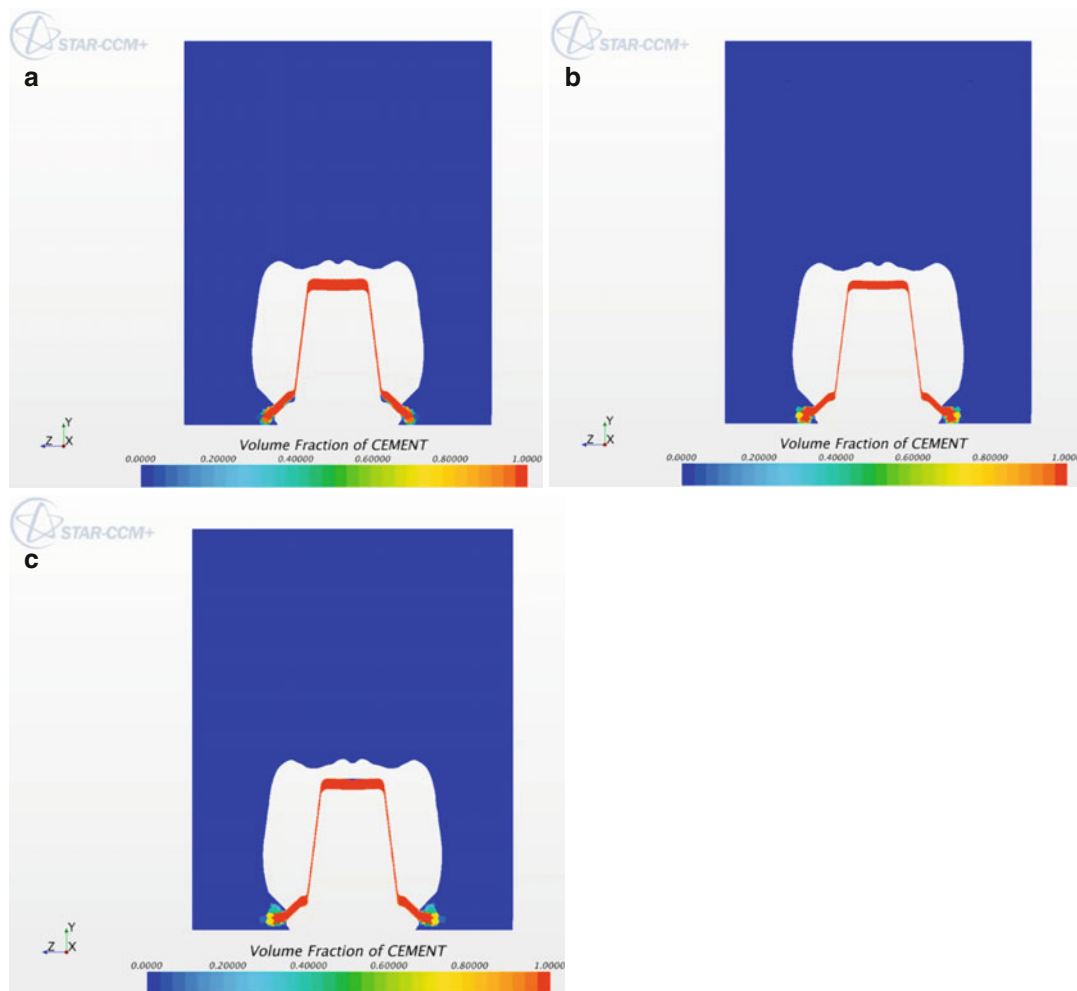
**Figs. 4.43** How speed of seating affects flow. (a) Crown seated on abutment in 0.25 s. (b) Seating time 0.5 s. (c) Seating accomplished in 1 s. (Note the difference in cement fill at margin and occlusal sites)

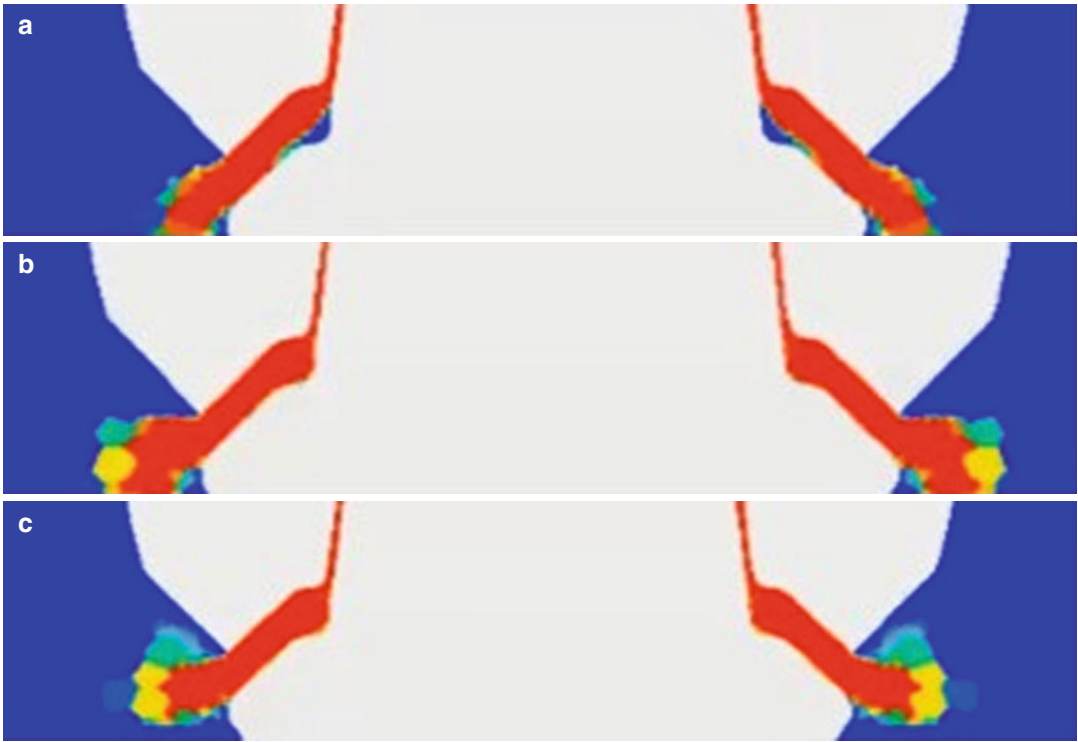
**Figs. 4.44** Enlargement of the margin site and extrusion patterns at (a) fast seating speed (0.25 s), (b) medium seating speed (0.5 s), and (c) slow seating speed (1 s)

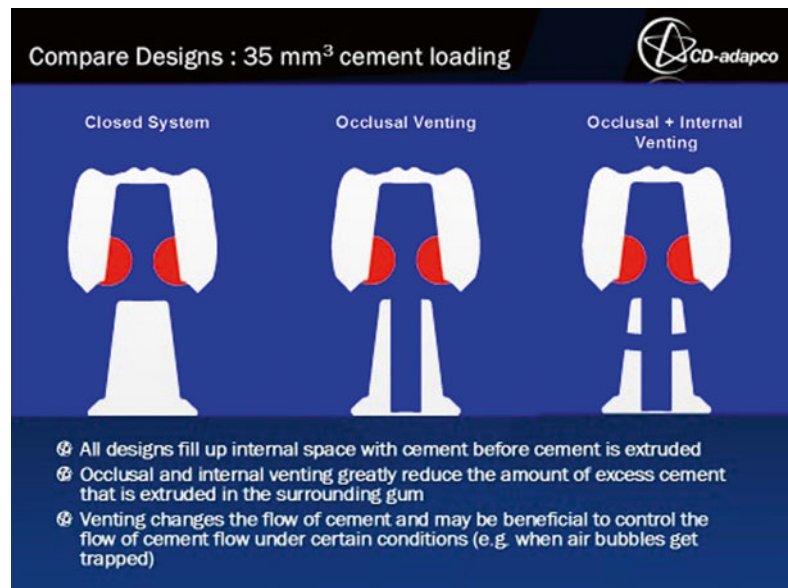
**Figs. 4.46 (a, b)** Evaluating how cement flows with an internal vented abutment when the cement is applied at different sites

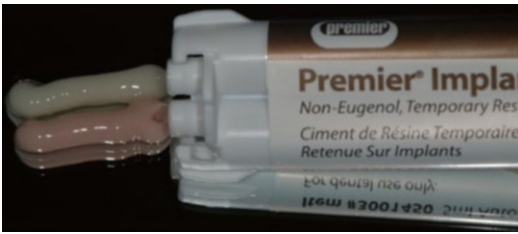
**Fig. 5.1** This cement manufacturer boasts “..tasteless, odorless cement that also provides esthetic gingival shading for natural esthetics.” In essence, this cement camouflages beneath the tissues and would be difficult to visually detect

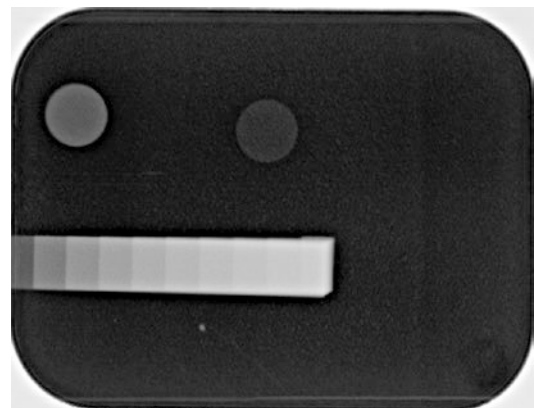
**Fig. 5.8** Premier Implant Cement (PIC) above and Premier Implant Cement with Modifier (PICM) below are just observable at lower exposures settings of 60 kVp, .32 s, 7 mA

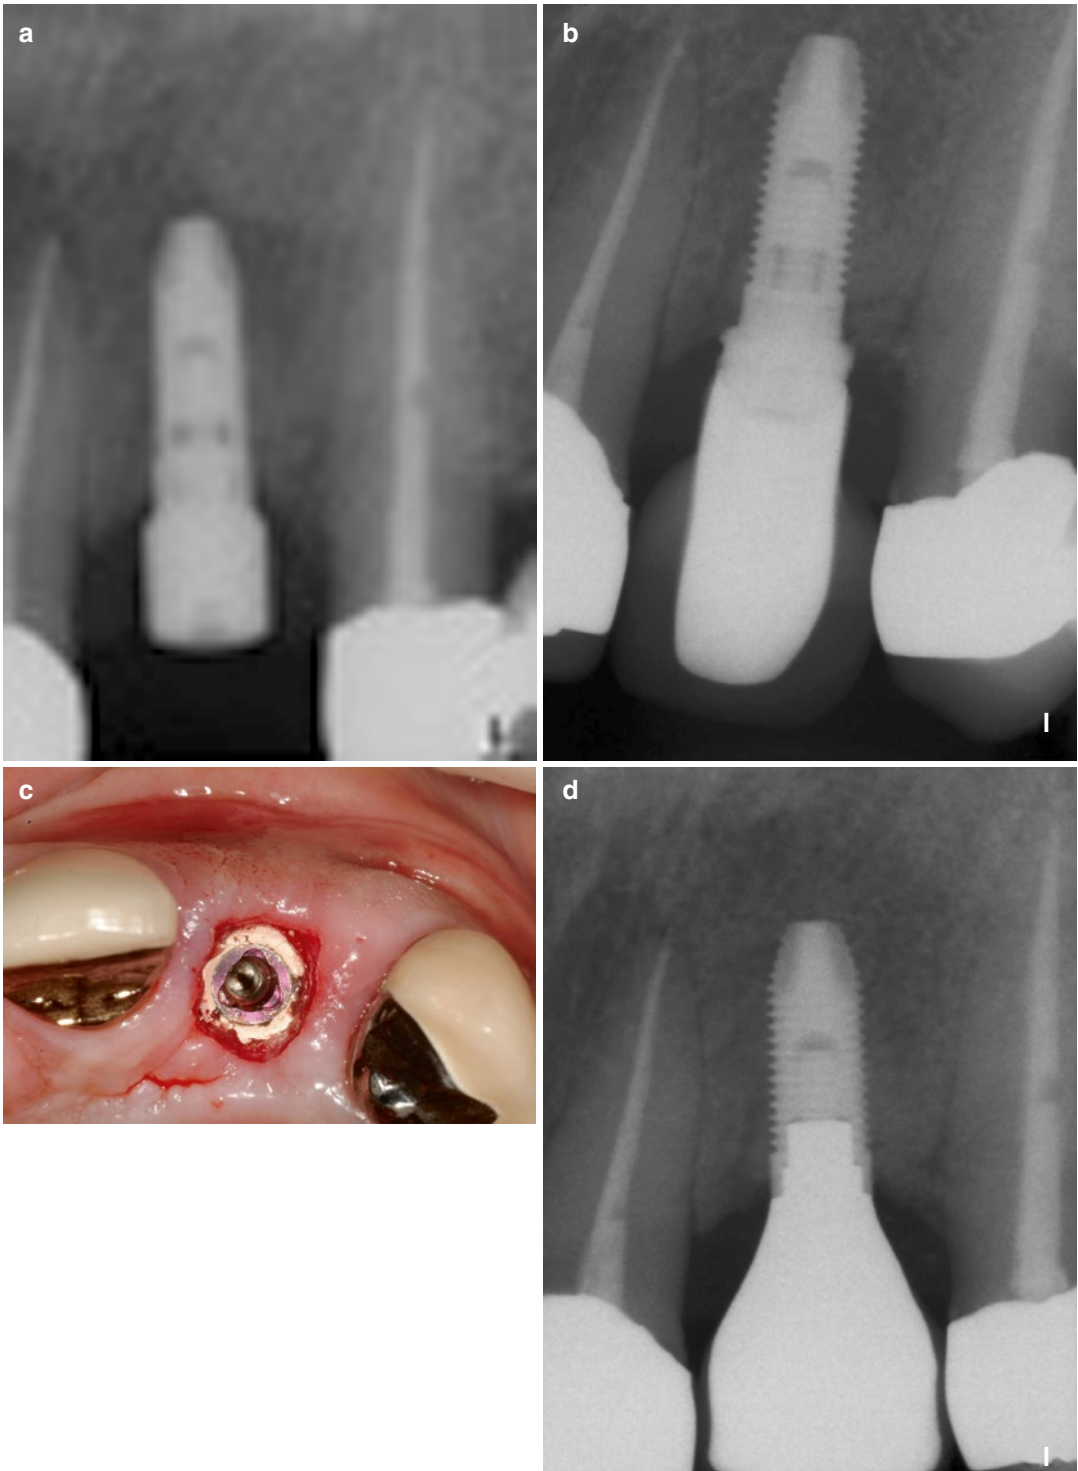
**Fig. 5.10** (a) Pre-restoration radiograph; implant considered integrated. (b) Post-cementation radiograph; restoration with radio-opacity noted. (c) Crown and abutment

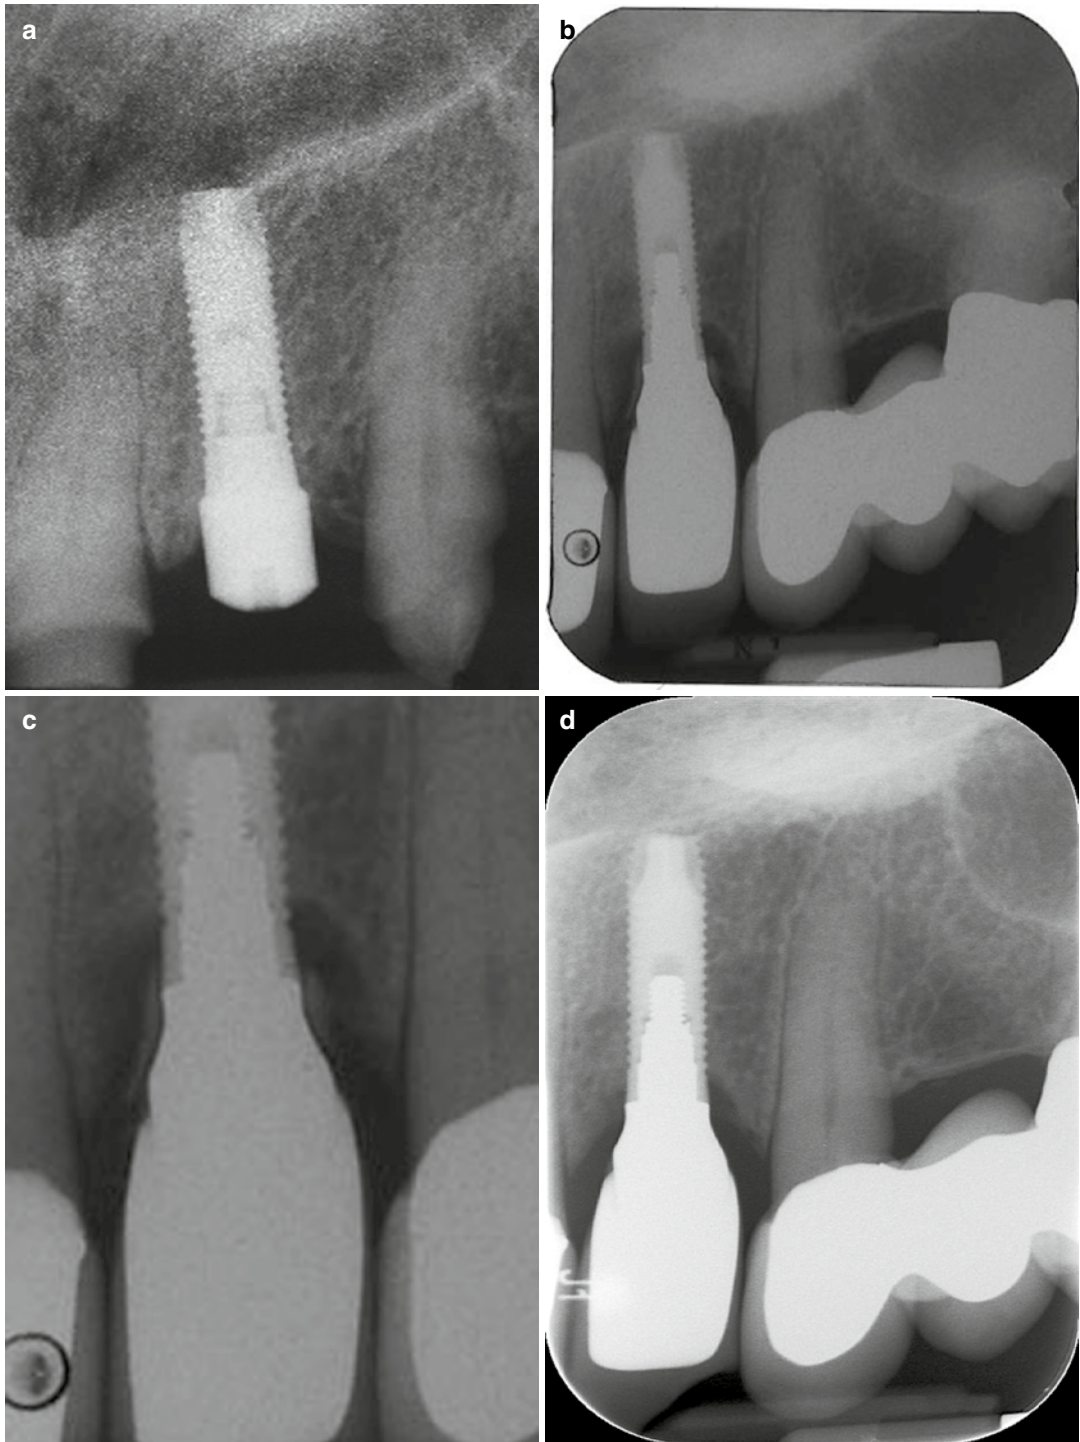
**Fig. 5.11** (a) Pre-restoration radiograph of implant. (b) Radiograph indicating “peripheral eggshell” effect—layer of REC. (c) Magnified view of B. (d) Post-treatment radiograph with cement removed

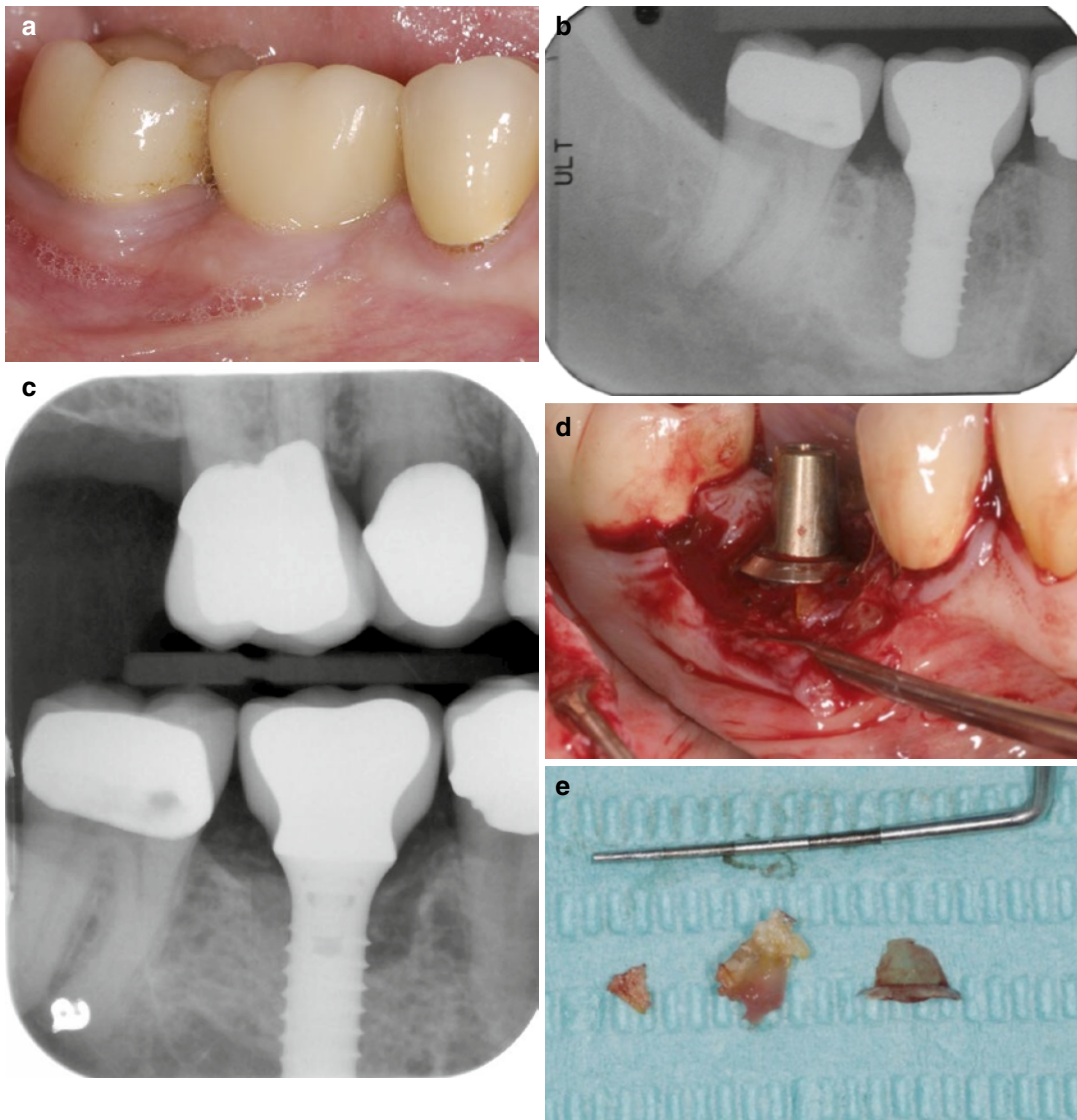
**Fig. 5.12** (a) Post-insertion radiograph of implant placed in mandibular right first molar site. (b) Fourteen months post-restoration radiograph, no evidence of bone loss around implant. (c) Thirty-two months post-insertion

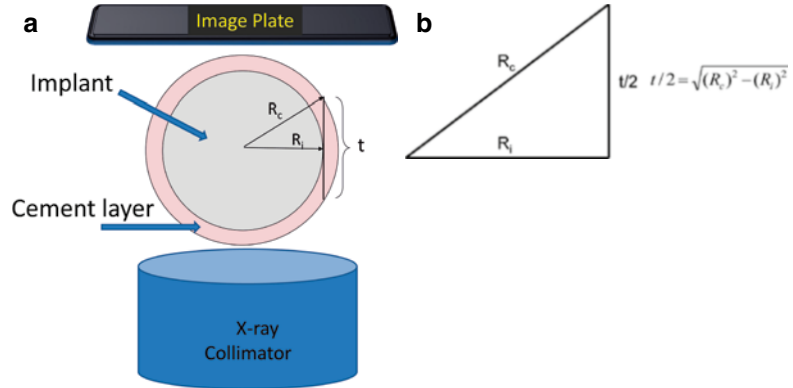
extruded facially to the implant surface, making detection problematic. The use of a radiographic tracer marker highlighted the origin of the tract, which, upon surgical exposure, revealed the REC.

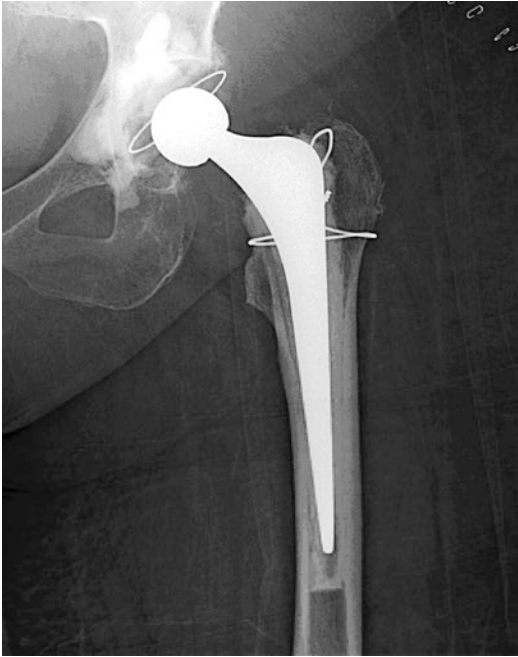
**Fig. 5.14** Anteroposterior radiograph showing the cemented total hip prosthesis with no obvious common femoral artery due to cement (From Reilingh et al. (2009))

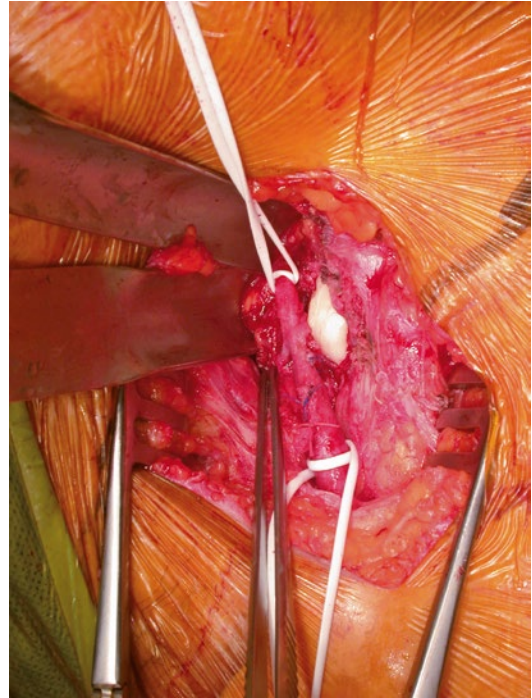
**Fig. 5.15** Lesion of the posterior aspect of the cement extrusion in the pelvis or soft tissues (From Reilingh et al. (2009))

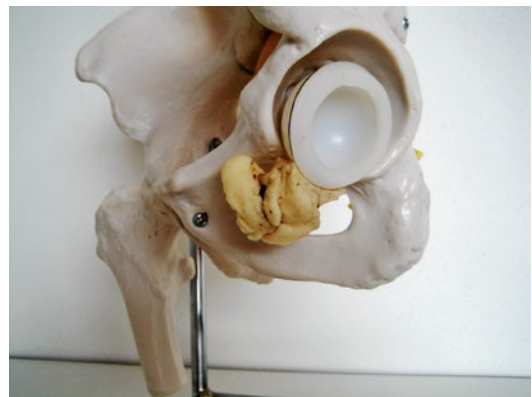
**Fig. 5.16** Reconstruction of the cement leakage under the transverse ligament (From Reilingh et al. (2009))

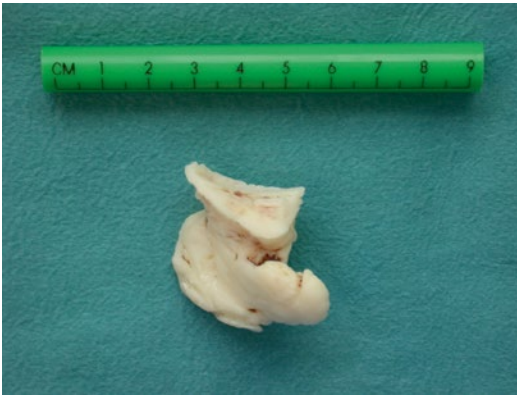
**Fig. 5.17** The unique print of the cemented acetabular cup on the extracted cement mass clearly demonstrates the pathomechanism of leakage under the transverse ligament (From Reilingh et al. (2009))

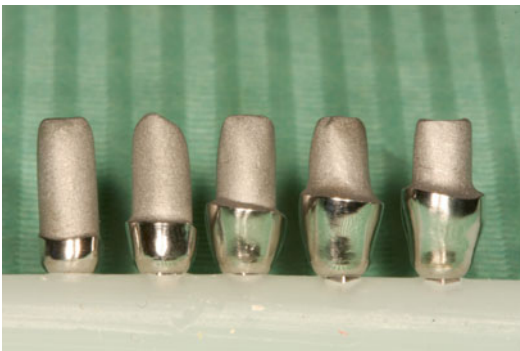
**Fig. 6.2** Individually casted prosthetic abutments with different location of cementation margins

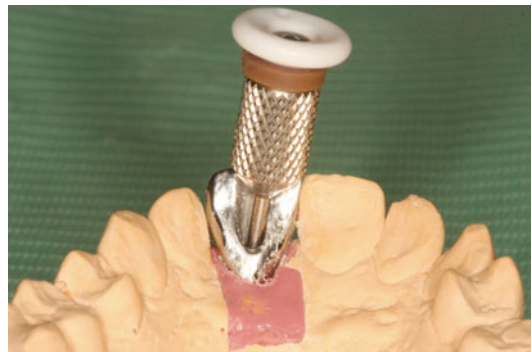
**Fig. 6.5** Removal of the restoration through palatal side

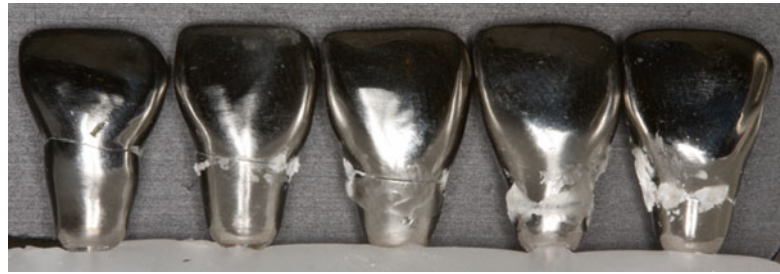
**Fig. 6.6** Cement remnants around abutments/crowns in different depth. Note the increase of cement as the depth of restorative margin goes deeper

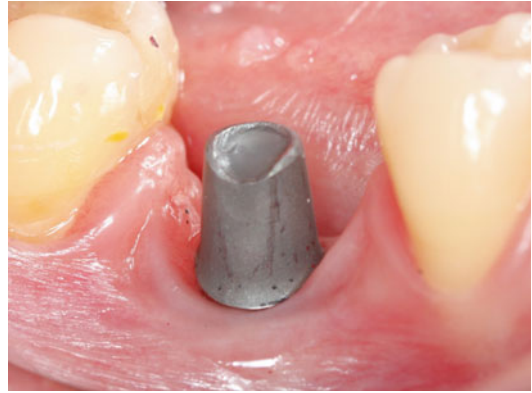
**Fig. 6.9** Different depth of the cementation margin in standard abutment in respect to soft tissues

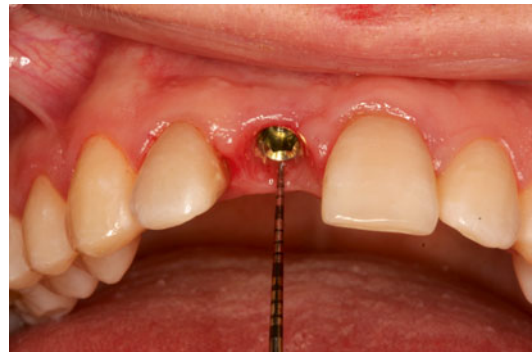
**Fig. 6.10** Measurements of implant depth in four quadrants

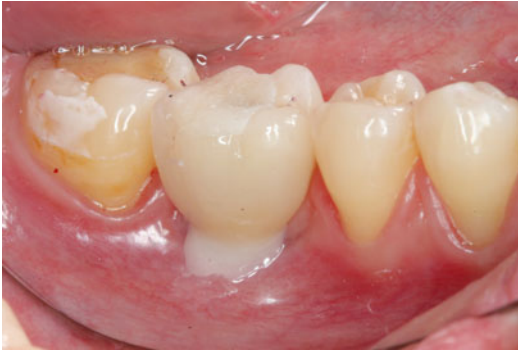
**Fig. 6.11** Cementation of the restoration. Note the composite on the occlusal surface to prevent the venting of the cement

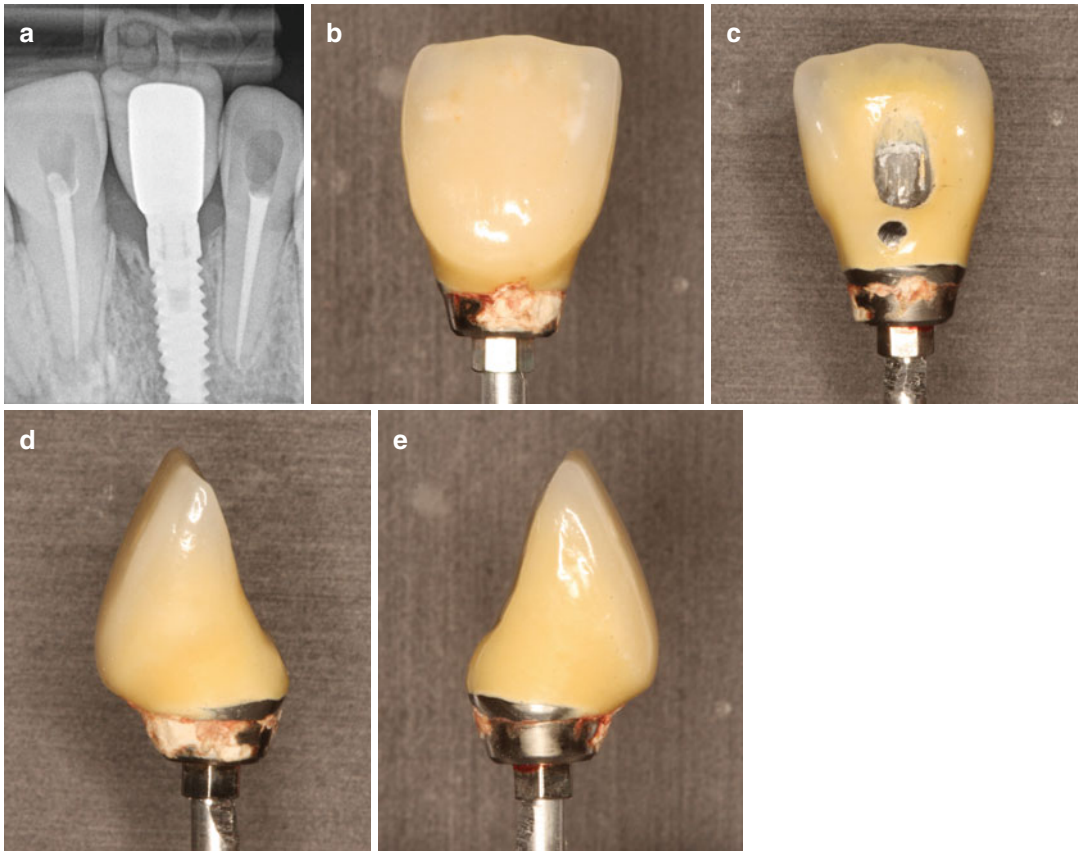
**Fig. 6.13** (a) X-ray of the implant crown, no cement remnants are visible; (b) the same retrieved abutment/restoration with visible cement remnants buccally, (c) lingually, and (d, e) interproximally

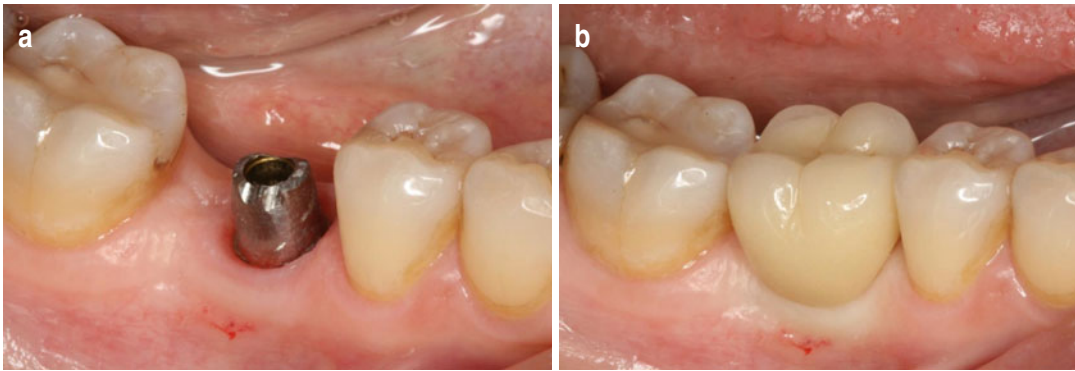
**Fig. 6.16** (a, b) Cementation margin is not deep; however, mesiodistal undercut is extensive; therefore, cement remnants would not be removed in this case

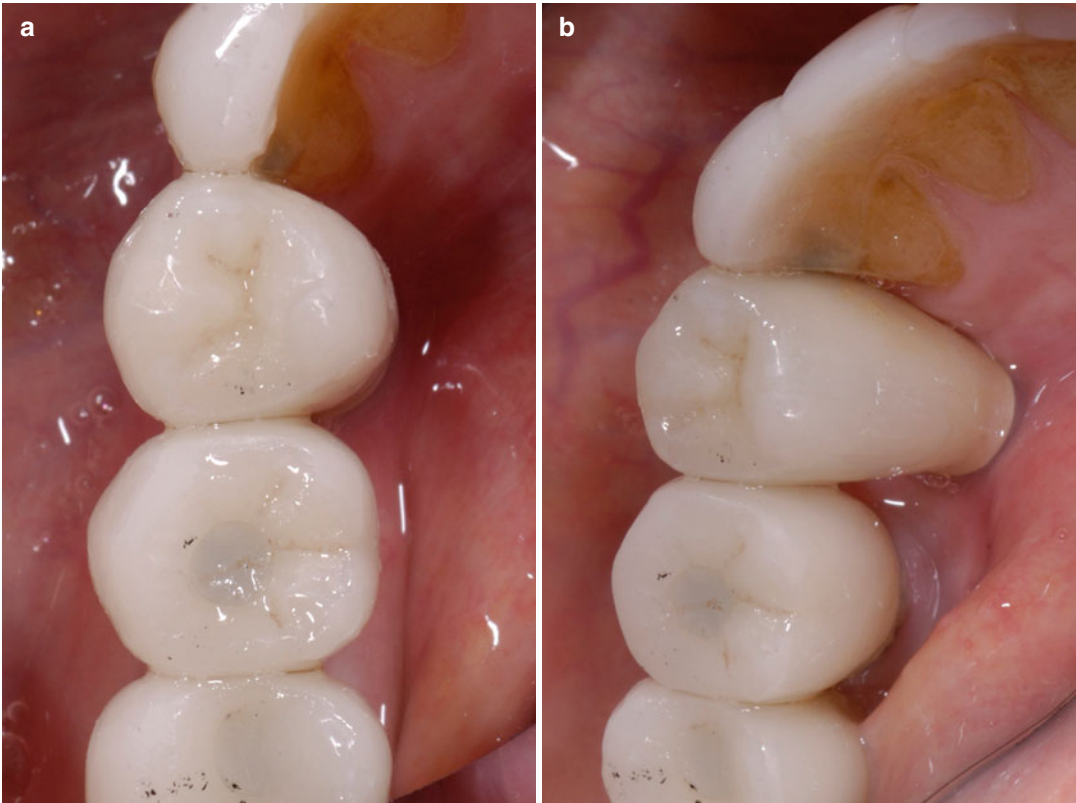
**Fig. 7.7** (a, b) Clinical views of the ICAP—occlusal and lingual of lower left first premolar with lingual plug

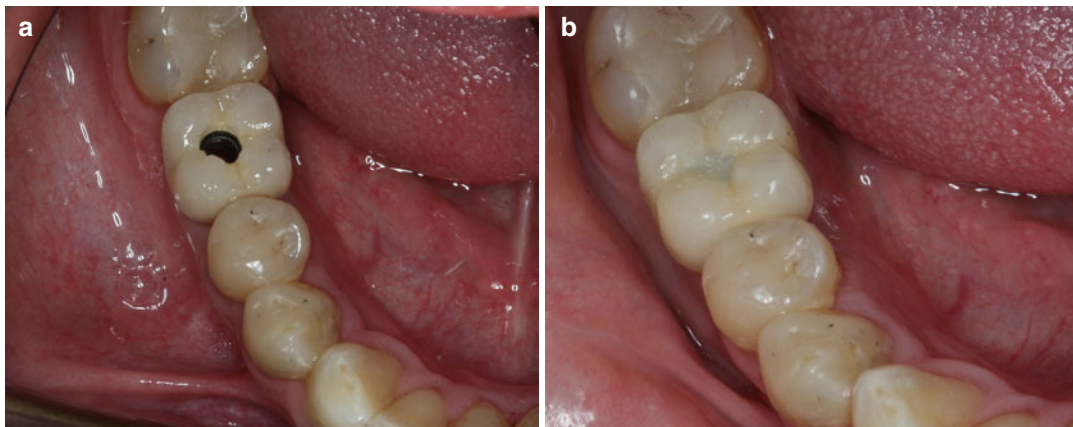
**Fig. 7.15** (a) Cement-screw-retained restoration is tightened to the implant, and (b) access hole is covered with composite

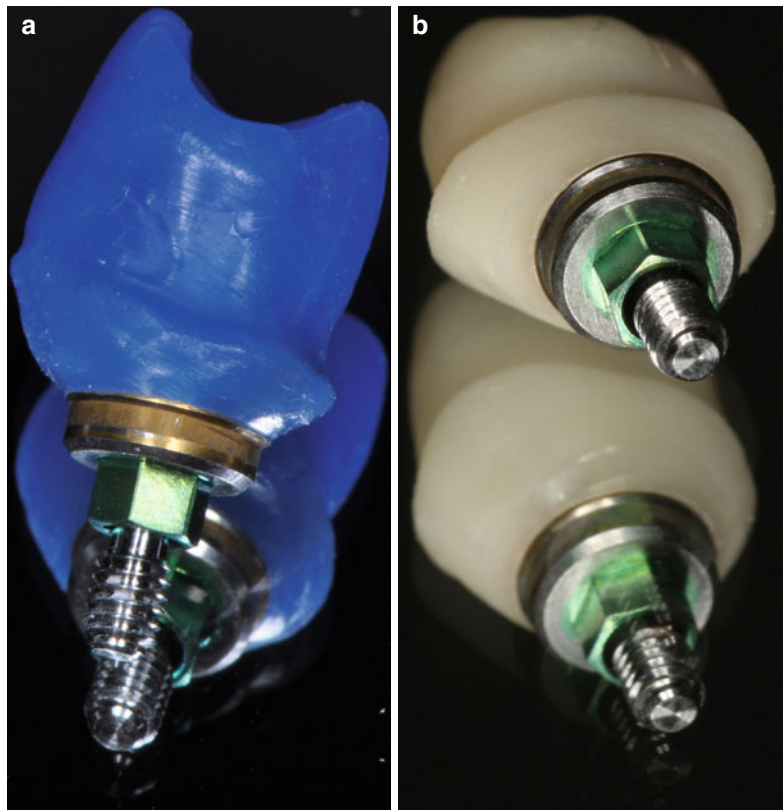
There is a common misconception about the use of non-hexed bases, as it is believed that in the absence of hex indexing, the force transfer mainly rests on the abutment screw; therefore, screw loosening or fracture may be common. The use of screw-retained restorations indeed

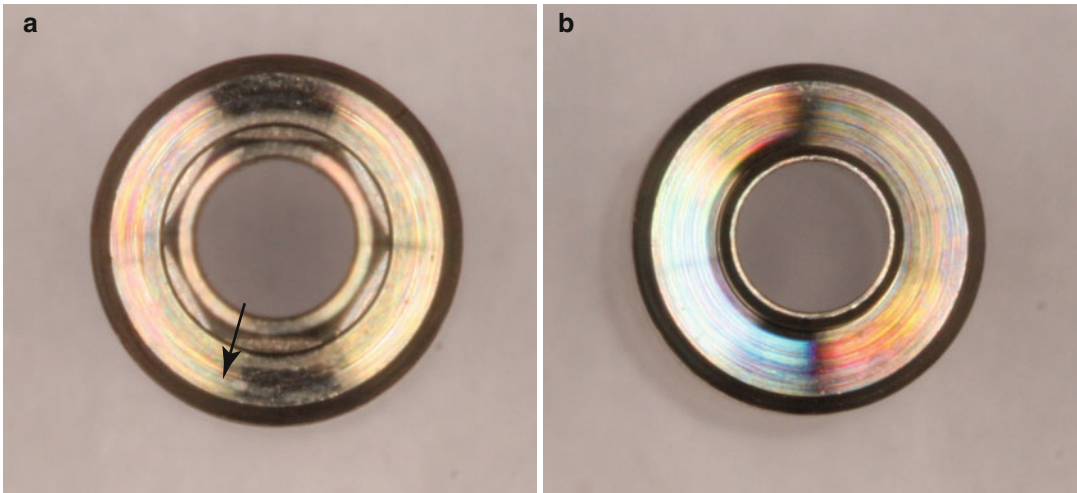
**Fig. 7.27** (a) Abutment with indexing hex and (b) non-hexed abutment. Note that conus connection is the same in both cases. Biohorizon implant
