Chandur P.K. Wadhvani  
*Editor*

# Cementation in Dental Implantology

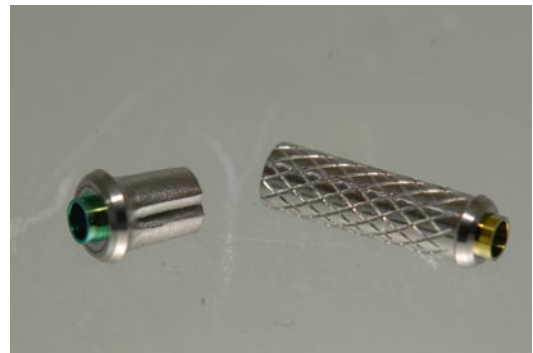
**Fig. 7.29** Reduced titanium base with lateral groove

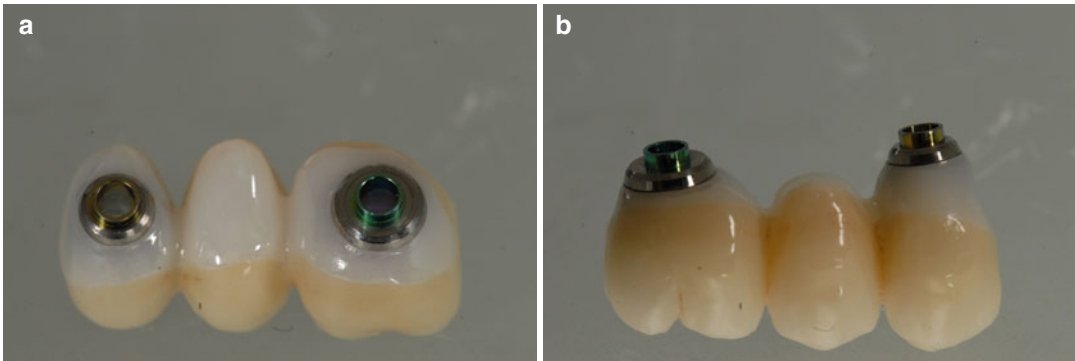
**Fig. 7.30** (a, b) Cement-screw-retained fixed partial denture. Note these are non-indexed (non-hexed titanium bases)

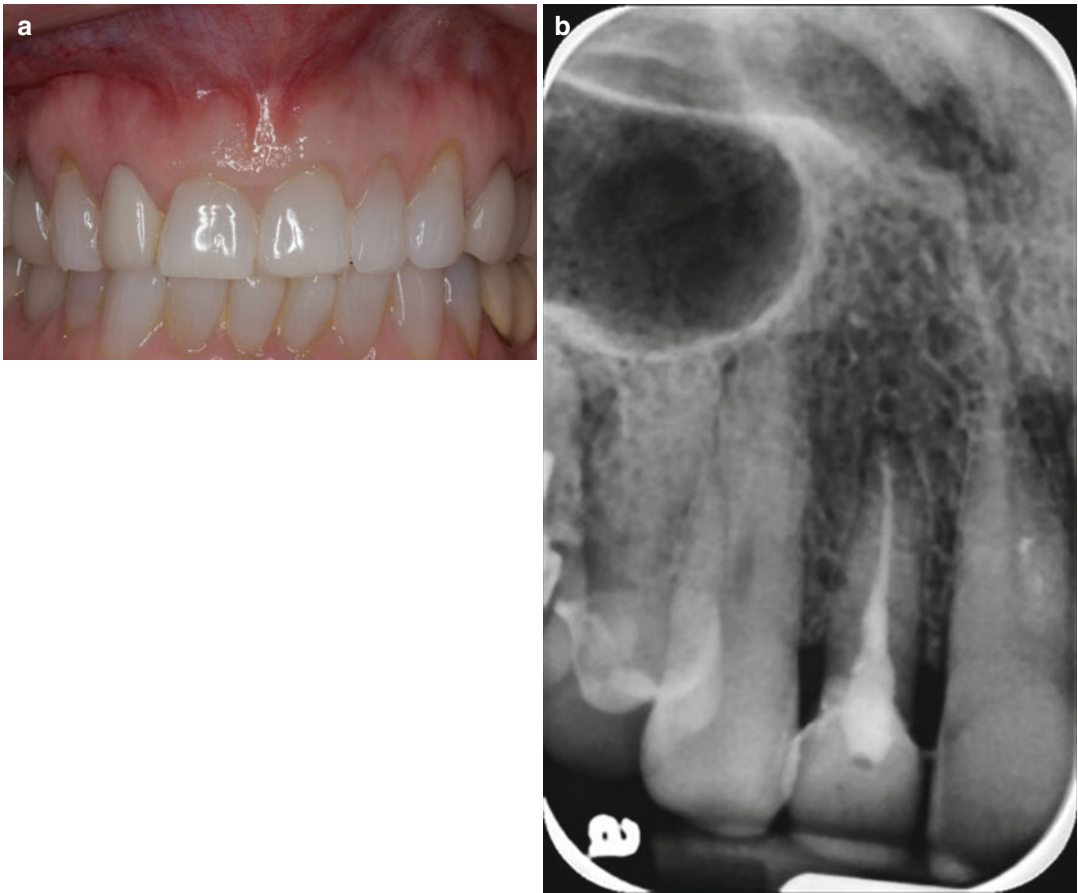
**Fig. 7.32** (a) Initial photograph and (b) radiographs of tooth 7 (right lateral incisor), which has a horizontal fracture

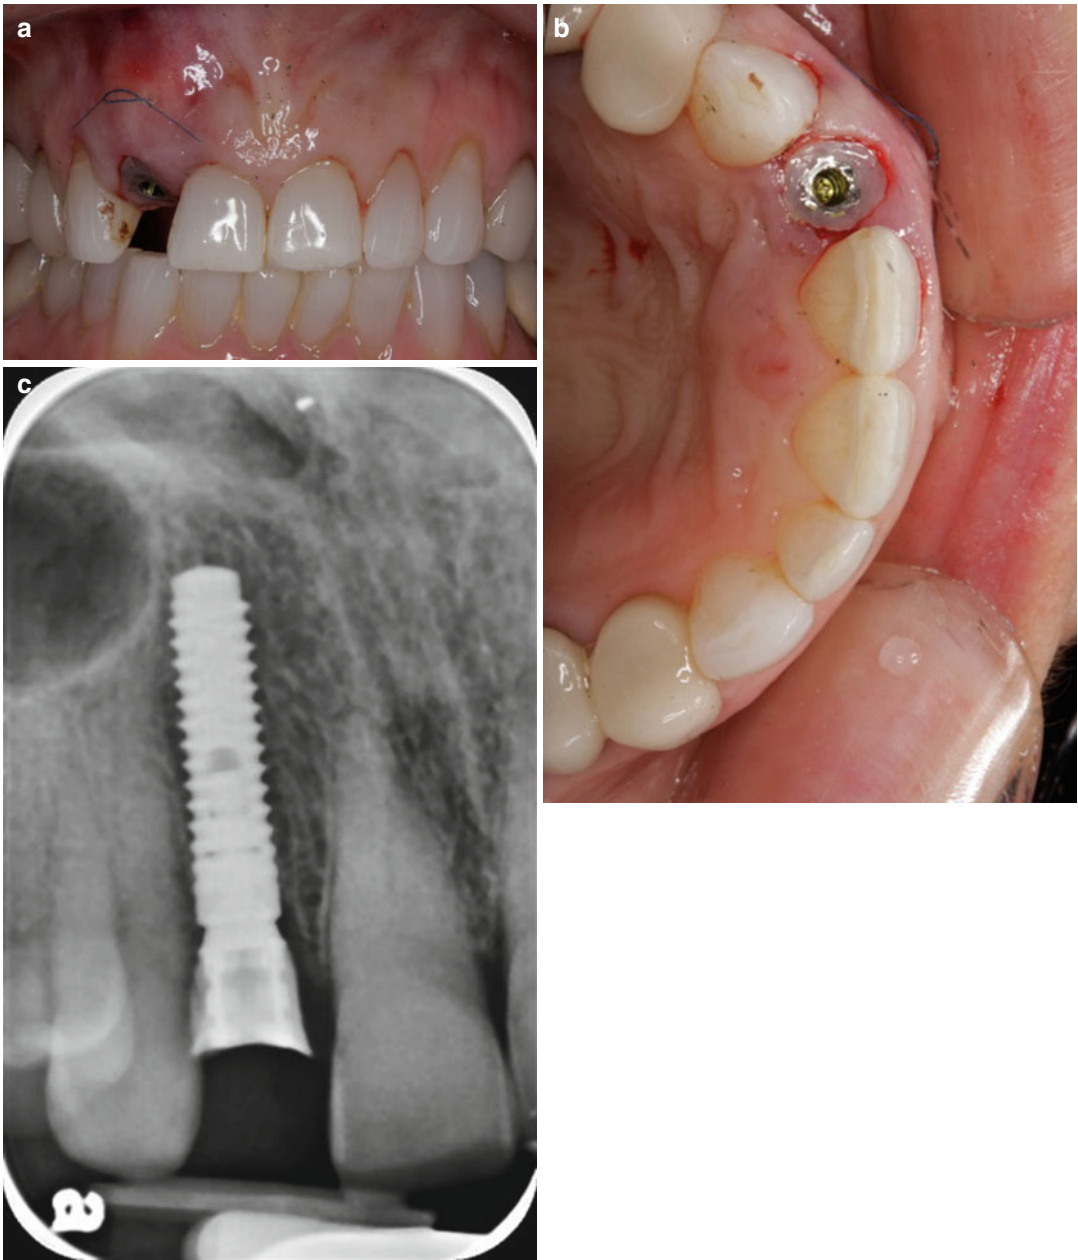
**Fig. 7.33** (a, b) Photographs and (c) radiograph of immediate implant placement following extraction of the fractured tooth

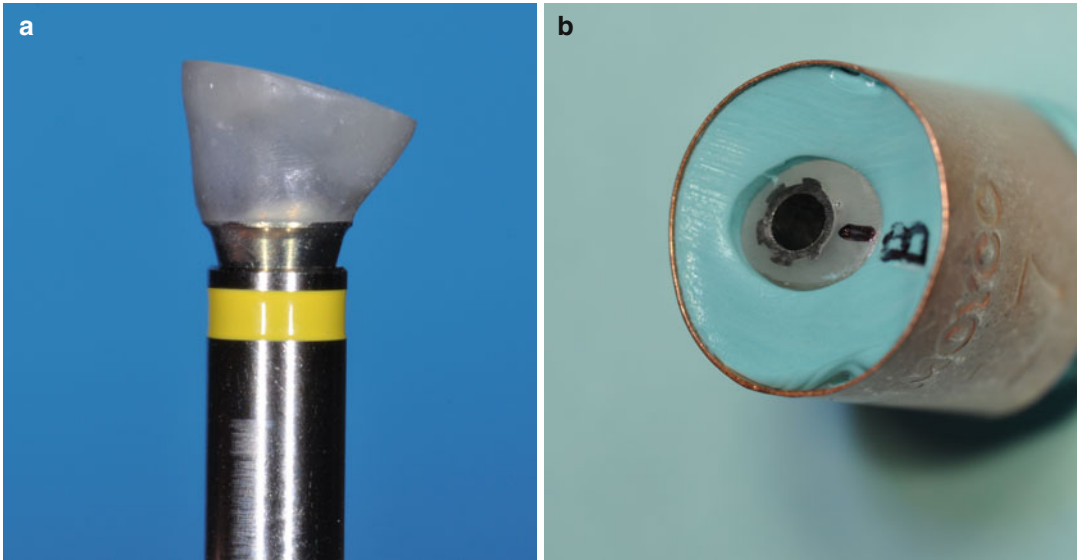
**Fig. 7.34** (a) Copying the healing abutment contours: custom healing abutment removed from the implant, then attached to a laboratory analog. (b) Analog and healing

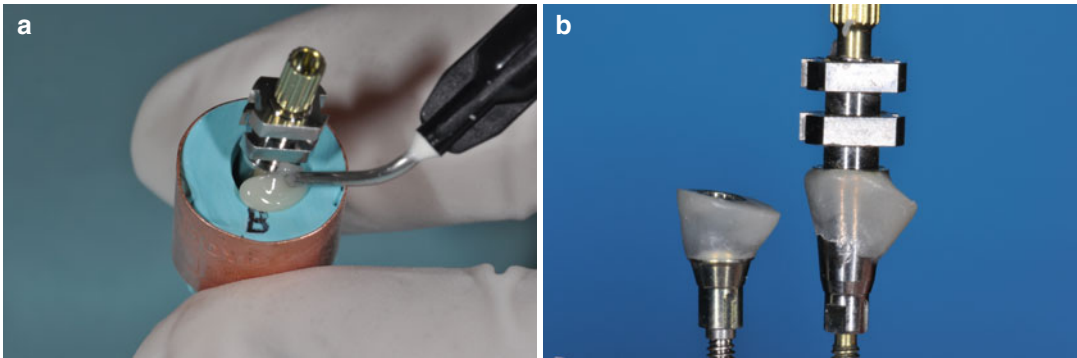
**Fig. 7.35** (a) Fabrication of custom impression coping. The healing abutment is removed and replaced with a standard impression abutment. Flowable composite is added to the impression abutment, copying the form of the

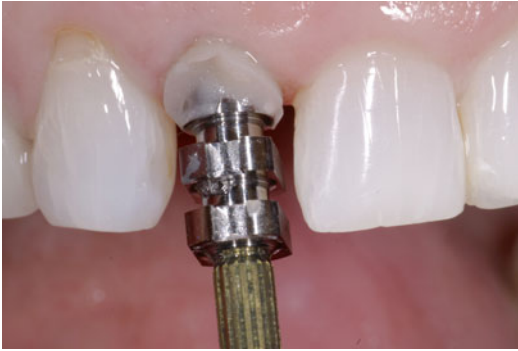
**Fig. 7.36** Custom impression coping placed into the implant site. Checked for orientation, before making an open-tray impression

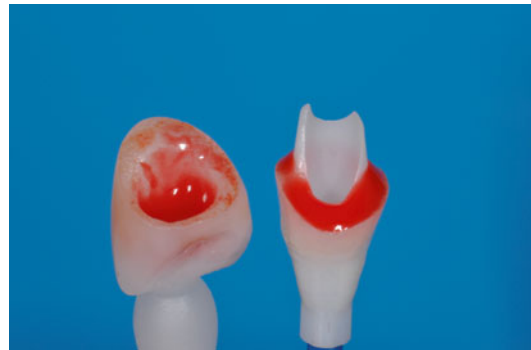
**Fig. 7.40** Hydrofluoric conditioning of ceramic bondable surfaces. Both the margins of the abutment and crown, as well as the intaglio of the crown, are susceptible to this process

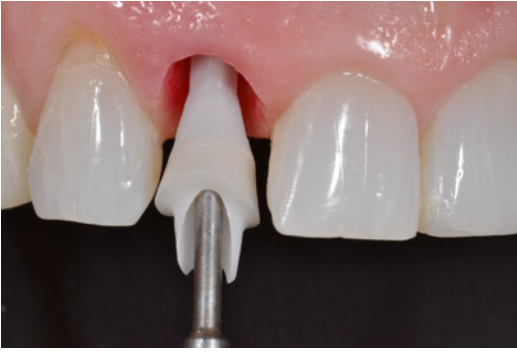
**Fig. 7.41** Zirconia abutment with custom-pressed ceramic margin being seated

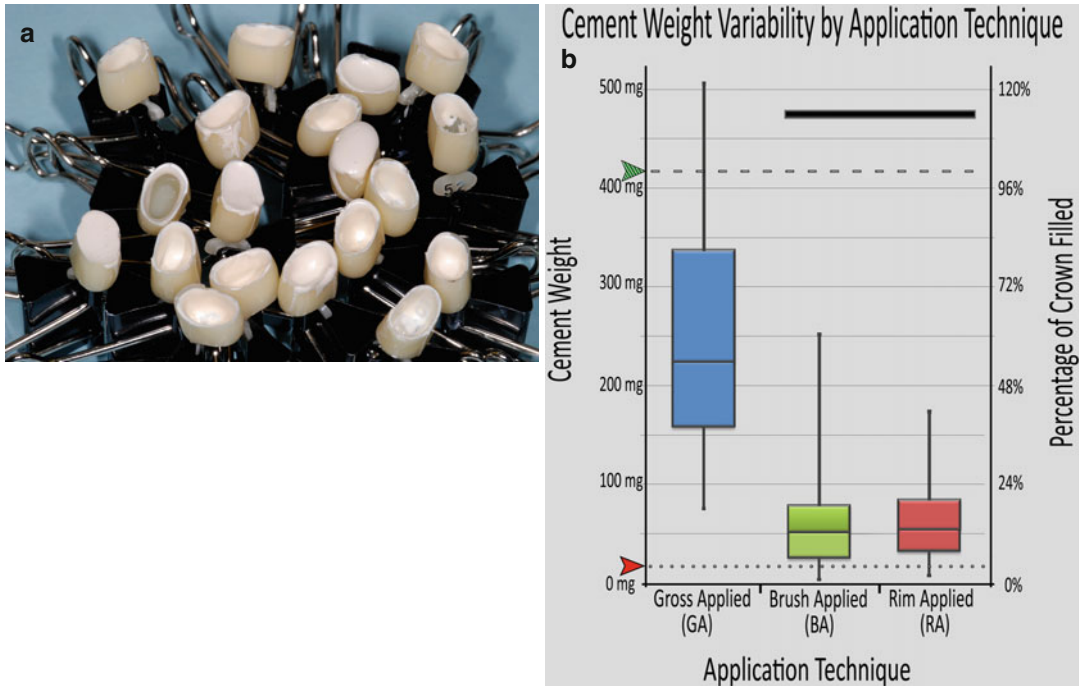
**Fig. 8.1** (a) Actual photo of how some dentists loaded crowns with cement as if they were to be placed on implants in their offices. (b) Mean and range of cement used with

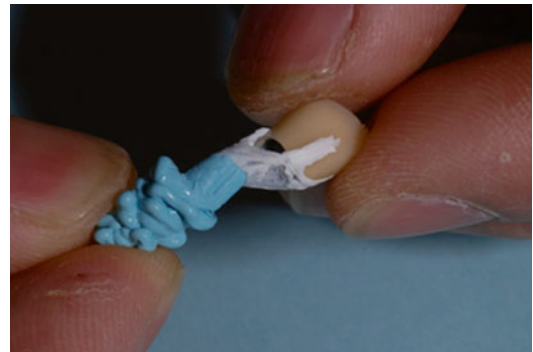
**Fig. 8.6** Remove the Blu-Mousse copy abutment, take out the PTFE and discard, and then follow with thorough cleaning of the crown

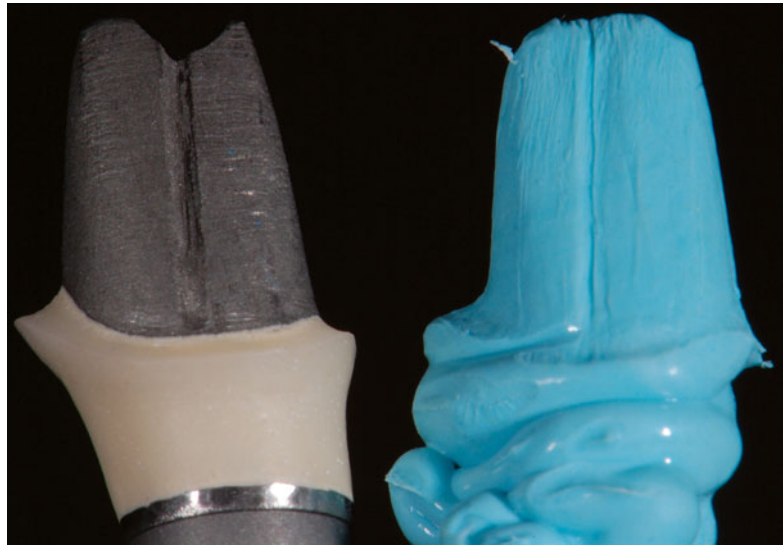
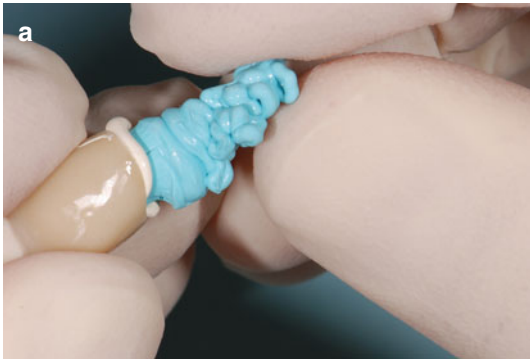
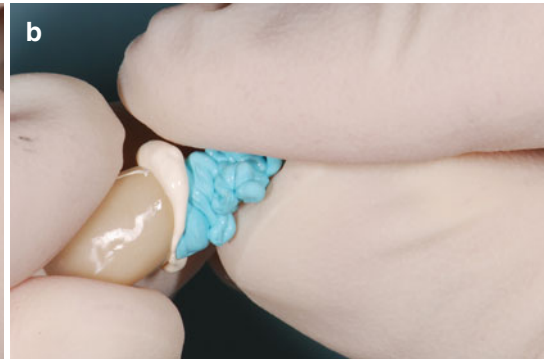
**Fig. 8.8** (a) The CCA is gently seated at first, (b) then completely pushed into the crown, allowing excess to be removed extraorally. Hint: when you first try this, use cement with an extended setting time

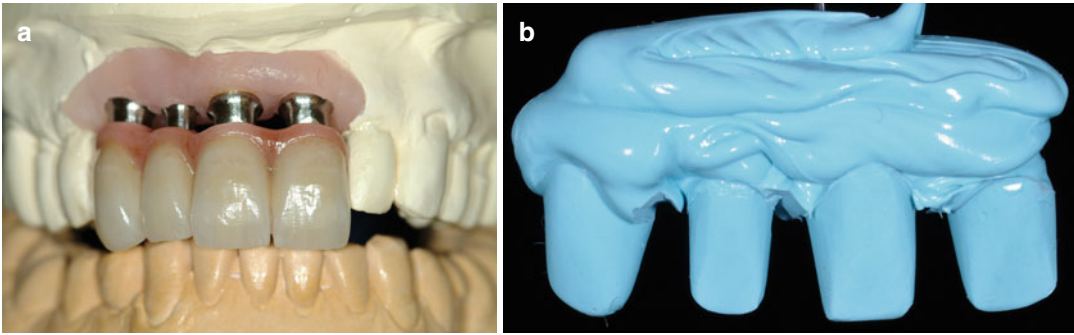
**Fig. 8.11** (a) This four-unit cemented prosthesis had a (b) copy custom abutment device made to pre-extrude excess cement. It was fabricated in a similar manner as the CCA using PTFE as a spacer providing 50  $\mu\text{m}$  lute space

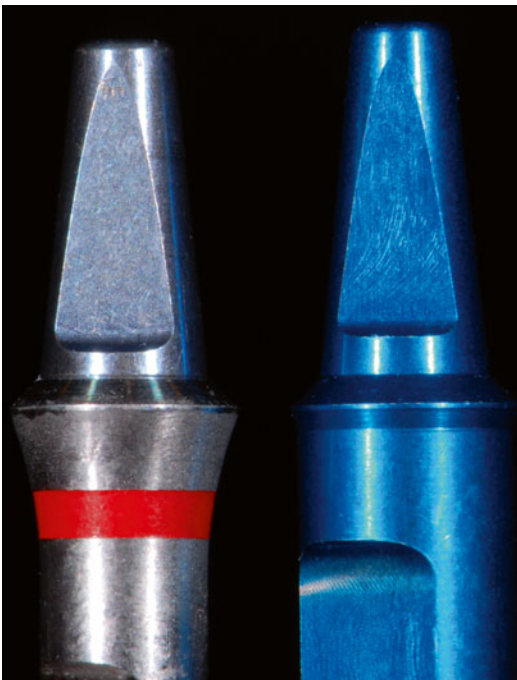
**Fig. 8.12** These images represent the solid abutment and its laboratory analog (*blue*). Although they appear the same size, the analog is larger in dimension by approximately 20  $\mu\text{m}$ . If it is used as a pre-extrusion device, insufficient cement will line the walls of the restoration

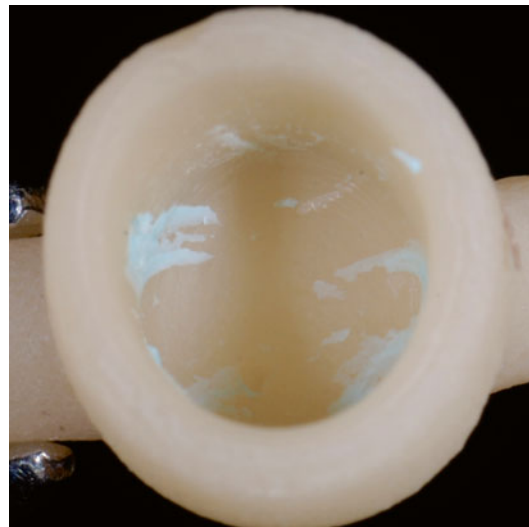
**Fig. 8.13** A vinylpolysiloxane (VPS) material has been placed directly into this crown. On removal, residue is noted. This could interfere with the cementing process and must be considered undesirable

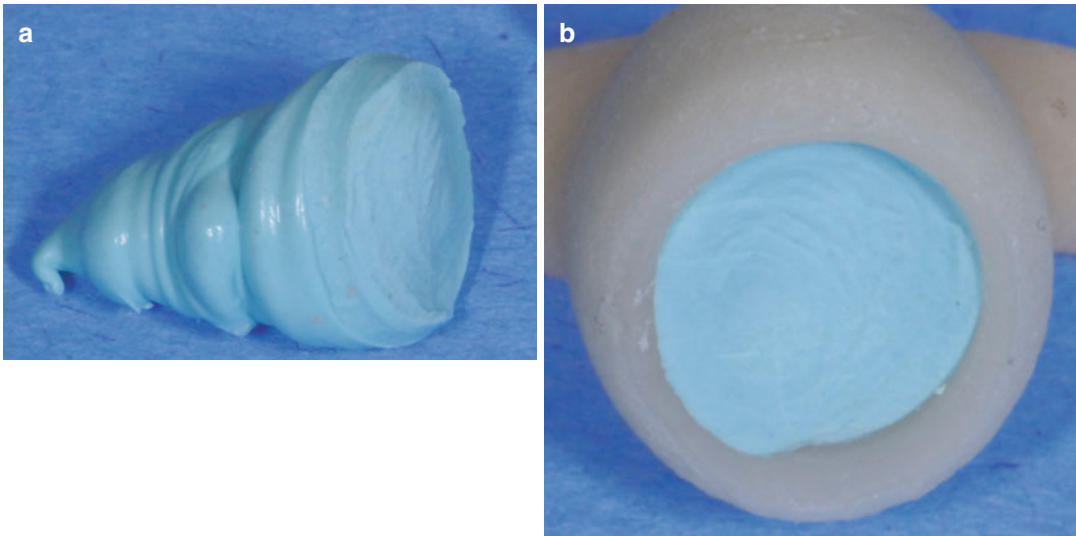
**Fig. 8.14** (a) This VPS abutment was fabricated without the PTFE spacer. It fractured on attempted removal; (b) the other part had to be removed from the inside of the crown

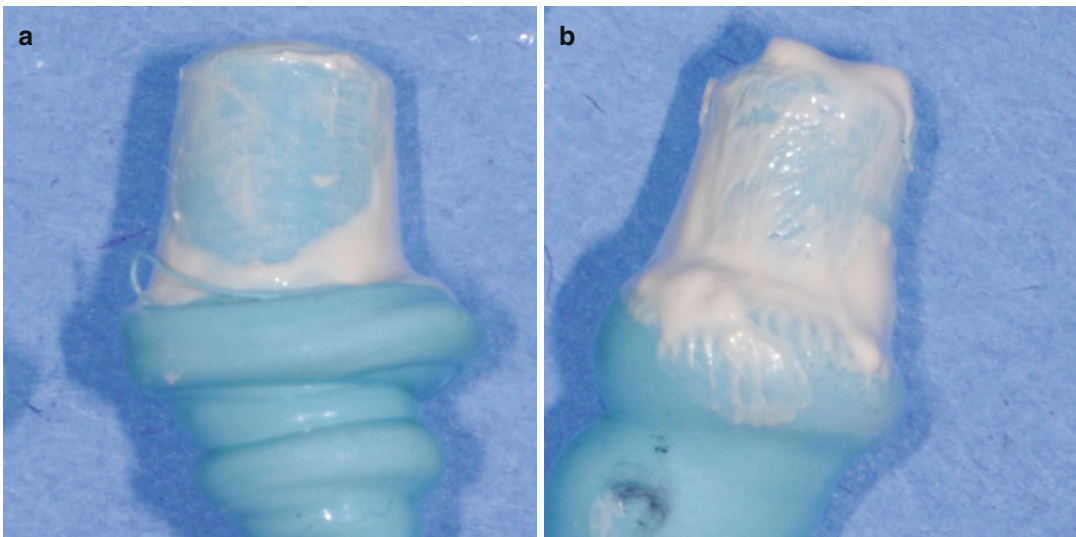
**Fig. 8.15** Comparing a copy abutment made (a) without the PTFE and (b) with the spacer. Note the distribution of the cement on the abutment—this is mirrored by the internal spread of cement lute within the restoration

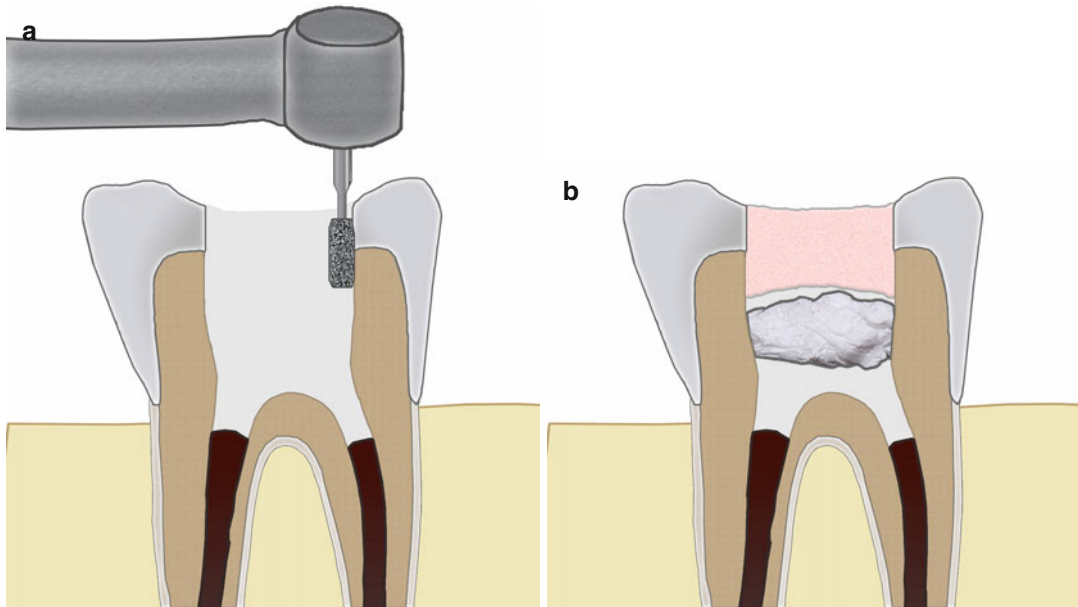
**Fig. 8.16** (a) Diagram of the experiment design. Endodontic access prepared and teeth sterilized. (b) The teeth were disinfected, rubber dam placed, and an end-

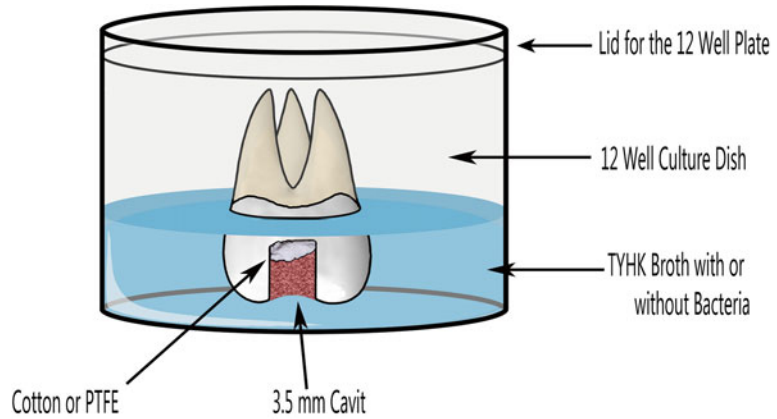
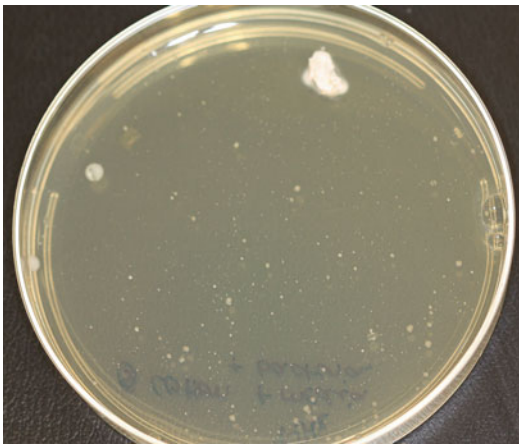
**Fig. 8.18** Example of agar plate with cotton wool pellet, demonstrating *S. gordonii* contamination; 9/10 showed similar contamination

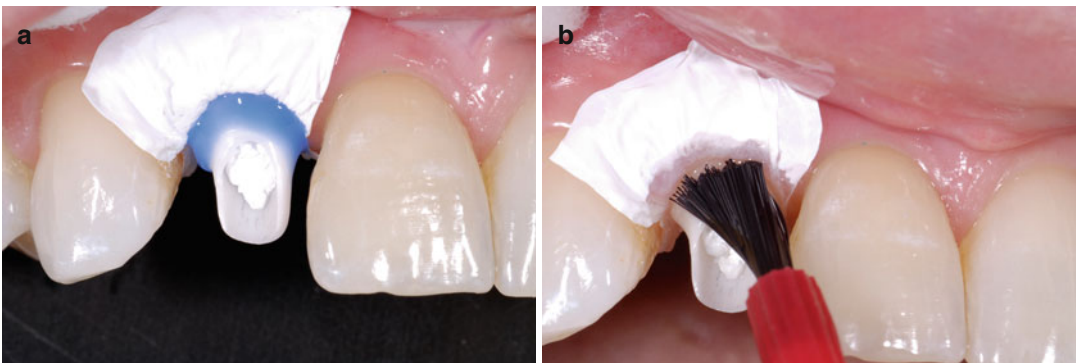
**Fig. 8.24** (a) The PTFE used to prevent phosphoric acid gel irritating the tissue. This is used to clean the porcelain and decontaminate from effects of saliva just prior to

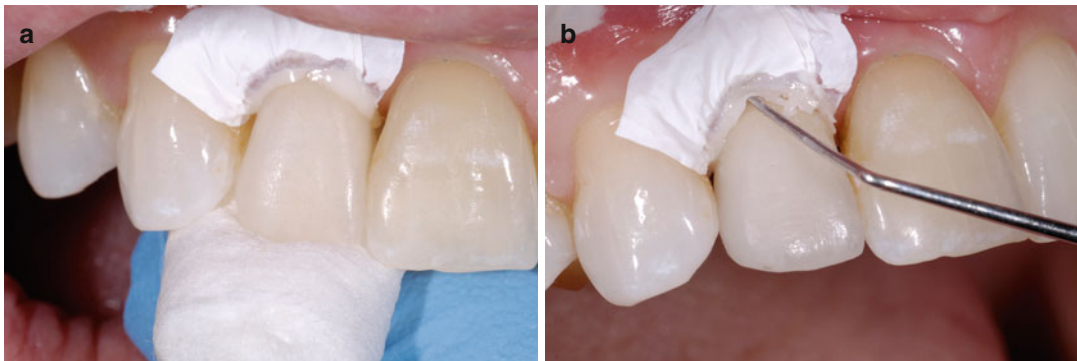
**Fig. 8.25** (a) During cementation of this ICAAM excess cement, it is necessary to have a dry, controlled environment for the porcelain-to-porcelain margin. The bib pro-

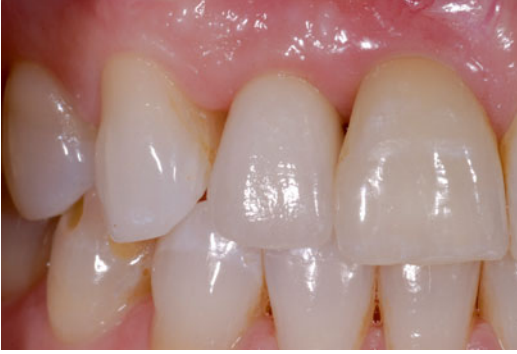
**Fig. 8.26** Immediately after cementation, the tissues have not been damaged by chemical insult, and the site has been controlled with respect to contamination

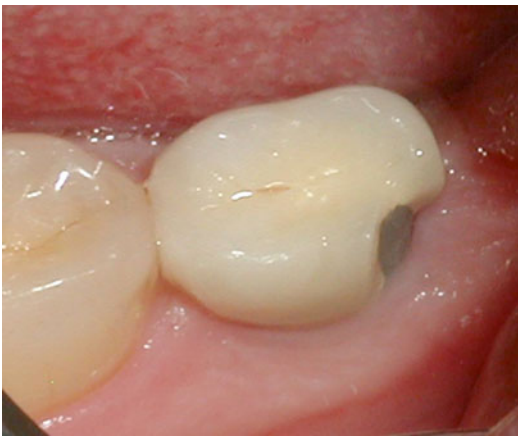
**Fig. 9.1** Fractured porcelain on this restoration necessitates removal and possible repair

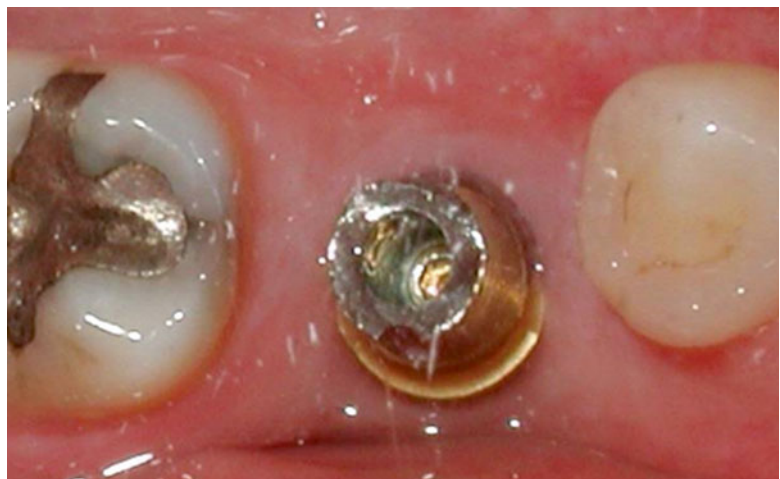
**Fig. 9.2** The restoration has been removed. The underlying abutment is damaged by overpreparation of the screw access hole. The abutment required replacement, needlessly increasing the cost of the replacement restoration

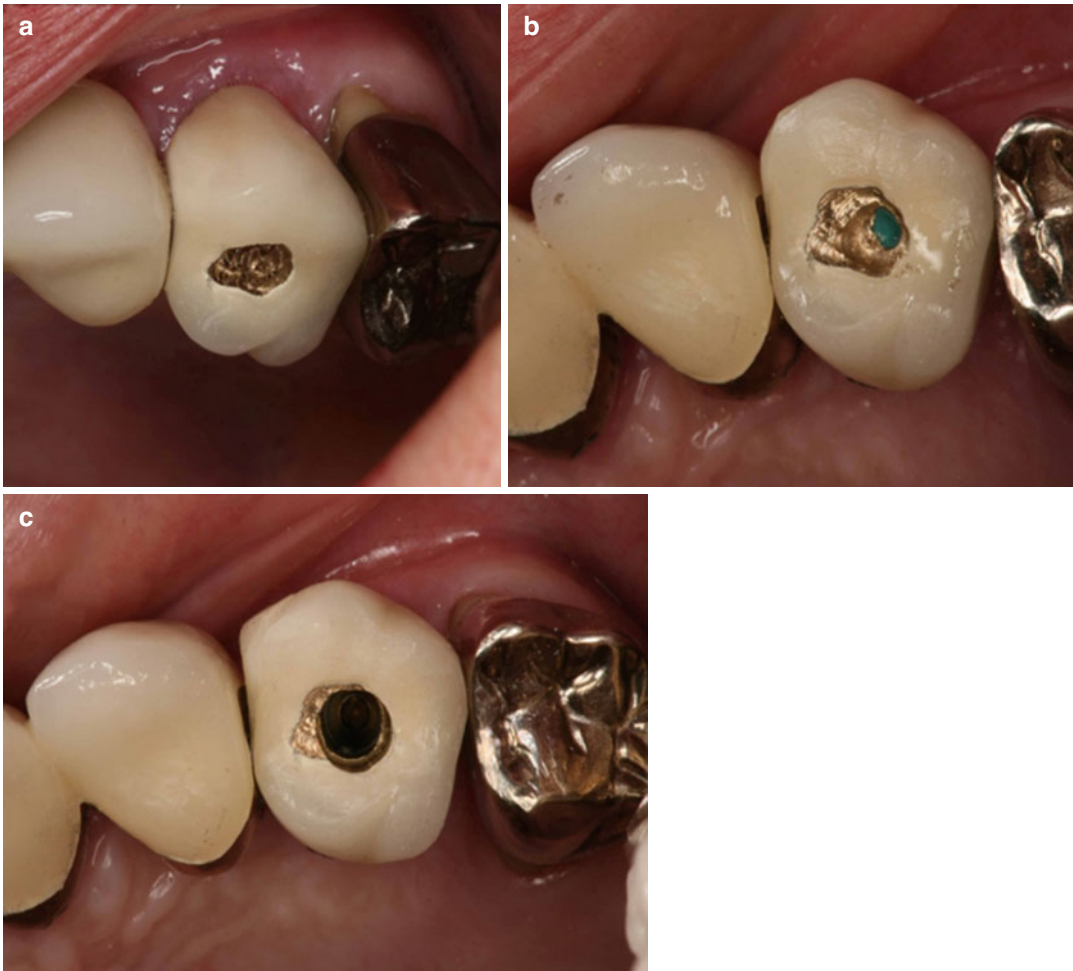
**Fig. 9.3** (a) Initial access to the screw channel is determined by “best guess” of the site and angulation. (b) Often a large area is involved. (c) More extensive destruction of the crown frequently occurs

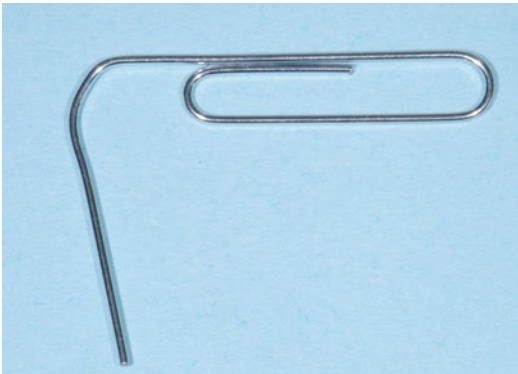
**Fig. 9.10** Sterilized paper clip; one arm is bent out to act as a handle

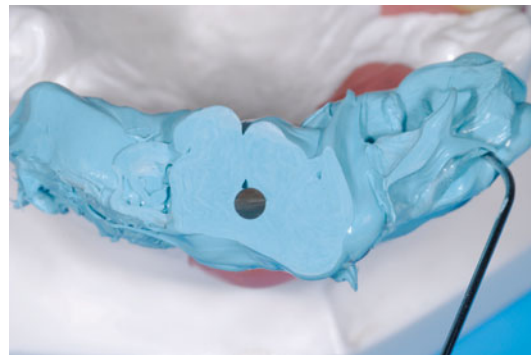
**Fig. 9.15** From the occlusal view, the hole made by the screwdriver lies directly above the screwhead

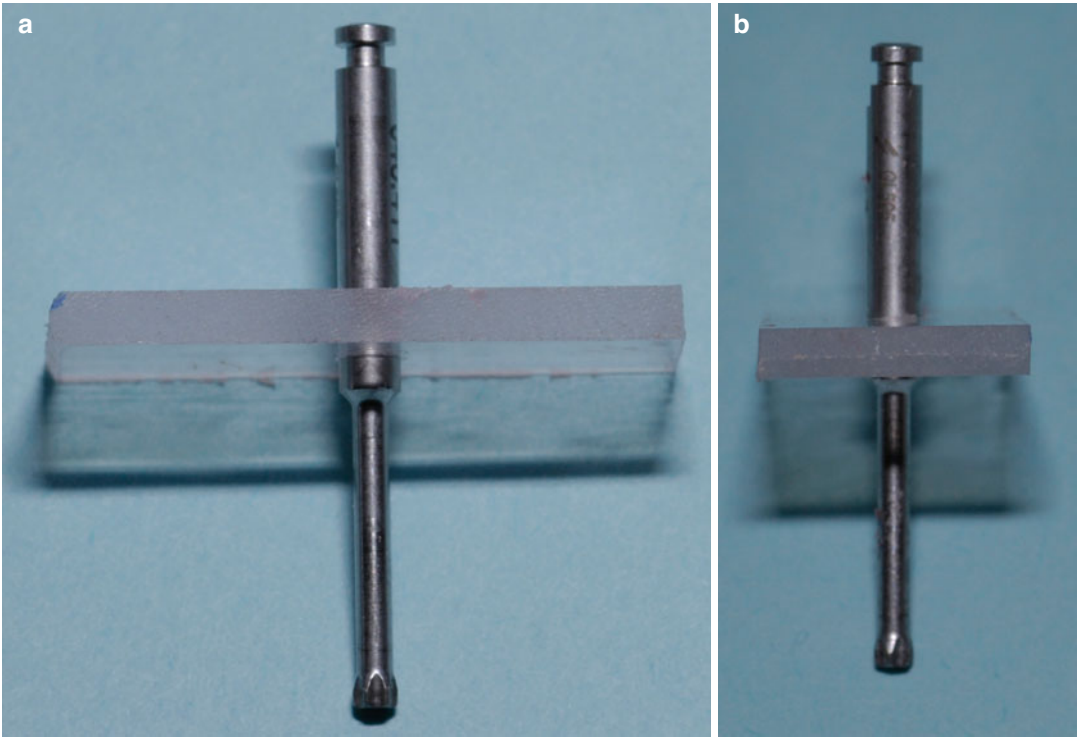
**Fig. 9.16** (a, b) Plastic plate holding the latch-grip screwdriver at 90°

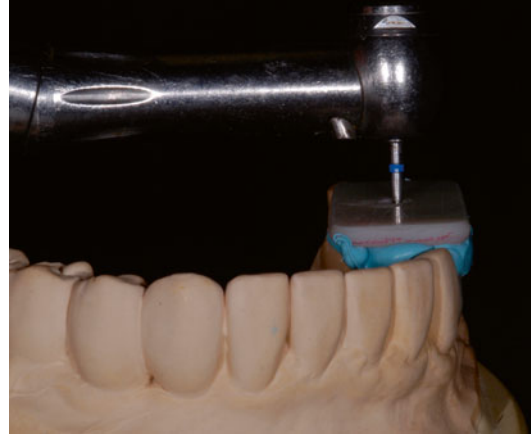
**Fig. 9.25** A bur is placed in the PILD guide, and when held at 90° to the plate, it will give the site and direction of the underlying screw with minimal time and damage to the crown

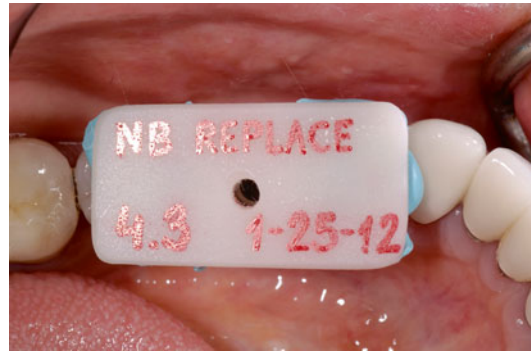
**Fig. 9.26** Information can be stored on the PILD, including implant type, date, laboratory where it was fabricated, etc.

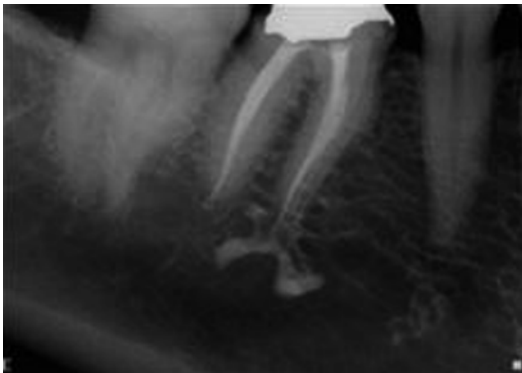
**Fig. 10.2** An example of alveolar space. The endodontist has used calcium hydroxide as an interim treatment. During the process of placing this into the root canal system, some has been extruded. Note the radiopacity in areas of the alveolar spaces that were previously occupied by marrow space

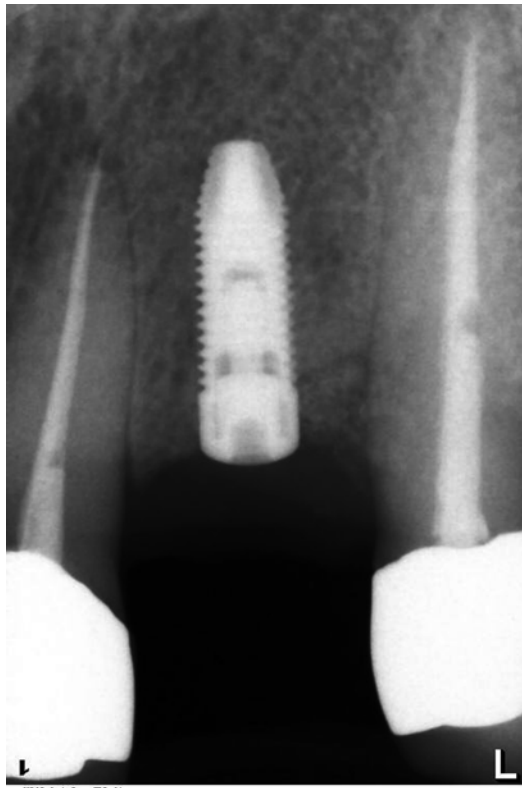
**Fig. 10.3** This radiograph was made prior to the commencement of the final restoration. It provides some information about possible pathological issues, the type of bone, how deep the implant is placed, and potential angulation issues with adjacent teeth. It can also be used as a reference to compare future serial radiographs against to evaluate long-term changes, provided they are all standardized

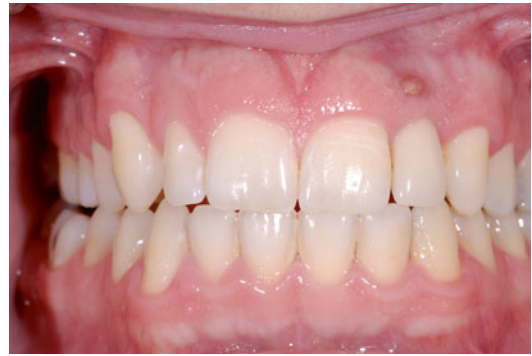
**Fig. 10.4** The restoration was placed on an implant, which trapped tissue between the implant body and abutment (CCJ). Once the tissue was released, the inflammation resolved. Follow-up revealed no further lesions

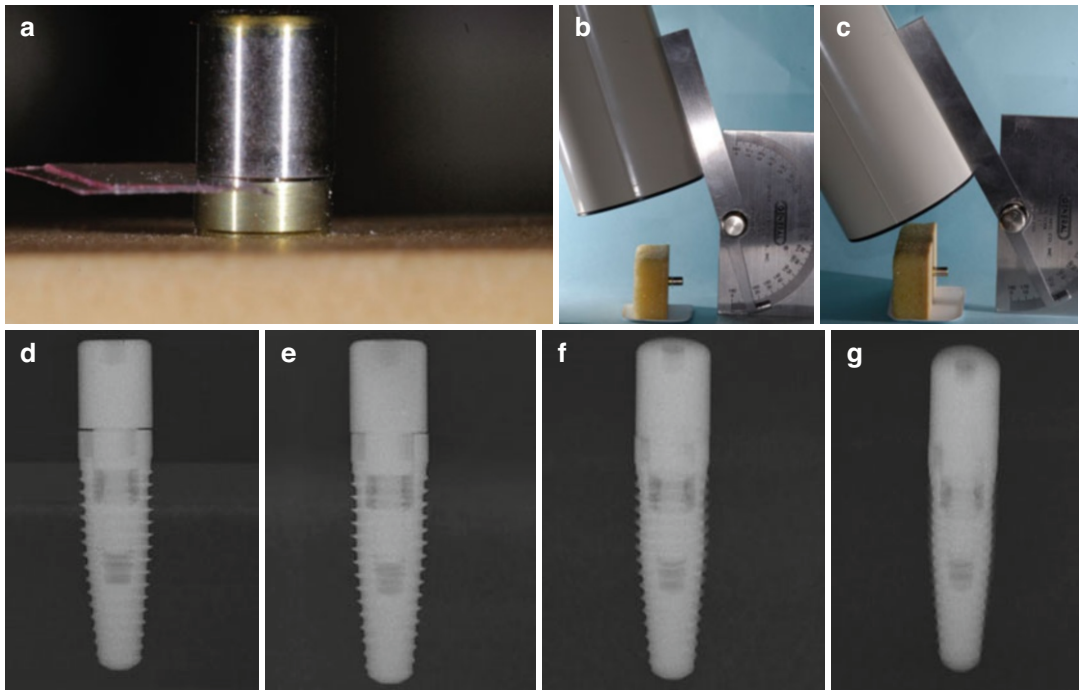
**Fig. 10.5** (a–g) These radiographs were made by altering the X-ray cone relative to the implant and healing abutment by (d) 0°, (e) 10°, (f) 20°, and (g) 30°. They show how minor errors in angulation alter the ability to detect component fit

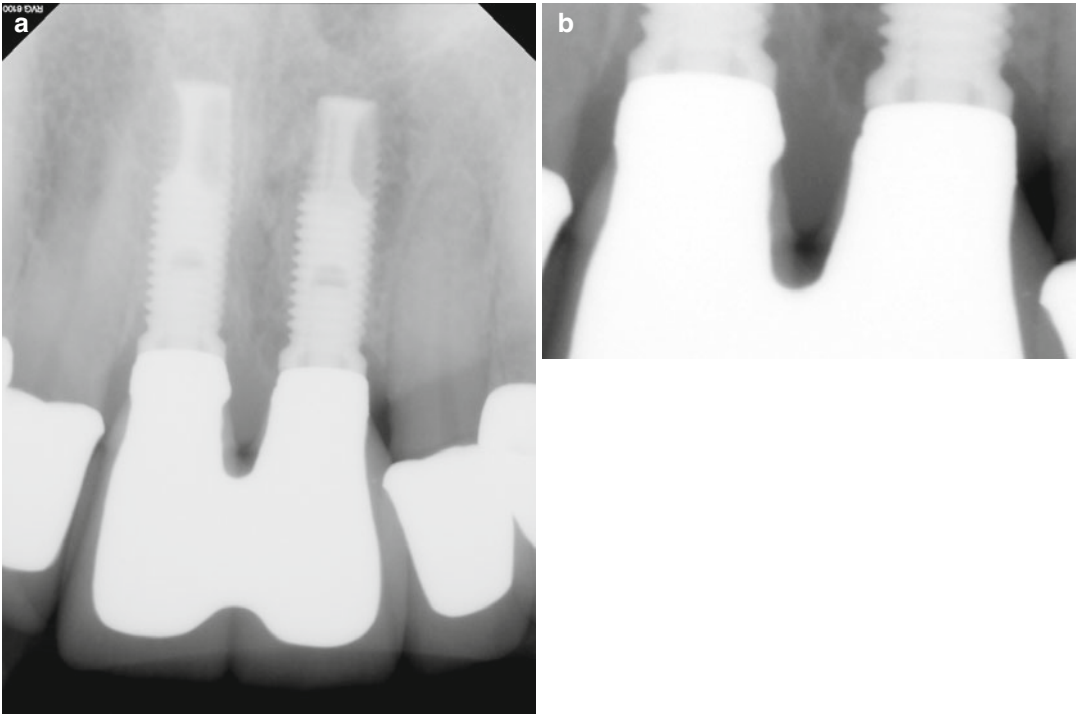
**Fig. 10.7** (a, b) On final delivery, an orthogonal radiograph indicates a misfit on the left central implant. The prosthesis was remade

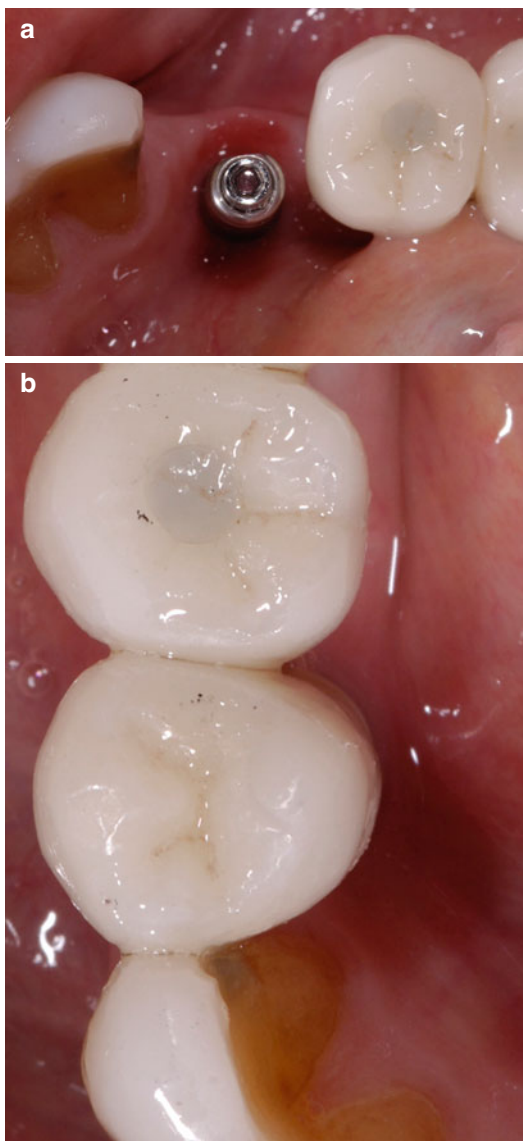
**Fig. 10.8** (a) It is important to access the implant with respect to radiographic techniques. This implant is angled toward the midline, which must be taken into account when making radiographs. (b) Now restored, the underlying implant's orientation can only be guessed at

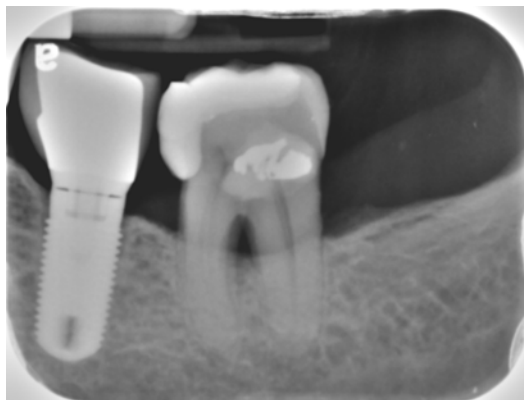
**Fig. 10.9** Understanding the radiographic properties of the implant system, it appears as if this Zimmer AdVent implant abutment only seats onto the implant body mesially and distally. This is a radiographic artifact—the so-called peripheral eggshell effect (PESE)

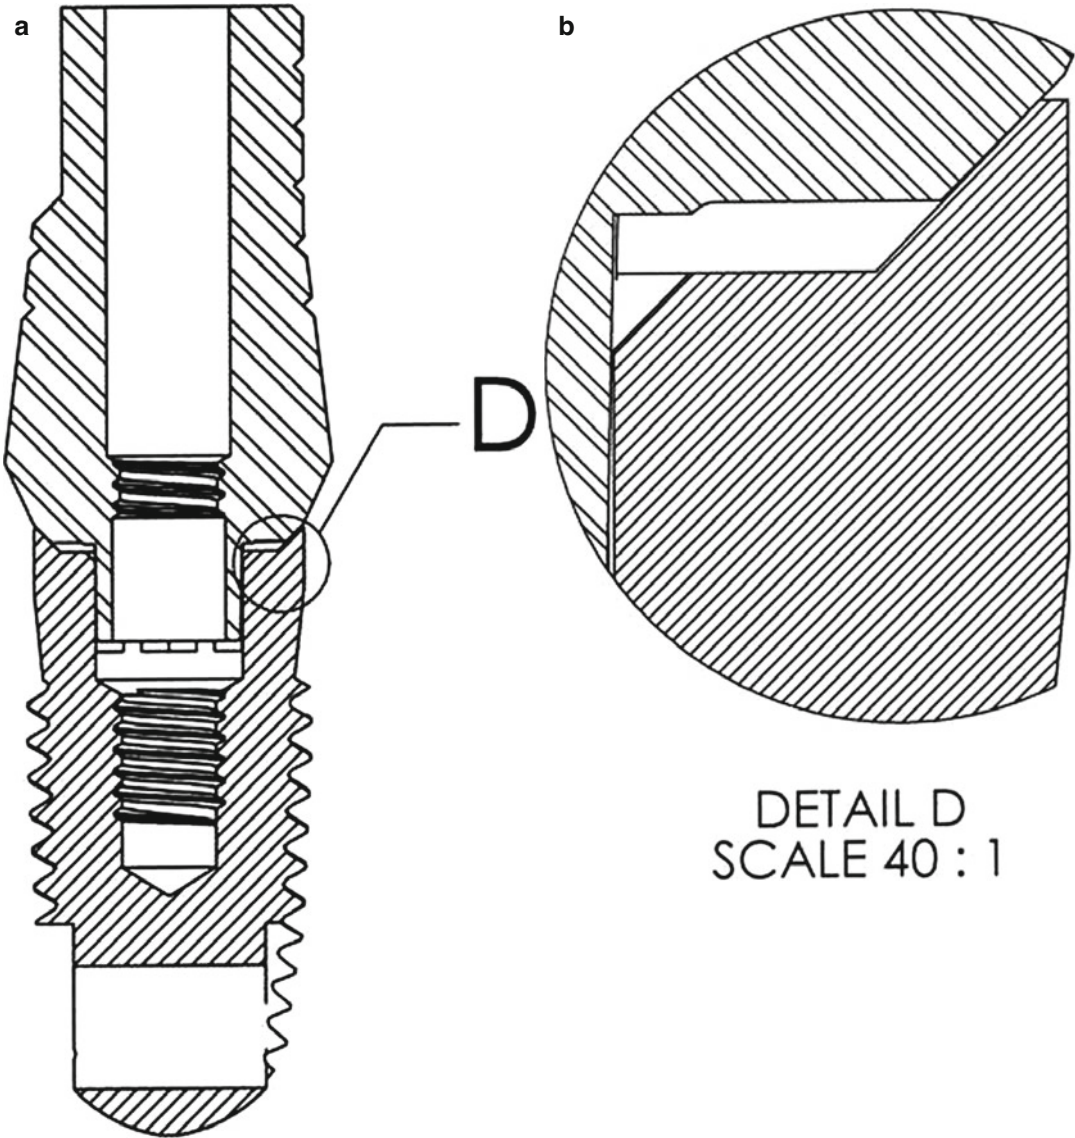
**Fig. 10.10** (a) The PESE results from the margin of the abutment contacting the lip of the implant only. (b) Enlarged image. This must be understood; failure would result in potential misdiagnosis of the components not

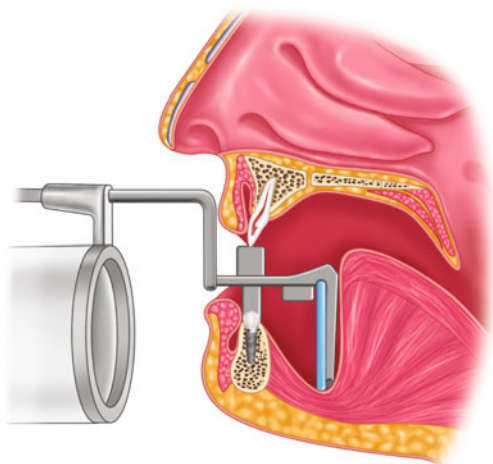
**Fig. 10.11** Example of existing devices that allow true orthogonal standard X-rays to be made. All must attach to the implant body (fixture) directly at each and during X-ray exposure (Reprinted from Cox and Pharoah (1986). Copyright © 1986, with permission from Elsevier)

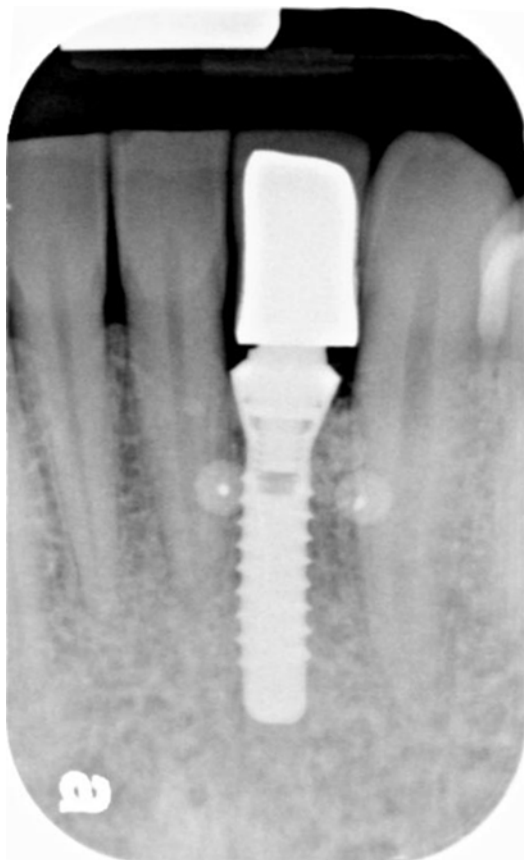
**Fig. 10.16** This restoration was cemented onto the abutment. No pre-cementation radiograph was made; the crown did not seat as intended. It is likely the adjacent teeth contacted the restoration prematurely, preventing its placement. The restoring dentist failed to detect this error

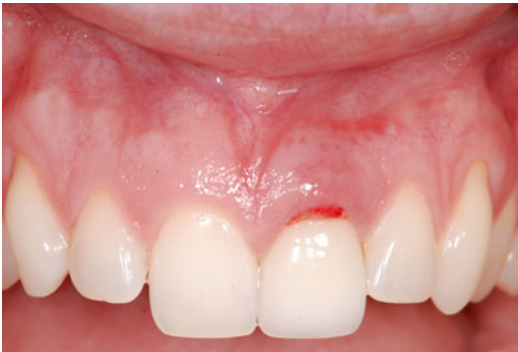
**Fig. 11.1** Clinical example of a dental implant (maxillary left central incisor) exhibiting biological complications following restoration

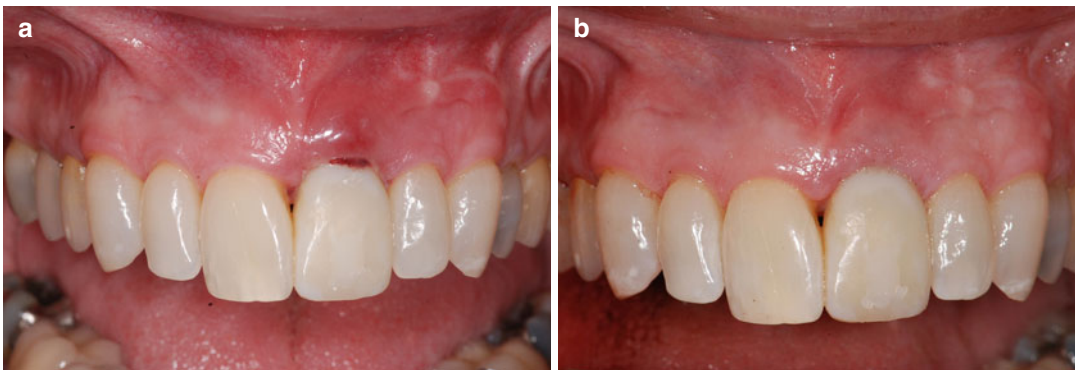
**Fig. 11.2** (a) Peri-implant mucositis as a result of micro-movement due to inadequately tightened abutment screw (maxillary left central incisor). (b) Uneventful healing 2 weeks following adequate torque of abutment screw

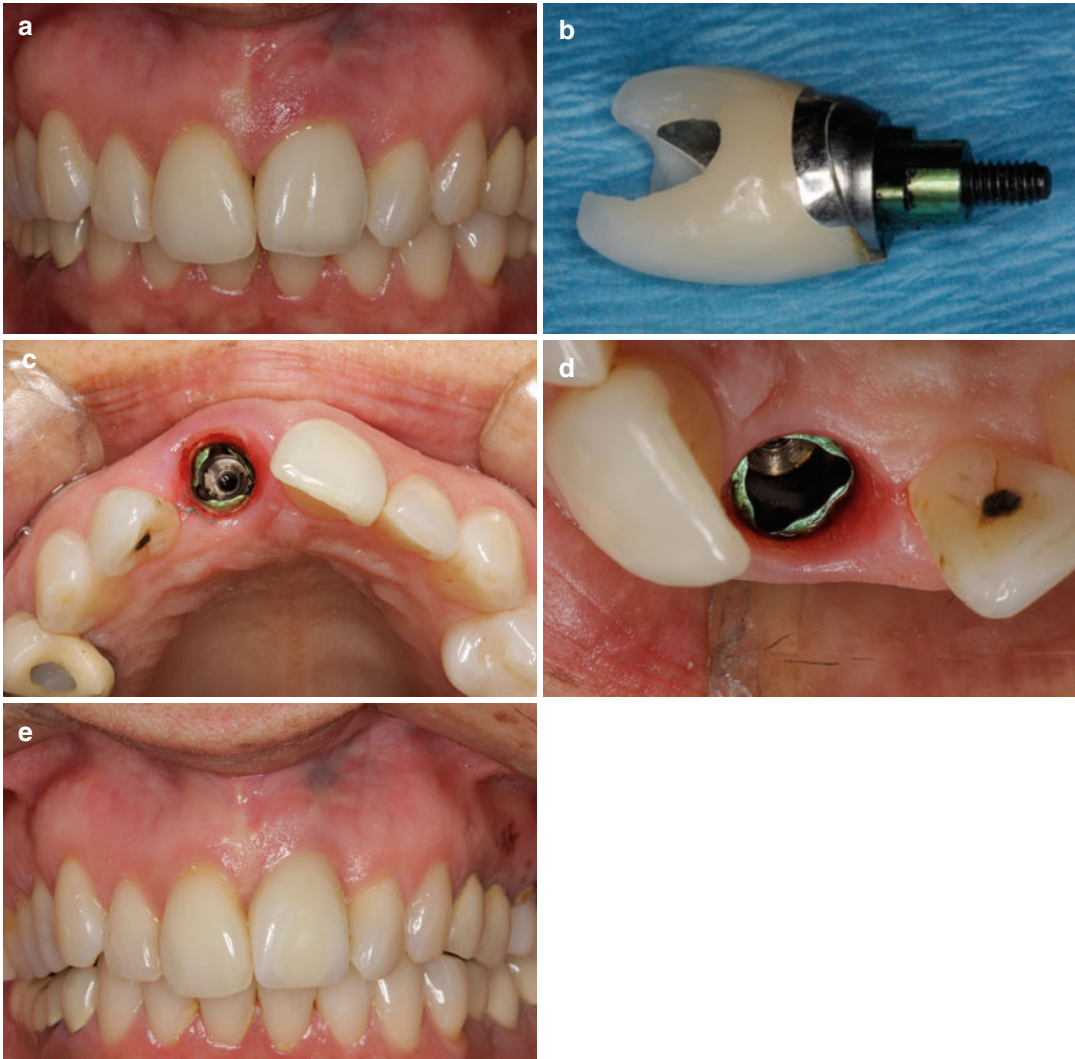
**Fig. 11.4** (a) Inflammation of the peri-implant mucosa. Residual cement was not detected on radiographic survey. However, considering the restorative design with a deep cement margin, incomplete removal of cement was suspected. (b) The decision was made to remove the crown and the abutment, by creating an access to the abutment screw. Upon removal of the crown/abutment complex,
