Chandur P.K. Wadhvani  
*Editor*

# Cementation in Dental Implantology

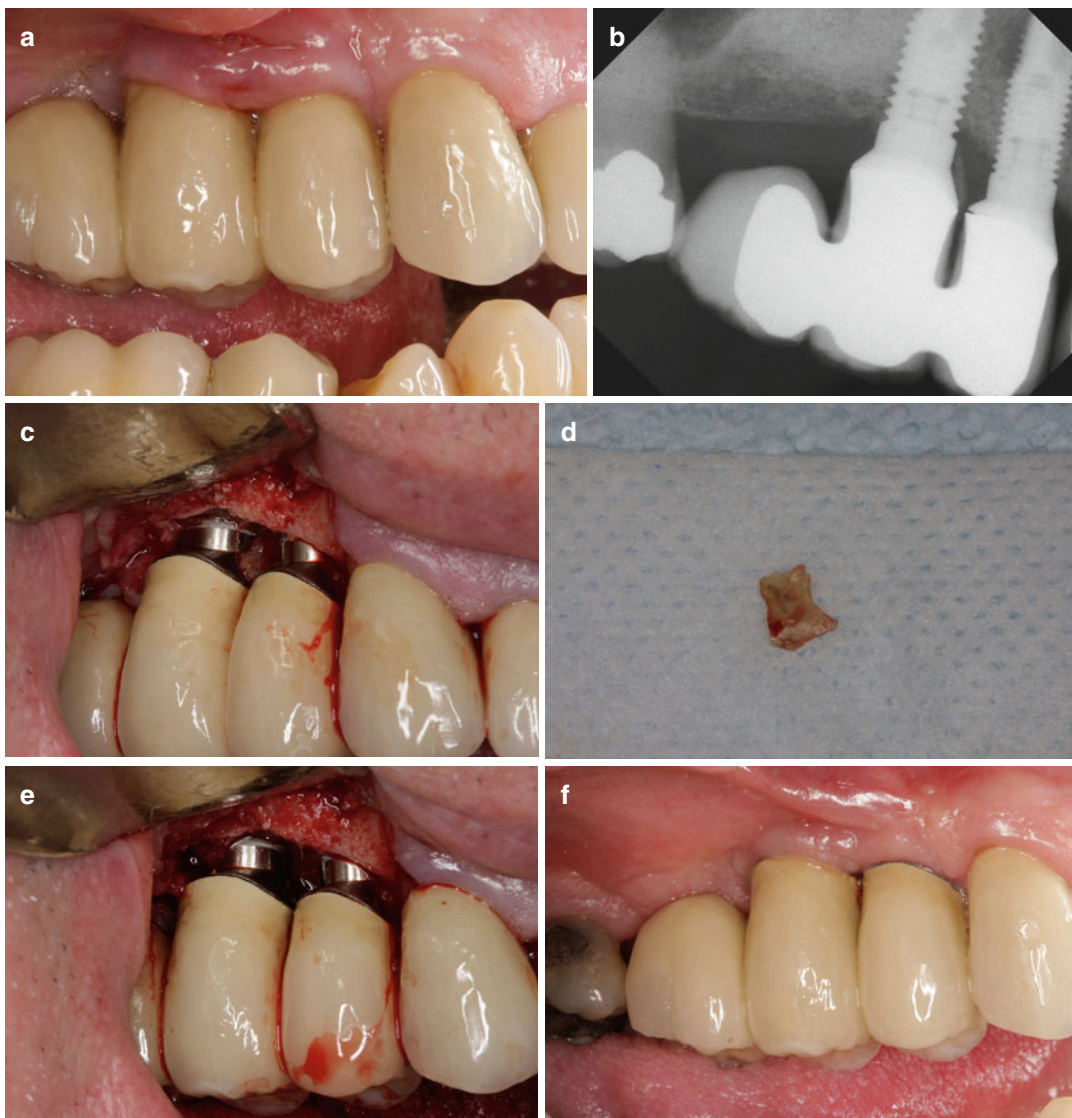
**Fig. 11.5** (a) Peri-implant mucositis is found on follow-up exam after the restoration was completed. (b) Radiograph of the area indicates REC. (c) Upon flap ele-

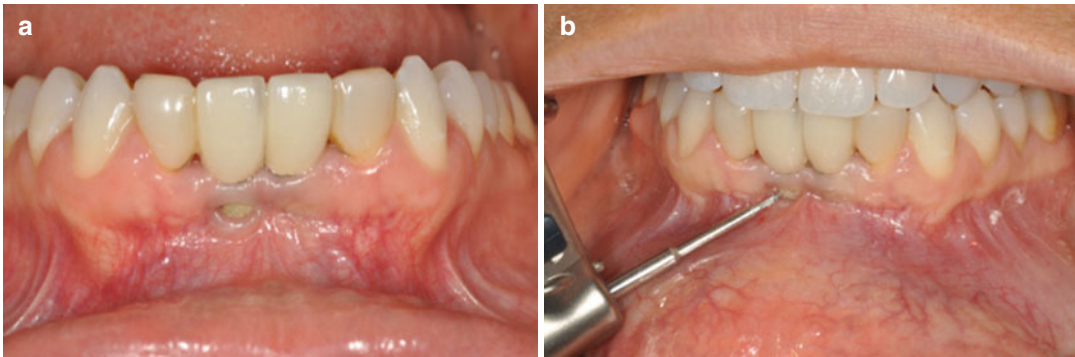
**Fig. 11.6** (a, b) Use of titanium brush through a soft tissue fenestration to clean the implant site

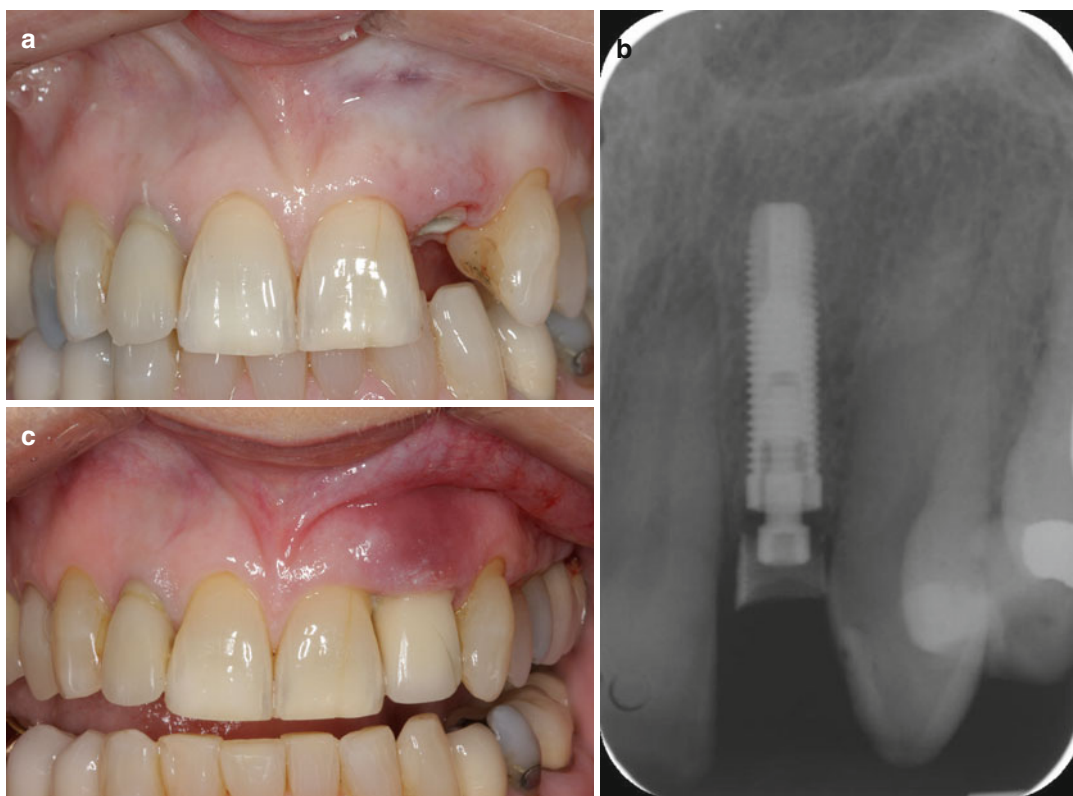
**Fig. 11.7** (a) Tooth #10 was removed and immediate implant was placed with customized healing abutment. Clinical view 3 months after the surgery, immediately prior to the restorative procedure. (b) Radiograph of the area showing good peri-implant bone level. (c) Four-and-a-half years after restoration, patient presented with severe gingival inflammation. (d) Radiograph of the area shows significant peri-implant bone loss. (e) Upon flap elevation,

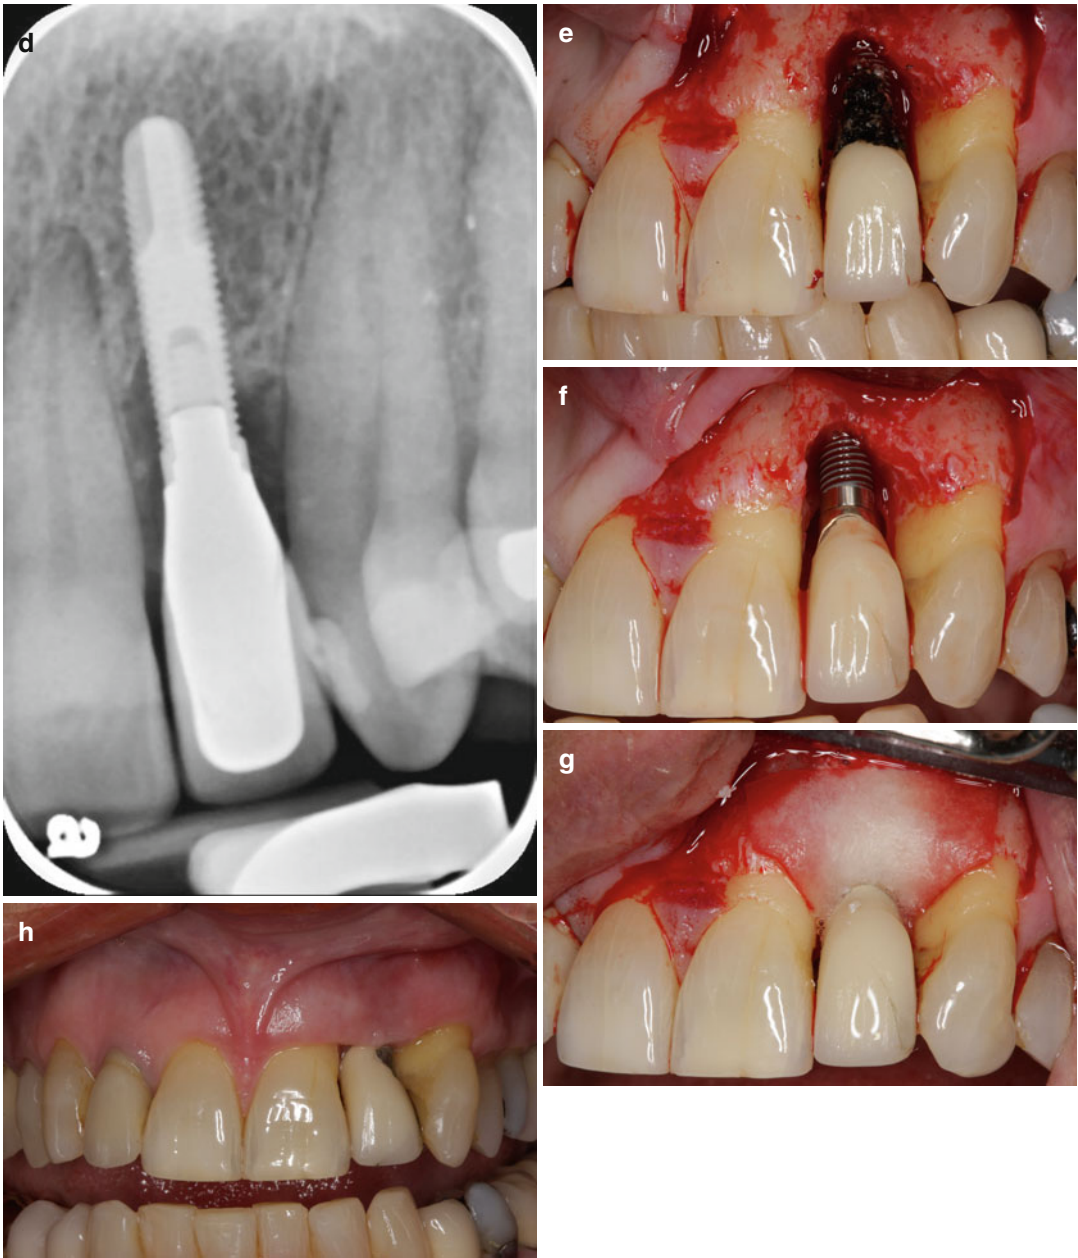
**Fig. 11.7** (continued)

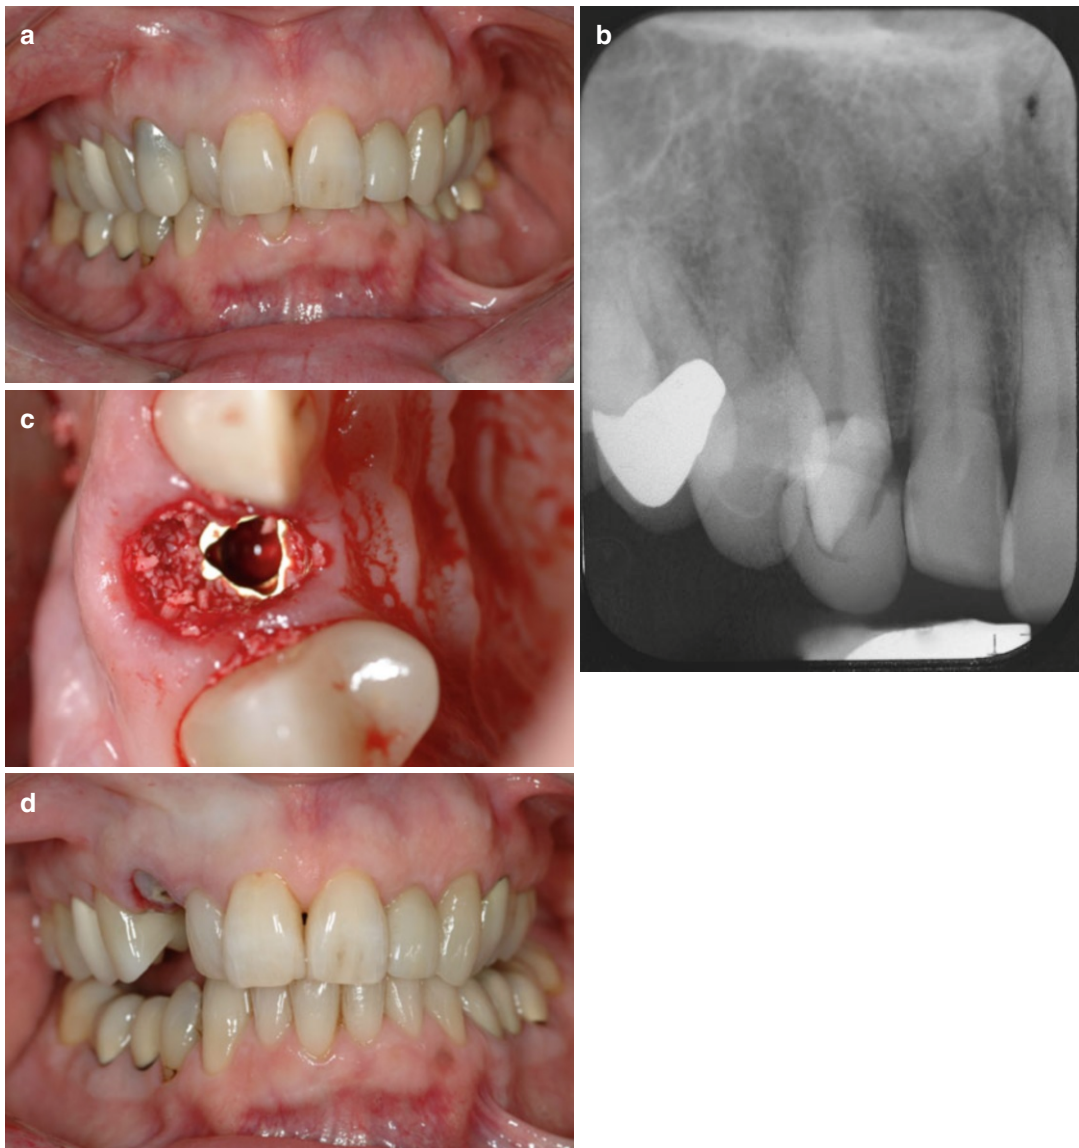
**Fig. 11.8** (a) Maxillary right canine with extensive secondary caries. Clinical view at the time of initial presentation. (b) Initial radiograph. Note note extensive caries under the existing restoration. (c) The tooth was removed and implant was placed immediately into the extraction socket. The remaining gap facial to the implant was grafted with deproteinized bovine bone mineral (DBBM). (d) Customized healing abutment was fabricated. Clinical view immediately after the procedure. (e) Radiograph 3 months post-implant placement upon confirmation of the integration. (f) Clinical view 3 years after implant was

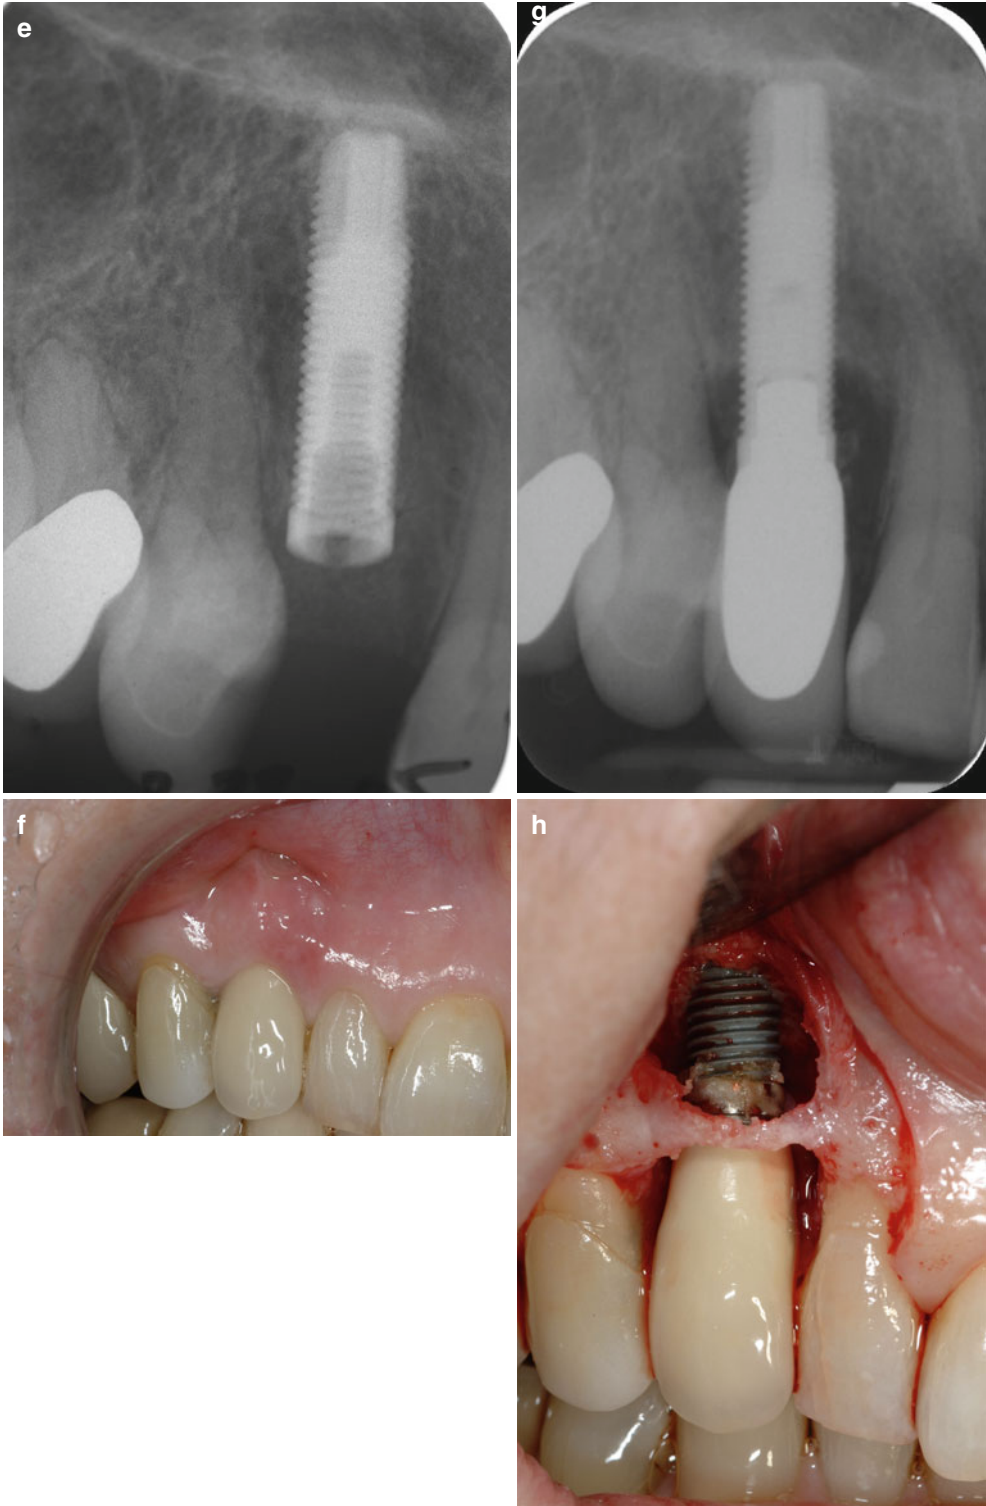
**Fig. 11.8** (continued)

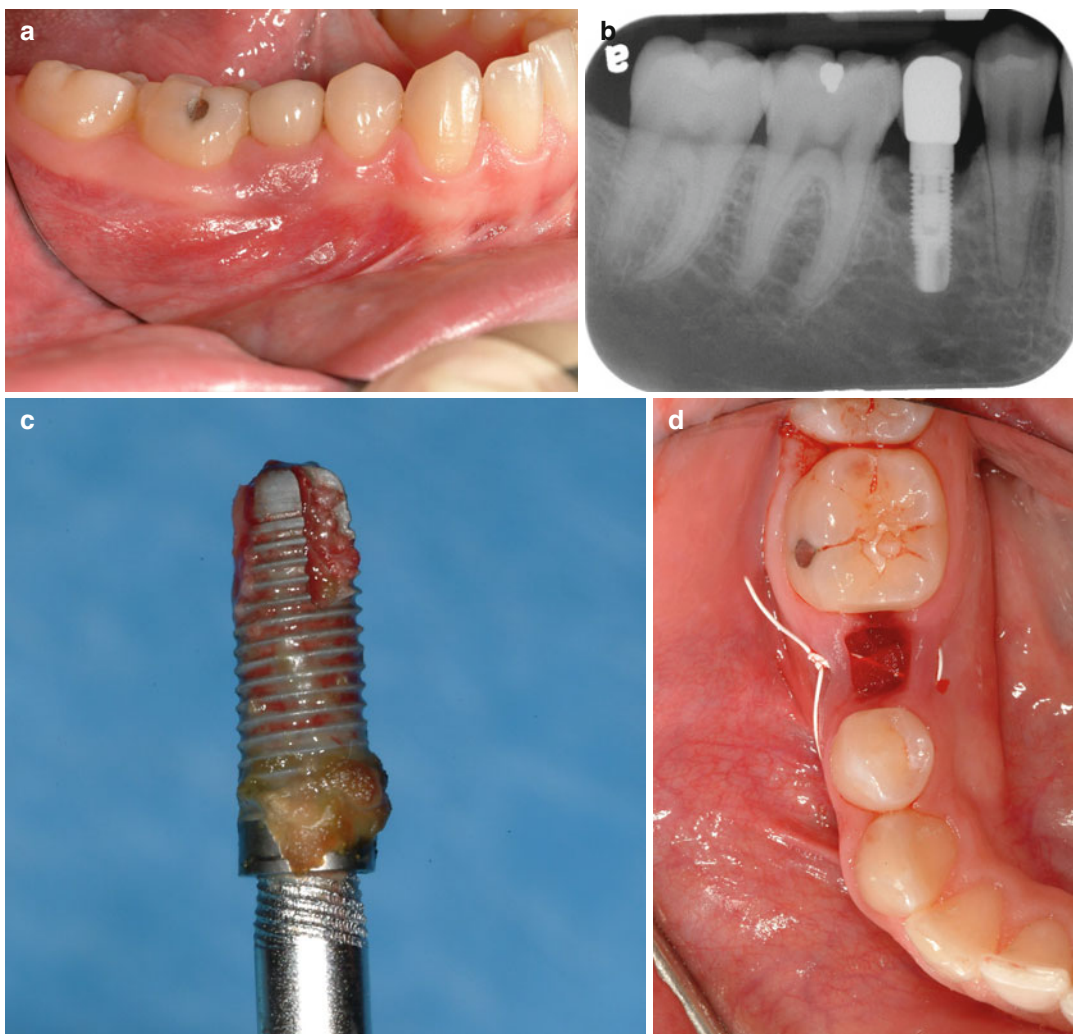
**Fig. 11.9** (a) Clinical photograph and (b) radiographic image of implant site. Lower right second premolar presenting with signs of peri-implantitis. (c) Implant removal using counter-torque device seen within the implant. REC is seen at the implant collar. (d) The explanted implant site

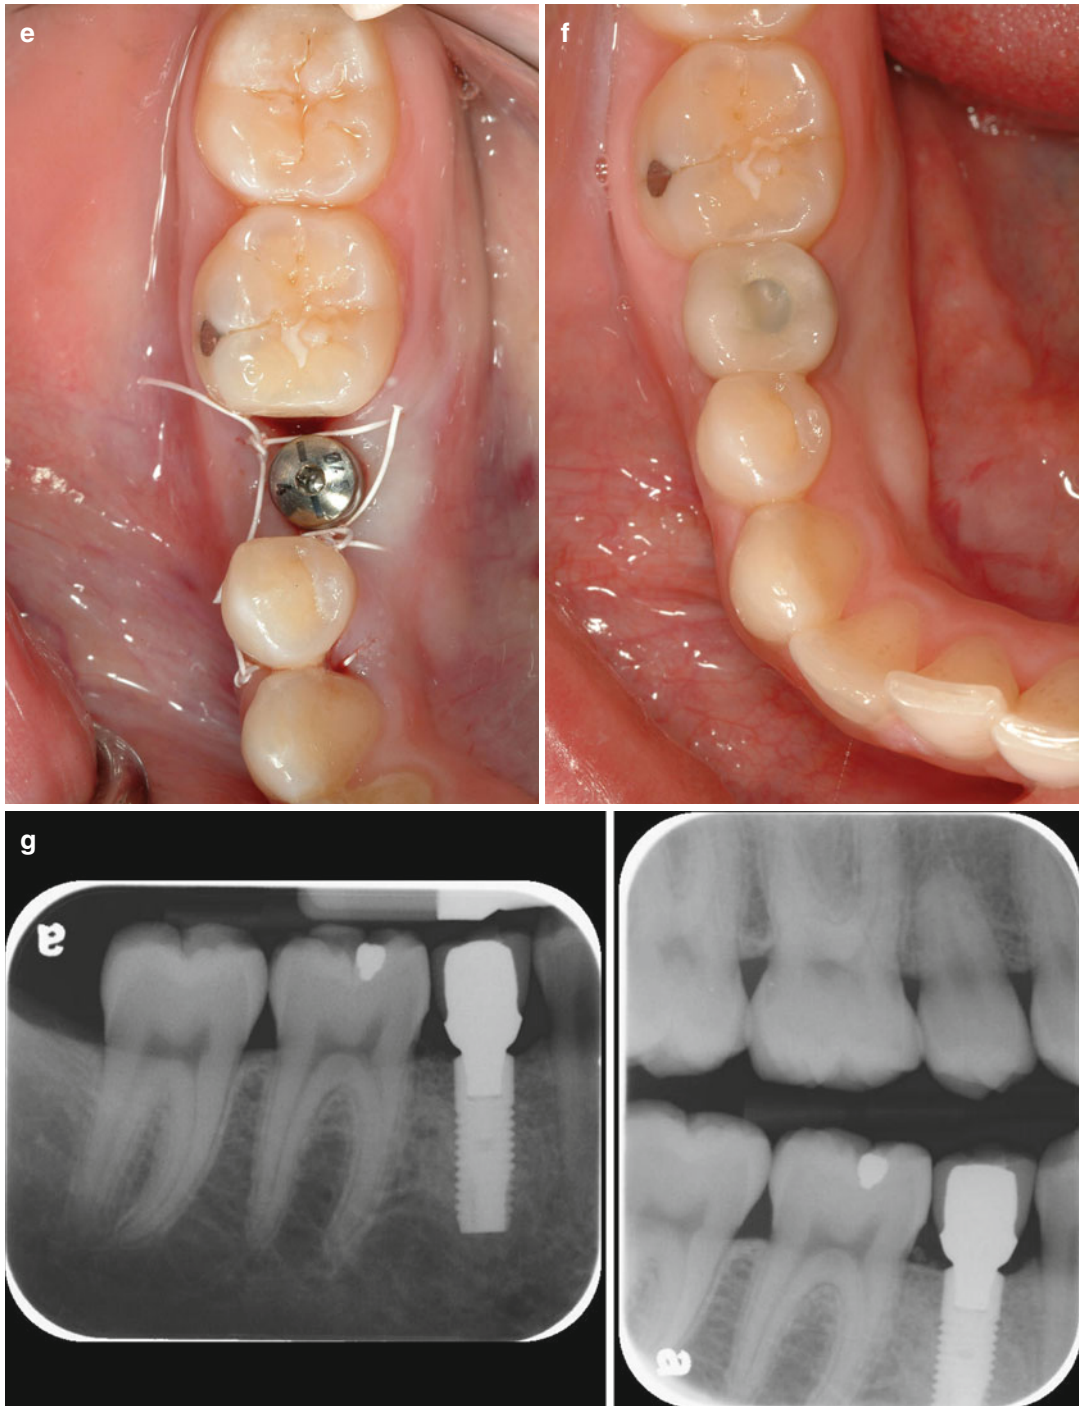
**Fig. 11.9** (continued)

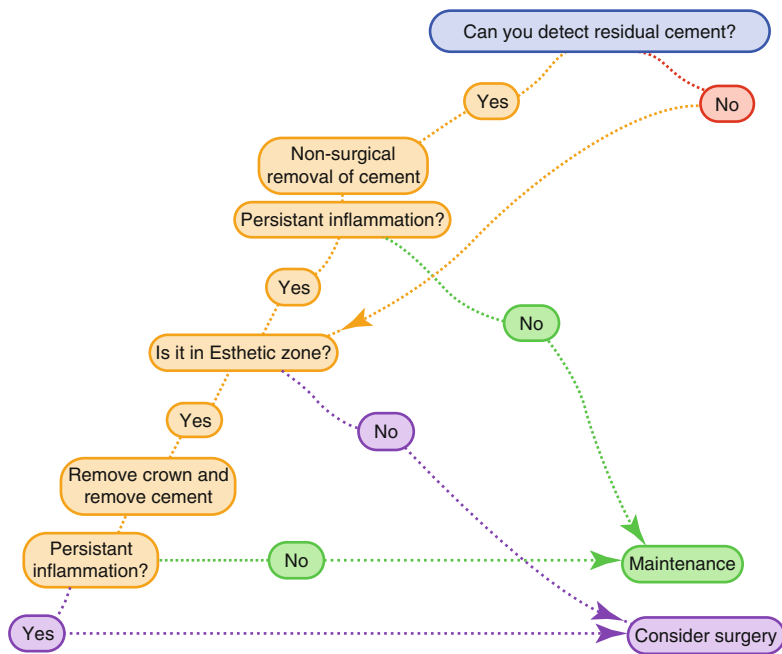
**Fig. 11.10** Proposed incremental treatment approach to prevent or treat peri-implant mucositis and/or peri-implantitis related to residual excess cement
