Temperature Effects on the Response of the Bridge “ÖBB Brücke Großhaslau”

Abstract The aim of this paper is the study of the effect of temperature variation on the structural response. In particular, the behavior of a railway bridge located in the south part of Austria is investigated using health monitoring system. Among the large amount of data collected the influence of the temperature variation of the structural response is analyzed.

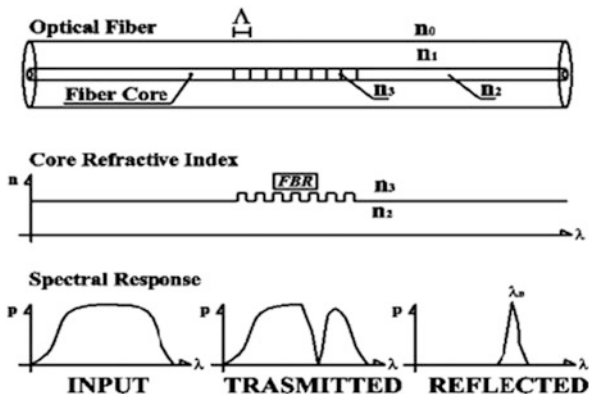
Fig. 1 Scheme of Bragg's grating

The SHM system installed on the bridge consists of Fiber Bragg Grating (FBG) sensors. The sensors FBG are particular spectrum sensors. The peculiarity of these sensors is the ability to modify the local value of the refractive index of the fiber's "core", using in an appropriate way a laser light. In other words, the device behaves as a filter in optical transmission and as selective reflector of the wavelength λ in reflection, as depicted in Fig. 1.

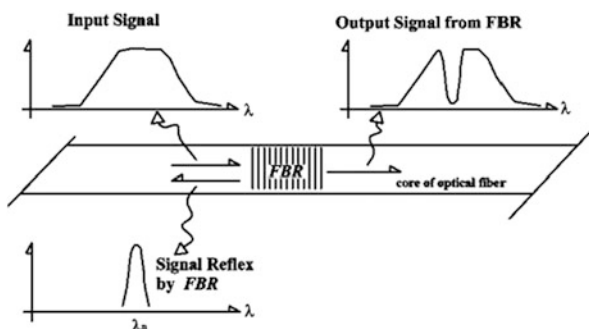
Fig. 2 Data transmission's scheme

The ability of the FBG to select a specific signal from a broadband light spectrum is the ground for the data transmission as shown in Fig. 2. In this way, the various FBG sensors filter and reflect back specific frequencies within the frequency package which constitute the signal. In order to understand this, one can

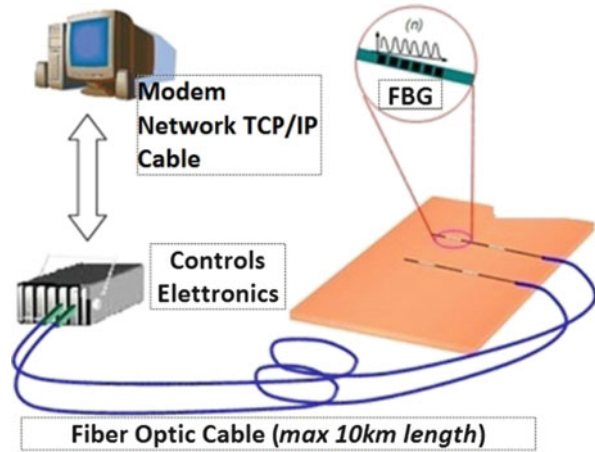
Fig. 3 Scheme of FBG’s system monitoring

make the analogy that the set of frequencies are similar to the set of conversations that are running on a telephone line and the *FBG* are appropriate selectors that extract a specific conversation (a specific frequency in our case) by sending it to the recipient where a suitable opto-electrical transducer translates the optical signal into an electrical signal for the final treatment up to our phone [4, 5]. A generic composition of a monitoring system that uses *FBG* sensors is shown in Fig. 3 and summarized as follows:

- Optical fiber with the *FBG* sensors;
- Fiber-optic cable connection between the sensors and the control electronics (max 10 km length);
- Control electronics: the electrical core of the system;
- A PC connected to the control electronics via a local cable, network, Internet or GSM modem, where data are stored and potentially analyzed.

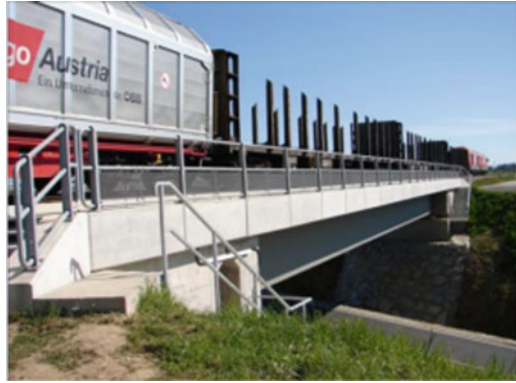
Fig. 5 ÖBB Brücke
Großhaslau

the road *Zwettler Straße – B36*. It is a single span, reinforced concrete T-beam bridge that is straight and supports dual-lane rail traffic. The dimension of span is about 30 m length and 8 m width. The bottom of the span is about 6.7 m from the street below (see Fig. 5). Just before bridge commissioning in the Spring of 2010, some problems on the structure were detected as a result of visual inspection. This inspection revealed cracks on the central support of the deck (see Fig. 6). They concluded that these problems were related to two principal aspects:

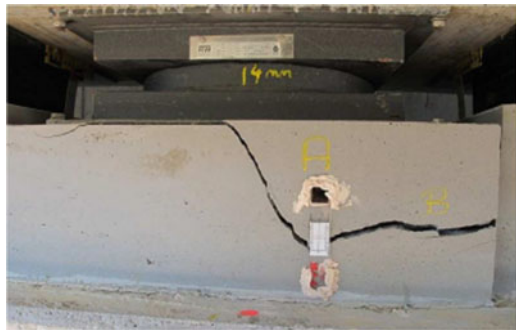
Fig. 6 Cracks on the central support

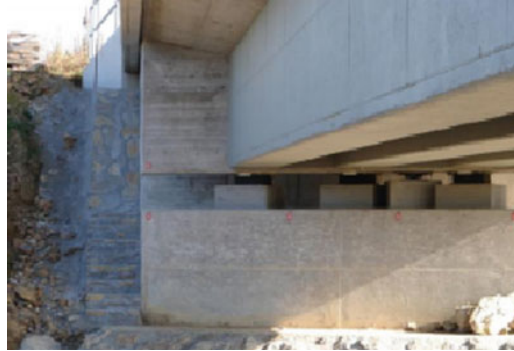
Fig. 7 Elastomeric support inserts under the deck

Worsening of the damaged condition was mitigated through the use of elastomeric supports under the deck as shown in Fig. 7. However, due to the damage, the bridge owner in cooperation with *Safibra s.r.o.*, a structural health monitoring company, decided to employ a bridge monitoring system to perform continuous monitoring to check in near real time the health of the structure, and at the same time to create a way to increase the degree of safety for the bridge's users. The *monitoring system* implemented is represented in the following picture (see Fig. 8). Two different kinds of sensors were employed. The first to detect the variation of displacement (see Fig. 9) and the second to detect the variation of temperature. In total, 10 displacement sensors and 4 temperature sensors were used.

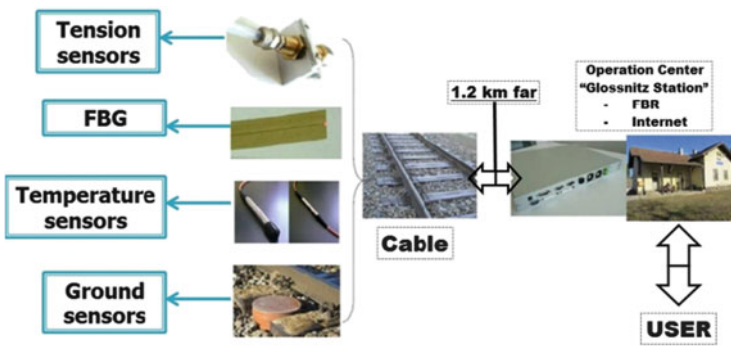
Fig. 8 Monitoring system implemented

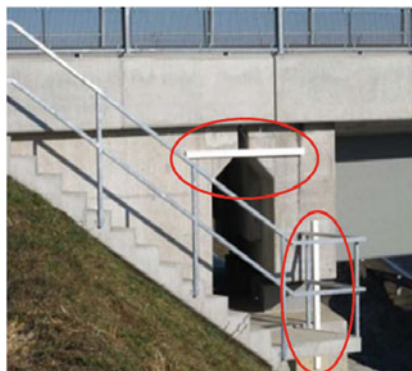
Fig. 9 View of the sensor attached to the deck of the bridge

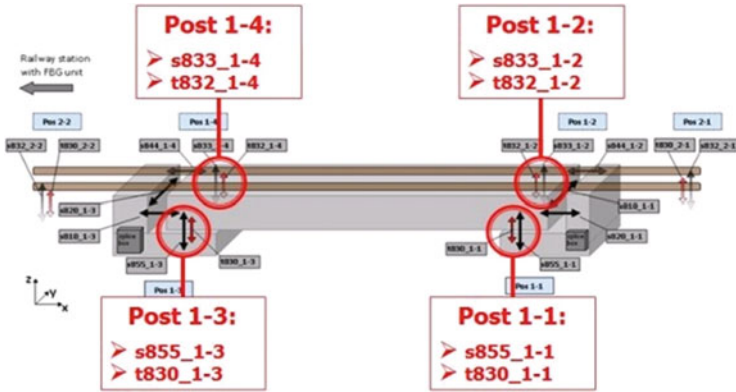
Fig. 10 Map of sensor positions

The sensors are located closer to the support where the cracks appeared. The labels and the positions of the sensors are represented in Fig. 10. Data are registered once per second, stored in a datalogger, and are then sent to a PC situated in an Operation Center where they are also uploaded in a Web page: enabled users can check or download them from a FTP server.

In this study, four sensor pairs (displacement and temperature) are used and are the ones indicated as circled in Fig. 10. To conduct the analysis, data from June to November 2011 are used. For the data displacements, it is noted that relative displacement between two nodes 1 m far each from the other in the original configuration are recorded. The measurement of temperature is expressed in *Celsius* degrees. All the data are managed by *MATLab* and *Microsoft Excel* software. For both displacements and temperature, data representations are provided for seasonal trend; monthly trend and global trend (3D) [6–8]. An example is shown in Fig. 11. For the quantification of the temperature effect for each event (represented by a train crossing) the investigated data are train crossing time, frequency of the first spectrum peak, peak value, and temperature at the time of train crossing. These data can be obtained from periodograms as the one shown in Fig. 12. From these graphs we observed that the event doesn't influence the frequency variation, but the temperature is the main factor responsible for the variations (see Fig. 13).

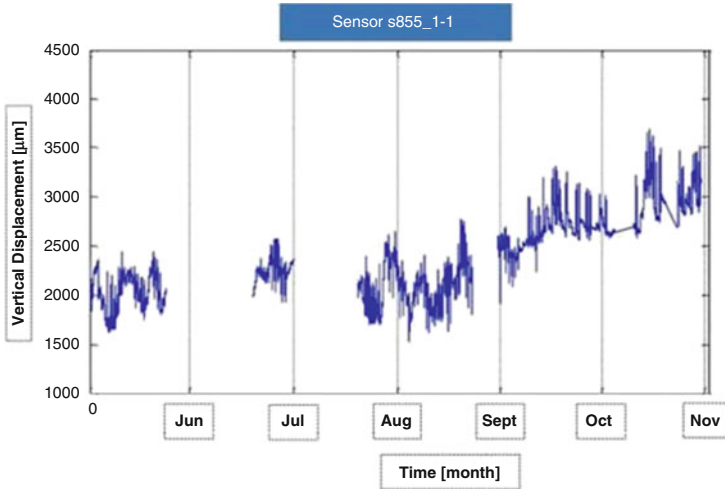
Fig. 11 Vertical displacement along the time monitoring measured by sensor s855-1-1

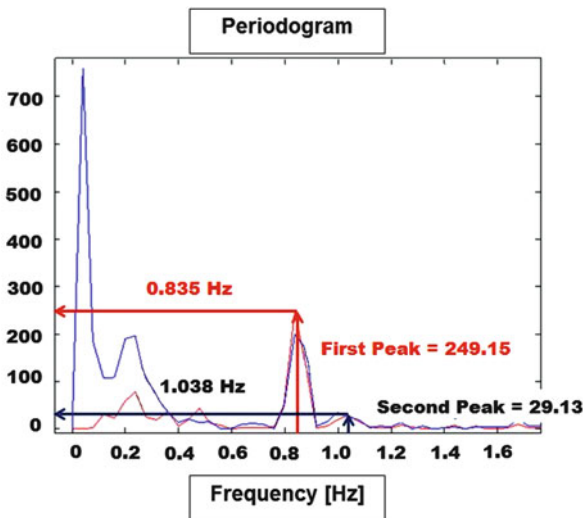
Fig. 12 Periodogram for event of June, 14. Time 15:30:46. Sensor s833-1-2

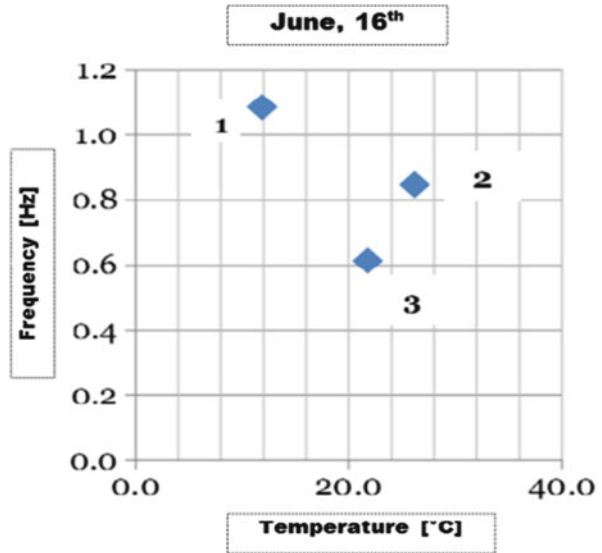
Fig. 13 First frequency peak – June, 16th – sensor s833-1-2 (1 = event from 04 to 06 am; 2 = event from 11 to 14; 3 = event from 15 to 18)

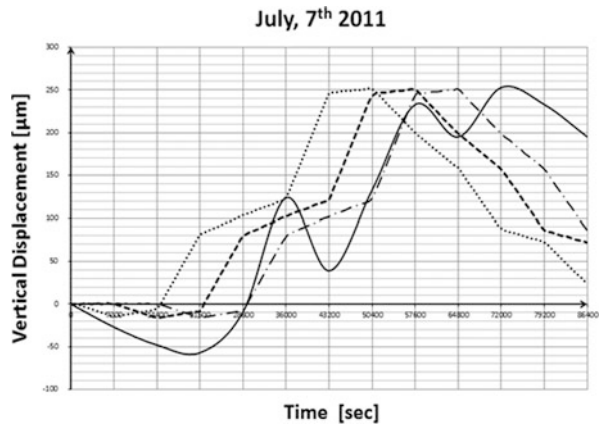
Fig. 15 Comparison vertical displacement versus time. *Solid line* represents the sensor s833-1-4 measurements. *Dotted line* the first attempt (no delay in function load). *Dashed line* a delay of 2 h. *Dashed-dotted line* the final assumption (4 h delay in function load)

by the sensor. This fact was related to the thermal inertia of the concrete. In order to compensate for this problem, and to take into account the thermal inertia of the material in a simple way, the temperature action was delayed by 4 h. In this way, the results of the model matched with the real behavior (see Fig. 15). In order to test

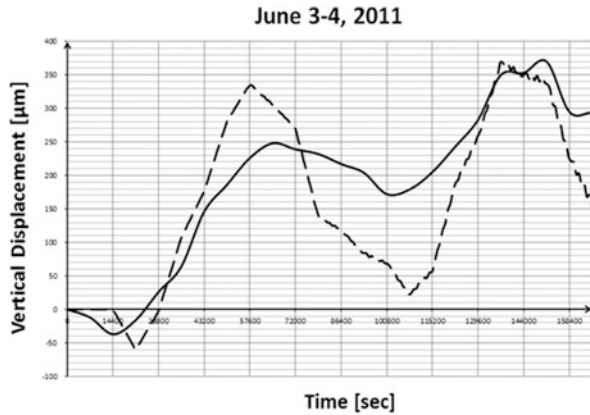
Fig. 16 Comparison vertical displacement versus time. *Solid line* represents the sensor s833-1-4 measurements. *Dashed line* the result of the numerical model (4 h delay in function load)

the goodness of the numerical model it applied to another data set covering June 3rd and 4th. Once again the temperature action was delayed by 4 h. The output result was very good as shown in Fig. 16.
