**APPENDIX: DAMAGE ASSESSMENT TO WAR AND NATURAL
DISASTERS IN BOSNIA AND HERZEGOVINA**

DAMAGE ASSESSMENT FOR MASONRY AND HISTORIC BUILDINGS IN BOSNIA AND HERZEGOVINA

M. HRASNICA*

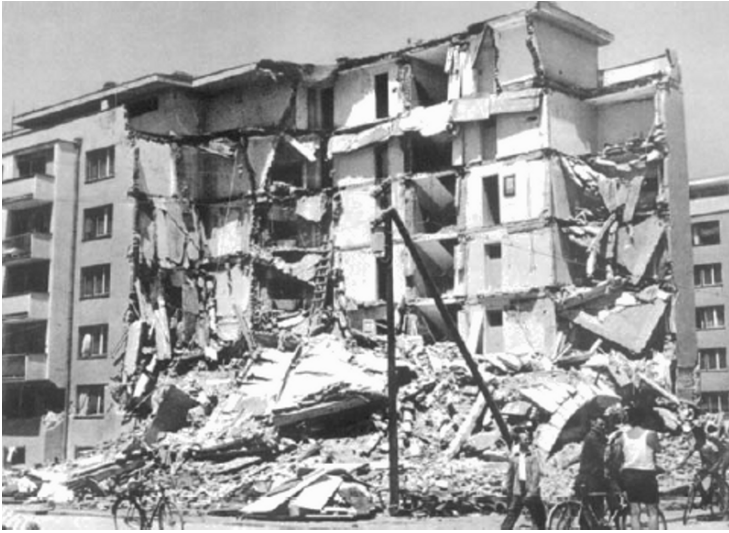
Figure 4. Total collapse of URM building, Skopje 1963 (Petrovski, 2004)

The most severe consequences after a strong earthquake are total or partial collapse of the building structures, which were observed for Skopje and Banja Luka earthquake (Figs. 4 and 5). Five-story masonry building without vertical R.C. confining elements could not withstand strong forces induced by the earthquake of the seismic intensity nine and collapsed (Fig. 4). Similar observation can be confirmed by failure of the corner building (Fig. 5).

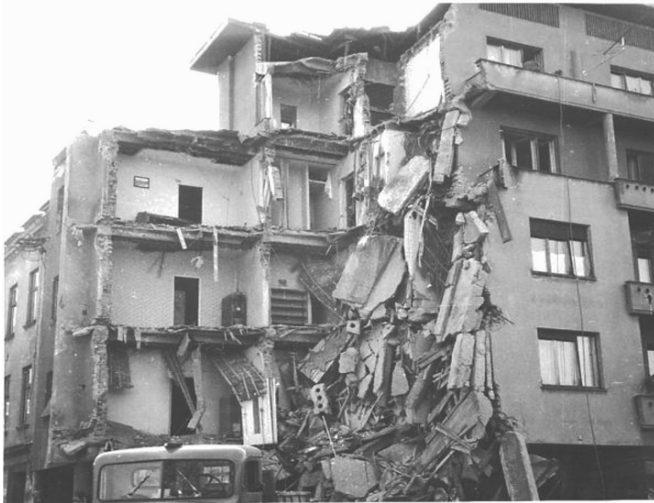
Figure 5. Partial failure of the masonry building, Banja Luka 1969

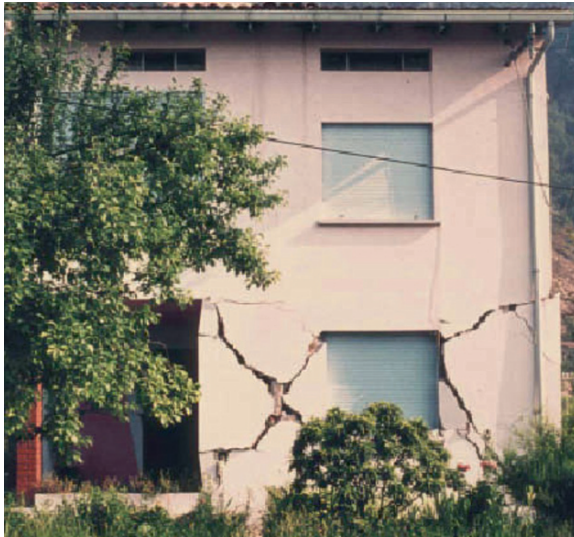
Figure 6. Diagonal crack in masonry walls and loss of corner wall URM masonry' R.C. floors (EMS)

Common damages of masonry structures caused by earthquake are diagonal cracks in the walls (Fig. 6). This type of damage on masonry structures was observed after many earthquakes, from minor cracks after less severe ground motion to larger cracks due to strong earthquakes, as illustrated on the figure below. This can lead to the buckling of the damaged wall and collapse of the whole building. The reasons for the diagonal cracks in the masonry walls are in their small resistance in tension. Due to the high level of the horizontal forces induced by an earthquake a sort of truss resistance mechanism is formed in the masonry walls or piers. The truss chords are floor structures, which in the case of R.C. floors can transmit the horizontal forces in efficient way, while the diagonals are formed in the masonry wall itself and fall in tension. The most of the existing masonry buildings in southeast Europe belong to the unreinforced masonry structures and this tradition is preserved. The improvement is made by almost regular built in of the vertical reinforced concrete confining elements, which improve overall structural ductility significantly.

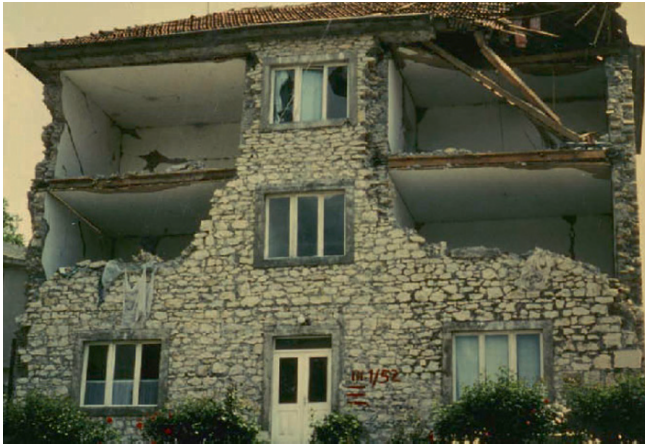
Figure 7. Stone masonry building with wooden floors, earthquake in Montenegro 1979 (EMS)

Traditional stone masonry houses were very often built in the Mediterranean region, where continuous seismic activity is permanently registered. Most of the houses are built with wooden floors. The damages at one of such buildings due to Montenegro earthquake are shown on the Fig. 7. The stone masonry wall collapsed, which caused partial collapse of the floor and the roof structures, leading generally to heavy structural damage of the building.

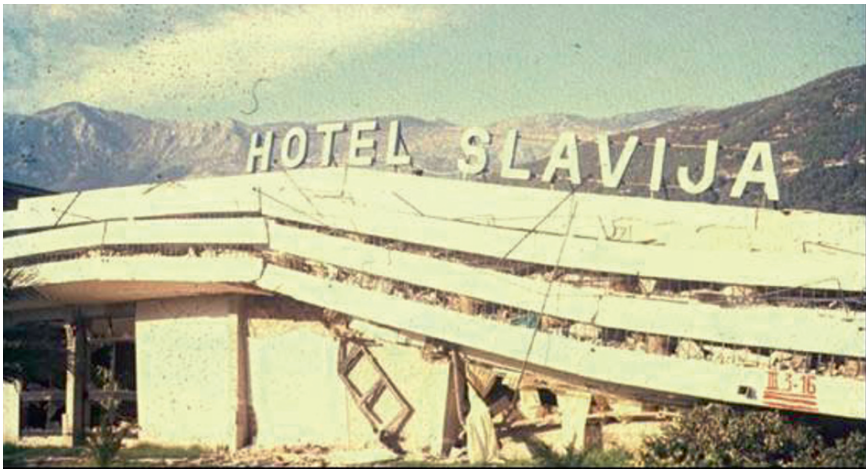
Figure 8. Soft-story and non-symmetrical structure Montenegro 1979

Figure 8 shows collapse of the fresh built reinforced concrete building with structural walls during Montenegro earthquake in 1979. The hotel building had been finished just before the earthquake happened, which means that it was constructed according the latest seismic code. But, two structural irregularities were fatal for it. First, flexible ground floor (soft-story) proved to be very sensitive to strong earthquake motion and then non-symmetrical distribution of the structural walls in the plan of the building. After the lessons from this earthquake the local seismic codes were modified, especially regarding restrictions for the buildings with soft-story.

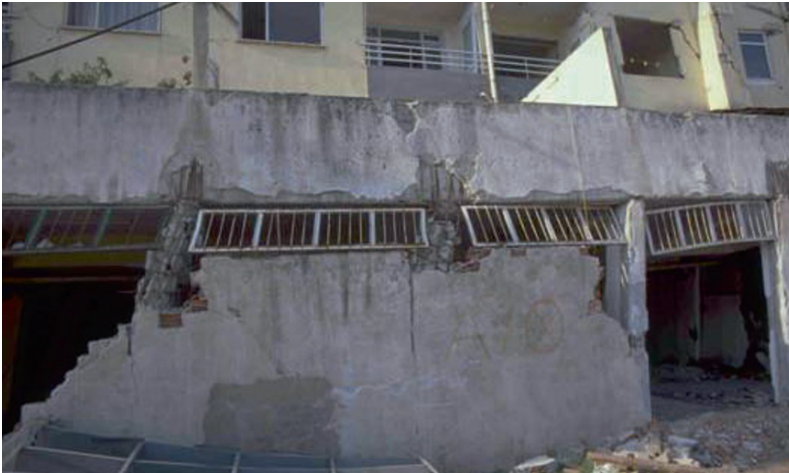
Figure 11. Damages on the R.C. frame structure due to masonry infill (SGEB, 2004)

As an example, the damages of the masonry infilled frame structure during earthquake in West Turkey 1999 are shown on the Fig. 11. Frame columns suffered very high structural damages.

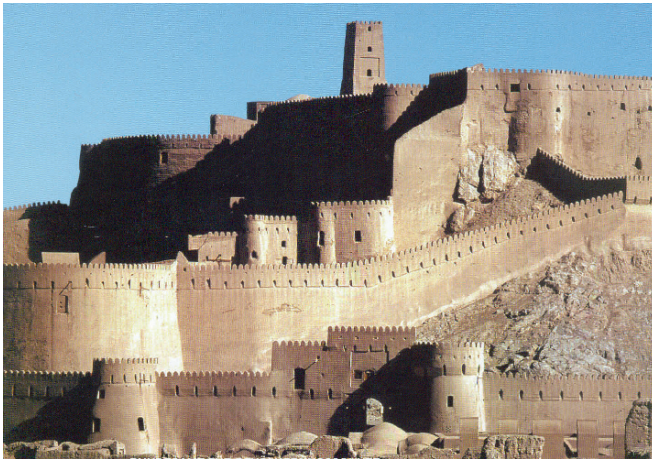
Figure 12. The old city of Bam in south-east Iran before the earthquake

How the strong earthquake can destroy old monumental masonry structure is illustrated on the example of the old city of Bam in southeast Iran. On the Fig. 12 is the view of the city before the catastrophic earthquake in 2004 and on the Fig. 13 after it. The unreinforced masonry structure couldn't withstand high seismic intensity in spite of the probably rather stiff and robust structure.

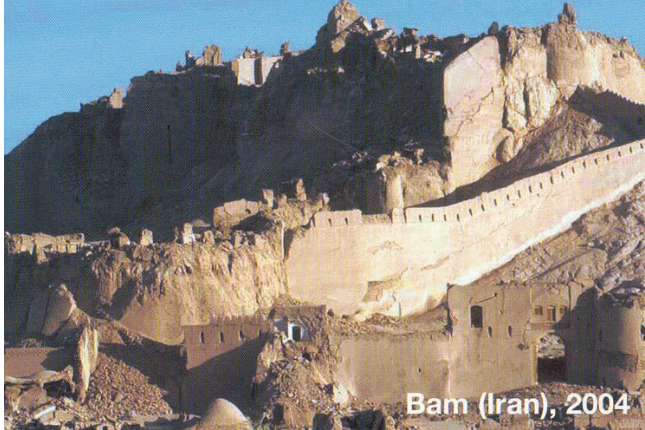
Figure 13. The old city of Bam in south-east Iran after the earthquake 2004

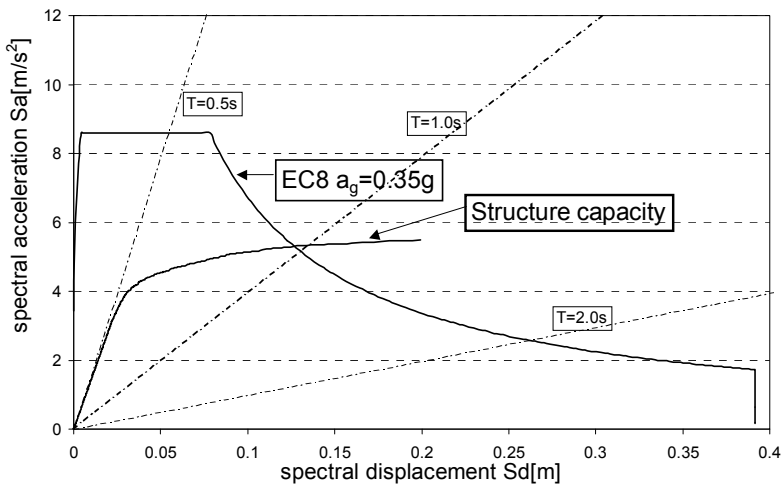
Figure 18. Structure capacity versus earthquake demand

The both curves are presented in acceleration-displacement-response-spectrum ADRS-format. On the Fig. 18 earthquake demand is represented by Eurocode 8 design spectra for the elastic behavior.

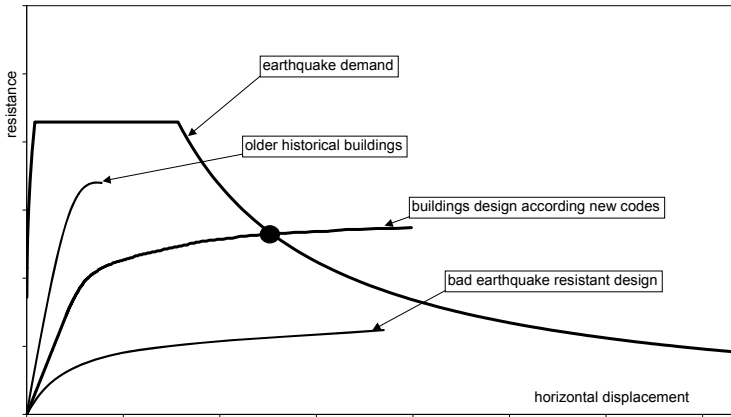
Figure 19. Capacity of different structures regarding their earthquake resistance

On the Fig. 19 the capacity curves for three different structures are compared referring to earthquake demand. The first curve, which does not intersect the demand curve represent behavior of brittle structures with low ductility. This is typical for older historical buildings constructed as robust unreinforced masonry structures. The fundamental period of such structures is usually in the range of high spectral acceleration. If the capacity curve does not go over seismic demand the structure generally cannot survive that earthquake intensity. On the contrary side there are very soft structures, with high ductility but without minimum of required resistance. The capacity curve also does not intersect the seismic demand, here in long period range. It is also example of bad earthquake resistant design.
