Impact of December 2004 Tsunami on Indian Coasts and Mitigation Measures

Sujatha C.H.* and Nify Benny

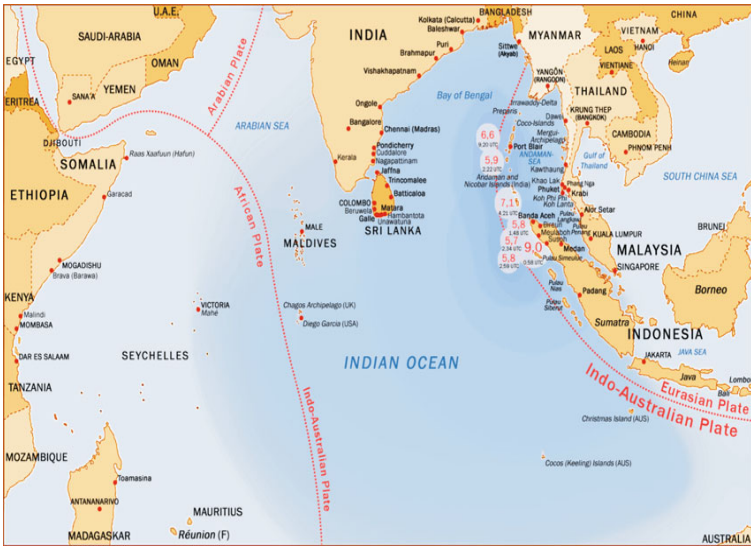
Fig. 1 Countries most affected (shown in red dots) by the 2004 Indian Ocean Tsunami
 (Source: Wikipedia, http://en.wikipedia.org/wiki/2004_Indian_Ocean_earthquake#Countries_affected).

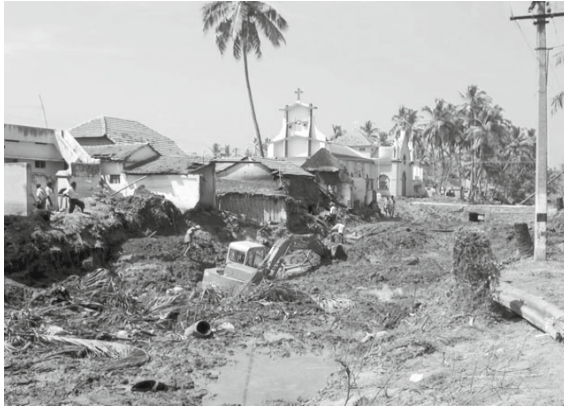
Fig. 5 The AVM channel in Kolachel, which became a death trap; more than 300 bodies were found in the slush of the AVM channel and open trenches (Photo: Sheth et al., 2006).

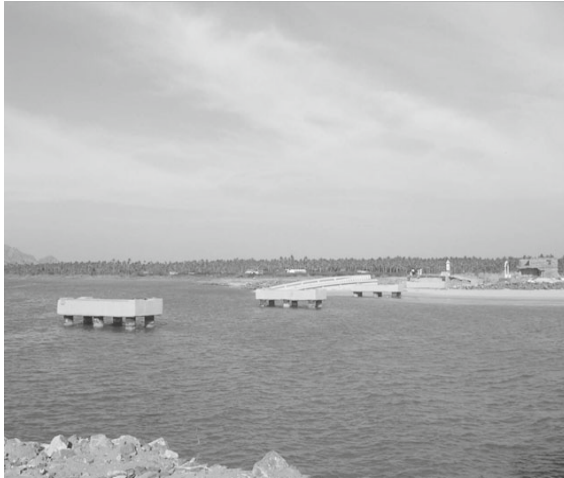
Fig. 6 All spans of the Melamanakudi Bridge came off their bearings. The end spans drifted upstream, while the middle spans sank into the river (Photo: Sheth et al., 2006).

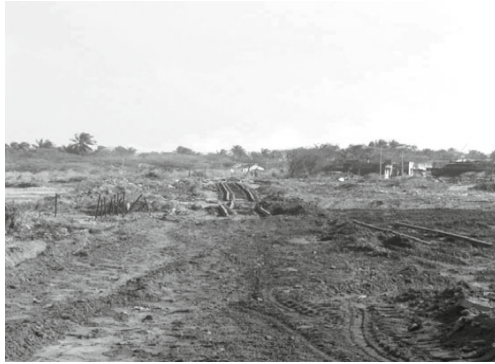
Fig. 7 Damaged railway line between Nagore and Nagapattinam in Tamil Nadu (Photo: Sheth et al., 2006).

Nagore: Due to high elevation (more than 3 m from sea level), no serious damage was reported at the oil jetty at Chennai Petrol Chemicals Ltd. at Nagore. However, 1,200 houses were destroyed or damaged. Water entered almost 1,000 m inland. The rail link to Nagore, which is a pilgrim town, was cut off as a 7-km meter-gauge track between Nagappattinam and Nagore was completely damaged (Fig. 7).
