Chapter 5

The *Ganga* Morphology

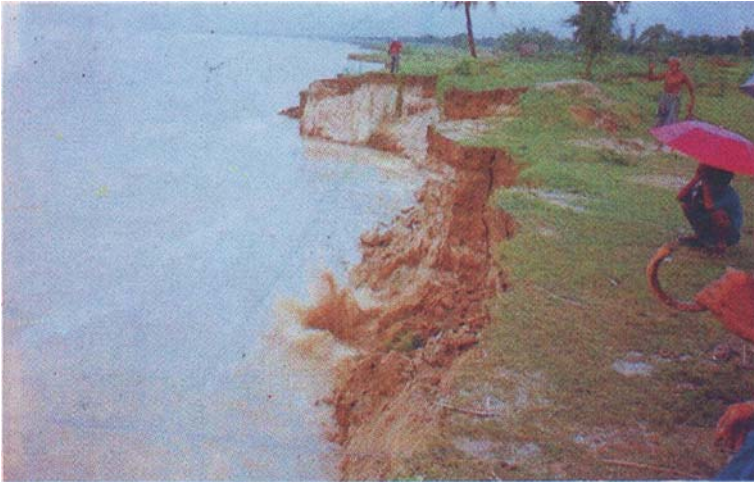
Photograph 5.1 Bank erosion near Panchmandapur in Malda district (See also Plate 1 on page 365 in the Colour Plate Section)

The barrage was constructed in 1975 over the Ganga – probably the largest such in the world over the alluvial bed – by blocking the river in such a manner that Nature took time to adjust. Before it, it had two meander bends between Rajmahal and Farakka. One was intercepted by the barrage, to which the river adjusted. The latest survey of 1993–1994 revealed that the Ganga had combined two meander bends into one, from Rajmahal to Farakka, by keeping the deep channel on its left bank on Malda side, by eroding the left bank. The reach near Manikchak and the one from Panchanandapur to Farakka were severely affected for the last 20 years. The marginal embankment near Toffi village at about 7 km above breached in 1980 and despite constructing several spurs and strengthening them by stone apron and side-pitching with boulders in crates, the erosion was minimised but could not be wholly stopped. It shifted downstream and the embankment near Simultala village, at about 3 km above the barrage, was severely affected by breach in embankment in 1987. It breached nine times thereafter and gradually shifted toward the land, year after year. The areas are inundated quite often and farmland and villages submerged. Three to five kilometre wide and 5–7 km long land has so far gone into the river. On the right bank, a big alluvial fan has formed and is increasing day by day. A point-bar (*char* land) has recently come up toward the right, just above the barrage and is shrinking the right channel, which some day will jeopardise the operation and maintenance of the barrage. Experts say, this is natural for an alluvial river but would not have occurred if there was no barrage and adequate protective measures were taken upstream along with this human interference by spending a little. They were not taken because of callousness, ignorance and negligence of the government which now spends a fortune without much benefit. Photograph 5.1 shows the type of bank erosion near Panchanandapur on left bank in Malda district.

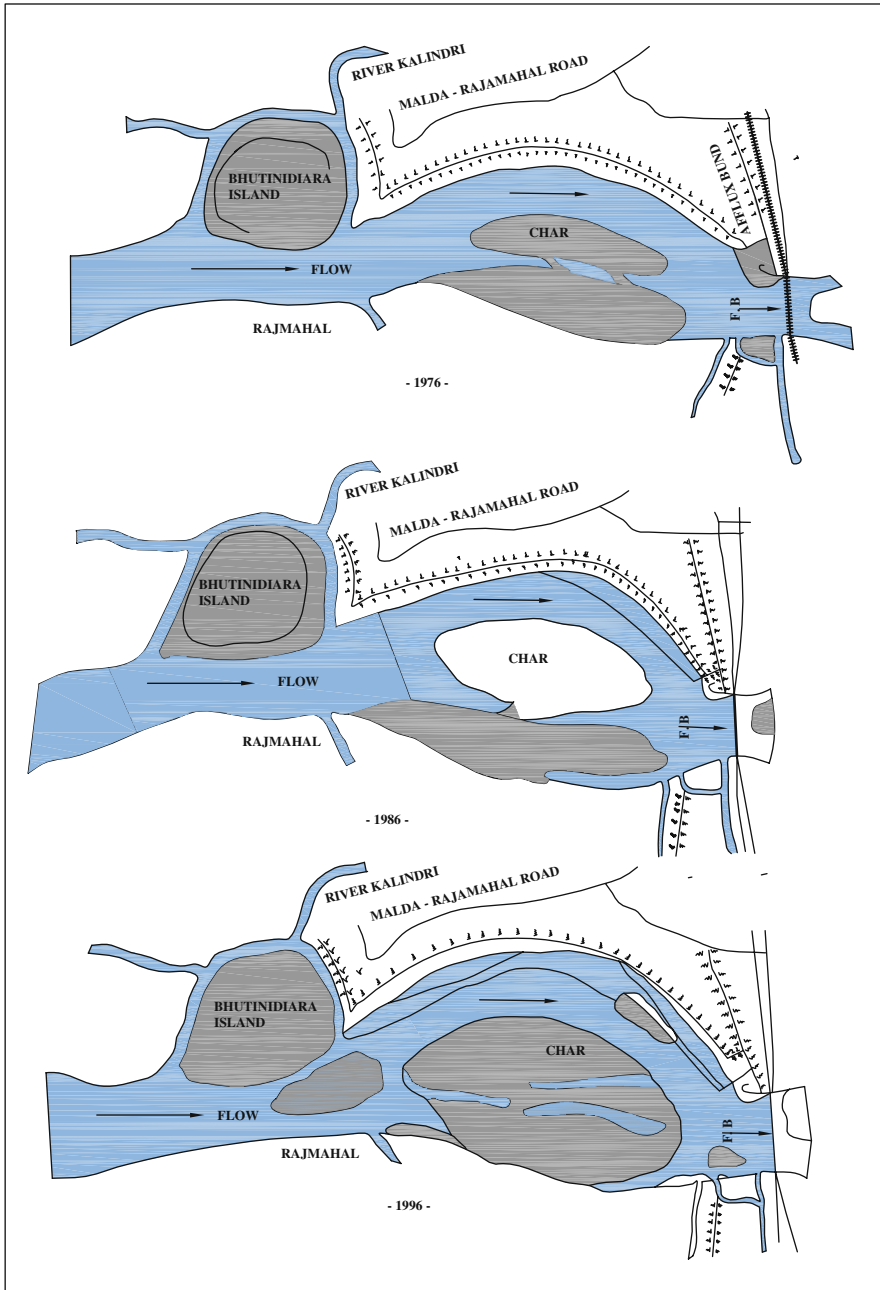
Fig. 5.8 Changes in river course between 1976 and 1996 on upstream of Farakka Barrage

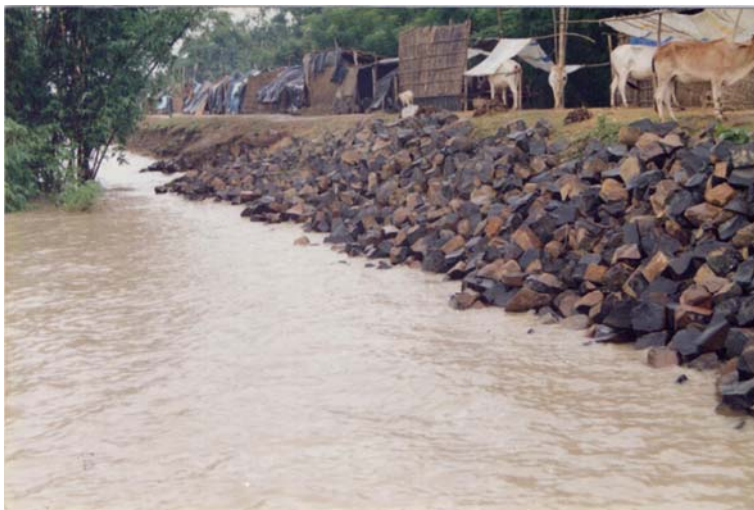
Photograph 5.3 Flood affected people taking shelter over marginal embankment (See also Plate 3 on page 367 in the Colour Plate Section)

the river a dynamic stability. Any further interference by long spurs, diversion canals etc. may make the river swing leftward and aggravate erosion, which would require more time for the course to adjust to such changes and stabilise (Fig. 5.8). Photographs 5.2 and 5.3 show the breach of a portion of the marginal embankment and people taking shelter over the embankment.

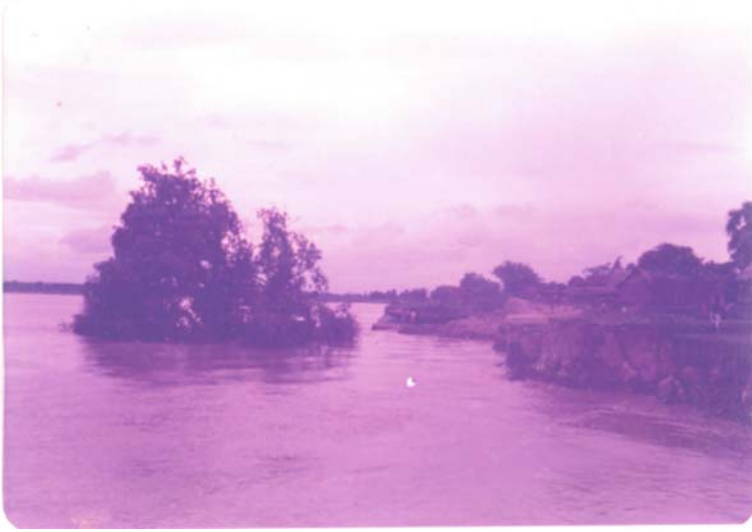
Photograph 5.4 Bank erosion of Bhagirathi near Palasi (See also Plate 4 on page 367 in the Colour Plate Section)

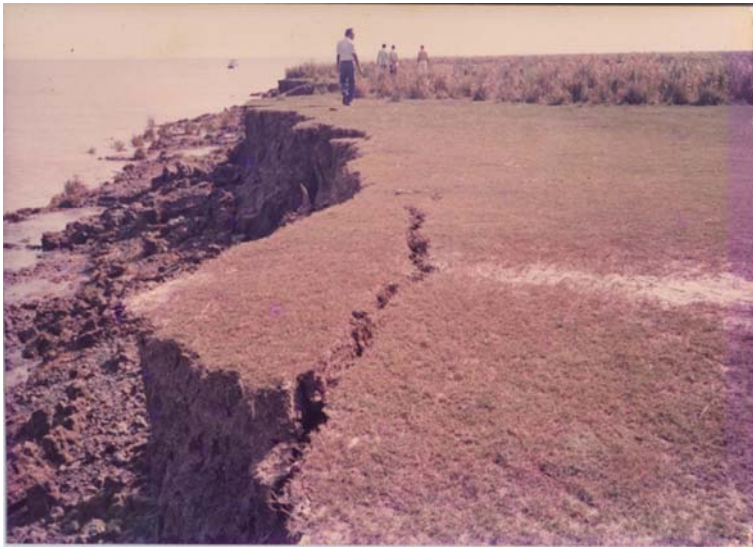
Photograph 5.5 Bank slip of Nayachara island near Haldia (See also Plate 5 on page 368 in the Colour Plate Section)
