Chapter 18

Precipitation Extremes and Disastrous Floods in Central Europe in July 1897

18.1 Introduction

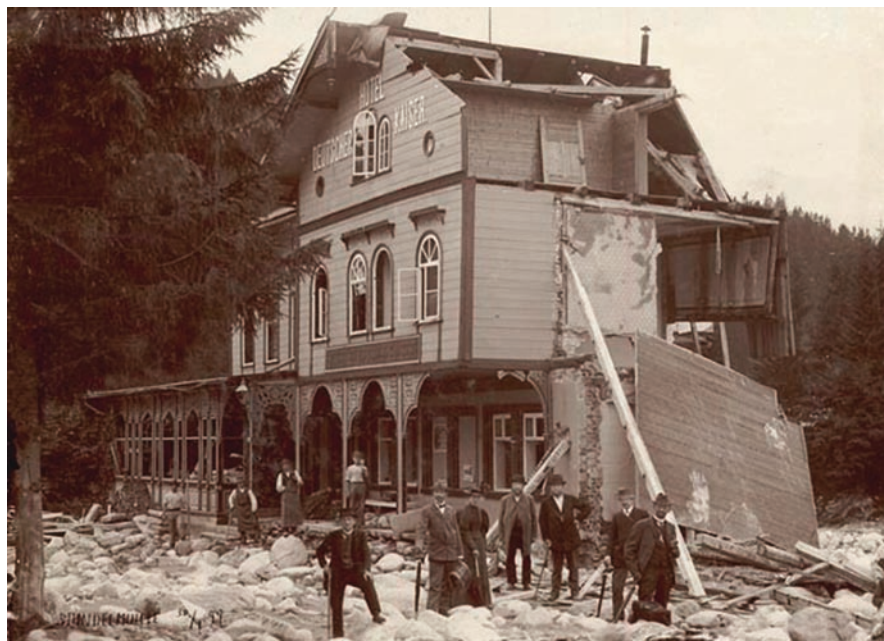
Fig. 18.2 Hotel Deutscher Kaiser in Špindlerův Mlýn (CZ) on 30 July 1897 (Photo F. Joffe – archives of P. Scheufler)

The disastrous flood with great damages (illustrated here with examples Figs. 18.2, 18.3, 18.4, 18.5) became an important impetus for a range of flood-control measures in all affected countries and regions. Numerous acts of law and flood-control regulations were issued and a decision was made on hydraulic engineering works that would contribute to the regulation of extreme discharge and to the mitigation of flood damages in the future.

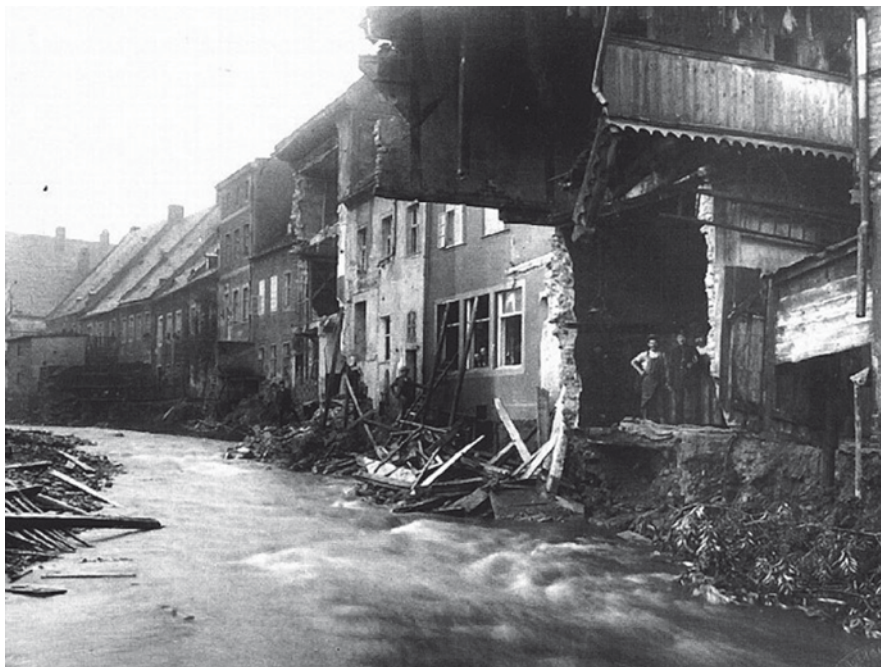
Fig. 18.3 Jedlica R. from the Bóbr/Bober R. basin and destroyed houses in Kowary (PL) after the flood in summer 1897 – according to Sawicki (2004)

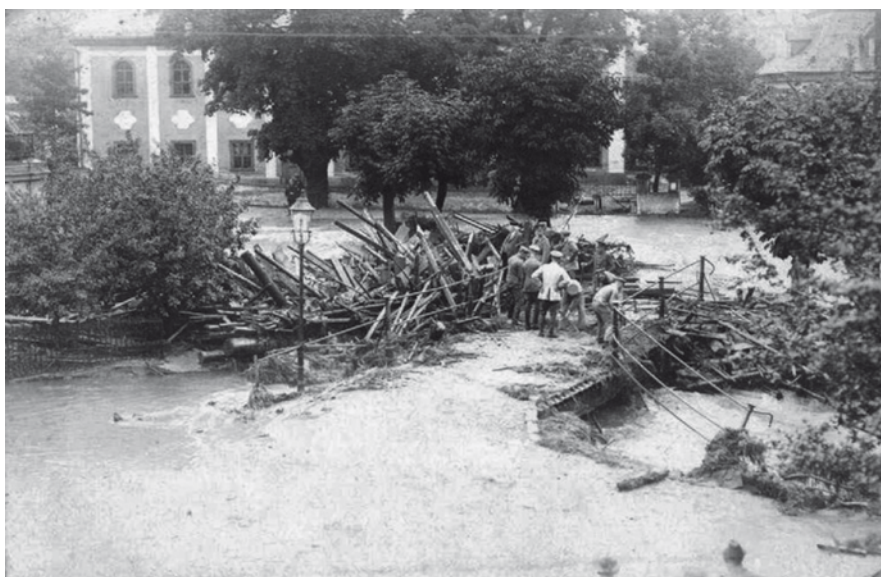
Fig. 18.4 Jelenia Góra-Sobieszów (PL): Woody depositions on the bridge after the flood 1897 blocked stream channel in the Bóbr/Bober R. basin (<http://wroclaw.hydral.com.pl>)
