Chapter 5

Assessment of bonding, delamination and interfaces

Jean-François Lataste and Patrice Rivard¹

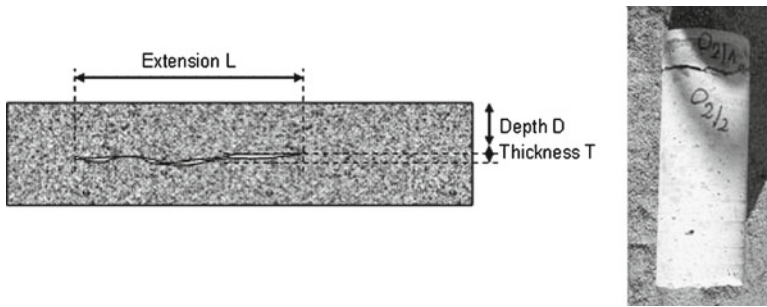
Fig. 5.1 Example of Delamination. Core (at the right) shows a typical delamination

Delamination is defined as cracks parallel to the surface. It is generally consecutive to a damage of concrete or to the structure: Fire, freeze/thaw, or rebar corrosion are classical causes of this kind of damage (Fig. 5.1). Unlike debonding, delamination is not located where there had been an interface yet. An example of common observed delamination is a splitting of the concrete at the rebar level. It stems from the expansion stress generated on the concrete by the corrosion products when the reinforcing steel is corroding. A hollow plane is then created in the concrete slab (Fig. 5.1).

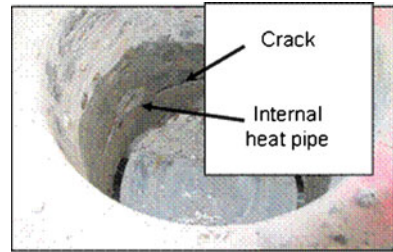
Fig. 5.2 Interface at heat pipe level in a concrete slab (P. Toussaint in Breysse et al. 2005)

Whole structures or a part of them can be investigated with regards to debonding or delamination. Multilayered debonding or delamination usually disturbs surfaces about some square decimeters to square meters. Interfaces can sit very close to the surface when they are associated with physico-chemical alterations coming from the surface (i.e. frost, fire ...). Other phenomena can generate interfaces deeper in concrete: limits between precast concrete and concrete cast on site, debonding around rebar or around internal heat pipe – Fig. 5.2 & Fig. 5.3).

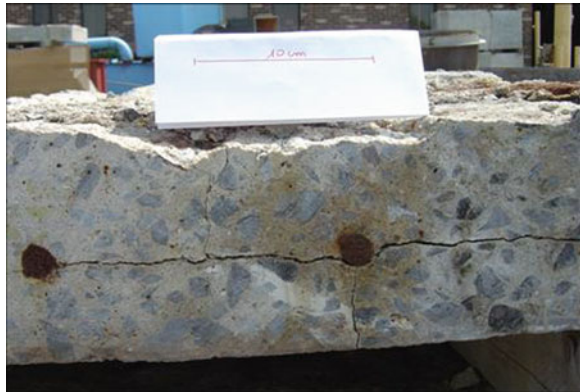
Fig. 5.3 Interface at the reinforcement level due to rebar corrosion (Naar, 2006)

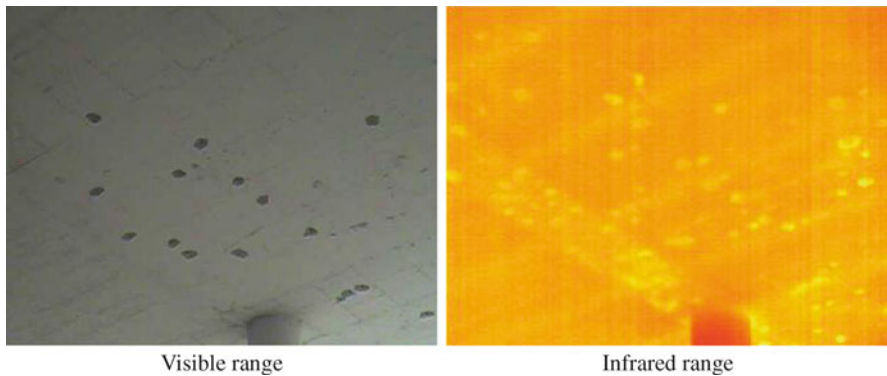
Fig. 5.5 Image of underface of an aqueduct (Gilles et al., 2007). Spalls pits are indicated by light shaded spots on the infrared image

is possible. Figure. 5.5 shows the detection and localization of spallings (few square centimeters) associated with the bad quality of spacers. These disorders are spread out spatially and the issue was only to locate altered zones within a 59m x 290m surface.

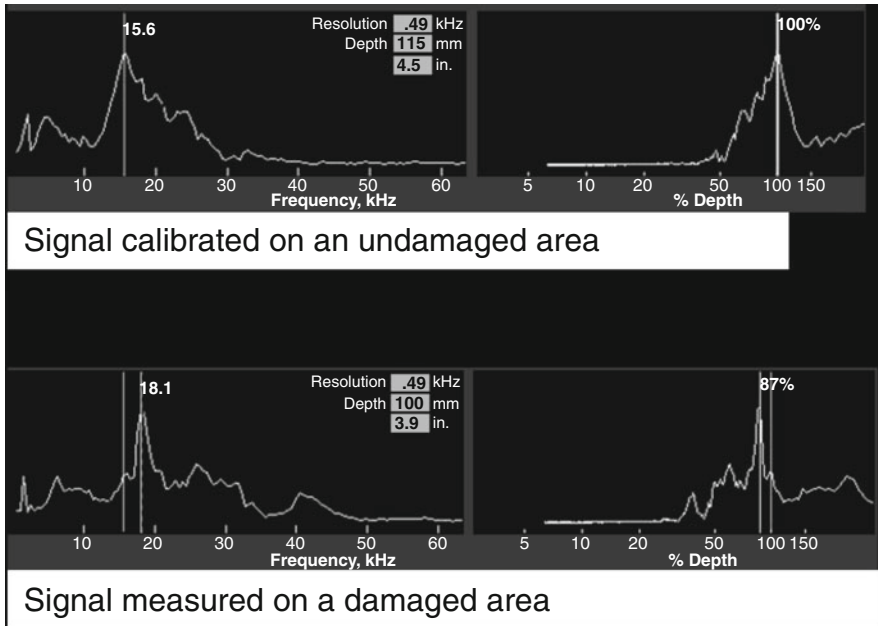
Fig. 5.6 Amplitude vs. frequency of signal for the impact echo technique. (This result allows detection of delamination within a concrete slab)

After having detected the lateral location of alteration, the next step is characterization of its position with depth. This description is based on the material properties and must be considered as an inverse problem to be solved. A first approach consists in comparing the results with regards to their location. With impact echo, for instance, the calibration is usually made on a reference zone (known to be sound), then, further results obtained elsewhere are compared with the reference signal (Fig. 5.6).

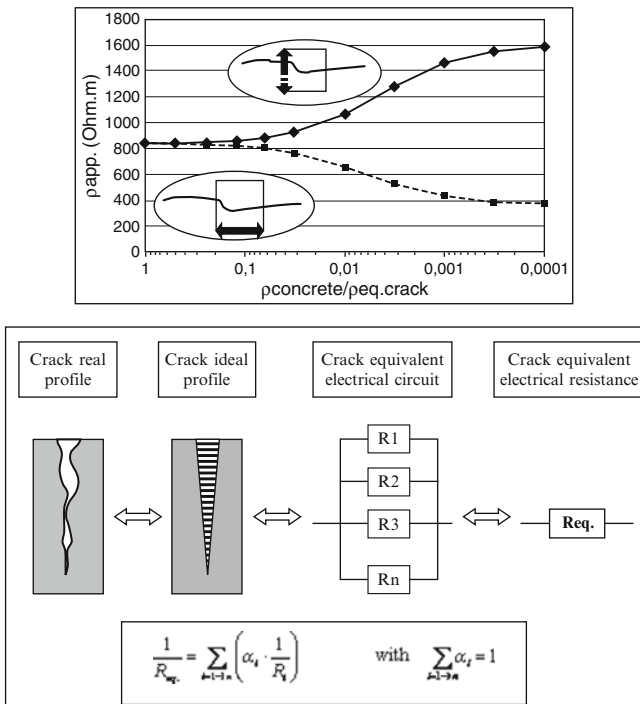
Fig. 5.7 Apparent resistivity depending on resistivity of the crack. Numerical results on resistive crack, and analogical model corresponding (Lataste et al. 2003(2))

an crack geometry can be expressed in term of electrical resistivity, stated as the “equivalent resistivity of the crack” (Fig. 5.7).

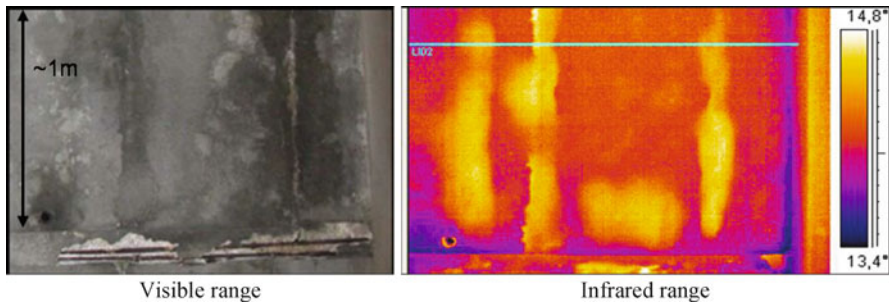
Fig. 5.8 Investigation of under face of a concrete slab of bridge using passive infrared thermography (Naar, 2005). Lighter shaded zones in the infrared image (right) (up to 14,4°C), correspond to spalled regions

One concern regarding this technique is that the thermal image shows only a surface view. The location of the subsurface flaw can only be localized in two dimensions, Fig. 5.8. The resolution of the measurements is related to the number of pixel per image, and depends on the distance between the camera and the investigated surface. The depth of the defect (i.e. the third dimension) requires locating the true position, which is unknown.

A second concern is the temperature contrasts: measurement conditions have to be convenient to flaw to be detected. It depends on the resolution and accuracy of scanner used and also on temperature contrasts. The structure must be warm enough to radiate heat in an enough wide band for the scanner to detect. (Alt 1996). The aim of any thermographic investigations is to detect hidden flaw (Fig. 5.8), and there is

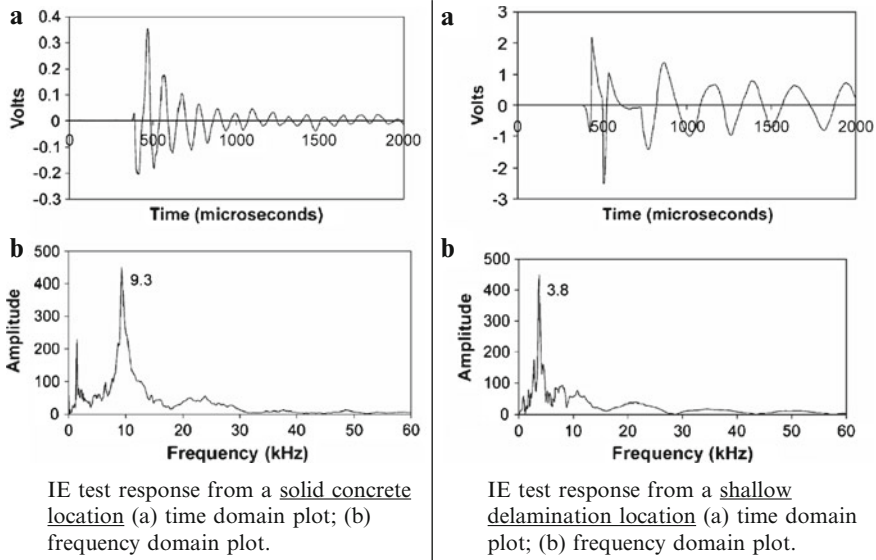
Fig. 5.10 Impact Echo response (Scott et al., 2003)

The method essentially is a spectral analysis of local vibration response of a structure. Fig. 5.10 presents recorded data (time domain plot) and processed results (frequency domain plot) allowing the interpretation: The technique is used either to detect delamination or debonding by comparison of measurements made on solid concrete, or to calculate the interface depth from the main frequency peak. In the second case, the accuracy of the technique is partly associated with the calibration of the compression wave velocity (the P-wave),

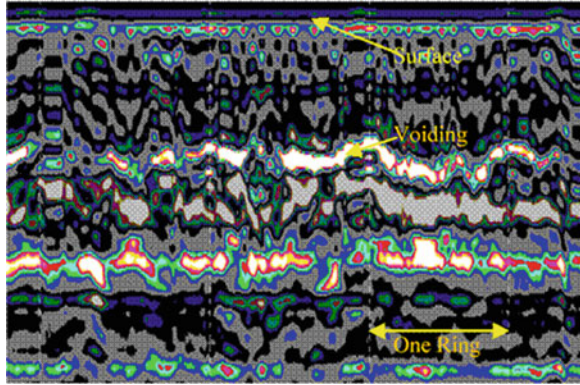
Fig. 5.13 Results of GPR investigation to characterize voids behind precast elements after grout injection (Davis *et al.*, 2005)

Radar is more adapted to detect large voids than delaminations (Fig. 5.13). Scott *et al.* (2003) tested radar on site (antenna of 1.5 and 2.4 GHz) and did not obtain consistent response to delamination. According to them, this technology may mature to allow delaminations to be detected. With a 1.5 GHz antenna adapted to concrete, the wavelength is about 6 cm, so the resolution is 3cm (about half the wavelength). Therefore, with this frequency, radar could detect delamination of few millimeters thick for strong electromagnetic properties contrast between concrete and the flaw. Radar could also detect delaminations and interfaces by their indirect effects on local properties when it is associated with a local moisture increase for instance. The concrete properties can be different close to the flaw, than further, modifying the electromagnetic wave propagation (in terms of attenuation or speed). The flaw can then be indirectly detected. An example has been given by Barnes *et al* (2008) where authors used reflected amplitude provided by radar to map moistened part of a bridge, in relation with corrosion induced delamination.

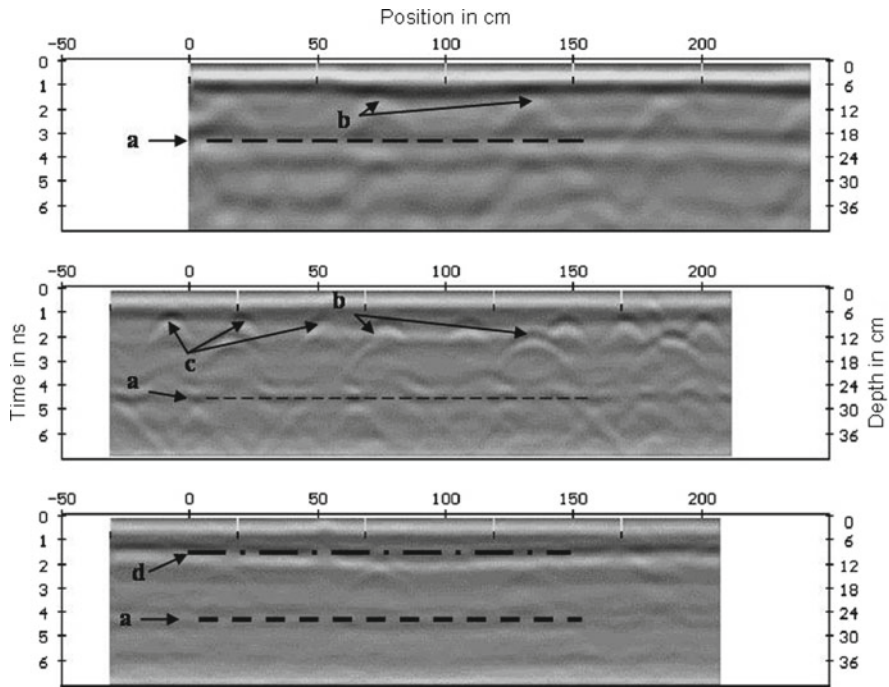
Fig. 5.14 Radargrams of a trace recorded with different antennas: **Top: 900 MHz antenna**, polarisation perpendicular to the rebars. The backside reflection (**a**) as well as the tendon ducts (**b**) are displayed; **Middle: 1.5 GHz antenna**, polarisation parallel to the rebars. The backside reflection (**a**), the tendon ducts (**b**) and rebars (**c**) are visible. **Bottom: 1.5 GHz antenna**, polarisation perpendicular to the rebars. Only the reflection from the delamination is visible (**d**)

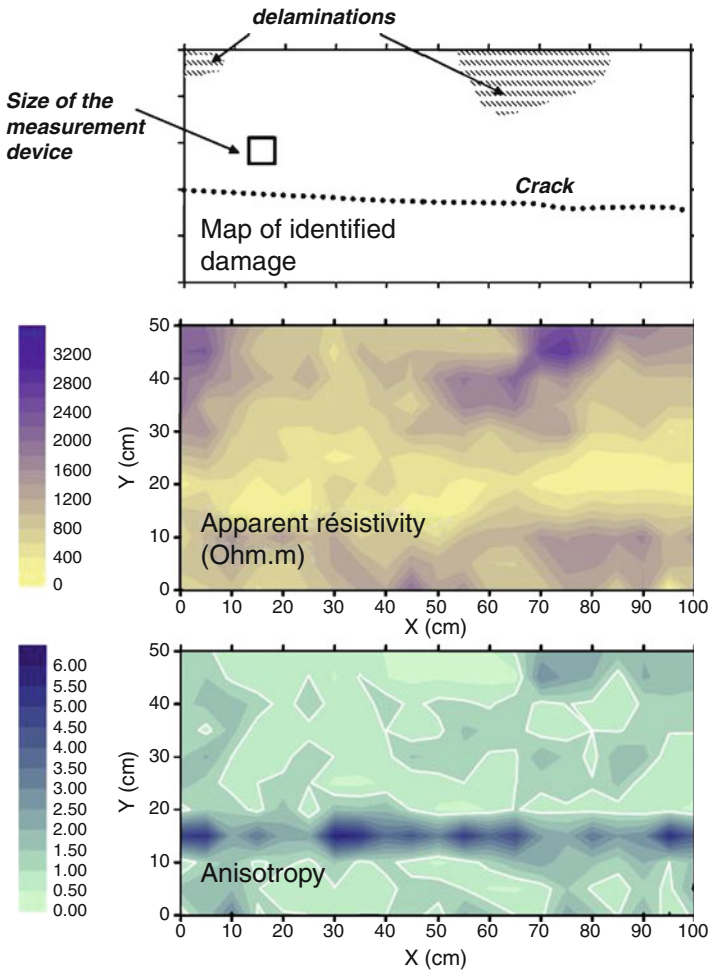
Fig. 5.16 Electrical resistivity used to detect and identify a delaminated zone in a concrete slab (Lataste *et al.* 2003(2))

The electrical resistivity increases due to an interface can be estimated according to the methodology developed in Lataste *et al.* (2003(1)) on edges influence on resistivity measurements. Indeed, if one considers delamination as a particular edge, this approach gives an optimistic range of the resistivity ability. An ideal delamination (perfect, without contact between wall filled with air, and infinitely laterally extended); and considering a noise level about 10% on resistivity measurements (classical mean values on site), can be detected and identified if:

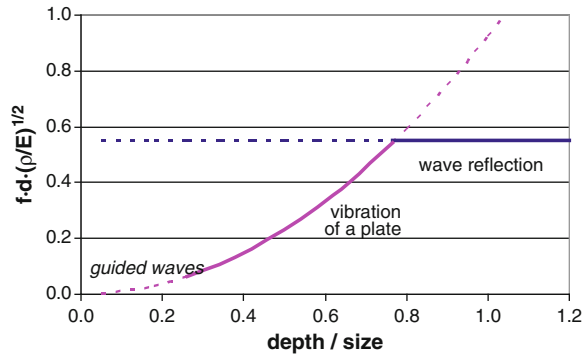
Fig. 5.17 Response of acoustical techniques in function of geometrical parameters of the fault

As a first tentative to separate the ranges pertaining to different principles the expected vibration frequencies of the impact echo (principle b) and of the vibrating plate (principle c) are plotted on the same graph (Fig. 5.17). To be more general, the frequency f is expressed in the dimensionless form: $f \cdot d / (E / \rho)^{1/2}$. This form is proportional to the depth of the delamination divided by a wavelength (d / λ), delaminated concrete cannot be considered as infinitely extended (relatively to wavelength). Indeed, in this case $V = (E / \rho)^{1/2}$; then $\lambda = (E/\rho)^{1/2} / f$. Where d is the depth of the interface, E is the Young modulus, ρ is the material density, f is the signal frequency, l is the wave length, and V is the wave velocity.

The shape of the defect is expressed by the ratio of the depth on the size (intended as the diameter of a delaminated disc) and the vibration frequency of the plate is a parabolic function of this ratio.

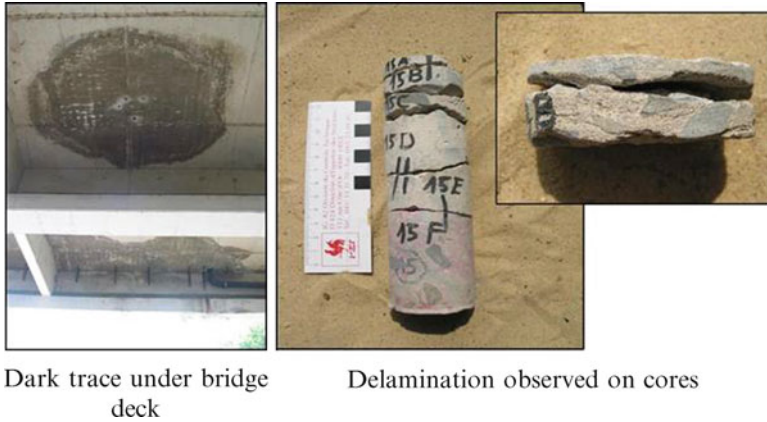
Dark trace under bridge deck

Delamination observed on cores

Fig. 5.18 Visual detection and destructive study of interfaces on Lommersweiler bridge, Belgium (Gilles, 2004)

The structure is a reinforced concrete bridge exhibiting delamination related to a highly altered concrete (Fig. 5.18). The characterization of damage was first performed by coring within a selected area. Ultrasonic pulse velocity carried out on

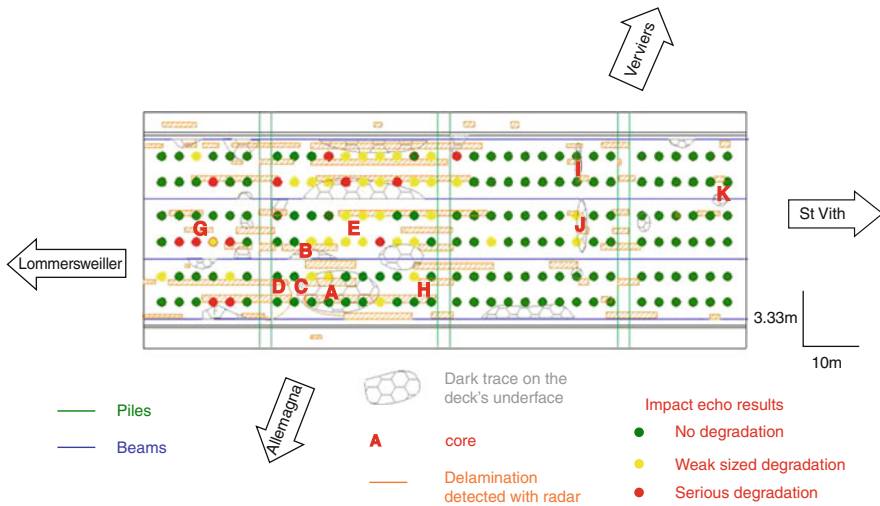
Fig. 5.19 Results of ND investigation on Lommersweiler bridge (Gilles 2004)

cores highlighted horizontal interfaces in the deck. The next step consisted in identifying the damaged zone on the whole structure.

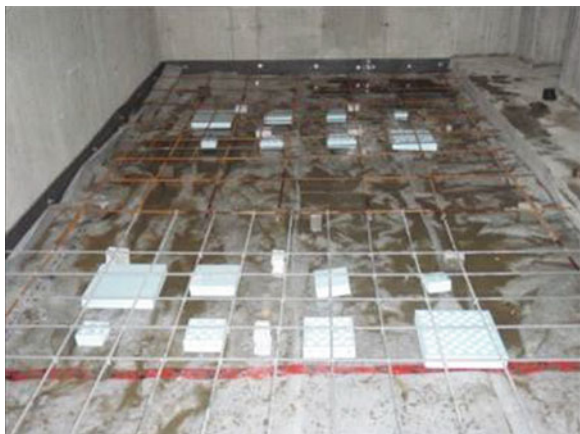
Fig. 5.20 Test site in Sherbrooke (Canada, Quebec)

In this group we could also list the University of Sherbrooke slab that has been presented above.

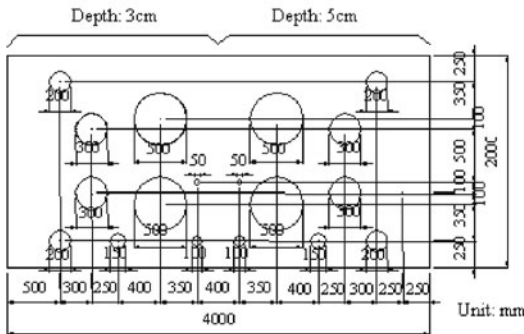
Location of defects inside the concrete specimen (Ex. defect depth: 3cm and 5cm)

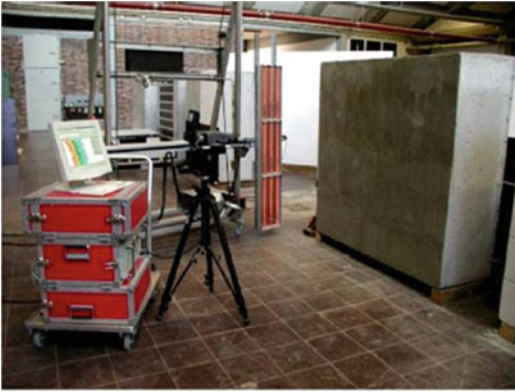
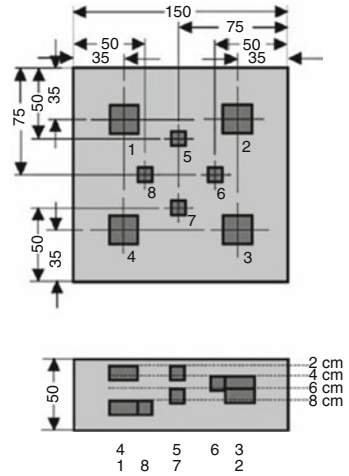
Fig. 5.22 Concrete test specimen with voids, general view (with apparatus for investigation with impulse thermography) and scheme (Maierhofer et al., 2002)

The investigation depth increases significantly with impulse thermography, and the inversion of results is possible. Maierhofer et al. (2002) combined experimental and numerical approaches considering voids up to 10 cm in depth. The heating time of 10 minutes allow recording temperature contrasts, which were variable during the cooling time (over 60 minutes). The value of heating time and the numerical approach enabled the determination of the depth (concrete cover) of the single defect.

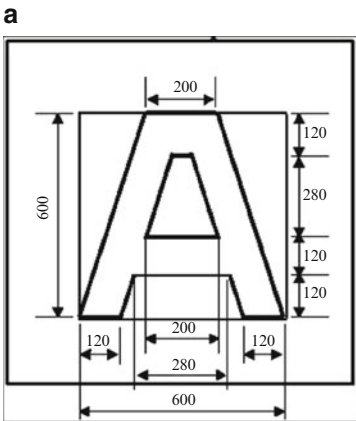
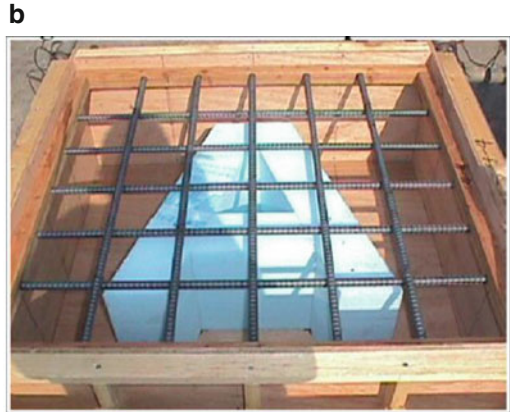
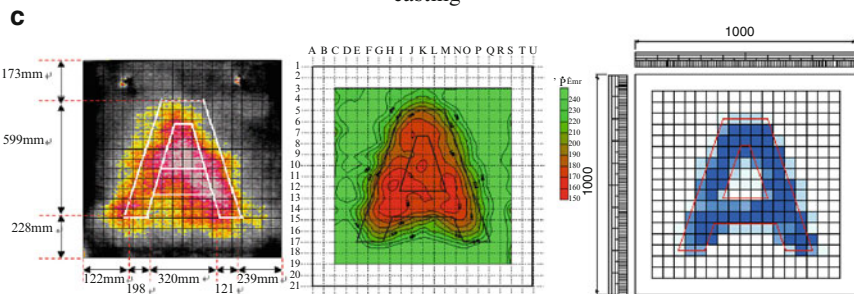
Detail of a specimen

Apperance of specimen before concrete casting

example of results respectively with thermography (combination of active and passive), ultrasonic, and impact echo

Fig. 5.23 Experimental element for NDT sensitivity study (Uomoto 2003)
