Chapter 6

Localization of grouting faults in post tensioned concrete structures

Martin Krause¹

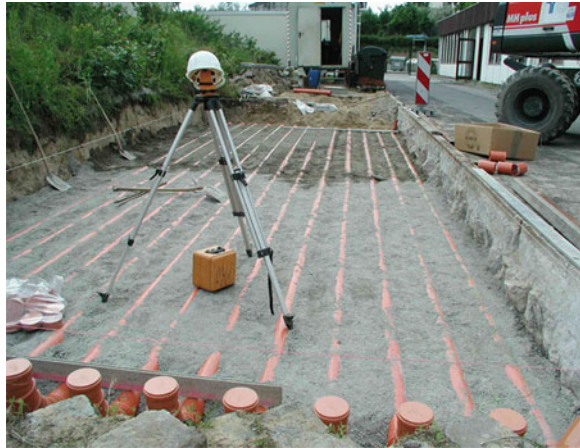
Fig. 6.2 Plastic tubes for Cobalt 60 source at Large Concrete Slab at BAM (after [Taffe et al, 2003])

The capability of Cobalt 60 sources is demonstrated at specimens constructed at BAM and LCPC Lyon (Figs. 6.1 to 6.3) ([Roennelle and Abraham, 2006], [Taffe and al, 2003], [Krause et al, 2008]).

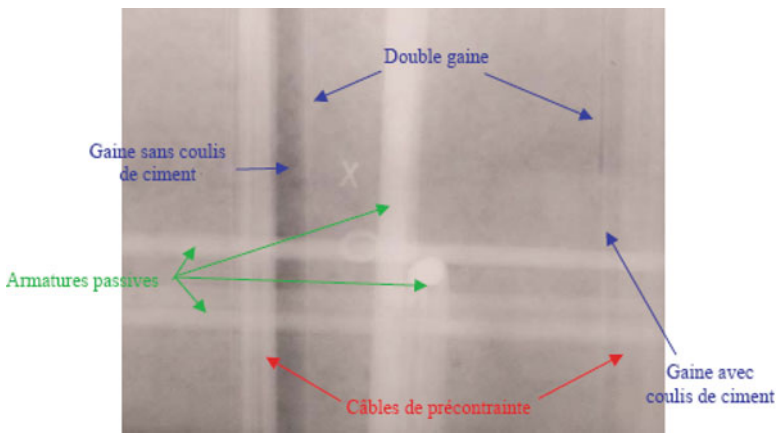
Fig. 6.3 Plan of tendon duct (diameter 40 mm) with artificial grouting faults (a) and verification with Gammagraphy with Cobalt 60 source (b); measured at Large Concrete Slab of BAM

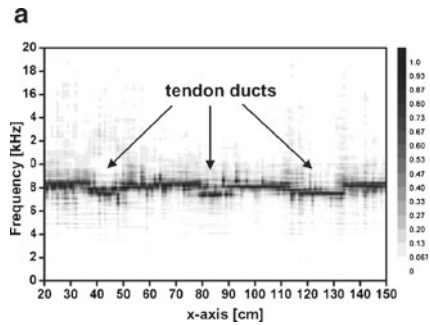
Fig. 6.13a) Impact echogram of concrete specimen with tendon ducts (grouted and ungrouted without strands)

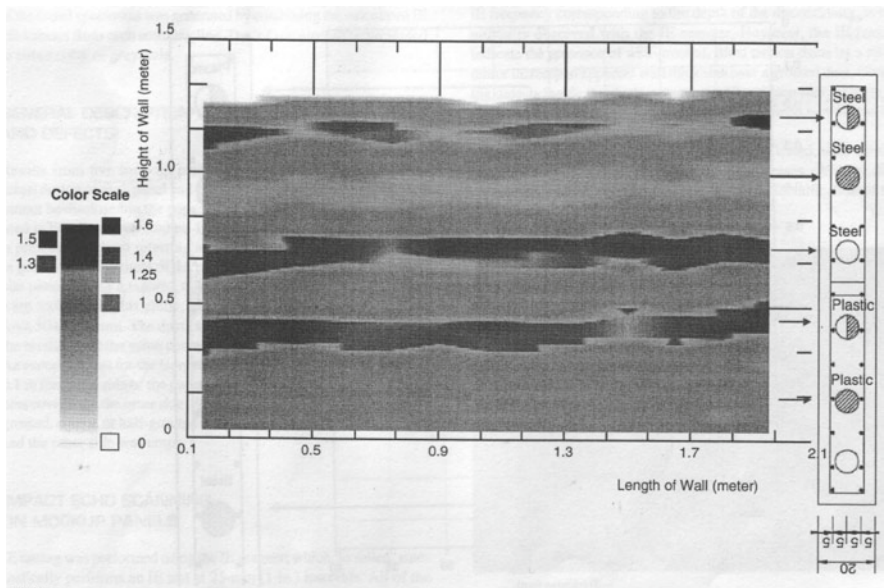
Fig. 6.15 Result of impact echo scanning experiment of a specimen with a thickness of 0.2 m. Visualisation of actual thickness indicated corresponding to the colour scale [Tinkey and Olson, 2008]

increase of apparent thickness over empty and partially grouted ducts [Tinkey and Olson, 2008]. These experiments were carried out on tendons without strands.

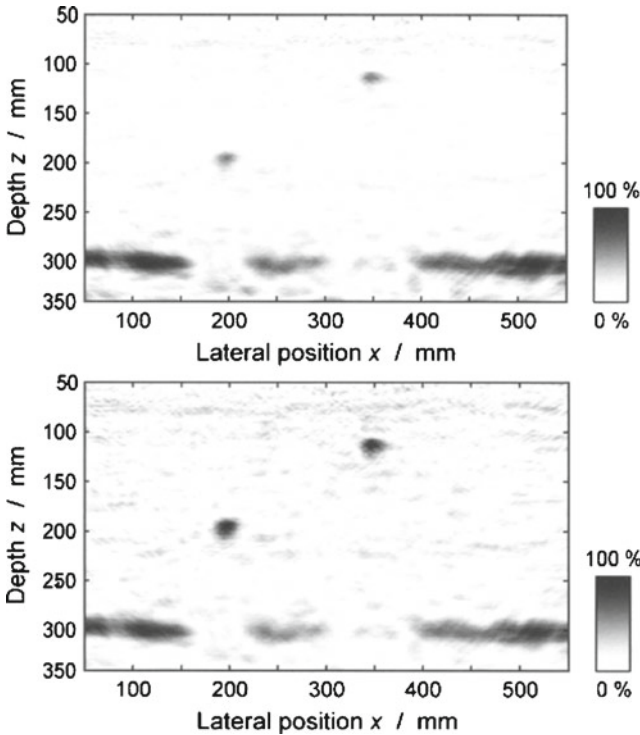
Fig. 6.23 SAFT reconstructions, depth corrected using reference reflectors (top) and noise statistics (down) [Schickert 2005]

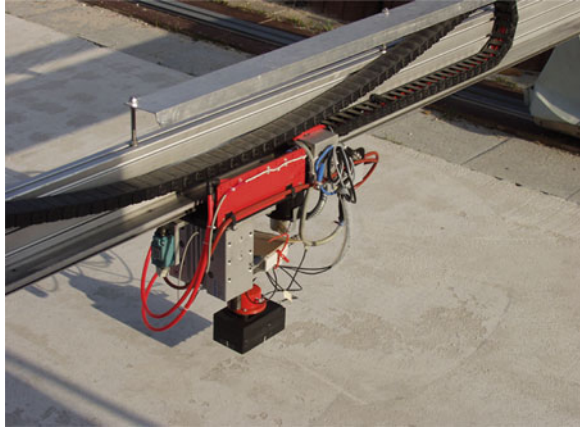
Fig. 6.24 2D scanner working with linear drives and a pneumatic system to press the point contact transducers without coupling agent (at BAM Berlin)

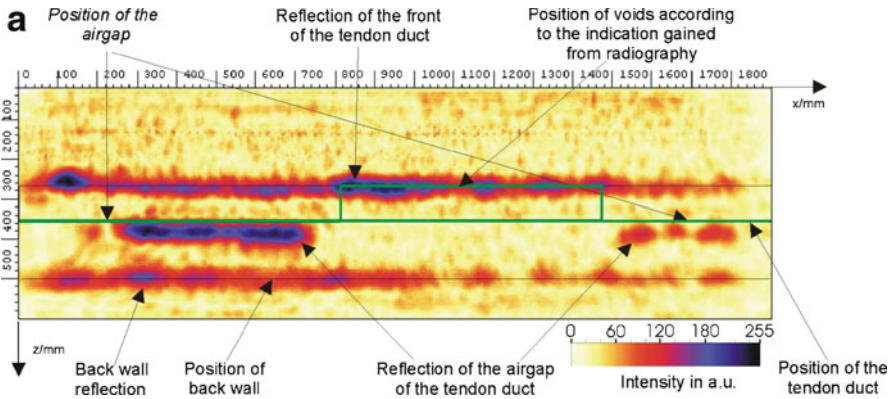
Fig. 6.27a) Result of imaging tendon duct in specimen FBS1 with shear waves: B-scan above the tendon duct from 3D-SAFT reconstruction. Polarization axis parallel x

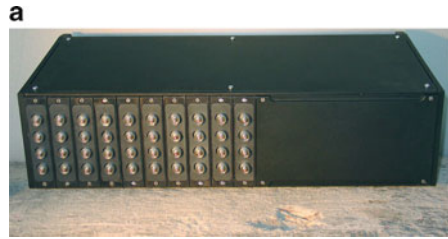
Fig. 6.33a) Linear array with dry contact transducers

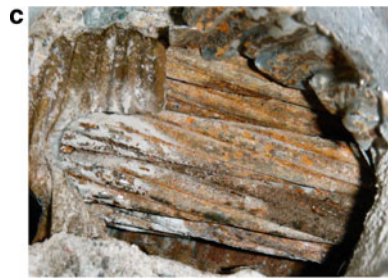
Fig. 6.35c) Verified grouting fault at duct 5

magnitude relative to duct 9 (top) is measured indicating bad grouting conditions. This was verified by opening duct 5 (photograph Fig. 6.35c)) and endoscopy. At other locations of the same bridge it was verified that a duct showing similar reflectivity as duct 9 was well grouted.

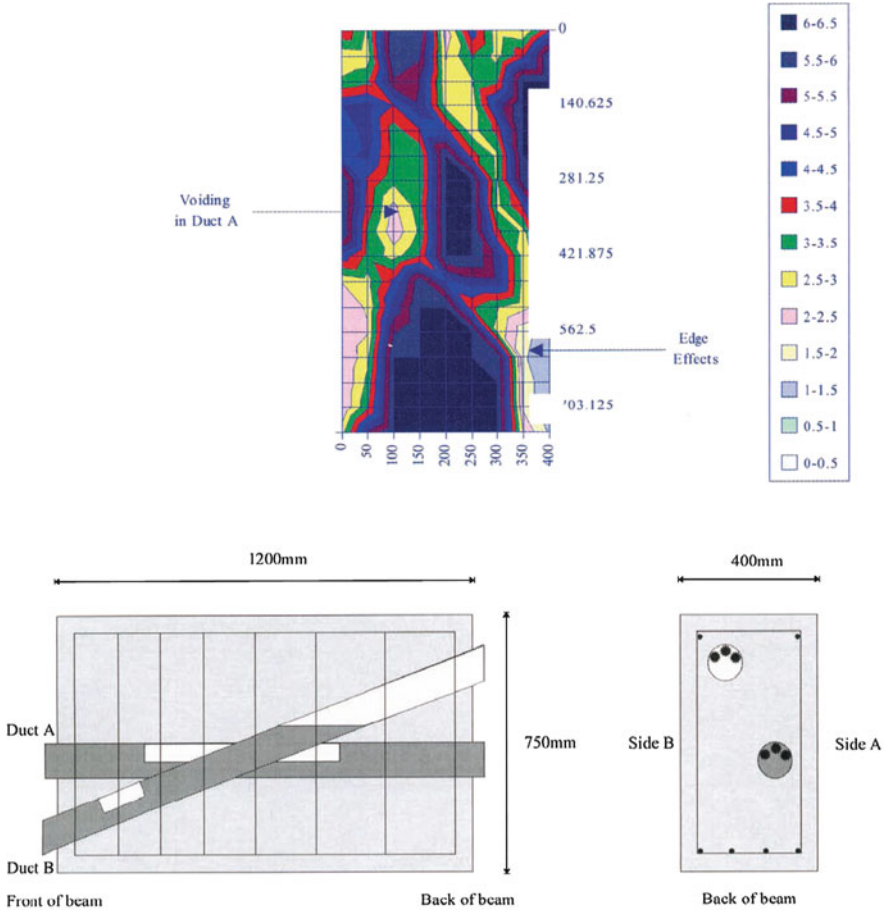
Note: The voids are formed by an air gap or a polystyrene box-out

As example the result of a beam from the second test is shown in Fig. 6.37. The beam is 750 mm deep (the plan of the beam is given at the lower part of Fig. 6.37). The measuring field is 400 mm wide with grid locations at 100 mm spacing - using all four faces. A voiding is indicated by a low velocity. Apparent areas of low velocity in the corners are due to the reduced number of transit paths producing unreliable results. It has to be noted that edge effects or errors occur when there is a corner or low density of transmission/reception rays in a model. Edge effects or errors are highlighted in the cross-sections. The method is somewhat time consuming and so should be used in conjunction with a simpler testing method, e.g. sonic impact-echo, which identifies areas of interest. The smaller the ducts to be investigated, the smaller the required distances between testing stations. This therefore significantly increases the testing time.
