Chapter 7

Ruptures of prestressing cables

Jean-Paul Balayssac, Carmen Andrade, Javier Sanchez Monteiro, and Horst Scheel¹

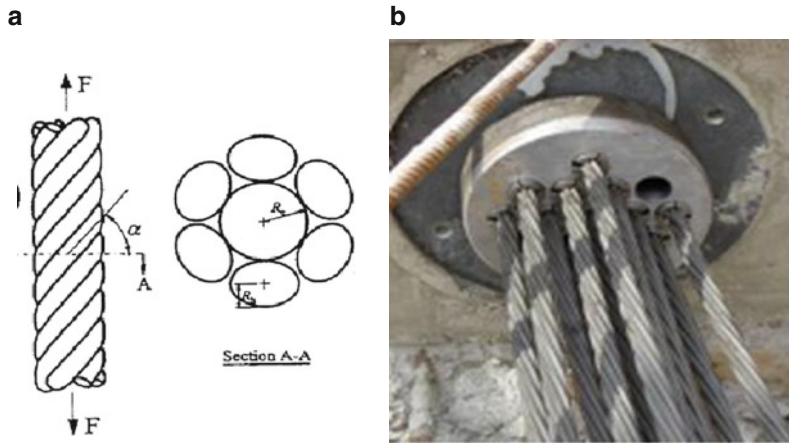
Fig. 7.1 Example of a strand (a) and of a cable (b) with many strands in the same duct at the anchorage

A strand is made up of several wires (usually seven), and the cable is generally made up several strands (Fig. 7.1). Usually the tendon is the whole system composed by both the cable and the duct filled by the grout.

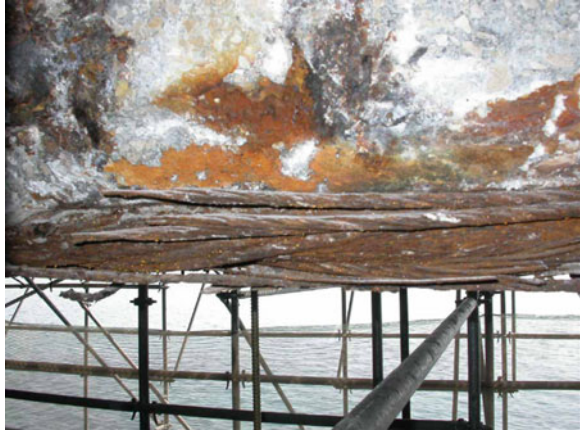
Fig. 7.2 An example of corrosion of strands with broken wires [Chauvin, 2005]

Many kinds of corrosion can occur, either a general corrosion or a pitting corrosion which leads to a stress corrosion cracking because the steel is under tension. Moreover, sometimes, corrosion reactions lead to the evolution of atomic hydrogen, which can be subsequently absorbed into the steel leading to hydrogen embrittlement of the steel and subsequently to failure. These damages can also be increased by creep and also by fatigue and fretting fatigue. See Fig. 7.2 for an example of corroded and broken wires.

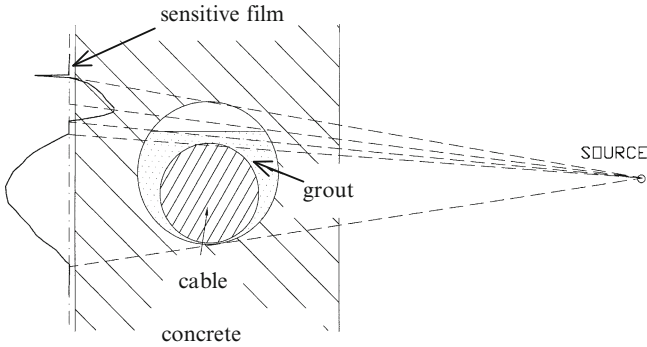
Fig. 7.3 Principle of radiography

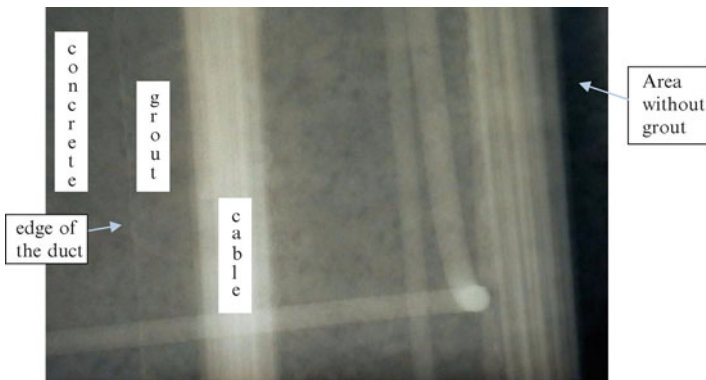
Fig. 7.4 Example of radiogram – sounding of an internal tendon [AFGC-B7, 2005]

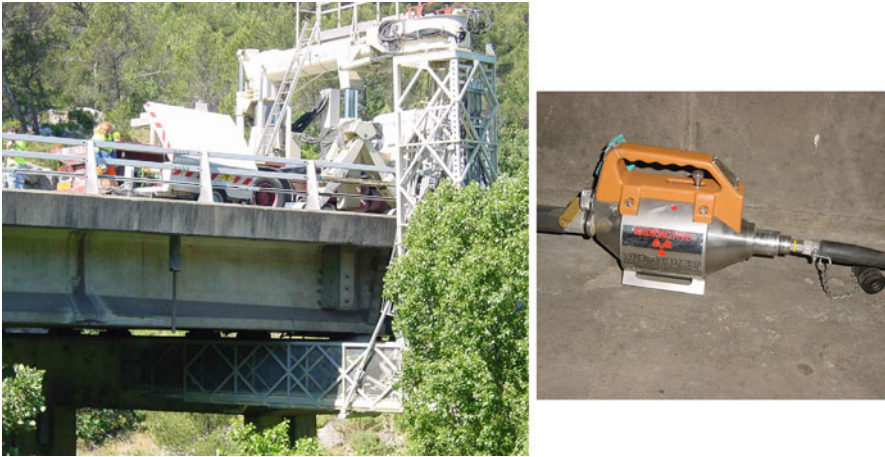
Fig. 7.5 Implementation of the technique at the intrados of a bridge deck (on the left) and a source of Iridium (on the right) – LPC France

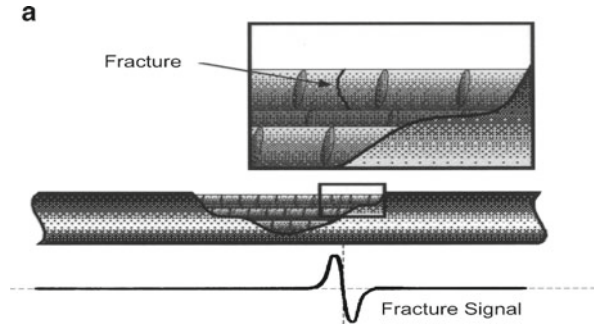
Fig. 7.6a Transverse component of the magnetic flux leakage measured above a cable fracture

the surrounding region. The transverse component of the magnetic flux density, measured at the concrete surface is shown in Fig. 7.6a. The characteristic leakage field allows detecting fractures of prestressing steel wires (Fig. 7.6b).

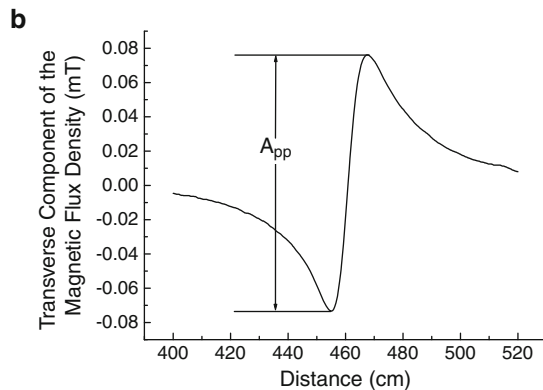
Fig. 7.6b The peak-peak-amplitude (A_{pp}) of the transverse component as a measure of the strength of the leakage field

order to avoid pre-magnetization because the magnetization will be destroyed partially and locally by the mechanical impacts during the construction process. This might produce signals similar to fracture signals. Demagnetization in the region of a fracture will disturb a fracture signal. The magnetized cable has a magnetic field similar to that of a bar magnet. Fractures of a single prestressing wire within a bundle of wires inside the metal sheathing are detectable by characteristic leakage fields. Figure 7.6b shows the transverse component (relative to the direction of the steel wires) of the remanent magnetic flux density measured at the concrete surface. At the location of a fracture the measurement curve of the transverse component shows a reversing polarity. The peak-peak-amplitude (A_{pp}) of the transverse component of the leakage field is used to measure the strength of a fracture signal (Fig. 7.6b).

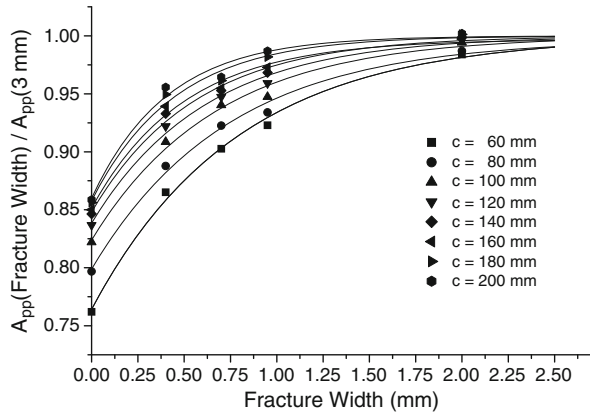
Fig. 7.7 Relative peak-peak-amplitude of the transverse component of the leakage field as a function of the fracture width for different concrete covers

- the fracture width (distance between the fracture surfaces): the peak-peak-amplitude increases when the fracture width increases (Fig. 7.7),
- the degree of prestressing: the peak-peak-amplitude increases or decreases depending on the type of steel with the increase of tensile stress,

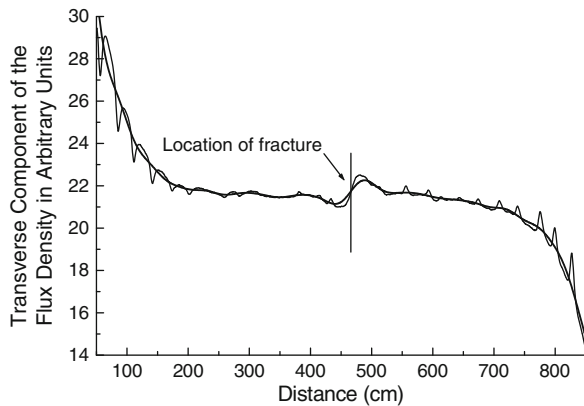
Fig. 7.8 Effect of FFT filter smoothing

the width of the fracture signal, e.g. nails, binding wires etc. Noise with a frequency greater than 5 Hz (depending on the measurement speed) is also filtered out. Fig. 7.8 shows a measurement curve and the resulting FFT filter smoothed curve: the measurement curve shows small peaks caused by the residual magnetization of stirrups. The smoothed curve shows the significant fracture signal while the stirrup peaks are filtered out.

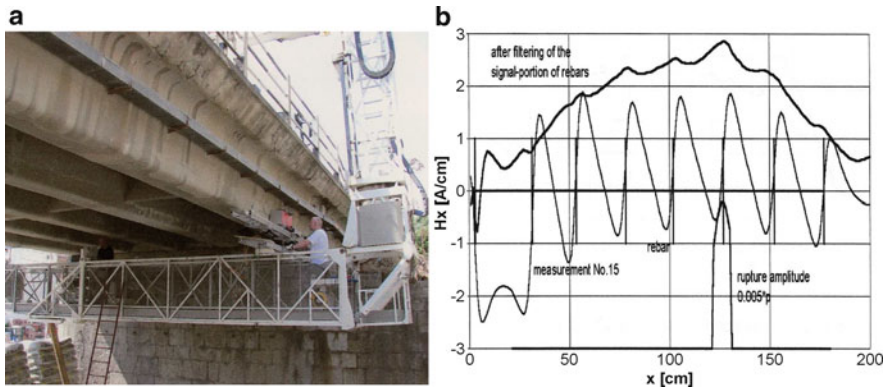
Fig. 7.9 Application of Magnetic Flux Leakage technique for a girder inspection

Fig. 7.9a presents an example of application on a girder of a highway bridge with one broken single-rod tendon (which was in a metallic duct) [Sawade, 2007]. Fig. 7.9b presents the different signals obtained along a 2 m long profile. First it is possible to see rough signal which was obtained by the measurement (called measurement N°15 on the picture). The rapid changes of the field amplitude are linked to influence of the reinforcing bars. After filtering the signal portion induced by the reinforcing bars (see 2.2.2.), the upper signal is obtained. The position of the rupture clearly appears on the diagram which plots the variation of the rupture signal at about 125 cm (bottom curve).

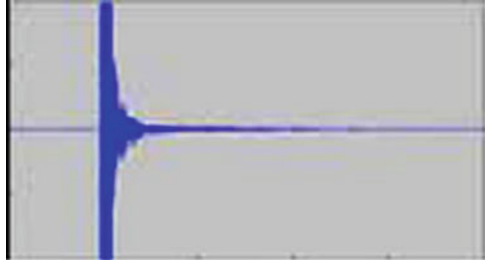
Fig. 7.10 Wire break: typical response of a sensor (time domain)

In the case of a prestressed cable the failure provides a sudden release of energy. This energy can be dissipated by means of acoustic waves through the surrounding media. The signals generated by wire failures must be detected above general noise levels and distinguished from events which are not of interest. By using several characteristics of the acoustic events including frequency spectrum it is possible to classify wire breaks and to reject environmental noise. Furthermore to assess the implication of each event on the structure it is important to locate the source of each emission. By analyzing the time taken by the energy wave caused by the failure as it travels through the concrete up to the different sensors, it is possible to calculate the location of the broken wire. Fig. 7.10 shows a typical acoustic response of wire

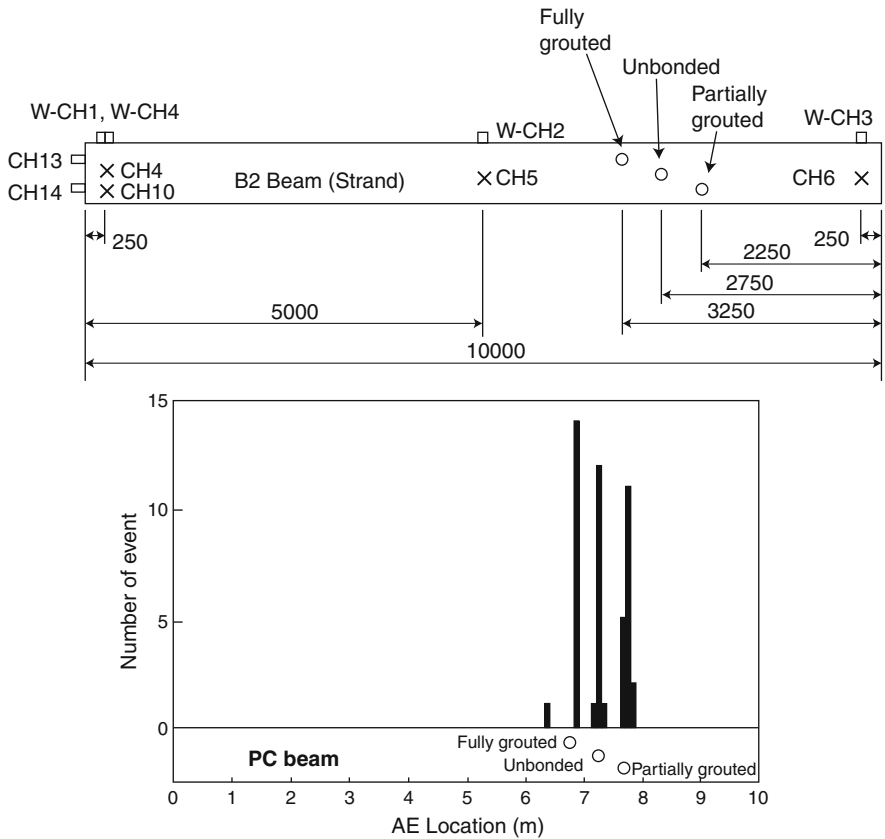
Fig. 7.12 Laboratory beam and location of wire failures (after [Yuyama et al, 2007])

It concerns a study realized both on laboratory beams and bridges in Japan [Yuyama et al, 2007]. AE is tested for the detection of wire failures due to corrosion. On a laboratory beam (Fig. 7.12) the failure is introduced by artificial corrosion (by applying anodic current) and the influence of grouting conditions is tested. The results show that the amplitude of the waves exceeds 100 dB and the source location is possible for the failures of unbonded and partially grouted cables. When the cable is fully grouted even if the detection is possible the location is not easily performed. Nevertheless, about 82% of the wire breaks are detected. Different resonant sensors

are tested (30 kHz, 60 kHz and 150 kHz) and it is clearly demonstrated that the sensitivity increases as the resonant frequency of the sensor decreases. The amplitudes detected by 30 kHz sensors are very high (over 100 dB), those by 60 kHz are high (60-100 dB) and those by 150 kHz are low (50-80 dB).

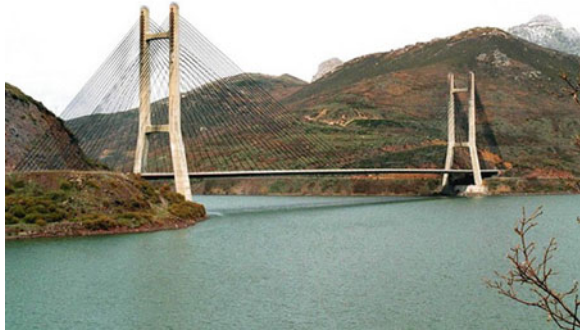
Fig. 7.13 “Barrios de Luna”
Bridge

The bridge was built in 1983; it is a cable-stayed bridge with three spans. The main span is 440 meter long (Fig. 7.13). The bridge is suspended by means of 228 tendons. Each cable has some high strength steel cable of 1.5 cm diameter. The measurement was made by removing the plastic duct and placing the corrosion rate meter directly on the grout (see Fig. 7.14c).

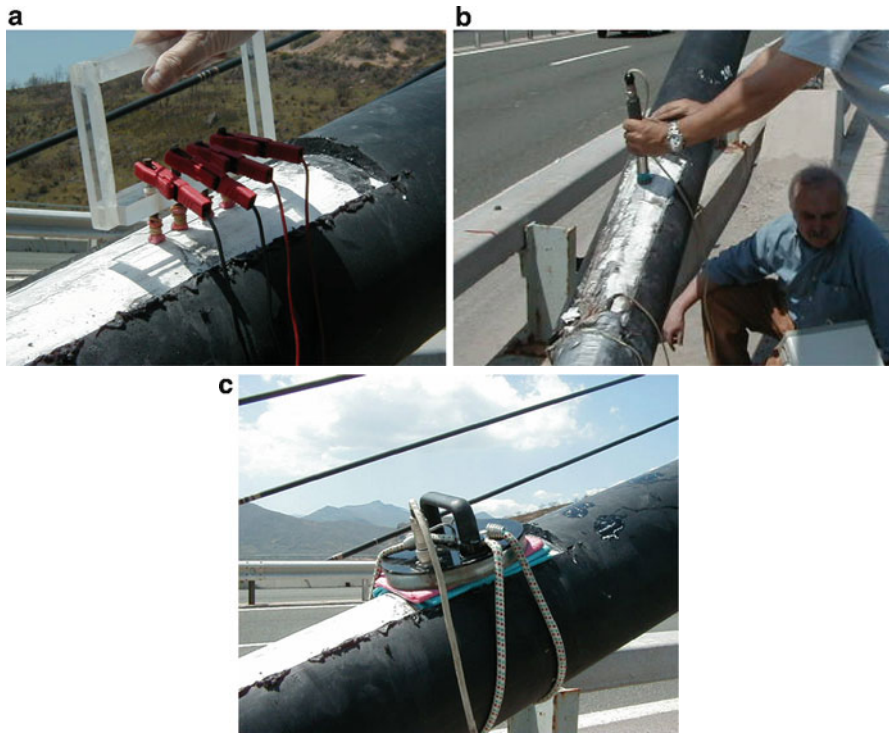
Fig. 7.14 Electrical and electrochemical measurements. (a) Resistivity measurement, (b) Electrochemical potential (c) Corrosion rate

Once it is achieved an electrical connectivity, it is possible to measure different electrical and electrochemical parameters: resistivity (Fig. 7.14a), potential (Fig. 7.14b) and corrosion rate (Fig. 7.14c). All these parameters let us to evaluate the service life of the bridge.

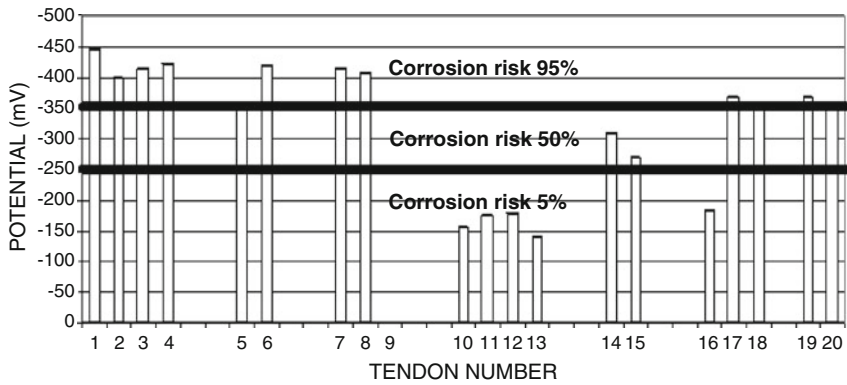
Fig. 7.15 Electrochemical potential of tendons

Fig. 7.15 and Fig. 7.16 show the potential and corrosion rate values of different tendons. Assuming that the process is that of generalized corrosion and that the standards used for the assessment of reinforced concrete corrosion are relevant in

A lot of values of the potential registered were in the range “moderate to high corrosion risk” (i.e. more than 50%) following ASTM standard. The potential readings are only qualitative and they serve to indicate that the tendons are in a situation where the corrosion is likely to grow.

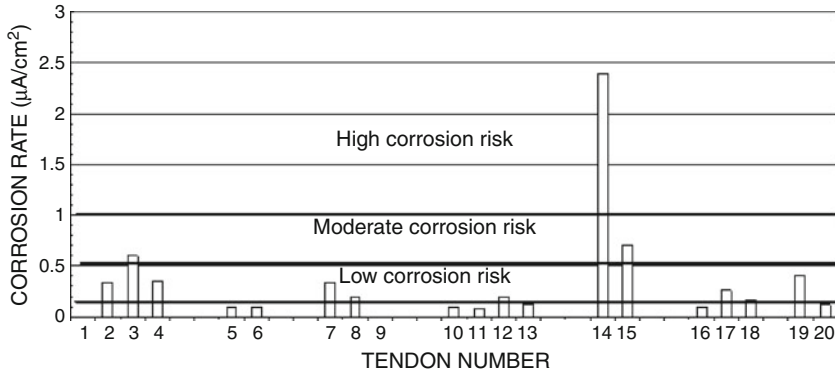
Fig. 7.16 Corrosion rate of tendons

The quantification is made through the corrosion rate (Fig. 7.16). It has been detected that several points show values of the corrosion rate higher than $0.1 \mu\text{A}/\text{cm}^2$.

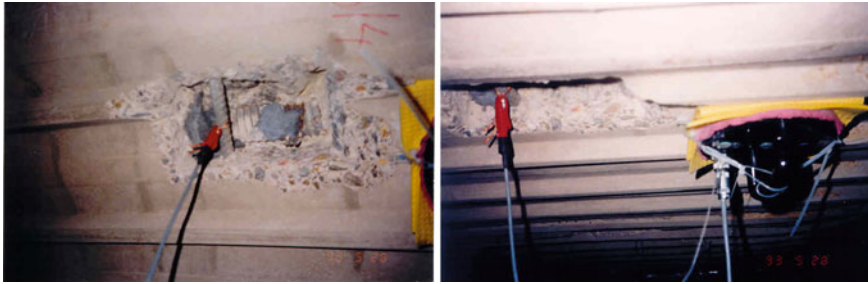
Fig. 7.17 Corrosion rate measured in-situ

the corrosion of the passive reinforcement was the same than that of the tendons. This was verified in one case, where direct measurement on the grout was made after performing a window in the duct (Fig. 7.17).

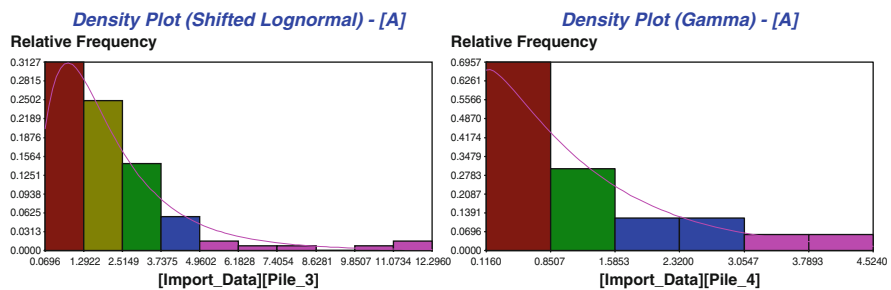
Fig. 7.18 Distributions of measured corrosion rate in sections 2 and 3

During eight years the bridge was continuously monitored in order to know the corrosion rate with the aid of a portable corrosion rate meter with modulated confinement of the current (Fig. 7.17). The results obtained in two sections of the deck are represented in the form of a distribution (Fig. 7.18).

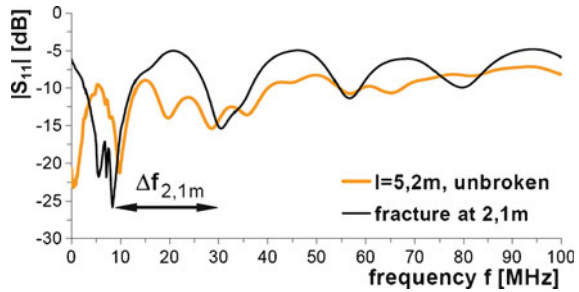
Fig. 7.20 Reflection parameter S_{11} versus frequency f for a 5.2 m long strand in air with and without fracture

with electromagnetic losses (concrete). An electromagnetic wave of variable frequency is coupled to the end of the cable (Fig. 7.19) and the reflection coefficient is S_{11} is scanned over a large spectrum (from low to high frequencies) by mean of a vector network analyser. The resonance frequencies are recorded and the spacing between two adjacent resonance frequencies Δf (Fig. 7.20) is inverse in proportion to the length l of the tendon, from the source and up to the fracture, and also depends on the dielectric permittivity of the surrounding material ϵ_r as it is shown in the following equation [Holst et al., 2008].

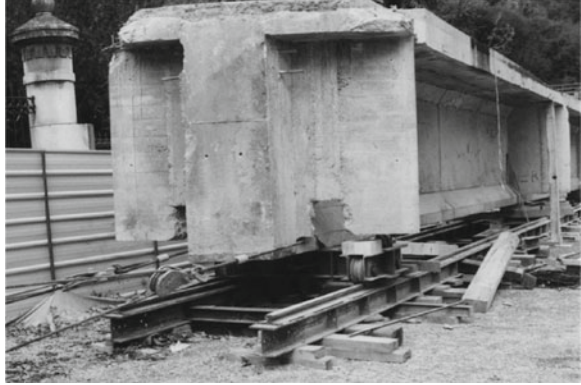
Fig. 7.21 Post-tensioned beam

During the bridge demolition, it was decided to perform an autopsy on the beam that presented the highest level of presumed defects in order to validate the acoustic monitoring. In addition, prior to the destruction of the beam (see Fig. 7.21), an experimental program to evaluate numerous non-destructive testing (NDT) methods was initiated. So, Impact Echo, radar and radiography were implemented on the areas where failures had been detected [Dérobert et al, 2002]. Radar was only used for the localization of tendons. For the radiographic investigation, a radiographic numerical system, called the digital phosphor system (DPS) which scans into a numerical film, has been used. Its major advantages, in comparison with the classical radiographic technique, consist of an accurate positioning of the prestressed ducts and tendons as well as of reinforcement bars. In the vicinity of the detected failures by

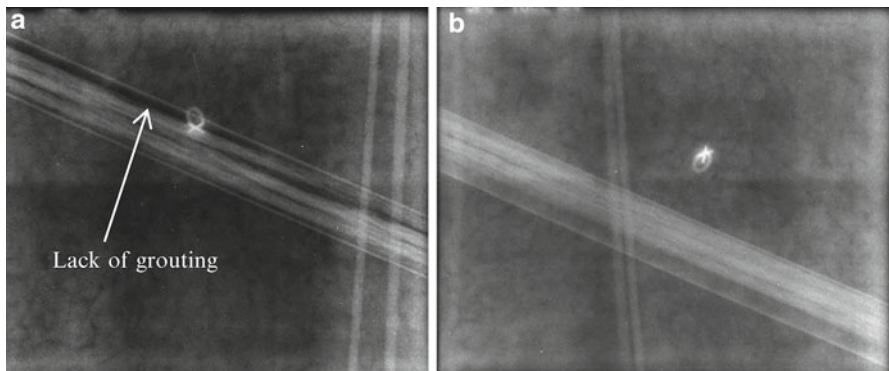
Fig. 7.22 Radiographic films

AE, two zones were investigated. The radiographic films obtained are presented on Fig. 7.22. The first zone revealed a complete lack of grouting (dark area above the cable) around the tendons (dark areas) in the central duct (Fig. 7.22a), while the second one indicates a correct injection in the central duct (Fig. 7.22b).

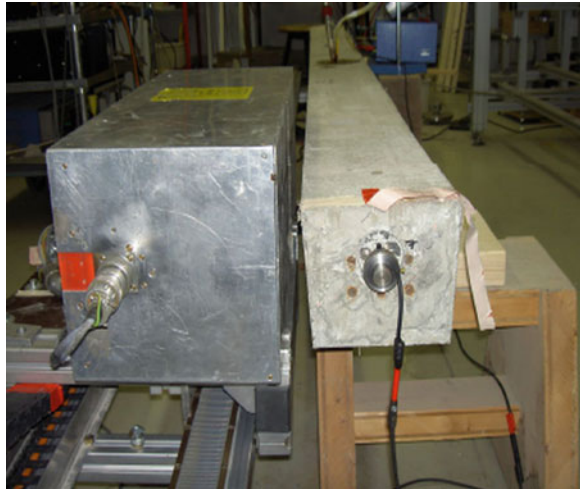
Fig. 7.23 Laboratory prestressed beam for detecting a wire failure by magnetic flux leakage method [Sawade, 2007]
