Conchalí Lagoon: Coastal Wetland Restoration Project (Chile)

Manuel Contreras, F. Fernando Novoa, and Juan Pablo Rubilar

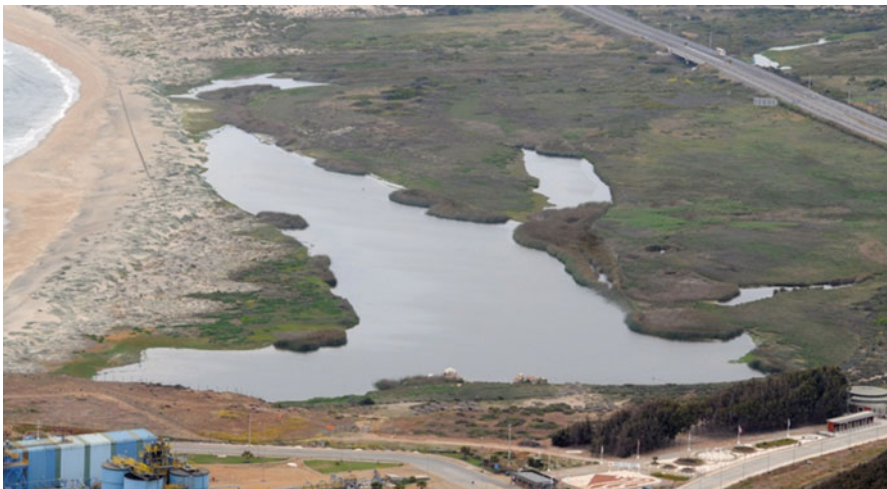
Fig. 1 Aerial view of Conchalí Lagoon (Photo Credit: © Centro de Ecología Aplicada, with permission)

Conchalí Lagoon (Fig. 1, $31^{\circ}52.757' S$; $71^{\circ}29.769' W$) is located 4 km north of the town of Los Vilos Region of Coquimbo (Wetlands International 2004). This water body is hydrologically dynamic since its catchment receives contributions of water and salt from both rivers and the sea. During periods of high recharge, the lake connects to the sea across a sand barrier and waters enter into a euryhaline condition. This contrasts with a lagoon characterized by freshwater during low recharge conditions and disconnected from the sea. This hydrodynamic connection/disconnection process generates inter- and intra-annual patterns in the aquatic flora and fauna, such as the dominance of aquatic plants and marine algae during periods of low and high salinity, respectively. As the sand barrier opens, fish migrate from the

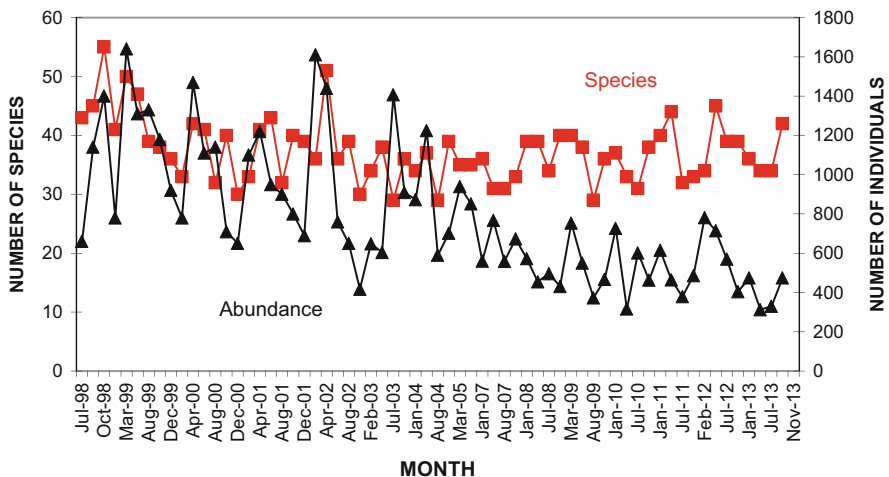
Fig. 3 Changes in the number of species and number of bird individuals observed during the period from July 1998 to November 2013 (Data: © Centro de Ecología Aplicada, with permission)

In the time series of avian abundance and richness, temporal changes can be observed with annual maxima abundance and richness occurring in autumn (March–April) and minima in summer (December–February; Fig. 3). In 2010, the lowest abundance was recorded (316 individuals), with an average richness of 37 species. However, in the last few years some aquatic species, e.g., *Fulica leucoptera*, *F. rufifrons*, *F. armillata*, *Anas platalea*, and *Egretta thula*, have

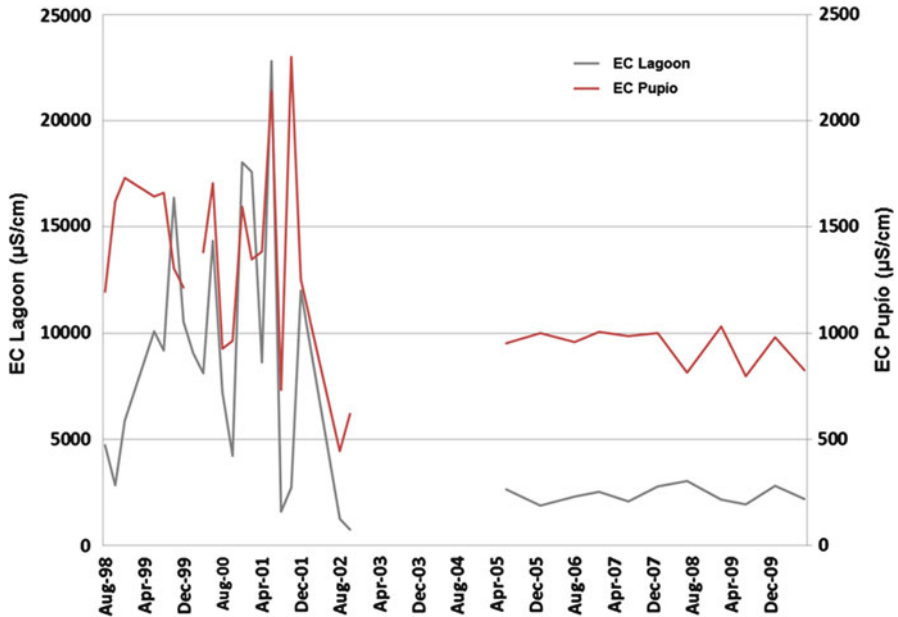
Fig. 5 Historical variation comparison of the EC ($\mu\text{S}/\text{cm}$) in Conchali Lagoon and Pupio tributary (Data: © Centro de Ecología Aplicada, with permission)

Between August 1998 and August 2002 monthly electrical conductivity (EC) values in the lagoon are highly variable but generally greater than $5,000 \mu\text{S}/\text{cm}$ with peaks reaching over $20,000 \mu\text{S}/\text{cm}$ (Fig. 5). The increase in EC and its variability is associated with events of marine water input breaking through the sand barrier separating the lagoon and the sea. These events caused changes in the internal dynamics of the lake, which can be seen in the seasonal variation and range in EC. The occurrence of maxima and minima during March and September, respectively, is related to the changes in contributions of freshwater and evaporation, which are factors that modify the lake's dilution capacity.

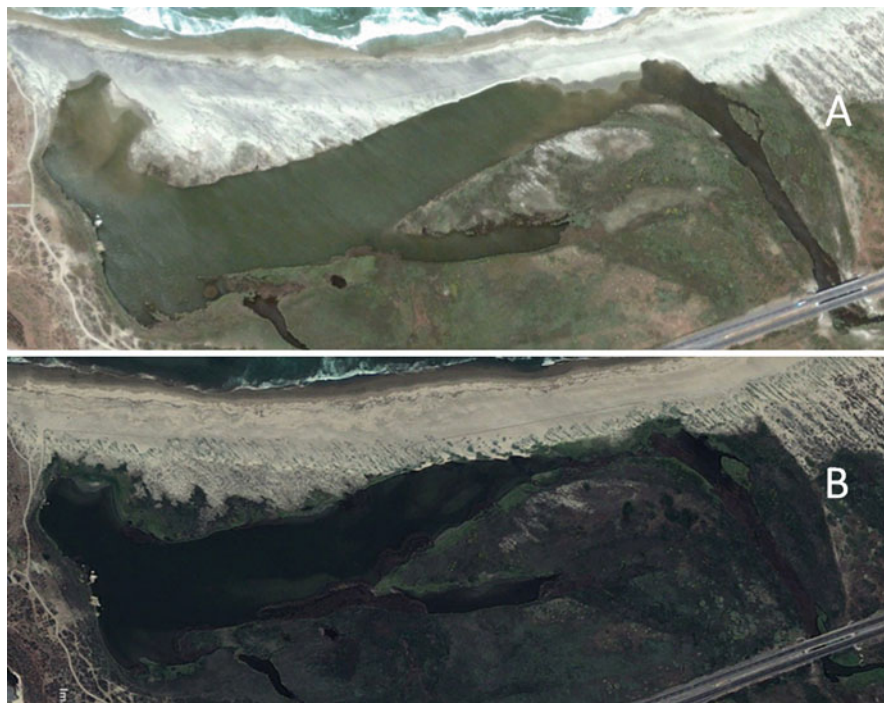
Fig. 6 Conchalí Lagoon in (a) December 2003 and (b) December 2012. Google earth V 7.1.2.2041. (July 13, 2007). Conchalí Lagoon, Chile. 31°52'45.30"S, 71°29'46.42"W, Eye alt 1.896 ft. DigitalGlobe 2003. <http://www.earth.google.com> (December 10, 2003). DigitalGlobe 2012. <http://www.earth.google.com> (December 5, 2012)

Through air-photo interpretation, classification, and area of Conchalí Lagoon's water, dune, reed bed, and pasture habitats were determined for 2003 and 2012 (Fig. 6). Between these two dates, reed beds ("junco") increased in extent

surrounding the lagoon, dunes were displaced toward the center of the lagoon, and a pasture formed upon the sand barrier which isolates the lagoon from the sea. The area of water decreased by 3.42 ha while reed beds increased by 2.07 ha (Table 1).
