J. Andrew G. Cooper
Orrin H. Pilkey *Editors*

Pitfalls of Shoreline Stabilization

Selected Case Studies

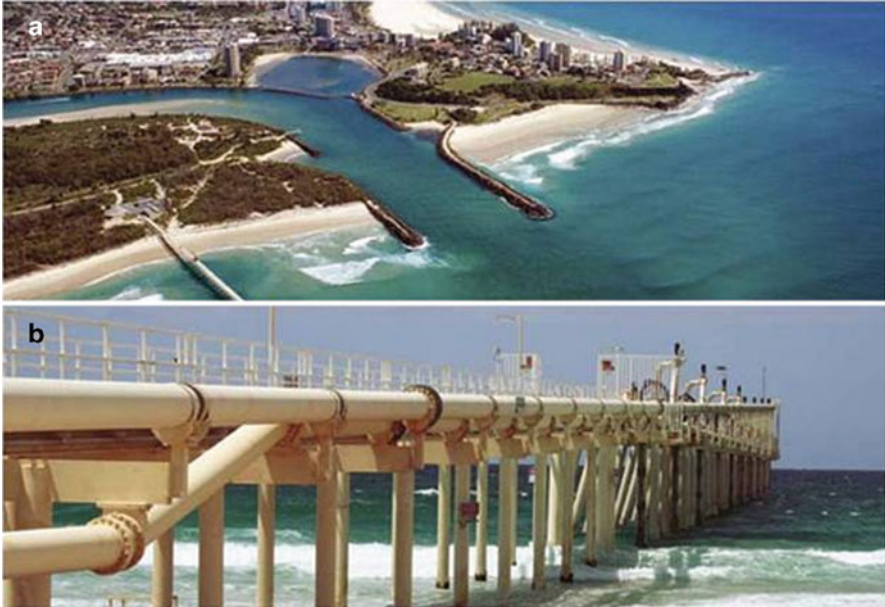
Fig. 1.4 Aerial view of the Tweed River entrance (a) showing the location of the training walls and sand pumping jetty (*bottom left*) and the jetty structure (b) (Source: NSW LPMA and QLD DERM 2011)

In 2001, a sand bypassing system was implemented to mimic the region's natural longshore transport process, delivering sand from Letitia Spit to the southern Gold Coast beaches while maintaining a safe entrance for navigation. The Tweed River Entrance Sand Bypassing Project (TRESBP) is a joint scheme between the New South Wales and Queensland Governments that is bound by the Tweed River Entrance Sand Bypassing Act 1998. A sand pumping jetty was built approximately 250 m south of the southern training wall (see Fig. 1.4) to collect and pump sand to four different outlets (Duranbah Beach, Snapper Rocks east and west, and Kirra Beach – see Fig. 1.1) (Boswood et al. 2001). Sand is pumped at a rate consistent with the net long-term average longshore transport rate of about 500,000 m³ per

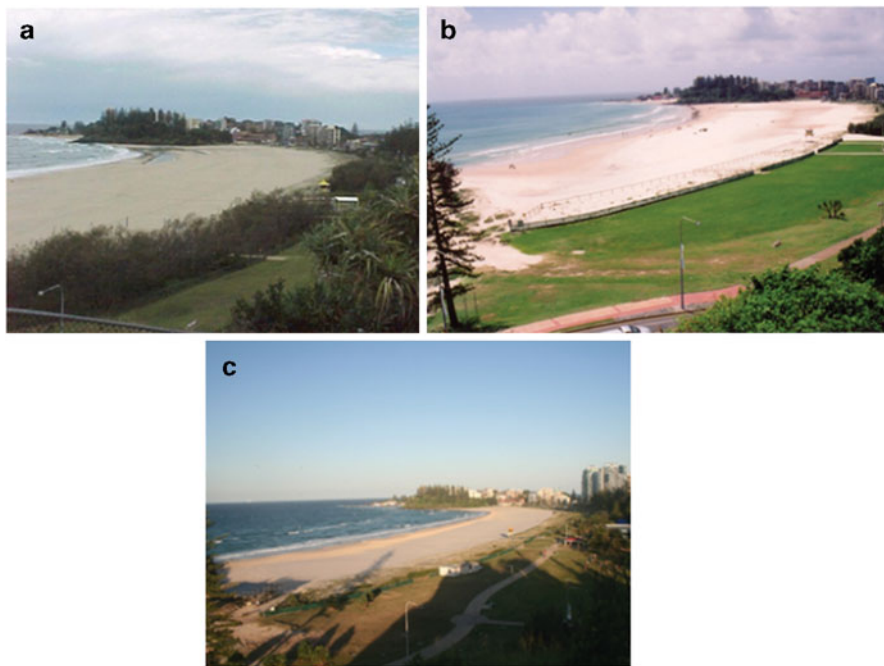
Fig 1.5 Beach widths of Coolangatta Beach at 6 months (19/11/2001) (a), 5 years (8/3/2006) (b) and 10 years (1/3/2011) (c) after sand pumping began (Source: NSW LPMA and QLD DERM 2011)

In 10 years since the opening of the TRESBP, the project has transported 7,580,293 m³ of sand from Letitia Spit to southern Gold Coast beaches (NSW LPMA and QLD DERM 2011). A deep and safe entrance for navigation has been retained and the severely eroded southern Gold Coast beaches have been widened. Although anticipated by operators, the initial operations brought community frustration over the effects on beach width from 'over'-pumping. Anticipated

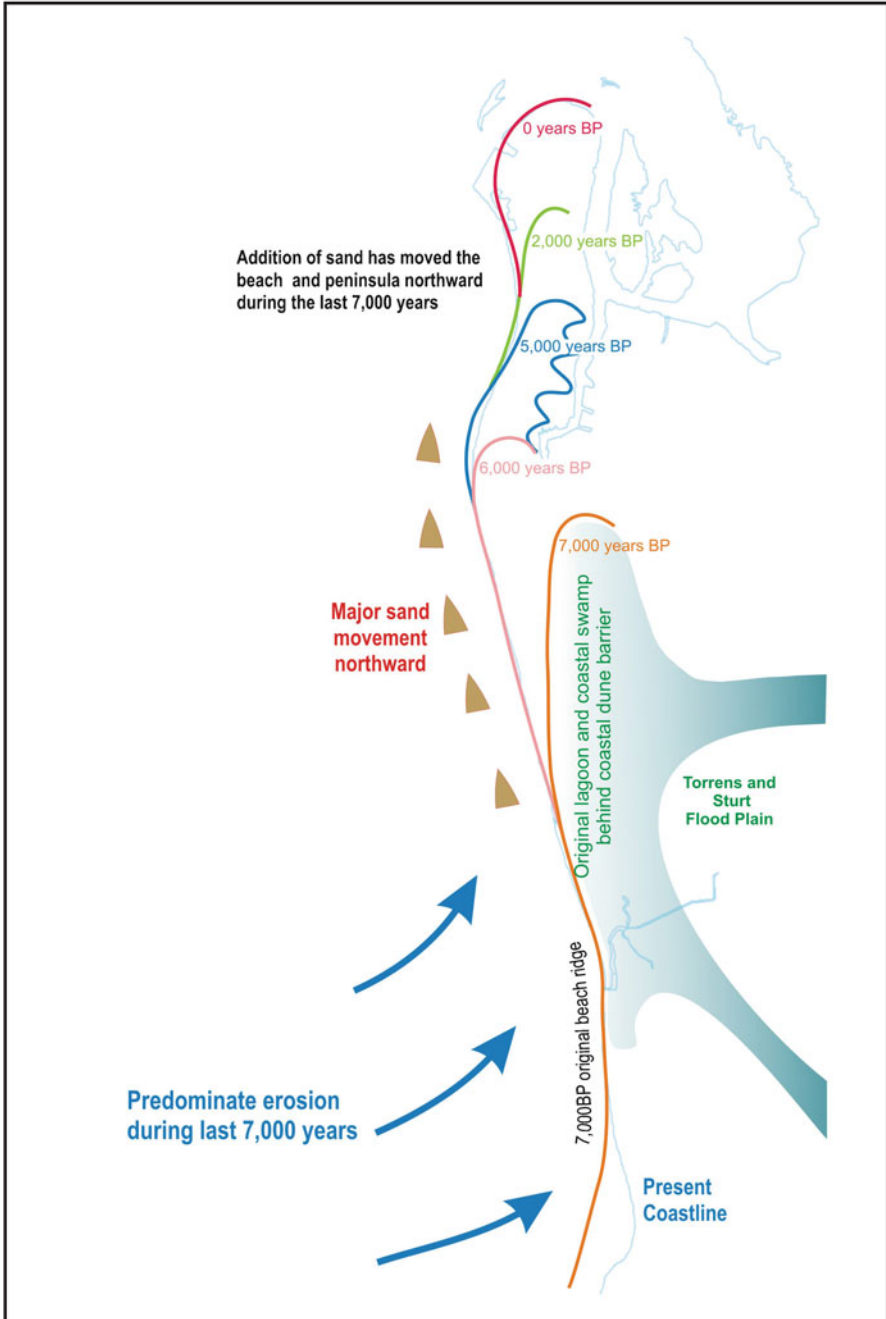
Fig. 2.2 Building out of the northern Adelaide coastline over the last 7,000 years (Based on Bowman and Harvey 1986; Source: DEH 2005)

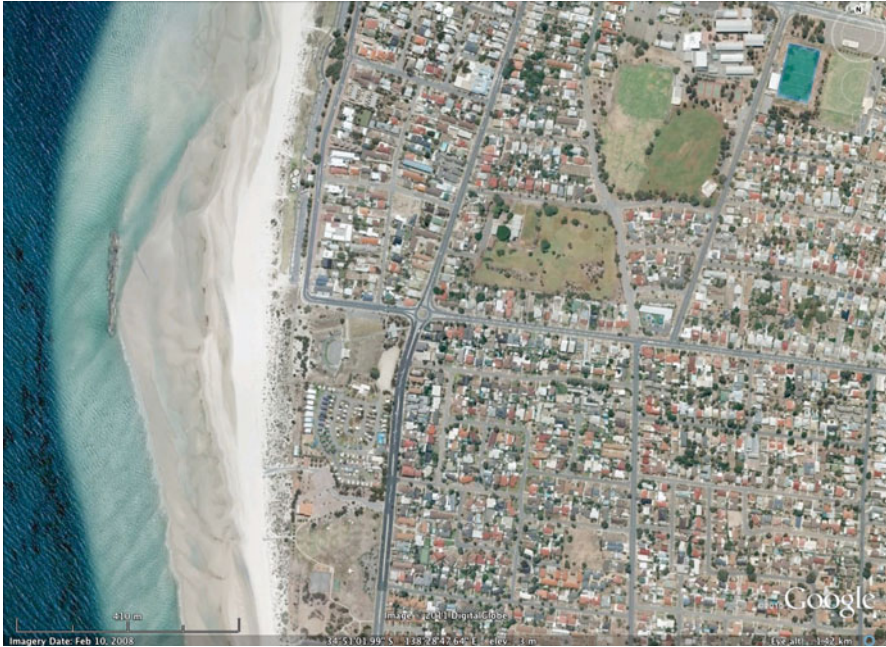
Fig. 2.9 The 200 m long detached Semaphore breakwater constructed in 2005. Note the sand accumulation between the shore and breakwater, and deep rip channel exiting north of the breakwater (Source: GoogleEarth.com)

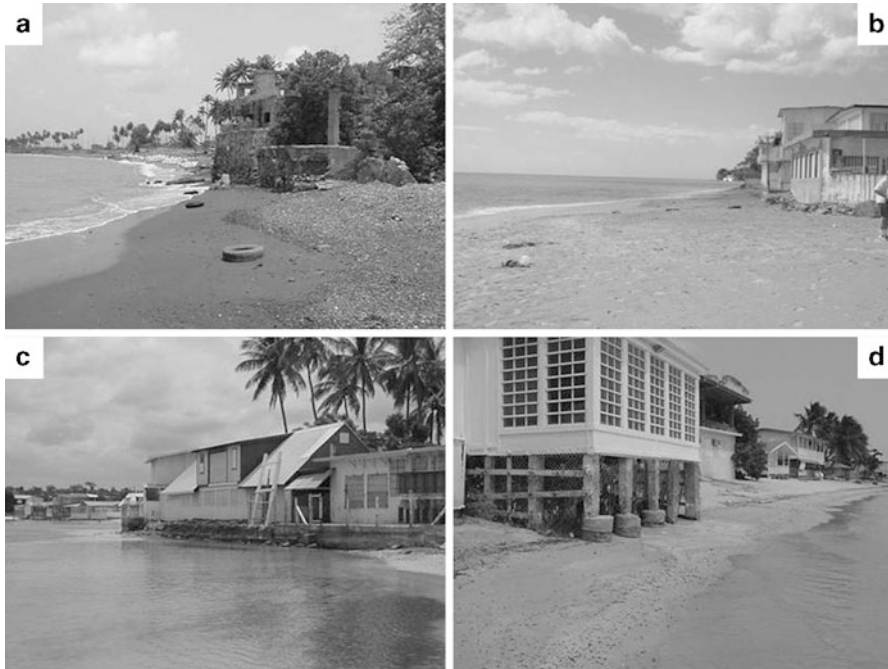
Fig. 4.2 Examples of shore-hardening structures destroyed, damaged, or threatened by shoreline retreat on the west coast of Puerto Rico (From Bush et al. 2009). (a) Damaged wall and beach loss west of Rincón in 2000. (b) Rip-rap and building-front bulkheads offer little protection from storm waves and contribute to beach narrowing at Punta de Boquerón in 2002. (c) Development at the immediate back of the beach (as in all of these examples) near Punta Guaniquilla (2000) contributed to total beach loss. (d) Dense along-shore development at El Combate (2000) resulted in a variety of small, inefficient walls, bulkheads, short groins, and frontal reinforcement of buildings that cut off sediment supply and resulted in beach narrowing

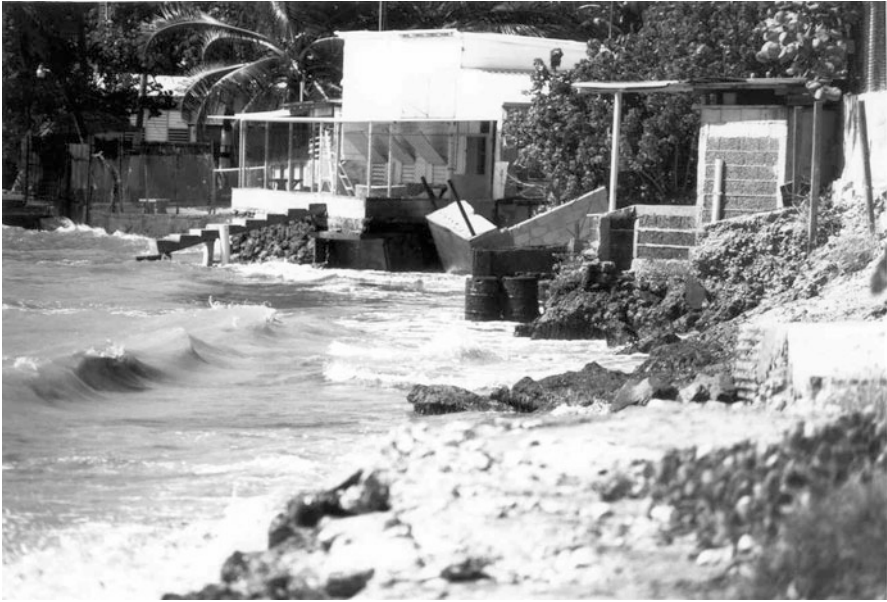
Fig. 4.3 No beach remains in front of these damaged buildings and collapsed portion of small seawalls in front of houses along Route 2 near Balneario El Tuque. The offsets of the closely spaced buildings and hodge-podge structures also have the effect of a groin field (From Bush et al. 2009)

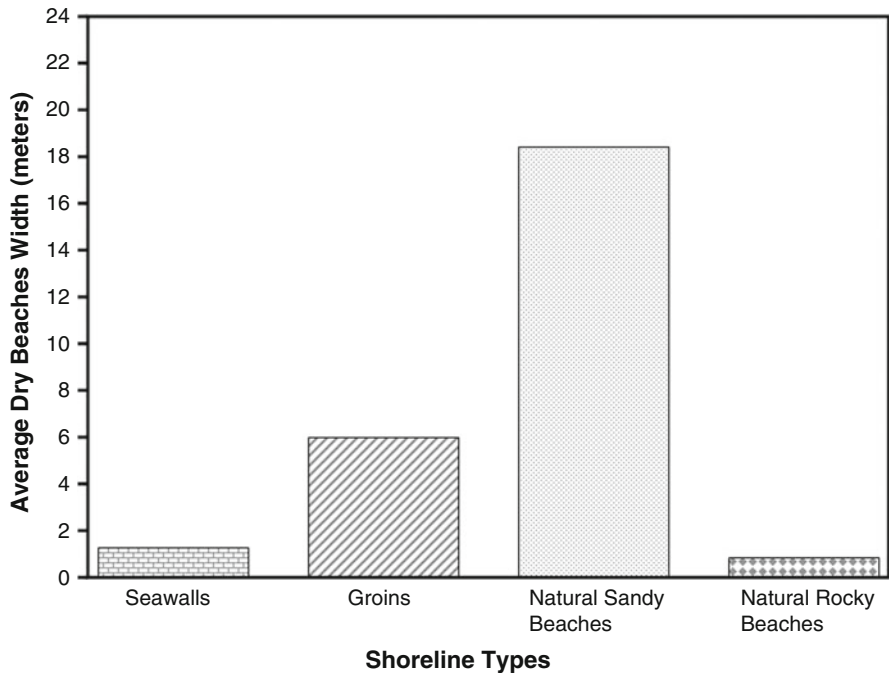
Fig. 4.4 Dry beach widths versus shoreline type along the San Juan metropolitan shoreline (From Bush et al. 2009). The approximately 45-km reach of shoreline stretches from Punta Boca Juana in the west to Punta Uvero in the east. Dry beach width is taken as an indicator of beaches having recreational value as well as providing some protection from average storm waves. Some of these data were presented in Pilkey and Wright (1988, their Fig. 4.6)

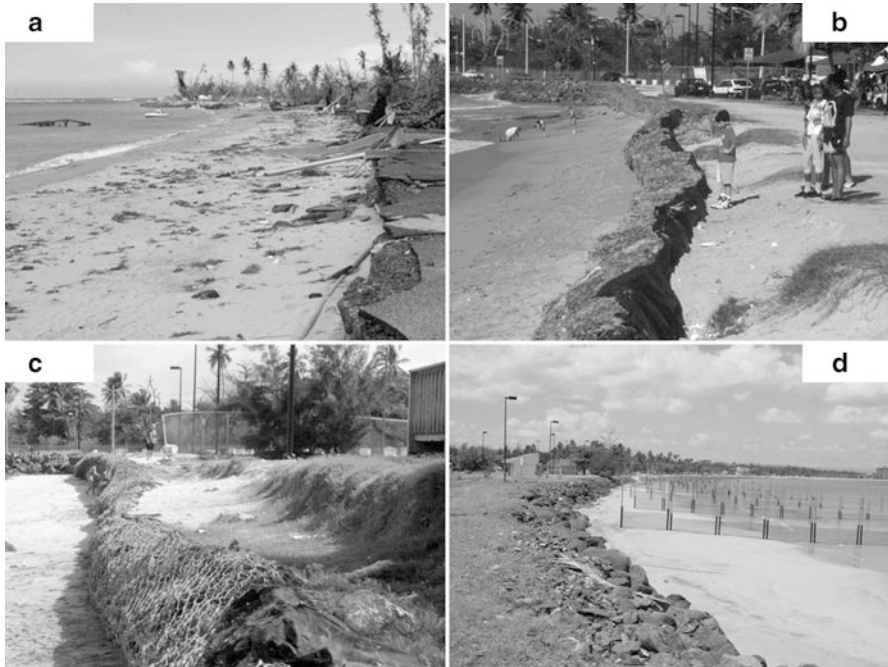
Fig. 4.5 Balneario de Carolina (previously known as Balneario de Isla Verde). Balnearios are public swimming beaches with amenities and maintained by a local government. Major erosion caused by swell from a January, 1988, winter storm, and the passage of Hurricane Hugo in September, 1989, resulted in the emplacement of gabions. Continued erosion along with deterioration of the gabions has led to several generations of modifications and repairs to the gabions. Ultimately the gabions have failed, spilling rock and wire debris onto the recreational beach (From Bush et al. 2009). (a) Immediately after the January, 1988, winter storm swell erosion. View to the east. The offshore boat ramp marks the shoreline previous to the mid-1970's. (b) Similar view as 2-a, but in 1994 after gabion has been built and begun to deteriorate. Note filter cloth behind gabion. (c) A wooden observation deck was added and threatened by erosion by 2001. View to the west. The gabion continued to be undermined and to collapse. (d) By 2006, the gabion wall had failed so completely that it had been replaced by a rip-rap wall. Beach narrowing continued and the "Removable Porous Groin System" had been emplaced, but this alternative device also failed. It was promised by the contractor that this porous groin system would restore the beach and prevent further erosion. No such beach restoration was noticed and the structures were removed by 2009

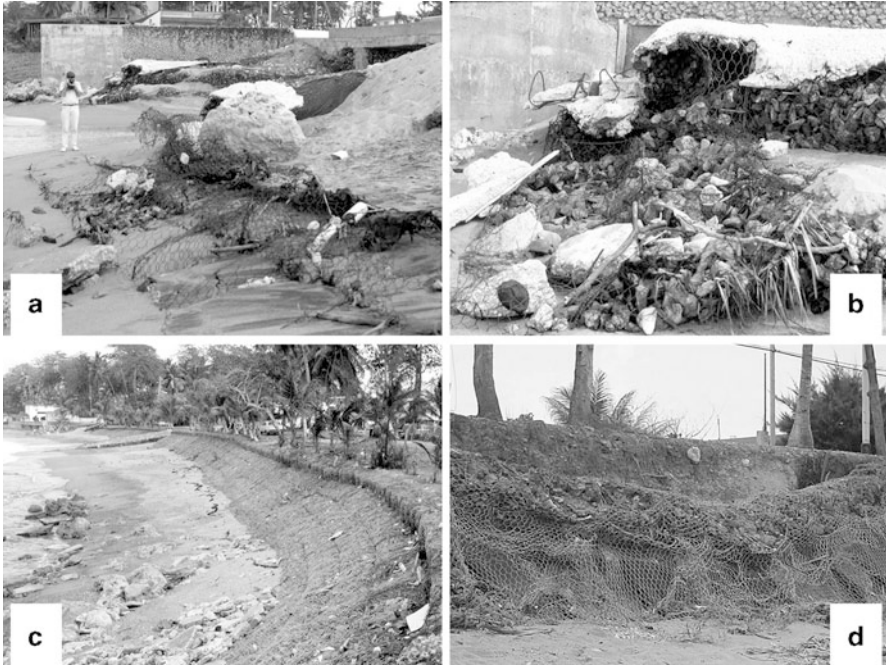
Fig. 4.6 Gabion wall near Aguada's Parque de Colon, built in the late 1980s (From Jackson et al. 2006). (a) and (b) By 1992 the wall had already deteriorated and been "improved" with a concrete covering, which in turn had been broken by storm wave action. Fill rock from the failed gabion was observed to be washed several tens of meters up into the small drainageway visible in upper right of photo a. Sharp, angular cobbles of leaked fill stone and protruding ends of wire strands made the narrowed beach hazardous to walk on. (c) Just to the south, the entire bluff was covered with a sloping gabion revetment/wall, visible in this 1992 photograph. Note that the wire mesh had trapped driftwood and flotsam. The steep wall cuts off the underlying sand scarp sediment source, and increases the erosional effect of waves. (d) By summer of 2000, the gabion in photograph (c) was severely compromised, ruptured and devoid of rock fill over much of its length, and partially slumped and toppled. The scarp was again eroding, providing some new sand to the beach

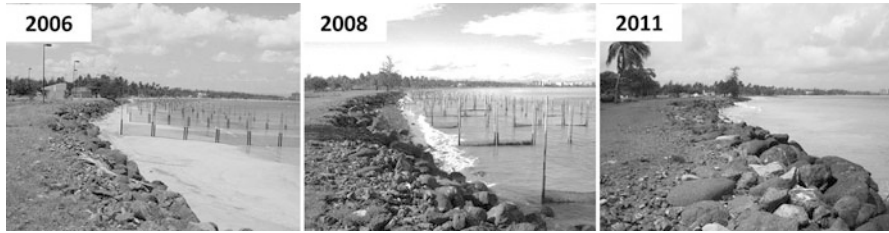
Fig. 4.13 Installation, failure, and removal of a “Removable Porous Groin System” along Balneario de Carolina from 2006 to 2011 (see text for further discussion). The recreational beach in 2006 along the rock seawall is no longer present in 2008 and there is severe deterioration of the groin structure. Note the removal of abandoned buildings and light posts between 2006 and 2008 that were once part of the public park behind the chronically eroding beach. Between 2008 and 2011, additional rocks were added to the seawall. A stated advantage of the groin system is, indeed, that it is removable. The system is purported to “regenerate” beaches. Obviously that was not the result in Puerto Rico

area. A persistent erosion problem was exacerbated by the cut-off of the sand supply by the jetty at Boca de Cangrejos, and earlier removal of sand from the beach system when the channel for the entrance to the Boca de Cangrejos marina was dredged. At the eastern end of this reach, rock revetments have been in place for many years to protect the road. The response was to build a gabion wall which failed and was replaced by a revetment (Fig. 4.5). When erosion continued, the local government paid over \$4 million for a “Removable Porous Groin System” in 2006 (Fig. 4.5, 2006 photo). It was promised that this groin system would restore the beach and prevent further erosion, however, it too failed leaving the beach littered with structural debris. Figure 4.13 shows the history of the porous groin at Balneario Carolina, including the groin’s removal and its replacement with a revetment. The shoreline segment was left with ultimately less dry beach. This proves the old adage that you get what you pay for, and the coastal protection corollary that if you opt for shore hardening you will need the most expensive structure, and you must be willing to give up your beach.

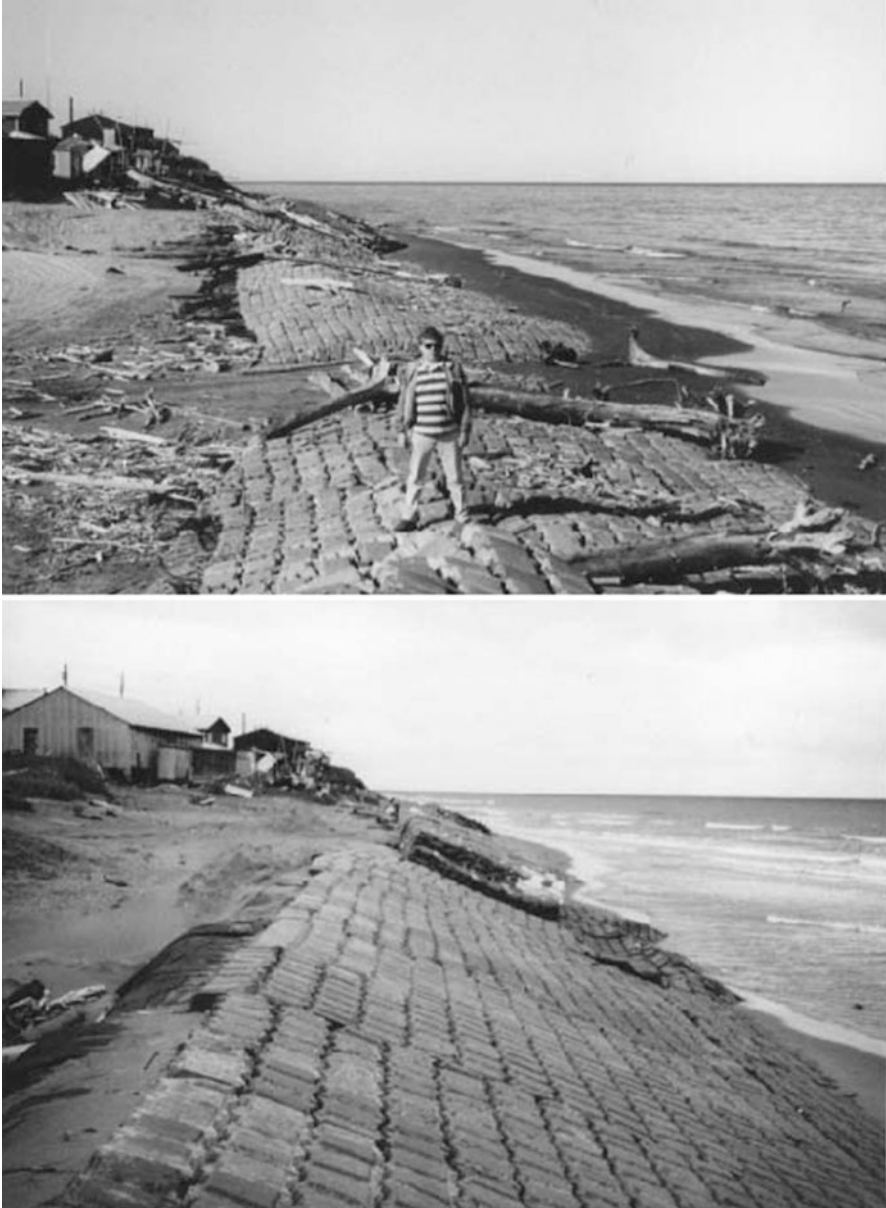
Fig. 5.3 Comparative photographs of 1980s concrete block revetment, *upper* as failed in 1992, *lower*, replaced in 1993

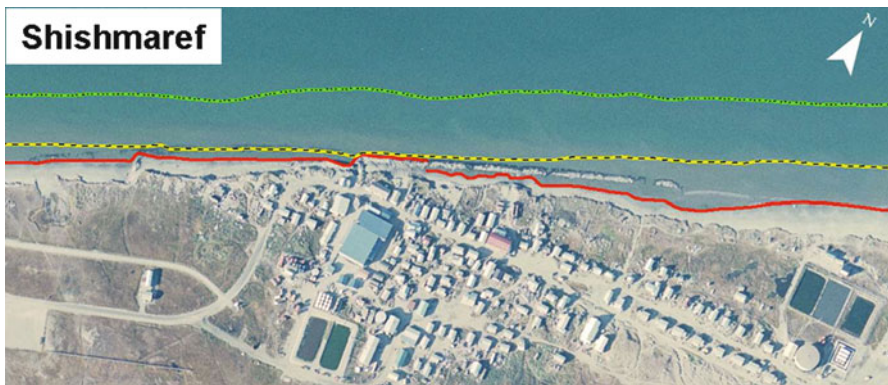
Fig. 5.5 Inferred beach margins, as calculated by CU study, this paper. *Upper*: 1948, *Middle*, *dashed*, 1980, *lower solid*, 2003. All three lines are plotted on the 2003 image. The lines may differ from the estimates of erosion based on bluff margin

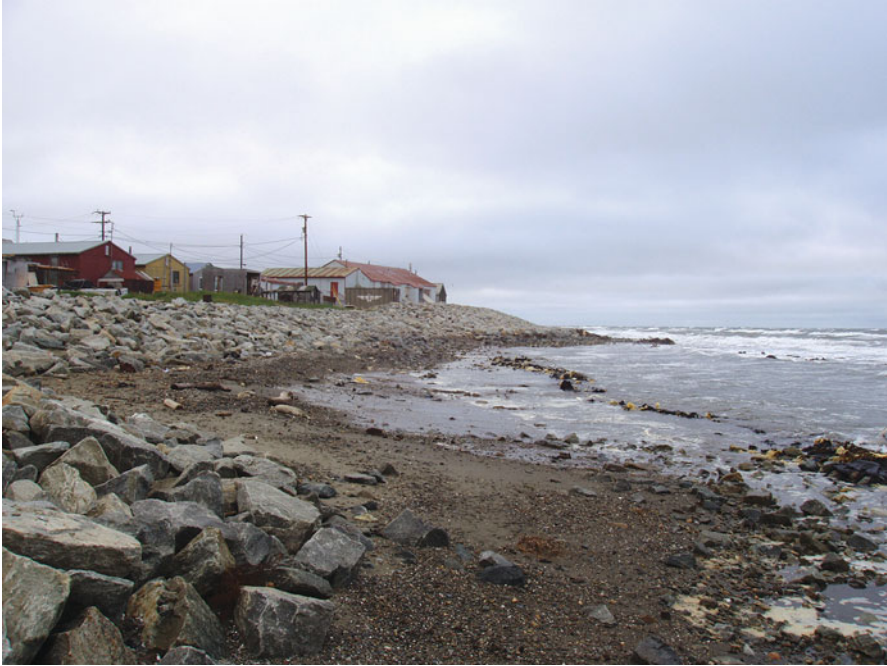
Fig. 5.6 Serial revetments in place along Shishmaref

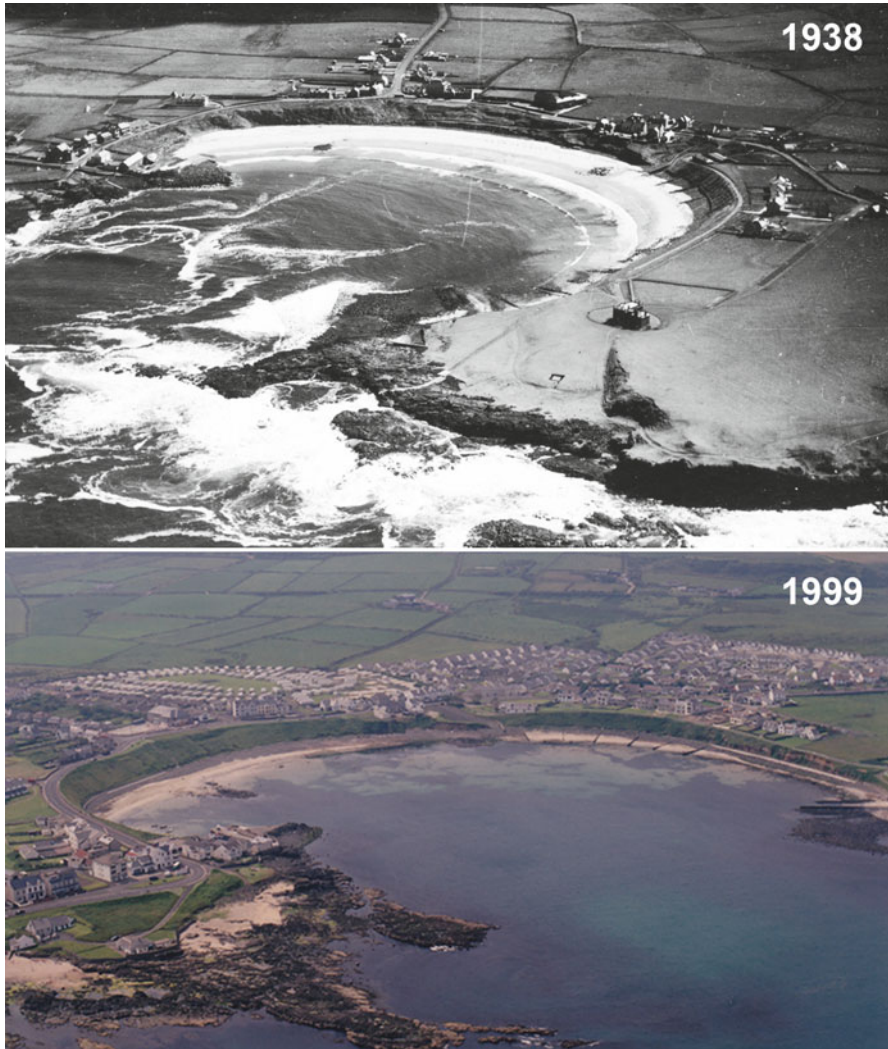
Fig. 6.1 A 1938 oblique (*top image*) aerial photo (Portballintrae, 8th April 1938, © Belfast Telegraph, Collection Ulster Folk & Transport Museum) showing a wide sandy beach system and in 1999 (*bottom photo*) the beach made up of only a thin veneer of sand on the lower beach face and a large cobble/boulder back beach, particularly along the western section (*right of picture*)

The sandy beach at Portballintrae has had a long history of change since the late 1800s, involving a succession of beach alterations largely instigated by human activities. An oblique aerial photograph of the site in 1938 shows a relatively extensive beach, over 150 m wide that is in stark contrast to the modern gravelly beach (Fig. 6.1). A ground view of the beach (Fig. 6.2) sometime around 1920 also shows the abundant sandy beach volume at the site. However, a study by Carter et al. (1983) of vertical aerial photos and maps between 1935 and 1980 showed a progressive loss of intertidal beach sand area at a rate of $1,000 \text{ m}^2 \text{ year}^{-1}$, to finally form a much steeper (and narrower), sand-limited, boulder-strewn beach by 1980.

Carter et al. (1983) calculated an overall volumetric loss of around $60,000 \text{ m}^3$ over a 75 year period. Field observations and aerial photography show that the beach has operated in a sediment-starved state since the 1980s and has shown little shoreline retreat since then. This suggests it has now adjusted to the prevailing forcing factors (mainly wave energy) and the limited amount of sand now available

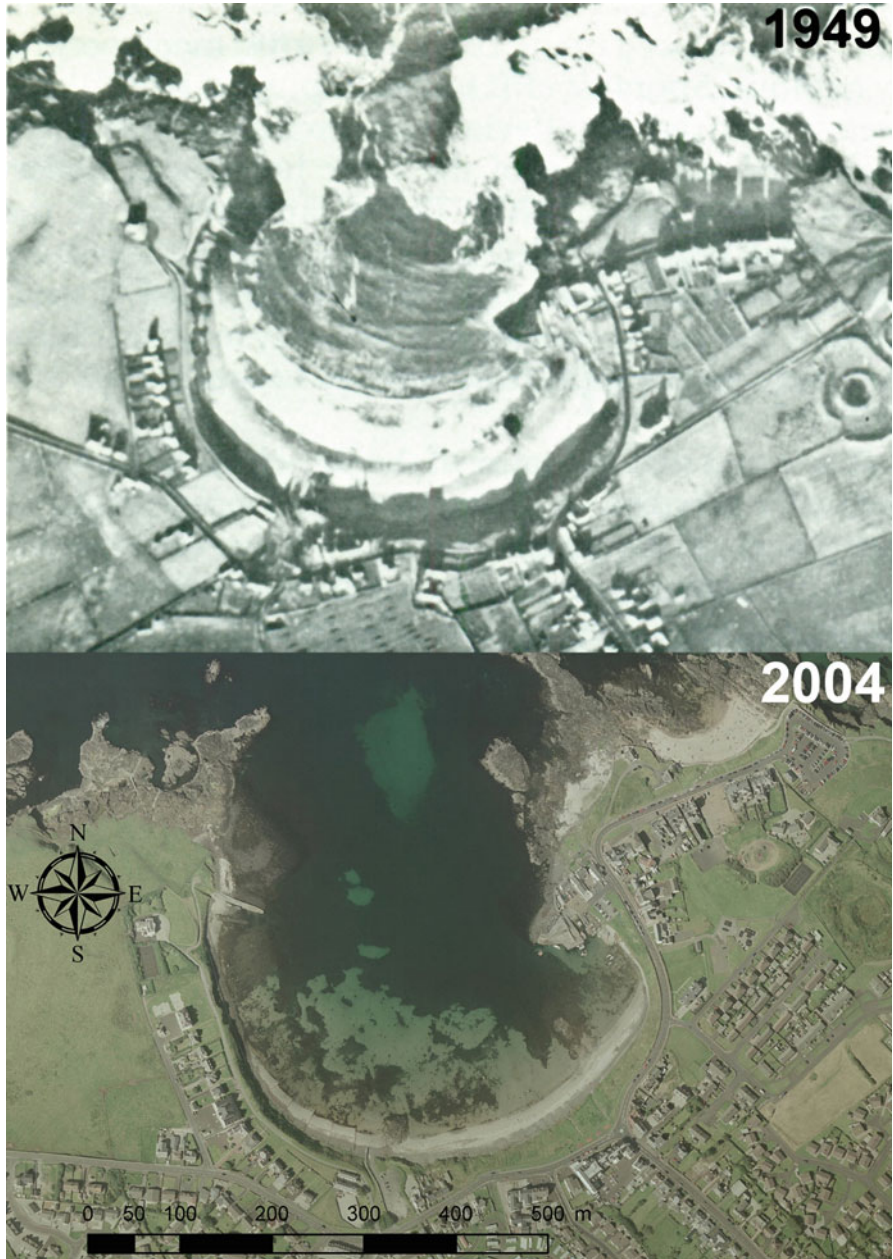
Fig. 6.4 Aerial views of Portballintrae in 1949 (*top*) and in 2004 (*bottom*) showing significant changes in beach width and sand volumes

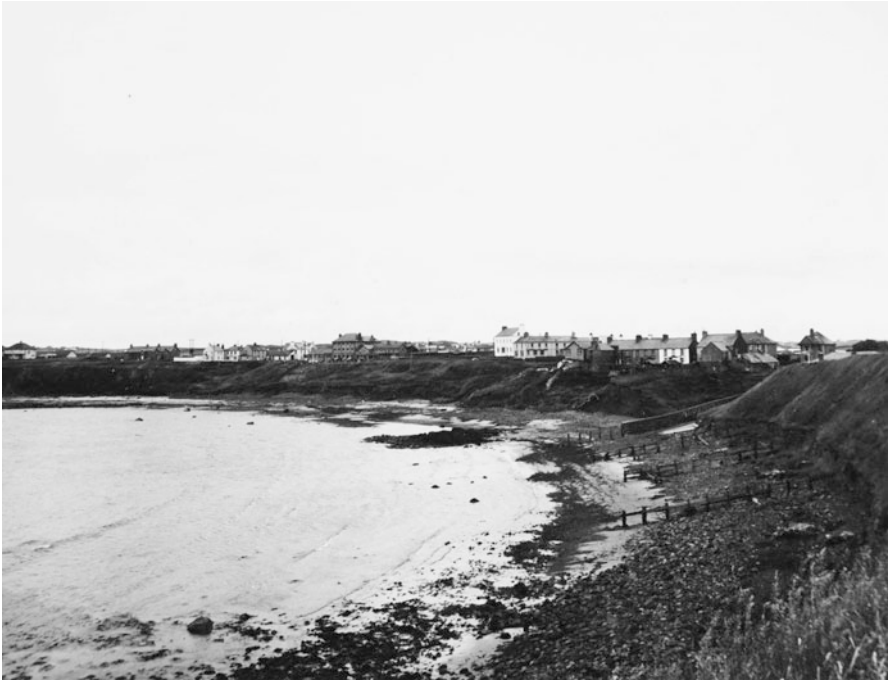
Fig. 6.5 Early emplacement of groynes at Portballintrae originally in 1904 shown here in a later photo, probably around the 1920's in a dilapidated state. Note that the beach had steepened and only minimal sand volume covers the lower beach face

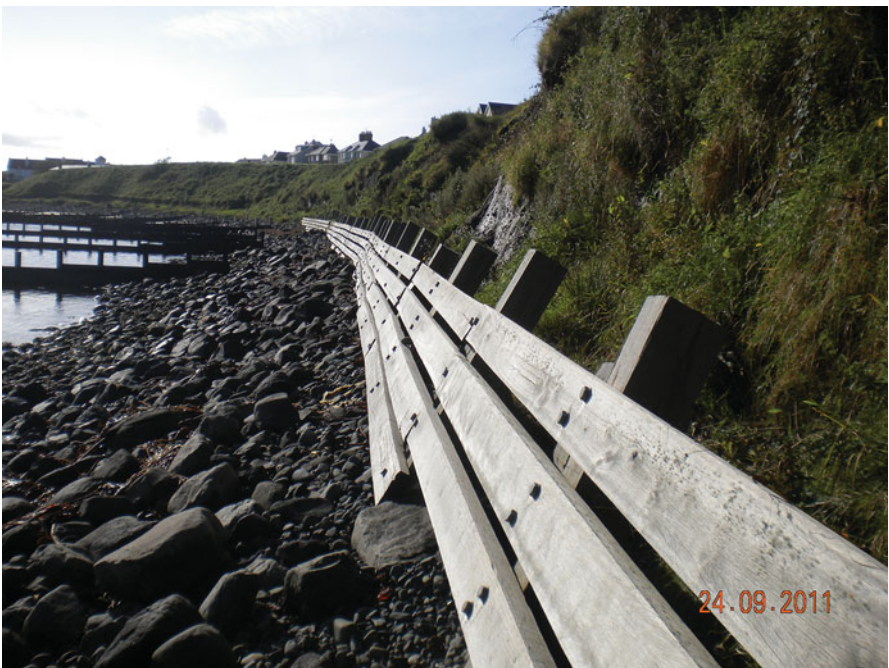
Fig. 6.6 Present (2011) ground view of current (recently upgraded) groynes and palisade barrier in place at Portballintrae's western shoreline, just down-wave from Leslie's Pier

During the period 1992–2003, further engineering works were completed (Kirk McClure and Morton 1992, 2003). In 1997, six 26 m-long replacement groynes were installed along with $1,200 \text{ m}^3$ (2,100 tonnes) of sand nourishment placed in the inter-groyne spaces to an approximate depth of 0.5 m. The re-nourishment sand was of unknown origin but was likely from an inland quarry source. In addition to the groynes, an extensive 150 m-long palisade barrier was also installed along the base of the western cliffs that were experiencing the most erosion (Fig. 6.6).

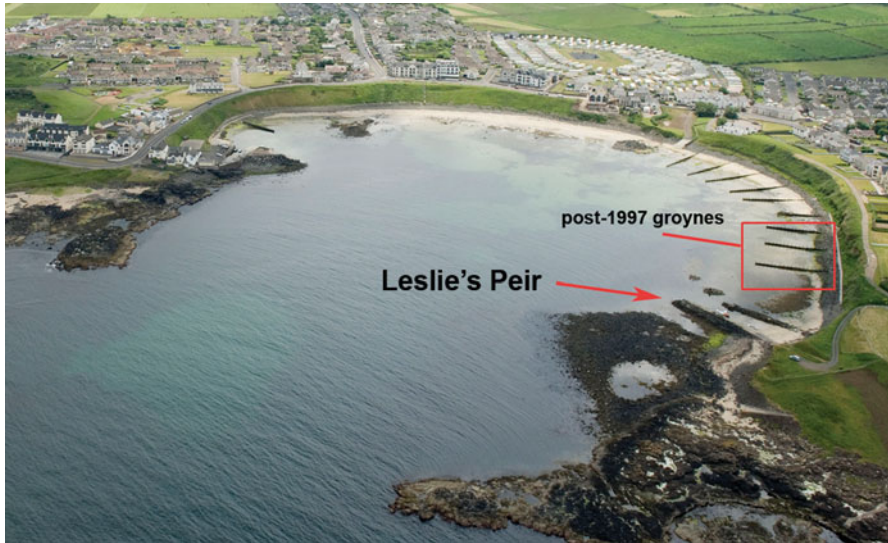
Fig. 6.7 Oblique aerial image of the site showing the latest groyne replacements now lying within the wave diffraction zone down wave of Leslie's Pier. Sediment re-nourishment to a depth of 0.5 m in between the new groynes has now lowered itself to a thin veneer of sand locked inside glorified sand pits between each groyne structure (Photo courtesy of Northern Ireland Water)

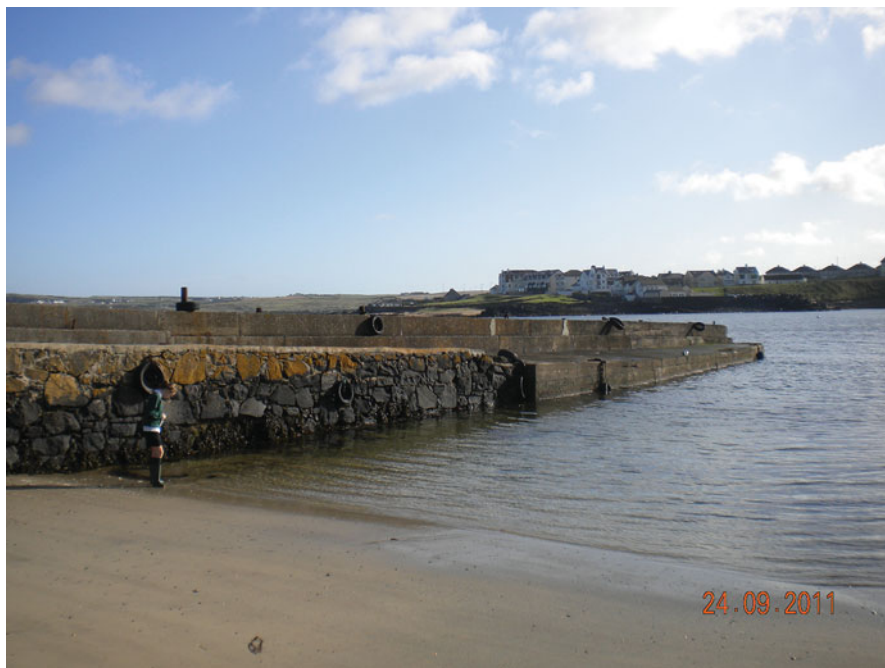
Fig. 6.8 The now rarely used Leslie's Pier, constructed in 1895, is most likely the main culprit in the removal of Portballintrae's sand. Natural in-bay wave refraction patterns were interrupted by the structure, in turn setting up artificial longshore currents in the western sector of the bay to ultimately invoke sand depletion of the beach system. Its removal is now imperative for future management of the site

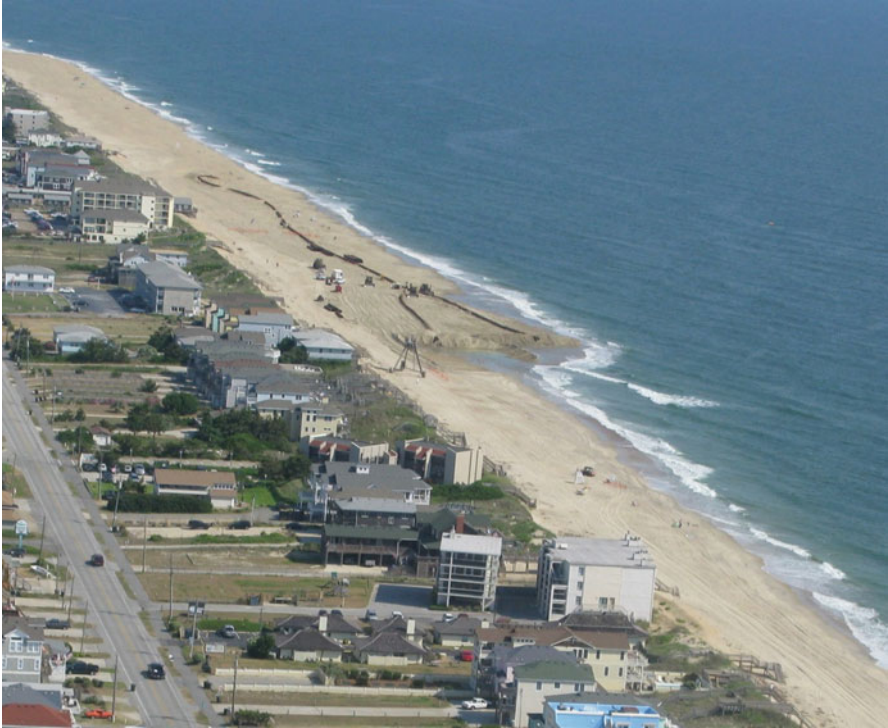
Fig. 7.1 A beach nourishment episode in Nags Head, NC

Nourishment moves the shoreline seaward from property, creating a sacrificial buffer for property that dissipates wave energy (Fig. 7.1). The primary functions of beach nourishment are to:

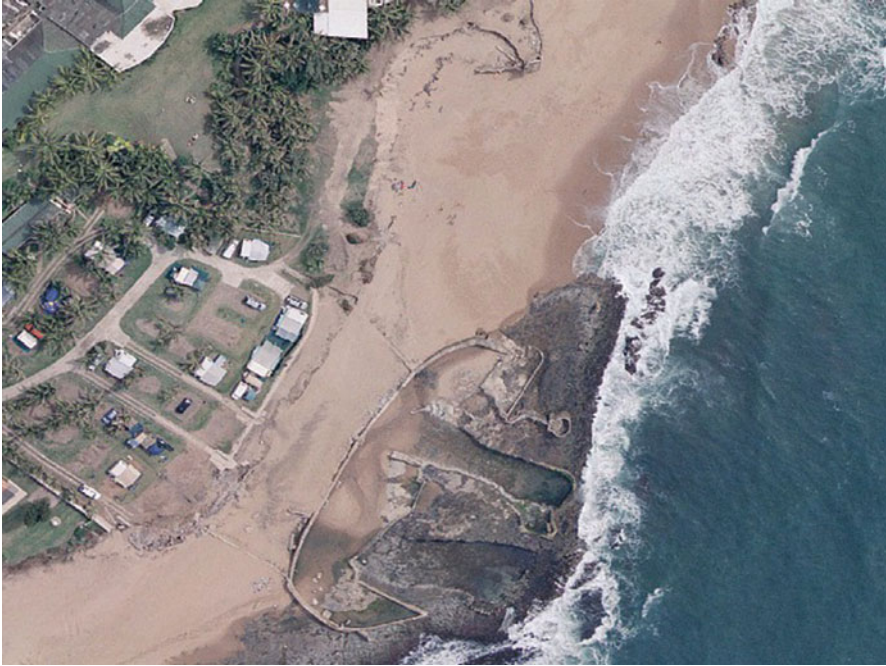
Fig. 8.2 Salt Rock, the above image was captured a month after the 2007 storm. The bottleneck section created between the defended beachfront properties and the landward wall of the tidal pool caused enhanced scouring of the beach

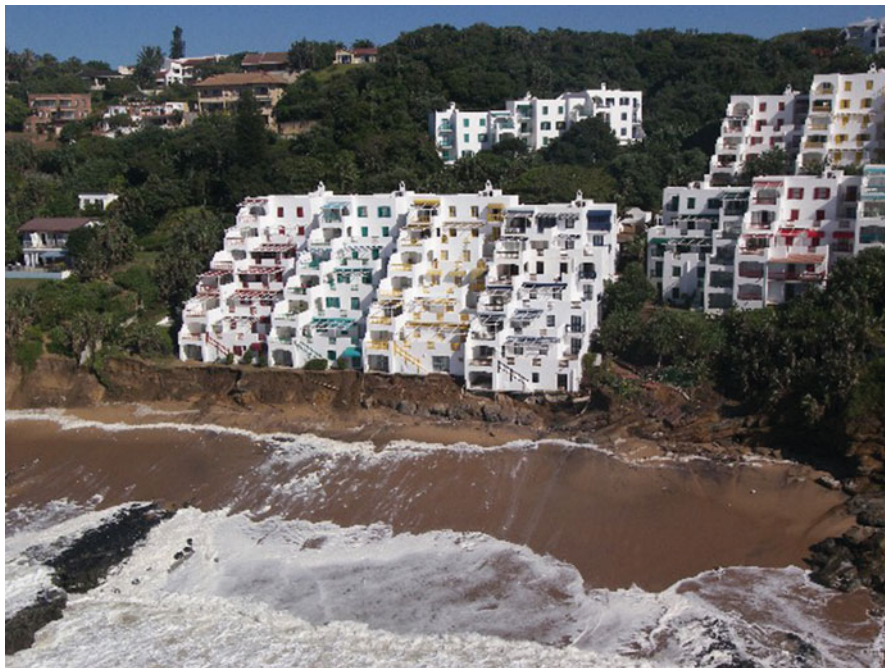
Fig. 8.3 View of Santorini undercut by erosion. Note hard rocky headland to right which stopped the littoral drift and caused megarip-current action. Older defences, constructed to repair coastal erosion from an earlier erosion event were exposed in the eroded scarp

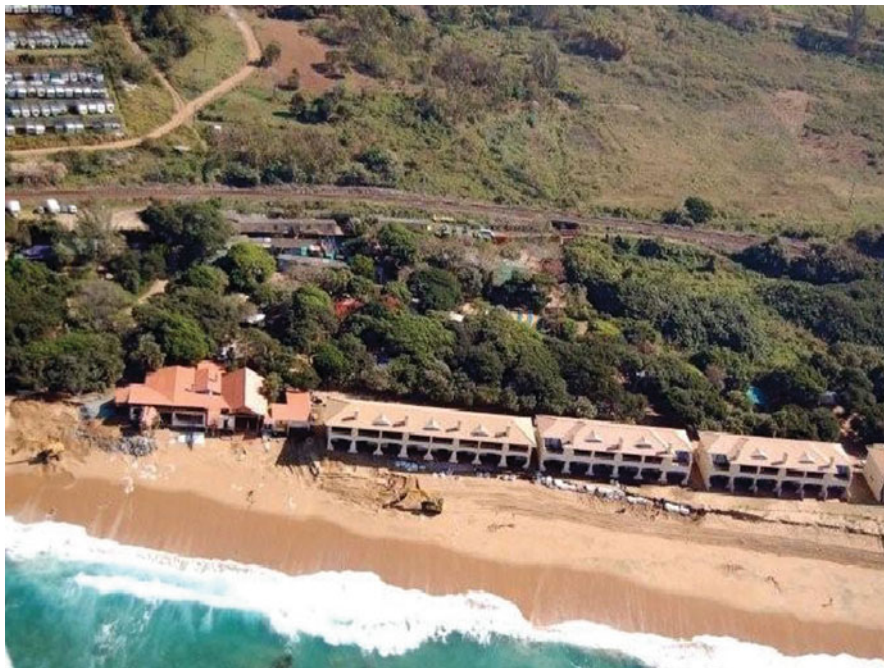
Fig. 8.5 Happy Wanderer's Resort which underwent catastrophic erosion during 2007. Photo taken during August event

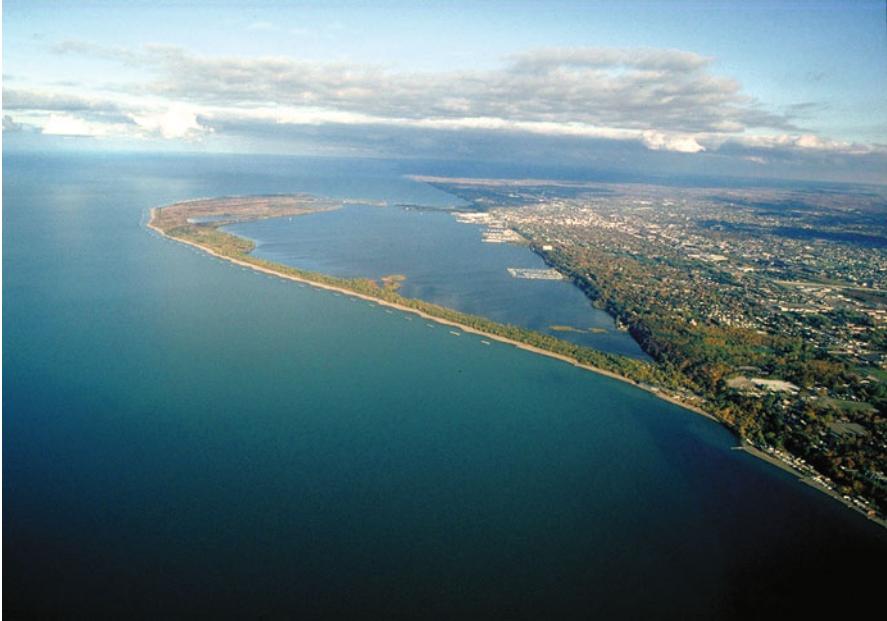
Fig. 9.1 Oblique photo showing the entire Presque Isle spit taken shortly after the breakwater project was finished. A number of “near-tombolos” are visible behind the structures. (Public Domain Photo, USACE)

Presque Isle (Fig. 9.1) is a compound, re-curved sand spit of 3,200 acres that protrudes into Lake Erie (one of the US Great Lakes) from the shoreline of Pennsylvania. The spit has about seven miles of open-lake shoreline with a width that ranges from a few tens of yards at the narrow neck that connects it to the mainland to as much as a mile in its mid-section (Fig. 9.2). Presque Isle is a state park founded in 1921 (Delano 1991) and is also a National Natural Landmark established in 1967, a designation that is one step below a National Park.

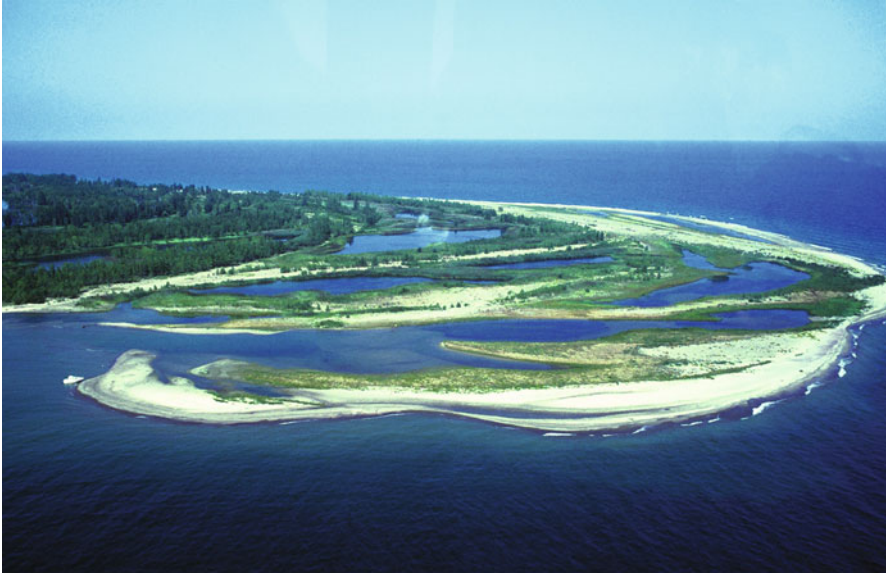
Fig. 9.3 Gull Point is shown in this photo taken before breakwaters were emplaced in 1992. Preservation of the wetland environment of the point was one of the major design goals for the project. (Public Domain Photo, USACE)

At the tip of Presque Isle is Gull Point (Fig. 9.3), a broad 250 + acre forested area with large wetlands. According to National Park Service, Gull Point is one of the few areas in the world where one can study the succession of plant life from a sand and fresh water environment to a climax forest within a few hundred yards. Gull Point may also be one of the few significant remaining fueling and resting spots between the Great Lakes and the Atlantic Ocean for a number of species of migrating shore birds. This includes plovers, sand pipers, whimbrels, and sanderlings. Presque Isle also supports many of Pennsylvania's rarest plant species (Bissell 1993). For these and other subjective reasons, the preservation of Gull Point was considered to be important and thus was a central issue of the societal debate over shoreline engineering on Presque Isle.

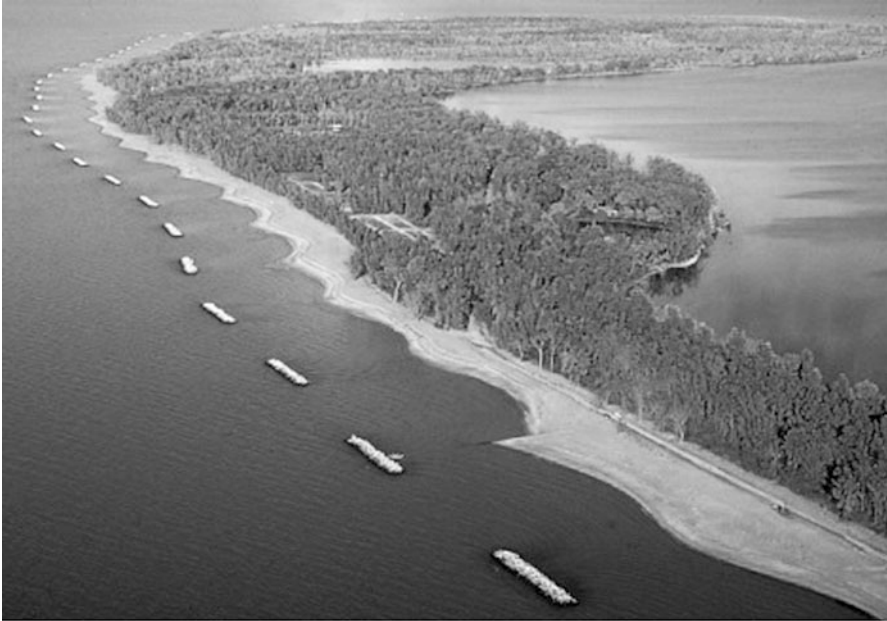
Fig. 9.4 Oblique aerial view of the eastern half of the spit showing the breakwaters and the incipient tombolos extending from the shore. Tombolo formation is quite extensive resulting in an ongoing bulldozing requirement moving around 30,000 cubic yards of sand annually. Photo Courtesy of the US Army corps of Engineers

The Corps design, finished in 1980 (U.S. Army Corps of Engineers 1986a, b, 1995) aligned the segmented breakwaters about 250–350 ft offshore (Fig. 9.4). Each breakwater was 150 ft long, 10 ft wide and 8 ft high above low lake water level and placed 350 ft apart. All told, more than 600,000 t of rocks were needed. Total construction cost was below \$30 m and the fully inflated 50 year cost including beach nourishment was estimated at \$150 m. Post-breakwater beach nourishment volumes typically are 32,000 cu yards per year.

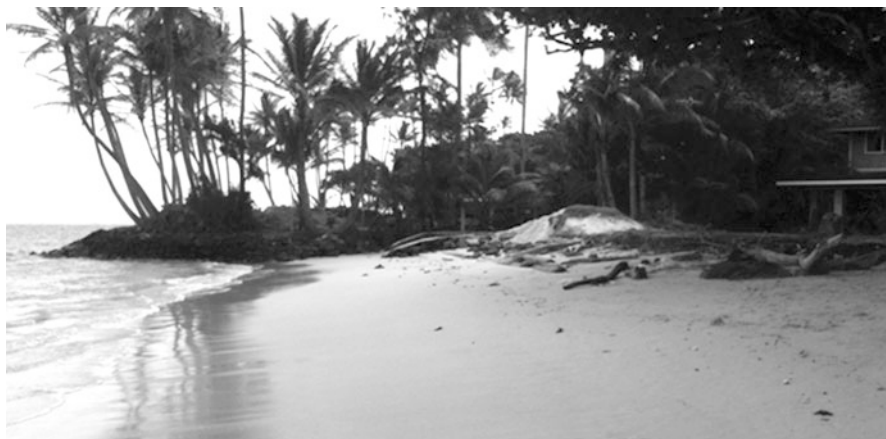
Fig. 10.6 Flanking erosion at Makalii Point (Photo location shown in Fig. 10.5; photo date, March 15, 2011)

The highest proportion of armoring, narrowing, and beach loss on any segment of the Oahu shoreline is found between Laie and Kaaawa on the northeast coast. Flanking erosion north of armoring at Makalii Point has resulted in shoreline recession of over 40 m since 1967, loss of beachfront property, and is threatening to undermine beachfront homes (Figs. 10.5 and 10.6).

There is strong evidence that coastal armoring has contributed to accelerated flanking erosion at Makalii Point following installation of armoring in the 1960s. Shoreline change rates calculated for the beach immediately north of armoring installed by 1967 show statistically significant increases in erosion rates (at the 95% confidence interval) when comparing rates from 1928 to 1967 and 1967 to 2005. As an example, directly adjacent to the armoring (within Fig. 10.6 photo) the rate changed from $0.5 + 0.4$ m/year (accretion) to -1.0 ± 0.5 m/year (erosion) following installation of armoring. Erosion also increased fronting the northern half of the 1967 armoring, though not to the degree measured on the flanking unarmored beach. Low rubble revetments were recently (2000s) installed to protect homes on the north side of the point.

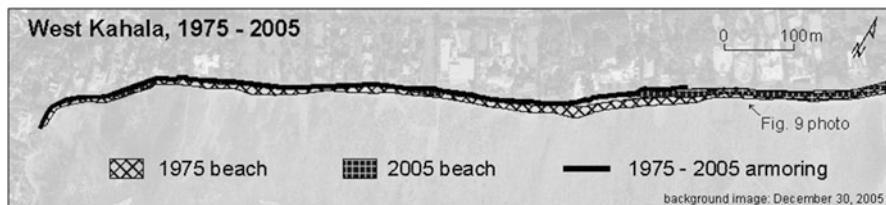
Fig. 10.9 Beach loss at Kahala, south Oahu (1975–2005, location shown in Fig. 10.8)

At the west end of Kahala Beach, roughly 900 m of beach was completely lost to erosion fronting coastal armoring (Fig. 10.9). Historical changes in the extent of armoring along west Kahala are difficult to discern from air photos due to dense cultivated vegetation along seaward property lines. It appears that most or all of the armoring was constructed prior to 1975 with extensions along a few adjacent properties in recent years in response to flanking erosion (Fig. 10.10). Analysis of changes in erosion rates on flanking beaches is not provided for this region due to the difficulty in mapping armored locations from historical air photos and limited shoreline data following the installation of armoring.

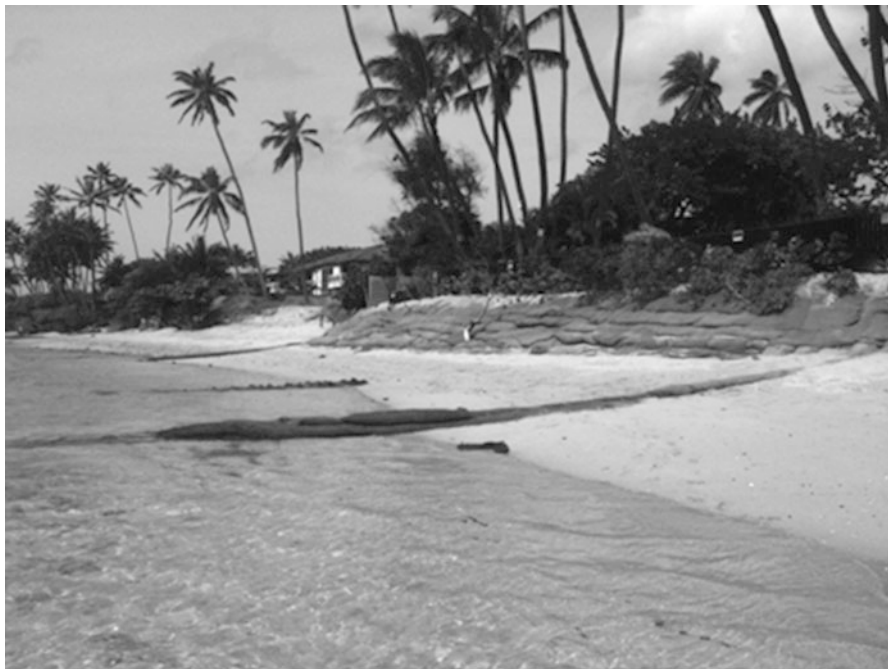
Fig. 10.10 Flanking erosion and temporary armoring (*sand bags*), west Kahala Beach (location shown in Fig. 10.9; photo date, March 21, 2011)
