J. Andrew G. Cooper
Orrin H. Pilkey *Editors*

Pitfalls of Shoreline Stabilization

Selected Case Studies

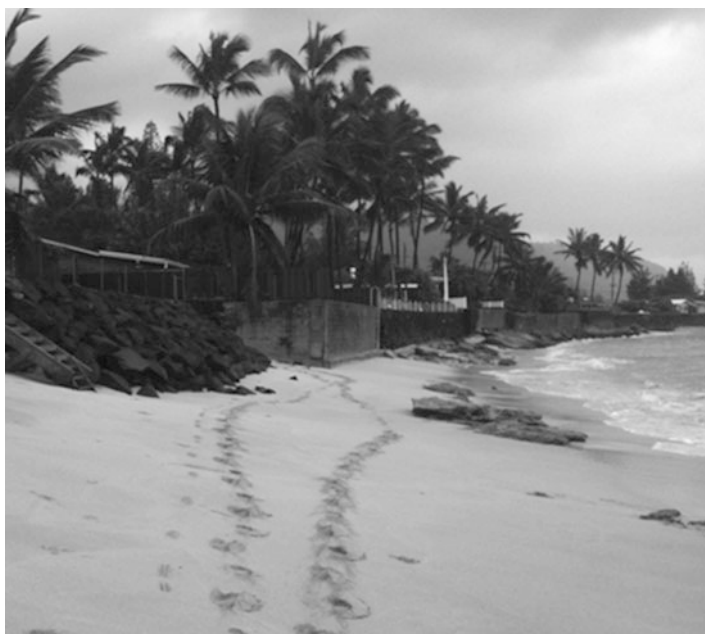
Fig. 10.15 Beach loss at Mokuleia, north Oahu (location shown in Fig. 10.14; photo date March 22, 2011)

Beaches are narrowed along most of a continuous beach between Mokuleia and Waialua, including armored and unarmored sections. Near-complete beach loss is observed in 2006 air photos of a small embayment at Mokuleia (Fig. 10.14). Armoring, constructed in the early 1970s, was extended in the 1980s and more recently to protect coastal properties threatened by flanking erosion. Continued narrowing has resulted in complete beach loss fronting armoring in the middle of the bay as observed in a site visit in March of 2011 (Fig. 10.15).

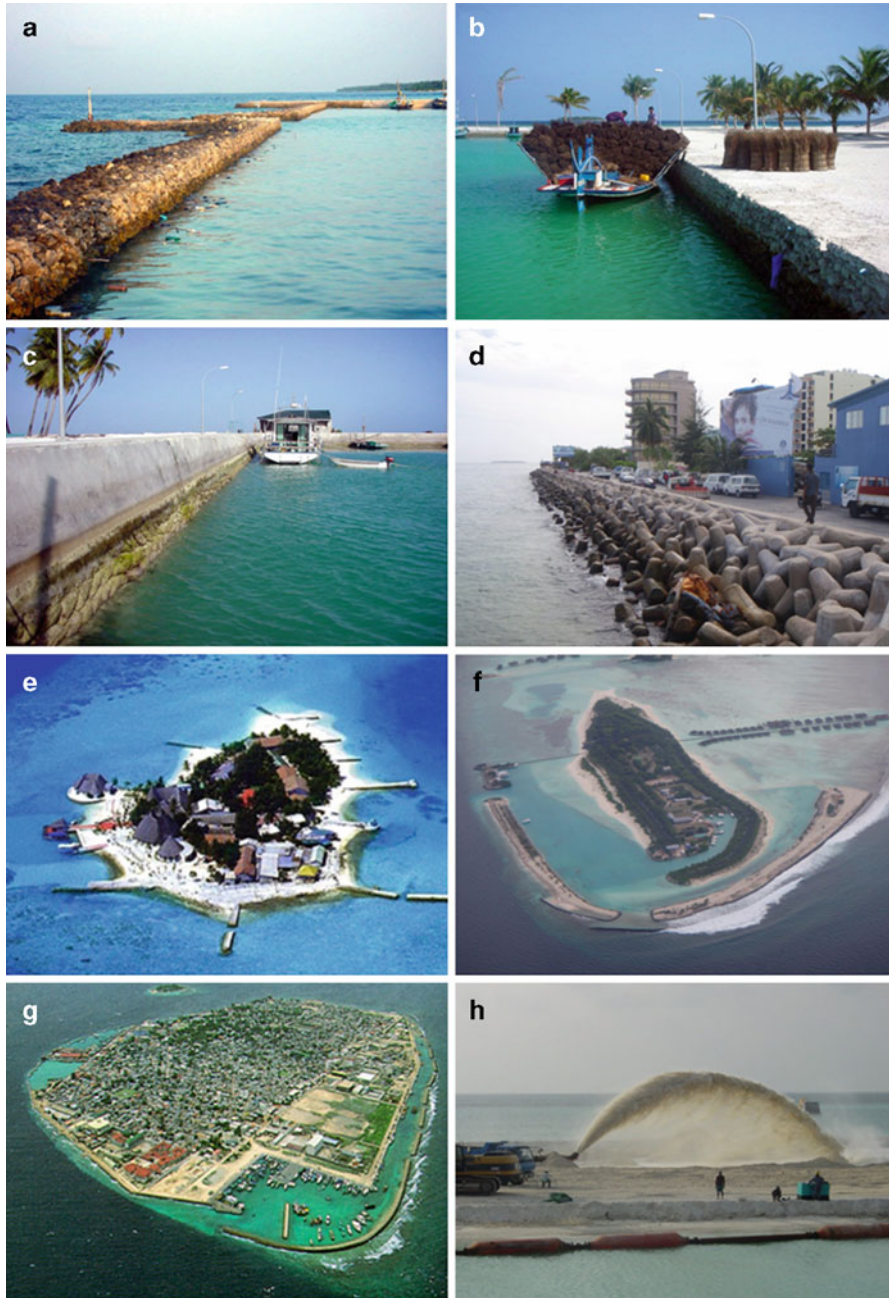
Fig. 11.2 Range of structures used to manage shoreline erosion. (a) Coral block seawall used as breakwater for harbor. (b) Coral block quay wall in harbor. (c) Concrete wall over stacked sandbag seawall. (d) Tetrapod seawall, Malé. (e) Arrangement of groynes on island shoreline. (f) and (g) Breakwaters on reef edge. (h) Sand pumping to reclaim land. A similar technique is adopted to nourish beaches

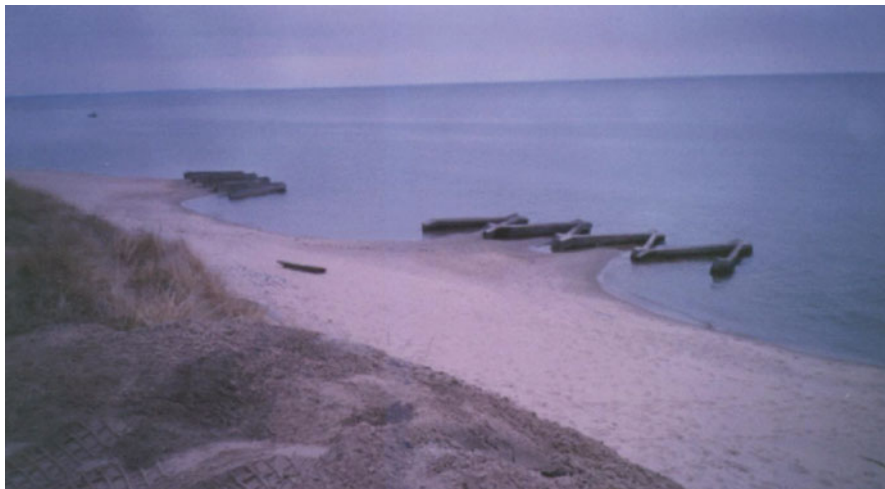
Fig. 12.1 Beach prisms on the Maryland shoreline of Chesapeake Bay

The devices described in this category are shore-parallel structures placed offshore, either submerged or floating. Their intended purpose is to modify the incoming wave so as to create a “wave shadow” on the beach causing sand deposition (Fig. 12.1).

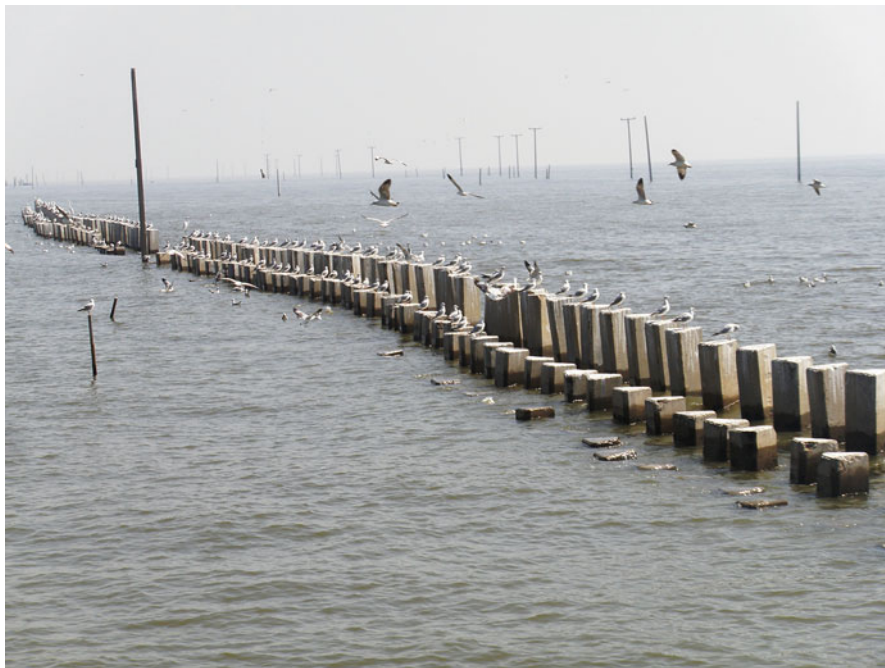
Fig. 12.2 Pilot emplacement of patented shoreline stabilization devices at Chao Phraya Delta involving wave baffles made of concrete

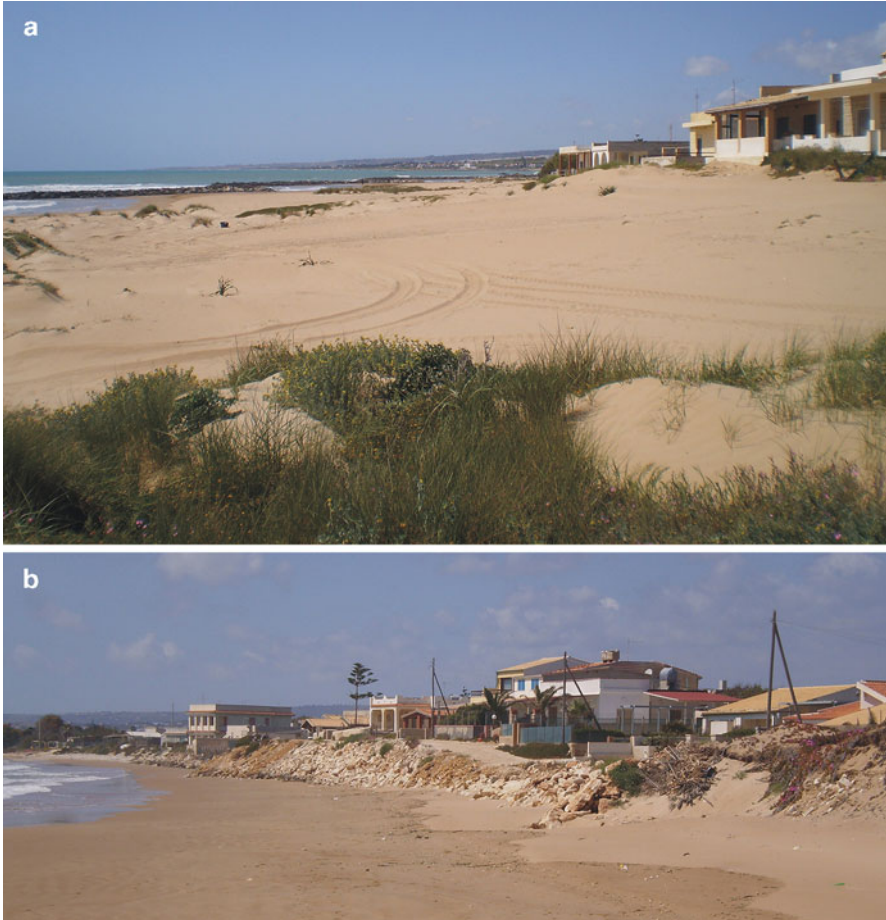
Fig. 13.6 Migrating dunes at the northern breakwaters emplaced downdrift (east) of Donnalucata harbour (a, April 2011); summer houses protected by rip-rap revetments downdrift (east) of easternmost breakwater at Modica Stream mouth (b, April 2011)

in the lee of offshore western breakwaters produced an important surplus of sediments which gave rise to the formation of landward migrating foredunes at places threatening summer houses and invading agricultural areas (Fig. 13.6e). East of the breakwaters extensive erosion processes reduced the beach width and a series of seawalls and rip-rap revetments were constructed to protect beach front properties (Fig. 13.6f).

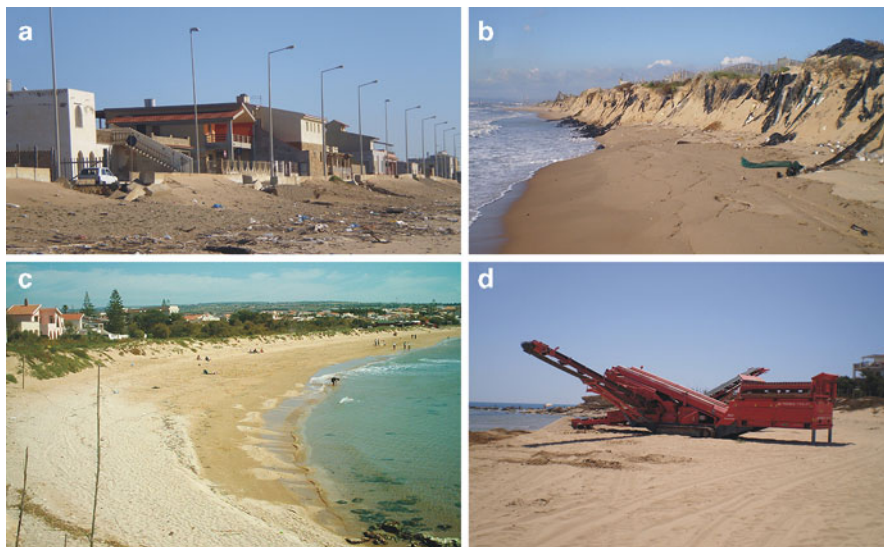
Fig. 13.8 Beach erosion and damages caused by run off processes at M. di Acate (a, December 2010); environmental degradation associated with greenhouses north of M. di Acate (b, December 2010); white gravel sediments coming from the nourished sector at Caucana (c, April 2006) and the mechanical machinery used in the attempt to remove gravel sediments (d, July 2010)

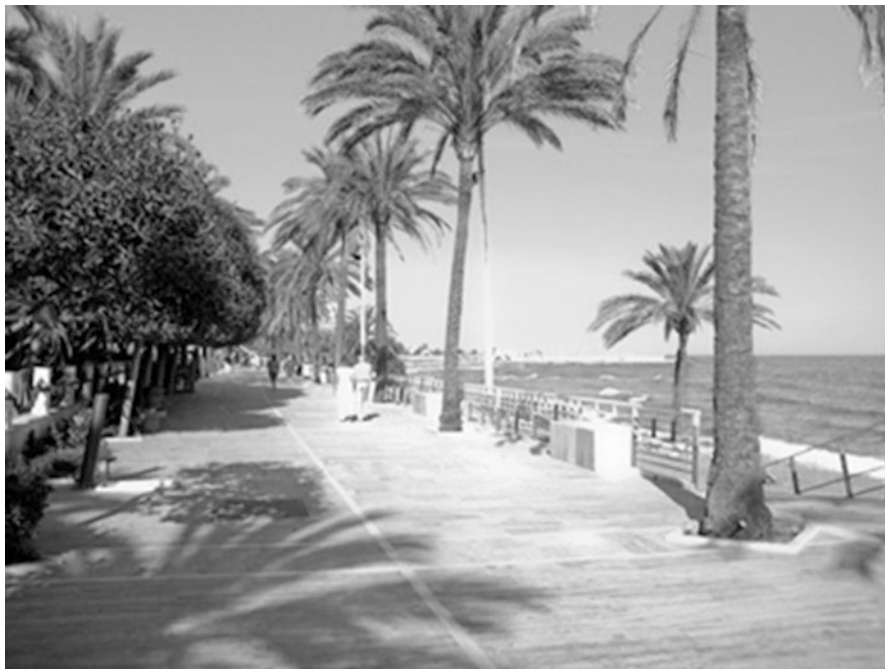
Fig. 14.3 Promenade on sea wall. The 1960s wall now supports major park-like use for the parks and gardens municipal system

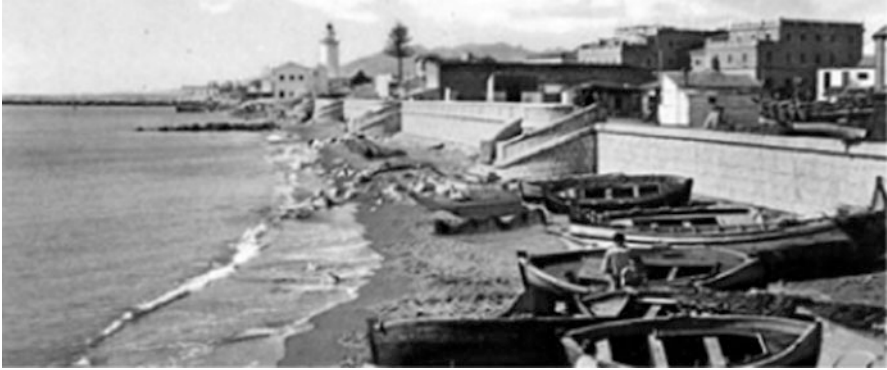
Fig. 14.4 Malagueta beach in Malaga after effects of sea-wall. The b is gone. Photograph from Archivo Histórico Provincial de Málaga

As is common with sea walls, the effects of undertow erosion did not take long to appear and narrowing of beaches was widespread along the coast (Fig. 14.4). This effect was accentuated along the Costa del Sol given the acute angle of approach of waves which commonly approach at a 45° angle to the shoreline and create significant littoral drift in the narrow surf zone. The sand in this context is transported to deep water and recovery by fairweather waves is impossible since the sand is beyond wave base. In addition, sea wall end effects translated erosion downdrift, to which the response was to extend the sea walls.

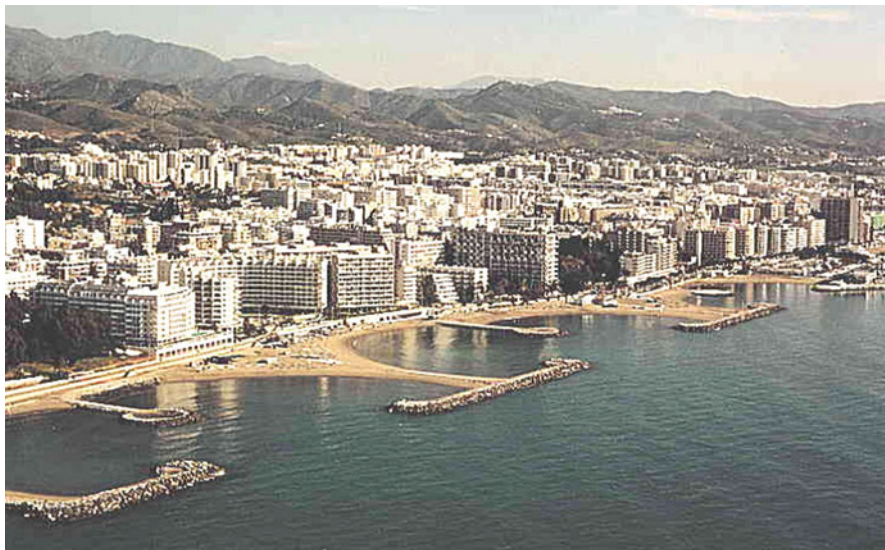
Fig. 14.5 A large groyne field at Marbella in the 1970s. The hammerhead design coped with onshore and longshore erosion but hampered water circulation at a time when sewerage plants were still not fully operational and discharges took place directly into the artificial embayments

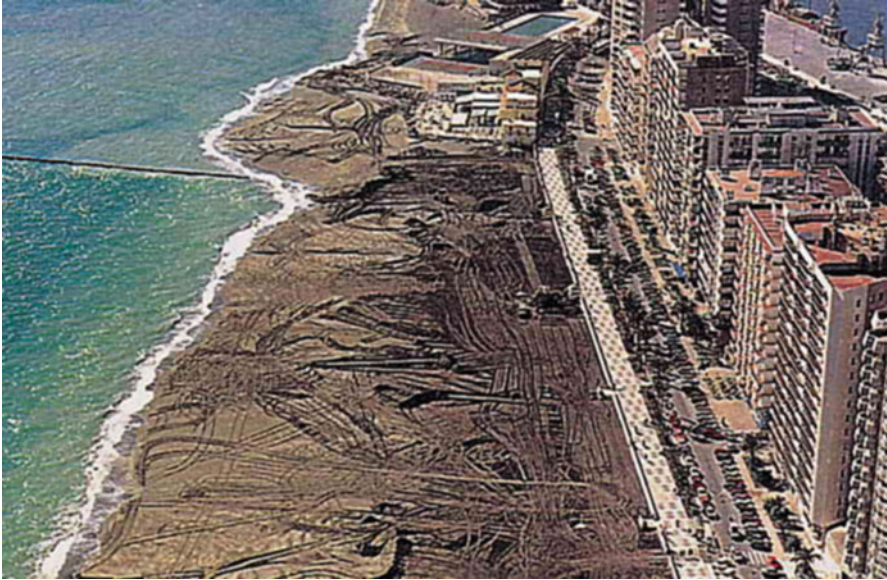
Fig. 14.6 Beach nourishment is a world wide shoreline stabilization method. Local hydrodynamics should aim at equilibrium profile. Malagueta beach in Malaga 1990. Photo from Demarcación de Costas de Málaga. Ministerio de Medioambiente

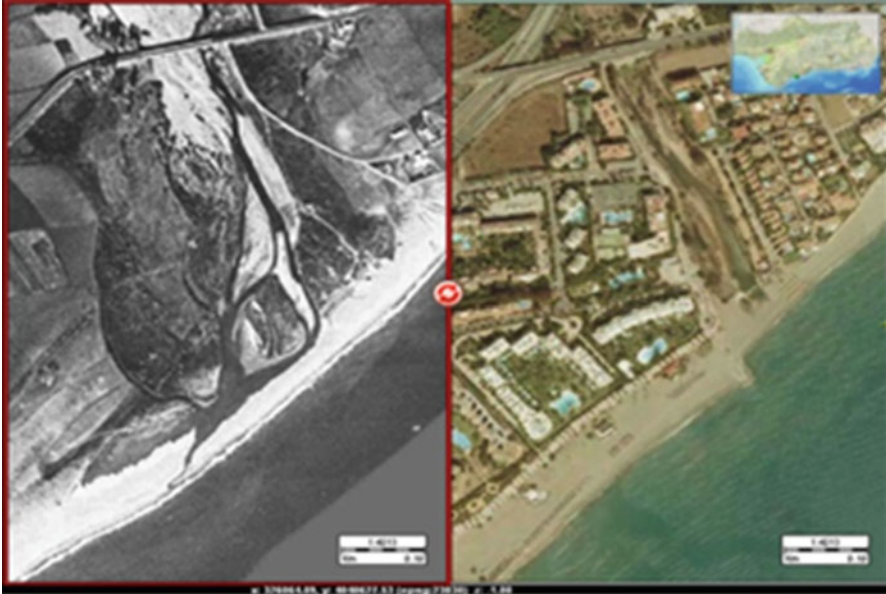
Fig. 14.9 River mouth of the Rio Verde in 1956 (a) and 2009 (b). Note the marked drift to the SW and blockage creating lagoons in (a)

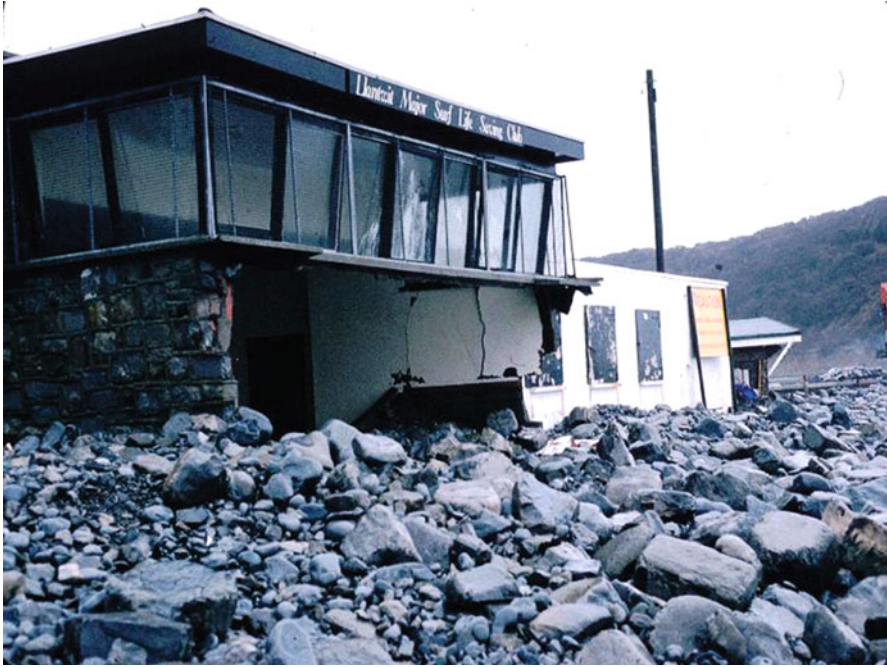
Fig. 17.2 Storm damage to Surf Life Saver Club

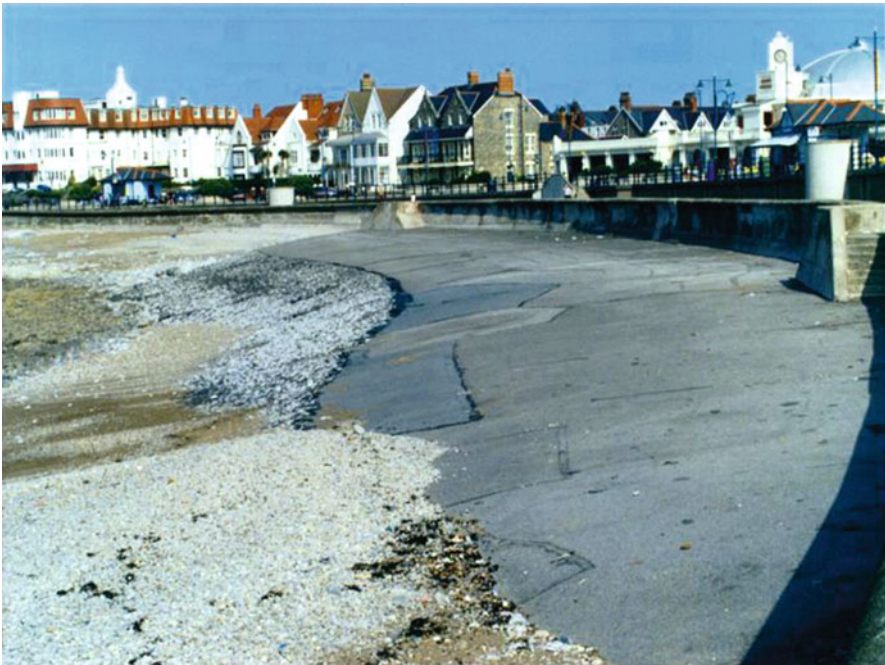
Fig. 17.5 Bitumen revetment covering upper beach

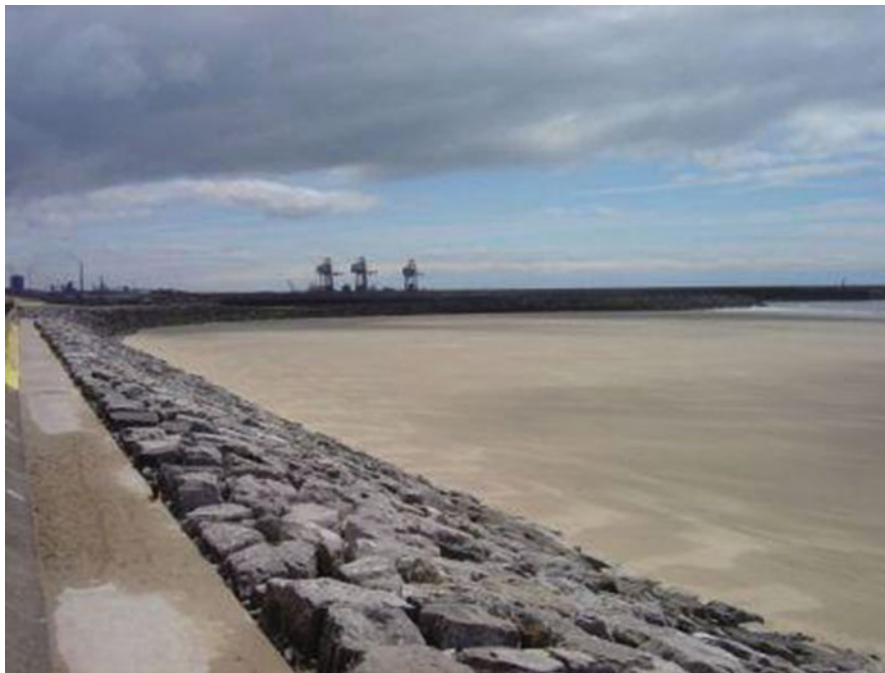
Fig. 17.7 Aberavon seawall

In January 1991, as a result of many internal voids that had developed within the seawall, a section collapsed in a not-very-severe storm (Bullen 1993). The south-eastern part was built seawards of high-water and toe erosion is on-going due to wave reflection and turbulence. This is exacerbated by the adjacent tidal harbour which interferes with northerly longshore transport and starves the fronting beach of sediment. Conversely, the north-western half of the seawall was constructed landwards of high-water. Here the fronting beach is outside the tidal harbour's influence and receives sediment recharge from the south, resulting in dry sand being blown against and over the wall. Therefore, adjacent to the tidal harbour beach levels have continued to fall resulting in exposure of sheet piles at the seawall toe and this has led to rock armour protecting the seawall which in turn is protecting the promenade (Fig. 17.7).

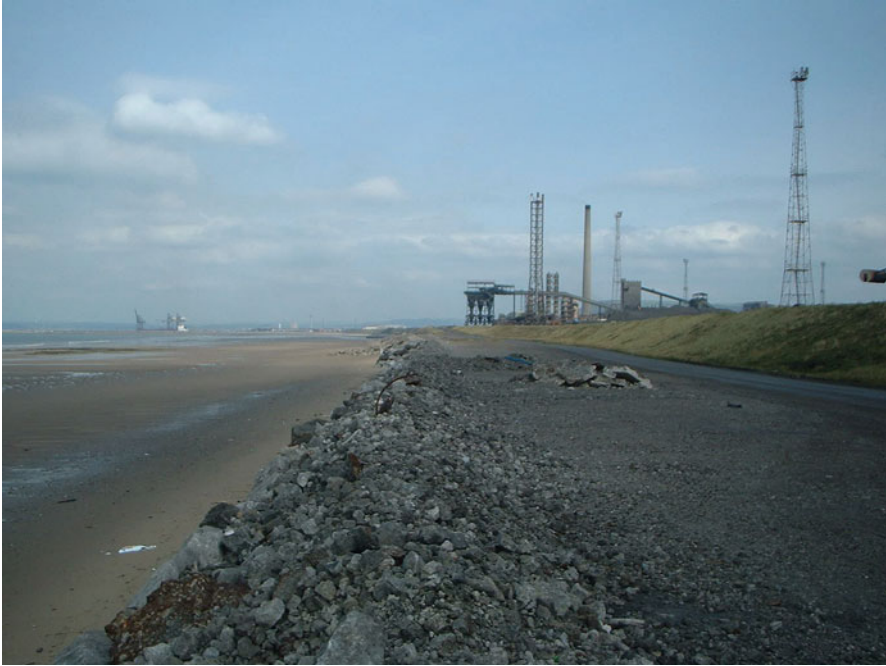
Fig. 17.8 Blast furnace slag revetment

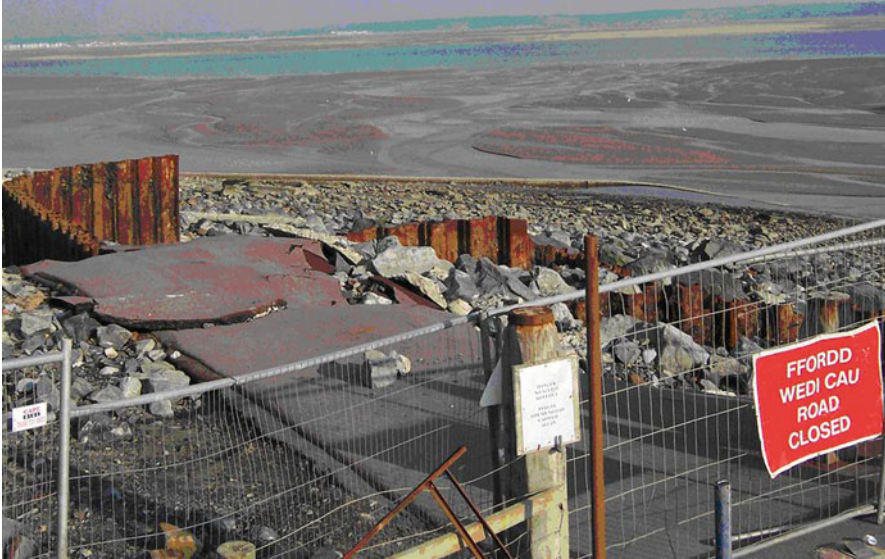
Fig. 17.11 Coastal footpath failure

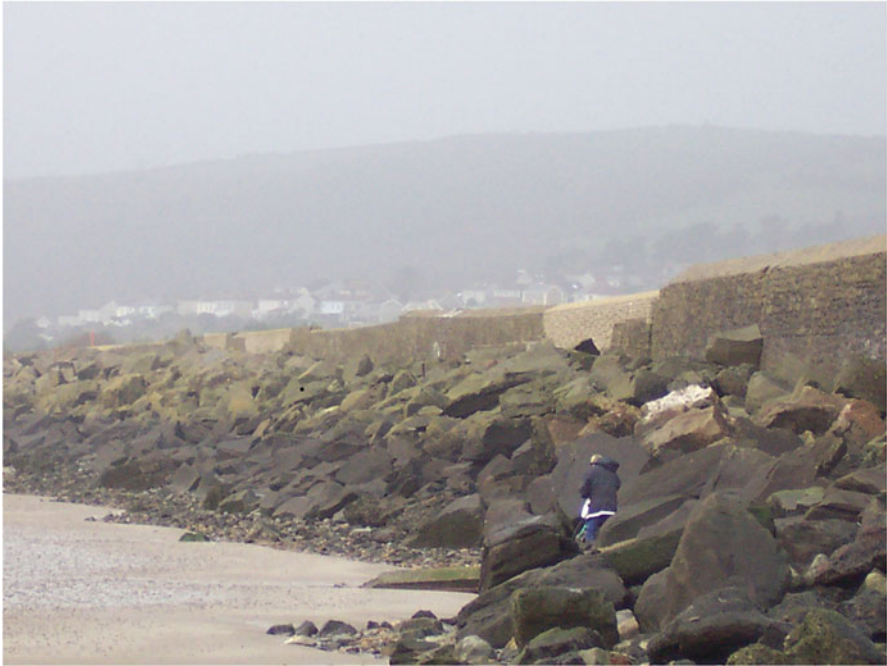
Fig. 17.12 Rock armour protection of rail link

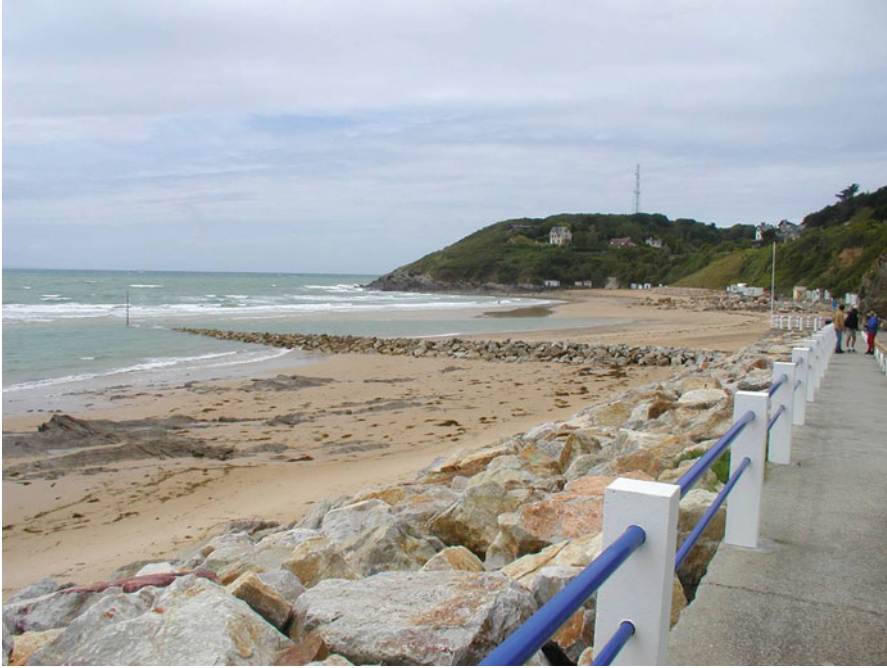
Fig. 18.2 An example of multiple coastal protection structures on a coastal resort in Normandy

In many ways both the causes of, and the response to, shoreline destabilization have been essentially a matter of ‘hard’ engineering (Fig. 18.2), for both historical and cultural reasons, although the situation has been changing over the past decade. Following a brief overview of shoreline stabilization procedures and structures in France, we will present four examples from various parts of the French coast, from the North Sea to the eastern corner of the Mediterranean (Fig. 18.1), that illustrate the benefits and disbenefits of shoreline stabilization.

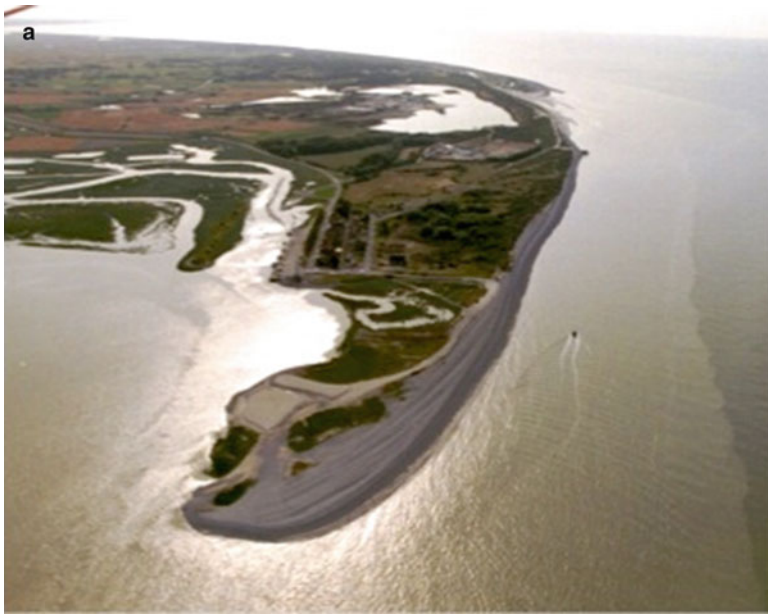
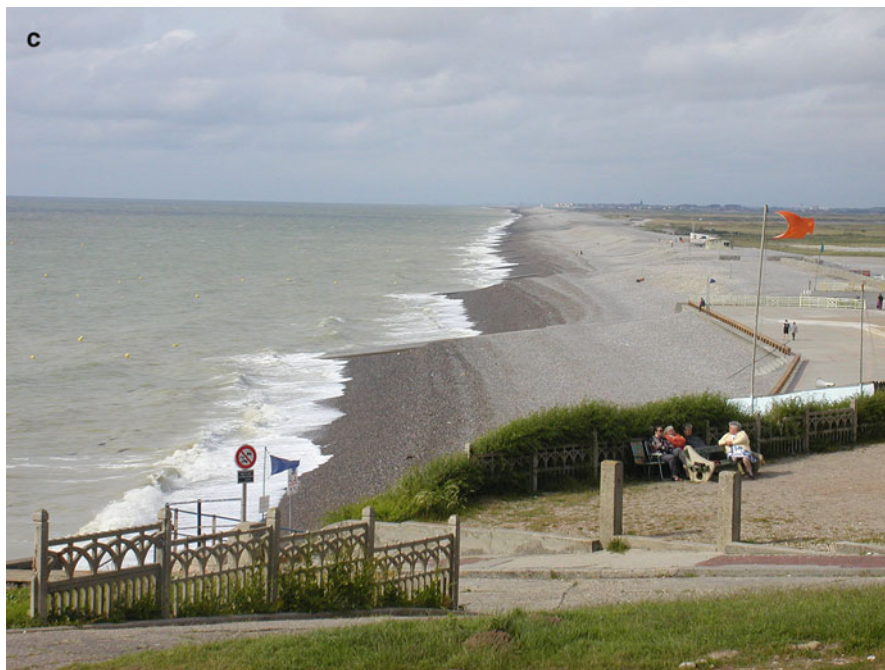
Fig. 18.4 Cayeux spit in Picardy, the largest gravel barrier in France. (a) Oblique aerial photograph of the distal part of the spit and the polders behind. (b) Erosional and accretional sectors of the spit, the former comprising a field of no less than 83 groynes between the proximal hinge point at Onival and the now-threatened seafront town of Cayeux-sur-Mer. (c) Offsets caused by the groynes near the proximal hinge point of the spit

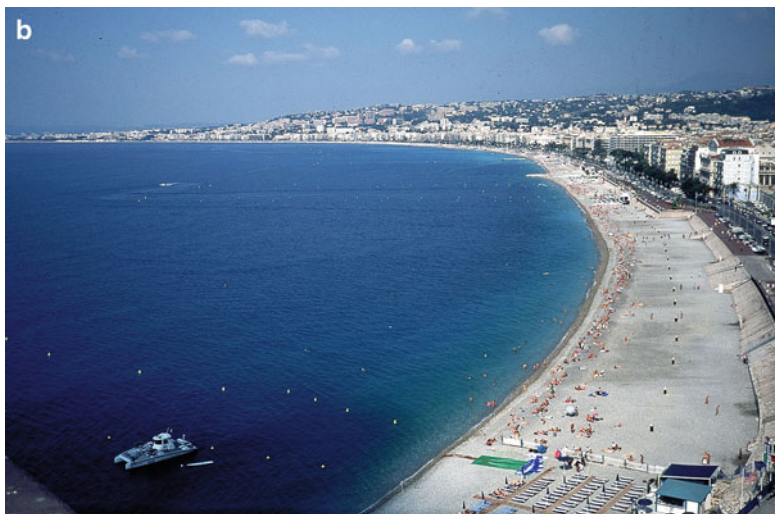
Fig. 18.6 The steep French Riviera margin in the Nice area (a). The figure shows an assemblage of the topography (Courtesy of IGN) and bathymetry (Courtesy of IFREMER). Photograph of Nice beach in early summer at the start of the tourist season (b). The seawall supports the prestigious *Promenade des Anglais*, the construction of which in the nineteenth century led to considerable narrowing of the original gravel barrier bounding the bay, bringing its seaward face close to the steep shoreface. Mean beach width has hardly varied over the period 1976–2005 in spite of massive nourishment (c) (After Anthony et al. 2011)

This case concerns the urban front of Nice, in the French Riviera in southern France (Fig. 18.6), a leading world tourist destination, especially attractive for its sunny coast. Rapid socio-economic development in the Nice area has brought considerable pressure to bear on the gravel beaches bounding the Baie des Anges, generating considerable beach narrowing (Fig. 18.6b). Other effects that have impacted the beaches include the reclamation and extension of the Var delta plain through infill, and armouring of the shoreline for the construction of Nice-Riviera airport (Fig. 18.6a), thus completely cutting off the former natural gravel supply from this river (Anthony 1994; Anthony and Julian 1999). The present beach sediment budget is one of zero natural sediment inputs, resulting in chronic beach erosion (Anthony et al. 2011). The 4.5 km-long beach has been artificially nourished since 1976 to the tune of 558,000 m³, representing an input of 123 m³ of gravel per metre of beach throughout the Nice seafront, making this long-term operation one of the most important in France, and certainly one of the most significant for gravel beaches in the world. The nourishment gravel is provided at little cost essentially from the numerous housing and construction sites on the Plio-Pleistocene puddingstone geological formations that constitute the hilly foundations of much of the city, and which are rich in rounded gravel clasts. Nourishment has been nil in certain years (1979, 1980, 1983–85, 2001–2002) but reached a peak of over 97,000 m³ in 2000.

The beach shows no significant change in net width (Fig. 18.6c) over a monitored 30-year period (1976–2006), despite the massive nourishment (Anthony et al. 2011). In fact the two sectors where beach width has shown a net decrease received over 211,000 m³ of nourishment. Analysis of wave climate records show no significant change in significant wave heights over the nourishment period. Since
