Chapter 6

Structural Health Monitoring of Sheffield University Arts Tower During Retrofit

Abstract The 78 m Arts Tower at the University of Sheffield has been refurbished during the period 2009–2011, with improvements that included replacement of facades and partitions. The structural changes have been reflected in changes in dynamic properties that have been tracked by a pair of roof-top mounted tri-axial seismometers. The response data have been analysed in real time and accessed by web-viewer, capable to show that natural frequencies have changed dramatically during and after the retrofit. The monitoring system has demonstrated significant variations in modal parameters at different response levels.

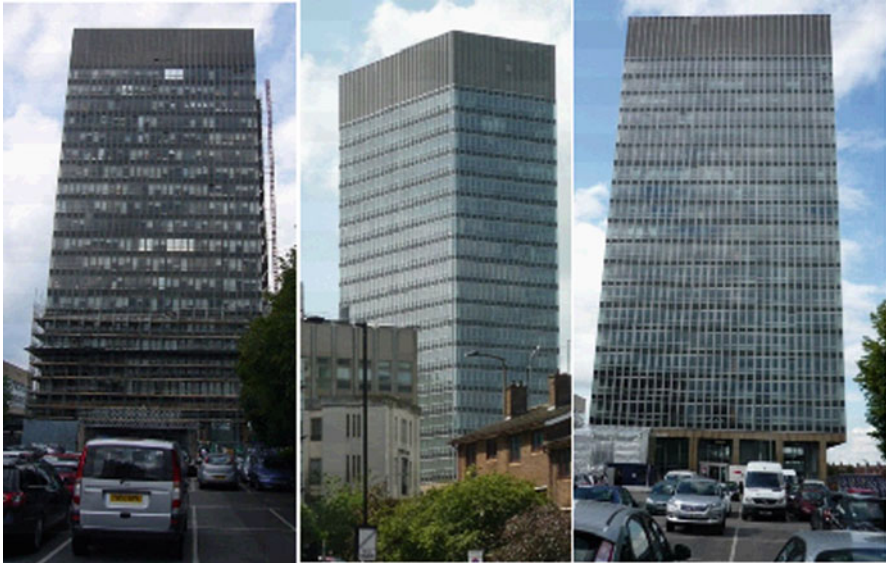
Fig. 6.1 Arts tower during (*left*) and after (*right*) retrofit

Figure 6.1 shows the building at various stages of the operation; with original façade and following its replacement, while Fig. 6.2 shows the internal floor plan before and after the retrofit and Fig. 6.3 shows the original and replacement partitions. The heavy masonry partitions, arranged as shown in the original floor plan, have been largely demolished in the lower left view in Fig. 6.3 which shows the narrow side of the floor. The middle view shows a totally cleared floor on the wider side with the two cores on the left, and the lower right view shows one of the many partition arrangement in the new configuration. Some floors now have no partitions, others have a combination of fixed and sliding partitions, as shown.

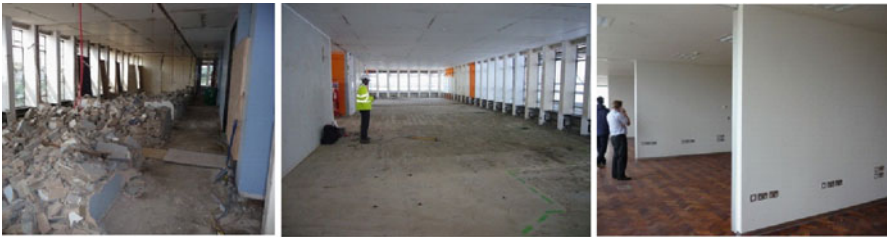
Fig. 6.3 Demolished masonry partitions, cleared floor and new movable partitions

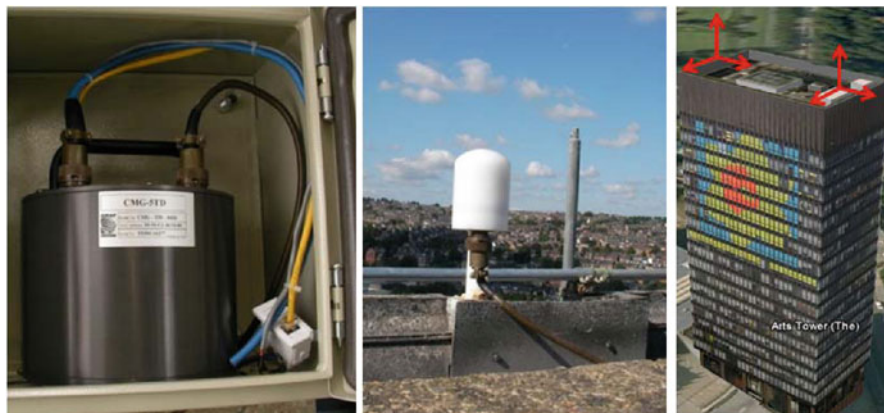
Fig. 6.5 Triaxial accelerometers and GPS antennae for FSDL system

In September 2009, during the refurbishment of the University of Sheffield Arts Tower, a vibration monitoring system was installed by Full Scale Dynamics Ltd (FSDL). The system, shown in Fig. 6.5, comprises a pair of Guralp CGM-5TD triaxial accelerometers mounted at two locations on the roof and synchronised by GPS. Six channels of acceleration signals are digitised and transmitted to a server for storage and processing.

In Fig. 6.5, the local axes of the two sensors are designated N and E, corresponding to the fixed internal labelling system used for this type of instrumentation. However the major (long) axis of the building is aligned close to the geographic East–West axis and hence the convention used by BRE identifying East–West (EW) for movement along the long axis and North–South (NS) for movement transverse to the long axis. The twisting or torsional vibration modes designated θ are also labelled TH.

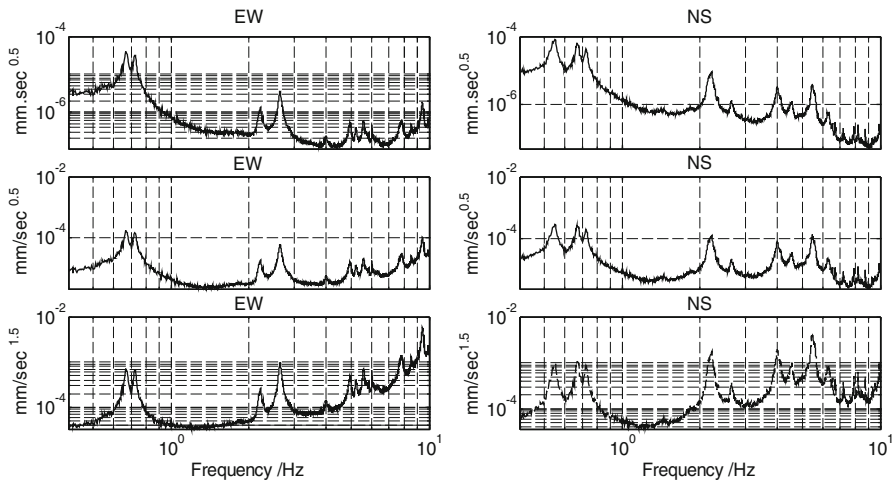
Fig. 6.6 Broadband displacement power spectra for 4 January 2011

Power spectral densities (PSDs, in square root form) of NS and EW response for 4 January 2011, a breezy day with winds between 4 and 8 m/s are shown in Fig. 6.6

for displacement (top), velocity (middle) and acceleration (bottom). The response levels are an order of magnitude smaller than for the strongest winds, but the data show features relevant for discussion.

In the PSDs mode NS1 (0.56 Hz) only appears in the NS response, while modes NS2 and 02 (2.16 Hz/2.22 Hz) are merged into one peak by the averaging process and the small variations of modal frequency during the day. Higher modes dominate the acceleration.

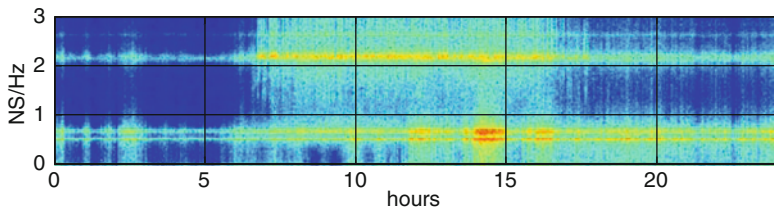
Fig. 6.7 Spectrogram of NS velocity corresponding to Fig. 6.6

Displacements and accelerations are derived by integration or differentiation of the seismometer velocity signals, which are shown in Fig. 6.7 as a spectrogram, for the NS component. The 0–3 Hz bandwidth is shown, covering the lowest six modes, which can be distinguished by close inspection of the bands.

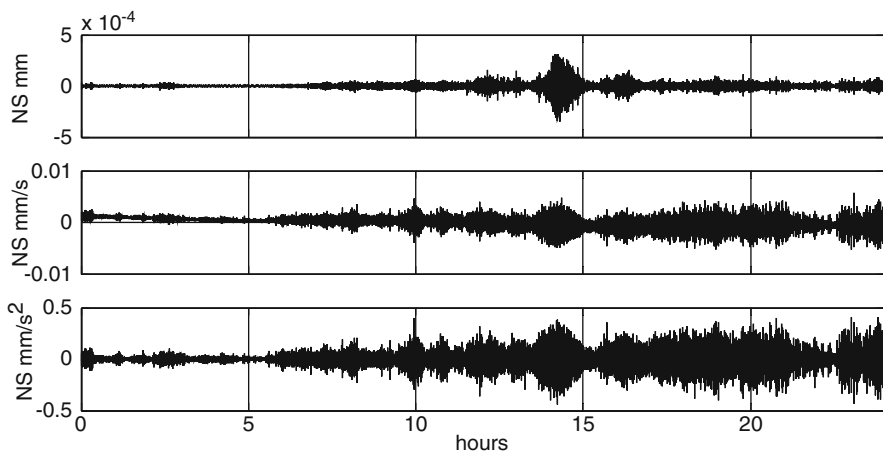
Fig. 6.8 Arts tower motion in NS direction on 4 January 2011

The raw time series for the NS component are shown in Fig. 6.8 for broadband and in Fig. 6.9 for the 0–1 Hz band containing the first three modes. Displacements (row 1) are very small and will be dominated by the first three modes. The contribution of fundamental modes to the total acceleration is clear from comparison of row 3 in the two figures and inspection of Fig. 6.6.

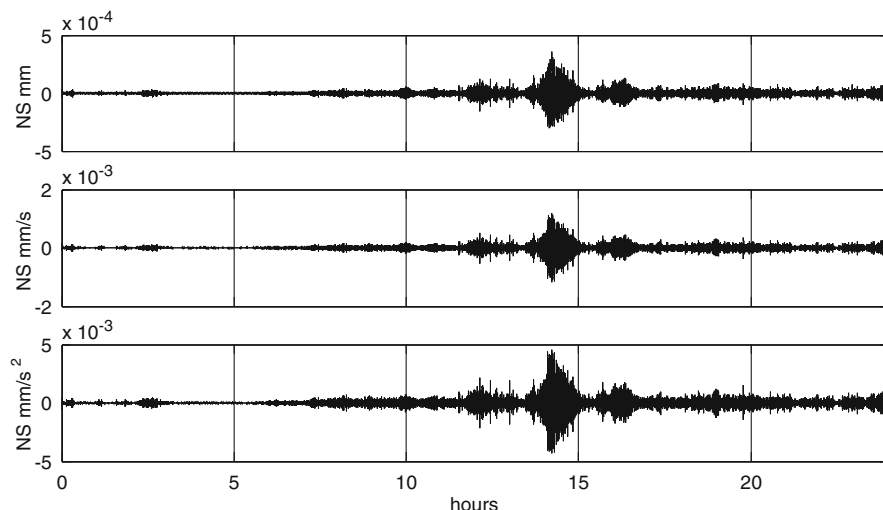
Fig. 6.9 Arts tower motion in NS direction on 4 January 2011, 0–1 Hz components

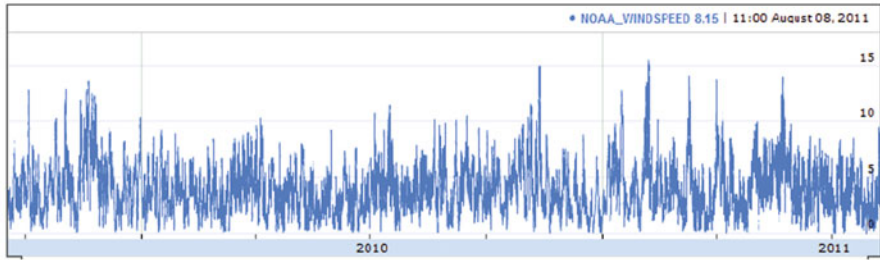
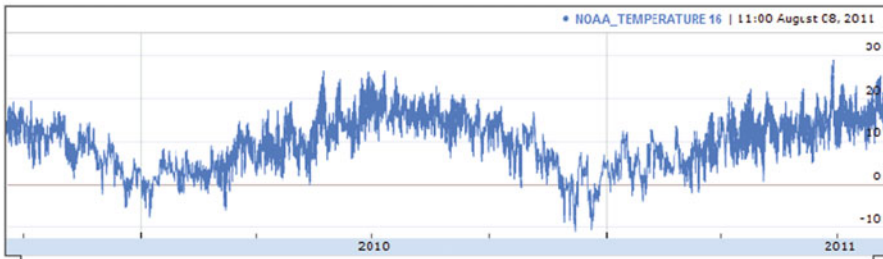
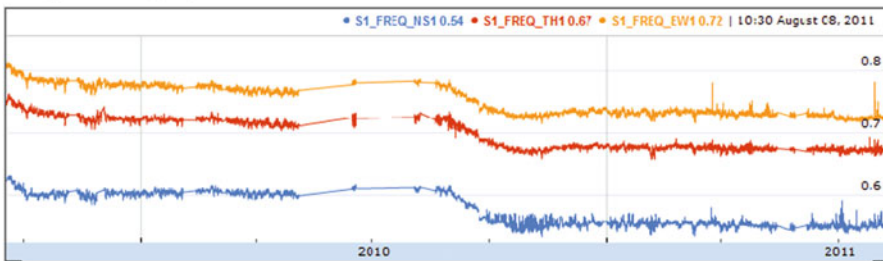
Fig. 6.10 Meteorological conditions and fundamental mode frequencies for duration of FSDL system. Data span 17 September 2009–8 August 2011

Phase 1 removal of masonry partitions (levels 9–19) began in August 2009 (before FSDL monitoring was operational) and was completed on 9 October 2009. This corresponds to the first period of steadily decreasing frequencies.

Demolition of the original façade was carried out from September 2009 to February 2010 working from the top (level 19) down. Installation of new façade was carried out from November 2009 to July 2010 working from the top down. The early part of the façade removal overlaps the partition removal so a distinct effect

cannot be seen, however the rise in frequencies over mid-summer 2010, even with missing data, corresponds with the façade re-installation.

Phase 2 removal of masonry partitions (levels 8 down to level 1) began in the first week of September 2010, with one week per floor. This period corresponds to the fastest and most significant drop in frequencies.

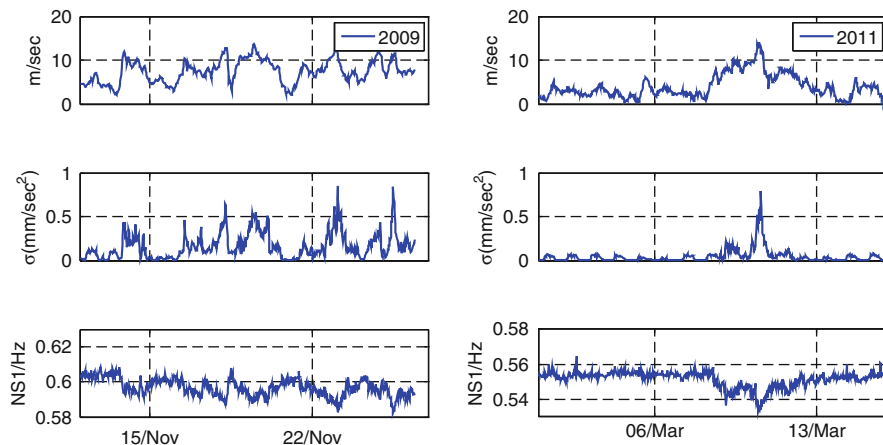
Fig. 6.11 Large amplitude response examples before and after retrofit: wind speed, RMS acceleration and mode frequency

For two periods when frequencies were not changing due to construction events, the relationship of response amplitude with frequencies is very clear. Figure 6.11 shows for both periods clear daily RMS variations.

For both periods, frequency drops are clearly linked to RMS response level, with similar amplitude dependence in higher order modes. Note the RMS is broadband, which is dominated by the lower frequency modes for strong winds.

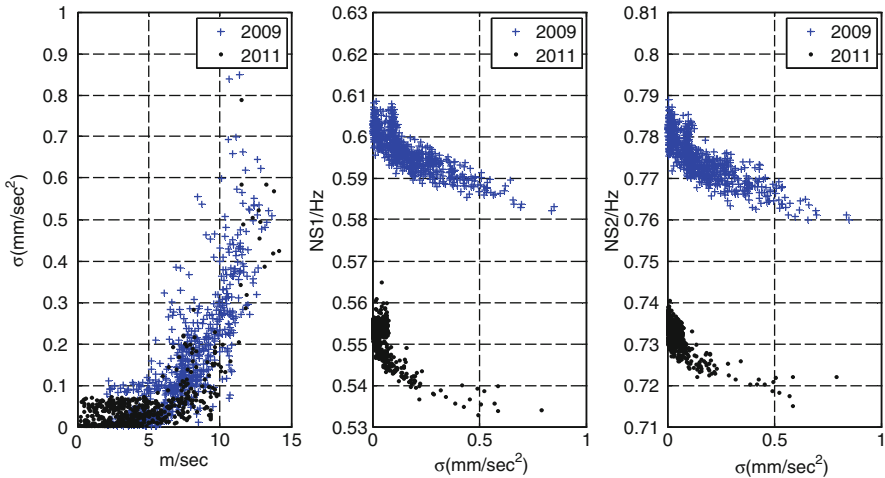
Fig. 6.12 Wind-amplitude and frequency-amplitude dependencies before and after retrofit

The relationships before and after the retrofit are presented in Fig. 6.12, with no obvious difference between the two periods for all the relationships. The lack of obvious difference of amplitude dependence on wind allays fears of the effect of reduced stiffness. Where narrow band RMS values (focused around specific modes) are available the trends are similar and not clarified.

Moreover Fig. 6.12 shows no obvious change in relationship between wind conditions and response. Changes in mass distribution due to all the alterations are not known (although removing masonry partitions is likely to have reduced mass) but the frequency drops will be primarily due to stiffness reduction. The only means of compensating for reduced stiffness will be increased damping, but the evidence for that is not clear.

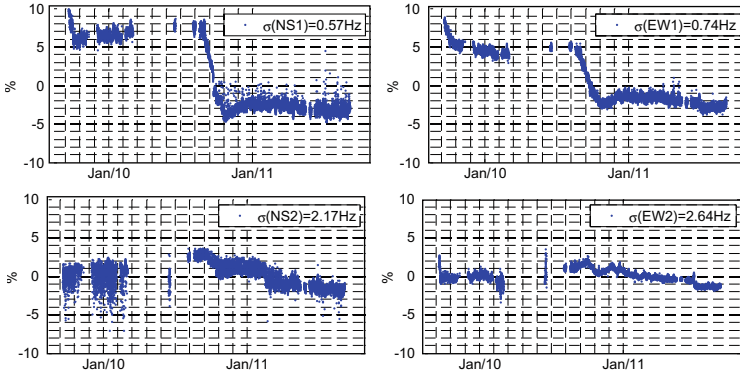
Fig. 6.14 Percentage changes in first four translation modes

Figure 6.14 shows trends in the lowest four translational modes as percentages of the mean value for the duration. The data points plotted correspond to the lowest levels of response, below 0.2 mm/s².

The two horizontal modes (NS2 and EW2) display a rather different pattern to NS1 and EW1. First, the changes are proportionally smaller. In particular the dramatic reduction in NS1 and EW1 frequencies is replaced by a modest rise followed by a modest fall, reaching a minimum frequency simultaneously with NS1 and EW1 frequencies. From then until the most recent measurements, NS2 and EW2 frequencies drop steadily, and more significantly (even in % terms) than NS1 and EW1. Ranges of EW1 and EW2 are larger than for NS1 and NS2.
