Chapter 8

Structural Health Monitoring Performance During the 2010 Gigantic Chile Earthquake

Rubén Luis Boroschek

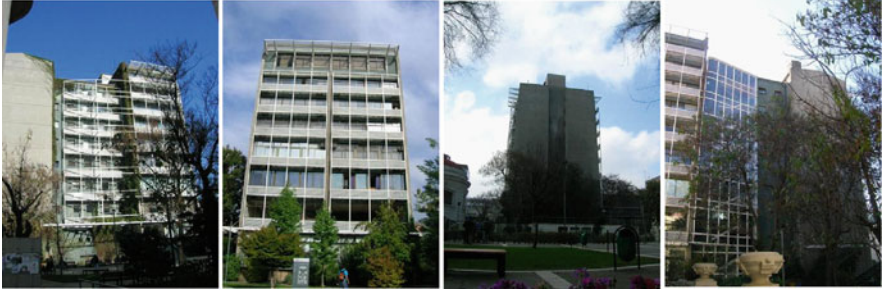
Fig. 8.3 Torre Central general view

One of the instrumented buildings, called Torre Central, was constructed in 1962. It is located at the Engineering Faculty of the University of Chile. The building has office and classroom use. It has nine stories above ground, two underground levels, and a total surface area of 4,602 m². It has a total height of 30.2 m and a plan area of 30 m \times 19 m (Fig. 8.3). The structural system consists of reinforced concrete shear

walls. Typical wall thickness is 35 cm and typical slab thickness is 25 cm. The ratio between total wall area and plan area for all above ground stories is 7.7%.

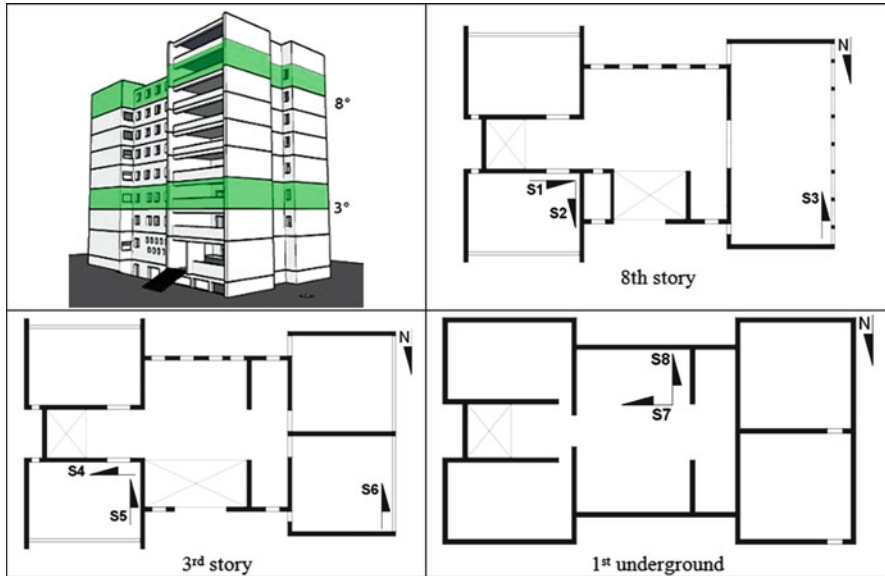
Fig. 8.4 Accelerometer location

The system has eight force balance accelerometers, configured in a range ± 1 [g] with two parallel acquisition systems: the first one, the seismic records with a trigger configuration; the second, with an amplification of the analog signal to capture continuously the ambient vibrations. The accelerometer location is shown in Fig. 8.4. Three sensors are located horizontally on the third and eighth floors, and two sensors are at the foundation level. This sensor distribution allows for the monitoring of the spatial motion of the structure, the identification of the modal

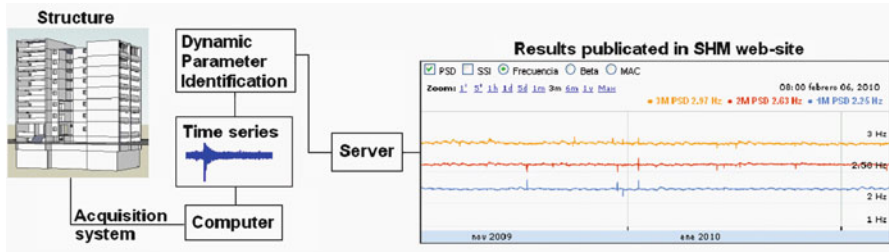
Fig. 8.6 Structural health monitoring network workflow

The structural health monitoring system stores all data in a computer that also controls the acquisition system. The computer and acquisition system are located in the first basement of the structure. The computer stores and post processes the data using two system identification techniques to determine modal parameters: peak-picking and stochastic subspace identification (SSI) methods. The results are synchronized with the Civil Engineering Department server and published on Internet (www.ingcivil.uchile.cl/shm). Figure 8.6 shows the network and processing workflow used to obtain and display selected results.

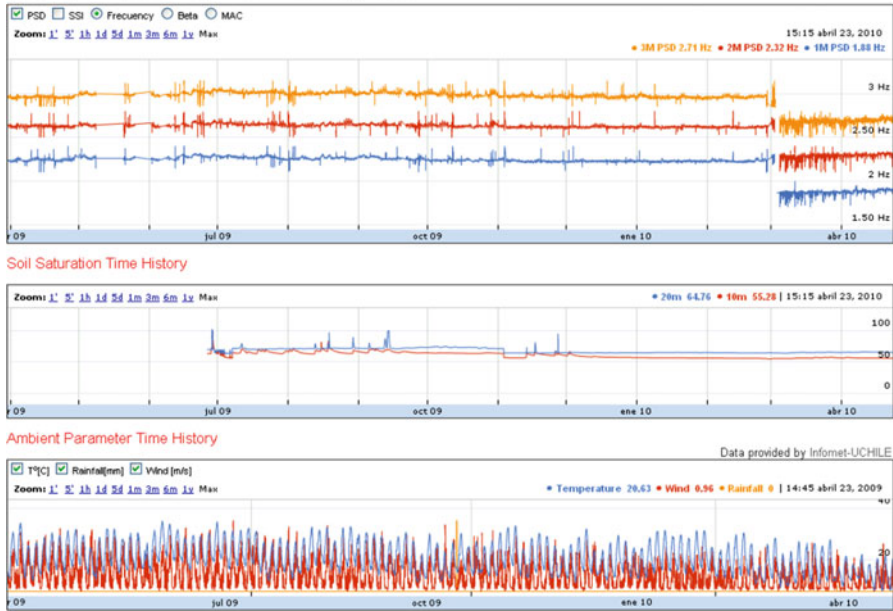
Fig. 8.9 SHM web page www.ingcivil.uchile.cl/shm

main page shows three graphics as a function of time: The first are the modal parameters showing the frequency and damping variations. The second shows soil humidity at three different positions, and the third shows ambient parameters, Fig. 8.9. The data can be zoomed easily by the user (Yañez 2009).

In Fig. 8.12, we observed that most of the period's change occurred after 30 s from the start of the records and is maintained during most of the strong motion phase closed to seconds at 100. This information as well as the information derived from the statistical analysis of ambient vibration-derived properties and the ambient vibration identification just before and after the earthquake, a merely maximum 15-min difference between all analyses done, gave a clear indication that the modal parameters have been permanently modified during the earthquake. The abrupt change in reported parameter can be seen on the web output in Fig. 8.9.

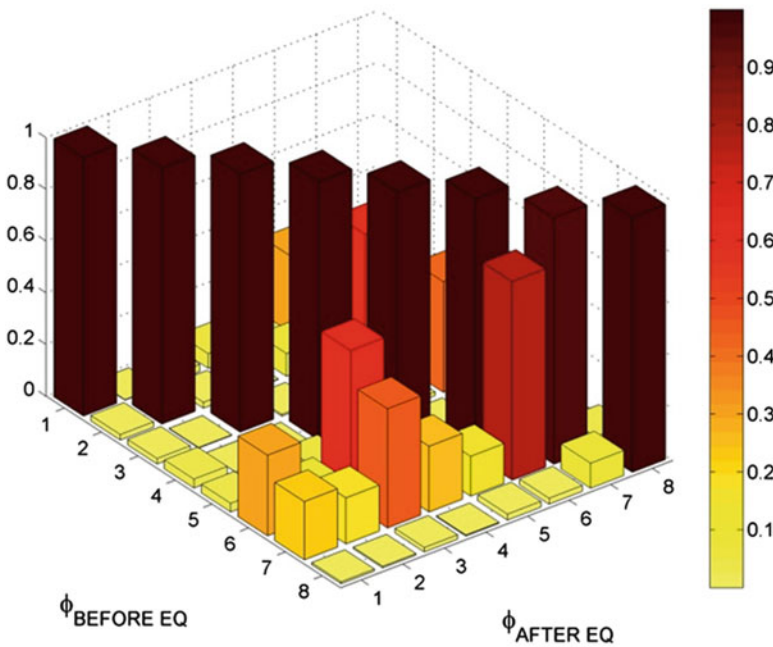
Fig. 8.11 MAC value for ambient vibration-derived modes before and after the main earthquake

values present a large dispersion. Mode shapes from pre- and post-earthquake identification process present minimum differences as can be seen from the excellent correlation between similar frequencies as observed from the MAC values presented in Fig. 8.11.

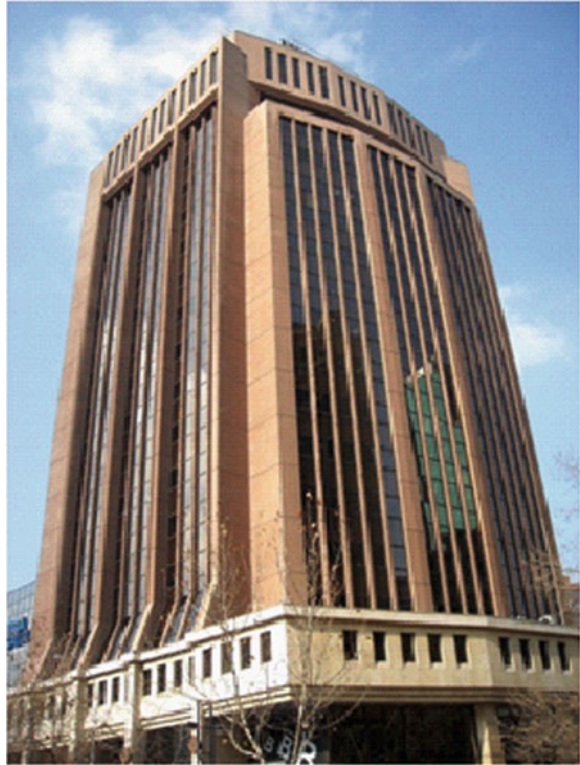
Fig. 8.15 Sensor location

This is the first permanently instrumented building in Chile. Initially the instrumentation consisted in three independent triaxial analog accelerograph located at the ground and at the middle and top levels. This system never recorded the earthquake so it was replaced by a digital network in 1995, with the help of the Chilean Science and Technology Council, CONICYT. The new network that has been in place for more than 16 years consists of 12 uniaxial force balance accelerometers connected to a central recording unit, Fig. 8.15. The sensors register the analog acceleration with a dynamic range of 135 dB between 0.01 and 50 Hz and 145 dB between 0.01 and 20 Hz. The analog signal is converted in to a digital record in the central recording unit with a-19 bit resolution. This bandwidth and dynamic range allows the recording of ambient and earthquake records with the same system. Three sensors are located horizontally on the 12th and 19th floors, two sensors are at

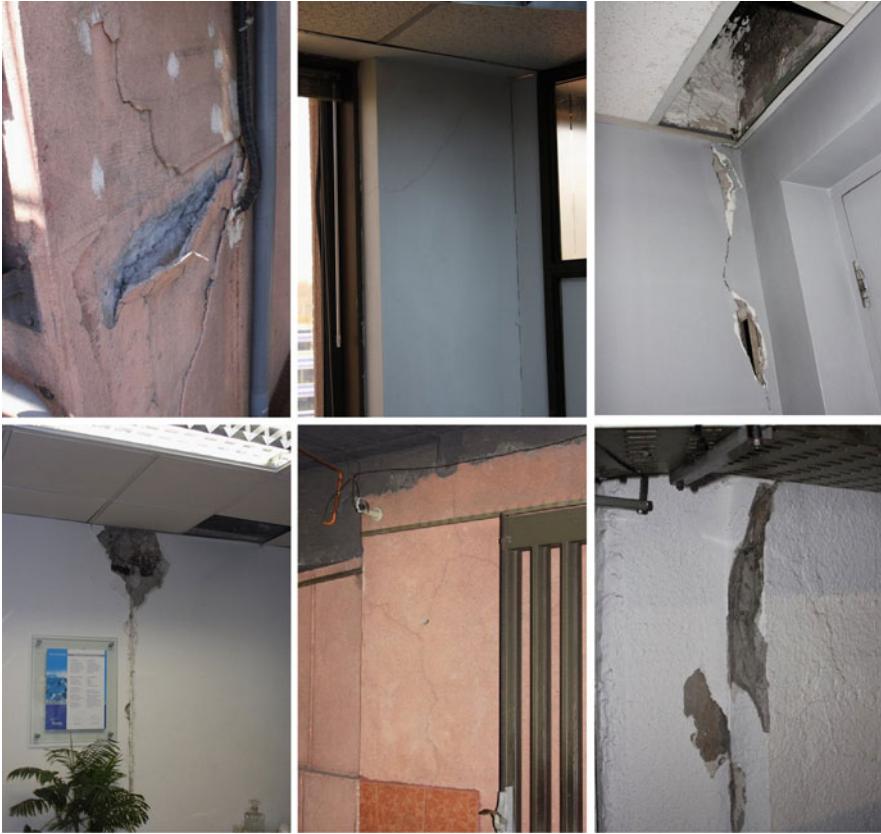
Fig. 8.16 Structural and nonstructural damage (Photo Bartolomé-Caroca)

During the 2010 earthquake, the building presented light structural and nonstructural damage. The damage was concentrated mainly in the perimeter concrete wall and frames and in some nonstructural partitions and ceilings, Fig. 8.16.

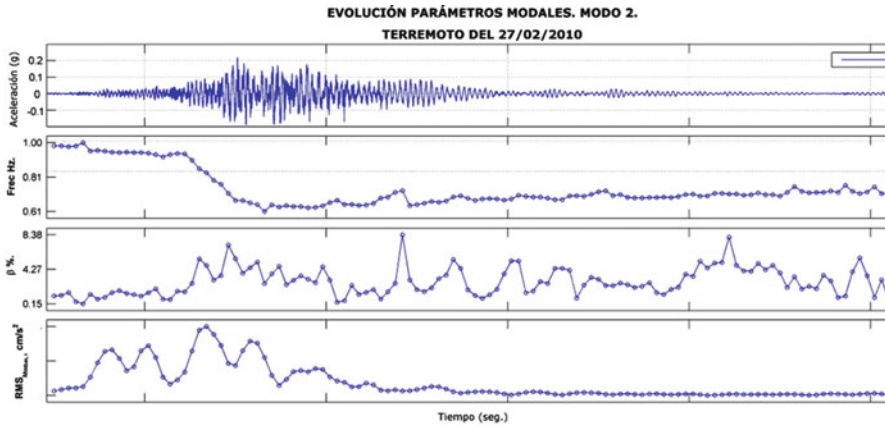
Fig. 8.19 Evolution of second mode frequency, damping, and RMS modal intensity

In a similar way as indicated in the previous building, we have performed a system identification using nonoverlapping sliding windows. Figures 8.18 and 8.19 present the frequency change as a function of time for a window of 4-s duration.

On top of each figure, we present one characteristic acceleration record, below the variation of the natural frequency, the variation of damping, and the RMS value of the modal response. From the frequency variation on both figures, we can conclude that the main change on natural frequency started with a ground acceleration amplitude higher than 0.08 g after that, no permanent change in natural frequency occurred. When the amplitude of the response diminished, the natural frequency increased to a value close to the post-earthquake ambient vibration level.
