# Geomorphological Impacts of Extreme Weather

Case Studies from Central  
and Eastern Europe

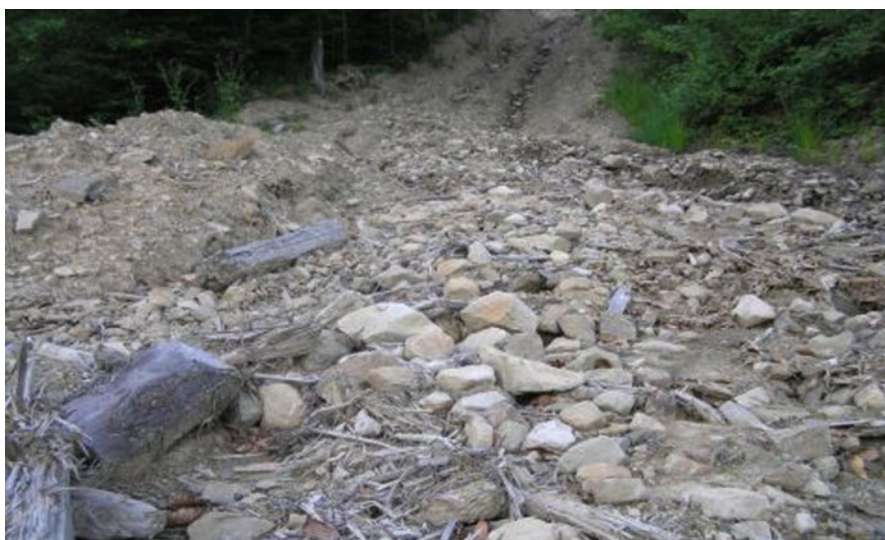
**Fig. 4.3** The fan of the mudflow activated by deforestation of slopes in summer 2004 and a heavy rainfall event on 10 June 2005 (an intensity of  $56 \text{ mm}\cdot\text{day}^{-1}$  recorded at the meteorological station in Oriava) (photo by O. Pylypovych)

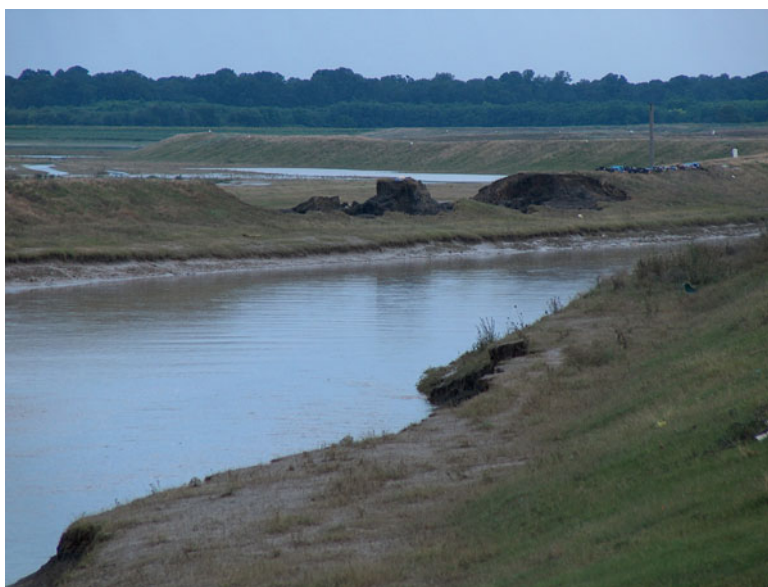
**Fig. 7.2** Dam breach at Condrea village

Dangerous levels were exceeded at all hydrometric stations on the Siret River before 2005, too. Peak discharges had a 2–5% (Table 7.7), the 4,650 m<sup>3</sup> s<sup>-1</sup> peak flow of 2005 at Lungoci 0.5% probability. Reconstructed flow for Cosmești was 5,500 m<sup>3</sup> s<sup>-1</sup>. The prognoses estimated over 6,600 m<sup>3</sup> s<sup>-1</sup>, but the local authorities ordered the opening of several dams and intentional flooding of inhabited enclosures to reduce the flow downstream (Fig. 7.2). Only due to these measures did the discharge of the Siret not exceed that of the Danube.

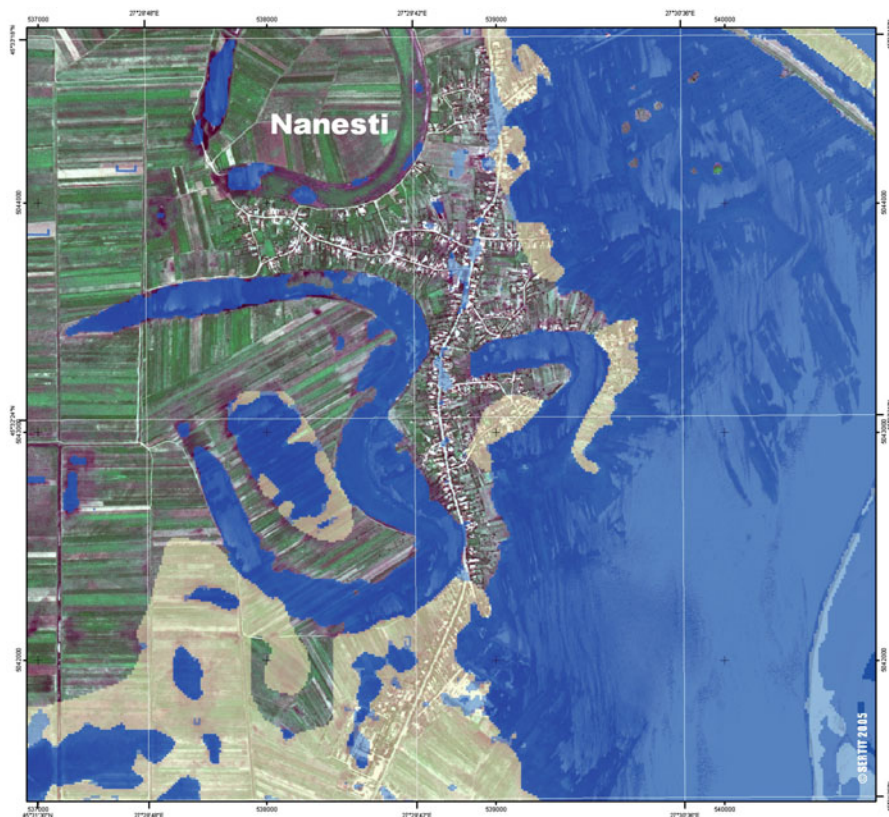
**Fig. 7.3** Flooding of Nănești village and of the abandoned channels on the Siret floodplain

High flow breached flood-control dykes and filled abandoned channels (Fig. 7.3), thus enlarging the areas where alluvia accumulated and also significantly eroded the concave banks. At Cosmești village, more than 50 m of the concave bank were eroded (Fig. 7.4), while at Piscu, a new accumulation strip of 100 m length emerged (Romanescu and Nistor 2011) (Fig. 7.5).

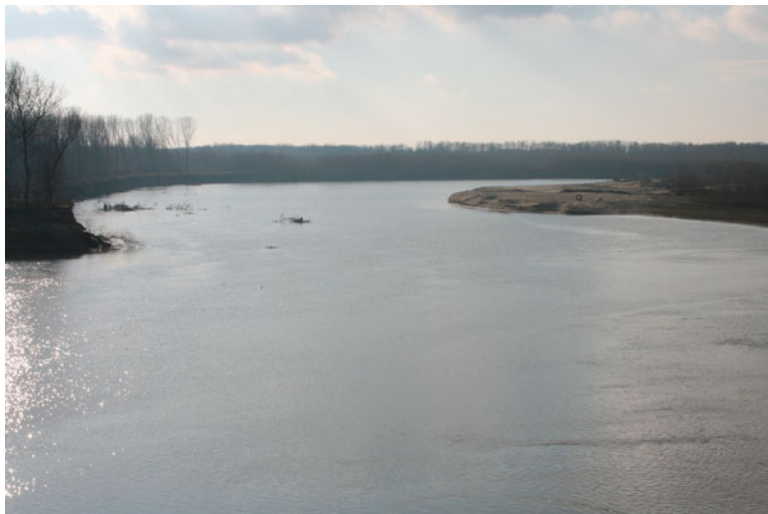
**Fig. 7.5** Alluvial accumulation at Piscu village (downstream of Lungoci)

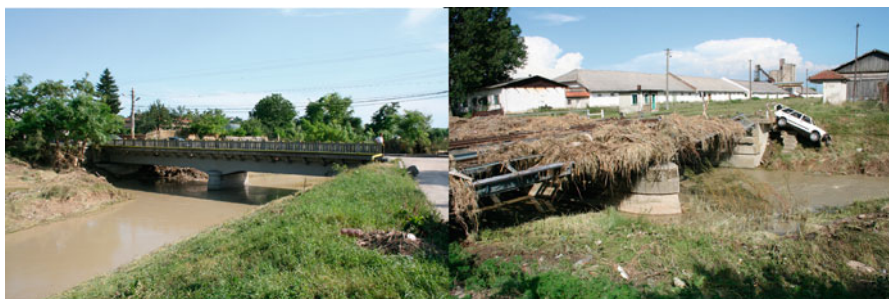
Fig. 7.13 Barriers (railway and road bridges) at Dorohoi town

an  $85 \text{ m}^3 \text{ s}^{-1}$  high wave caused material damage and took a death toll in two rounds (Fig. 7.11). At first, areas on the Buhai watershed were flooded to the backwater effect (oversized bridges did not allow the water to flow through). After the major riverbed filled up and the water passed over the bridges, a second wave followed. Then the common floodplain of the two streams was flooded and the flood wave from the Buhai Stream moving at full speed managed to ‘climb’ the dam of the Ezer reservoir (Fig. 7.12). The waters penetrated the lake through the high-water spillway, situated at an altitude of 153 m. The high-water wave reached 153.5 m in height and spilled over in 50 cm depth. As this phenomenon was noticed and analysed for the first time in the literature, it was named ‘*spider flow*’, referring to the fact that the water climbed the walls. Since the rainfall event occurred at night, the hydrologic warning came with delay. The consequences were devastating: six deaths, public buildings destroyed, and over 1,500 dwellings damaged (Fig. 7.13).

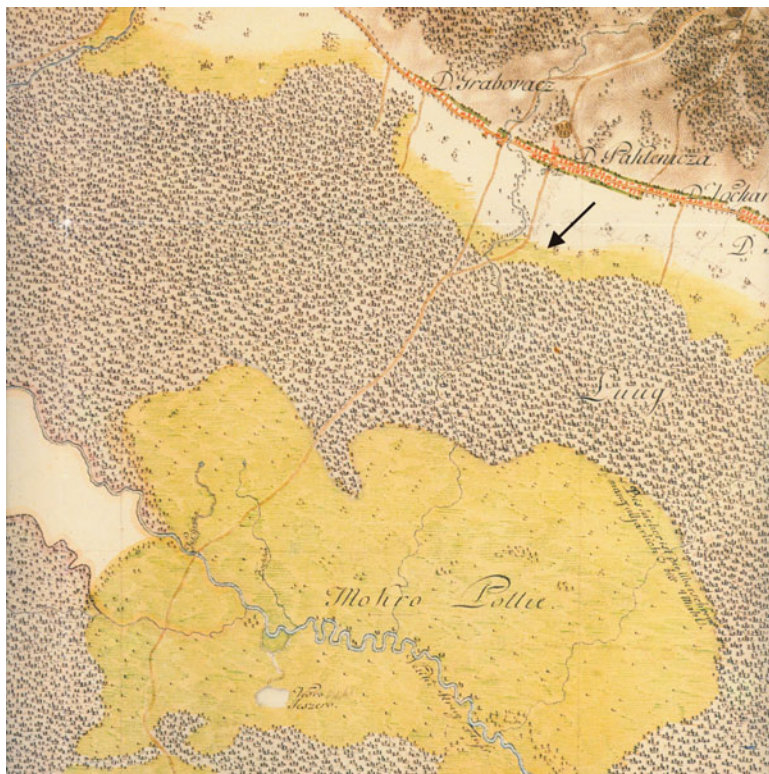
**Fig. 8.3** Adaptation of the location of settlements and traffic routes to lowland floods, example from the Pannonian Basin (*izmera Slavonska vojna krajina* “survey of the Slavonian Military Frontier,” 1780–1782), section 4 map of the military survey from the end of the eighteenth century (Zorn 2007). The map bears the text: *Bis hieher ist die Uberschwemmung alljährlich 3 bis 4 Mahl* (“floods extend to this point three or four times per year”). The arrow shows the extent of annual floods. Current urbanization in Slovenia too often does not consider past knowledge about the landscape (Komac et al. 2008b; Komac 2009), which considerably increases damage during lowland floods

area (Fig. 8.3). This is not the case for flash floods (Fig. 8.4). Buildings are often right alongside the beds of small streams of gentle flow but with flash flood hazard (Komac et al. 2008a).

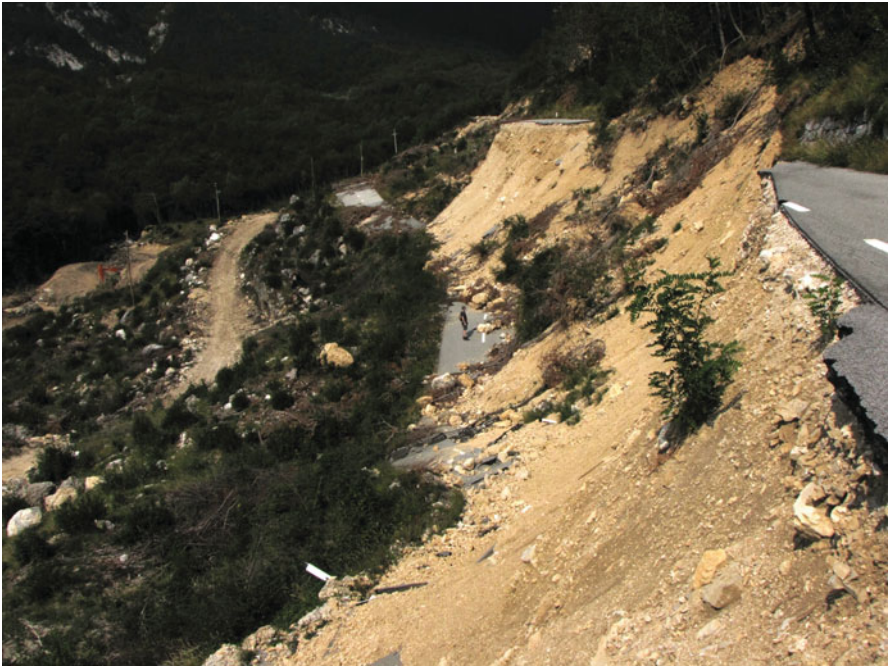
**Fig. 8.7** During extensive precipitation in September 2010, the Stogovce landslide was triggered, which destroyed a kilometer of the road between Ajdovščina and Predmeja (photo by M. Zorn)

the coastal area around Koper, the Vipava Valley, and the Pohorje Massif. Nearly 100 landslides were triggered in the municipality of Laško (in eastern Slovenia) alone, of which 15 threatened residential structures. The Stogovce landslide (Petkovšek et al. 2011) near Col destroyed a kilometer of the road between Ajdovščina and Predmeja (Fig. 8.7). Sediments from floodwaters were visible in the Gulf of Trieste (in the northern Adriatic) (Fig. 8.8).

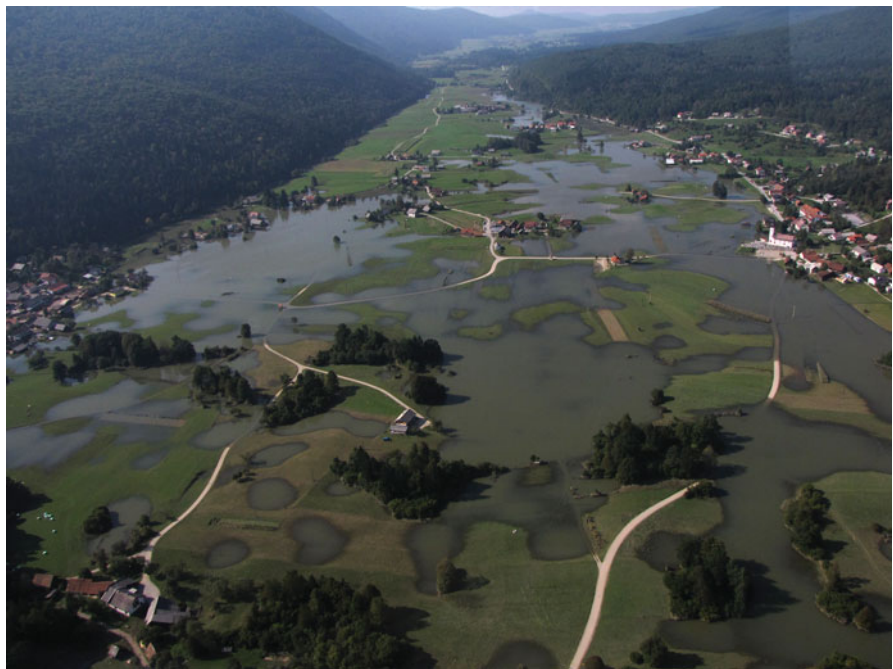
Fig. 8.12 Flooded karst mosaic in the Dobrepolje karst polje between the villages of Podtabor (left) and Paka (right), 23 September 2010; an example of extreme karst flooding. Bottom of the picture: flooded dolines (photo by M. Zorn)

The Rašica drainage basin, in which surface watercourses predominate, and the Dobropolje karst polje in the region of Suha krajina are connected by a dry valley between Ponikve and Predstruge that shows hydrological activity only during exceptionally high water levels. Flooding both in the Rašica drainage basin and the northwestern Dobropolje karst polje is of the lowland type. Karst flooding occurs in the southeastern part. In the Dobropolje karst polje, floods are frequent in the southern and southeastern areas, near the settlement of Pri Cerkvi–Struge (Figs. 8.12 and 8.13). *Extreme flooding* occurs in Dobropolje because of high water

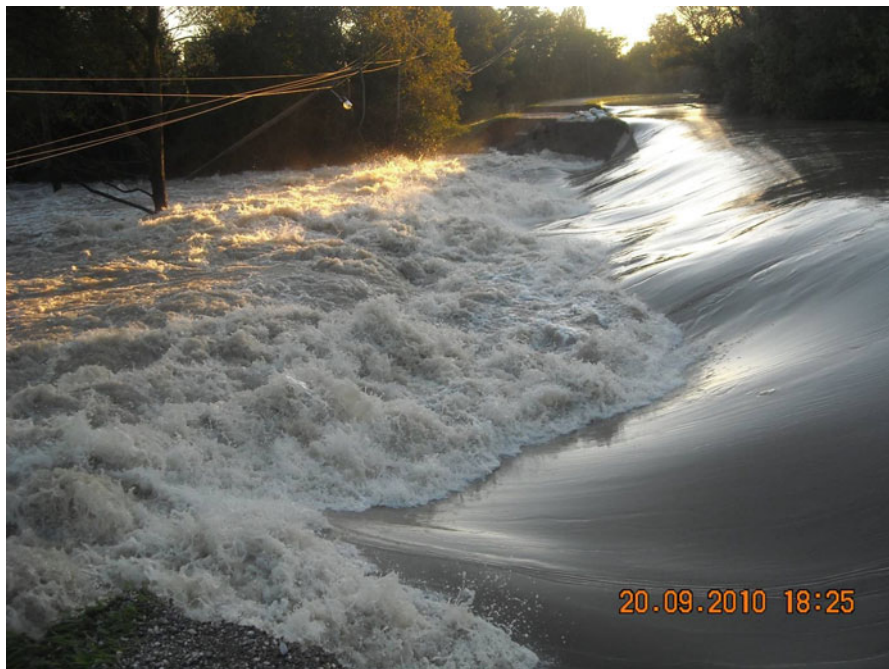
**Fig. 9.3** Overflow of the right-bank Sava embankment downstream of Zagreb, 20 September 2010 (*Source:* Hrvatske vode)

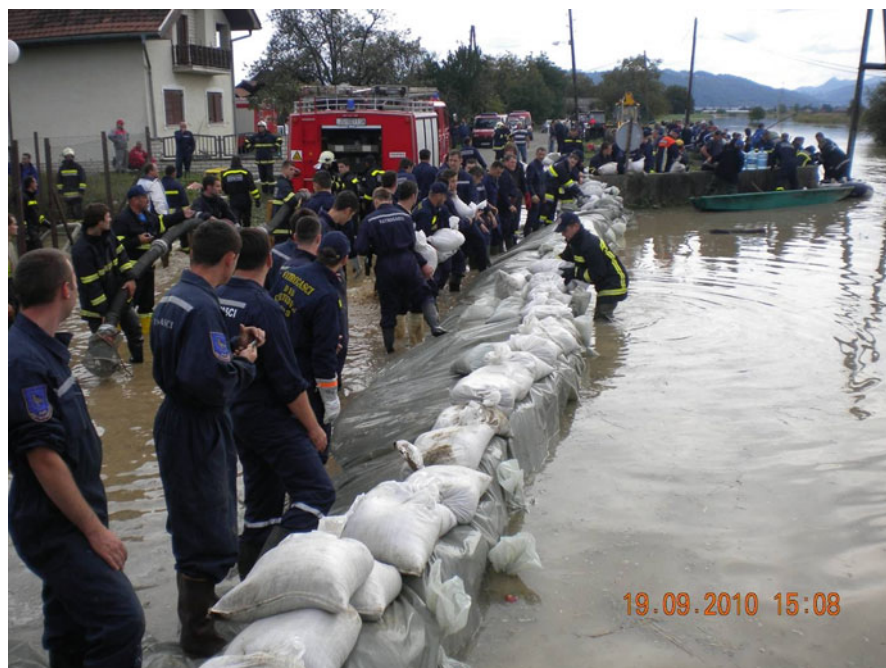
Fig. 9.4 Flood defence in the broader Zagreb region, 19 September 2010 (Source: Hrvatske vode)

Pursuant to the Water Act and the State Flood Defence Plan, Hrvatske vode carried out flood defence measures with the aid of companies licensed for works in water management. In the case of a higher level of hazard (Fig. 9.4) identified according to the protocol on cooperation with the National Protection and Rescue Directorate and county emergency centres, they coordinated the deployment of Croatian army units, police, fire fighters, and civil protection units of local self-governments.

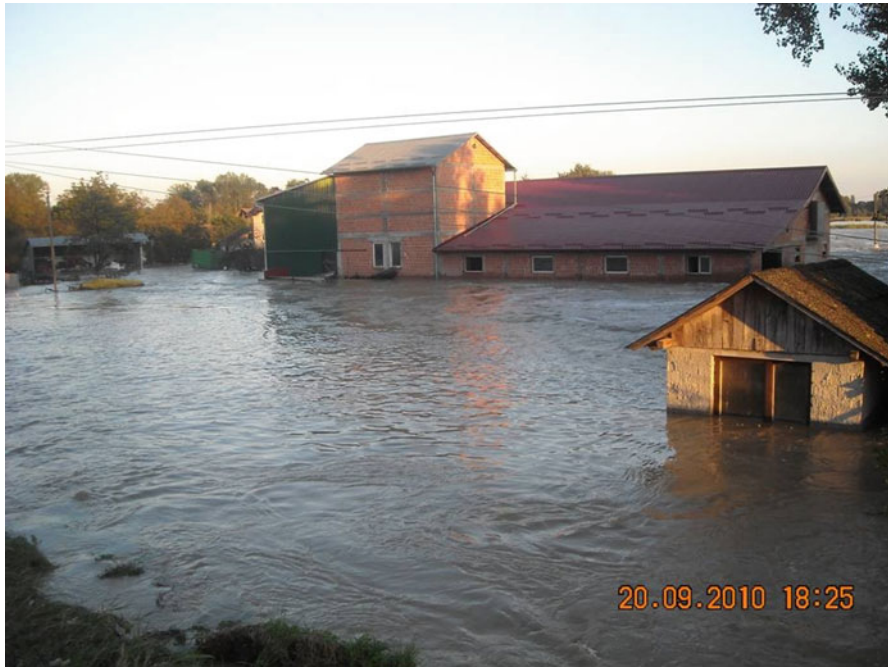
Fig. 9.7 Flooded village Čičkova Poljana along the Sava River downstream of Zagreb, 20 September 2010 (Source: Hrvatske vode)

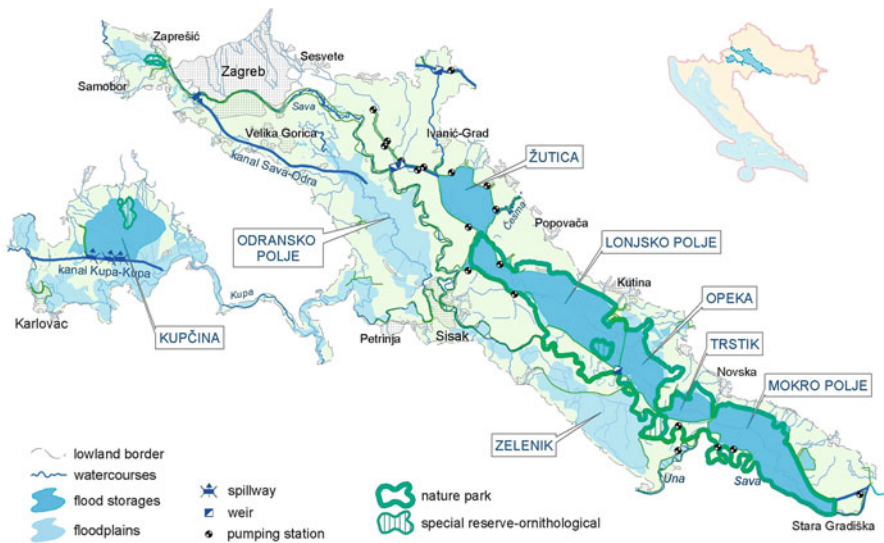
Fig. 9.8 Flood protection system in the Central Sava region (Srednje Posavlje)

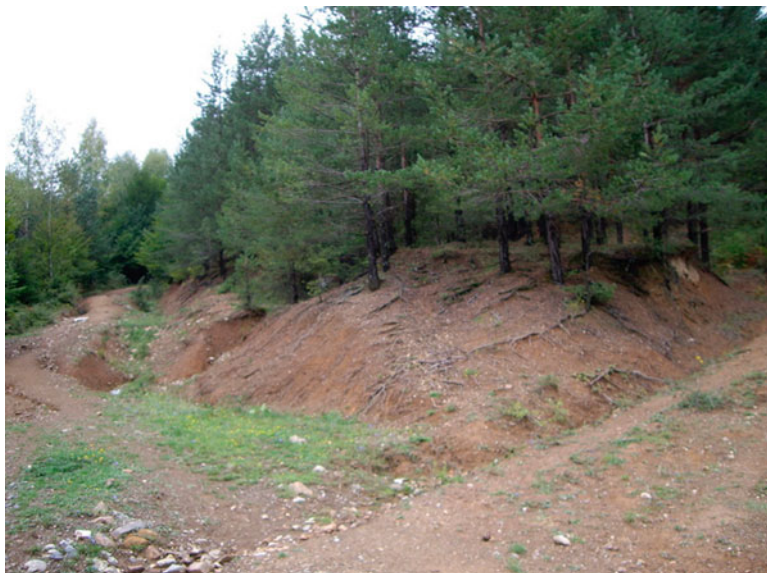
Fig. 12.2 Erosion in the basin of the Ravnitsa Stream

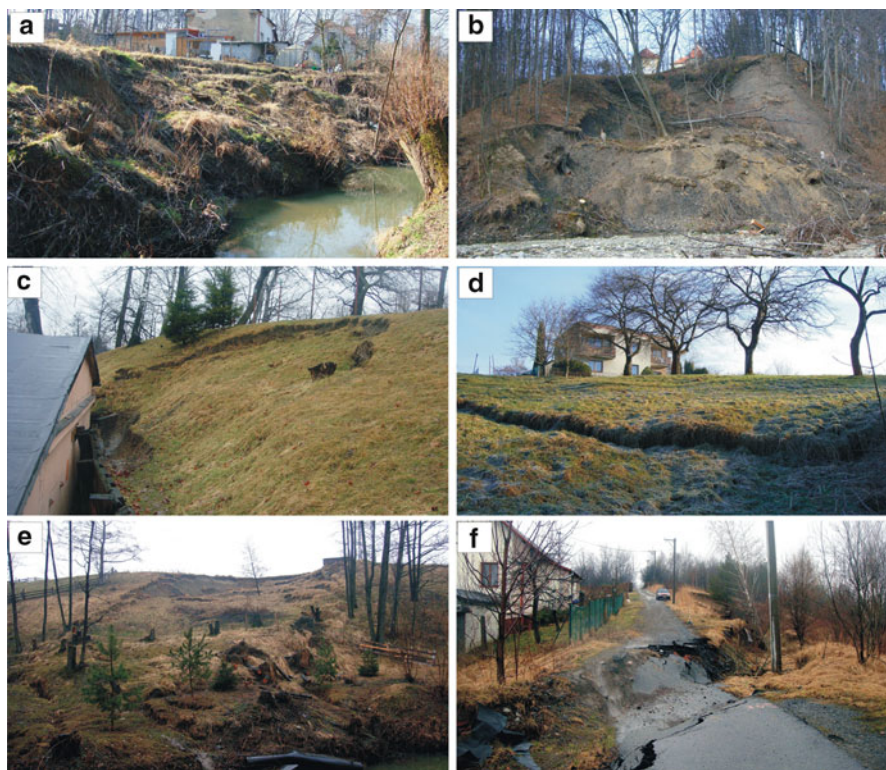
**Fig. 13.4** Examples of typical landslides of the May 2010 event. (a) Right bank of the Horní Datyňka River is affected by translational landslides along a length of 100 m due to lateral erosion (Horní Datyně village). (b) A debris slide situated below the church in Skalice village formed due to lateral erosion of the Morávka River. (c) Incipient translational landslide in Orlová town. (d) Tension cracks in the upper part of a shallow translational landslide, Horní Bludovice village. (e) Rotational landslide in the Quaternary deposits, endangering two houses in Stonava village. (f) Large rotational landslide in Doubrava village. Two houses suffered structural damage and had to be demolished (Photos by L. Kubiszová)

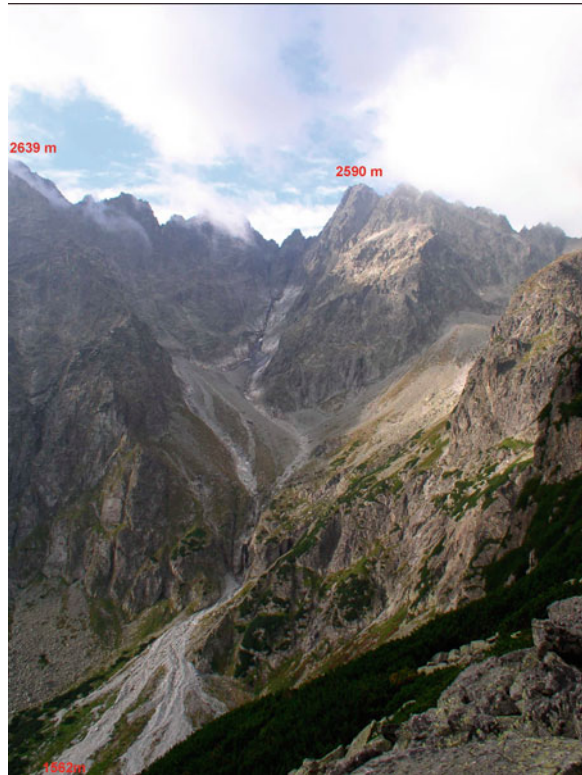
**Fig. 14.2** View of the Medena Dolinka valley, Slovakian High Tatra, with hanging cirque and glacial trough, a suitable setting for the development of gullies and levees of valley-confined debris flows, which transport material from ridge to valley bottom through subnival, alpine to subalpine belts (Photo by B. Gądek)

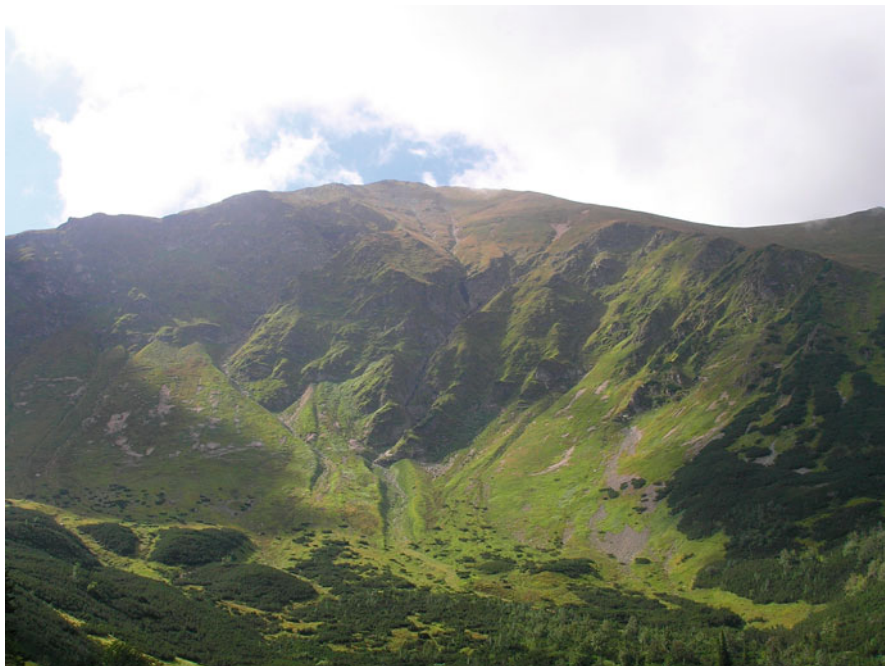
**Fig. 14.3** View of the Starorobociański glacial cirque, Western Tatra. Three-partite slope composed of (from ridge crest to valley bottom) periglacial slope, rocky slope dissected by chutes, and alluvial slope. The active valley-confined debris flows begin in the subnival or alpine belts and continue to the subalpine belt (Photo by Z. Rączkowska)

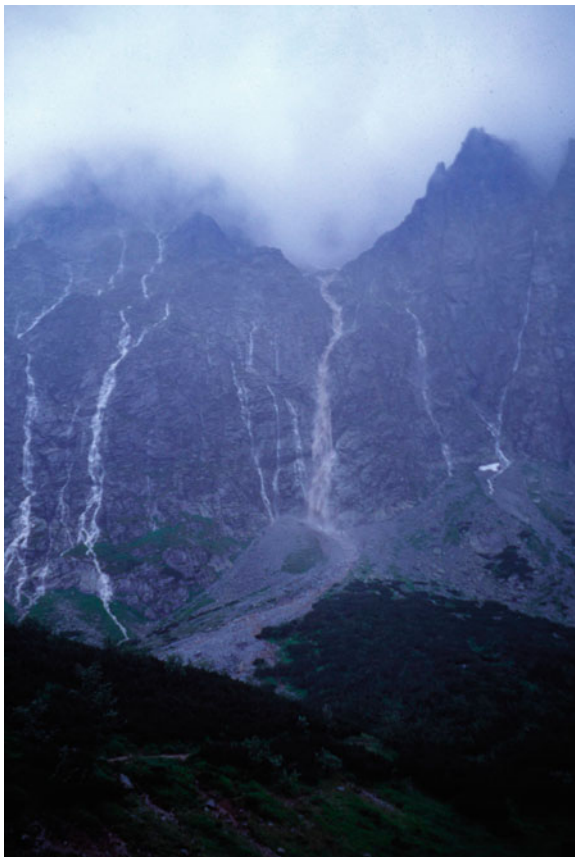
**Fig. 14.5** Overland flow on the rockwall of Maly Kežmarský štít peak on 17 July 2001, triggering a debris flow which affected the whole length of debris slopes. Rainfall intensity was 64 mm in 6 h (Photo by G. Bugár)

In the High Tatra, the systems of debris flows are more complicated. The Pleistocene glaciers formed classical, alpine-type valleys. In the highest regions, a debris flow is triggered by rainwater concentrated in chutes which flows rapidly onto gravitational talus heaps and talus cones (Fig. 14.5), forming typical *hillslope debris slopes*. As rock steps and exaration depressions with tarns occur, the longitudinal profiles of the main valleys are graded. In the High Tatra, debris flows start in the highest located cirques and continue downvalley. During extreme precipitation events in summer months, debris flows are set into motion, producing a complex system (Fig. 14.2), and weathered material is transferred across two or three vertical climatic zones (Kotarba and Strömquist 1984).

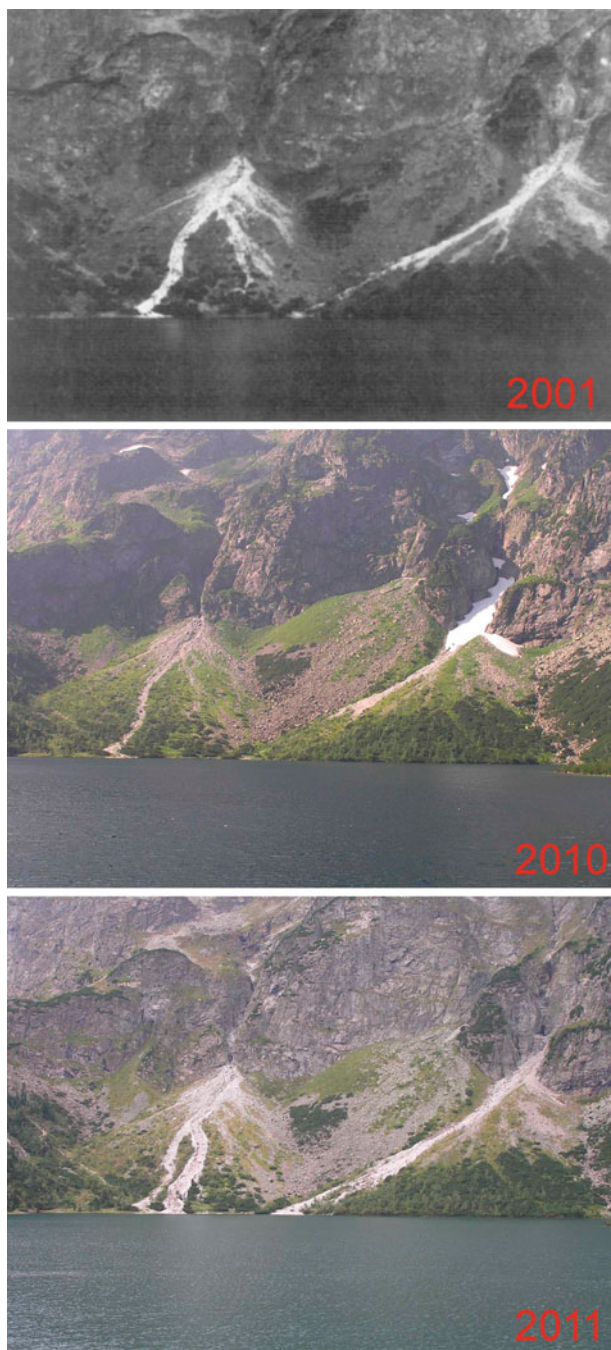
**Fig. 14.7** Hillslope debris flows at the Szeroki Piarg and the Zielony Piarg above the Morskie Oko lake, where fresh gullies evidence frequent debris flow activity in 2001, 2010, and 2011, but no geomorphological impact of the high precipitation in 2010 (2001, photo by T. Ferber; 2010 and 2011, photo by Z. Rączkowska)

Oko lake, where numerous debris flow gullies evidence that such processes are common (for instance, on the debris slopes of Szeroki Piarg and Zielony Piarg). Three photos, depicting the entire slope, provide evidence for the occurrence of new hillslope debris flows at least once per 10 years. At the same time the photos show that the slope surface was not changed in 2010 (Fig. 14.7). Debris flows were triggered by the 41.4 mm rain lasting 1.5 h on 23 August 2011. Precipitation as high as that was recorded at the valley bottom in 1 km distance from the emerged forms. At the crests, precipitation amounts might have been even higher and intensity above  $1 \text{ mm min}^{-1}$ .

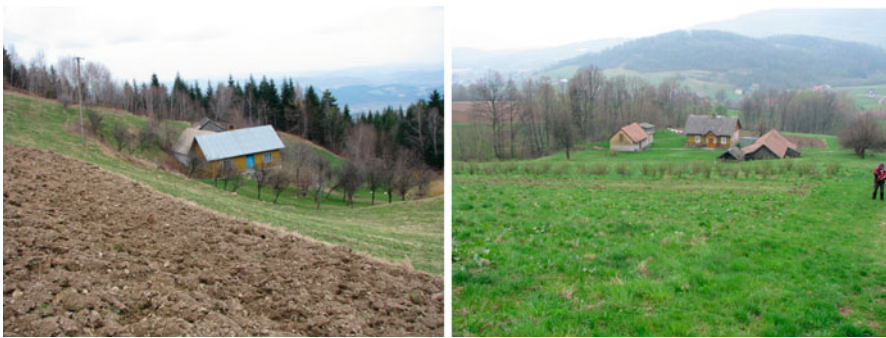
**Fig. 15.5** Examples of houses located in landslide niches

The large number of new and old buildings situated atop landslides is the result of inadequate landslide identification and the lack of local zoning laws. *Flat terrains* appear to be naturally suited for development (Fig. 15.5). Large packet-type landslides consisting of rocks and weathering material and formed in the Magura and sub-Magura units show numerous flat surfaces, particularly in the Beskid Wyspowy. Mass movements have been found to exert a positive effect on human settlement patterns. Margielewski (2000) states that past landslides offered an opportunity to settle at higher elevations, especially in the Beskids. Landslides reduced slope gradients, which made human settlement more likely. Other favorable features of landslide areas include springs, relatively deep soils, and a locally milder mountain climate promoting agriculture and animal husbandry.

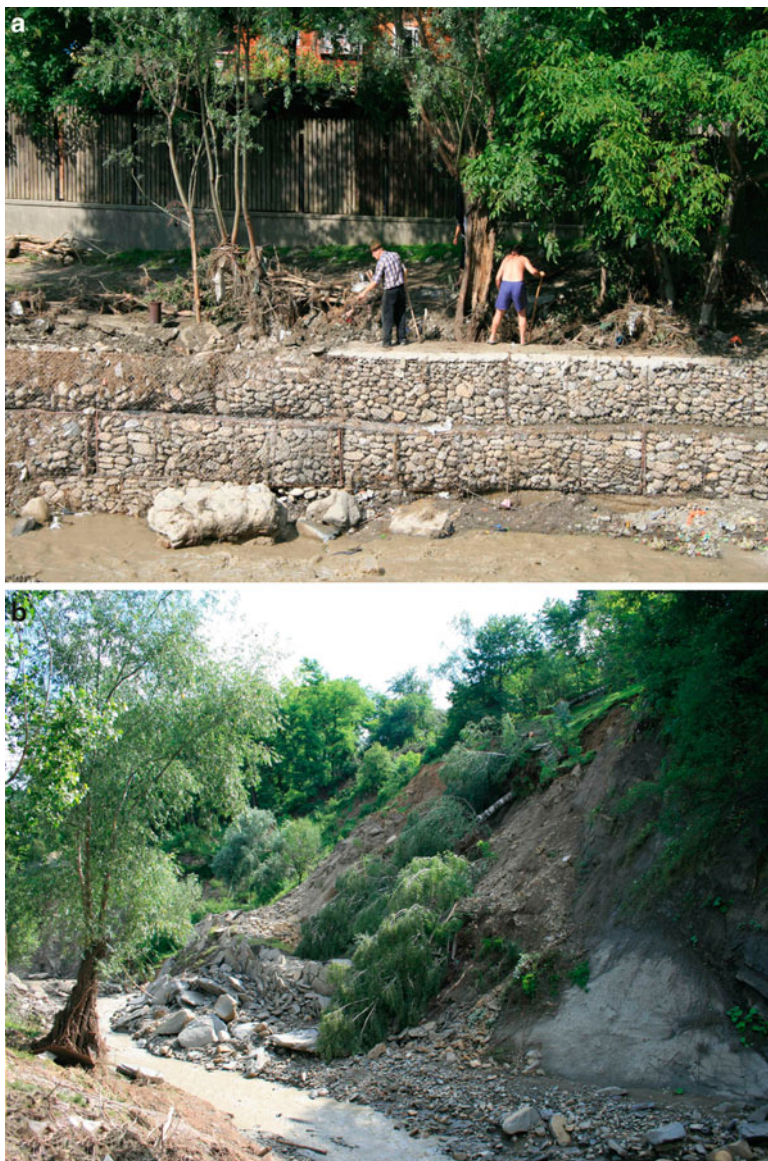
**Fig. 16.5** The flash flood of July 2010 on the Drajna catchment (Cerașu, Prahova County) overpassed bank protections by 2 m (a), damaging 18 households and causing numerous riparian landslides (b) through lateral erosion (Photo by M. Micu)

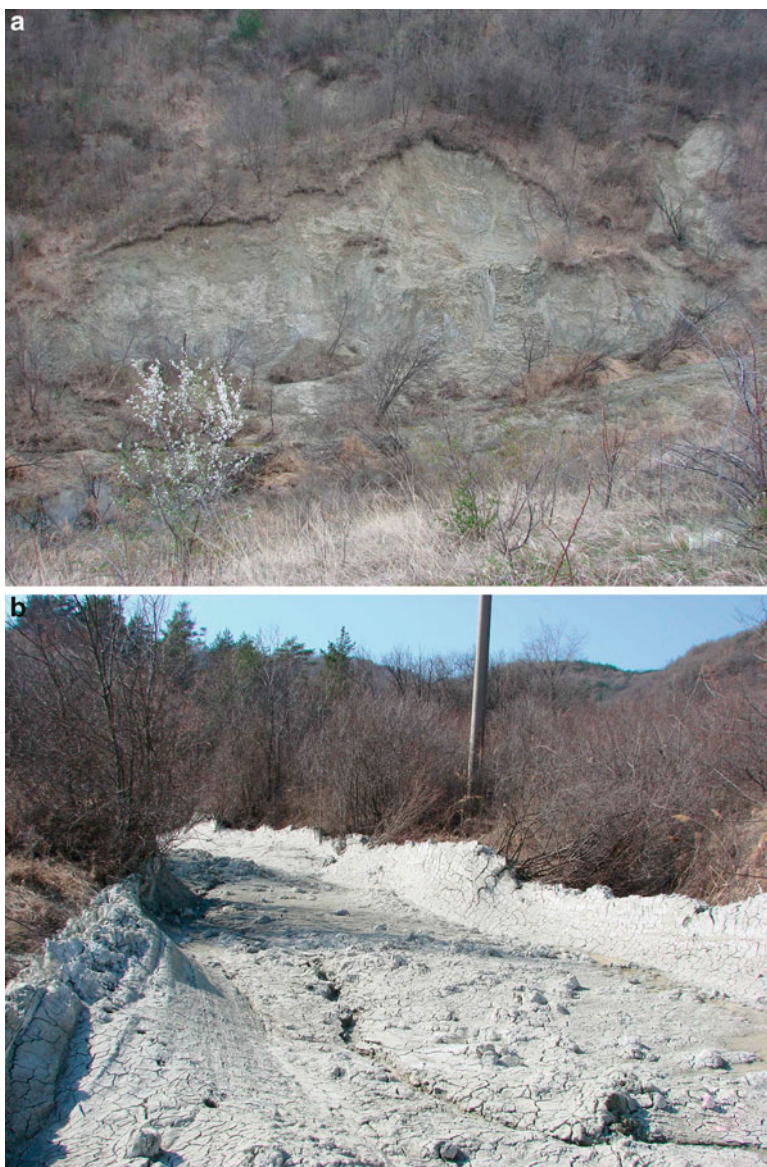
**Fig. 16.8** Lateral source areas (a) reactivated during January–February 2010 nourished an 800-m-long mudflow (b) which blocked DN 10 (national road) (Photo by M. Micu)

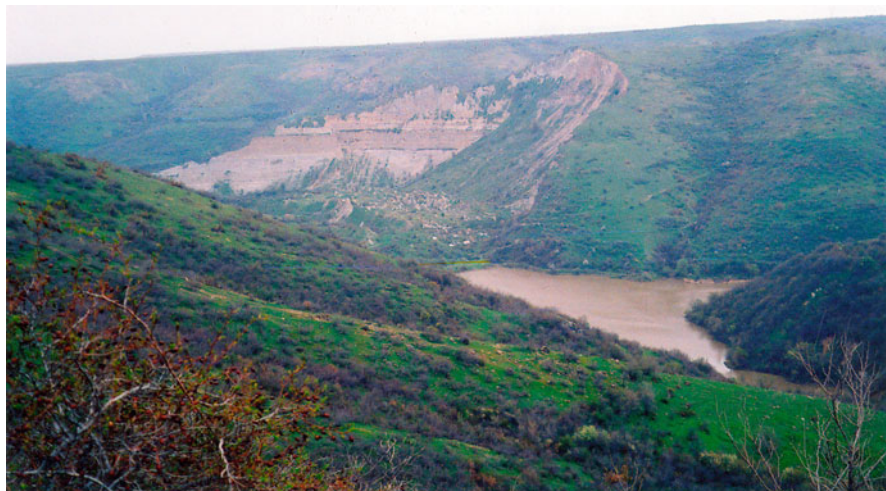
**Fig. 17.2** Scar of the Gradot landslide with impounded river (Photo by B. Markoski)

At the *Gradot landslide*, near the town Kavadarci, the western slope of a hill failed at a speed of  $6 \text{ km h}^{-1}$  in 1956. Landslide width was 800 m, length 400 m, relative height 200 m, and the total mass moved ca  $20,000,000 \text{ m}^3$  (landslide *C* in Fig. 17.5). A river valley was covered by 70-m-deep water (Fig. 17.2). Fatalities included 11 people and many animals. Infiltrating waters caused the piping of sand grains in overloaded tuff and generated creep at ca.  $15 \text{ mm year}^{-1}$  long before the movement.

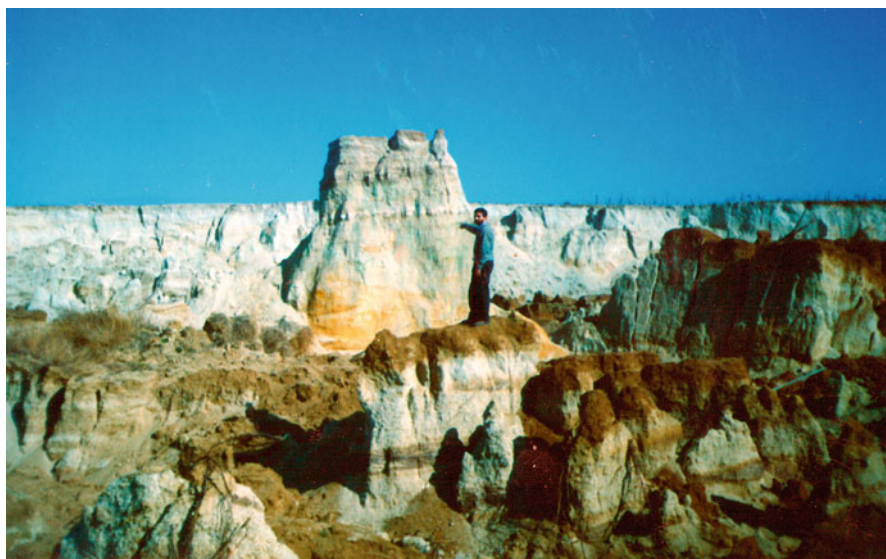
**Fig. 17.3** Timjanik landslide with earth pyramids in 1994 (Photo by I. Milevski)

Several kilometers to the northeast, near the village *Timjanik*, heavy rainfall on 26 September 1994, activated a landslide of 250 m in length and 150 m in width (landslide *E* in Fig. 17.5). The sliding mass was 10–15 m deep and its total volume ca.  $400,000 \text{ m}^3$ . Here Pliocene sands overlie clay beds, and interesting landforms, marked earth pillars, and pyramids were created (Fig. 17.3). Damage included destroyed vineyards, local roads, and 200-m-long modern irrigation canals.

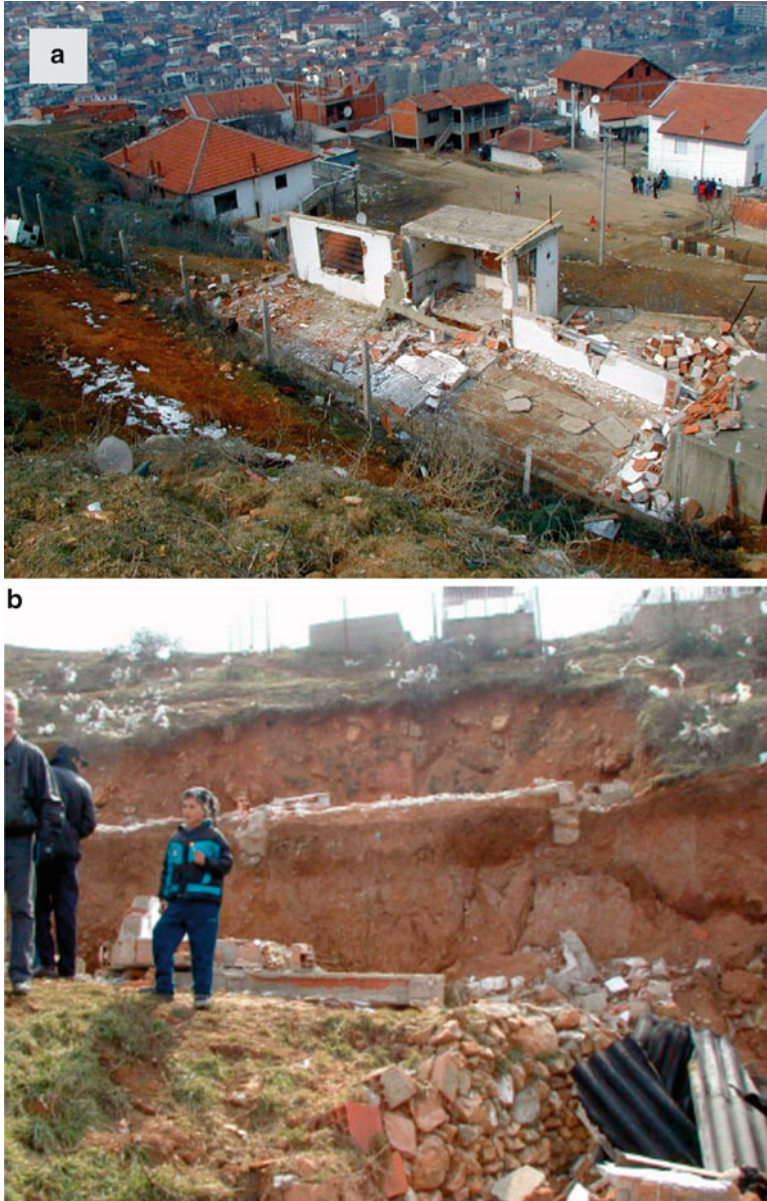
**Fig. 17.4** View from the top of the Ramina landslide onto the built-up area (a) and on the main scarp (b) (Photos by M. Jovanovski)

A major landslide occurred in *Veles* (landslide *D* in Fig. 17.5) in 1999 and 2002 on an illegally settled hill called *Ramina* and caused widespread damage to houses and infrastructure (Fig. 17.4). The landslide is ca 320 m long, average width is

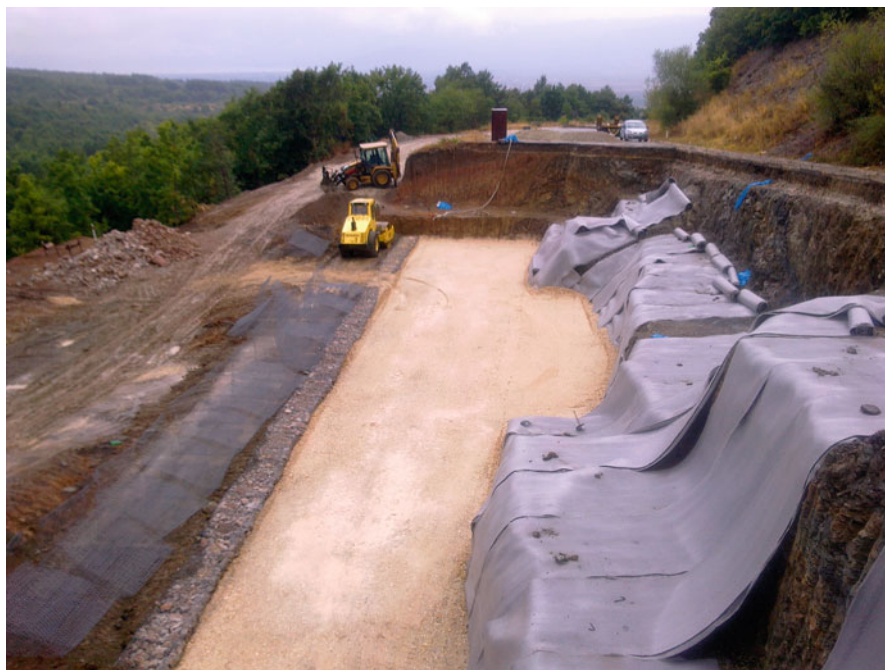
**Fig. 17.7** Repairing the national road M5 between Resen and Bitola (south-western Macedonia): unloading the slided mass, stabilization with gabions, and reinforced soil surface (Photo by A. Strašeski)

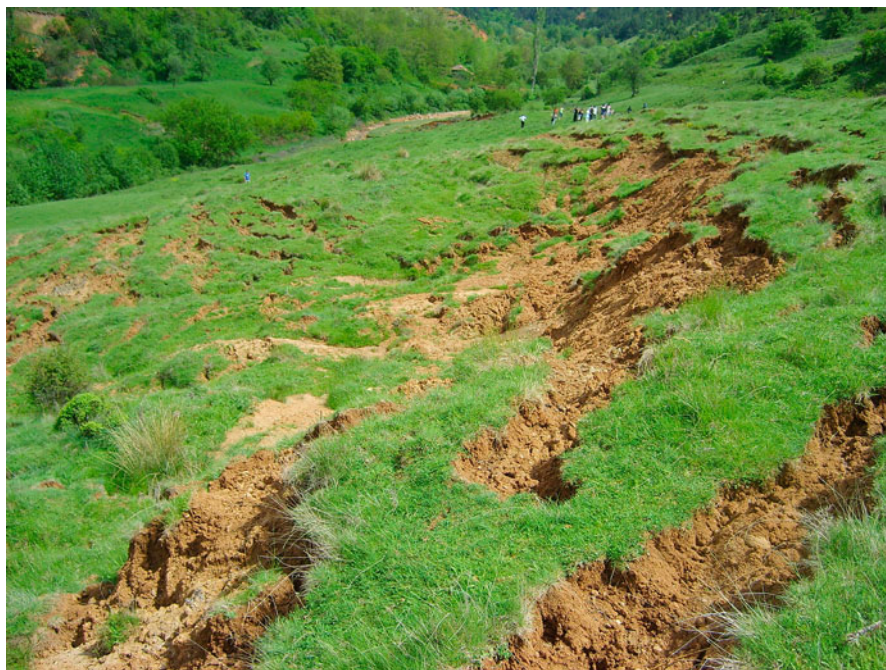
**Fig. 17.8** Cracks on the Crnik landslide and mass movement towards the Crnička River in May 2010 (Photo by I. Milevski)

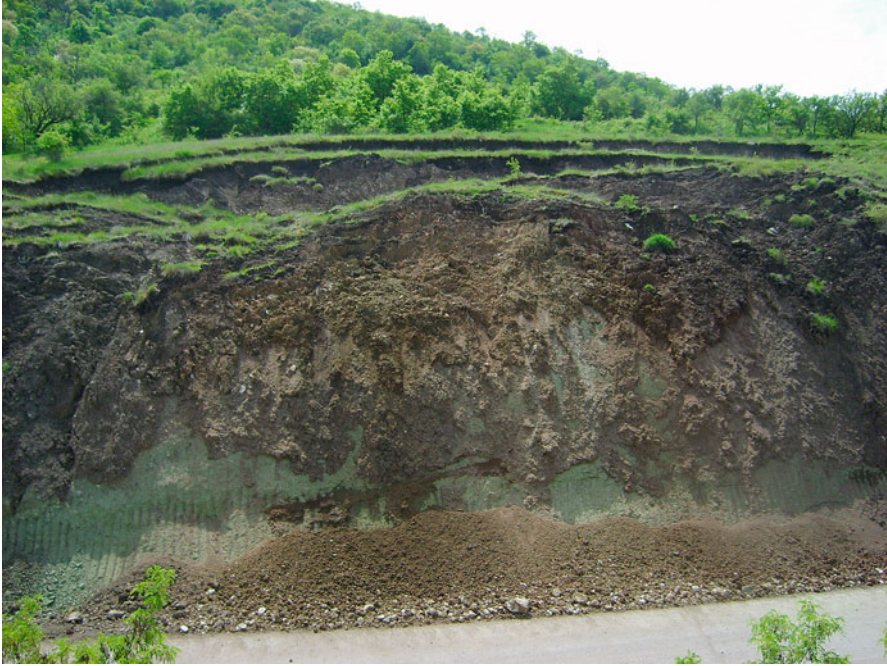
**Fig. 17.9** The Stracin landslide on the international road Corridor 8, highly active in early 2010 (Photo by I. Milevski)

In the same period, a highly active landslide occurred on the Stracin pass along Corridor 8 towards Bulgaria (landslide No. 9 in Fig. 17.5), where the road is cut 10–12 m deep for several hundred meters into stratified volcanic tuffs mixed with clay. A field survey in May 2010 showed that the Stracin landslide was 85 m long and active along 54 m, indicated by progressive falls of debris upon the road. Many new scars gave a stairlike shape to the landslide mass (Fig. 17.9). During the peak of activity in March 2010, most of the road was covered with debris, slowing down traffic.

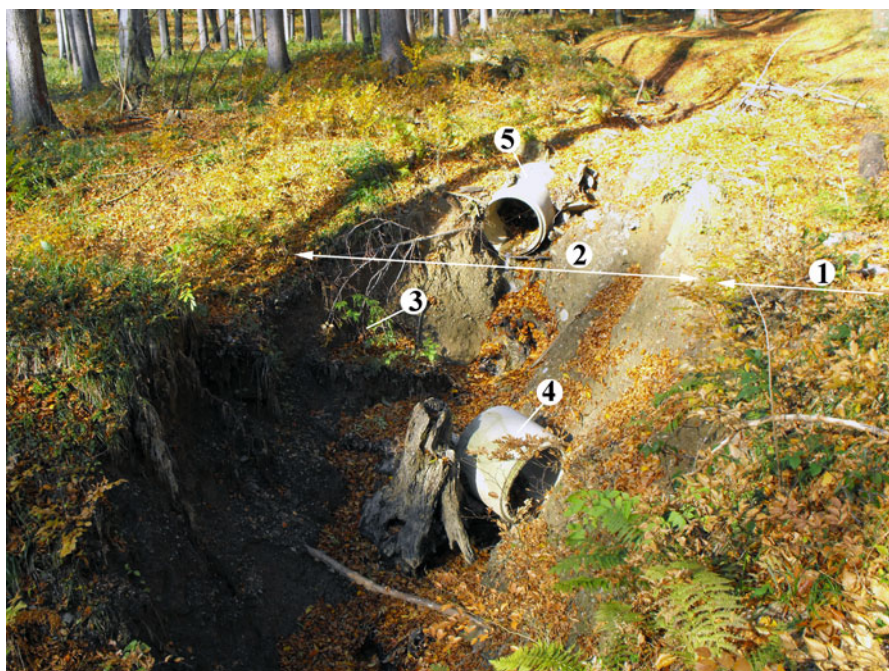
**Fig. 19.8** Culvert in the Bozsok Valley on October 30, 2010. 1 – Valley floor. 2 – Channel. 3 – Caved-in channel side. 4 – Displaced concrete ring. 5 – Stable concrete ring

Observation concerning the influence of artificial structures, like *culverts*, could also be made (Fig. 19.8). Some concrete rings withstood the flood, while others were displaced. Sediment deposition upstream of the culvert was followed by scouring beyond it, where channel slope increased. Intensive channel incision (exceeding 3 m) on the floor of the Bozsok Valley happened downstream of *bridges* in at least three sites in 2009.

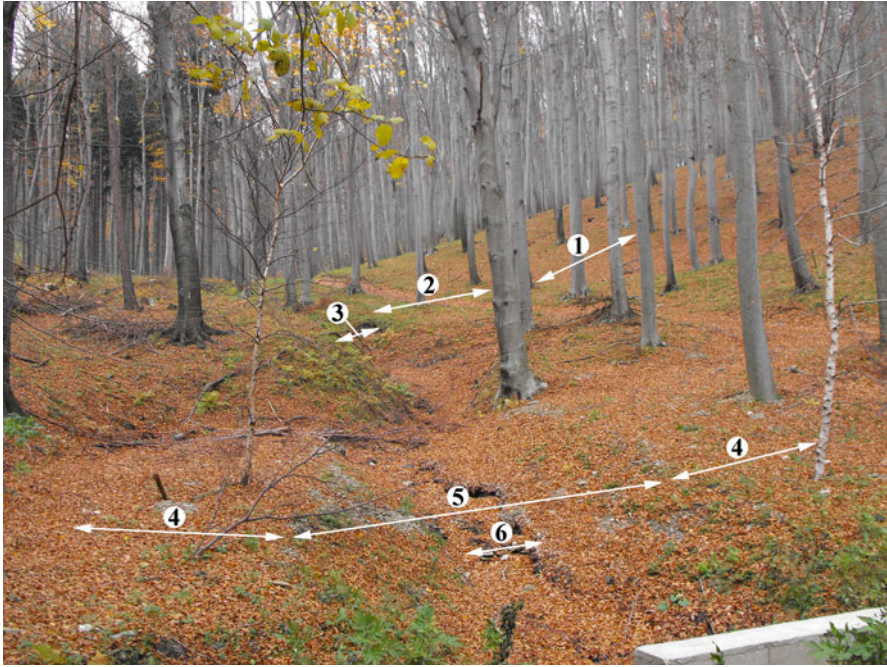
**Fig. 19.9** Accumulation landforms in the Bozsok Valley (Photos taken on October 30, 2010). 1 – slope of Bozsoki valley, 2 – floor of Bozsoki valley, 3 – floor channel, 4 – alluvial fan which developed on June 24, 2009, 5 – channel on the alluvial fan, which developed after June 24, 2009, 6 – new channel which developed after June 24, 2010

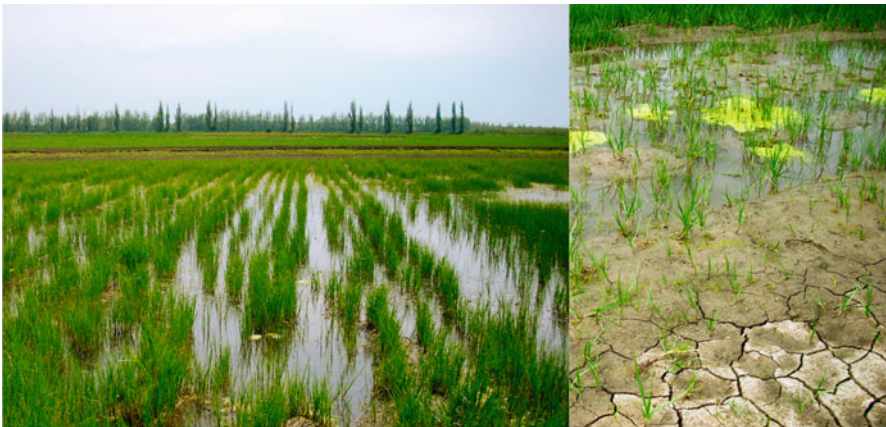
**Fig. 20.2** Inland excess water and soil properties on an arable field in South Hungary (Photo by authors)

The direct and indirect causes of *excess water* have often been analysed (Salamin 1966; Rakonczai et al. 2003; Pálfai 2004; Várallyay 2005; Bozán et al. 2008; Körösparti et al. 2009). The conclusion of researchers is that this phenomenon is a compound system with several key factors, including hydrometeorology, relief, soil, geology, groundwater, land use and technical influences. According to multivariate correlation analysis, the decisive elements are soil properties (Fig. 20.2) (Körösparti et al. 2009).

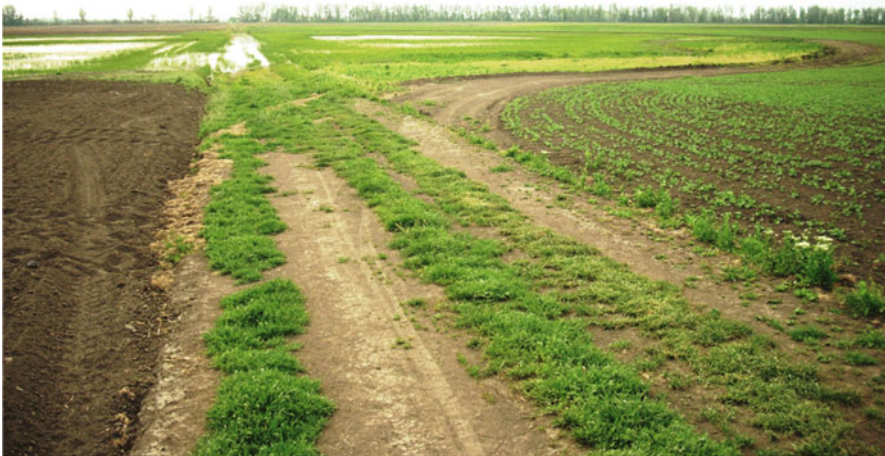
**Fig. 20.10** Road course had to be changed after water inundation at the study site in Békés County, Hungary (Photo by authors)

Studying the results of vertical penetration resistance, plough hard pans can be identified at depths of 15–20 and 40–50 cm. Higher penetration resistance measured at the edges of the inundated patches can be explained by the observation that vehicles have to make a detour around such patches. Therefore, the higher moisture content in their neighbourhood is associated with the compaction by vehicles (Fig. 20.10).

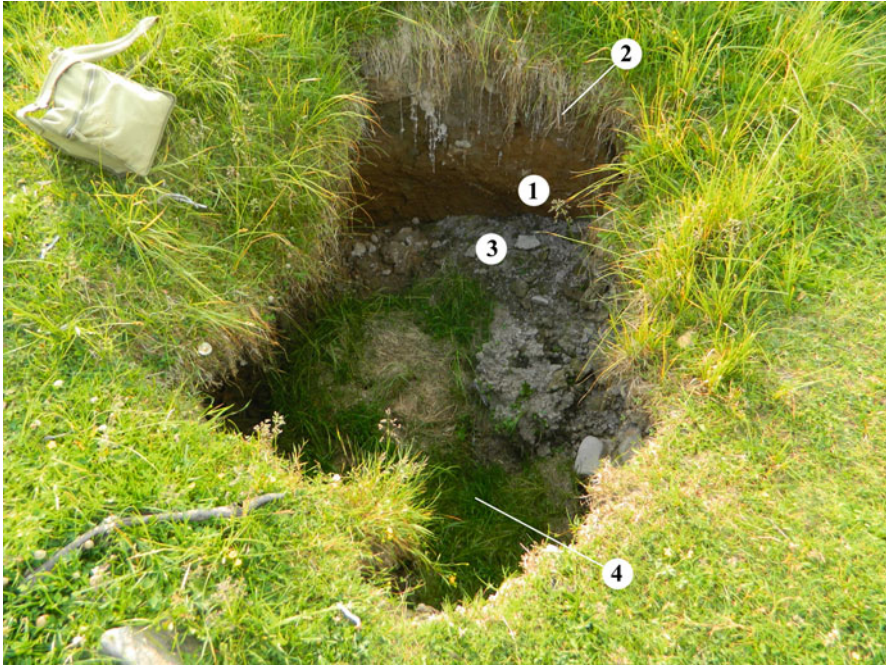
**Fig. 21.4** Features attesting to recent and rapid development in a dropout doline (Padis Plateau, Romania, in 2012). 1, steep surface in sediment cover; 2, plant ‘beard’ due to fall; 3, caved-in cover; 4, spots of living plants fallen in
