# Geomorphological Impacts of Extreme Weather

Case Studies from Central  
and Eastern Europe

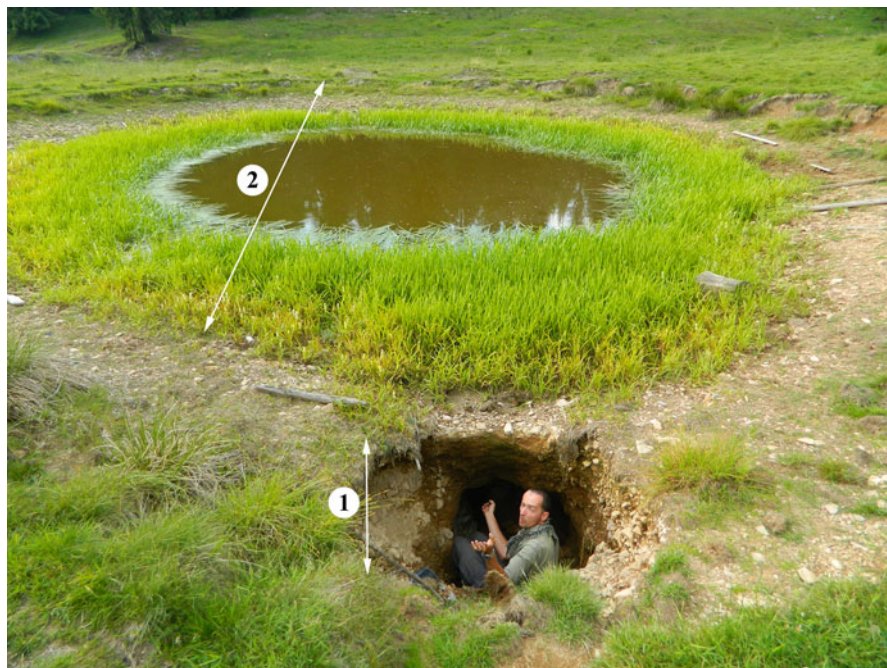
**Fig. 21.5** Opening formed between 31 August 2011 and 5 June 2012 (Padis Plateau). 1, opening; 2, infilled ponded doline

*Collapsed features* are young (some months old) if their walls are (sub)vertical, vegetation-free with traces of sod or grain crops on their floors (Fig. 21.4); failure fronts are fresh, the rim is sharp (Fig. 21.5), and collapse mounds are not yet destroyed or dissected by rilling. Plant residues, tilted or uprooted trees, displacements or upward wedging crack-like passages show rapid development. Short-term and recent accumulation is indicated by buried trees and human utensils (e.g. cans, tires – Fig. 21.6, Table 21.2). Serial collapses can also be documented (Fig. 21.7).

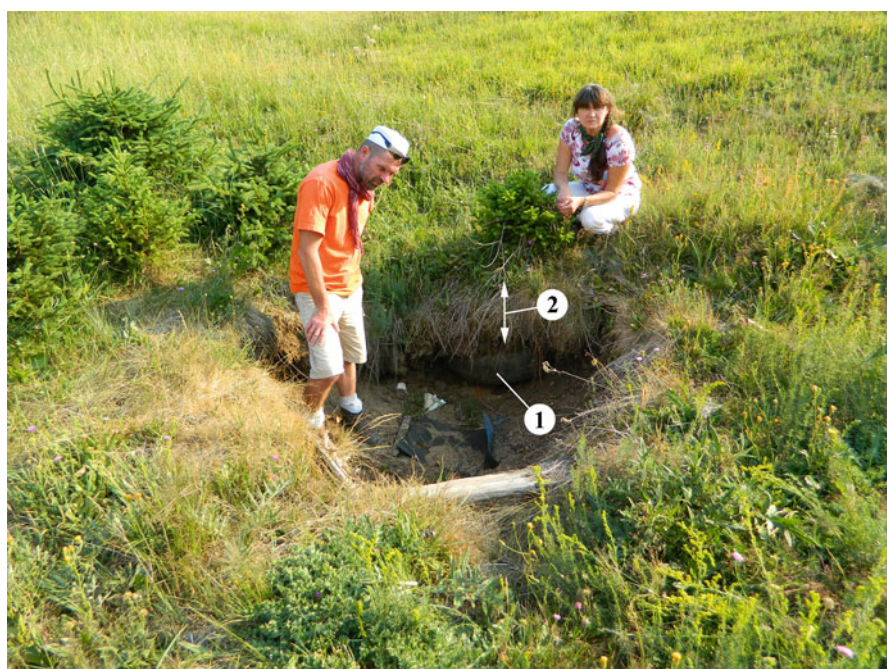
**Fig. 21.6** Intensively infilling doline (Durmitor Mountains, Montenegro, in 2012). 1, buried tire; 2, deposits on tire

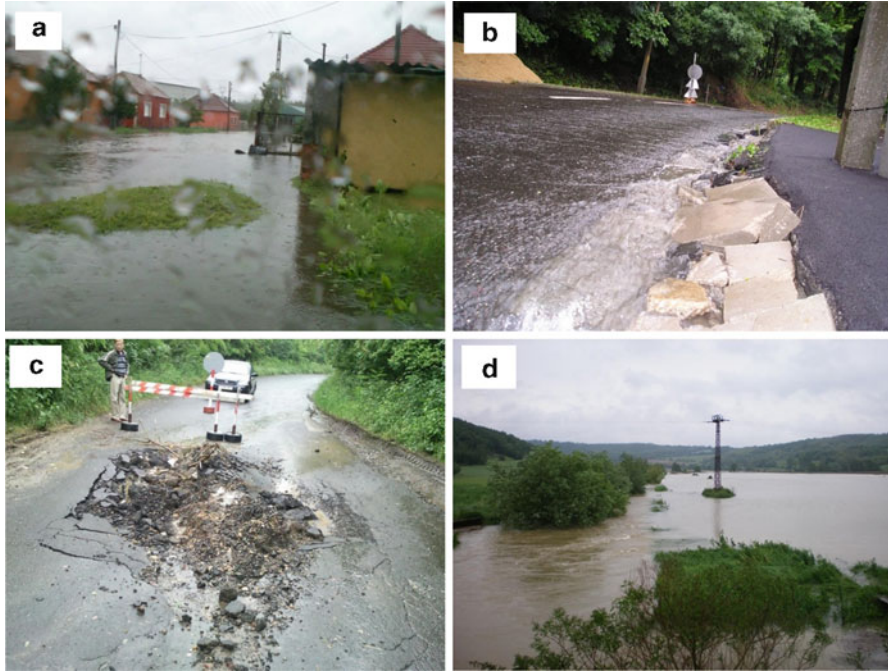
**Fig. 22.5** Various types of flood impacts in Pécs and vicinity during 15–18 May. The photos (a–c) were taken in Pécs, while (d) was taken in Sásd, about 30 km to the north (Photos by L. Ronczyk)

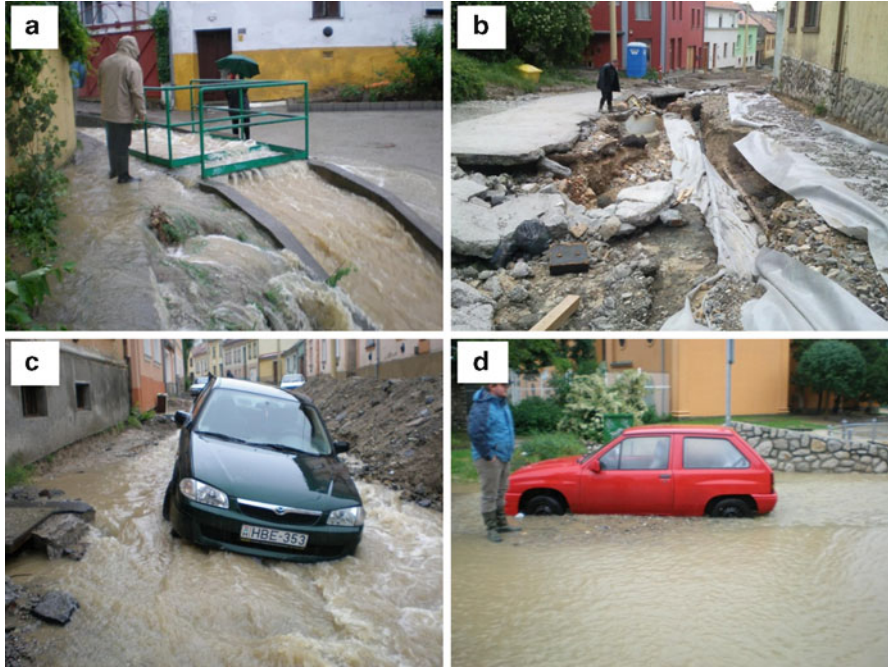
**Fig. 22.6** Damages in the Vince Street on 17 May 2010. (a) Clogged drainage filter at the northern end of the street; (b, c) damaged road surfaces; (d) accumulation of deposits at the southern end of the street and on Ágoston Square (Photos by L. Ronczyk)

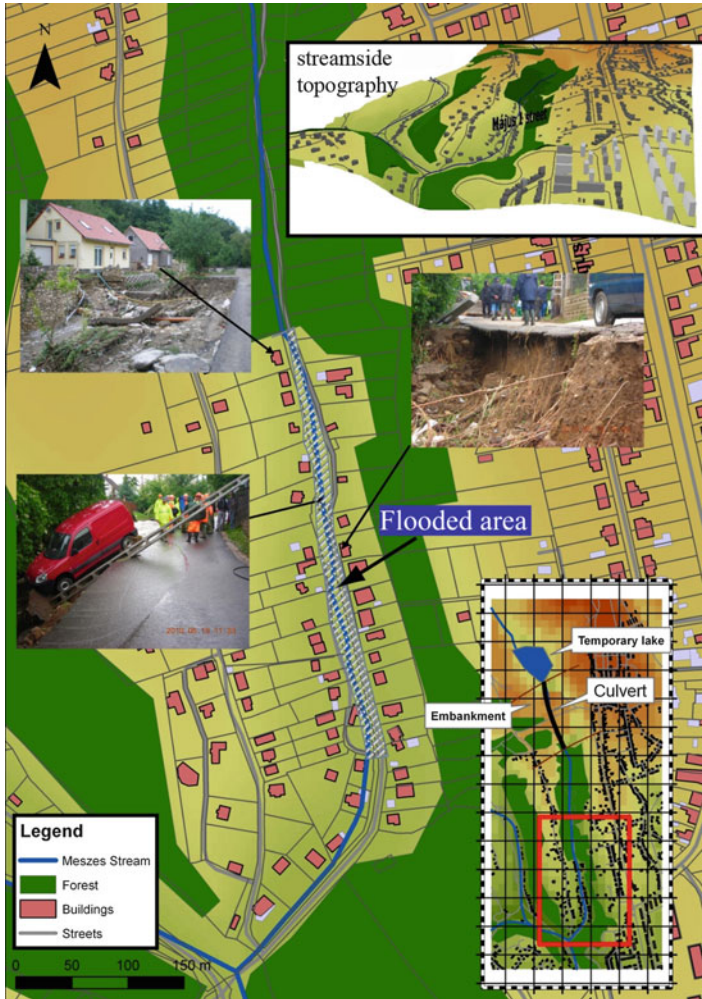
Fig. 22.7 Damages in Május 1 Street on 17 May 2010

Another example of urban flash floods triggered by fundamental land use change (coal mining activities) occurred in the eastern part of the city, in Május 1 Street. Active mining affected the headwaters of the Meszes Stream, which flows along Május 1 Street. A dike was built along the street with a road on top. Here a culvert of 100-cm diameter conveys the water underneath the dike. By 15 May, 2010, the culvert completely clogged up with debris; various communal waste and tree branches and a hydraulic head of 20 m formed behind the dike. The high hydraulic head unplugged the culvert and allowed water flow through. Ca half million m<sup>3</sup> water inundated Május 1 Street causing losses around two million Euros. The water damaged houses and, pedestrian bridges, overtopped several cars, destroyed retaining walls and seven properties became inaccessible. The street itself became impassable for any vehicle, including fire trucks and ambulance cars (Fig. 22.7).
