Chapter 2

Channel Changes due to Extreme Rainfalls in the Polish Carpathians

Abstract This chapter describes a role of extreme rainfall events in the development and transformation of channels in the Polish Carpathians. An analysis was based on the example of four selected events, which occurred in different parts of Polish Carpathians (Western Tatra, Bieszczady, and Beskid Niski Mountains) during the period 2003–2010. The findings underline that changes of the largest extent follow short and heavy rainfalls. Furthermore, their geomorphic impacts are the most significant in small watersheds. The research showed that the largest transformations of mountain rivers occur in the main channel, while the floodplain is only locally altered. The regularities identified in the study areas are relevant for mountain river channels in forested terrains, where a large supply of woody debris, for example, stems and branches, is ensured.

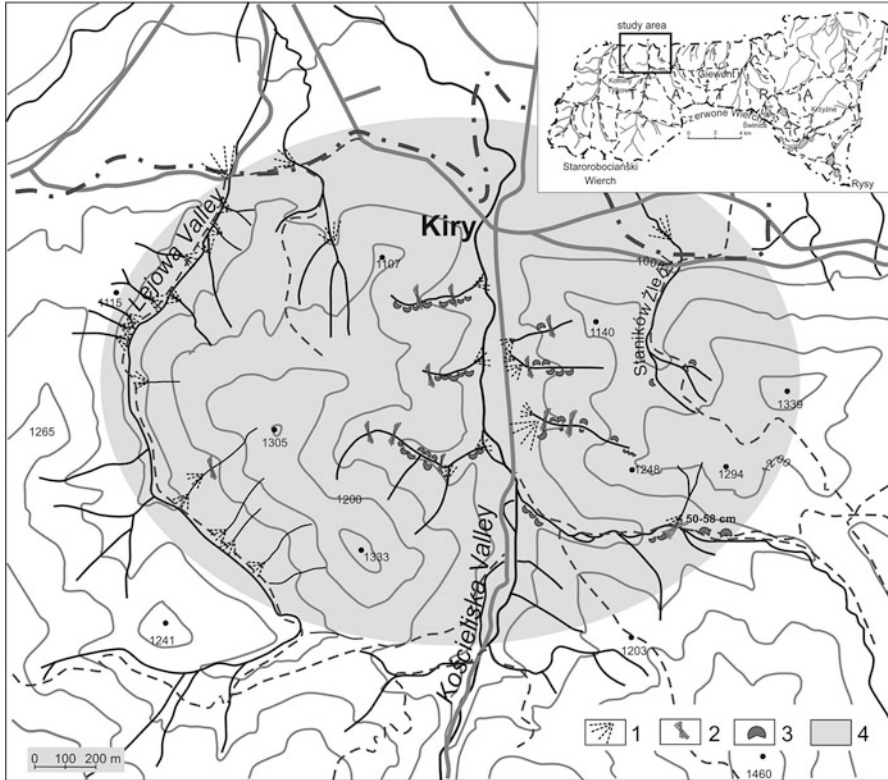
Fig. 2.4 Geomorphological effects of catastrophic rainfall on 5 June 2007 in the Western Tatra Mountains (After Gorczyca and Krzemień 2008); 1 – torrential fan, 2 – woody-debris-dam, 3 – landslide, 4 – area of geomorphological impact of catastrophic rainfall

An extreme rainfall event in June of 2007 affected the montane zone of the Western Tatra Mountains, including the Kościeliska, Lejowa, and Stanikow Żleb Valleys (Fig. 2.4). This middle mountain area is mainly built up of limestones, dolomites,

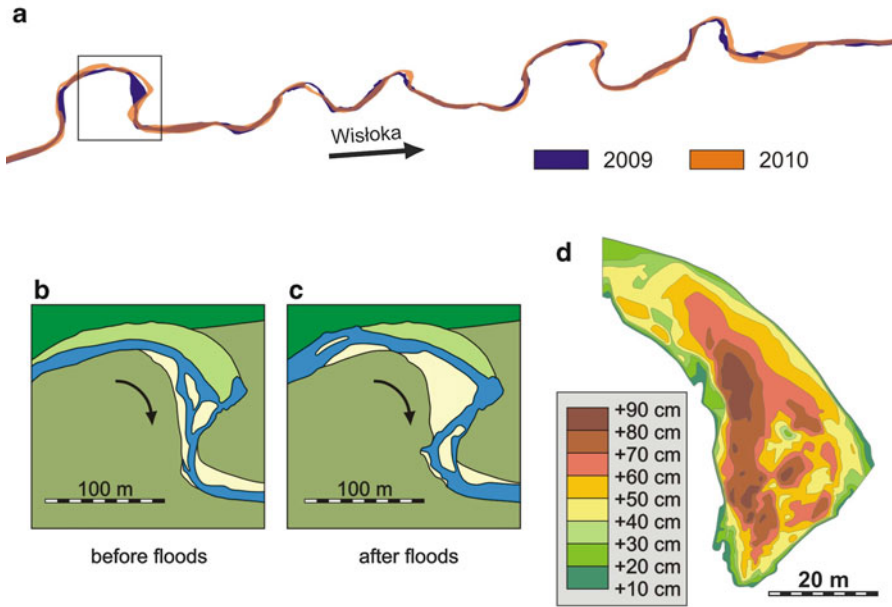
Fig. 2.6 Changes in the studied section of the Wisłoka River channel following floods in May and June 2010: (a) Wisłoka channel changes between Nieznajowa and Rozstajne, (b, c) changes of the undercut reach in Nieznajowa, (d) differential surface in the area of developed point bar

During the two floods, the largest scale of change was found in the *broader sections* of the valley. A two-kilometer reach of the river between two adjacent gap sections was selected for a more detailed analysis (Fig. 2.6). The segment involves a 200–400 m wide valley floor, out of which the channel and the lower terrace make up 200 m. Located within the Magura National Park, the meandering channel with braiding migrates freely, without human intervention, over the floodplain.

Analyzing *channel changes* on orthophoto maps from 2009 to 2010, we found that, as a result of the floods, the channel became broader and showed more developed meanders (Fig. 2.6a). Land surveys performed both prior to and following the events showed progressing lateral erosion of both the flood and dry terraces at the site of the undercut reach studied. Maximum channel shift was ca 20 m (Fig. 2.6b, c). This was accompanied by deposition, particularly on the inside of the bend, point bar accumulation providing new land available for the expansion of vegetation. A general overhaul of the pool and riffle pattern attests to a considerable modification of the channel.

The second land survey helped assess the change in bed load volume in the channel. The map shows a segment of the channel at Nieznajowa where a bar has expanded. Isolines connect points of equal vertical debris accumulation (Fig. 2.6d).

The irregularities in the distal section of the bar are a result of a high rate of change in this part of the channel. The deposition of large woody debris induces local

scour and fill. Hanging channel reaches are found within the bar that developed during the descending of the flood wave in supercritical flow conditions. These features are shown as measured during the first and second surveys, and the differential surface reflects the complexity of factors driving the development of this channel system.
