Chapter 7

Natural Hazards in the North-East Region of India

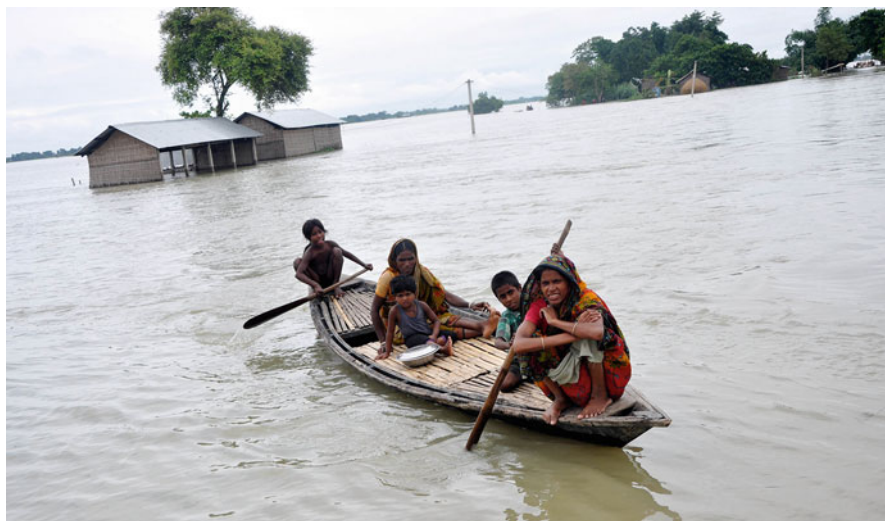
Photo 7.1 Brahmaputra in flood (Photo Dasrath Deka)

of crops, houses and damage to other properties. Cattle are washed away, trees are uprooted and wildlife is threatened and often perishes in the process of emergency migration (Photo 7.1). Many plants and animals suffer huge and sometimes irreparable damage. Some of the wildlife sanctuaries like Kaziranga suffer greatly, as animals trying to escape meet death in road accidents. Others are caught by unsocial elements.

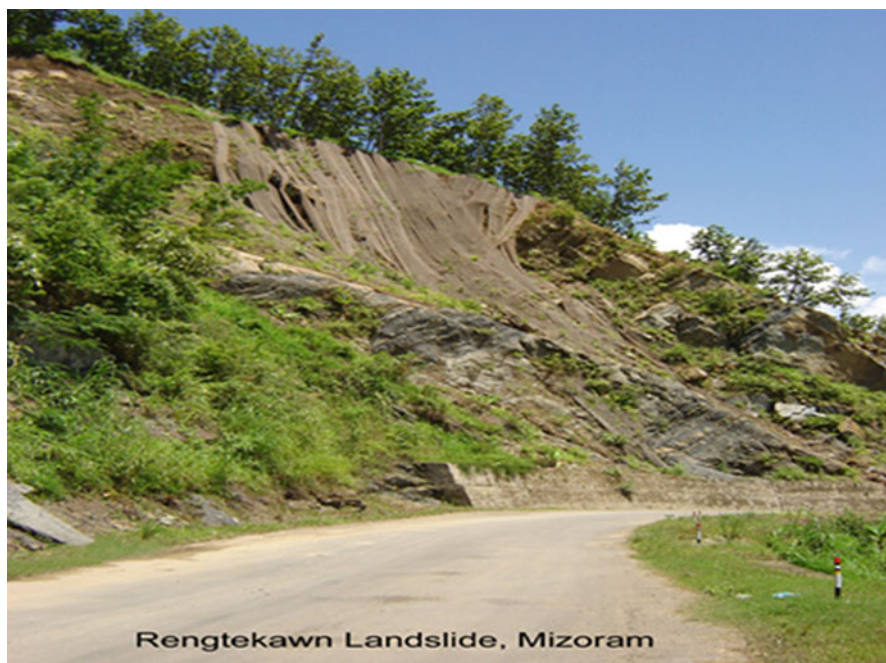
Photo 7.2 The Rengtekawn landslide, Mizoram (Photo Dr. R P Tiwari)

dipping anticlinal folds in argillaceous and arenaceous rocks of Neogene period. The tectonic instability coupled with steeply dipping fold facilitated a slide down of weathered and partially weathered rocks (Photo 7.2).

The states most affected by landslides are Mizoram, Manipur and Arunachal Pradesh. Tiwari and his associates (1996:96) have studied a series of landslides in Mizoram, of which the two most severe are those of Bawngkawn ($23^{\circ}45'30''\text{N}$ and $92^{\circ}44'\text{E}$) and South Hlimen ($23^{\circ}41'\text{N}$ and $92^{\circ}43'\text{E}$), which are very significant. The Bawngkawn landslide located on the northern outskirts of Aizawl, occurring on 17 September 1994, caused disruption of traffic on Aizawl–Lunglei road for 3 days, as the entire area was covered with the debris and other clastic material sliding down from the upper segments of slope. Two factors that seem to have caused this landslide are as follows: (1) the instability of a fault in the vicinity and (2) the high

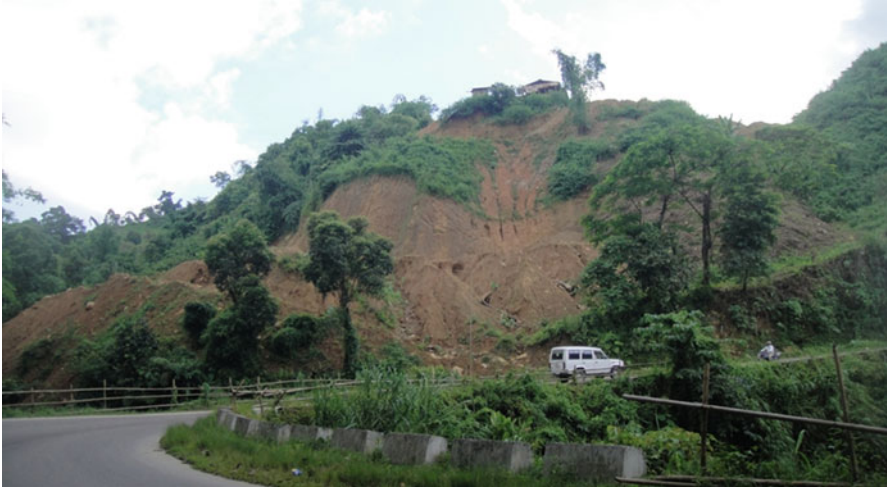
Photo 7.3 Landslide on NH-52A near Pahalwan Mod, Arunachal Pradesh (Photo Dr. (Ms.) Tage Rupa)

Most studies of the landslides, in the North-East region, show a roadside location. In such a situation, slope failure is the obvious triggering point for landslides. This concentration of landslides on the roadsides raises the question – whether the landslides occur more frequently on the roadsides or that this reflects the choice of investigators who prefer traversing largely along the roads for reasons of easy movement (Photo 7.3). Whatever the reason, landslides are a menace for the region and preventive measures need to be taken. The task of addressing this problem is undertaken by the Geological Survey of India (GSI) who is fully committed to introduce preventive measures, wherever necessary.
