New Approaches to Building Pathology and Durability

Building Pathology and Rehabilitation

Volume 6

João M.P.Q. Delgado
Editor

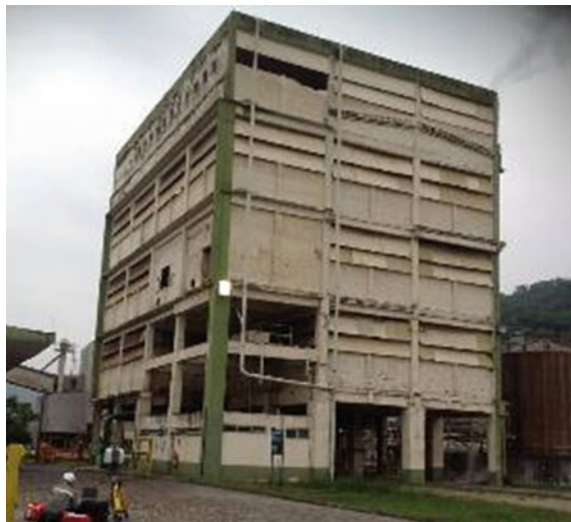
Fig. 1 Building neutralization overview

From the remaining plant most of the construction was nearly deactivated, using only the region between the 9 and 11 axes serving as support tanks and equipment

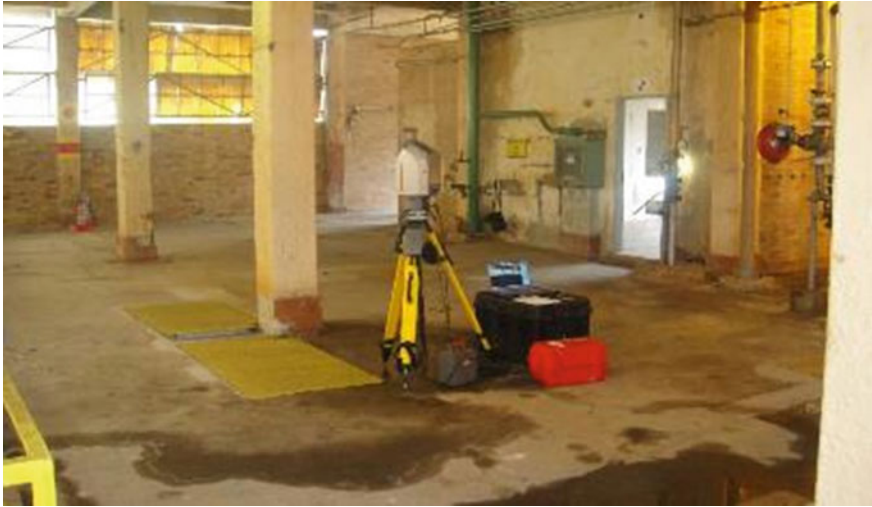
Fig. 4 ScanStation inside the building

- Surveys Accuracy
- Increased safety and reliability of the measures (millimetric precision). Requiring no stairs, platform lifts, tape measures, etc. They can be made out of risk areas as runner-propelled machines, and no physical contact with the elements in the facility, avoiding risks for humans, as well as smaller numbers of people for surveys in the unit.
- Possibility to include AS-BUILT pipes or equipment in the future.
- Eliminated the need to return to the location to new measurements or conferences, facilitates the generation of 2D documentation (seen in plan, section, elevation, isometric, etc.).

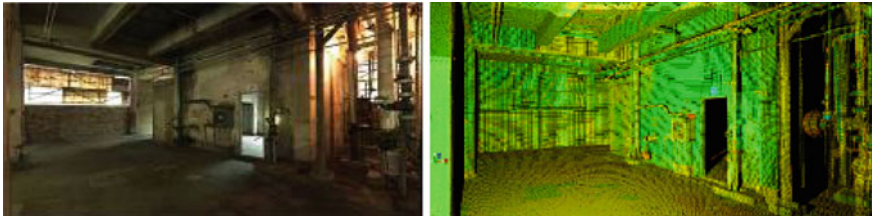
Fig. 5 Photographic image/3D scanner points cloud

For scanning unification it was used several fixed points called Target's (targets). In Fig. 5 we can observe the third floor of the building and cloud points obtained through the scanning.

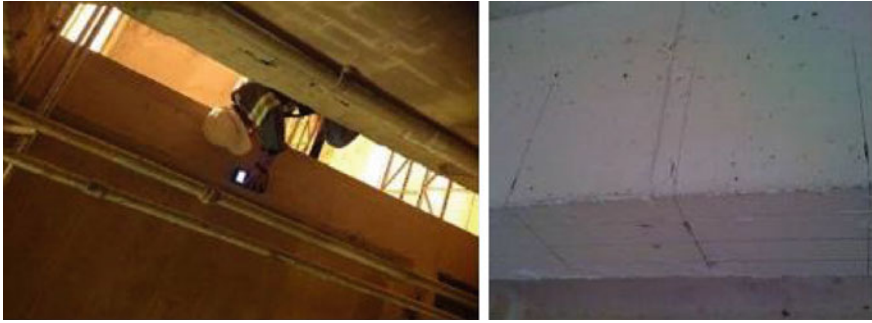
Fig. 6 Reinforcement lifting and positioning

- locate steel frames
- locate the midpoint between the frames
- determine the concrete layer
- estimate the frame diameter
- determine the frame direction

(concrete beam/ stirrup/ metal profile/ soldered)

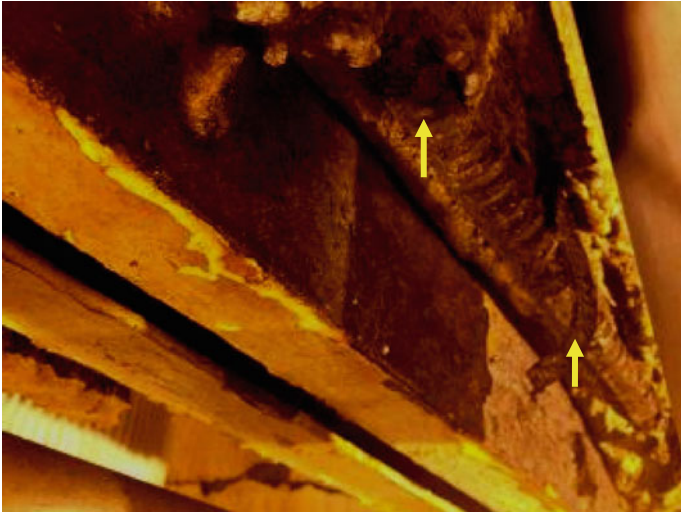
Fig. 8 Metal profiles stirrups interruption

Figure 8 shows a point where the concrete was already broken around the profile enabling the observing of that constructive detail.

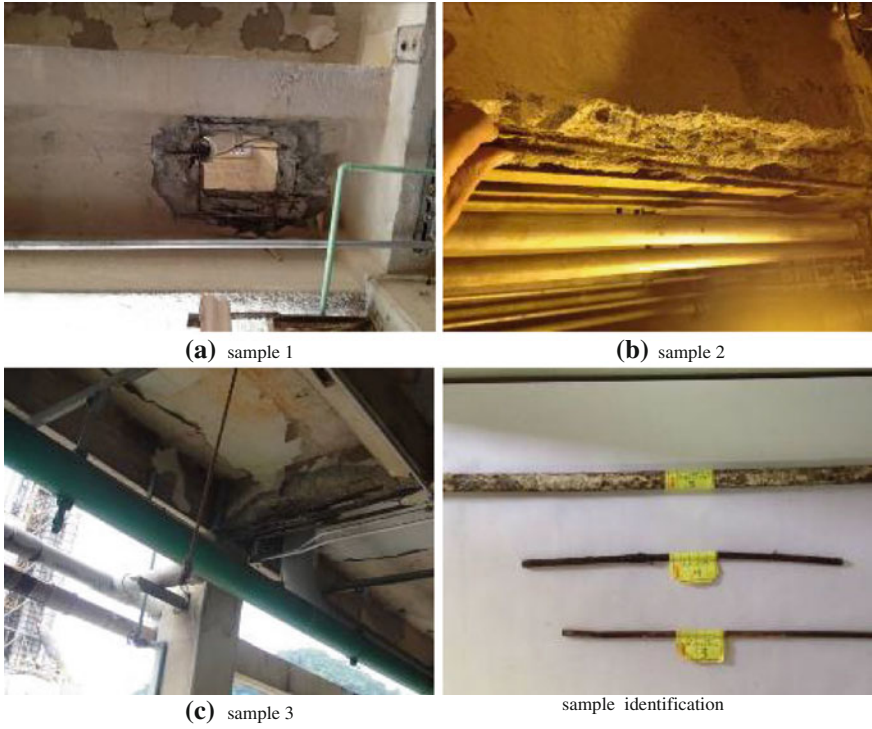
Fig. 9 Steel frames samples

To determine the resistance and the reinforcement steel damage it was extracted 3 samples at different spots of the structure, spots where the concrete was already broken and the frames were shown, in order to be able to test as shown in Fig. 9, and they were tested at the Instron Satec Systems traction in pneumatic (see Fig. 10).

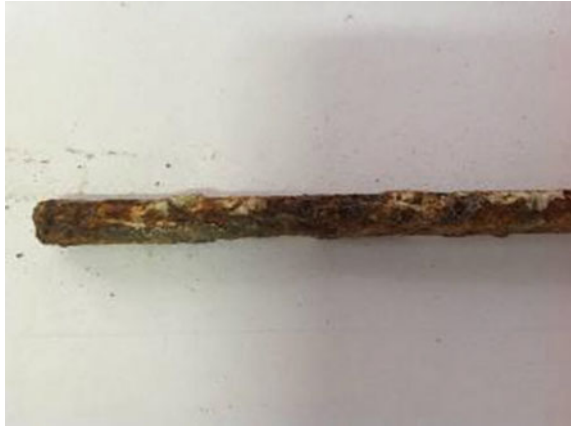
Fig. 12 Transcrystalin or transgranular corrosion

The transgranular corrosion phenomenon is manifested in the form of cracks, which propagates through the interior of the material grains, as in the case of stress corrosion cracking, the image as shown in Fig. 12 is amplified.

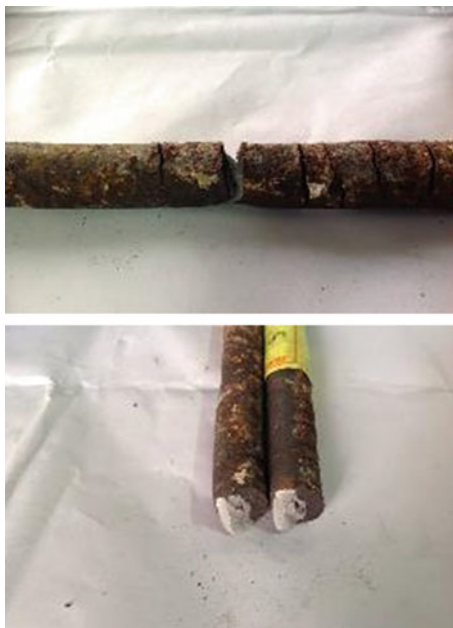
Fig. 13 Transgranular corrosion (sample 3)

The steel structure seems fully integrated to the sufficient traction application of force to the opening of these cracks, as shown in Fig. 13. Thou has its resistance limited by the most damaged area's cross section.

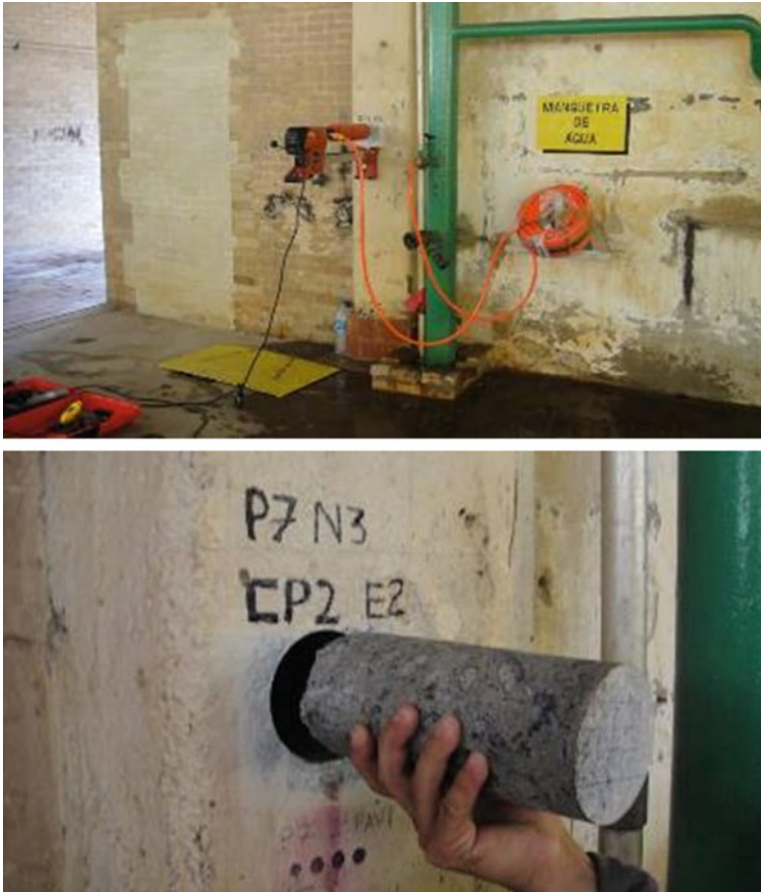
Fig. 14 Testimonies extraction

The existing concrete is characterized by withdrawal of cylindrical bodies of the test piece called testimony and tested according to the recommendations of NBR 7680 (2007) (extraction, preparation, testing and analysis of testimonies of concrete structures). 4 witnesses were taken using electric Hilti DD120 model equipped with diamond crown drill with 4 in. in diameter, pulling bodies of the test piece with about 10 cm in diameter and 20 cm in length (Fig. 14).

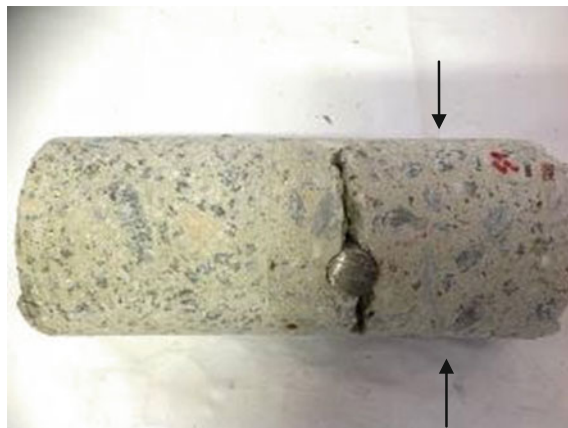
Fig. 15 CP4 image

During the testimony extraction in Pilar P12 (CP4) reinforcing steel was found in about 12 cm of depth from the surface where it could be seen two distinct concrete layers (Fig. 15), indicating the implementation strengthening by encapsulating about 10 cm from that area.

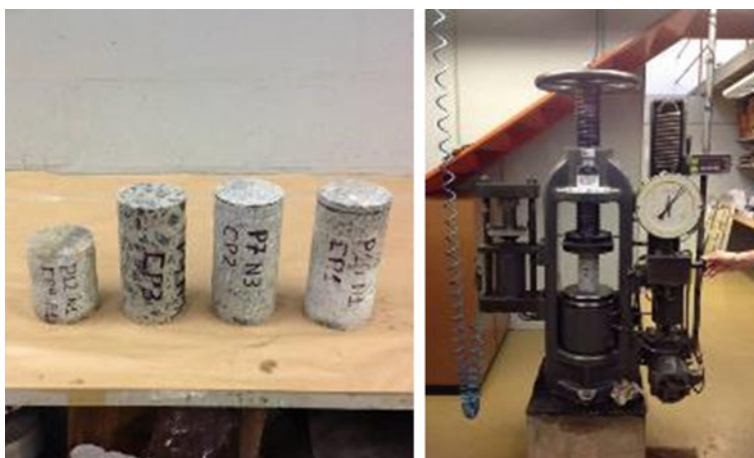
Fig. 16 Rectification and testing of the bodies of the test piece

The test bodies were identified immediately after the removal and sent to the Department of USP Construction from São Carlos laboratory for grinding the edges and uniaxial compression test as shown in Fig. 16.

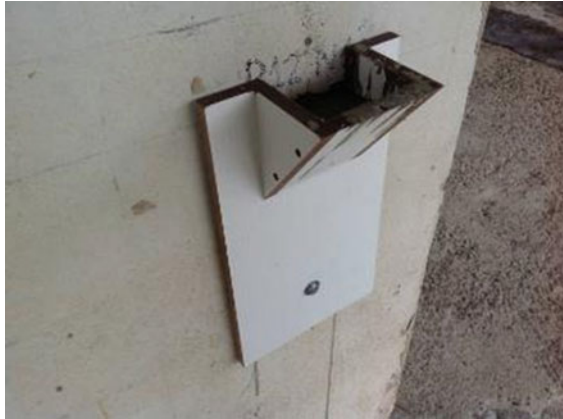
Fig. 17 Reconstitution of testimony extraction points

After removing the structure evidence which was compounded with high strength grout (Supergraute of Quartzolit), following all the manufacturer's recommendations, reaching chemical and mechanical characteristics superior to the existing concrete for the application of MDF grout pipes which were properly set as shown in Fig. 17.

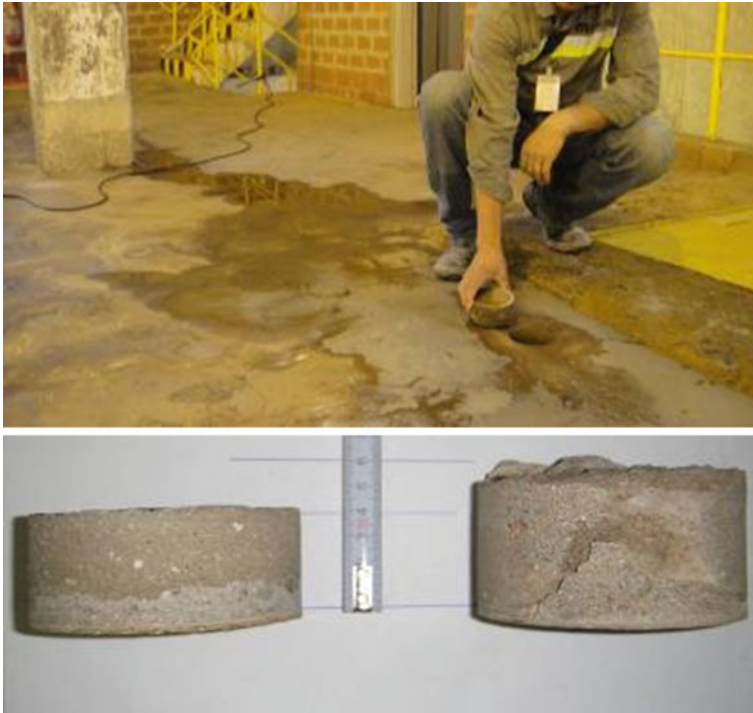
Fig. 18 Floor against level samples +13.50

Samples were also taken from the L428 and L431 level +13.50 slabs for checking the thickness of counter floor (see Fig. 18). The flooring appears to have a great thickness variation from one side to the other of the structure. It was

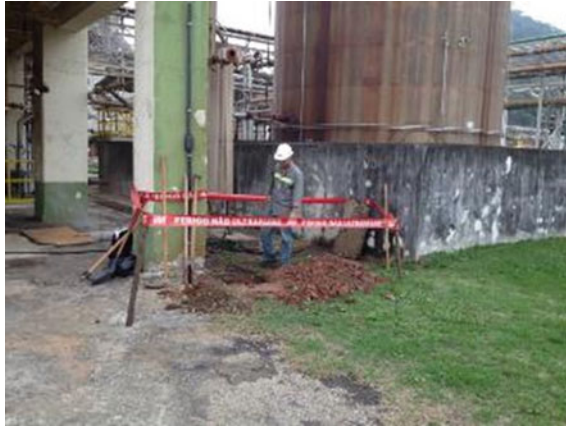
Fig. 19 Excavation spot on an isolated area

An excavation was performed around the P16 column (see Fig. 19) in order to investigate the kind, position and state of foundation structures and baldrame beams, this point was chosen because it was not necessary to break any floor, it did not have pipes or equipment close by and it was way from people circulation area, having previously been approved by a technical Vale team and endowed digging certificate.

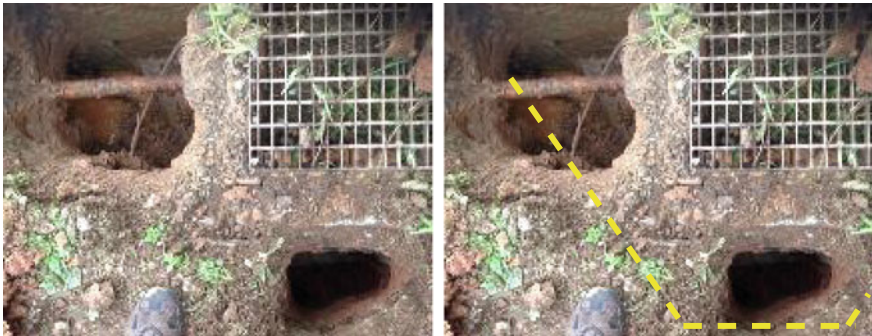
Fig. 20 Type and form the foundation structure

Through this research it was observed that a triangular three-stake block, was in a deep foundation, beneath the baldrame beams (see Figs. 20 and 21). The data was used to design and structural modelling.

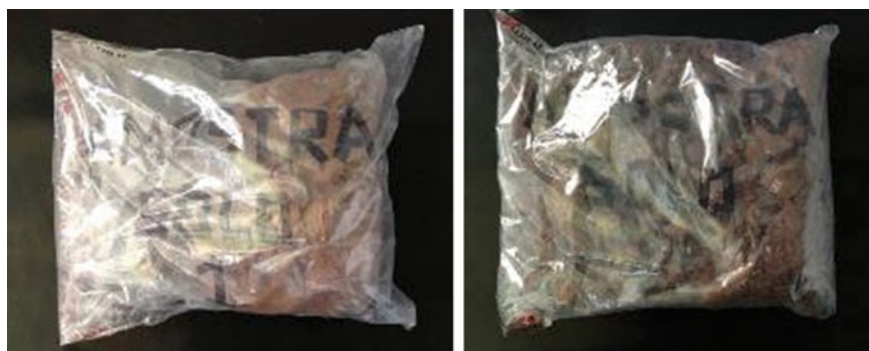
Fig. 22 Sample packs for soil testing

Verifying possible soil contaminants that can chemically attack the foundation structures, two soil samples were taken close to pillar 16 and another next to the column 20, the samples were identified, packaged (see Fig. 22) and sent to the laboratory for chemical analysis. The results are shown in Tables 3 and 4.

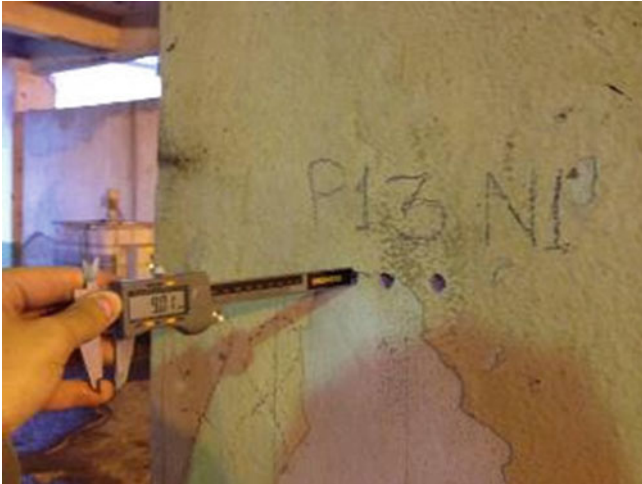
Fig. 23 Carbonation depth determination

As the biggest problem is the pH fall it is applied an alcohol solution of phenolphthalein, which remains colorless when applied in carbonated concrete, and changes to pink in the concrete and does not carbonated. This test was performed at different spots of the structure, especially in the pillars near the floor at half height, making 16 mm diameter holes and deeping them from the surfasse to each 2 mm, and also applying the solution until it found concrete not carbonated. Then its depth was measured as shown in Fig. 23.

The carbonation depth tests were compared with the average coating frames on each pillar. It is important to emphasize that a very large frame coating variation, which complicates the definition of areas susceptible to corrosion, was found. On the other hand, the microregion (position within the structure) where the component deepens the carbonation has a great variation. It's more frequently the corrosion emergence happening at the base of pillars which gradually spread into the upper regions. The relative humidity of the air near the floor can be 10–20 % higher than on the liner (WEXLER et Paulo RL Helene).

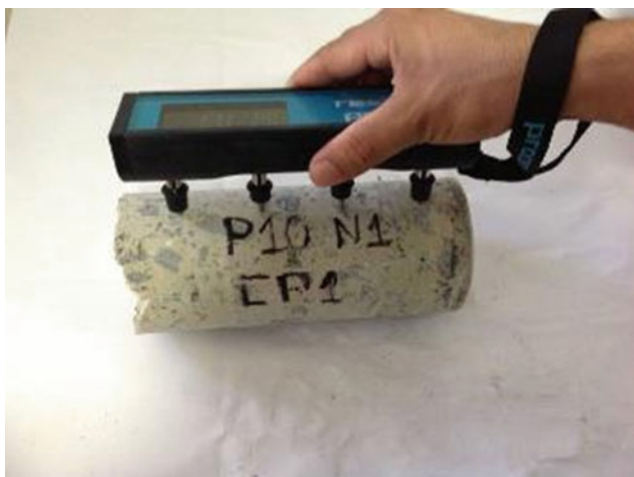
Fig. 24 CP1 testimony electrical resistivity test

the frames to be more susceptible to corrosion. The electrical resistivity of the concrete testimonies was measured by a Resipod equipment that applies a current to two probes at the edge and measures the potential difference between two internal probes as shown in Fig. 24.

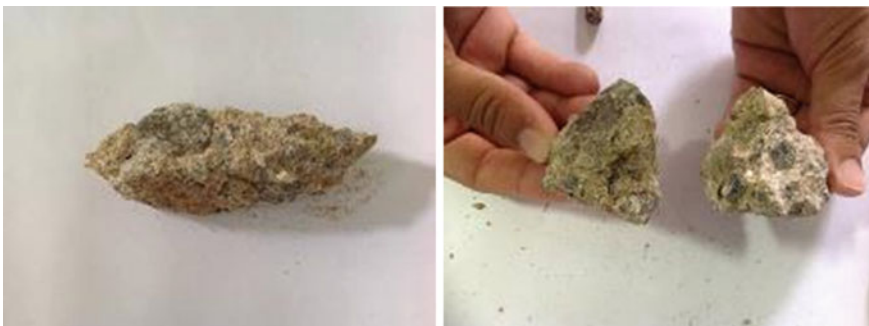
Fig. 25 Concrete samples which suffered nitric acid attack

Prolonged attack acidic solutions can provoke the loss of some cement characteristics, as seen in some parts of the building, Fig. 25 shows a concrete sample showing these characteristics and it can easily break apart with bare hands.

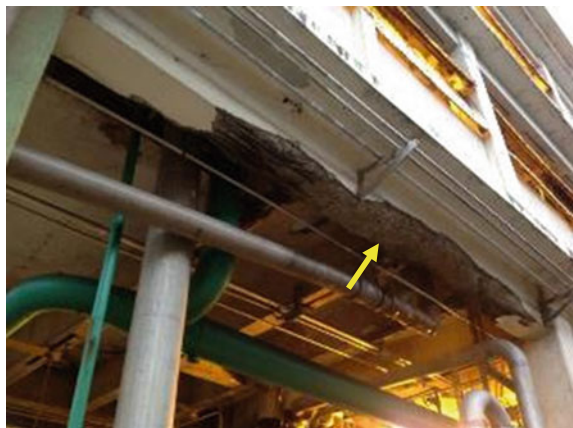
Fig. 29 Pilar P9—ground level

The pillars, in a simplified way are the elements that have the function of taking the loads from other structural elements in the foundation, essentially the compression work and depending on the integrity of the concrete section. Figure 29 shows P9 pillar on the ground level where you can see virtually cracks, concrete peeling, thereby decreasing its useful section.

Therefore the structure has serious pathologies, it justifies an Immediate Action Plan where temporary shoring are placed to reduce the risk of collapse until the implementation of structural recovery are defined.

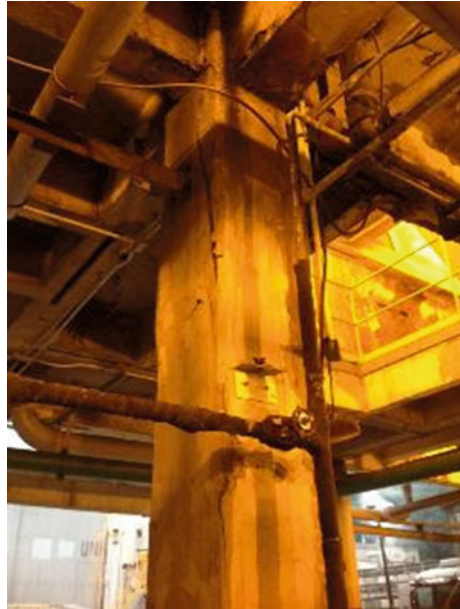
Fig. 30 Masonry detachment near the column, possible displacement of the support (L)

The conditions were mapped and classified into three levels according to the type, risk offered and difficulty of maintenance, which are: *Light* when it presents no direct structural risk, but impairs the functionality and/or aesthetic aspect (ex. floors degradation, closing masonry paints, etc.); *Average* that can compromise the structural performance over time, diagnosed admits some standardization; *Grave* causing risk of collapse, which require individual analysis, that do not follow the conventional inspection engines and do not follow the routine maintenance schedules, so the recovery will be monitored by a professional in charge and must have highly specialized knowledge. The following examples in Figs. 30, 31 and 32.

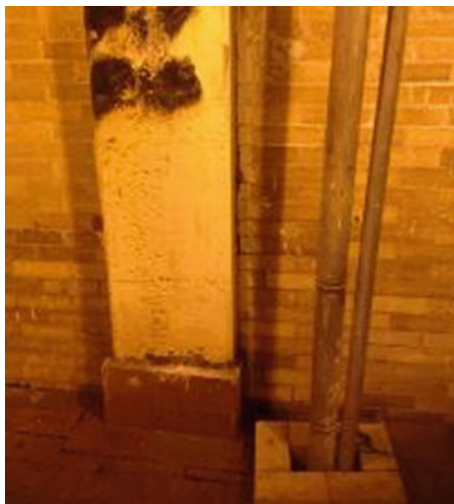
Fig. 31 Pilar with high carbonation depth along the floor (M)

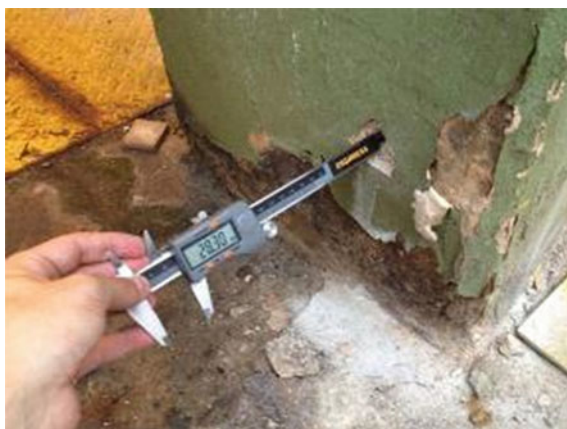
Fig. 32 Pilar with peeling exposed and frame along the floor (G)

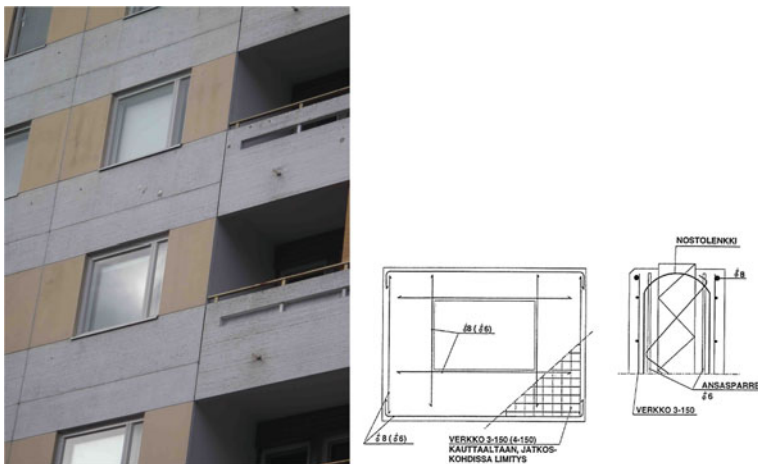
Fig. 1 Typical Finnish concrete facade made of prefabricated concrete panels (*right*) from 1960 to 1979

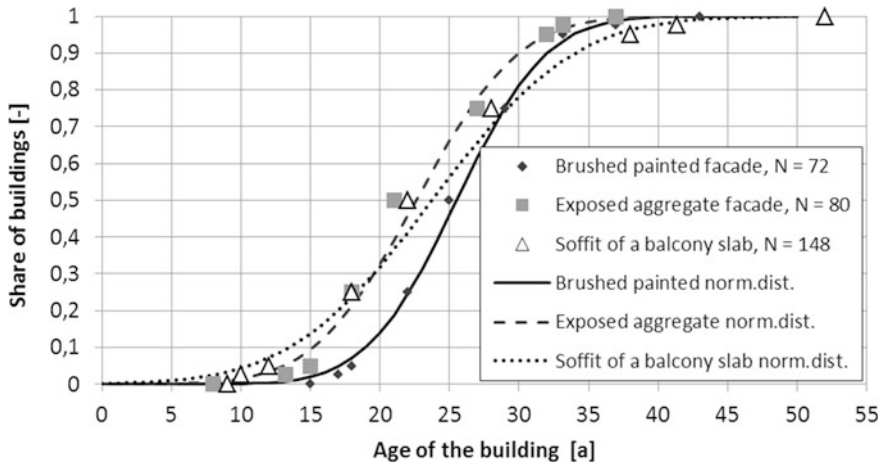
Fig. 5 Statistical model for the evolution of corrosion damage

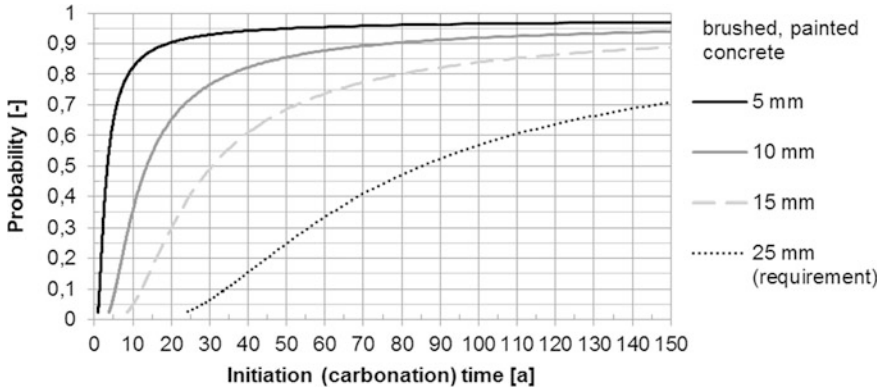
Fig. 6 The distribution of initiation time by carbonation to different depths of cover of reinforcement in brushed and painted concrete facades

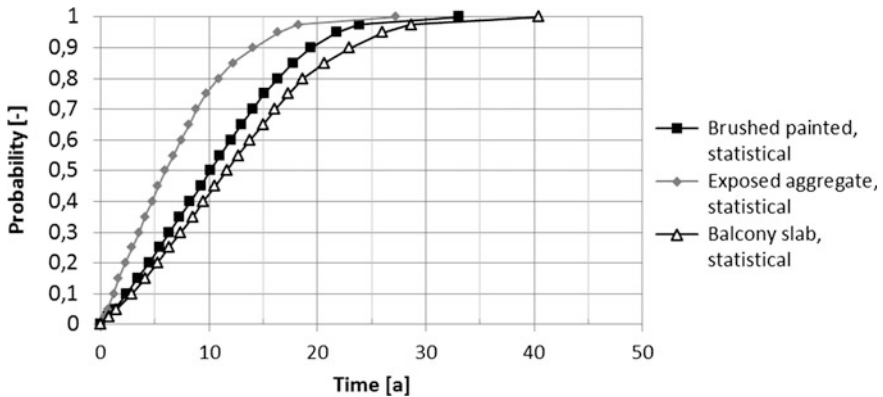
Fig. 7 Propagation time to form visual damage observed in different facade structures by statistical simulation

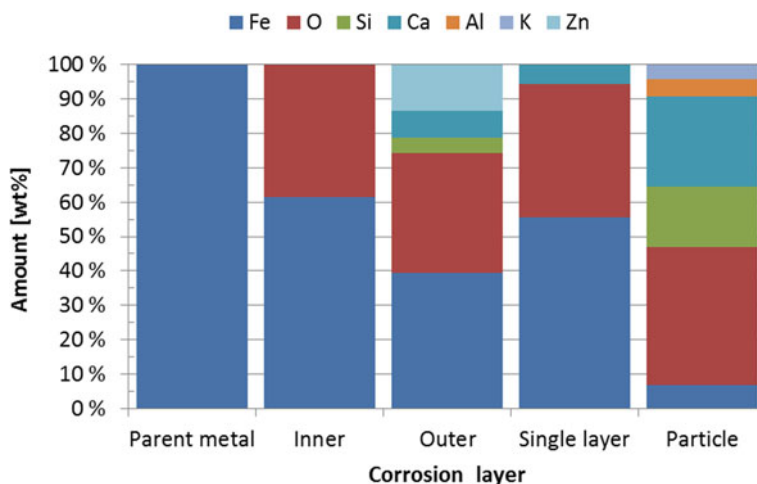
Fig. 8 The element composition (wt%) of different rust layers on corroded reinforcing steel samples (only elements >5 wt%)

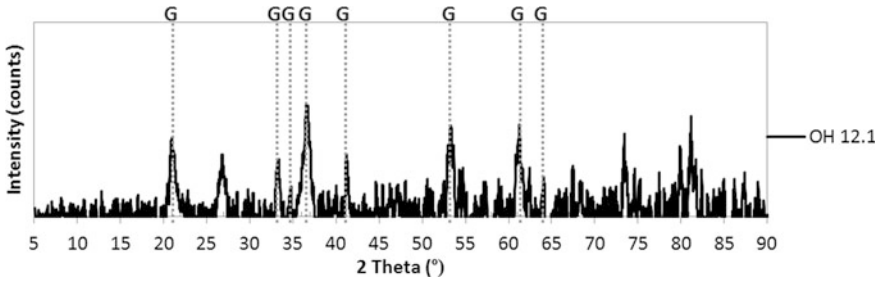
Fig. 9 XRD pattern of the rust scraped from the sample OH 12.1, *dotted lines* correspond to goethite (G)

XRD patterns of the rust scraped from the samples OH 12.1 and VI 7.2 (Figs. 9 and 10) illustrate the typical rust composition in the studied samples. Mainly Goethite, Ferroxhyte and Lepidocrocite corrosion products were identified in

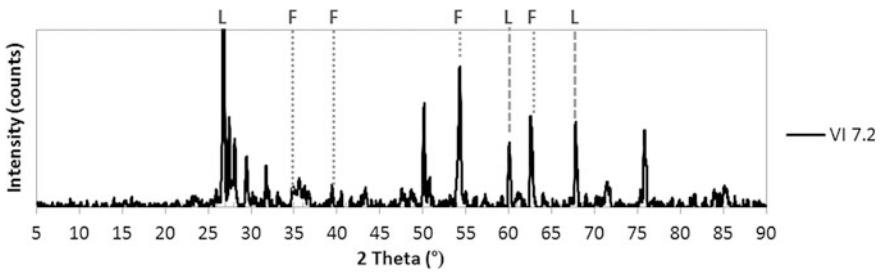
Fig. 10 XRD pattern of the rust scraped from the sample VI 7.2, *dotted lines* correspond to ferroxihite (F) and *dashed lines* to lepidocrocite (L)

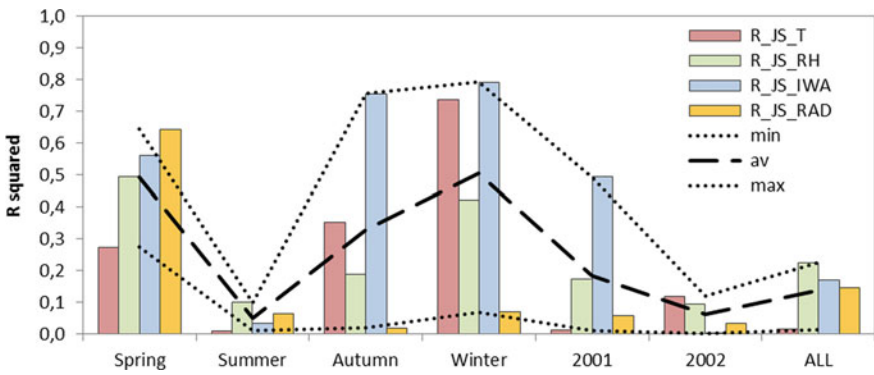
Fig. 12 The coefficients of determination of the predictions of corrosion rate based on single weather parameters. Inland, Fysiikanpolku 5 site

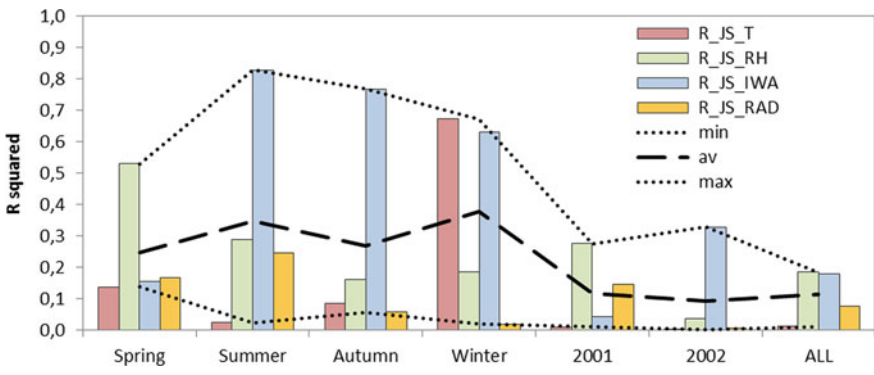
Fig. 13 The coefficients of determination of the predictions of corrosion rate based on single weather parameters. Coastal area, Joupinrinne 4 site

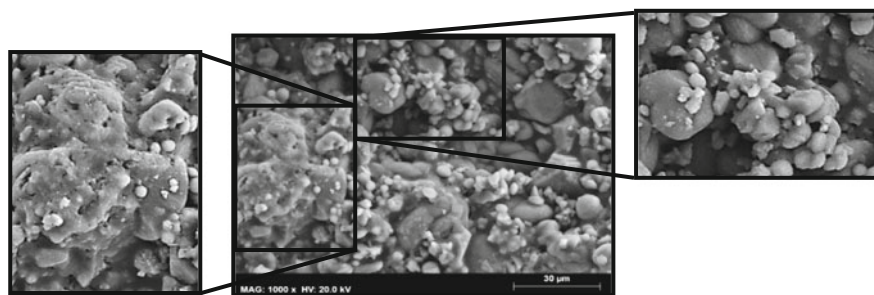
Fig. 2 SEM photographs showing the biofilm (*left*) and spheres of calcite (*right*)

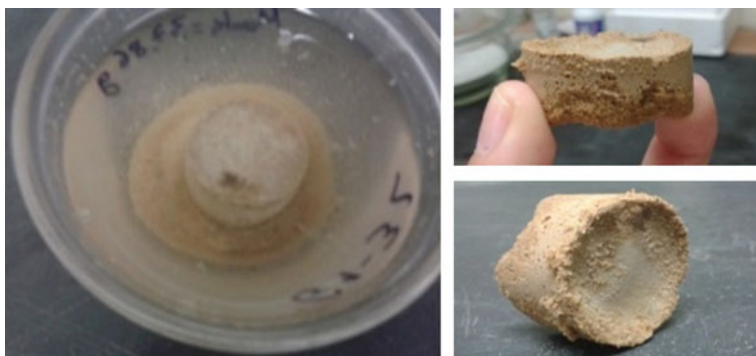
Fig. 3 Submersion test and the stiff aspect of the specimens after one month (G2)

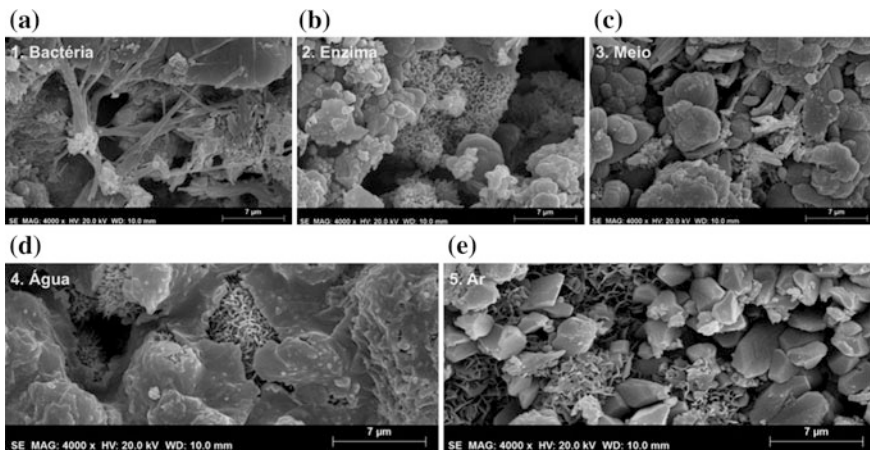
Fig. 7 Scanning electron microscopy photographs: **a** bacteria; **b** enzyme; **c** feeding solution; **d** water and **e** dry chamber

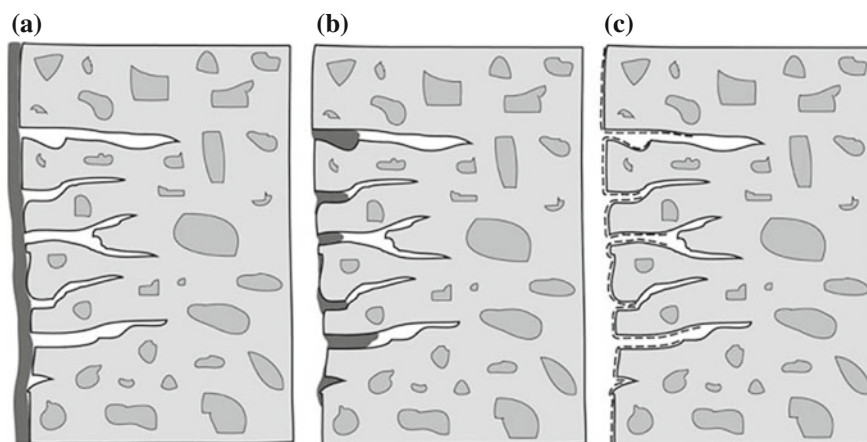
Fig. 1 Schematic representation of the mechanism of action of water repellents: **a** coating, **b** pore blocker, **c** pore liner. Adapted from Medeiros and Helene (2009)

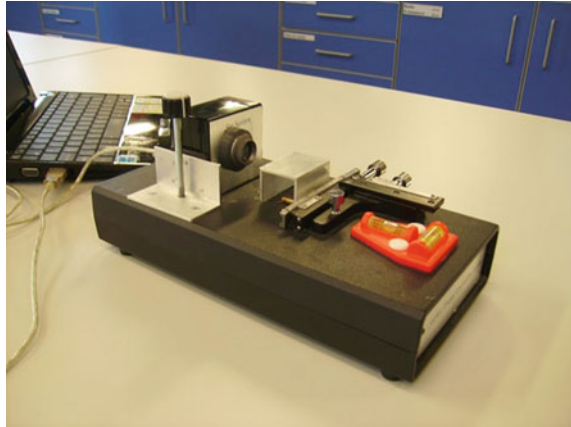
Fig. 6 Equipment for the evaluation of contact angle

Even though this is a technique that is well established and used in different fields it is worthy of note that Klein et al. (2012) have published a comparative study on the evaluation of the wettability of mortar component granular materials through contact angle measurements. Additionally, it is also of relevance the review work published by Crick and Parkin (2010) regarding the preparation of super-hydrophobic surfaces which gives a good overview of the methods available to prepare surfaces that are super-hydrophobic to water droplets, discusses the most relevant models to describe the interaction between the surfaces and water and the effect of different parameters namely that of surface roughness.

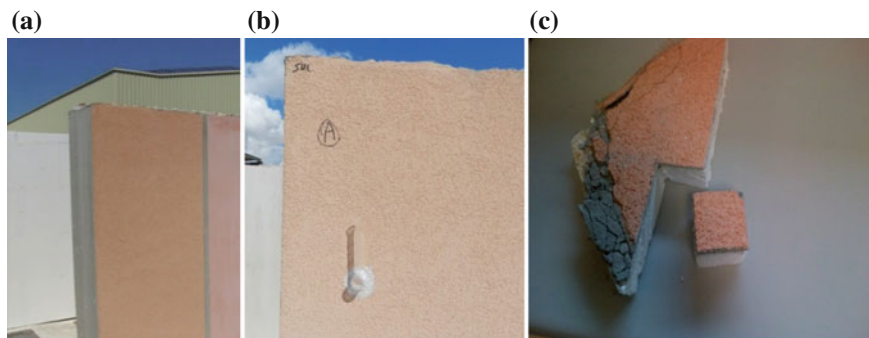
Fig. 7 **a** ETICS samples preparation; **b** Karsten tube test; **c** extracted sample for the determination of the coefficient of absorption of water by capillarity

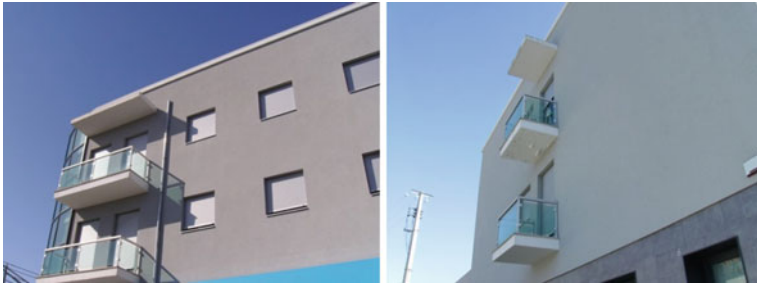
Fig. 8 Visual inspection of in situ evaluation of ETICS at the beginning, after 4 years exposure conditions (*left* South orientation; *right* North orientation)

Visual inspections were carried out over time starting in 2008 up to 2014 (i.e. 6 years exposure conditions) in order to evaluate aesthetical performance in all orientations, Figs. 8 and 9.

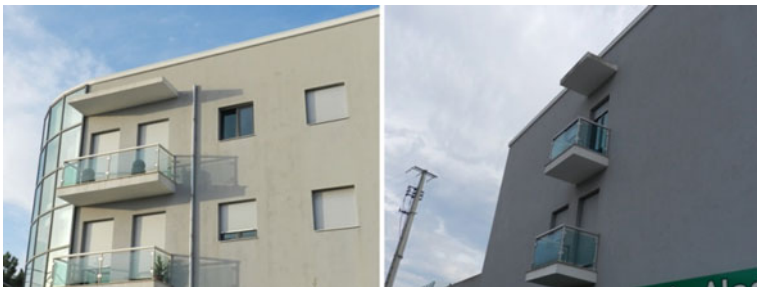
Fig. 9 Visual inspection of in situ evaluation of ETICS at the beginning, after 6 years exposure conditions (*left* South orientation; *right* North orientation)

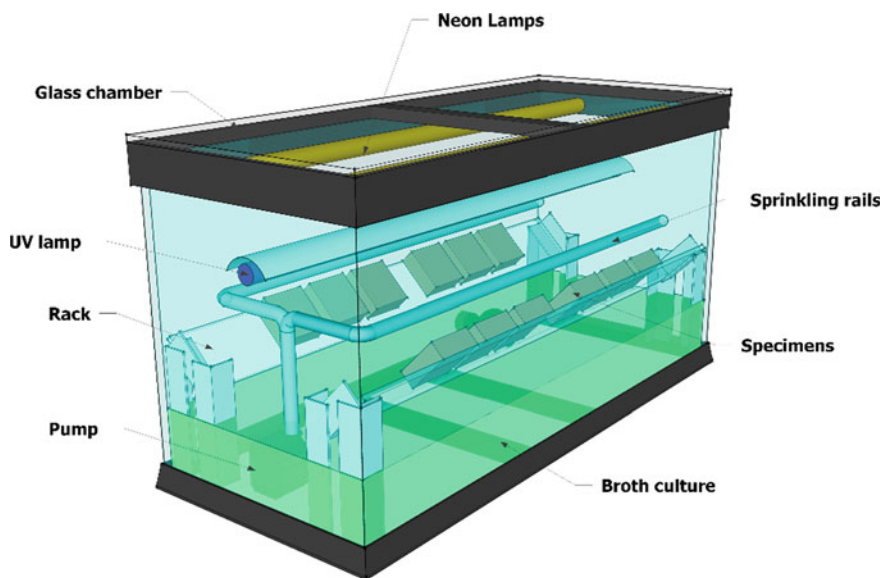
Fig. 3 Scheme of glass chamber used for accelerated growth test

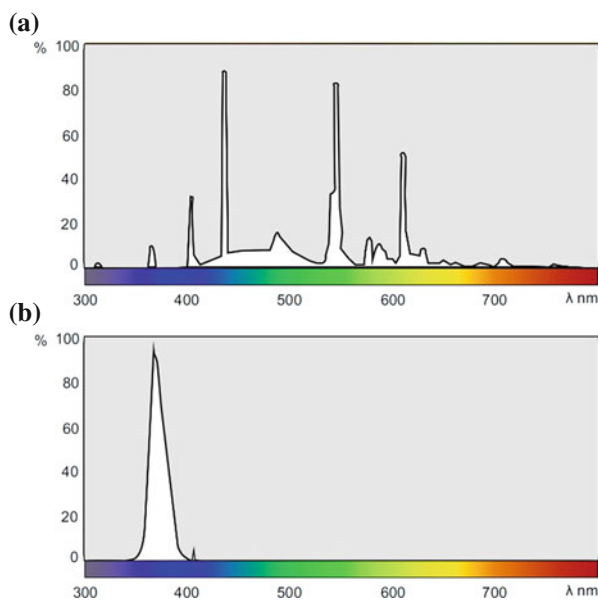
Fig. 5 Light spectrum of daylight neon lamps (a) and UV-A lamp (b) used in accelerated growth test

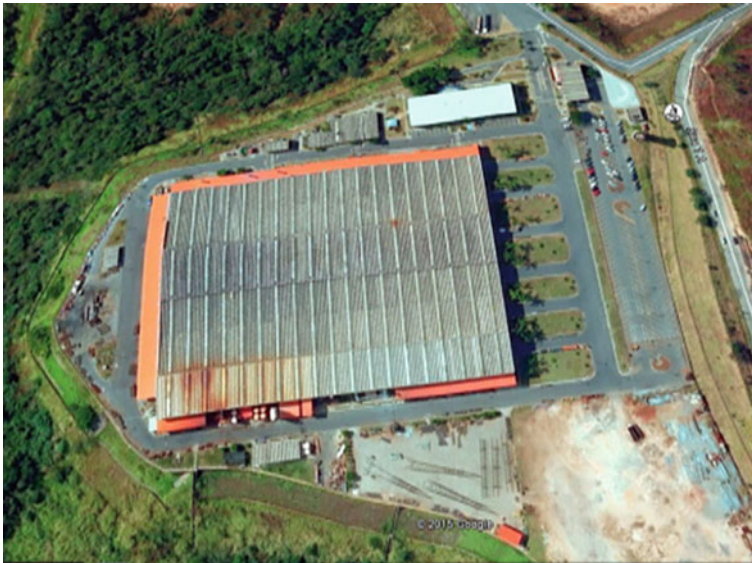
The fence panels, in a double “T” geometry, have the following dimensions: height 14 m; width 2.5 m. Various pathologies were observed in the concrete panels and a photographic record was made for more detailed study.

Fig. 1 Overview of the galvanizing facilities. *Source* Authors, 2013

Here we describe the pathologic manifestations observed in an industrial galvanizing plant, built in 1999, using precast and prestressed, concrete panels and the methodology used for the recovery and rehabilitation of its structures (see Fig. 1).

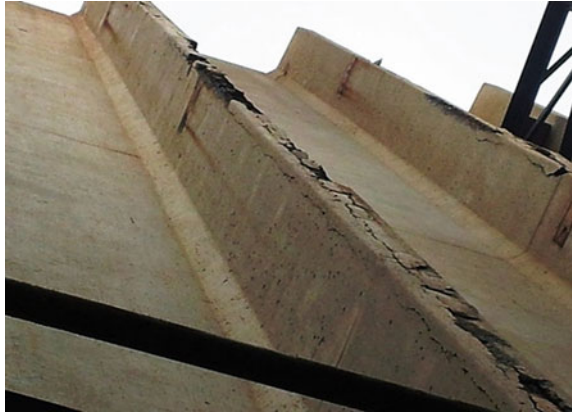
Fig. 2 Pathologies presented by fence panels. *Source* Authors, 2013

Initially, carbonation fronts, chloride ions attacks, reinforcement corrosion, spalling and leaching of concrete and several cracks were identified (see Fig. 2).

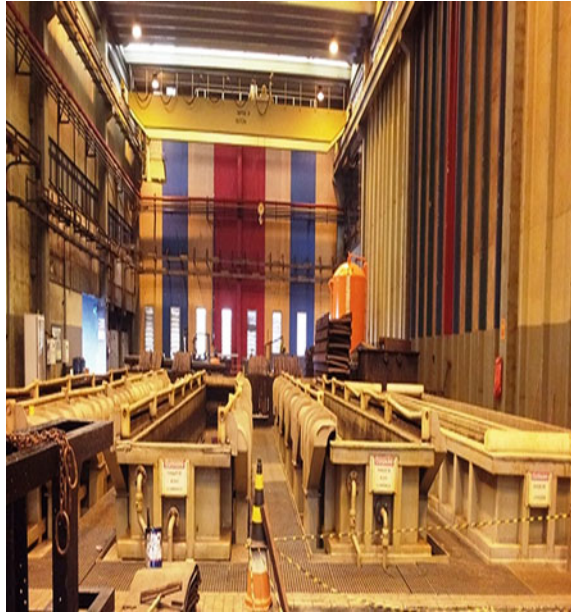
After 15 years under action of pathogenic agents, severe damage was caused to concrete structures. It is noteworthy that the facade in question is oriented from east to west, thus receiving solar heat during the entire day, making the damage worse because at night the structure is subject to hydrochloric acid fumes which are condensed on the surface.

Fig. 3 Hydrochloric acid tanks for pickling. *Source* Authors, 2013

According to Bakker, cited by Figueiredo (2005) the carbonation and chloride combination is the most common cause of severe corrosion problems (as seen on Fig. 3).

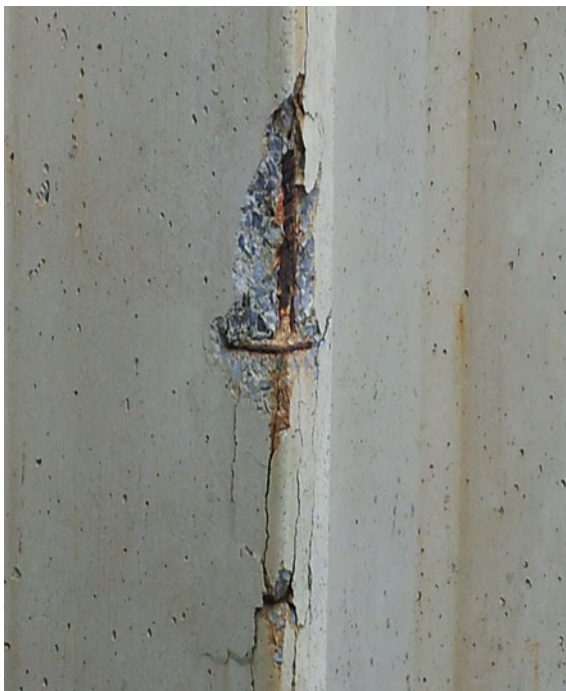
Fig. 5 Corrosion with pitting of the steel taking place.
Source Authors, 2013

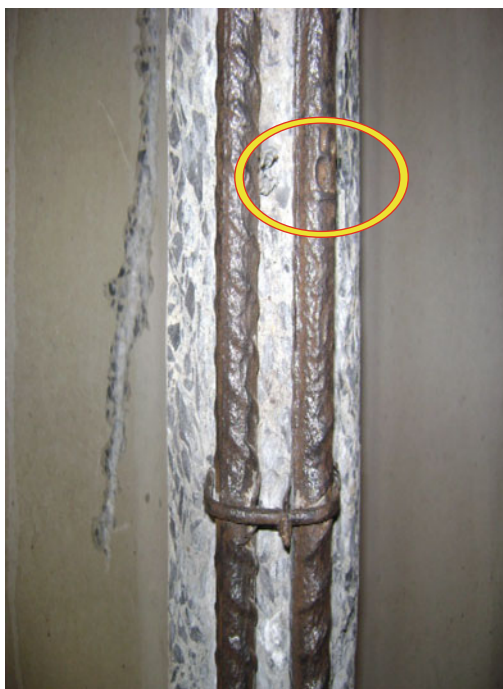
Corrosion of reinforcement in concrete has two important effects on the concrete: produces spalling and decreases the resistant section of the rebars (Canovas 1988).

These two problems have been identified in almost all the panels. With the corrosion of the diameter of the rebar's, there was an increase in volume of up to six times. Internal stress in the section was generated, so that there was a loss of adhesion between the concrete and the reinforcement, causing “spalling” of the concrete.

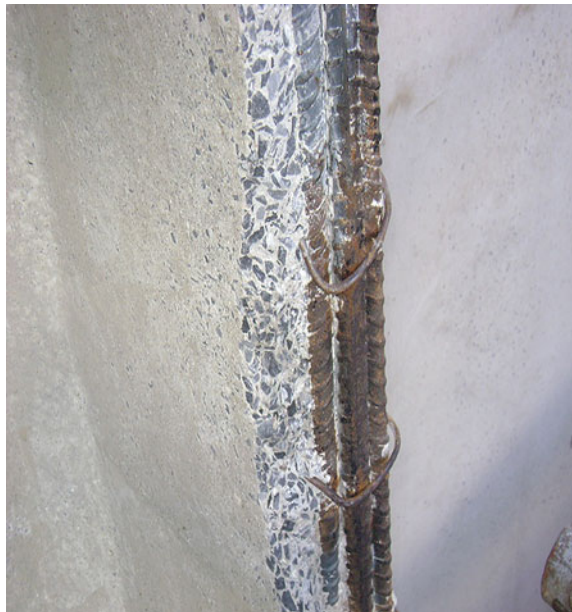
Fig. 7 Steel Corrosion Process (Source Chloride resistance of concrete–cement concrete and aggregates— Australia, June 2009)

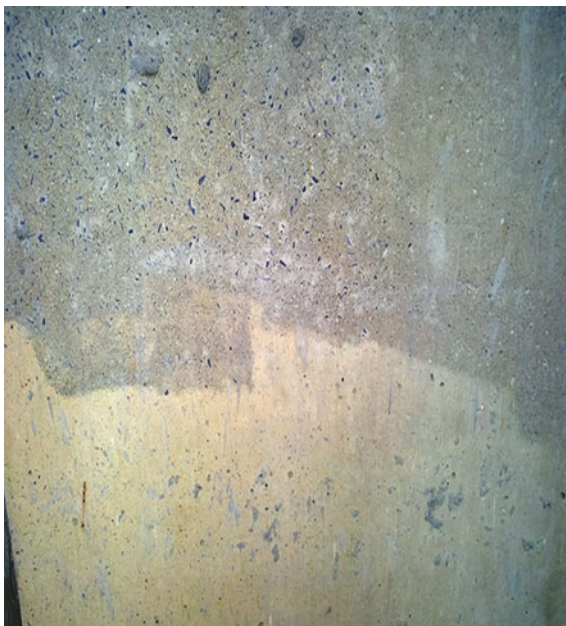
Fig. 9 Second step of cleaning: washing with pressurized water and detergent. *Source* Authors, 2013

All concrete structures were washed in 3 steps (Figs. 8 and 9).

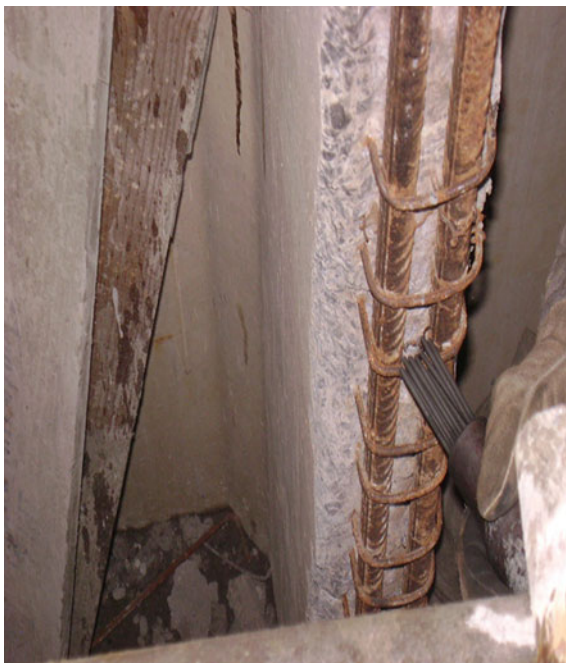
Fig. 10 Reinforcement cleaning using needle gun. *Source* Authors, 2013

- Cleaning of armor using needle guns and wire brushes to remove all corrosion points;
- Replacement of armor that had loss of greater than 5 % nominal section;

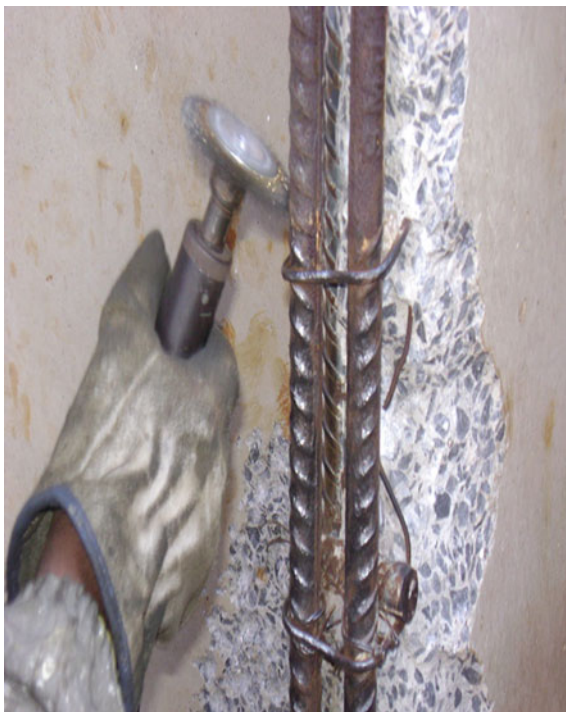
Fig. 11 Reinforcement cleaning. *Source* Authors, 2013

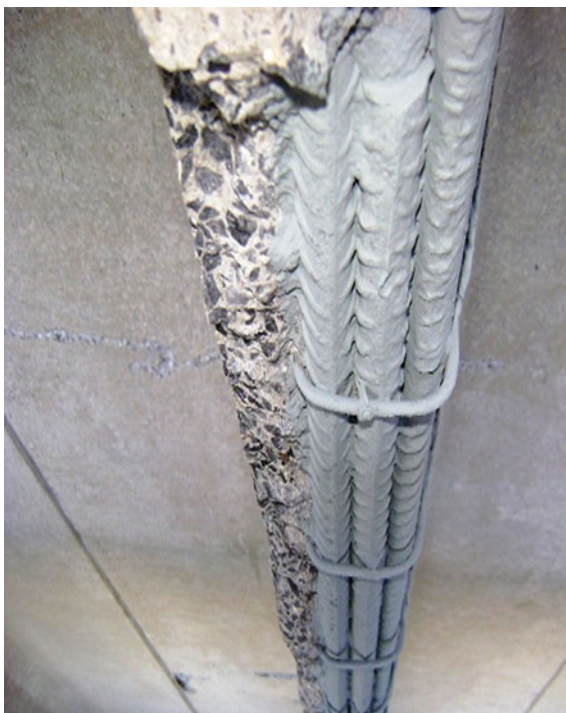
Fig. 13 Application of structural cementitious mortar for repairs up to 7 cm deeper.
Source Authors, 2013

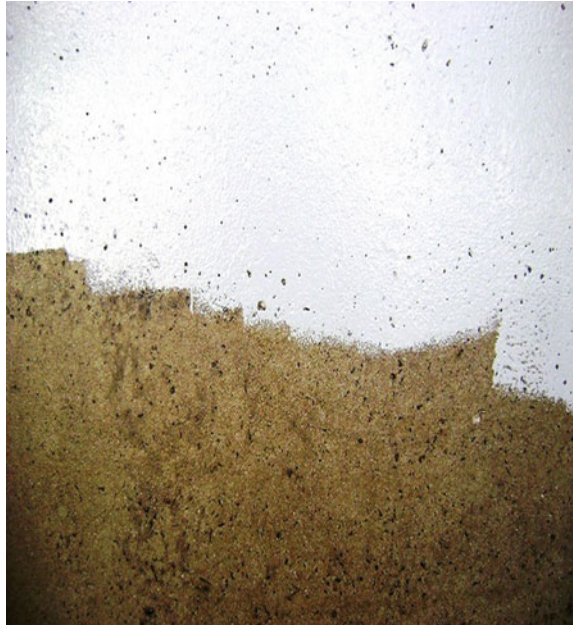
Fig. 14 Application of epoxy varnish sealer and application of intermediate coat in epoxy two-component polyamide cured. *Source* Authors, 2013

- Application of two intermediate coats with bi cured epoxy polyamide component, high-build, fast drying, developed to protect;
- Carbon steel and concrete in industrial exposures environment, applied dry film thickness of 150 μ ;

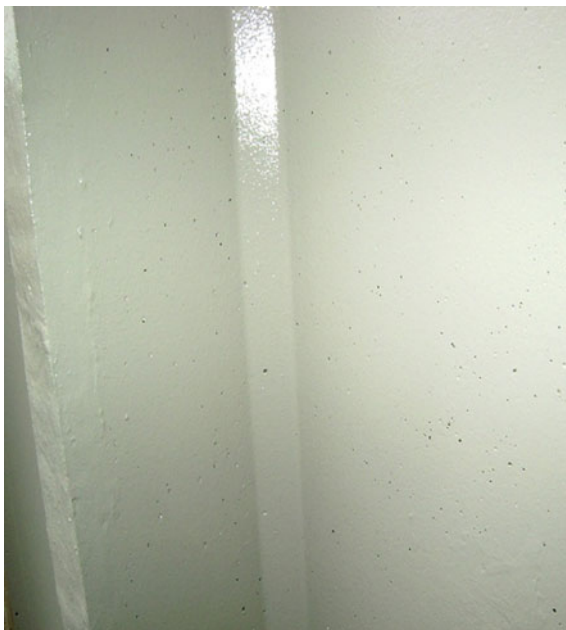
Fig. 15 Application of final coat in acrylic aliphatic polyurethane low (VOC).
Source Authors, 2013

- Apply a finish coat of acrylic aliphatic polyurethane high build, bi component with a low content of volatile organic compounds (Low VOC). Paints in acrylic aliphatic polyurethane has excellent weathering resistance, excellent flexibility and toughness to withstand the harshest working conditions, with dry film thickness of 100 μ .

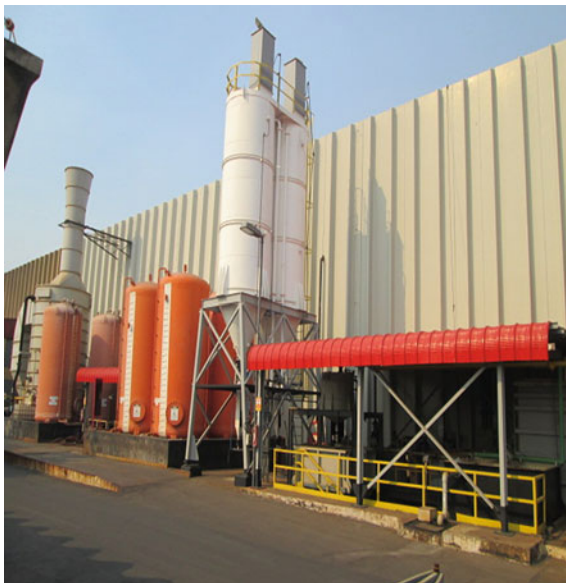
Fig. 16 Facade overview after recovering. *Source* Authors, 2013
