New Approaches to Building Pathology and Durability

Building Pathology and Rehabilitation

Volume 6

João M.P.Q. Delgado
Editor

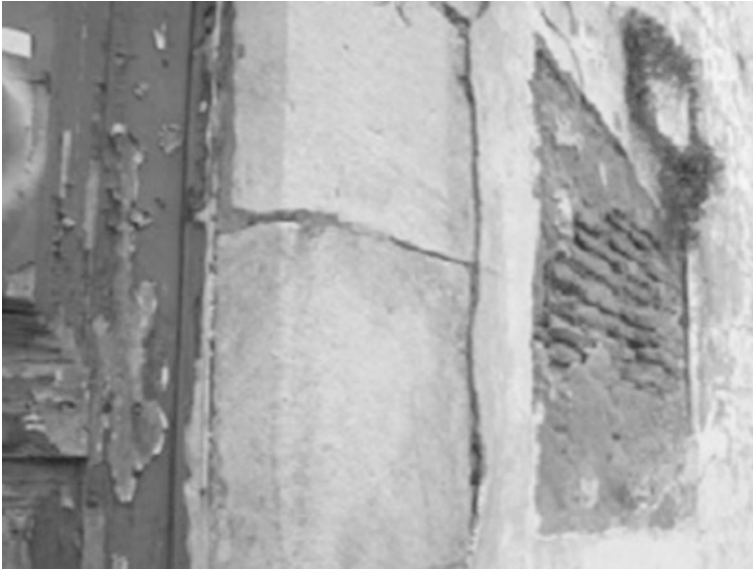
Fig. 7 Revetment overlaps the stone with invasive vegetation

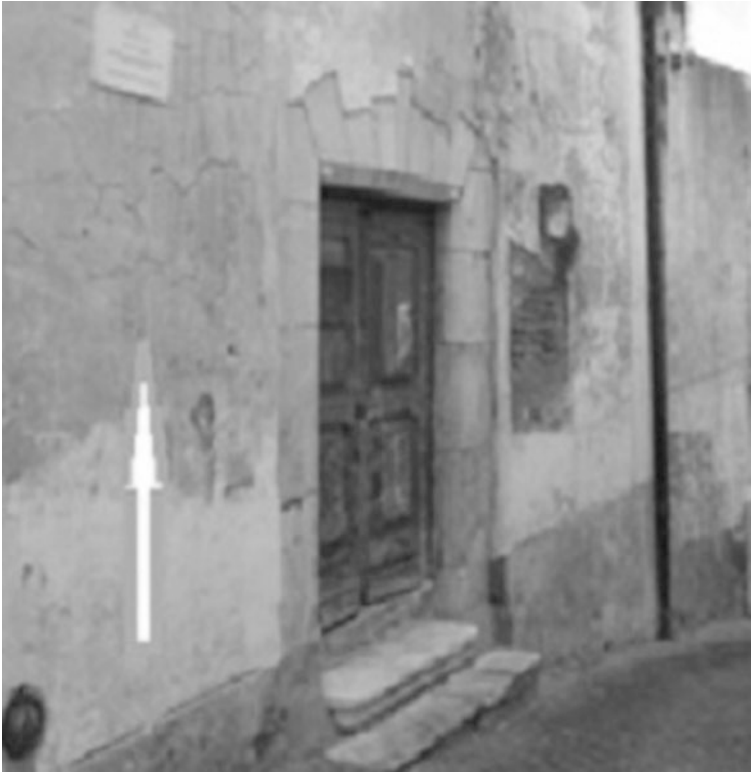
Fig. 8 Diffuse cracking of the coating on the main facade

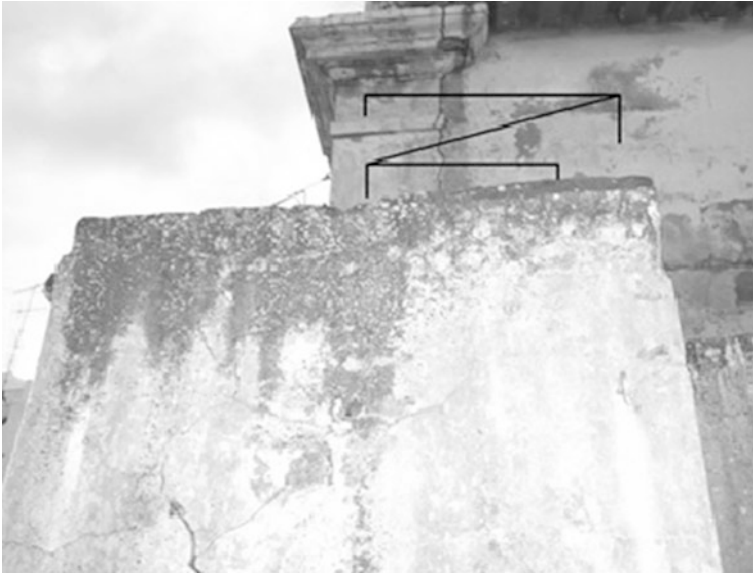
Fig. 10 Possible interventions with stapling, inserted in the wall and in the stonework

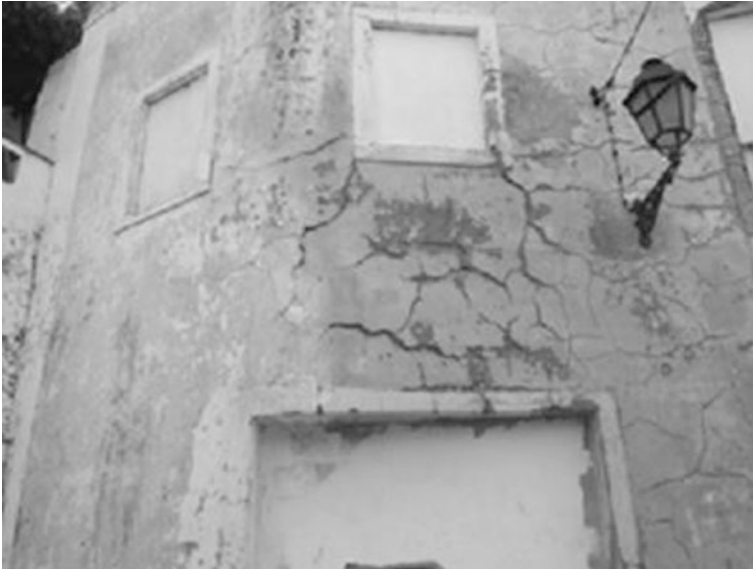
Fig. 11 Cracks under the sill of the window and in the lintel

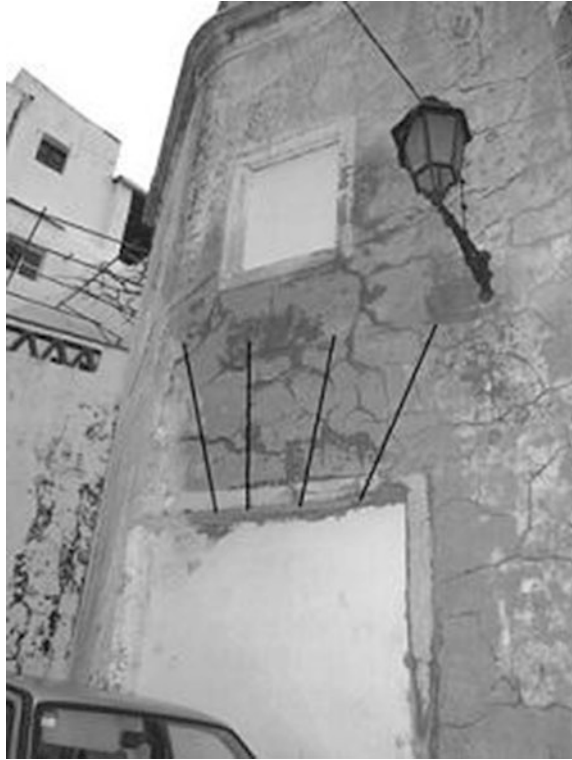
Fig. 12 Possible solution of anchorage of the lintel

- Opening of “small diameter holes, carefully located, in which are placed anchors consisting of stainless steel rods. Sealing in masonry is achieved through deformable sleeves injected” [Translation (Cóias 2007)], see Fig. 12.
- Reduction of the thickness of the coating in the cracked areas by mechanical means without percussion. See Sect. 5.2.2 for more details.
