Building Pathology and Rehabilitation

Strengthening and Retrofitting of Existing Structures

Aníbal Costa · António Arêde
Humberto Varum
Editors

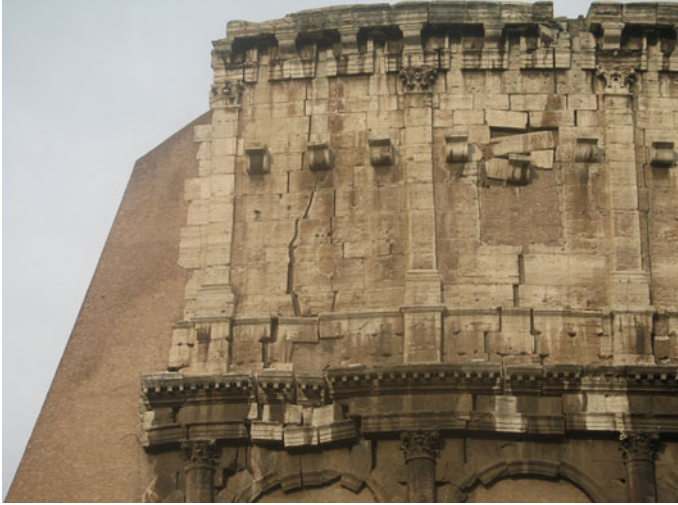
Fig. 2 Brickwork buttress of the Stern restoration (1807) of the Colosseum in Rome [7]

Similarly, an exemplary intervention is the huge 3 m thick buttress built by Raffaello Stern [7] for the stability of the Colosseum in Rome in the year 1807: the solution is preserving the damage suffered by the building due to earthquakes, which are still very evident, and is clearly differentiated from the monument, as it is built in brickwork instead of stone (Fig. 2). One year before, in 1806, Rondelet [8] also strengthened the central pillars of the Panthéon in Paris by means of a thick layer of new stone masonry in order to double the insufficient cross section (Fig. 3).

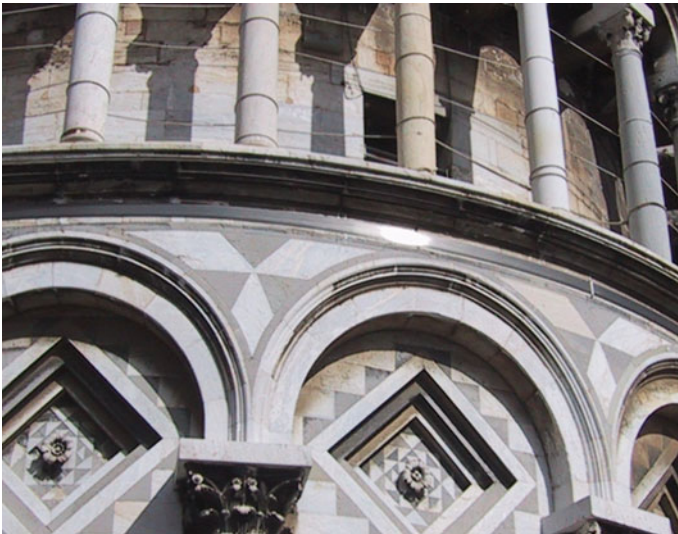
Fig. 4 Leaning Tower of Pisa; Pretensioned circumferential tie realized with a removable stainless steel band

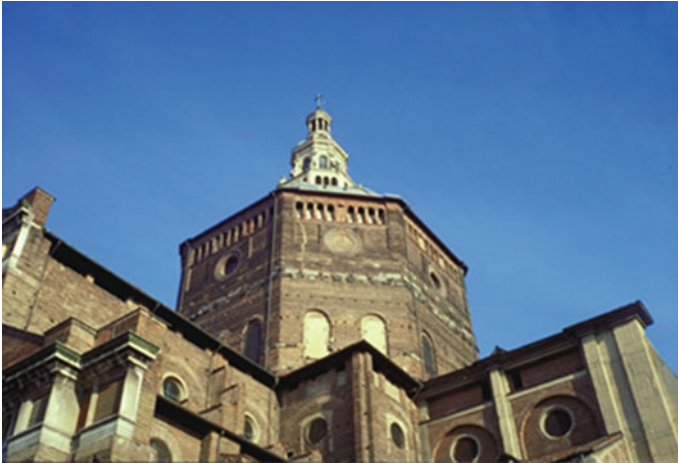
Fig. 5 The cathedral of Pavia (1488—today)

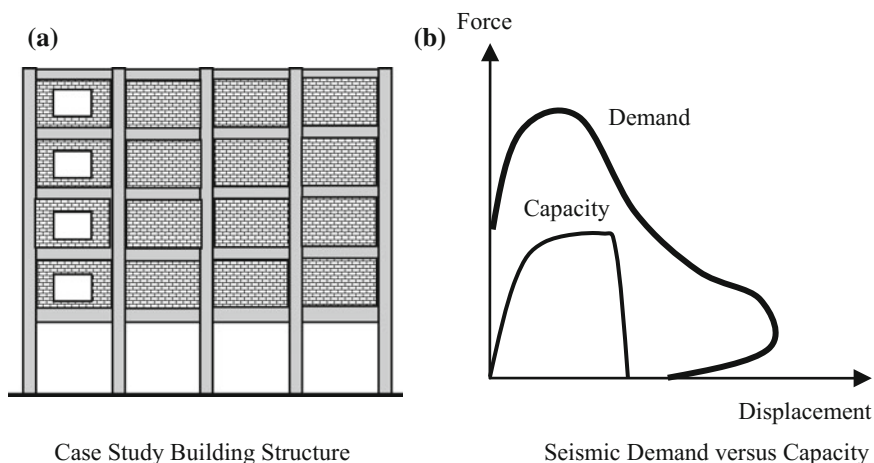
Fig. 8 **a** A case study building prone to the formation of a soft-storey during earthquake shaking, and **b** comparison of the demand and capacity, expressed in terms of force-displacement axes

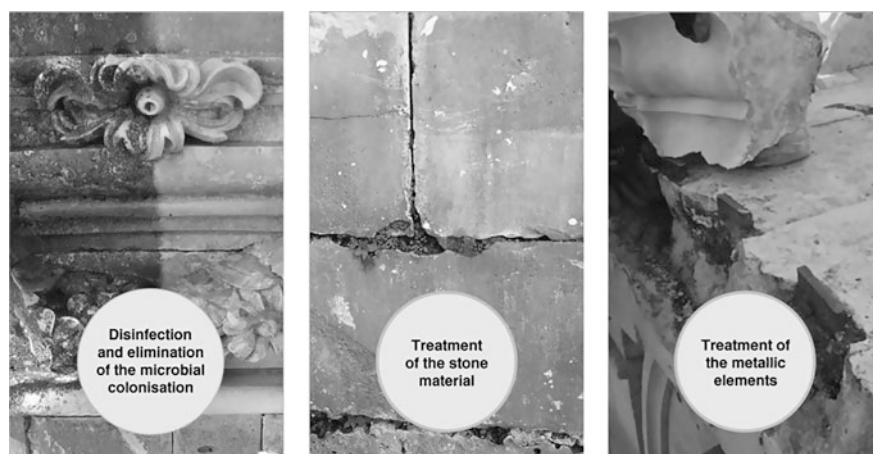
Fig. 6 Conservation works performed

The conservation and restoration works took place from March 2010 to August 2010. Besides the main action of cleaning and treatment of all surfaces, assumed as ordinary planned maintenance, other reactive maintenance actions aiming at restoring the stability conditions and the cohesion of the architectural elements, as well as of ornamentation elements that presented signs of instability and risk of imminent fall, were also taken. The suppression or mitigation of the action of agents responsible for the degradation of materials and the attainment of better conditions

to resist the action of external atmospheric agents were other maintenance actions carried out [11]. It is worth highlighting that the specific nature of this intervention entailed the adoption of individual strategies and methodologies, not only during the preparation works, but also during the accomplishment of the different tasks. Figure 6 schematises the conservation works performed, which are herein grouped and described in the following paragraphs.

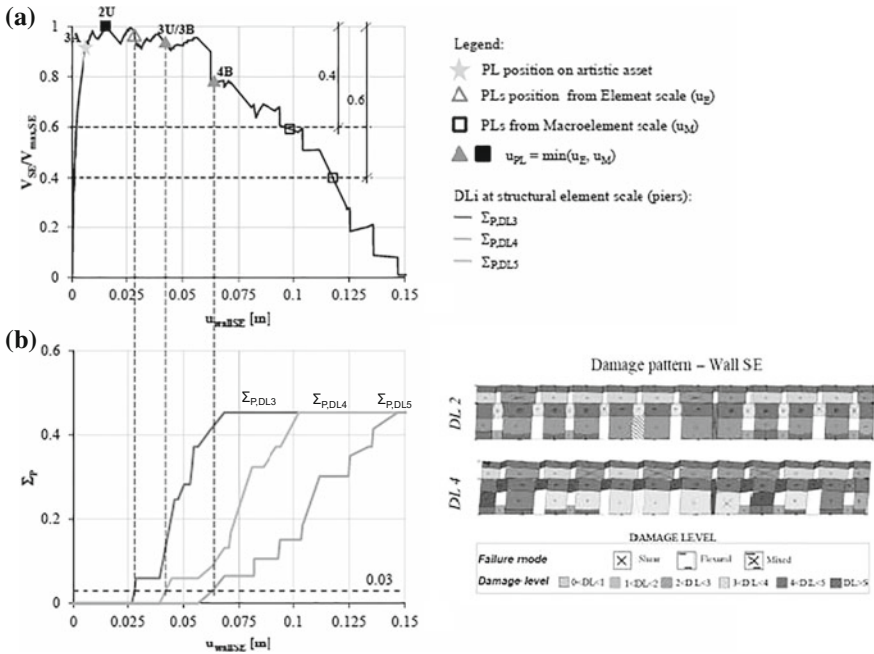
Fig. 13 Definition of PLs on the pushover curve of SE wall of Great Mosque according to the multiscale approach (by the strips is indicated the pier which the *mihrab* is connected to) (adapted from [30])

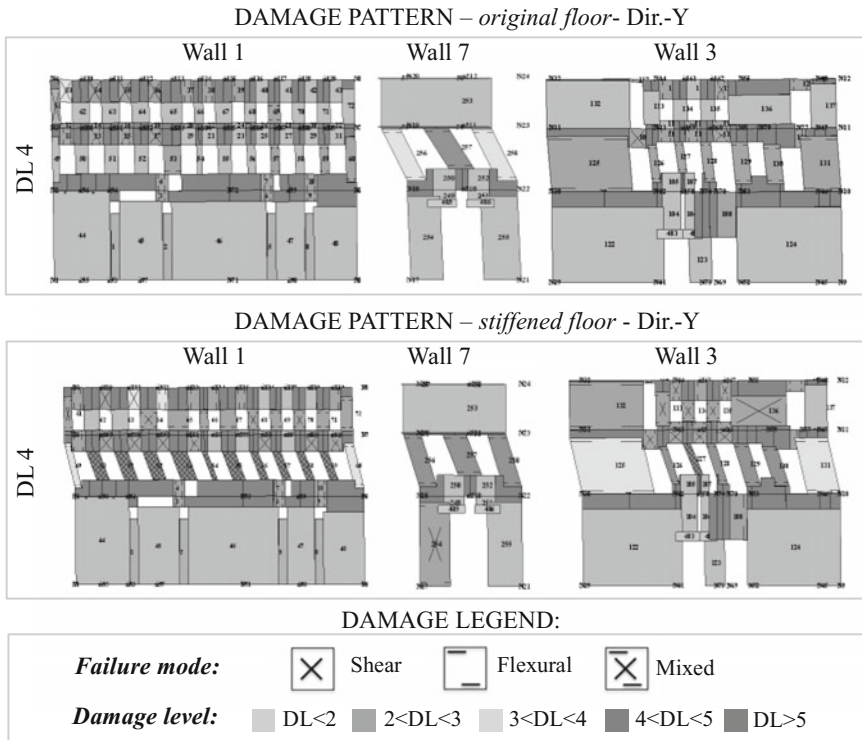
Fig. 20 Effect of floor stiffening in case of the Hassan Bey’s Mansion on the damage pattern and the overall response (adapted from [29])

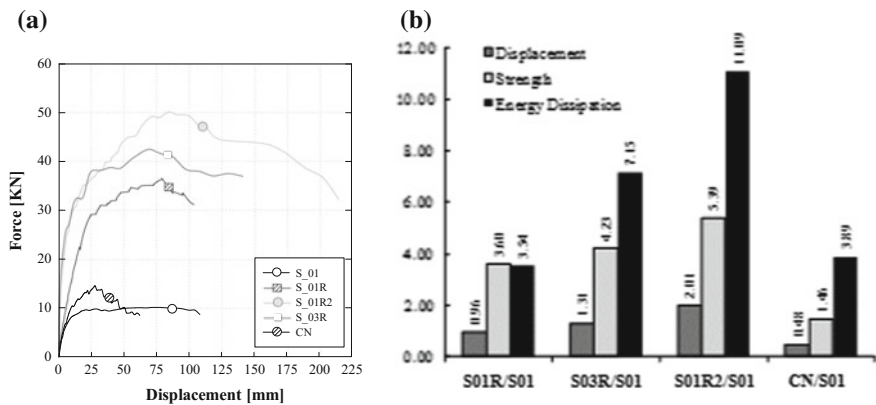
Fig. 11 Experimental results on original (non-strengthened: *S_01* and *CN*) and strengthened (*S_01R*, *S_01R2* and *S_03R*) specimens with reinforced plaster, under out-of-plane cyclic tests [68]: **a** lateral out-of-plane force-displacement envelopes, **b** global comparison in terms of ratios relative to non-strengthened specimen *S_01*

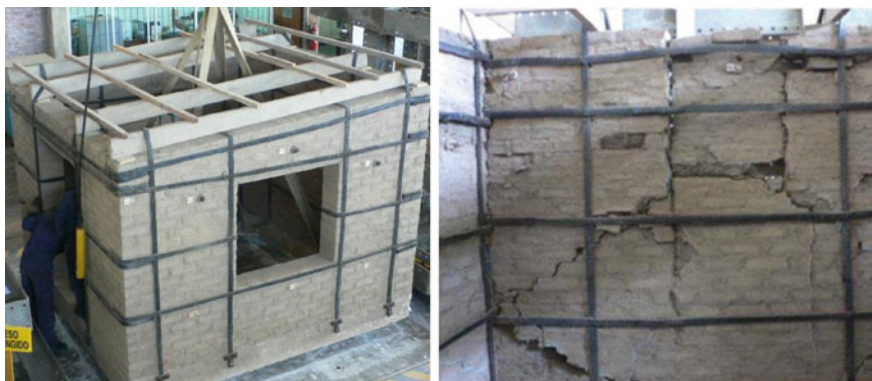
Fig. 12 Shaking table test on an adobe model strengthened with tire straps [58]

spiral cutting a tire into a continuous strap (Fig. 11). The tire straps were then placed horizontally and vertically on the adobe walls and tied through holes in the walls. An adobe model using this strengthening solution was tested in the shaking table (Fig. 12). The results obtained showed a significant increase in the deformation capacity of the model, without collapse, thus proving the effectiveness of this strengthening solution.

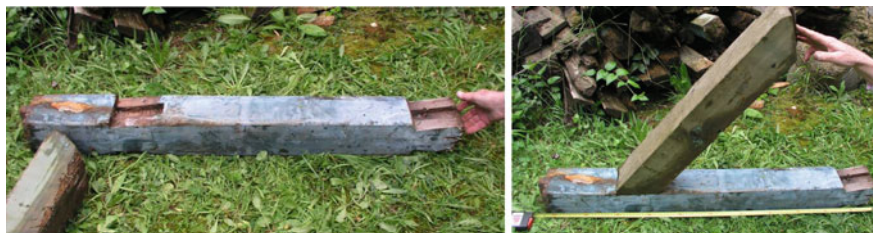
Fig. 1 Notched joints with tenons

In the past, the actions taken by carpenters to strengthen joints were based on experience and precise observations of failure modes encountered in real structures and a good understanding of their behaviour and their weakest points. In some cases this led to an improvement in the designing of the joints and one can say that many carpentry joints are an evolution or a “reinforcement” of older primary joints. For example, a notched joint with a tenon can be considered as a “reinforcement” or an improvement of a tenon joint because the notch increases the load bearing capacity of the joint (Fig. 1).

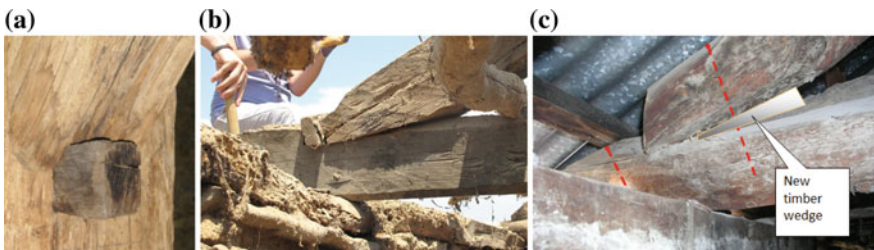
Fig. 3 a Tenon and mortise joint: additional wooden wedge used to ensure a tight contact between the tenon and the mortise, b additional wooden piece to ensure the contact of the timber elements, c proposal for the reinforcement of a poorly constructed heel joint. Addition of a new wedge and screws

Whatever the joint is, in order to ensure the transmission of the loads from one member to the other and the required strength and stiffness, it is important to keep all the surfaces of the joints in close contact. In the case of reverse loads, uplift, poor construction (Fig. 3c), or high shrinkage of the wood elements, joints may develop gaps between connected elements, reducing the contact areas. One traditional reinforcement technique consists in placing a wooden wedge or a piece of timber to ensure perfect contact between the tenon and the mortise or the timber elements (Fig. 3). This wooden wedge should be made of hardwood (for strength and stiffness) and its moisture content (MC) should be as close as possible to that of the reinforced wooden elements in order to avoid any shrinkage of the wedge.

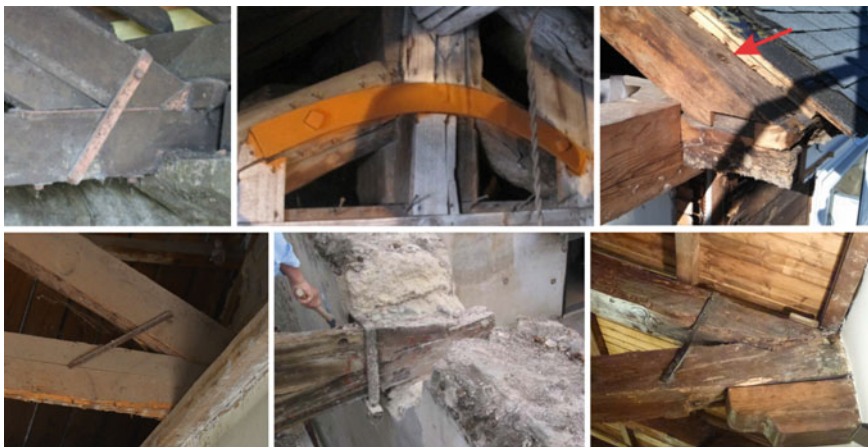
Fig. 8 Examples of original metal elements used in notched joints

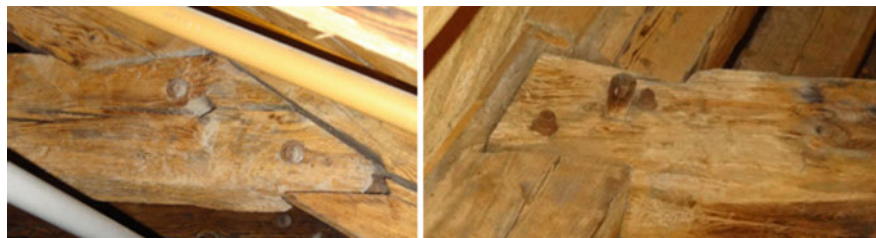
Fig. 11 Traditional reinforcement of dovetail-lap joints under tension loads by adding wooden dowels

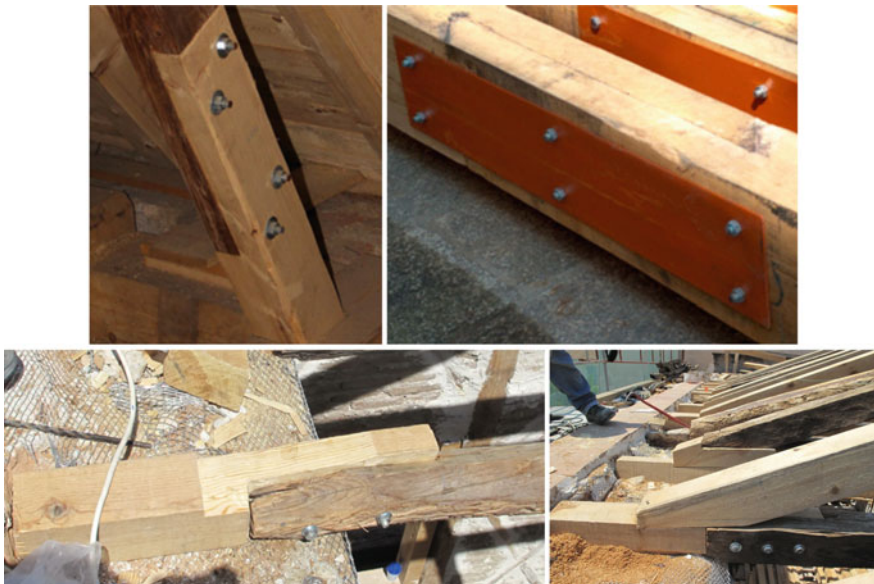
Fig. 12 Scarf joints reinforced with metal fasteners and plates. Prosthesis with scarf joint and bolts realized at the heel joint of a roof

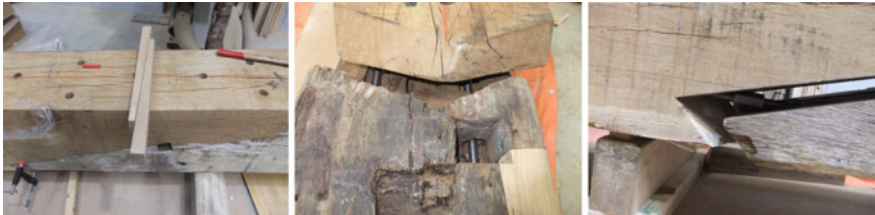
Fig. 14 Scarf joint reinforced with glued in rods: steel rods are glued in both timber members and connected with a long nut. *Credits* Pascal Lemlyn. Restauration du Moulin de l'abbaye de la Paix Dieu, Institut du patrimoine Wallon, Belgique

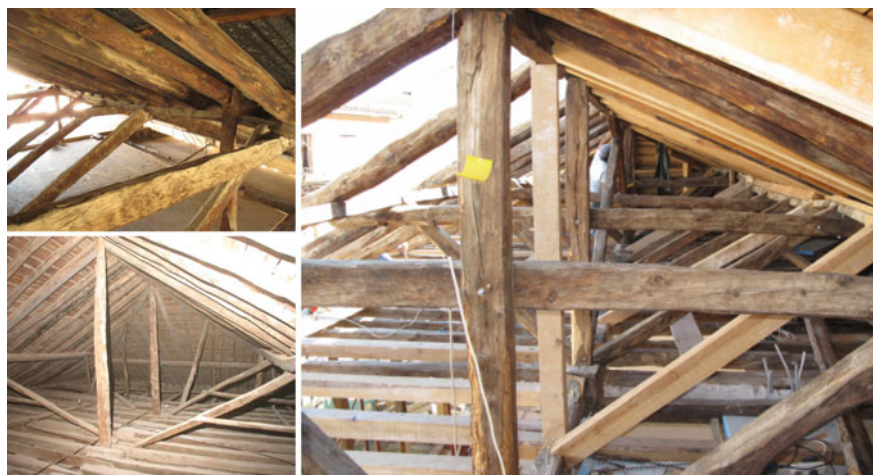
Fig. 21 Post and beam type of roofs of Post-Byzantine mansions in Greece [14, 16]. Excessive deformation of the longitudinal horizontal beams that support the rafters. Reinforcement by adding just new timber struts

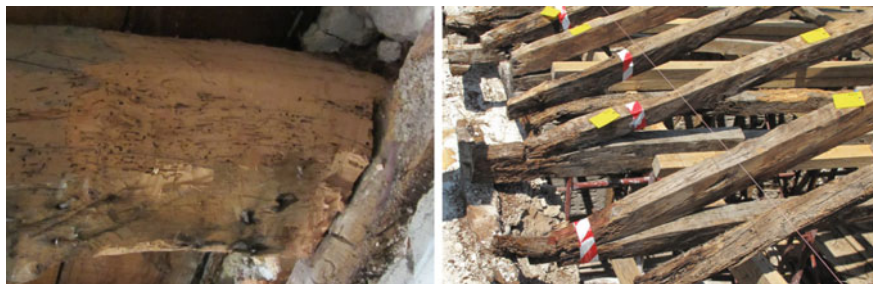
Fig. 25 Examples of decayed old timber end beams that can be found both in floor and roof systems

floor boards and in some cases, mainly in important buildings by the high safety level normally applied in the past in the design of those structures. In domestic architecture (traditional buildings, houses) the dimensions of timber are usually small). Very often, as in roofs, intervention on timber floors involves end-beams repairs. End-beams, embedded in masonry walls, are the more exposed zones to biological agents. If a high level of humidity is present in masonry e.g. due to infiltration, when disconnections or damages occur in roofing elements (tiles etc.) and the adsorbed moisture cannot be evaporated because of lacking in ventilation, the suitable conditions for biotic attacks are established and therefore degradation of end-beams can be expected (Fig. 25).

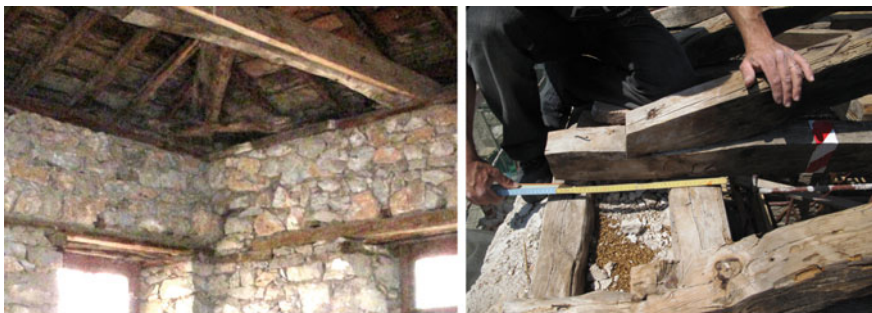
Fig. 30 Roofs nailed on timber ties that connect the vertical load bearing walls of the buildings (masonry or timber-framed) improving their seismic resistance [15, 16]

In Italy, Spain and Portugal, the connection to the wall is achieved using metal devices (Figs. 23 and 32b). In Greece and in most of the countries eastern than Greece, for thousands of years a horizontal continuous system of timber ties/lacings, a timber grid, running around all masonry walls, is tying the building as a belt in several levels (Figs. 23 and 30). On these timber ties the floors and the roofs were nailed improving the connection and the collaboration of the walls (box behaviour). The improvement of the diaphragmatic action of the timber roofs and floors is considered a successful reinforcement of the buildings against severe earthquake events [13–16].

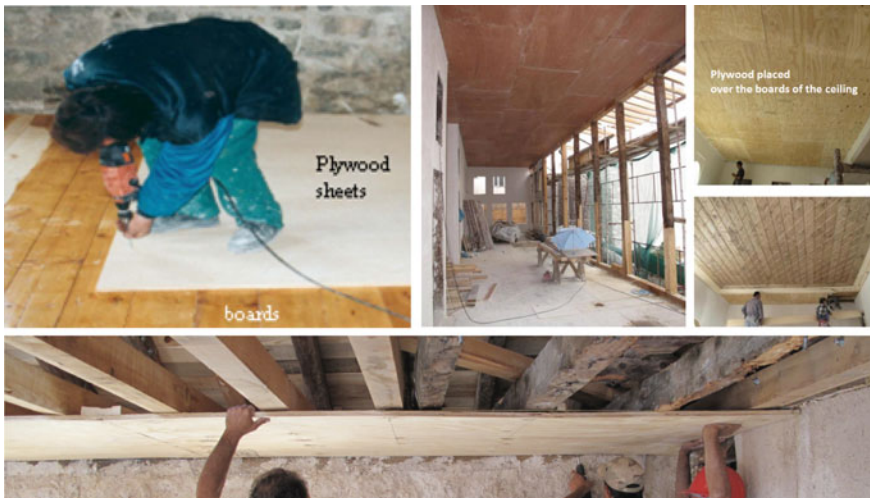
Fig. 31 Use of plywood panels over the existing floor boards and under the second layer of boards for the pavement. Use of plywood panels between the horizontal tie-beams of the roof and the boards of the ceiling for the improvement of the diaphragmatic action of the floor and the roof

As mentioned before, there are several techniques for strengthening existing timber floors. Their effectiveness in terms of in-plane stiffness too differs depending on the strengthening technique used [44–47]. The most effective ones, in terms of in-plane stiffness, are those which reinforce the compression side of the floor cross-section. The basic idea is to improve the in-plane stiffness of the floor system by implementing a more efficient T-section as for vertical loads. Among the various possibilities, the addition of a concrete layer over the timber structure is common practice [45, 48]. Another possibility is to use timber or wood-based materials (e.g. plywood) (Fig. 31), instead of a concrete slab to enhance the in-plane stiffness [16, 32, 46, 47].

An alternative to the traditional technique of adding a second layer of floorboards to strengthen the floor placed transversally to the existing ones consists to place either floorboards placed diagonally or plywood panels, over the existing planks and under the new ones, since the last layer has to be made by boards. At the level of the roof, the plywood panels can be added between the horizontal tie-beams and the planks of the ceiling (Fig. 31) [16]. CLT (cross laminated timber) panels can be used over the floor beams too and screwed onto them. It must be noticed that, thanks to the enhanced mechanical performances of CLT, namely good in- and out-plane load bearing capacities and two way action capability, it is possible to

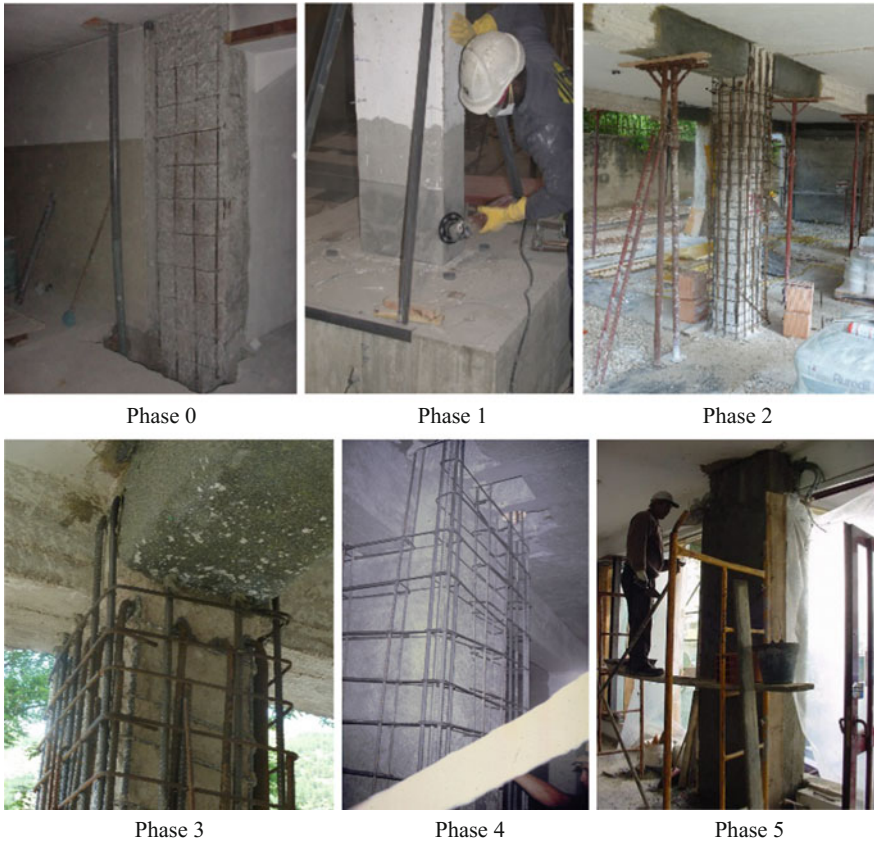
Fig. 1 Construction process of RC column jacketing

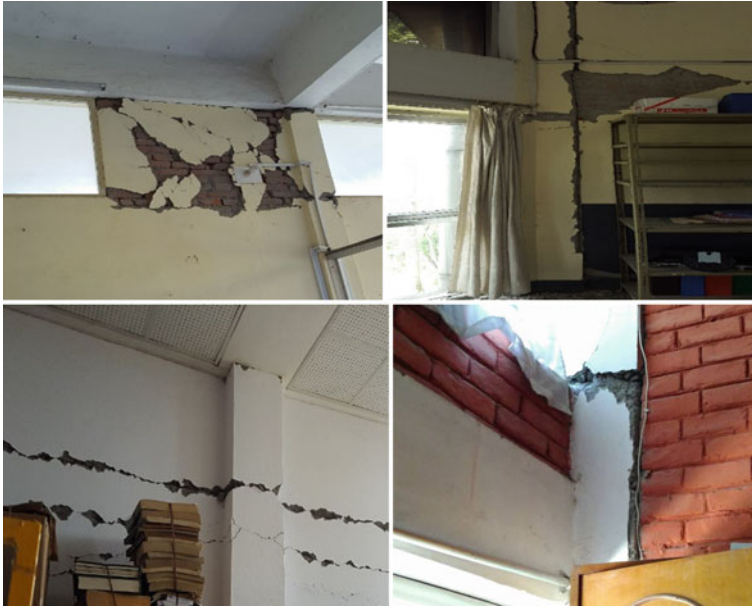
Fig. 6 Damage observed in Kathmandu University Central Library (Dhulikhel) after the major earthquake

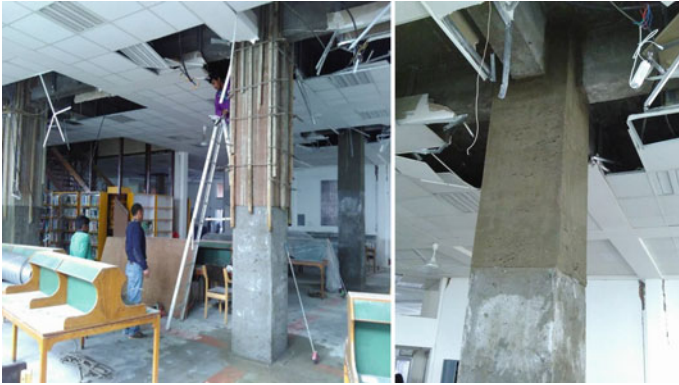
Fig. 7 Concrete jacking in columns of Kathmandu University Central Library (Dhulikhel)

Step 2—Column retrofitting: The retrofitting of deficient columns is essential to prevent storey collapse. Hence, it is more important to retrofit columns compared to beams. The columns are retrofitted to increase their flexural and shear strengths, to increase the deformation capacity near the beam-column joints, and to strengthening the regions of faulty splicing of longitudinal bars. The columns in an open ground storey or next to openings should be prioritised for retrofitting. The retrofitting strategy is based on the strong column-weak beam principle of seismic design. Concrete jacketing involves the addition of a layer of concrete (Fig. 7), longitudinal bars and closely spaced lateral ties (Fig. 8). As shown in Fig. 8,

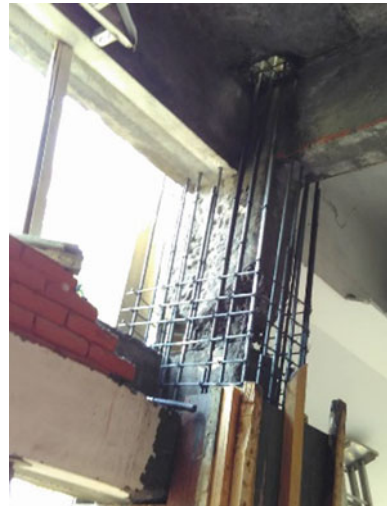
Fig. 8 Concrete jacking of a damaged column

the jacket increases both the flexural and shear strength of the column. If the thickness of the jacket is less than 100 mm on each side of column, the effectiveness will be lower in terms of stiffness.

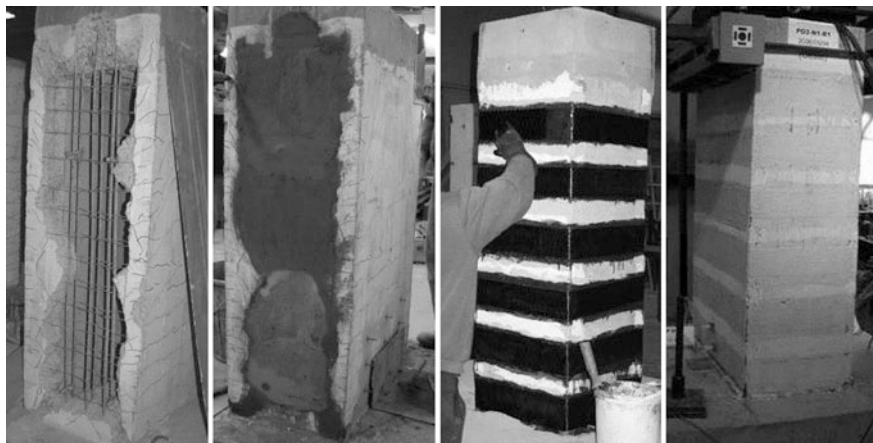
Fig. 3 Hollow piers before and after the shear retrofitting with CFRP sheets

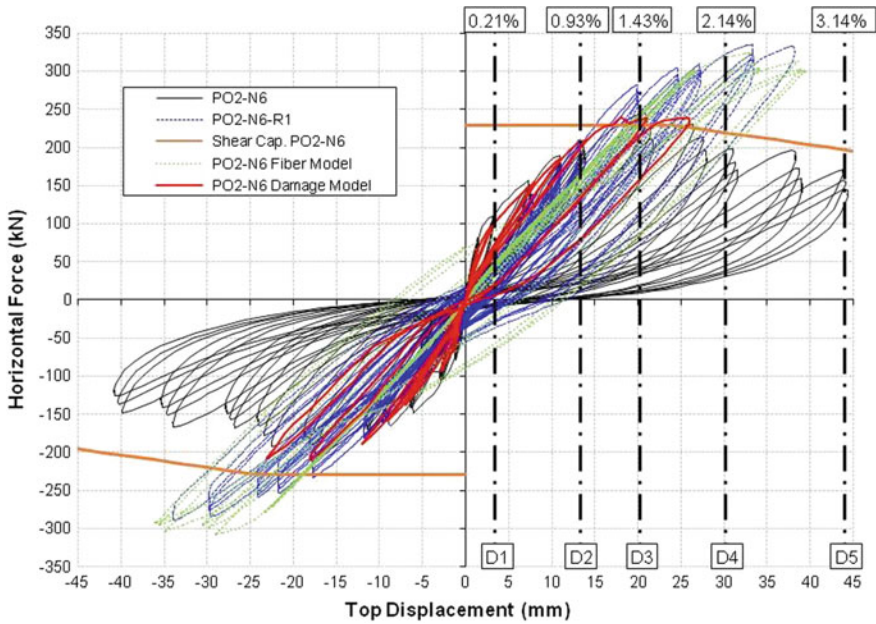
Fig. 5 Experimental and analytical results—comparison of PO2-N6 versus PO2-N6-R1

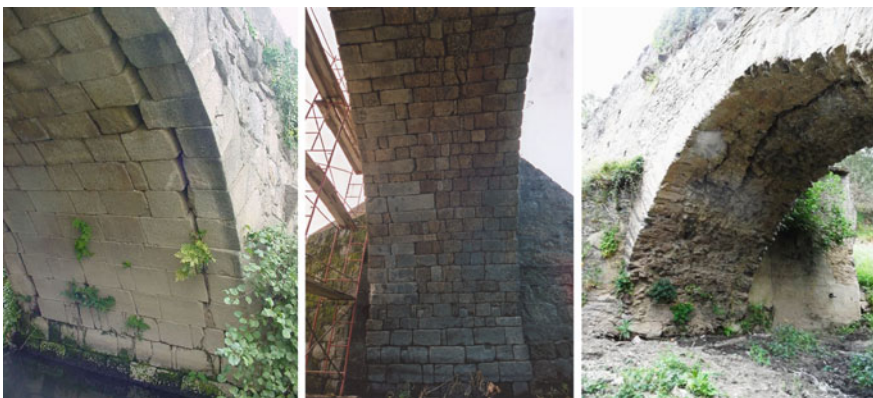
Fig. 2 Longitudinal cracks due to the bridge structural performance in the transverse direction

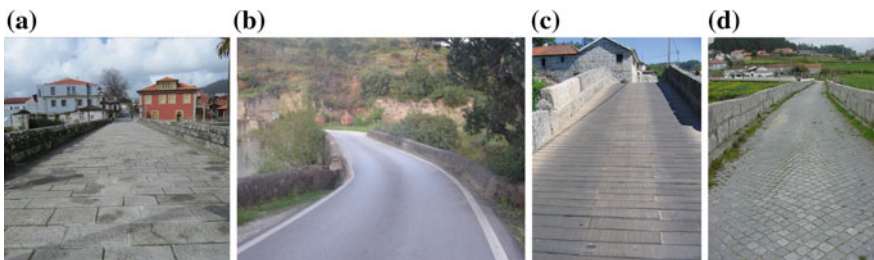
Fig. 7 Pavement repair: **a** Replacement of masonry stones, **b** Bituminous pavement overlay and **c, d** Replacement pavement

The solutions that involve the repair of the paving stones are intended to keep the bridge operation through one of the following options (Fig. 7): (i) repairing the original bridge pavement, reusing the masonry stones in good condition and adding new similar slabs, where necessary; (ii) covering the original pavement with an additional layer usually made of bituminous material, taking due care to keep operational the drainage system which is often negatively affected by the height increase of the pavement and, (iii) replacing the original pavement by a new one, made either of bituminous material or stone units.

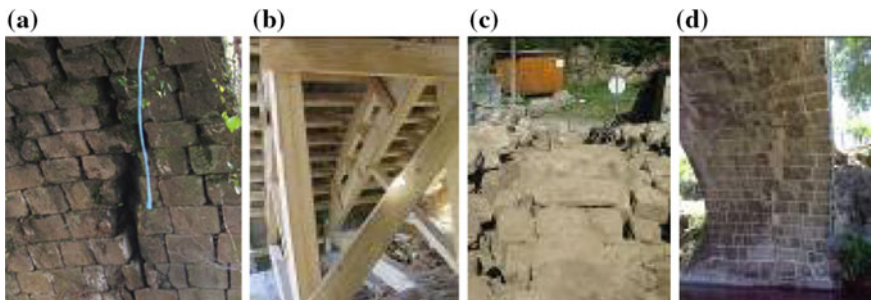
Fig. 9 Esmoriz Bridge: **a** View of the arch intrados before the intervention, **b** Falsework, **c** View of the arch extrados after infill removal and spandrel walls' dismantling, **d** View of the arch intrados after reconstruction

The Esmoriz bridge exhibited serious structural damage such as longitudinal cracking in the arch intrados, pavement deformation, subsidence and crushing of foundations, widespread damage caused by moisture, vegetation and biological pollution and loss of mortar in the joints (see Fig. 9a). Before dismantling the structure, paving stones and spandrel walls have been numbered with erasable ink and this numbering has been recorded through photographs taken *in situ*. After placing the falsework shoring (see Fig. 9b), the arch blocks were readjusted keeping the original bridge stones that were in good conditions. Cracked and damaged stones were replaced by other similar granite stones cut in the appropriate way (Fig. 9c, d). The reconstruction of spandrel walls was made ensuring appropriate interlocking of stone blocks and the infill material was replaced by well-graded and compacted granular material.

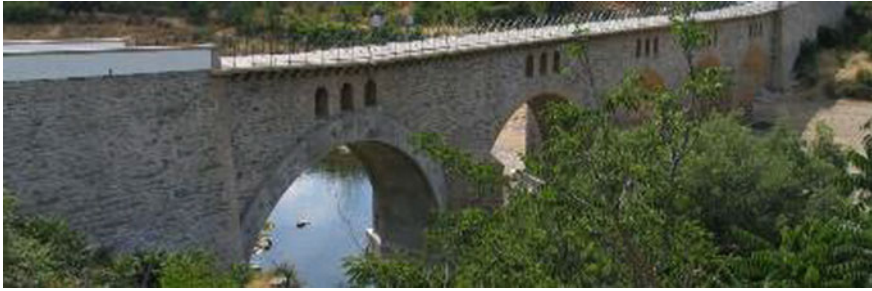
Fig. 12 Downstream view of Remondes bridge after the arch reinforcement with shotcrete

The strengthening with shotcrete in the intrados consists in thickening the arch to increase its load bearing capacity. The new material is high-pressure sprayed and as a result adheres to surfaces and compacts the material already applied forming a new layer that usually is reinforced with rebars [15].

As main advantages, this process is fast and does not require formwork. However, their effectiveness is seriously compromised in the case of deterioration of the bond between the two layers, particularly vulnerable due to concrete retraction problems.

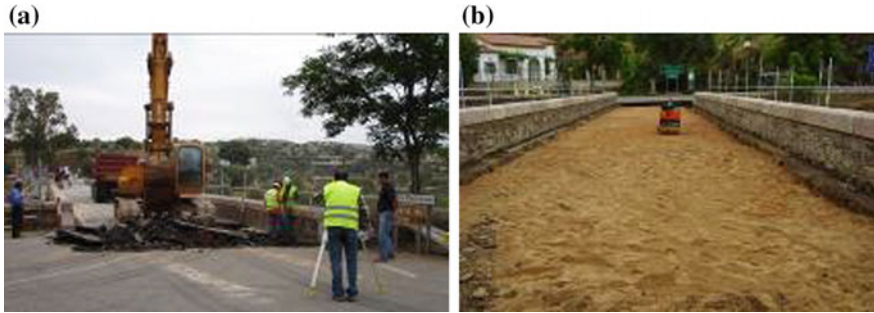
Fig. 13 Segura bridge: **a** Bituminous removal and **b** Surface regularization for the application of a concrete slab on the pavement [21]

For example, the rehabilitation and strengthening of the Segura bridge, Portugal [22], included the application of a reinforced concrete slab as part of the pavement. Figure 13 shows two phases preceding the slab execution, namely the removal of the existing bituminous layer and the regularization of the surface for application of the slab [21].

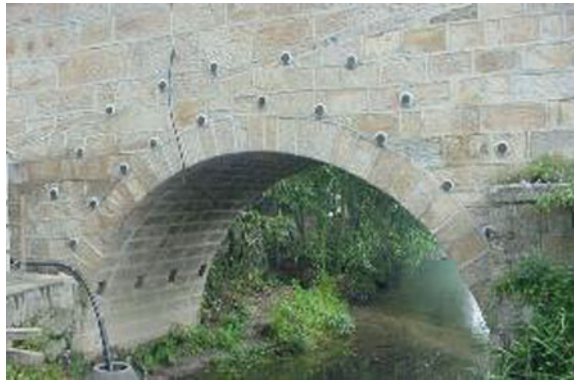
Fig. 19 Transverse ties in the bridge over the River Sul [46]

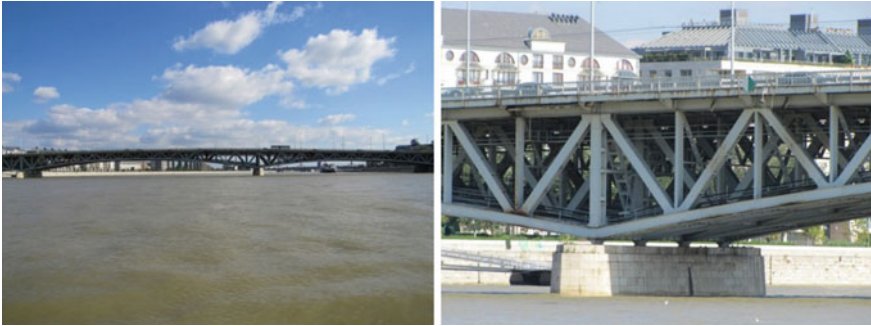
Fig. 1 Deck-type truss bridge

among other variables. In all cases, reinforced concrete is the most common material used to construct the deck. Historic bridges use steel trusses or steel girders to support the deck. Figure 1 shows a typical deck-type truss bridge, where the deck is over the top chord of the truss.

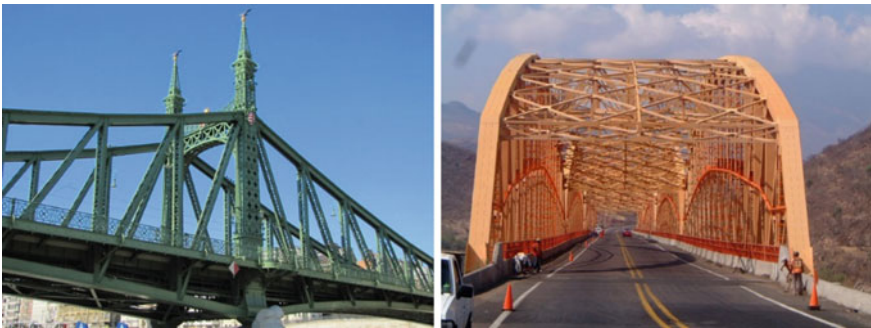
Fig. 2 Through-type truss bridges

In through-type truss bridges, the deck slab is located at the bottom chord plane. Figure 2 shows this type of bridge. Steel truss bridges have been used as a suitable solution for bridge span lengths that range from 30 m to 400 m. The selection of the truss type depends more on the space limitations beneath the superstructure than on structural issues. However, the top chord in truss bridges is subjected to compression, which is an additional difference between these two types of structures. In deck-type bridges, the compression chord can be inside of the deck slab, which avoids the buckling problem in these elements.

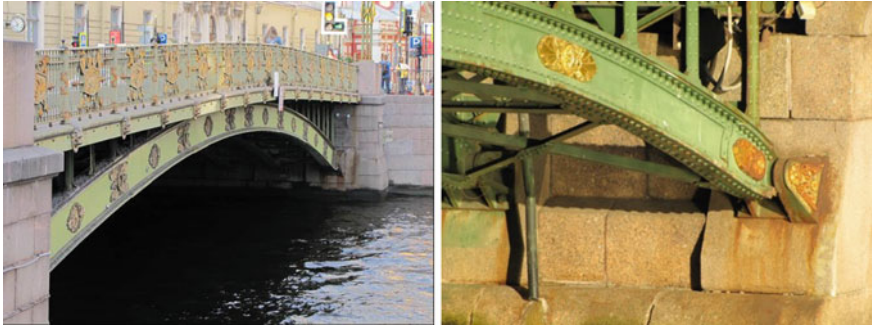
Fig. 3 Arch-type bridge with pin bearings

Arch steel bridges are also commonly used; Fig. 3 shows an arch bridge that conforms with I-type girders composed of steel-bolted plates. Although they have been used in small span lengths, their use is more attractive for span lengths that range from 150 m to 450 m.

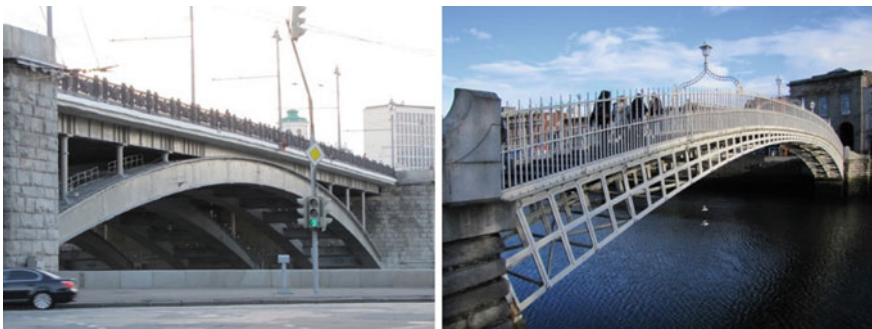
Fig. 4 Arch-type bridges

The arch can be built by several pieces or by several open elements to increase the depth at the arch ends (Fig. 4). In any case, transverse elements (bracing) connect the arch girders to give stiffness and an integrated action in that direction.

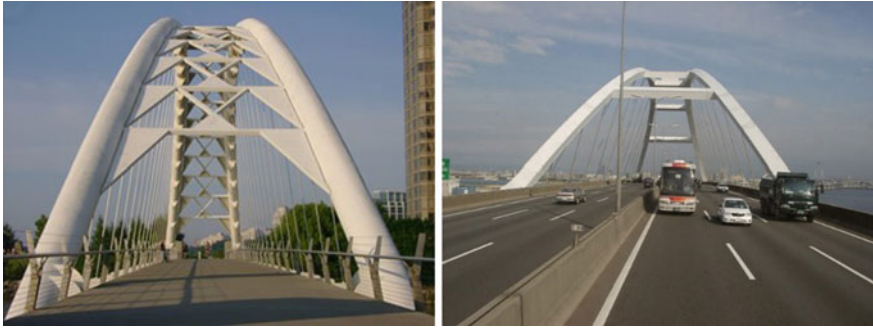
Fig. 5 Arch bridges with tubular- and box-type cross-sections

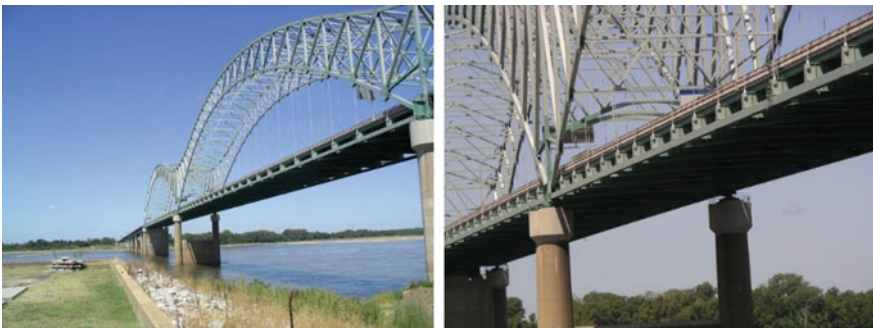
Fig. 6 Arch bridge with a truss structure

When the span length is longer, arch bridges can be created with truss elements. Figure 6 shows an arch bridge in which the arch is a truss structure with variable depth. This versatile structure uses the advantages of both systems and creates an aesthetic bridge structure.

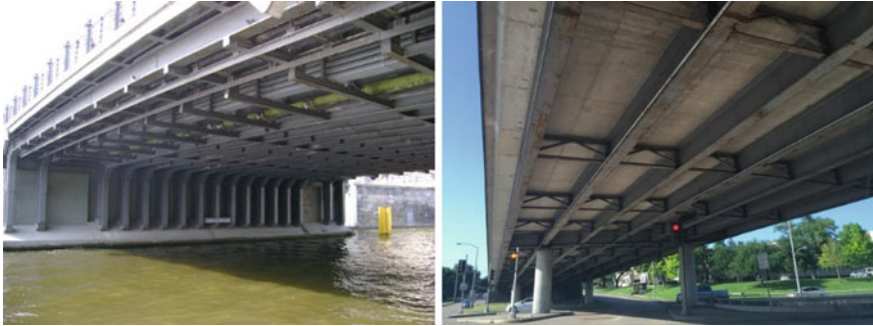
Fig. 8 Steel girder bridges

On the left, Fig. 8 displays a bridge built with bolted steel plates and an orthotropic deck system and on the right, an I-type girder superstructure with a reinforced concrete (RC) deck slab. In the left image, steel columns support the girders, which form a steel frame structure, and in the other image, the girders rest on rocker steel bearings on RC columns.

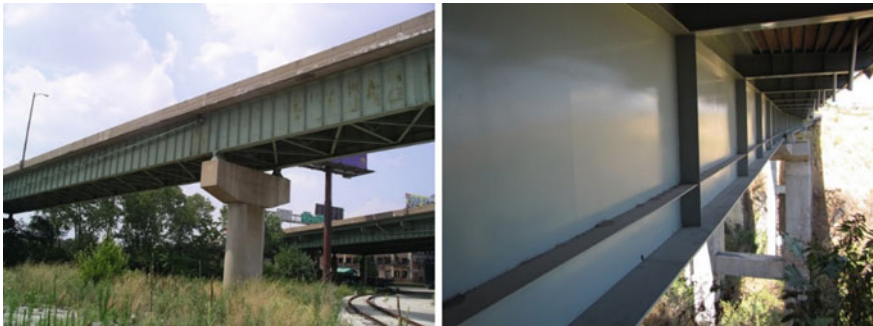
Fig. 9 Steel girder bridges with web stiffeners

Figure 9 shows two typical steel girder bridges. The girders typically have webs with a high depth/thickness ratio that requires web stiffeners along the girder length to avoid local buckling of the plates.

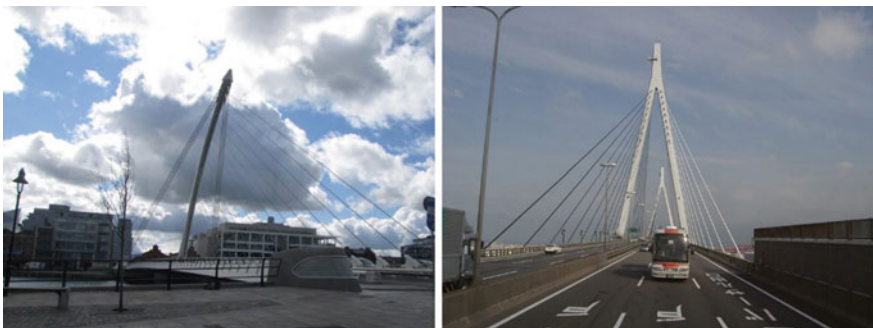
Fig. 10 Cable-stayed bridges

The superstructure of cable-stayed bridges mostly consist of steel girder elements. These bridges can reach a span longer than 1000 m, and the cables are generally fixed to either side of the tower in orthotropic steel decks. Figure 10 displays two cable-stayed bridges. In the left image, a single-span bridge with only

one tower is shown, and in the right image, a three-span bridge with two A-shape towers is shown.

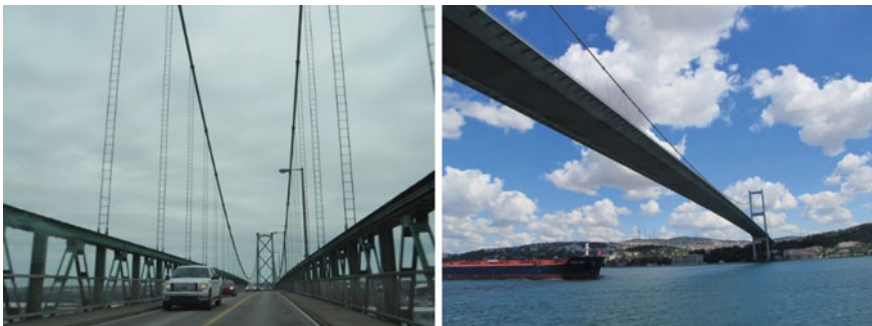
Fig. 12 Suspension bridges

Modern suspension bridges have lighter elements and can reach span lengths close to 2000 m. Figure 12 shows two suspension bridges. In both cases, the deck is constructed with steel elements.

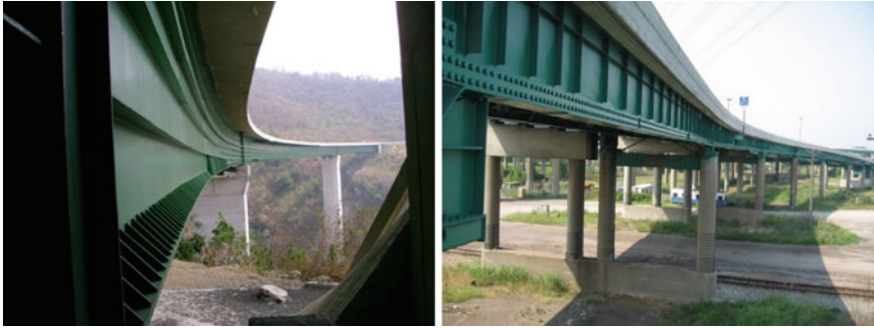
Fig. 13 Curved steel bridges

Curved bridges are often constructed with steel superstructures. The malleability of the steel makes it a suitable material to build girders with this shape. Figure 13 shows two curved bridges, where a box-type girder is shown on the left, and an I-shaped girder is shown on the right.

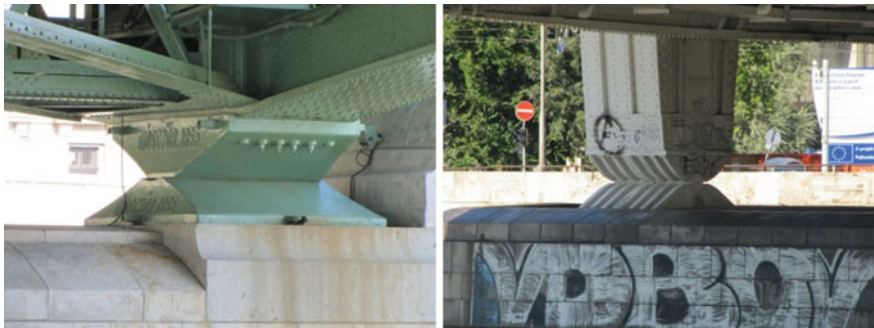
Fig. 14 Pin bearings in old steel bridges

Bearings in steel bridges depend on several variables, such as span length, bridge age, and bridge location, among others. Figures 14, 15 and 16 present several of the most common bearings found in old and contemporary steel bridges.

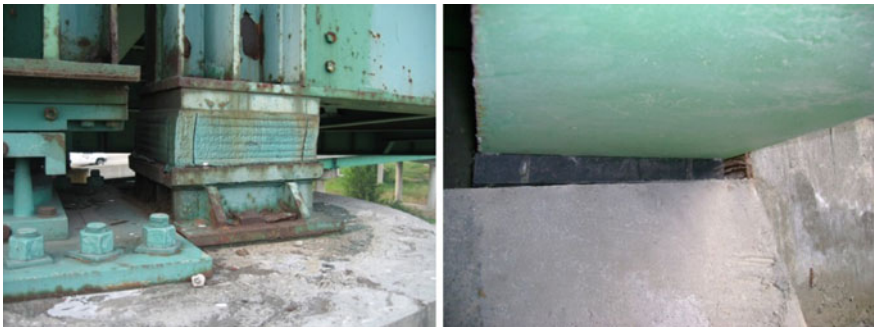
Fig. 15 Elastomeric bearings in steel bridges

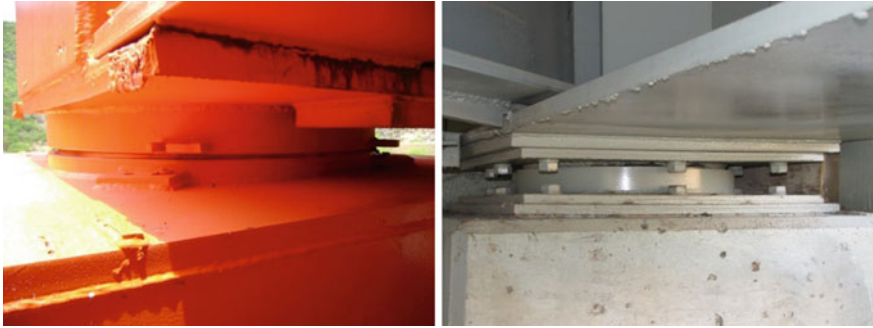
Fig. 16 Pot bearings in steel bridges

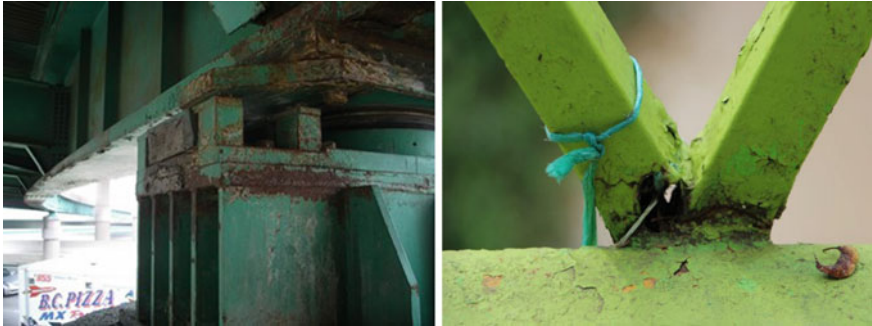
Fig. 17 Corrosion in bridge structural elements

Life-cycle behaviour of steel bridges involves damage due to several factors, including overloads, exposure to aggressive environments, vehicle impacts, fatigue, hurricanes, and earthquakes, among others. Corrosion is often observed during physical inspections of bridges. Figure 17 shows the corrosion in a bearing (left) and in webs of a pedestrian truss bridge (right).

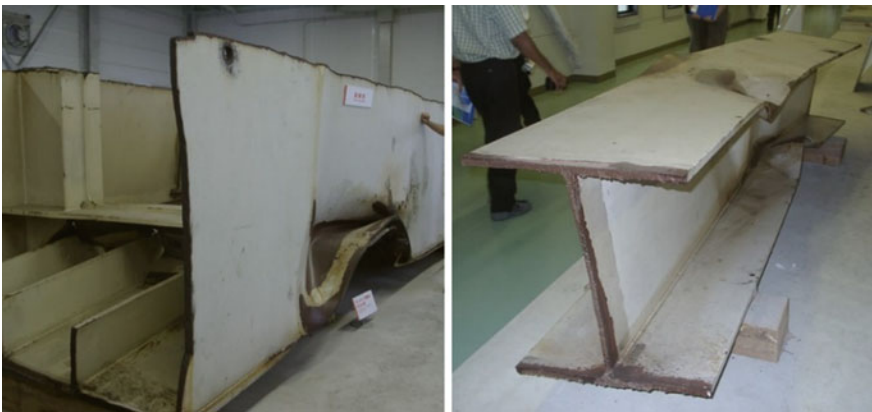
Fig. 18 Damage to structural elements caused by the 1995 Kobe earthquake

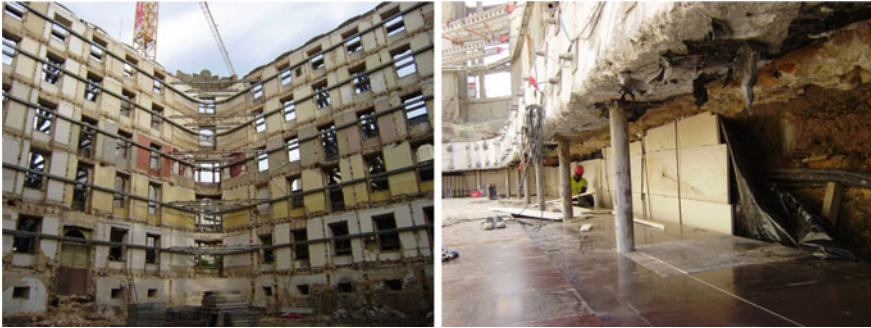
Fig. 1 Underpinning for the re-use of the façade of a building

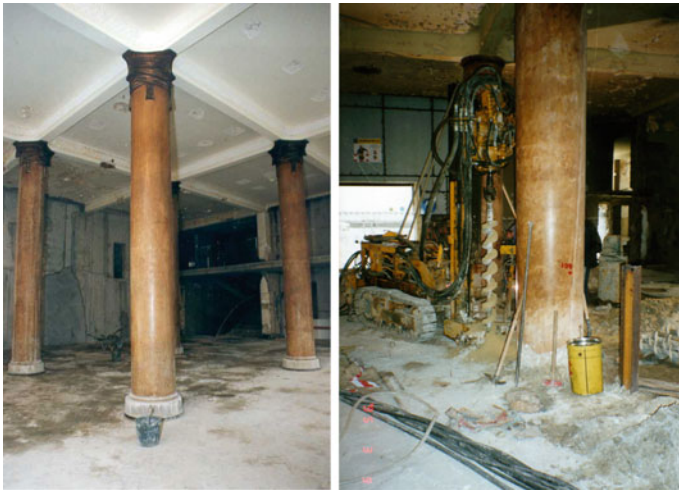
Fig. 8 Rivoli theatre building: Rivoli theatre building: execution of H steel piles (drilled borehole of 0.20 m diameter)

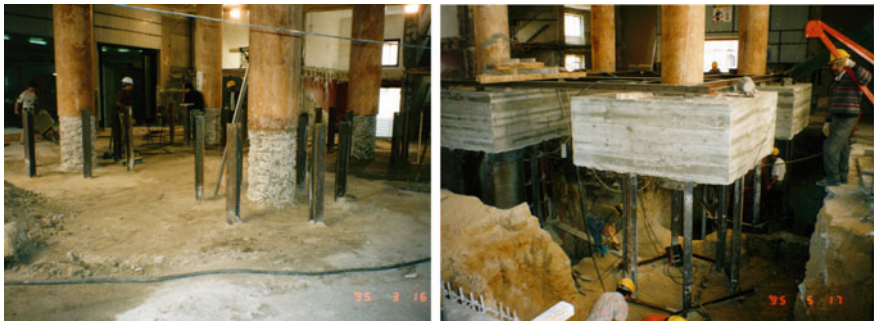
Fig. 10 Rivoli theatre building: preparation of the pillar to connect the reinforced concrete minipiles' cap and the execution of the structure of the pillar suspension, concreting of the definite pillar with the bracing reinforcement

structure and demobilized after finishing the bottom of the pillar and the definite footing at the end of the load transference. The mini piles were integrated into the final structure, also contributing to the stiffness of the foundation, forming a kind of

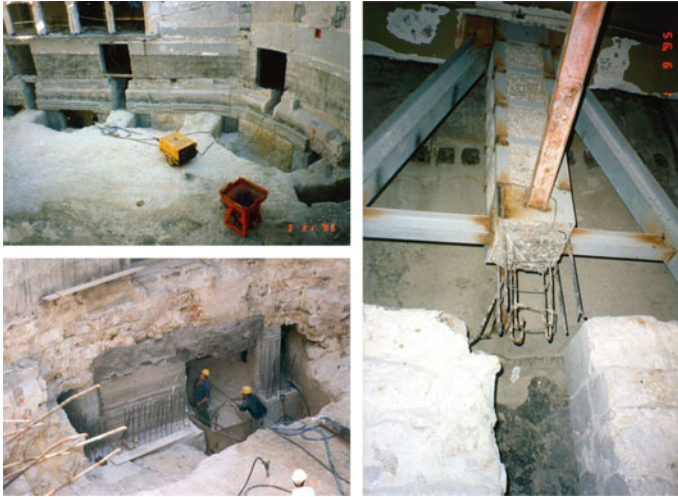
Fig. 11 Rivoli theatre building: execution of wells for underpinning

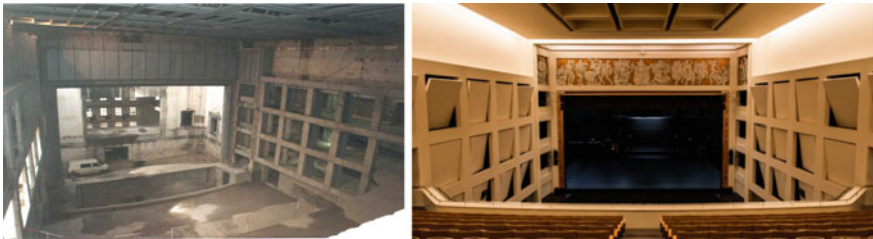
Fig. 12 Rivoli theatre building: view of the interior work already built

Pile-Raft structure. In the next figures, some pictures illustrate the final steps of the described process (Figs. 11 and 12).
