Building Pathology and Rehabilitation

Strengthening and Retrofitting of Existing Structures

Aníbal Costa · António Arêde
Humberto Varum
Editors

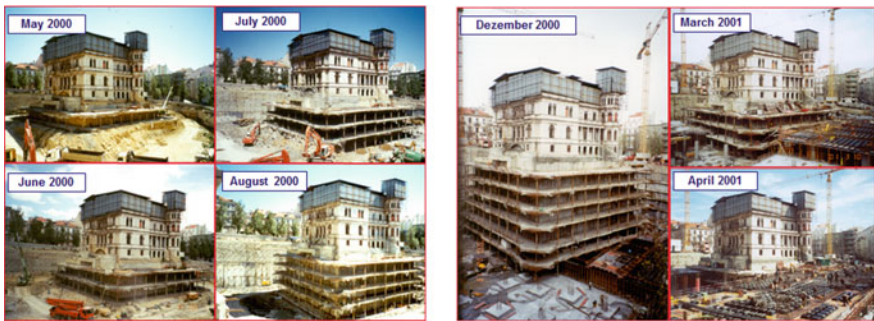
Fig. 16 Sequences of excavation and construction of the underground slabs around the Palace

Due to the Palace structure and geometry (low head room), the internal walls original foundations were underpinned with micropiles capped by a grillage of prestressed concrete beams, which were connected to the masonry walls with pairs of prestressed “Gewi” bars (see Fig. 15). The underpinning of external walls was done with a contiguous bored piles ($\varnothing 0.80$ m spaced 1.0 m) wall, connected to the masonry walls through the piles cap beam. The piles were lined with sprayed concrete. Due to Palace geometry and the existence of the internal micropiles, the piles were braced at 6 levels by external concrete ring beams. These beams were cast against the ground and their levels were defined in order to agree with the final underground slabs. The beams were supported by vertical steel profiles in order to restrain their vertical deformation (see Fig. 16).

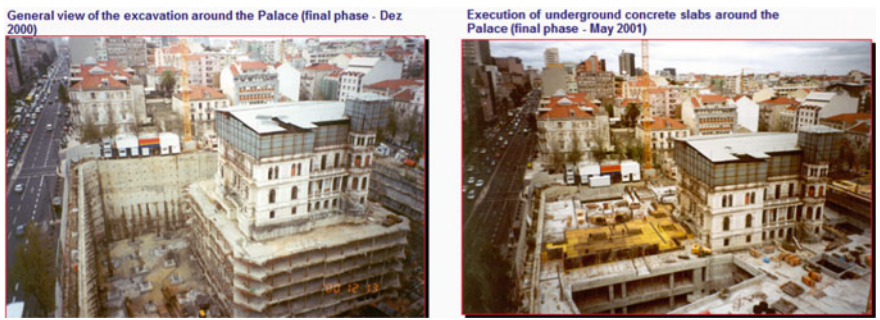
Fig. 18 Final phases of excavation and construction of underground slabs around the palace

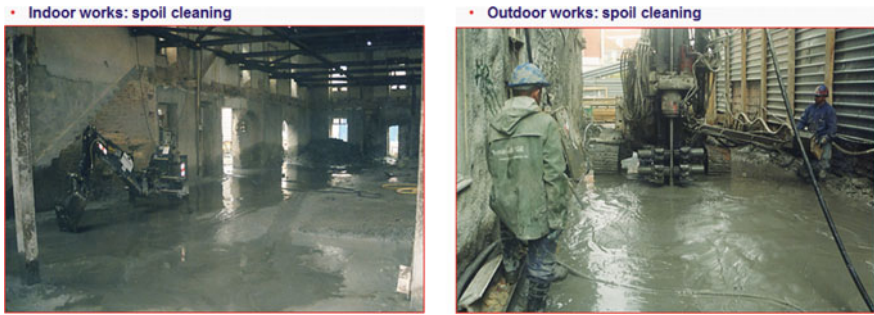
Fig. 22 Cleaning of the indoor and outdoor jet grouting spoil

The use of jet grouting solutions on a very sensitive urban location demanded the need to manage the indoor and the outdoor spoil (see Fig. 22).

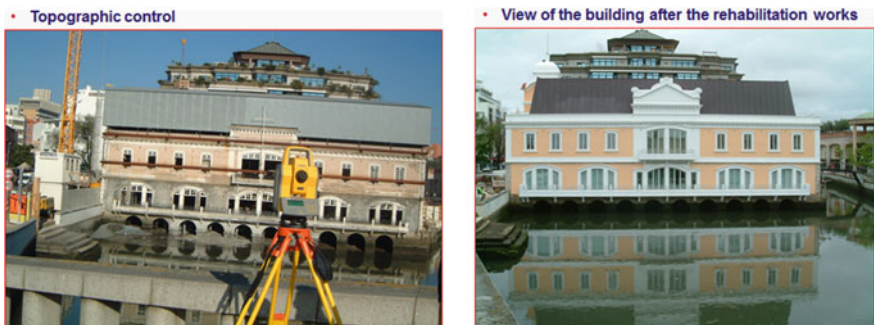
Fig. 23 Topographic control and view of the building at the end of the refurbishment works

The new building as well as the surrounding buildings performance was analysed through a Monitoring and Survey Plan, comprising mainly topographic marks (reflective targets). During the jet grouting works, data was collected once a week (see Fig. 23) and also all the execution parameters were logged and analysed.

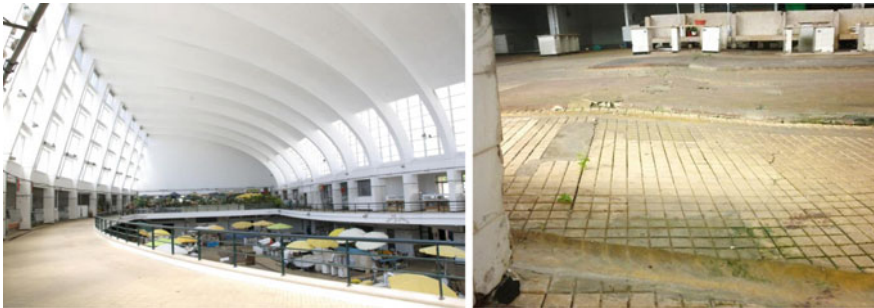
Fig. 24 The building of “Bom Sucesso” market in Porto and settlement of the ground level

The building of “Bom Sucesso” Market was opened in 1952 with an impressive reinforced concrete structure (Fig. 24) designed by the Civil Engineer Joaquim Sarmiento (Professor of Structures in the Civil Engineering Department of FEUP in the University of Porto), being in full service until 2010, fulfilling its original commercial function. The building was classified as Monument Public interest by the Ministry of Culture in 2011.

In view of the deterioration in his state in recent years, it imposed a significant intervention to repair a good number of anomalies installed, which extended even to the ground floor, where large settlement were observed (Fig. 24).

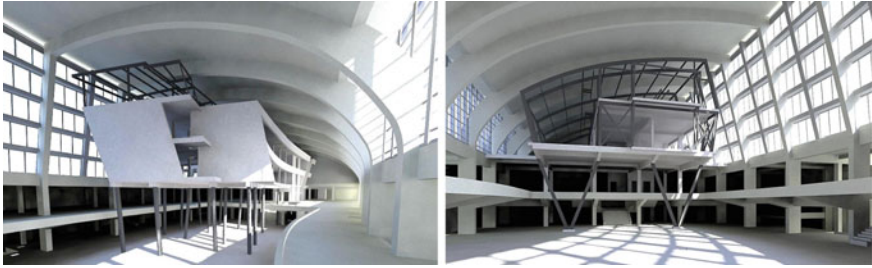
Fig. 26 Perspective of the hotel and the offices' building

While the hotel was designed independently of the existing structure, the set of offices involved the construction of a building which structure intercepted the original one (Fig. 26).

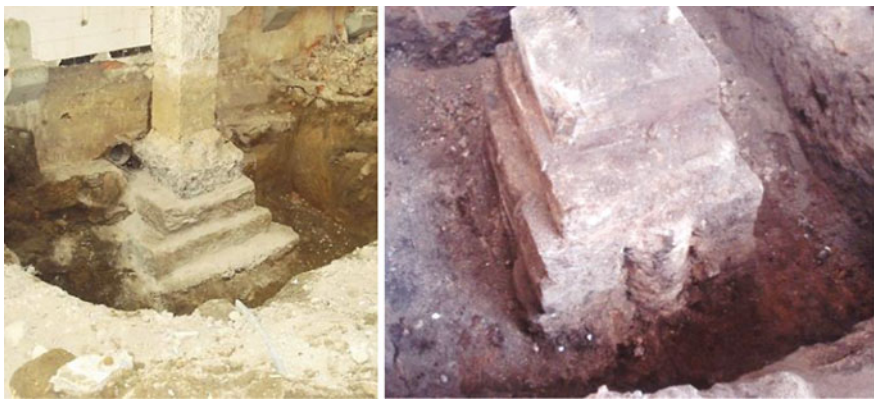
Fig. 28 Footing laying over a stone masonry, capping the original piles

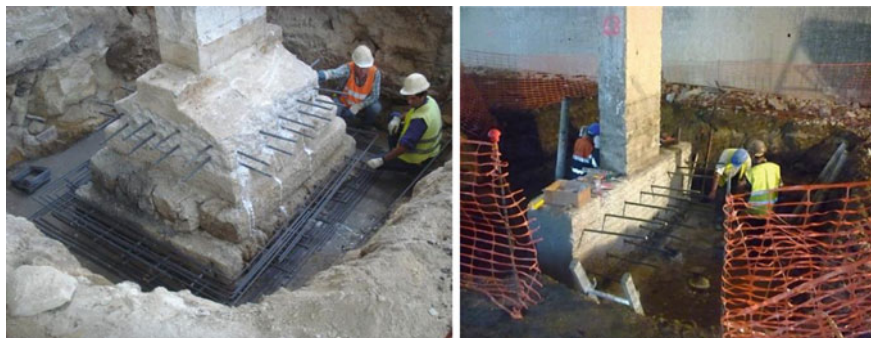
Fig. 29 Reinforcement of shallow foundations

foundation and ensuring the link between the new concrete and the existing concrete and stone masonry elements through the installation of steel rods, sealed with epoxy resin. The pile foundation were reinforced by micropiles, headed by a massive reinforced concrete, connected to existing concrete using steel rods (Fig. 29).

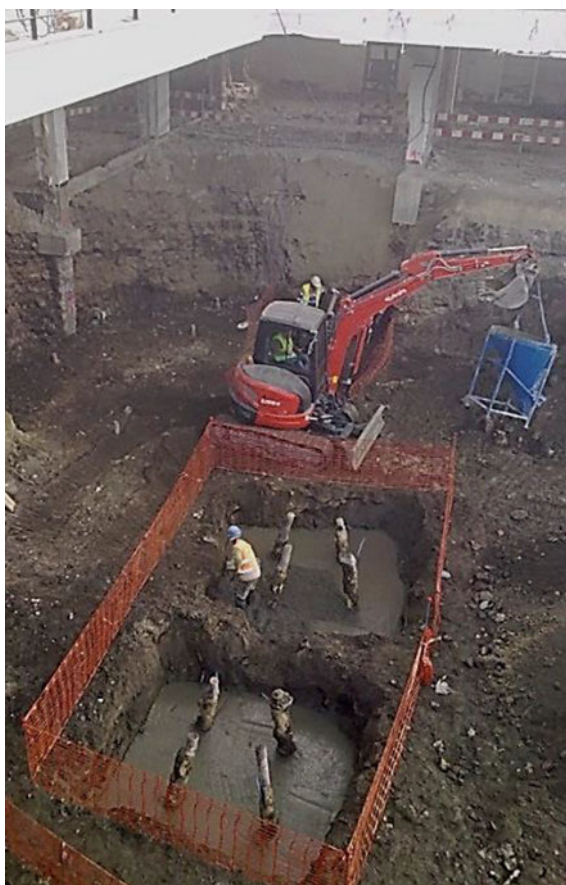
Fig. 30 Foundation by micropiling
