Rock Mass Slope Stability Analysis Under Static and Dynamic Conditions in Mumbai, India

Ahmed Shaz, Endalu Tadele Chala and K. Seshagiri Rao

Abstract The rock slope stability has gained much importance in the recent years owing to the development of infrastructure in/on rock slopes areas in the form of high-rise building, roads, railways, dams, and other rock engineering projects. Rock slope stability is generally affected by the property of rock material along with the discontinuities in the rock mass. It is also dependent on slope angle, slope height, surcharge, groundwater conditions, rainfall, and dynamic forces like earthquake. If these factors, coupled with deep weathering of the rock mass, complicate the entire behavior of the rock slope and makes the analysis of rock slopes challenging task. For the present work, fieldwork was carried out for joint mapping on differentially weathered volcanic rock of selected slope sections at Mumbai in Deccan trap regions. Block and core samples were collected from each category of the rocks and their respective geotechnical properties measured experimentally and presented here in. The rock slope stability analysis was done using numeric

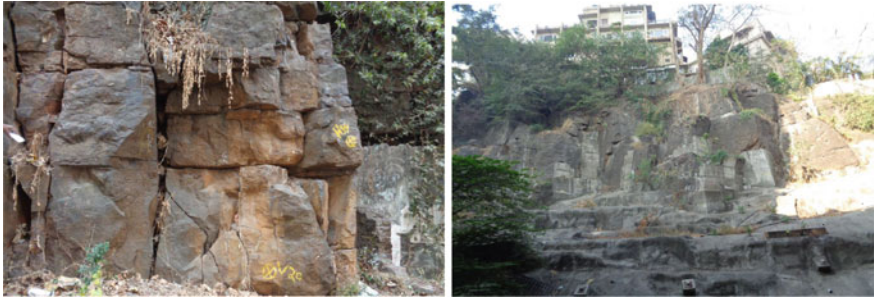
Fig. 1 Present rock slope appearance on out crops from eastern to western corner of the slope **a** dominant joint sets, discoloration, and staining of rock material due to weathering clearly visible **b** already stabilized portion of the rock slope

The rock slope is located at the eastern scarp of Cumballa Hill in Tardeo, Mumbai. Regionally, the rocks in Maharashtra and around Mumbai are of volcanic origin known as Deccan trap. The Deccan trap is composed of very hard, tough, and compact rocks. The rocks are susceptible to weathering which begins on the exposed surface and along joints, cracks, and fissures. With time, it penetrates deep into the rock masses and resulting in complete loss of original skeleton structure of the rock mass. Chala et al. (2016) studied the strength properties of different degree of weathered basaltic rocks of some locations in Deccan trap and observed that weathering has drastically reduced the strength of rocks. They found the strength of slightly weathered basalt to be 50% less than the fresh basalt strength (Figs. 1 and 2).

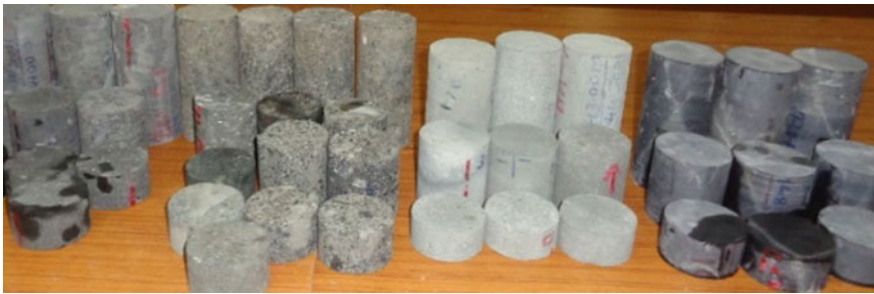
Fig. 2 Specimen prepared for testing under tensile, uniaxial, and triaxial loading

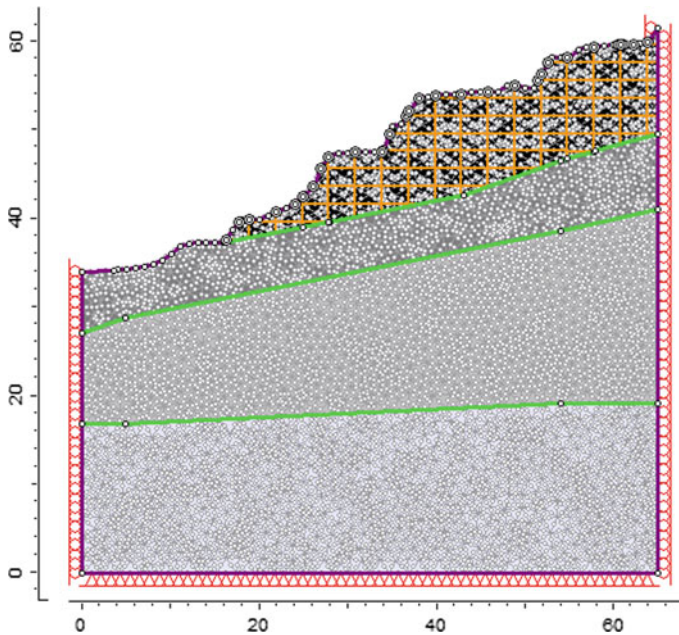
The geometry was made for different slope sections at respective chainage and each rock strata in every slope section was assigned with corresponding rock mass and joint properties accordingly in the Phase2 model. Then the boundary conditions were assigned to the model (Fig. 4).

The ground surface of the slope was made free in both X - and Y -direction. The vertical boundaries of the section were free to move in Y -direction only and restrained in X -direction. The base of the section of slope was fixed and was restricted to move in both X - and Y -direction. A uniform mesh was used in the FEM model for the analysis of all the five slope sections.

Fig. 4 Discretized Phase2 model of slope section at 65 m chainage

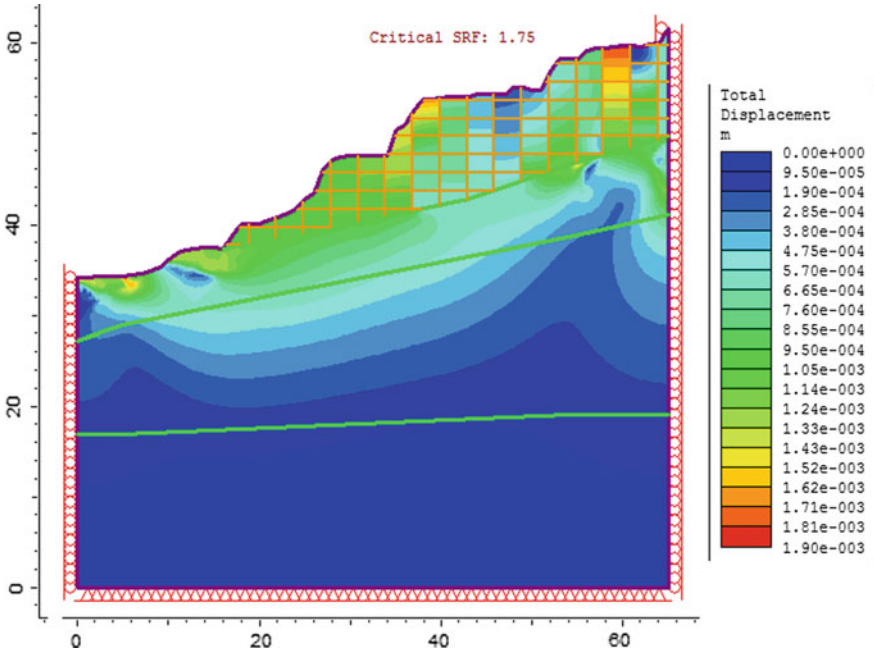
The critical SRF for the slope section at 65 m chainage was found to be 1.75 from the normal static gravitational analysis without any seismic conditions (Fig. 5).

Fig. 5 Total displacement contour plot at critical SRF of section at 65 m chainage
