International Perspectives in Geography
AJG Library 9

Makiko Watanabe
Masayuki Kawahigashi *Editors*

Anthropogenic Soils in Japan

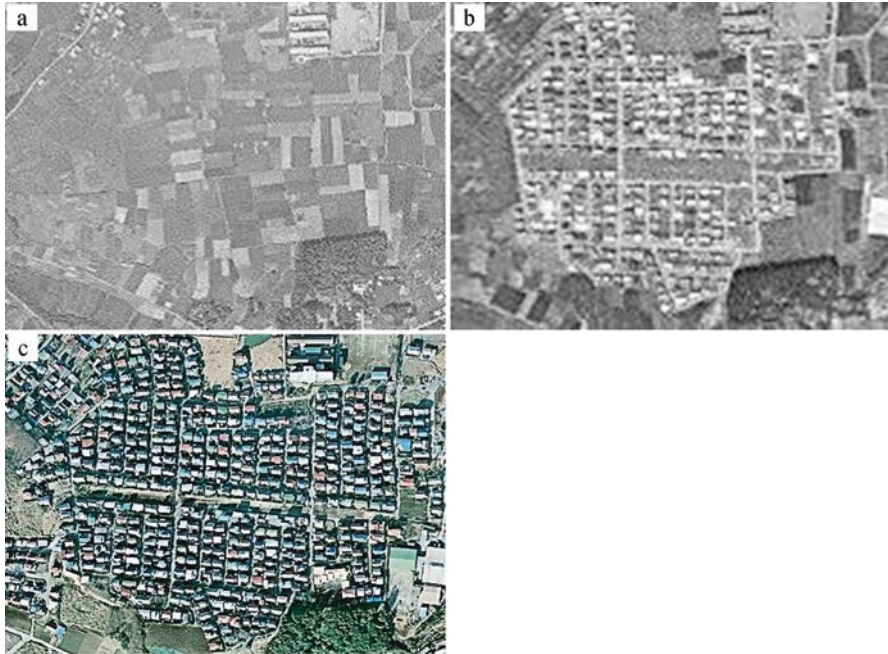
Fig. 1.2 Aerial photo of the Sanda-town conversion from agricultural (a: 1961) to residential zoning (b: 1964). Photo (c) taken in 1974 shows the extent of asphalt pavement. The sealing condition has been continuous from the mid-1960s until now. Periodic road maintenance can disturb the subsoil beneath the site. The research site has been covered with asphalt since 1970. Photos from Geospatial In-formation Authority of Japan. (GSI: (a) MKT616-C2-8, (b) MKT646X-C1-5, (c) CKT7416-C3313)

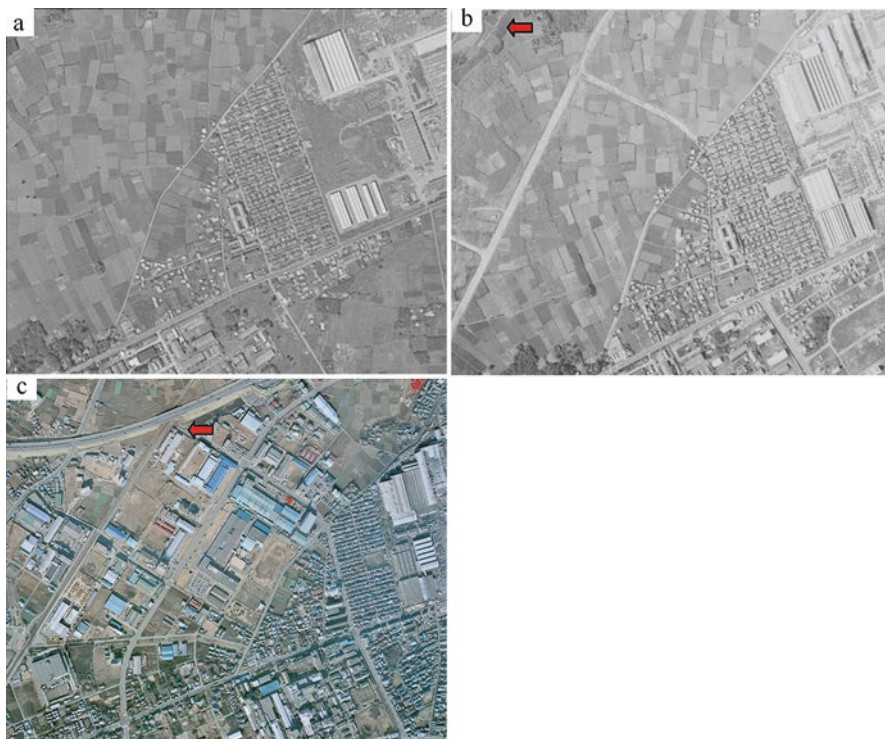
Fig. 1.7 Aerial photos of the Ishikawa-town site. In (a), a photo taken in 1957 shows previous agricultural land use. The photo in (b) taken in 1961 shows the construction of a road. The asphalt pavement in photo (c) is proof of the continuing existence of asphalt pavement in 1974. Red arrows indicate the constructed road at the research site. The original agricultural field changed into a factory space covered with asphalt and concrete. The road appeared in 1974, indicating that 40 years passed since the construction. Photos are from Geospatial Information Authority of Japan. (GSI: (a) KT573YZ-C1-174, (b) MKT615-C29B-7, (c) CKT7416-C31-18)

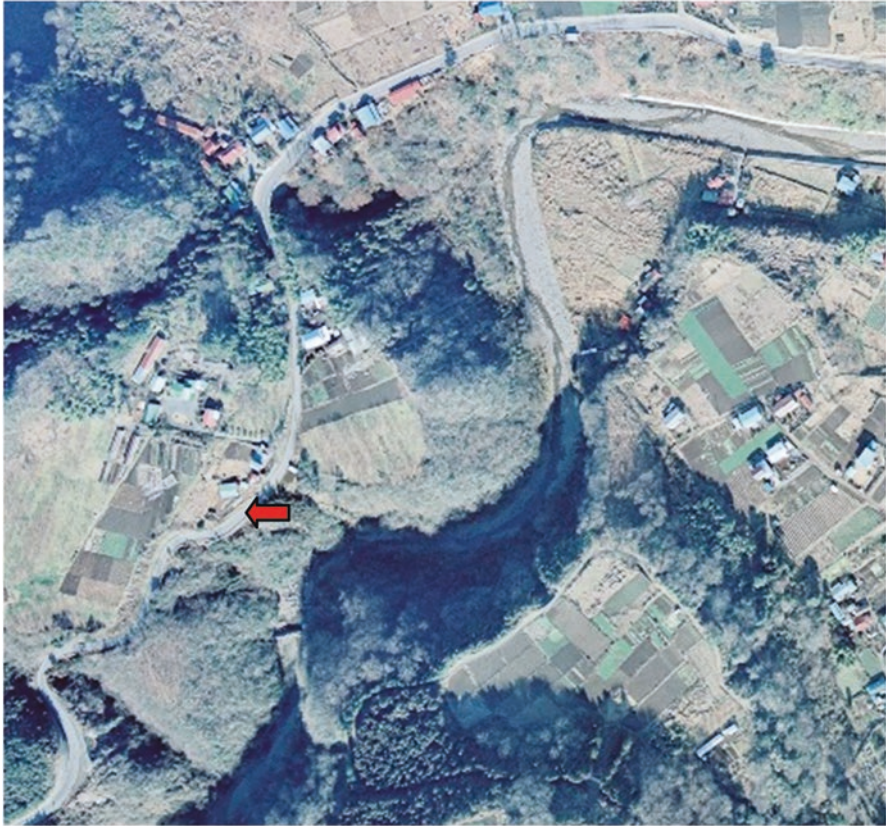
Fig. 1.10 Aerial photo of the Ogura-town highway construction site taken in 1975. Red arrow indicates the position of the research site. The road has already been paved. Photos from Geospatial Information Authority of Japan. (GSI: CKT7416-C39-10)

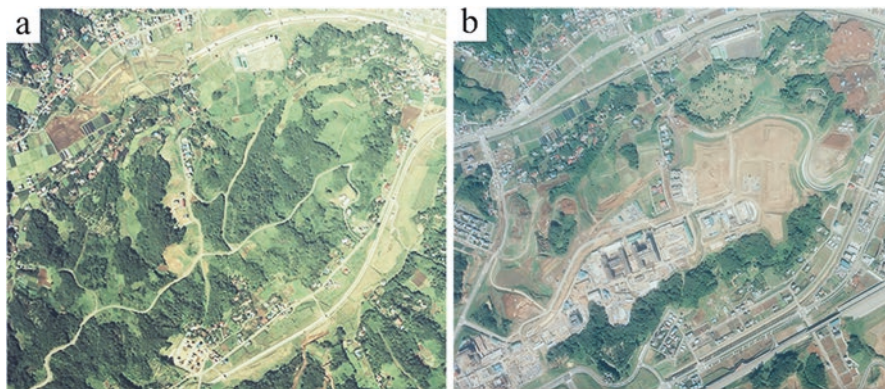
Fig. 1.13 Aerial photos of land use change at Minamiosawa from (a) 1979 to (b) 1989. The hill top has been removed to flatten the area for construction of buildings. Cut and banking also took place for land leveling. Soils have been disturbed through the process of construction. Photos from Geospatial Information Authority of Japan. (GSI: a; CKT841-C28-18, b; CKT841-C28-18)

Soil profiles beneath asphalt and interlocking pavement were studied on the campus of Tokyo Metropolitan University, Minamiosawa campus, located in Minamiosawa, Hachioji-city, Tokyo, Japan (Fig. 1.12). Pre-construction land development in the early to late 1980s included clearing of forest vegetation, followed by land cutting up to 10 m in depth and land filling in order to create a level surface (Fig. 1.13a). Construction at the university building site started at the end of 1980s (Fig. 1.13b). The study sites where profiles were investigated are located in land cutting areas.

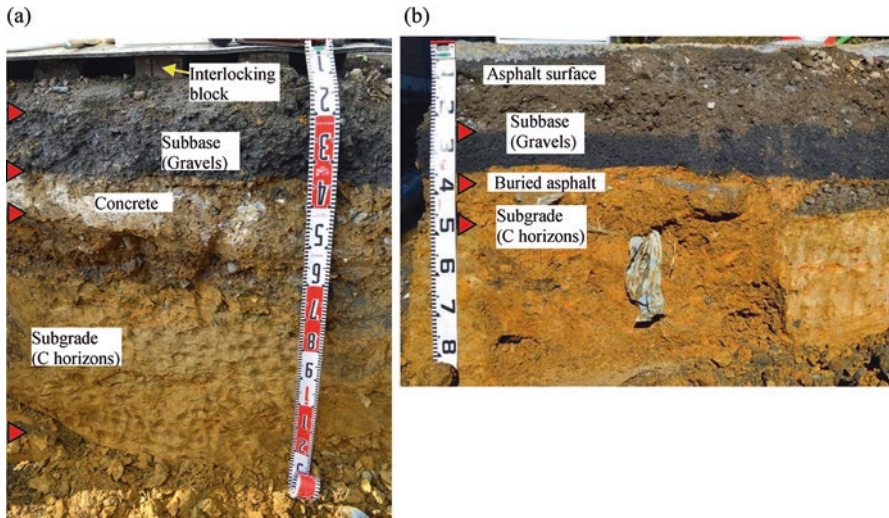
Fig. 1.15 Photo (a) shows the soil profile beneath the interlocking pavement. Photo (b) shows an artificially piled soil profile beneath asphalt pavement. Interlayers consisting of concrete and asphalt were observed to enhance the bearing capacity to traffic load. Red closed triangles on the profiles indicate the border between layers in the soil profiles

Soil profiles, location overview, and properties of soil and paving materials are shown in Figs. 1.14 and 1.15 and Table 1.4, respectively. Soil sealing, which occurred in 1988, was renewed using interlocking pavement in 2014 (Fig. 1.14a). The asphalt pavement, which had been constructed in 1988, also was renewed in 2010 (Fig. 1.14b). Buried concrete pavement was observed in the profile beneath the interlocking pavement. Such buried concrete or asphalt layers are commonly used to stabilize the area beneath the interlocking pavement. Different soil materials were observed in the profile beneath the asphalt pavement due to disturbances of the

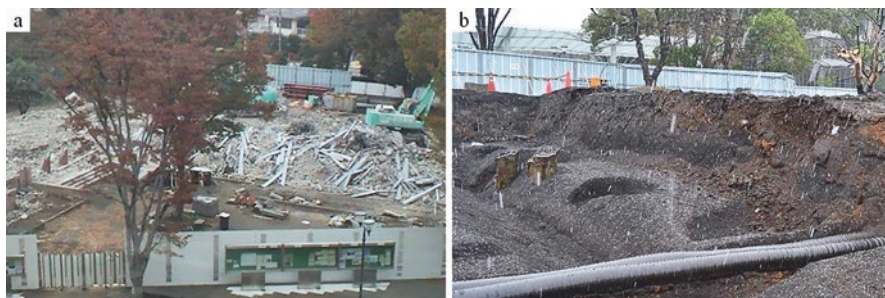
Fig. 1.16 Photo (a) shows the construction area where Andosols have been located in the research area. Sealants consisting of asphalt, concrete, and interlocking blocks were removed prior to the start of construction. Photo (b) shows the ground surface being prepared for new buildings. This site provided a valuable case to have a survey between demolition and reconstruction of buildings

Soil profiles beneath asphalt pavement and a recently demolished building were examined at the Shonan campus of Nihon University, located in Kameino, Fujisawacity, Kanagawa-prefecture, Japan (Figs. 1.16, 1.17, and 1.18). This campus was established in 1943. Prior to the founding of the campus, the area was used as an agricultural field. The buildings and asphalt pavement covering the profiles were removed for reconstruction before the soil survey in 2014.

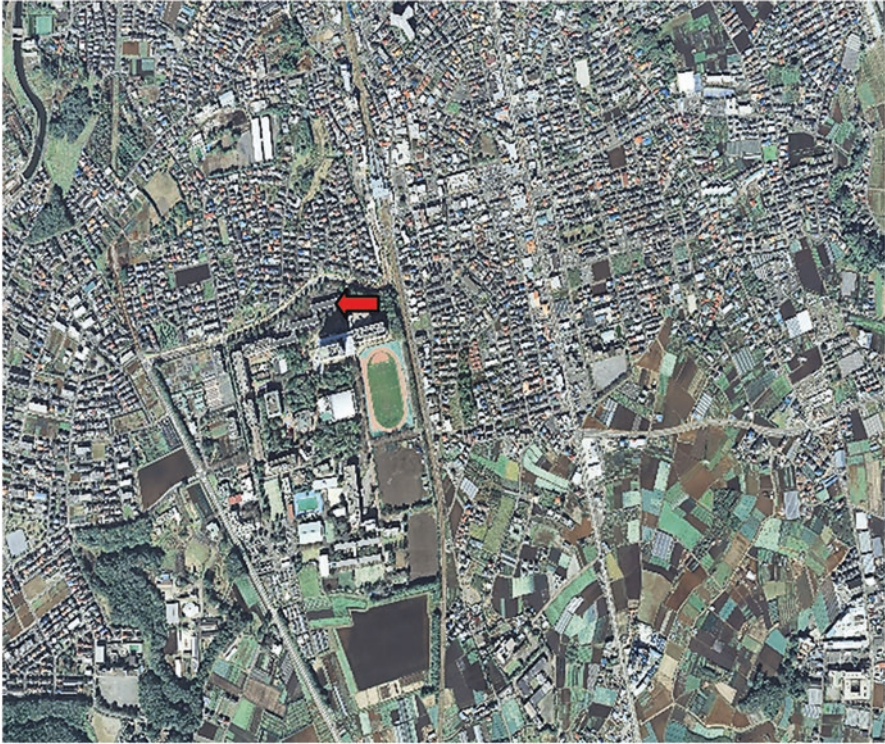
Fig. 1.18 Aerial photo taken before the demolition of buildings on the Shonan campus of Nihon University in 2007. Red arrow indicates the research site at which the building demolished and rebuilt. Photos from Geospatial Information Authority of Japan (GSI; CKT20074-C3-26)

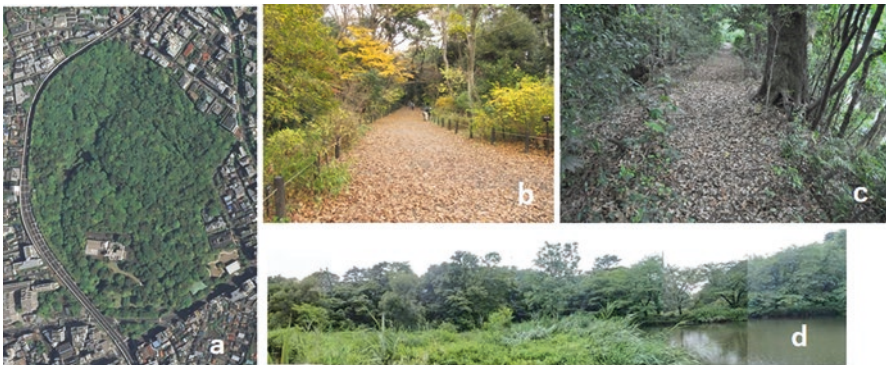
Fig. 4.2 Overview of the Institute for Nature Study in Tokyo. (a) Aerial panorama photograph, (b) promenade, and (c) earthwork site No. 5 (Fig. 4.4), (d) valleys and wetland

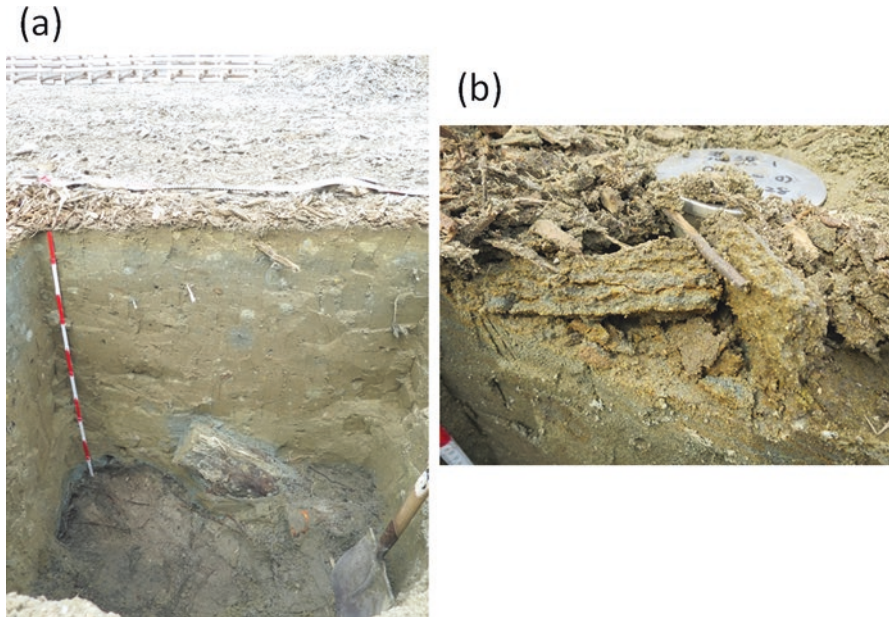
Fig. 5.3 (a) Photograph of soil profile 1 from newly constructed berm for planting black pine seedlings in April 2013 to restore the coastal disaster prevention forest, and (b) Photograph of iron cementation of topsoil on the surface of the cracks between platy structures created by machinery compaction. Profile depth is 120 cm

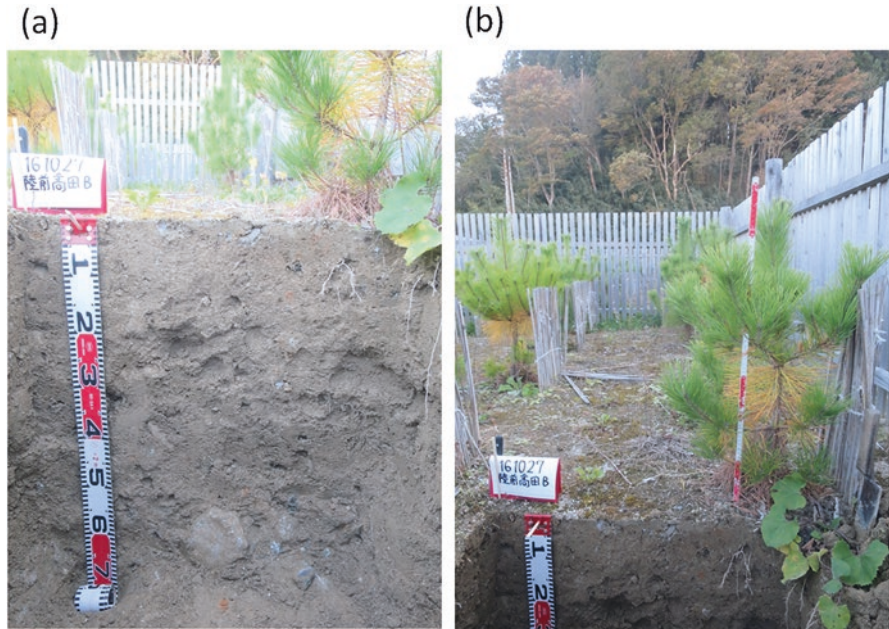
Fig. 5.12 Picture of soil profile 5 in Plot B (Tillage) of the experimental site which was built in a tsunami-hit paddy field by the Japan Greenery Research and Development Center in 2015. (a) soil profile 5 in Plot B, to a depth of 75 cm, (b) planted seedlings near the survey pit in Plot B

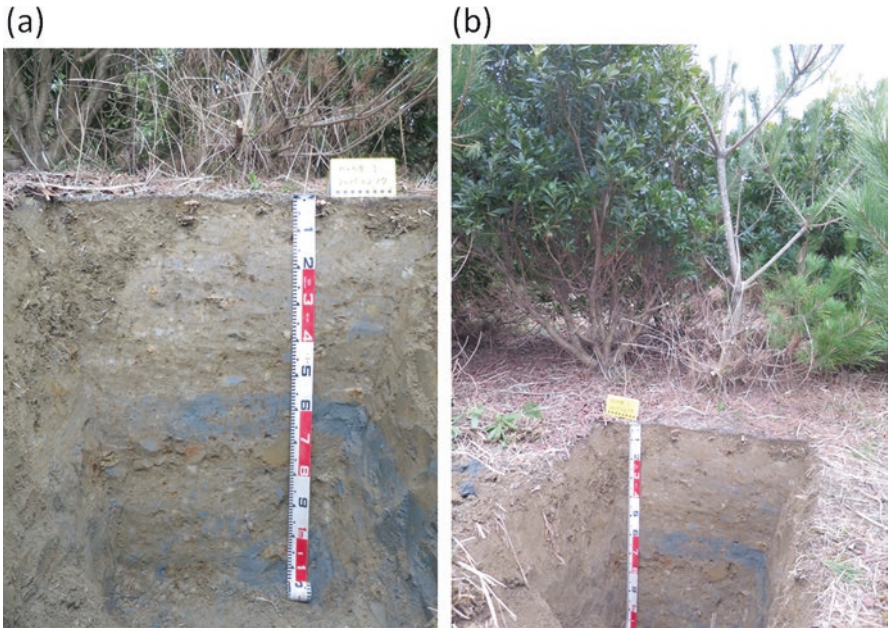
Fig. 6.3 Photos (a), (b) of soil profile 1, consisting of newly constructed infilled swamp areas as planting foundations for coastal forests. Black pine and some shrub seedlings were planted in 2009

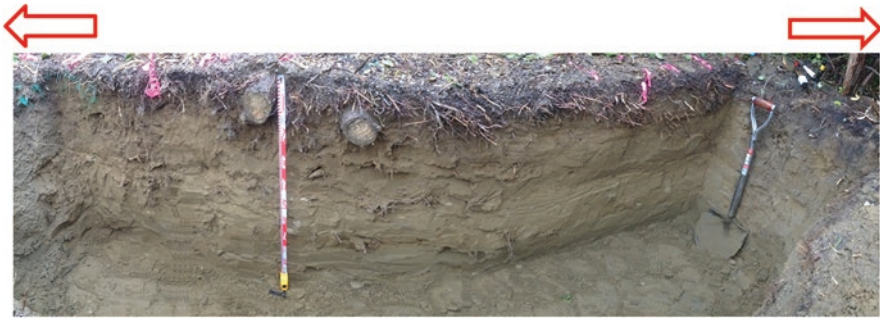
Fig. 6.7 Photo of soil profile 2 in newly constructed foundation in swamp areas to reforest the coastal forest in 1994. We can see two large horizontal roots in the profile

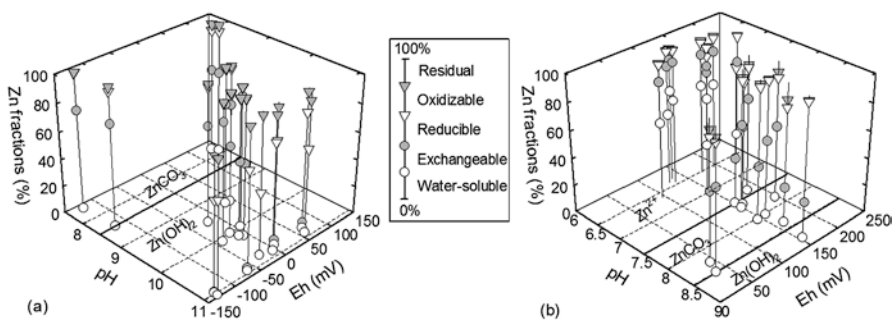
Fig. 7.4 Zn fractions affected by pH and Eh values in batch leaching test: (a) MSWIA-seawater system, (b) Clay-leachate system (Inui et al. 2009)

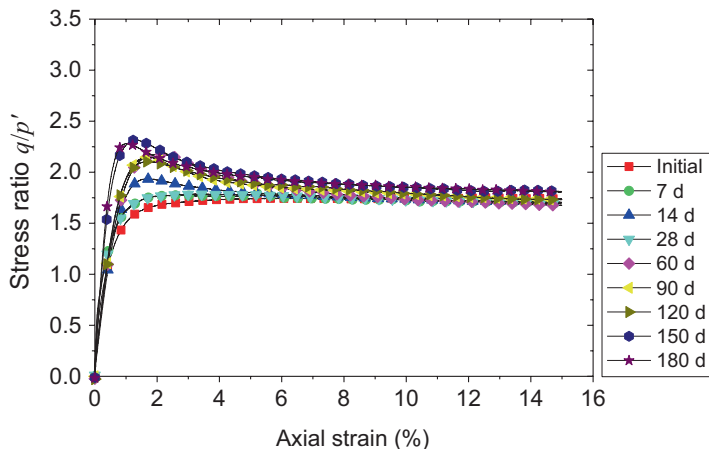
Fig. 7.5 Stress ratio q/p' versus axial strain at $\sigma_c = 150$ kPa. (Nguyen et al. 2015)

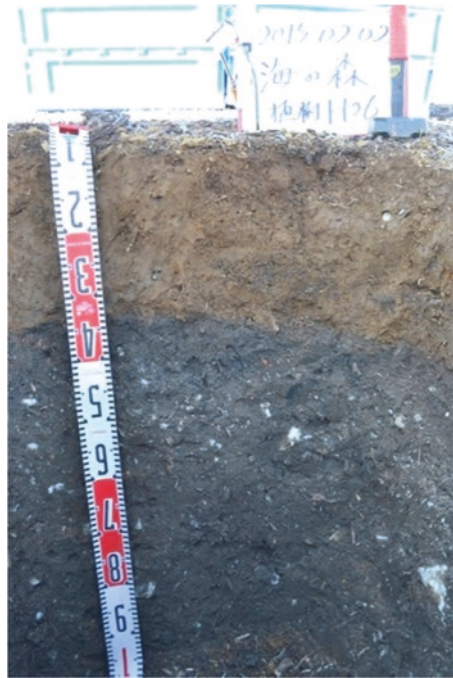
Fig. 8.3 Soil profile of the newly constructed soil to plant young trees in November 2014

The soil profile shown in Fig. 8.3 shows a clearly different material in the surface layer compared to the rest of the profile.

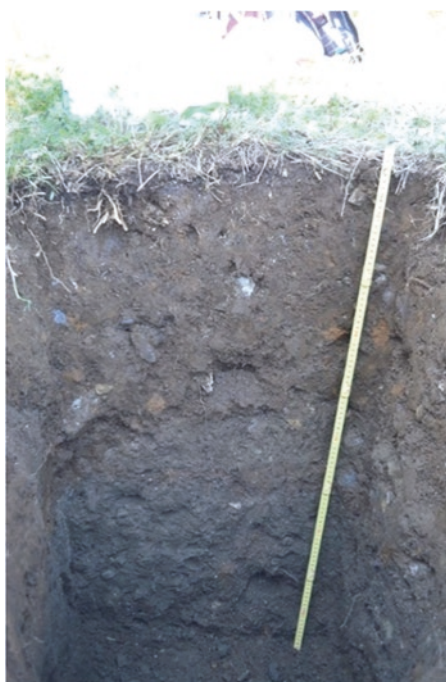
Fig. 8.4 Soil profile of the newly constructed soil to plant young trees in 2012

General physico-chemical properties for the 2012 planting area are shown in Table 8.2. The boundary between the surface and the subsurface horizons was unclear (Fig. 8.4), differing from the soil profile constructed in 2014. The soil constructed in 2012 is also classified as Urbic Spolic Technosols by the WRB (IUSS Working Group WRB 2014). Soil reaction was slightly to moderately alkaline, except for the surface soil which had an acidic soil reaction. Electric conductivity

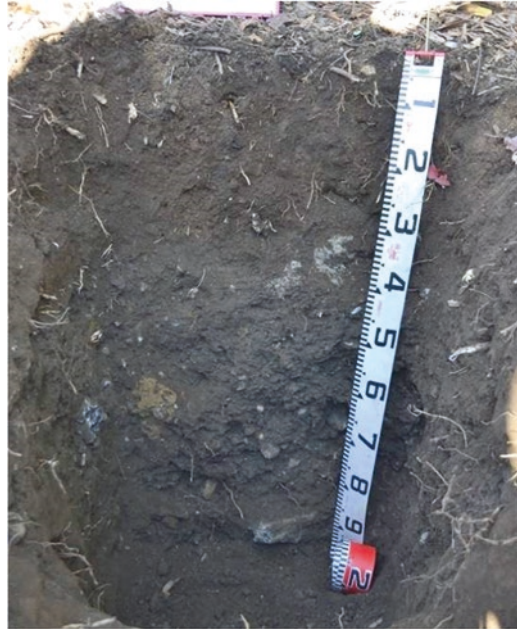
Fig. 8.5 Soil profile of the constructed soil in November 2008

General physico-chemical properties of the 2008 planting area are shown in Table 8.3. The clear smooth boundary between the surface horizon and the sub surface was not observed, indicating dredged materials and construction wastes were completely mixed in (Fig. 8.5). The soil in the Uminomori Park at this site was also classified as Urbic Spolic Technosols using the WRB (IUSS Working Group WRB 2014), and is characterized by the high content of artifacts. Soil reaction was slightly to moderately alkaline. High proportions of solid phases and soil compactness in deeper soil horizons reflected strong initial compaction at the beginning of the construction. The high organic carbon content reaching up to 60 g kg⁻¹ indicates that applied organic matter, such as bark compost, was broken down into fragments with

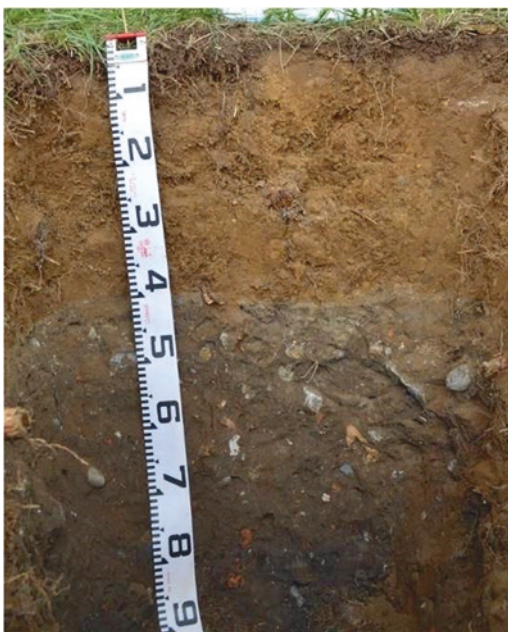
Fig. 8.8 Soil profile in Wakasu Seaside Park

General physico-chemical properties are shown in Table 8.4. The soil profile shown in Fig. 8.8 shows a clear distinction between the surface soil (0–40 cm) and deeper soil (40–90 cm) consisting of different materials. The deep horizon includes many artifacts such as bricks, concrete, and asphalt, and remains highly compacted below 40 cm due to heavy machine construction despite its age of 40 years. The soil in the Wakasu Seaside Park is classified as Urbic Technosols by the WRB (IUSS Working Group WRB 2014) because of the high content of artifacts.

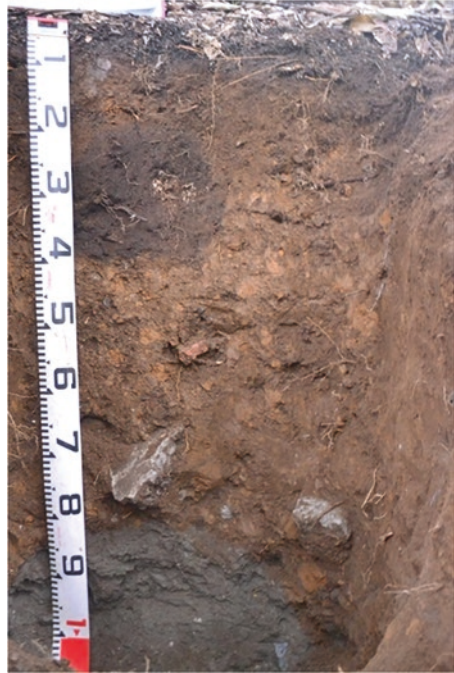
Fig. 8.11 Soil profile in Tokyo Port Wild Bird Park

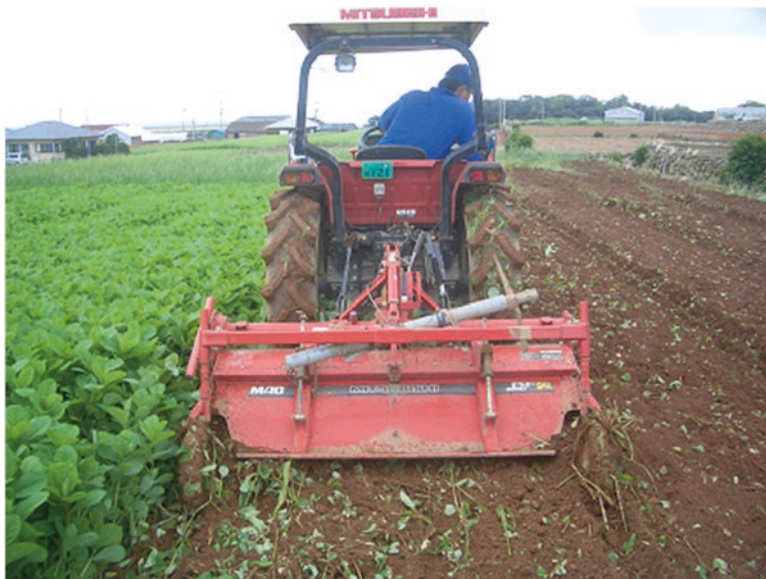
Fig. 9.5 Plantation and plowing-in of cover crop to reduce chemical fertilizer application

In the peripheral areas, in order to reduce negative environmental impacts at the same time as promoting production, application of shallow water puddling, side-dressing fertilizing, and controlled availability of fertilizer are being introduced for paddy rice cultivation (Fig. 9.4). In open field vegetable cultivation, planting of cover crops (green manure crops, Fig. 9.5), localized fertilizer application, and introduction of low concentration fertilizer with reduced phosphate and potassium are being promoted to suppress turbid water inundation during the rainy season.

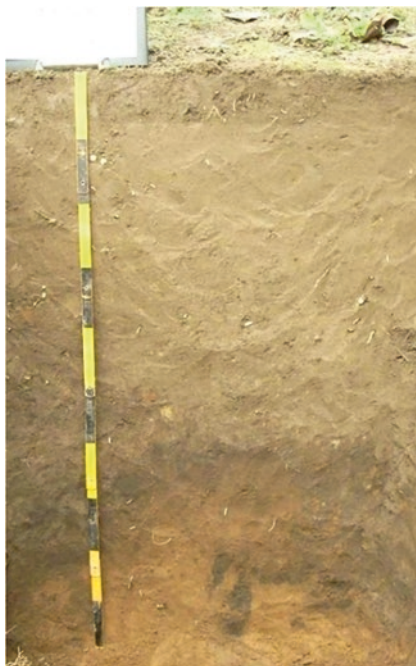
In the soil profile of Fig. 10.3, the buried black color horizon (2A5) is a remnant of the original Andosol topsoil. The brighter color horizons above are an anthropogenic epipedon consisting of a mixture of the original topsoil and the alluvial soil material. The anthropogenic epipedon, unlike plaggen soils in Europe, generally contains no artifacts.

Fig. 10.3 Soil profile of the *Kawataya* series (in Kitamoto City)

Ap: 0 to 8 cm, brownish black (10YR2/2), clay loam, moderate medium sub-angular blocky structure and weak fine crumb structure, moderately moist, compactness 11, high organic matter, smooth clear boundary,

A1: 8 to 27 cm, brownish black (10YR2/3), clay loam, weak coarse sub-angular blocky structure, moderately moist, compactness 19, high organic matter, wavy gradual boundary,

A2: 27 to 39 cm, brownish black (10YR3/2), clay loam, moderate coarse sub-angular blocky structure, moderately moist, compactness 14, high organic matter, very weakly positive NaF reaction, wavy diffuse boundary,

A3: 39 to 51 cm, brownish black (10YR3/2), clay loam, weak medium sub-angular blocky structure, moderately moist, compactness 15, high organic matter, weakly positive NaF reaction, irregular diffuse boundary,

A4: 51 to 64 cm, brownish black (10YR3/1), light clay, moderate coarse sub-angular blocky structure, moderately moist, compactness 16, high organic matter, moderately positive NaF reaction, irregular clear boundary,

2A5: 64 to 84 cm, black (10YR2/1), light clay, moderate medium sub-angular blocky structure, moderately moist, compactness 14, very high organic matter, strongly positive NaF reaction, irregular gradual boundary,

2Bw: 84 to 100+ cm, dark brown (7.5YR3/4), heavy clay, moderate coarse sub-angular blocky structure, moderately moist, compactness 24, medium organic matter, strongly positive NaF reaction.

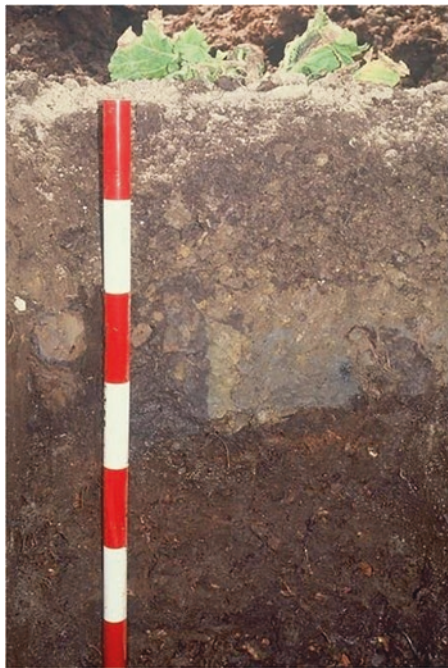
Gp: 18 to 38 cm, greenish gray (5G5/1), light clay, structureless, slightly wet, common mottles, hardness of 18, no gravel, abundant humus (including decomposed peat), dipyriddyI+, no NaF reaction, and a clear, smooth boundary,

Fig. 11.2 Soil profile of Nanporo-1, the site of soil dressing on low-moor peat land

He: 38 to 63 cm, brown (7.5YR4/6), decomposed low moor peat (reed), moist, hardness of 10, no gravel, no NaF reaction, and a relatively clear, smooth boundary,
 Hi: 63+ cm, bright brown (7.5YR4/6), poorly decomposed low moor peat (reed), moist, hardness of 8, no gravel, and no NaF reaction.

1982 and then to 35 cm during large-scale plowing that took place in the spring of 1989. Use of the upland fields first commenced that year and cabbages have been regularly cultivated since then. The profile photograph in Fig. 11.2 was taken in April of 1990.

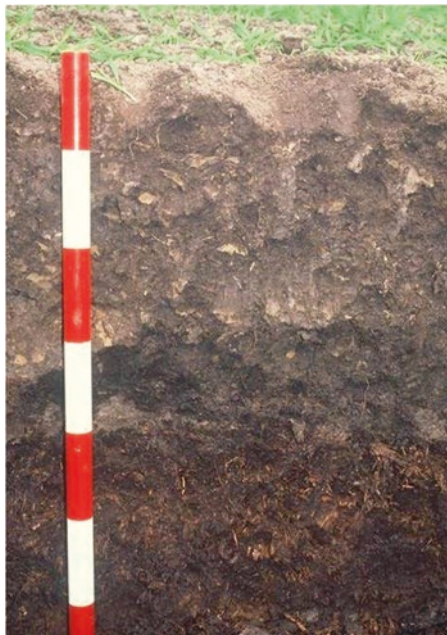
Ap1: 0 to 22 cm, grayish yellow brown (10YR4/2), light clay, sub-angular blocky structure, slightly wet, hardness of 18, no gravel, abundant humus (including decomposed peat), no NaF reaction, and a relatively clear, smooth boundary,

Fig. 11.3 Soil profile of Nanporo-2, the site of soil dressing on high-moor peat land

Ap2: 22 to 40 cm, grayish yellow brown (10YR4/2), light clay, structureless, slightly wet, no mottles, hardness of 24, no gravel, abundant humus (including decomposed peat), no NaF reaction, and a relatively clear, smooth boundary,
 Ha: 40 to 55 cm, black (7.5YR2/1), decomposed high moor peat (with no fiber), wet, hardness of 18, no gravel, no NaF reaction, and clear wavy boundary,
 Hi: 55+ cm, dark brown (7.5YR3/3), poorly decomposed high moor peat (*Carex middendorffii*), wet, hardness of 13, no gravel, no NaF reaction.

The location of the Naporo-2 site is 7.0 m above sea level, and at 43° 2' 32.73" N latitude and 141° 35' 17.28" E longitude. It is located about 1 km from the Chitose River, a tributary of the Ishikari River (Fig. 11.1). The most recent 15 cm-thick soil dressing was carried out using clay soil in 1981. Similar to the Naporo-1 site, prior soil dressing history is unknown, but is said to have been carried out at least four to five times. The field was tilled to a depth of 40 cm in a deep plow in the autumn of 1985 when the two different types of base materials, namely the conventional surface horizon (a soil dressing and peat mixture) and peat in the lower layer, were mixed to form a new 40 cm deep surface horizon (Ap1 + Ap2). Local drainage is available and the groundwater level (stagnant water level) is at least 1 m deep. It has been used as an upland field since 1986 and constantly used for spring-sown wheat and autumn-sown wheat crops. The profile photograph of Fig. 11.3 was taken in October 1989 after autumn-sown wheat had been harvested.

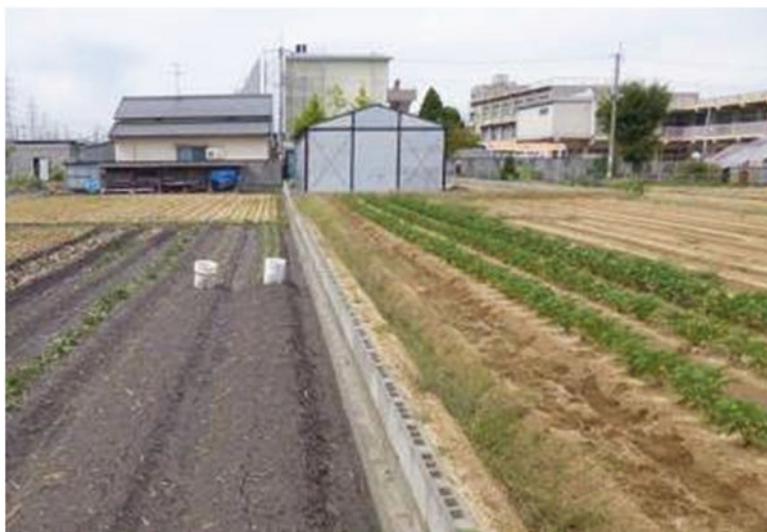
Fig. 12.1 Man-made soils in urban agricultural area in Osaka Prefecture. In the field on the right of the photograph, soils were dressed on a former paddy field, resulting in a surface level that was higher than that of original field

In agricultural fields of the Osaka Prefecture, man-made soils are widely distributed (Fig. 12.1), especially in greenhouse areas. According to the Japanese Classification system of Cultivated Soils, soils over 35 cm thick consisting of materials transported from other sites that are dressed on the surface layer are classified as man-made soils (Cultivated Soil Classification Committee 1995). Soils used for

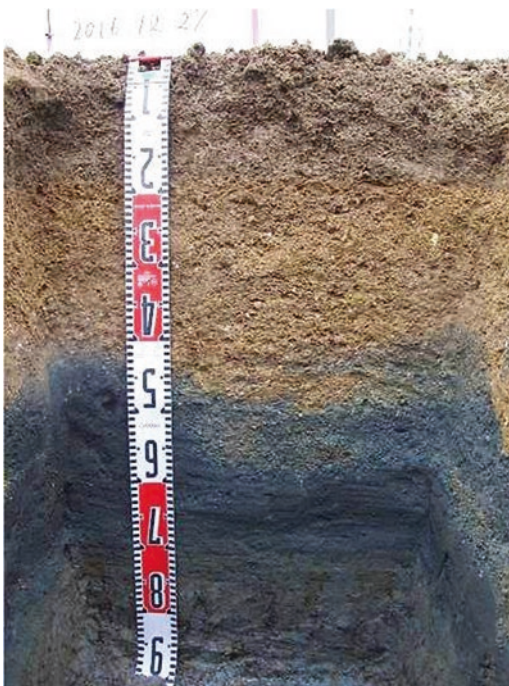
The soil profile for Site 1 is shown in Fig. 12.4, and features nine horizons. Horizons in this soil profile are clearly different in terms of material and color.

2C3: 42 to 54 cm, olive gray (10Y 5/2), no mottles, loam sand, no gravels, massive structure, slightly sticky, slightly plastic, compactness 23, no roots, wet, positive reaction of dipyrindyl test, irregular boundary,

Fig. 12.4 Soil profile at Site 1

3Cg1: 54 to 69 cm, brownish black (7.5YR 2/2), few root-like mottles (brown 7.5YR 4/3), sandy loam, no gravels, massive structure, slightly sticky, slightly plastic, compactness 23, no roots, wet, strongly positive reaction of dipyriddy test, smooth gradual boundary.

4Bg1: 69 to 76 cm, brown gray (10YR 4/1), many root-like and common tubular mottles (brown 7.5YR 4/4), sandy clay loam, no gravels, massive structure, slightly sticky, slightly plastic, compactness 27, no roots, wet, strongly positive reaction of dipyriddy test, wavy gradual boundary,

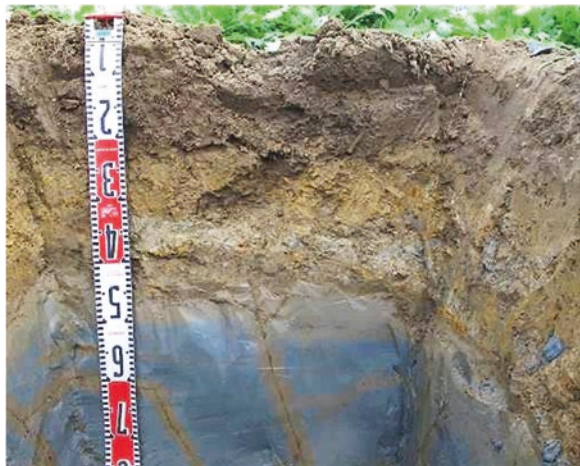
The soil profile for Site 2 is shown in Fig. 12.6, and features five horizons. This soil profile also exhibits clearly different materials and colors.

3C2: 44 to 48 cm, grayish olive (5Y 5/2), filmy mottles along cracks (dark reddish brown 5YR 3/4), heavy clay, no gravels, massive structure, sticky, very plastic, compactness 27, no roots, moderately wet, no reaction of dipyrindyl test, wavy gradual boundary, a vertical crack from this horizon to a deeper horizon,

Fig. 12.6 Soil profile at Site 2

3C3: 48 to 77 cm, dark greenish gray (5G 4/1), filmy mottles along cracks (dark reddish brown 2.5YR 3/4), heavy clay, no gravels, massive structure, sticky, very plastic, compactness 27, no roots, moderately wet, strongly positive reaction of dipyrindyl test, slightly positive reaction of tetra base test along the mottles, ground water appeared from vertical cracks trending below the depth of the profile.

3C2 was a very thick layer and separated by its color, being more grayish than the upper layer and more brownish than the lower layer. This layer may be derived from marine clay. When the fields had been reclaimed, this layer surfaced, suggesting the original reducing characteristics would be changed. Indeed, the Fe(II) test was negative, and pH (H_2O_2) was not lower than pH (H_2O). The reddish filmy mottles along cracks are a notable characteristic of this horizon.

3C3 showed the grayish blue color that would be derived from marine clay. The positive Fe(II) test indicated that this layer was still characterized by reducing conditions. The pH (H_2O_2) was lower than pH (H_2O), suggesting that some reductive

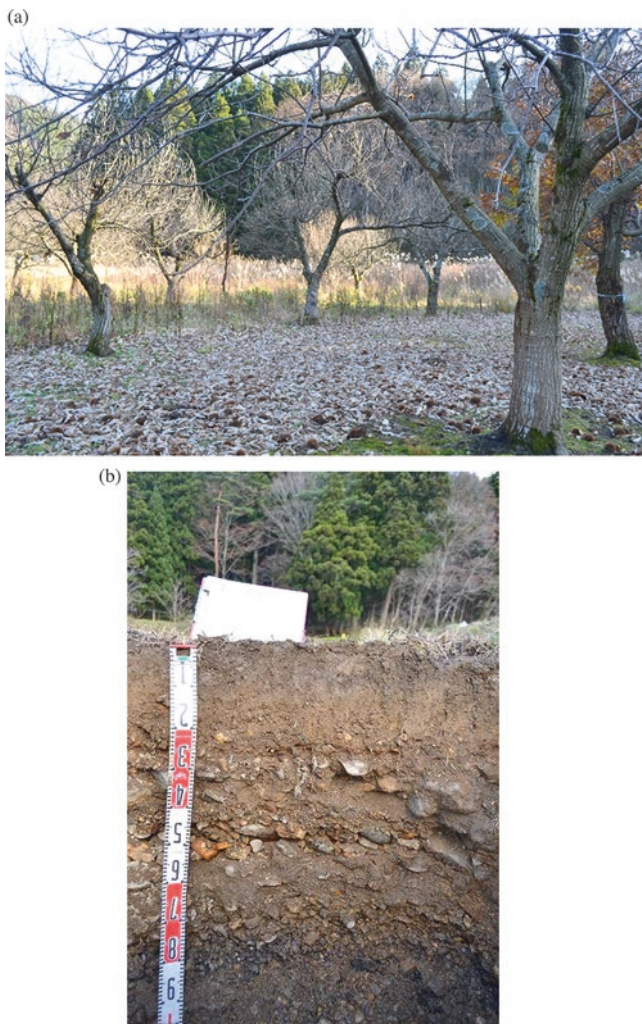
The soil profile at the chestnut orchard is shown in Fig. 13.2. Soil was dressed over the pre-existing alluvium (consisting of boulders) to provide adequate rooting space for planted trees.

Cg: 40 to 55 cm, yellow brown (10YR 5/2), abundant root-like mottling (dull reddish brown: 5YR 4/4), sandy clay loam, common slightly weathered sub-angular and sub-round gravels (ϕ 2–5 cm), no structure, slightly sticky, very plastic, compactness 16, no porosity, few medium root (ϕ 2–5 mm), moist, no positive reaction of dipyriddy test, positive reaction of tetra base test, smooth clear boundary,

C1: 55 to 70 cm, brown (7.5YR 4/3), no mottling, sand, common slightly weathered sub-angular and sub-round gravels (ϕ 1–5 cm), no structure, slightly sticky, slightly plastic, compactness 13, no porosity, no roots, moderately moist, no

Fig. 13.2 Overview (a) and soil profile (b) of Chestnut orchard site

reaction of dipyriddy test, slightly positive reaction of tetra base test, wavy gradual boundary,

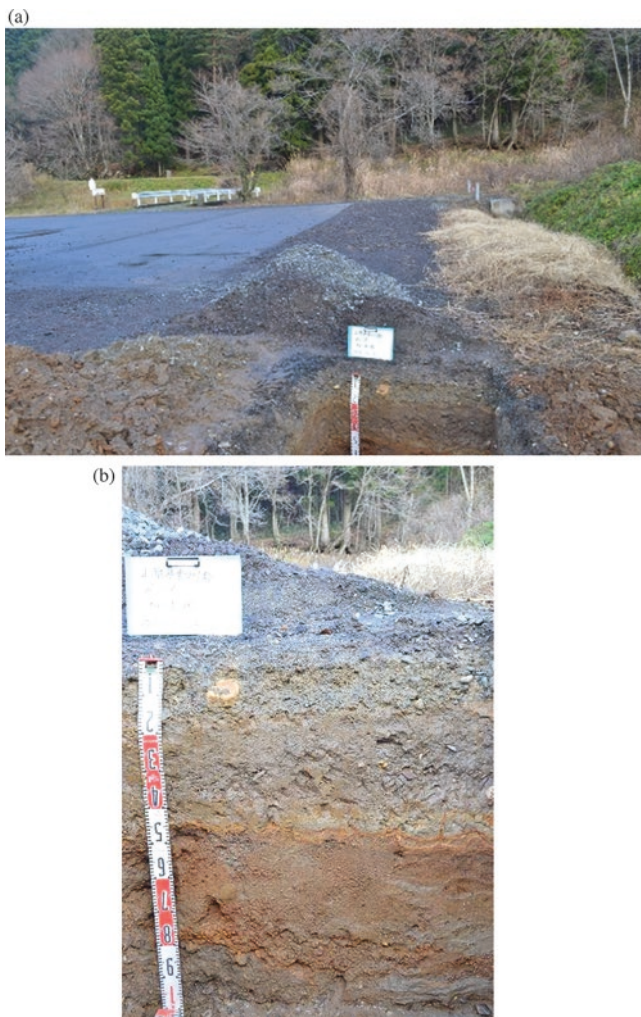
The parking lot soil profile is shown in Fig. 13.3. A subbase layer onto which a thin asphalt layer was applied has been identified above the original agricultural surface horizon, Bg.

C2: 50 to 65 cm, dark reddish brown (2.5YR 3/6), no mottling, sand, abundant slightly weathered sub-round gravels (ϕ 1–10 cm), single grain, slightly sticky, slightly plastic, compactness 15, no porosity, no roots, moist, no reaction of dipyriddy and tetra base tests, smooth clear boundary,

C3: 65 to 85+ cm, brown (7.5YR 4/6), no mottling, sand, few slightly weathered sub-round gravels (ϕ 10–20 cm) abundant slightly weathered round gravels (ϕ

Fig. 13.3 Overview (a) and soil profile (b) of Parking lot

0.2–10 cm), single grain, slightly sticky, slightly plastic, compactness 9, no porosity, no root, moist, no reaction of dipyrldyl and tetra base tests.

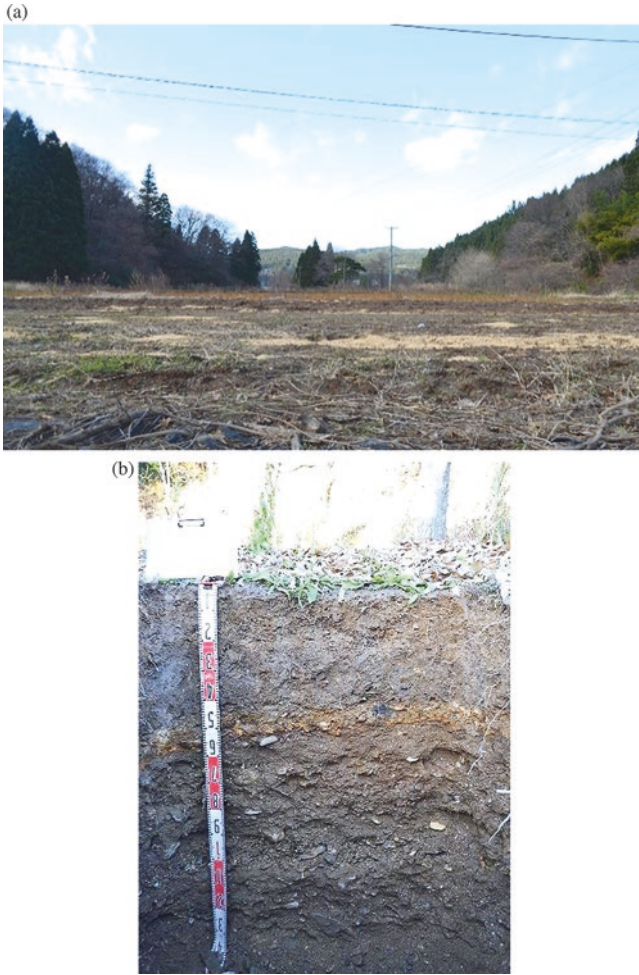
Figure 13.4 shows the soil profile at the buckwheat field, at the lowest elevation of the three survey sites. Dressing of the surface soil occurred in 2000 when the site began its tenure as an upland field.

Fig. 13.4 Overview (a) and soil profile (b) of Buckwheat field site

Ap: 0 to 8 cm, dark brown (10YR 3/4), no mottling, loam, few sub-round gravels (ϕ 5–10 cm), weak crumb structure (ϕ 2–5 mm) and weak sub-angular blocky structure (ϕ 1–2 cm), sticky, plastic, compactness 8, common vesicular porosity (ϕ 0.1–0.5 mm), few very fine roots (ϕ 0–0.5 mm), moderately moist, no NaF reaction, wavy gradual boundary,
