# Modernization of Port

R. Sundaravadivelu

**Keywords** Modernization of port · Deepening · Touch pile wall · Rehabilitation Artificial reef

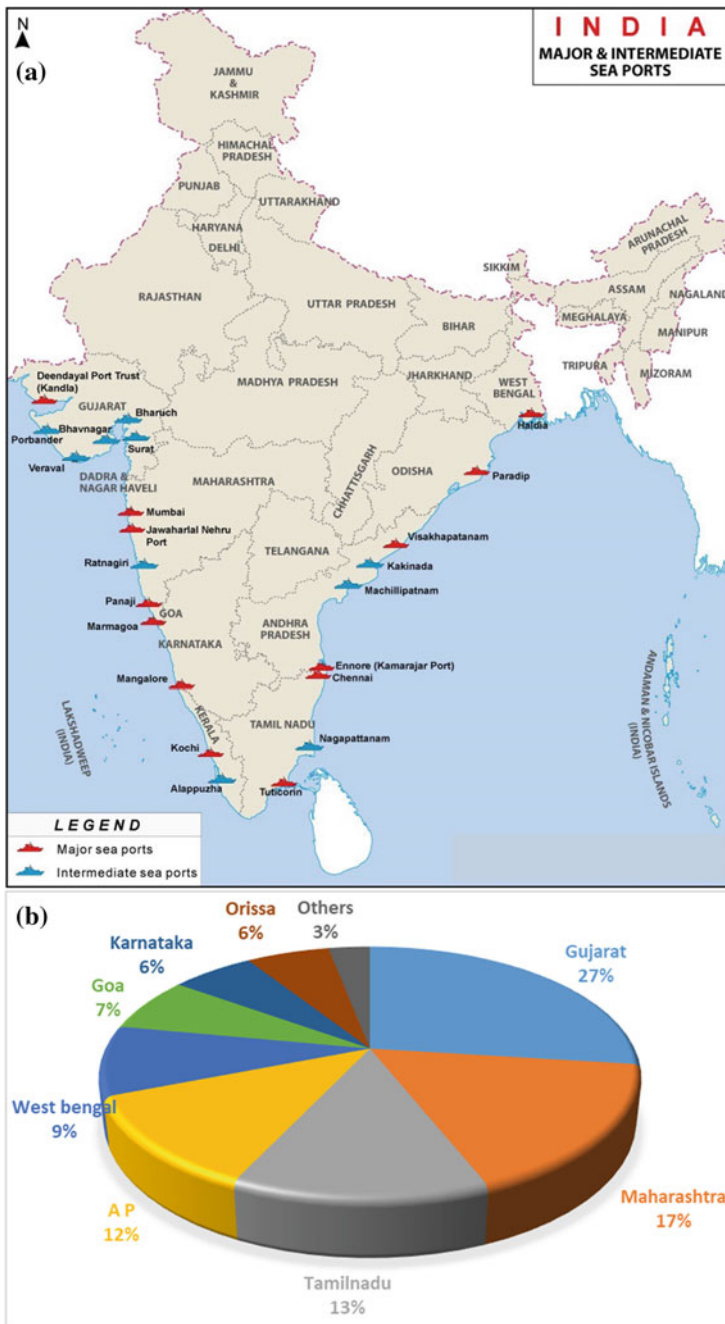
Fig. 1 Ports of India (a) and commodity handled in the various states (b)

India has a coastline spanning of 7516.6 km, forming one of the biggest peninsulas in the world. According to the Ministry of Shipping, around 95% of India's trading by volume and 70% by value are done through maritime transport. It is serviced by 12 major ports, 200 notified minor and intermediate ports. Central government's shipping ministry administers the major, the minor and intermediate ports which are administered by the relevant departments or ministries in the nine coastal states: Andhra Pradesh, Odisha, West Bengal, Tamil Nadu, Kerala, Karnataka, Goa, Maharashtra and Gujarat. All the major and minor ports visualized on India's map are

shown in Fig. 1a, and the percentage of total commodity is compared in given pie chart Fig. 1b.

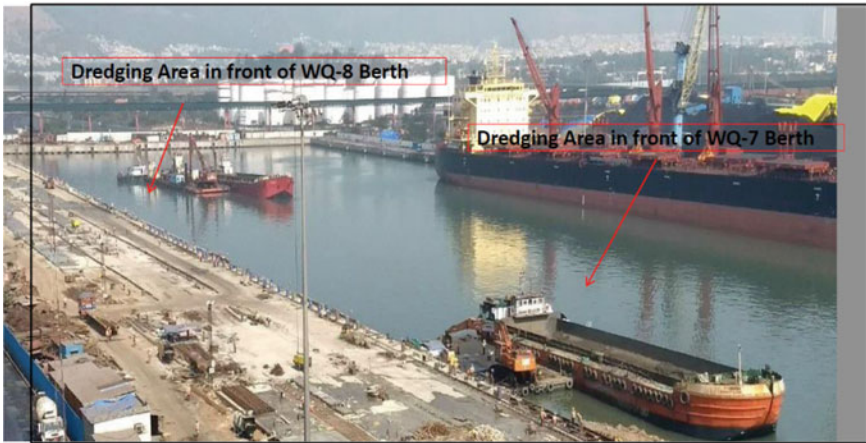
Fig. 2 Dredging work in Vizag Port

The dredging of harbour basin in Visakhapatnam Port (Fig. 2) and VOC Port (Fig. 3) is planned in such a way that the berths are in operation. The type of structural arrangement used is pile touch pile wall, rear berthing platform or pile sheet pile wall.

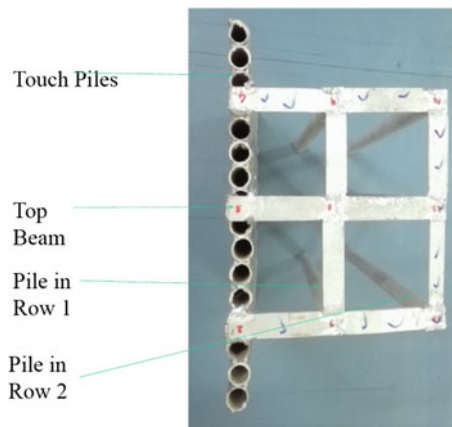
Fig. 4 Top view of berthing structure model

In order to understand the behaviour of this type of berthing structure, the model structure is created with scale ratio of 1 in 50. Aluminium pipes of 25 mm diameter with 1 mm thickness and 600 mm length are used as piles, and the aluminium pipes are welded together to act as touch pile wall. Piles are placed in two rows and three columns with a spacing of 0.12 m. Model of berthing structure is shown in Fig. 4.

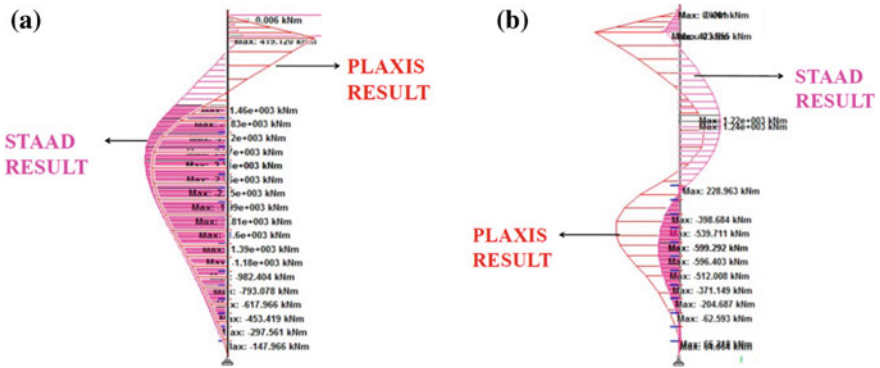
Fig. 6 Comparison of bending moment for seaside pile (a) and dockside sheet pile (b)

The typical berthing structure with touch pile wall (Fig. 5a) is analysed by STAAD.Pro software, and the design is carried out as per IS4651. The cofferdam structure shown in Fig. 5b is analysed using STAAD.Pro and Plaxis. The influence of soil pressure among various loads can be applied on the pile via spring analysis in the STAAD.Pro, whereas interaction of soil with pile structure is directly applied by assigning the properties of soil in Plaxis analysis. The results of STAAD.Pro and Plaxis analysis are compared. The bending moment of pile in seaside and dockside is compared separately which is given in Fig. 6.

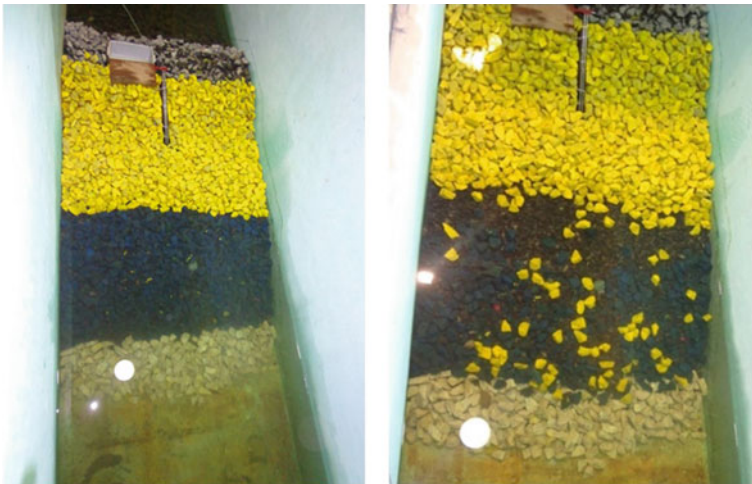
**Fig. 7** Photographs showing the model before and after testing

A well-controlled experimental programme has been performed to ascertain the damage level for the breakwater section in 10 m water depth (Fig. 7).

For the stability tests that conducted on the section consists of Armour Layer (4–7 Ton)+ Under Layer+Core (model-A; 1:2 slope), and the results clearly demonstrate that the primary layer seems to be very stable as the percentage damage is zero for wave periods of 6 and 7.5 s. Damage level is insignificant for wave period of 9 s. In actual practice, the damage level up to 5% is allowed. Hence, the section adopted is safe and the seaward slope can be increased to 1:1.5. However, if the slope of 1:1.5 is to be adopted, it is recommended to use armour weights of 7–9 Ton. Similarly, model B (Under Layer+Core; 1:2 slope) and model C (Under Layer+Core; 1:1.5 slope) are stable as per the physical model study.

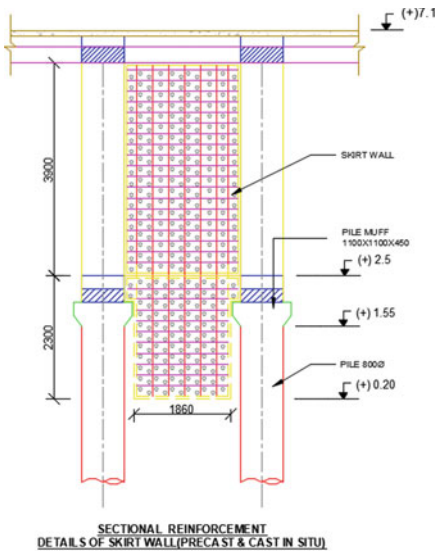
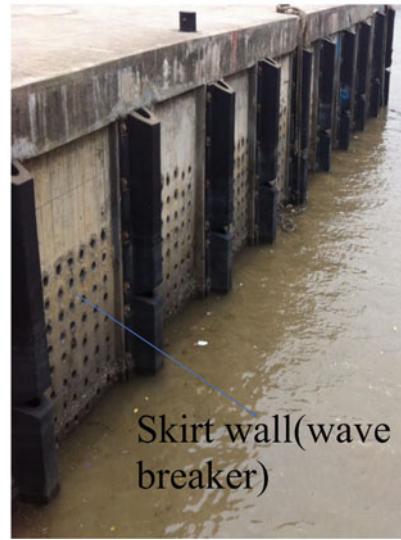
Fig. 8 Sectional view of landing jetty and site image

The landing jetty has wave dissipater in seaside. It is facilitated to provide the tranquil zone since it will dissipate the wave energy by means of perforated panel. Landing jetty is used as ferry terminal at JNPT. Ferry service from India Gate to JNPT. JNPT is influenced by very heavy tidal variation. To eliminate the wave energy/dissipate, the wave energy skirt walls are provided. Figure 8 shows the sectional view and site image of the landing jetty with skirt wall as wave dissipater.

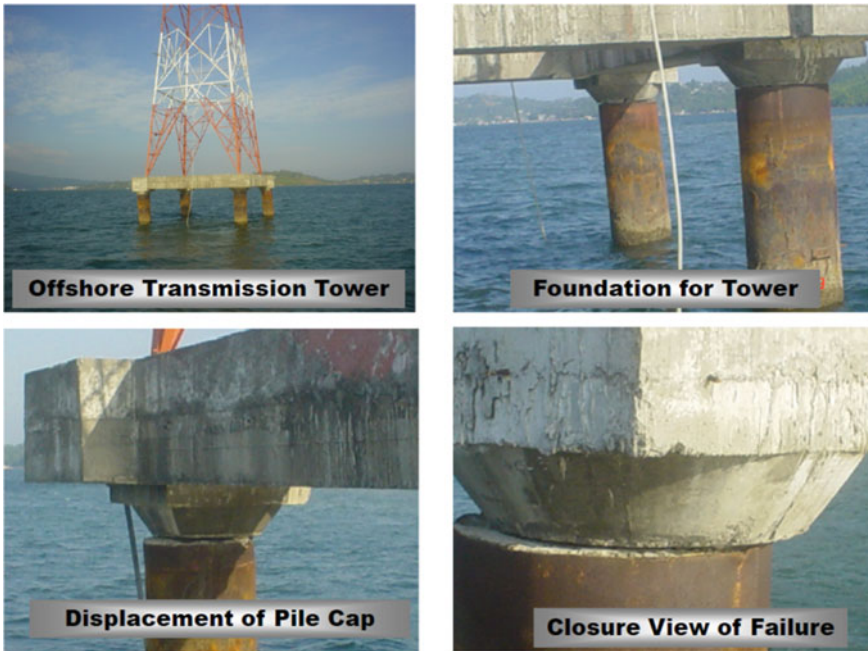
Fig. 9 Displacement of pile cap in offshore transmission tower

Transmission tower from Suryachakra to Port Blair is present. It was damaged due to Tsunami in 2004. The significant damage was occurred on the junction between pile and pile cap. The pile cap has been dislocated from the original position. Figure 9 shows the offshore transmission tower and displacement of pile cap. The rehabilitation is carried out while the tower is being supported by the deck. The load from the deck is transferred to the pile by passing the damaged pile–pile cap joint. The retrofitting using additional reinforcement, micro-concrete and shear connectors is completed in three months.

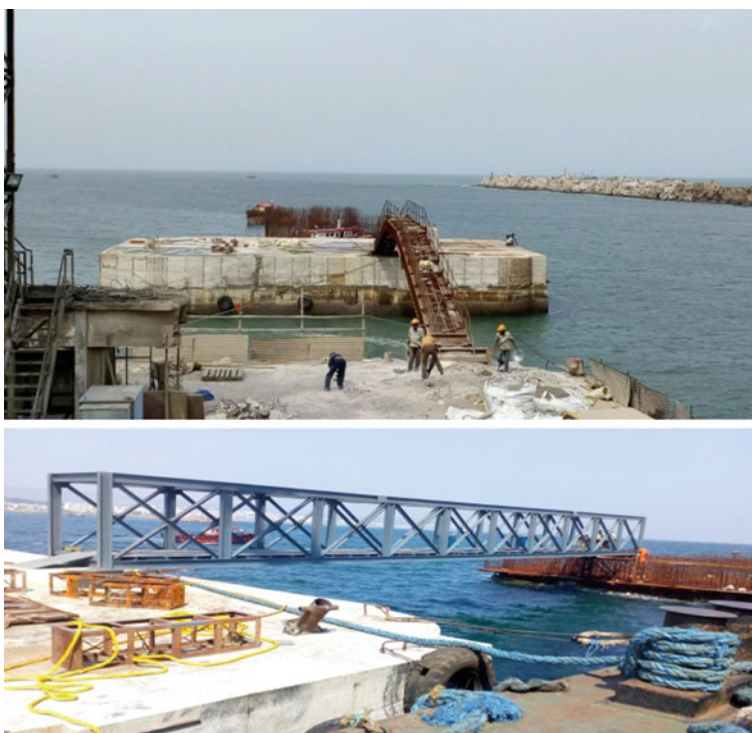
**Fig. 11** View after completion of deck slab (top) walkway between berthing and mooring dolphin (bottom)

- Dismantling and surface preparation on damaged dolphins
- Access working platform
- Drilling/installation of Rebar's
- Shuttering for micro-concrete wall
- Micro-concrete
- Mass concreting on BD and sand filling on MD'S
- Deck slab concrete and facia walls on south side of BD, MD'S
- Construction of facia beam and fixing of fenders on BD
- Fixing of marine fixtures, walkway bridge, foam tower on BD (Fig. 11).

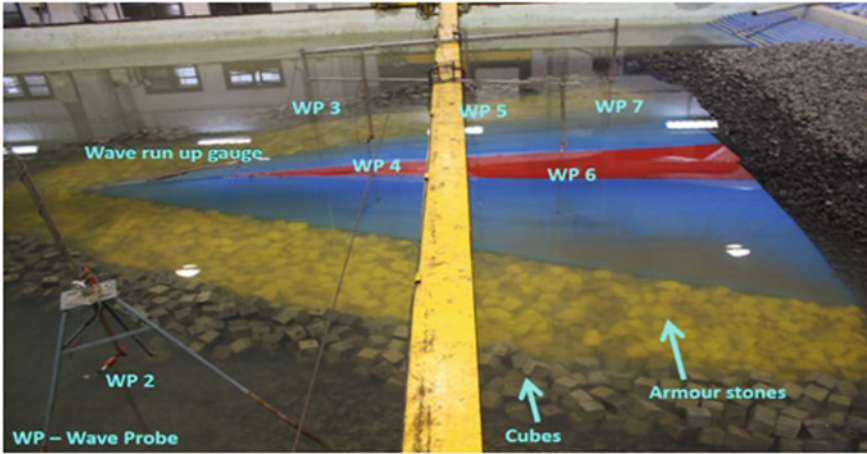
Fig. 12 Experimental set-up (1:10 scale) at shallow wave basin at IIT Madras

A submerged triangular reef was constructed using 25-mm-thick IS2062 grade steel sheets with base length 5 m and base height 6 m. The steel wedge consisted of top plate (horizontal crest) of 1 m length and 4.5 m height followed by slope of 1:0.8 on both the sides of the plate. The steel wedge has a height of 2.5 m and installed in the basin with the toe of the wedge 7.3 m from the wave maker. The horizontal crest of the steel wedge was at the water level for 50 cm water depth. At the opposite end of the wave generator in the basin, a beach with a 1:40 slope was made using 20 mm aggregate. Armour stone of size 10 cm was placed all around the steel wedge for a width of 1 m. Stones were placed for a depth of 10 cm to prevent toe scour. Additional concrete cubes of size 10 with 2 cm holes on all the six sides were placed all around the armour stone for a width of 0.5 m. Concrete cubes with holes were placed in random for a depth of 20 cm to dissipate the wave energy. The experimental set-up inside the shallow wave basin is shown in Fig. 12.
