Migration of Chilika Lake Mouth

R. Sundaravadivelu, P. Shanmugam, A. K. Patnaik and P. K. Suresh

Abstract Chilika lake is the largest lagoon along the east coast of Indian state Odisha, situated between latitude 19° 28' and 19° 54' N and longitude 85° 05' and 85° 38' E. The place is known for rich biodiversity and is the largest wintering ground of migratory bird and largest population of Irrawaddy dolphin, habited by migratory birds and by a special type of dolphins. The highly productive ecosystem of the lake supports the livelihood for fishermen and also acts as drainage for Mahanadi River Basin. The estuary is very sensitive to the sediment dynamics. The closure of estuary mouth or shifting of Chilika Lake mouths tremendously changes salinity and ecology of the lake system. The east coast of India along this coast is having a net alongshore drift of about $0.7 \times 10^6 \text{ m}^3$ annually toward north direction. The inlets of Chilika Lake are under the influence of alongshore sediment transport from the coast. Apart from this, the rivers bring sediments during peak southwest monsoon season. Because of this the inlets are migrating, depending on the season. The details of

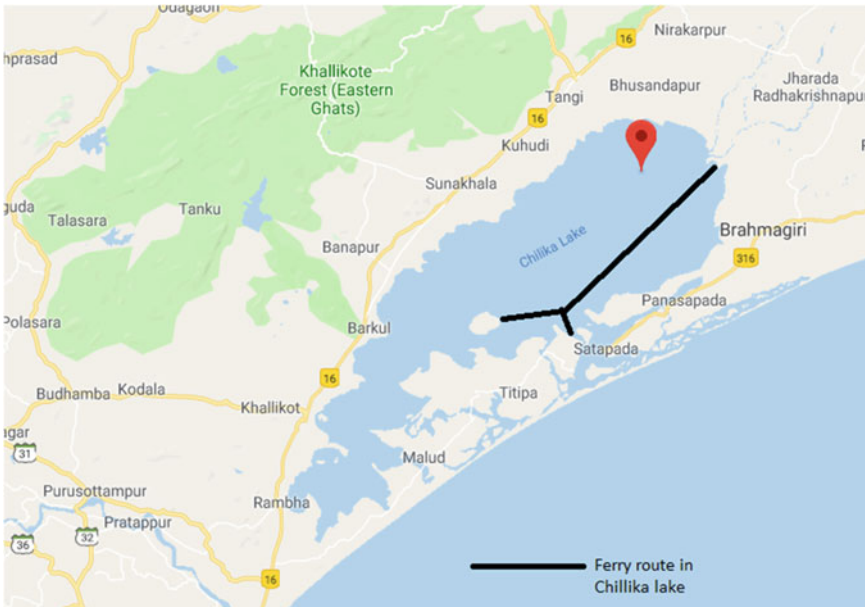
Fig. 10 Ferry routes in Chilika lake

From the above observation, it has been felt that some further interventions inside the lake are essential like the desiltation in the main connecting channel from the mouth to lake, Balugaon channel and a ferry route is shown in Fig. 10. The ferry route will be maintained for years together as the propeller of the boats moving inside will make the channel free from siltation. The depth of ferry route with respect to mean sea level is shown in Fig. 11.

By desiltation of the channels, the navigation in the lake will improve. The desiltation processes will also pave the way for the recruitment of juvenile from sea as 85% of the fish in Chilika Lake are migratory in nature. The lead dredged channel also facilitate in discharge of flood water from Delanga, Kansa, and Brahmagiri block, in the Mahanadi catchment (Chilika) in Puri district of Odisha which is more than 70,000 hectare of cultivable agriculture land.
