Analyses and Design of the Highly Jointed Slopes on the Abutments of the World's Highest Railway Bridge Across the Chenab River in Jammu and Kashmir State, India

T. G. Sitharam, Srinivas Mantrala and A. K. Verma

Abstract Indian Railways have embarked on the construction of world's highest railway bridge as a part of Udhampur–Srinagar–Baramulla Rail Link Project, a major infrastructure project in India. The bridge is being constructed across the river Chenab. The bridge consists of a main span of 467 m arch bridge on the steep slopes on the banks of the river Chenab. The bridge is about 359 m above the high flood level of the Chenab River. The bridge is located in highly seismic area characterized with maximum credible earthquake with a peak horizontal acceleration of 0.36 g. Considering the iconic nature of the bridge and highly jointed rock mass, a variety of tests were conducted to assess bearing capacity of the foundations and stability of the slopes. Continuum analyses using Slide and FLAC softwares were carried out. The slopes were also checked for wedge failure and toppling failure considering the joint characteristics. The slope stabilization measures against wedge failure

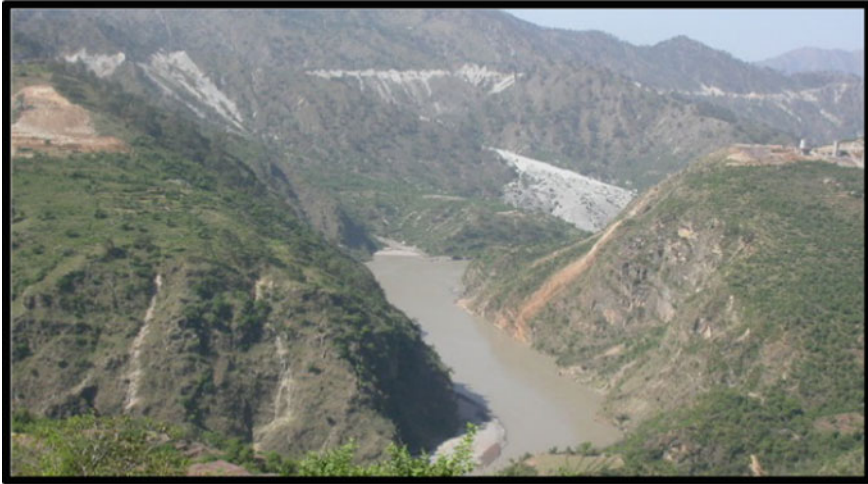
Fig. 2 Left and right banks of Chenab Bridge before commencement of work

Indian Railways are building the iconic Chenab bridge across the river Chenab which will be world's highest railway bridge once completed. The bridge is located in young Himalayan Mountains, which are active. The general arrangement of the bridge is indicated in Fig. 1. Out of eighteen foundations, seven foundations are coming on the slopes. The founding strata consists of highly jointed dolomite with three joint sets. The joints are closely spaced. Since the foundations are coming on the slopes, the slopes need to be designed very carefully considering the long-term stability requirements. The photograph taken at the proposed site before the commencement of the excavation of the slopes is presented in Fig. 2.

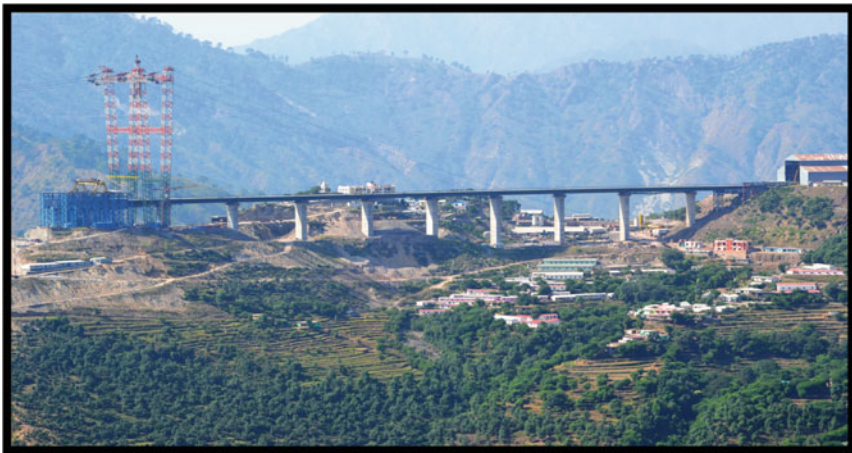
Fig. 3 Completed viaduct on the right bank

Figure 3 shows the photograph of the completed viaduct portion from S80 to S180. The portion from S130 to S180 is on transition and circular curves. For the first time in the world, the deck was launched incrementally on a combined circular and transition curves. The photograph of the deck is shown in Fig. 4. The stabilization of the slopes on both left and right banks was completed and the construction of foundations on the slopes has been completed. The photographs showing the stabilized slopes on the left and right banks are placed at Fig. 5 and Fig. 6 respectively.

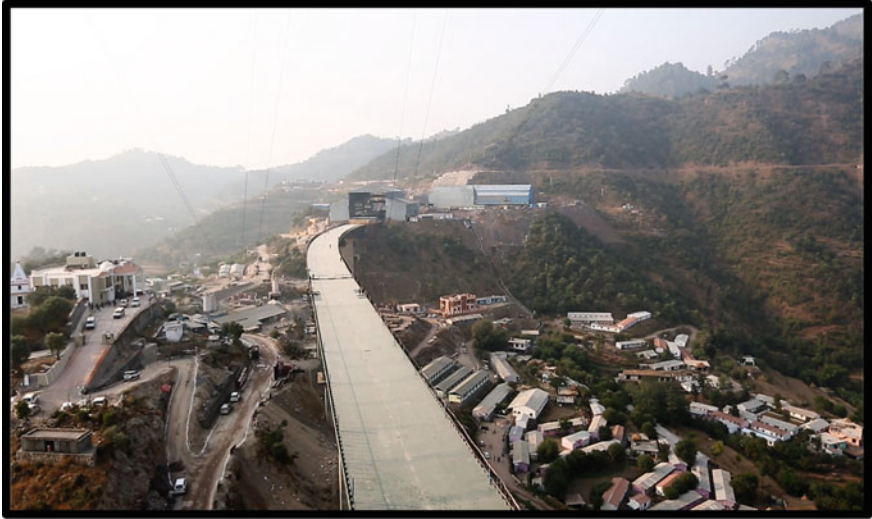
Fig. 4 Incrementally launched deck on combined circular and transition curves

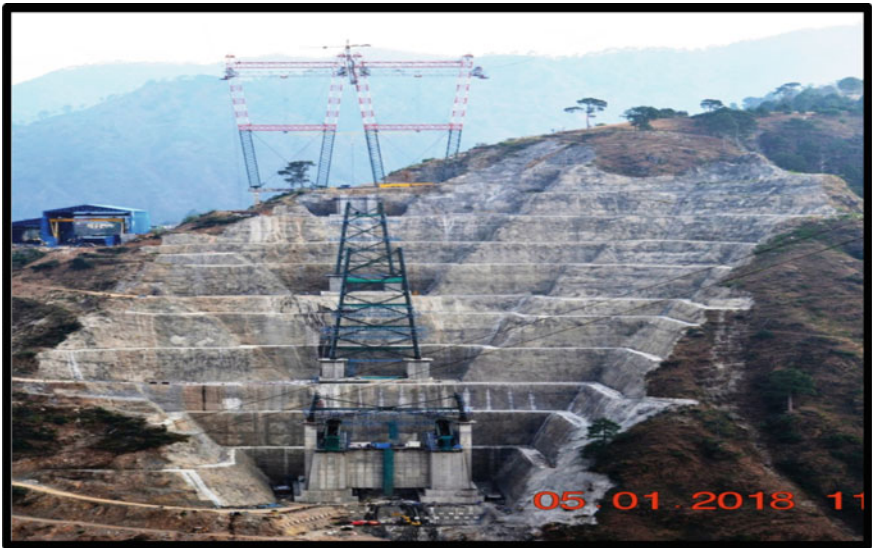
Fig. 5 Stabilized slopes on the left bank

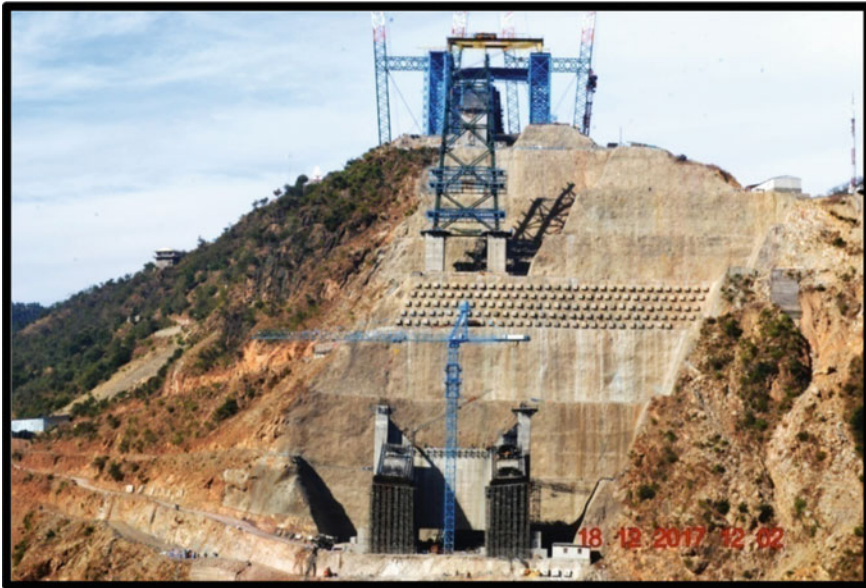
Fig. 6 Stabilized slopes on the right bank

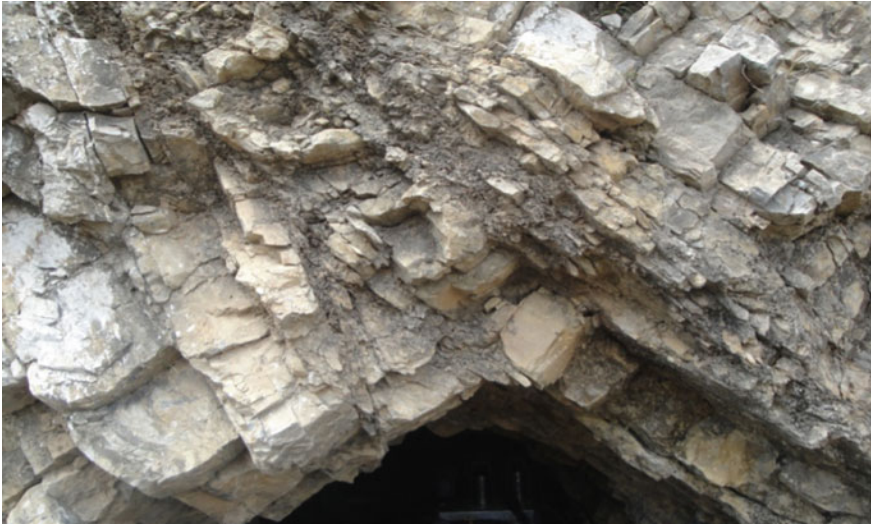
Fig. 7 Rock mass exposed at the bridge site

The rocks present at the bridge site are heavily jointed. The subsurface at the extent of the bridge site considered for slope stability analysis essentially consists of Dolomitic limestone with different degrees of weathering and fracturing. The main discontinuities at the site are one sub-horizontal foliation joint dipping about 20° – 30° in North-East (NE) direction and two sub-vertical joints. Figure 7 shows the rock mass exposed at the bridge site. The figure also depicts the intensity and spacing of the prevailing joint sets at the bridge site. Figure 8 shows the joint orientations at two drift locations.

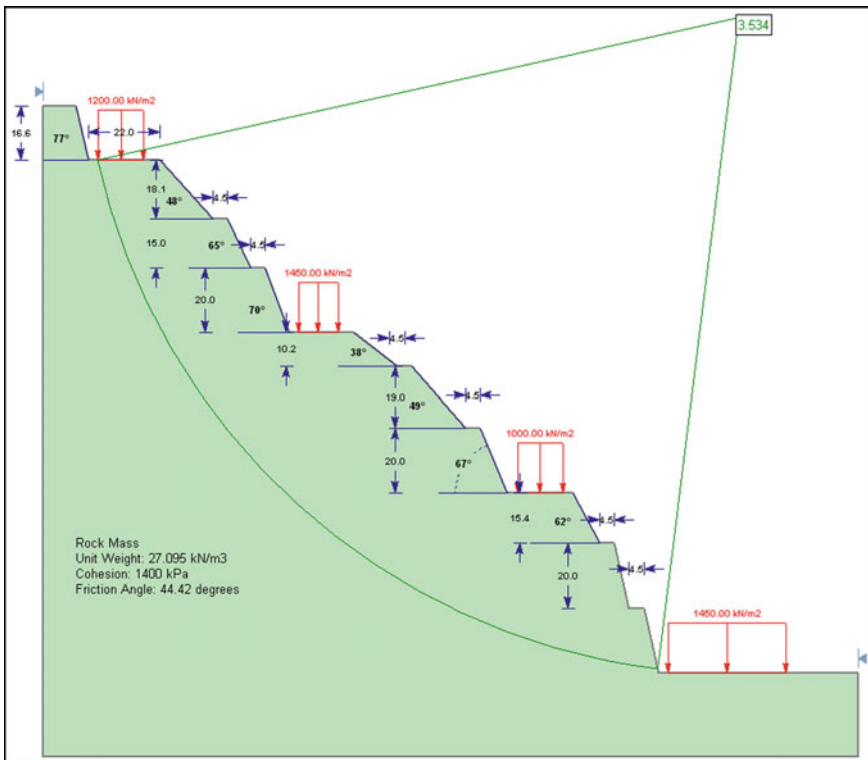
Fig. 9 Static analysis: circular global failure (FS = 3.534) using set 1 values

Using SLIDE software continuum analyses, both with circular and non-circular slip surfaces were carried out using two sets of properties as decided by the entire team and as per Design basis note. Static analyses, pseudostatic analyses with MCE loading, and pseudostatic analysis with DBE loading conditions were carried out with two sets of properties for all the slopes. Sensitivity analyses were also carried out with subset properties. Further, analyses with two-layer model considering pore water pressures were also done. Figures 9, 10, and 11 show the typical results from SLIDE analyses for some of the cases. Figures also show the factor of safety obtained for a circular slip analyses using Bishop’s simplified approach for an equivalent continuum material.

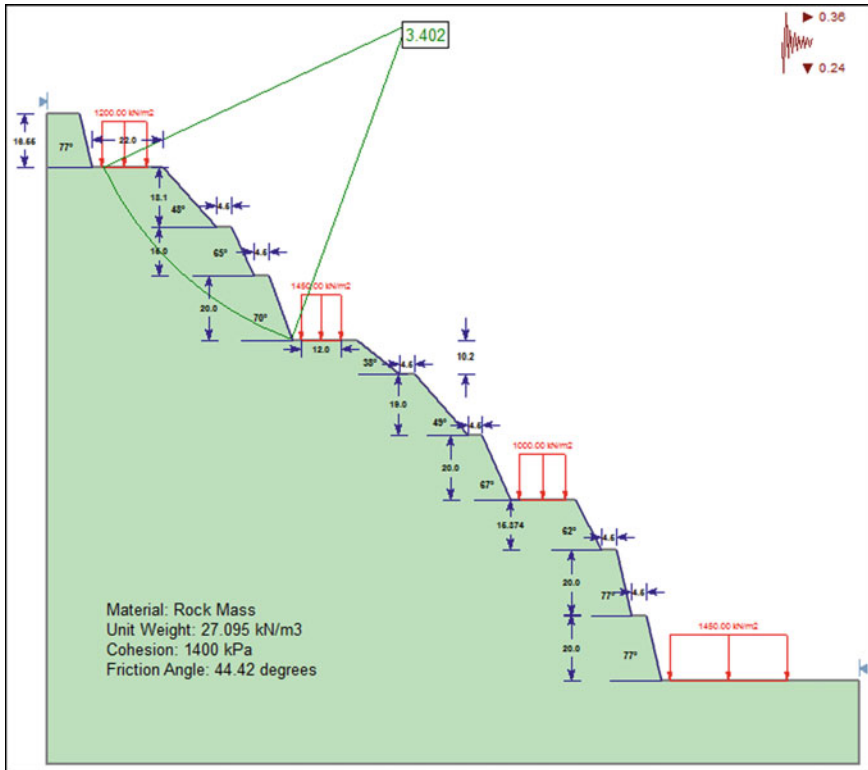
Fig. 10 Pseudostatic analysis: shallow slip failure (top), MCE condition ($\alpha_h = 0.36$, $\alpha_v = 0.24$) with set 1 values

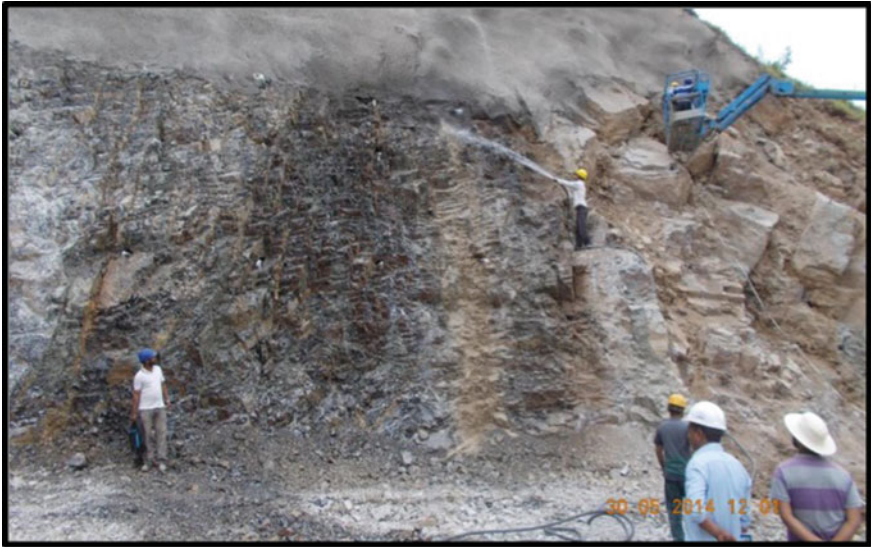
Fig. 15 Cleaning of excavated slope with water jet

After the slope is excavated, the surface is cleaned with water jet as shown in Fig. 15 and the geological log of the slope is prepared. Typical geological log is placed at Fig. 16. The data from the geological log are used for the validation of the design of slope stabilization measures.

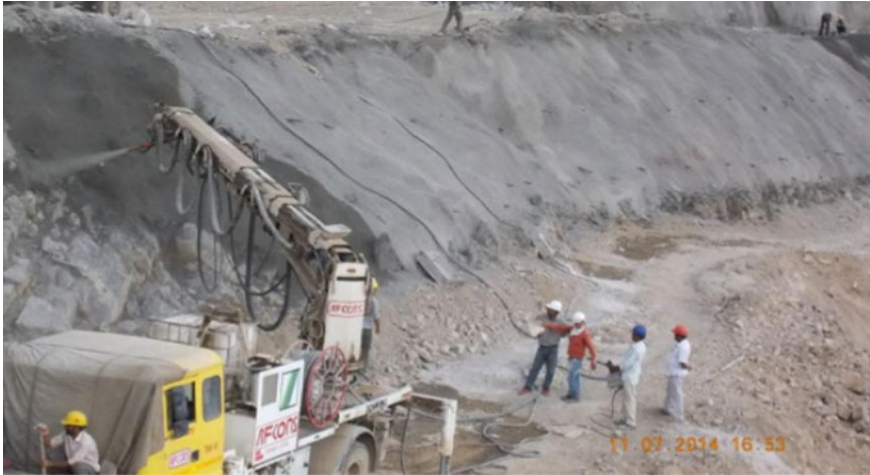
Fig. 17 Application of 50 mm thick steel fibre-reinforced shotcrete

After the geological logging is completed, the first layer of 50-mm-thick steel fibre reinforced shotcrete was applied as shown in Fig. 17. Later the location of rock bolt was marked on slope in accordance with the approved layout drawing.

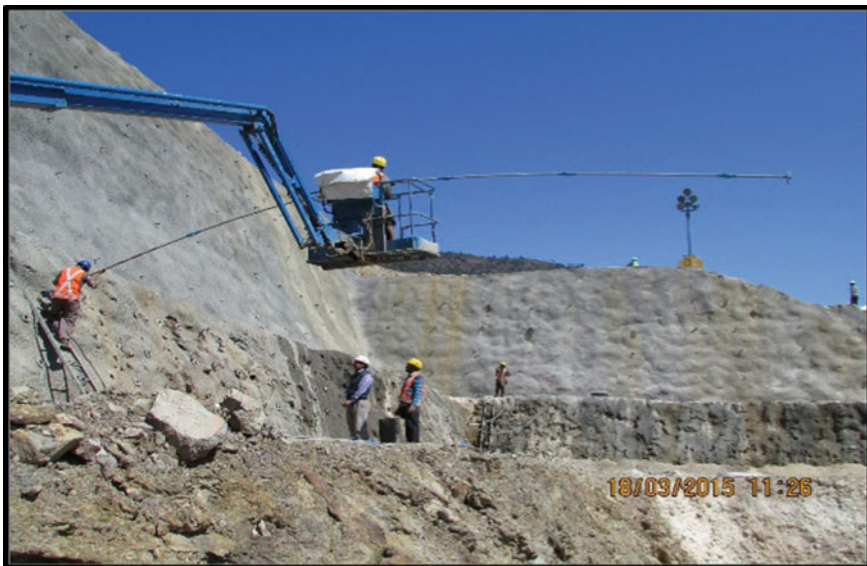
Fig. 18 Installation of rock bolts in progress

The drilled holes were flushed by means of air jet to remove any loose materials. The rock bolt was inserted into the hole carefully along with centralizers and grout pipe. A photograph indicating the installation of rock bolts is placed at Fig. 18.
