# Impact Study on Desiltation of Water Tanks in Rural Areas Using Spatial Technology: A Case Study Work Under MGNREGA

**Abstract** This study was conducted under the Mahatma Gandhi National Rural Employment Guarantee Scheme (MGNREGS) in Gural Mandal, Vizianagaram District, Andhra Pradesh, to identify the improvement around irrigation tanks which were desilted under this programme. In rural areas, small tanks serve as the major source for irrigation and groundwater. Improper soil management has led to a significant reduction in water tank surface spread area and depth due to the accumulation of the sedimentation process. Desiltation of these selected tanks would improve the water spread area, thus improving total volume. Remote sensing and GIS support continuous analysis of the study tanks using satellite images and Modified Normalized Difference Water Index (MNDWI) before and after desiltation work. This index has supported the seasonal water storage/spread area, crop pattern change and income level in rural villages.

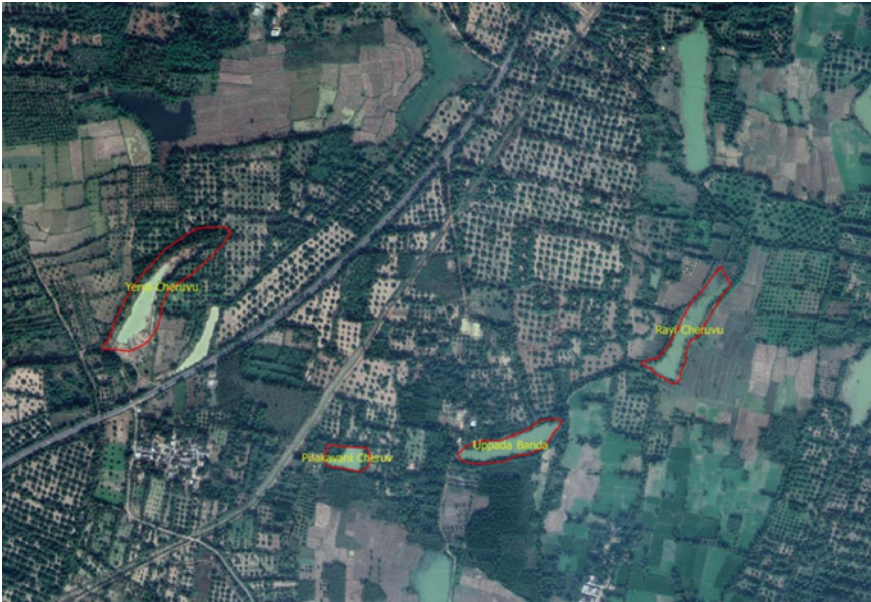
Fig. 5 Google image of study cluster 2

**Cluster 2** It includes four tanks named as Yerra Cheru, Pilakavani Cheru, Uppada Banda and Rayi Cheru (Fig. 5). Yerra Cheru and Uppada Banda come under Achyutapuram Panchayat, and Pilakavani Cheru and Rayi Cheru come under Chodavaram

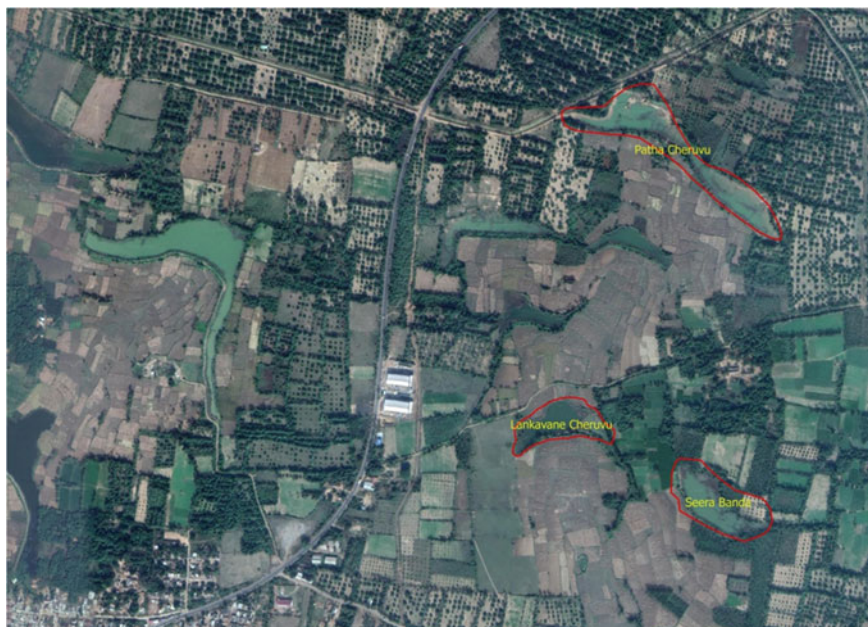
**Fig. 7** Google image of cluster 3 tanks

**Cluster 3** It shows three tanks, namely Patha Cheruvu, Lankavani Cheruvu and Seera Banda (Fig. 7). Three of these tanks belong to Chodavaram village, in the Gurla Mandal. Average annual rainfall is 915.12 mm. Water spread area of Patha Cheruvu and Seera Banda is 1.6 ha and Lankavani Chruvu is 2.4 ha. These tanks often suffer from weed spread above 50% of the tank surface. These tanks support single and double crops in their command area. Compared to 2010 and 2011 tank, MNDWI values show variations due to siltation. Figure 8 clearly shows that 2015 MNDWI values are comparatively lesser than 2010 which has led to shrinking of the lake in terms of depth and surface area. Table 7 gives maximum MNDWI values for all three tanks. Among them, all tanks are showing gradual improvement in values.

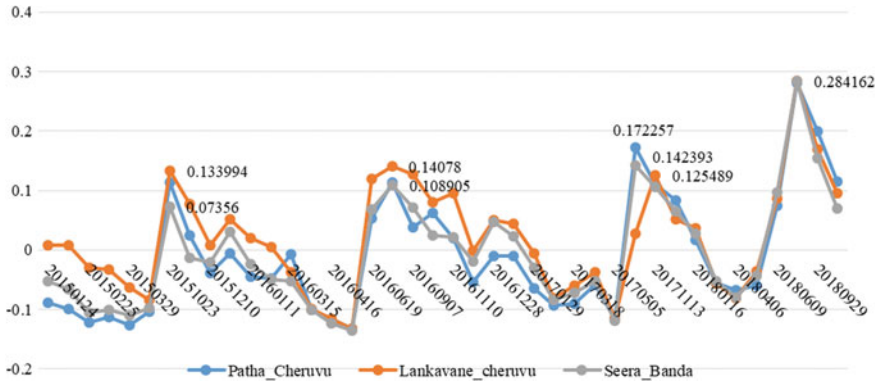
Fig. 8 MNDWI values of cluster 3 tanks for 2015–2018

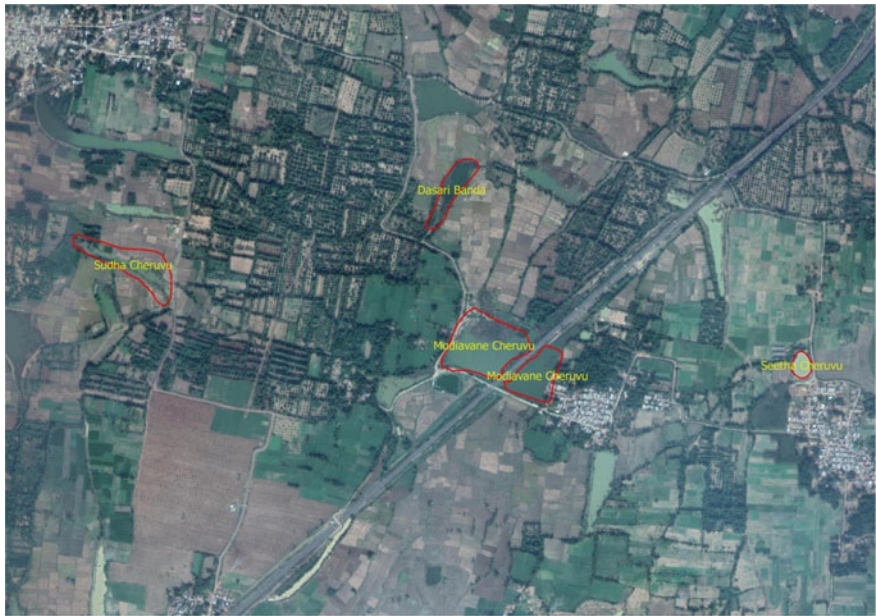
Fig. 9 Google image of cluster 4 tanks

**Cluster 4** It includes four tanks named as Modiavane\_cheruvu, Dasari\_Banda, Sudha\_cheruvu and Seetha\_Cheru (Fig. 9). All the four tanks come under Garida Panchayat. The average slope of this area is 3%. Modiavane\_cheruvu, Dasari\_Banda and Seetha\_Cheru have three sluices outlets. Moidavani Cheruvu comes under the above medium irrigation tank with 7.36 ha with 50% weed infestation. For October

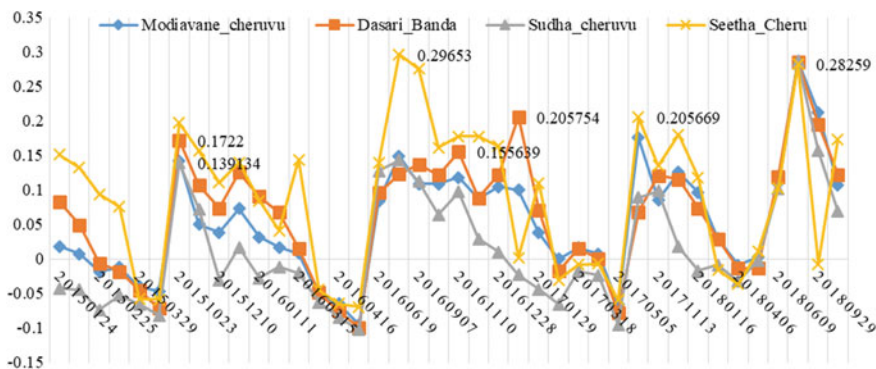
Fig. 10 Cluster 4 MNDWI variation from 2015 to 2018

month from 2015 to 2018, MNDWI values increase in all the four tanks like for Mo-davani Cheruvu it raised from 0.10 to 0.21 after desiltation work. It can be attributed to the removal of 3 acres of encroached land and desiltation. Dasari Banda is situated in Meesalapeta village with 12.48 acres of Ayacut area with 15 farmers cultivating this land. This tank was taken for renovation works as the reconstruction of three sluices and inlet waterway from Laxmana Cheruvu. Surplus course widening and desiltation work improved MNDWI values gradually from 2016 to 2018 (Fig. 10). Sudha Cheruvu and Seetha Cheruvu also show changed MNDWI values with tank renovation work Table 8.

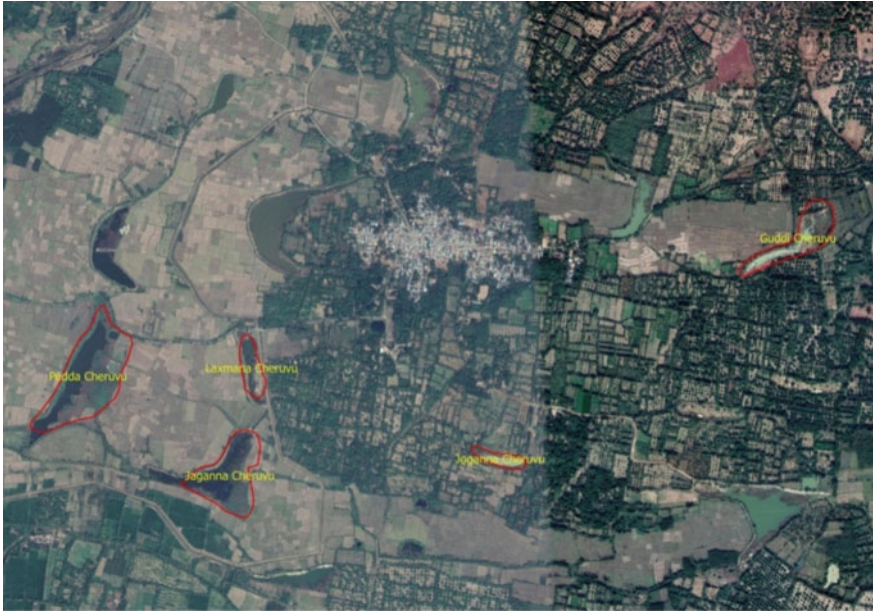
Fig. 11 Google image of cluster 4 tanks

**Cluster 5** It includes five tanks named as Pedda Cheru, Jaganna Cheru, Laxmana Cheru, Joganna\_Cheru and Guddi Cheru (Fig. 11). All the five tanks come under Polayavalasa Panchayat. Pedda cheruvu and Jagganna Cheruvu are relatively bigger tanks. Due to siltation of tanks, farmers could able to irrigate Ayacut area only for one month. During the rainy day, these two tanks easily get full level but not sufficient volume. Pedda Cheruvu surplus water moves into Jagganna cheruvu and Laxmanna cheruvu. Desiltation work in these tanks supports more water accumulation. Table 9 and Fig. 12 show the changing MNDWI values in all the five tanks. Removal of encroached area and silt can retain more water in monsoon season thus recharging more water into the ground level. Ayacut area farmers can irrigate through bore wells/wells during less water in tanks.

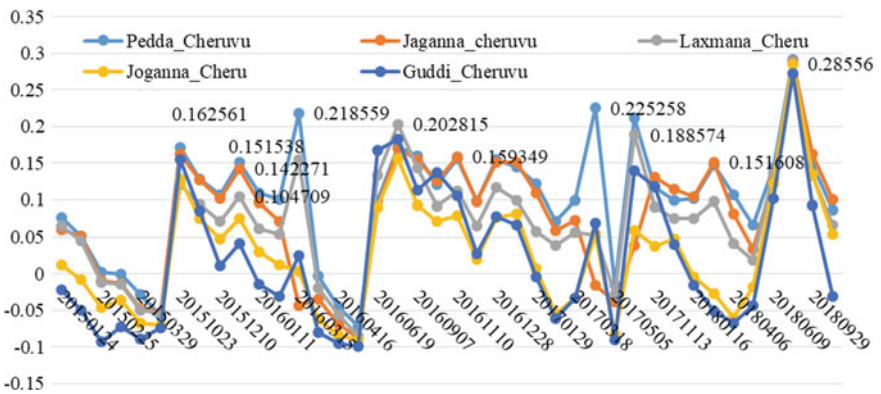
Fig. 12 Cluster 5 MNDWI variation among tanks for 2015 and 2018
