# Use of Electrical Resistivity Tomography in Predicting Groundwater Contamination Due to Non-engineered Landfill

**Abstract** One of the major causes of groundwater contamination in urban areas is the flow of leachate from non-engineered landfills. Use of conventional test wells to predict the contamination is a cumbersome process. In this pilot study, a small-scale landfill having dimensions 4 m × 2.4 m × 0.6 m height was prepared to determine the efficiency of electrical resistivity tomography (ERT) in predicting groundwater contamination due to uncontrolled landfill. ERT survey was performed for five months, and the variations in groundwater contamination were observed. Water samples from the site were analysed for contaminant concentrations. The resistivity of the soil was found to be decreased considerably from around 200 to 20  $\Omega$ -m. This low resistivity zone ensured the presence of leachate flow followed by contamination of groundwater. The increased depth of low resistive zone below landfill evidenced the extended depth of groundwater contamination. Charts were prepared by correlating the contaminant concentrations in groundwater with the resistivity values. This c

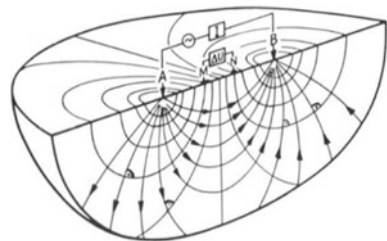
**Fig. 1** Current flow pattern and potential distribution in subsurface

ERT is an advanced near-surface geophysical technique evolved to solve the complex field problems. This is a non-destructive method which does not need trenches, borehole (BH) and other destructive methods to serve the intended purpose. ERT survey needs a resistivity recording device and electrodes to determine the subsurface data including physical and geological characteristics (Abdul Nassir et al. 2000). Though this method is not very new, its extensive use in investigating the emerging environmental concerns needs to be explored to a greater extent. The depth of investigation can be increased by increasing the spacing between the electrodes along the resistivity profiles. A typical current flow pattern and potential distribution in a resistivity survey are shown in Fig. 1.

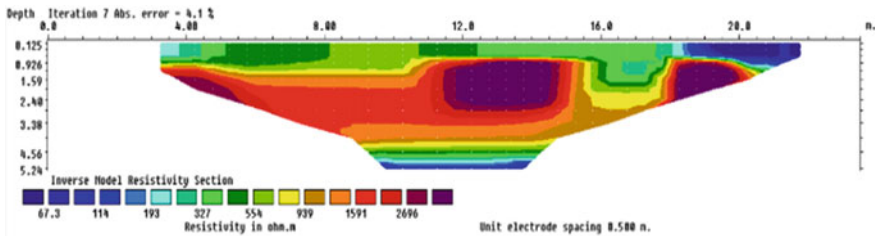
Fig. 2 Resistivity profile at site 1

survey was carried out at three possible places in the campus after a preliminary investigation. The observed resistivity profiles at the sites, before selecting the final one, are presented in Figs. 2, 3 and 4. Among the possible sites available, the site 3 corresponding to Fig. 4 was finally selected as per the requirement of the experiment. There was no evidence of groundwater table at sites 1 and 2 for which these two were rejected for the proposed experimental work. Moreover, these two sites were filled soil where large amount of gravel and broken brick pieces were present. The selected site was at the foot of a stepped slope near a lake as shown in Fig. 5. The hydro-geological features at the site are presented in Fig. 6. The gravimetric flow of groundwater was along the slope of the natural ground surface towards the lake which was evidenced from the piezometric analysis of depth of groundwater in the observation wells at the site.

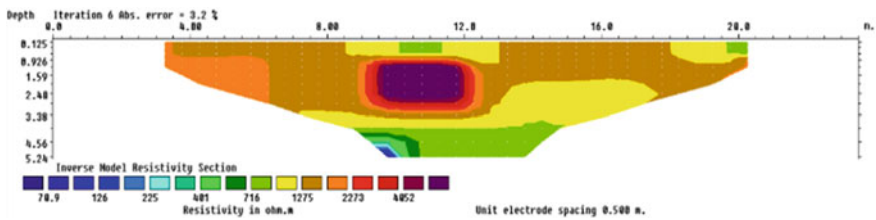
Fig. 3 Resistivity profile at site 2

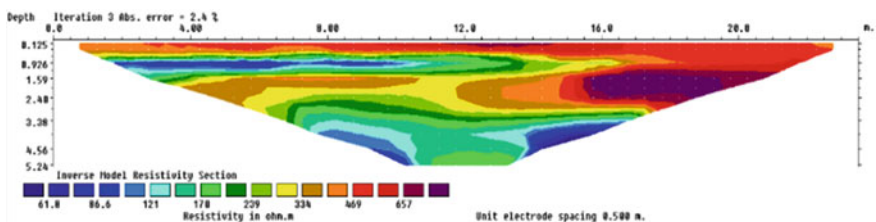
Fig. 4 Resistivity profile at site 3

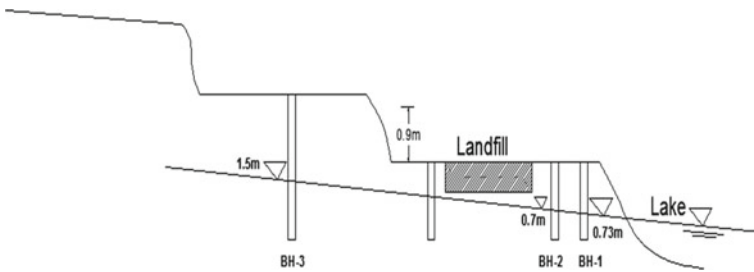
Fig. 6 Hydro-geological features at selected site

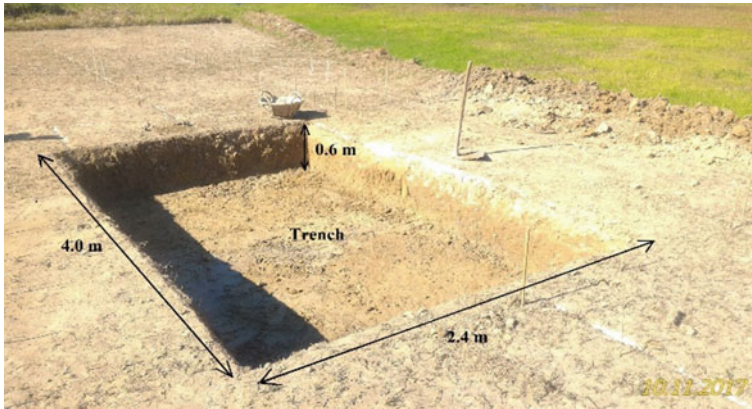
**Fig. 7** Trench prepared to accommodate the wastes

A trench was prepared with size  $4 \text{ m} \times 2.4 \text{ m} \times 0.6 \text{ m}$ . The trench was made nearer to a lake. The prepared trench and the modelled MSW dump are shown in Figs. 7 and 8, respectively.

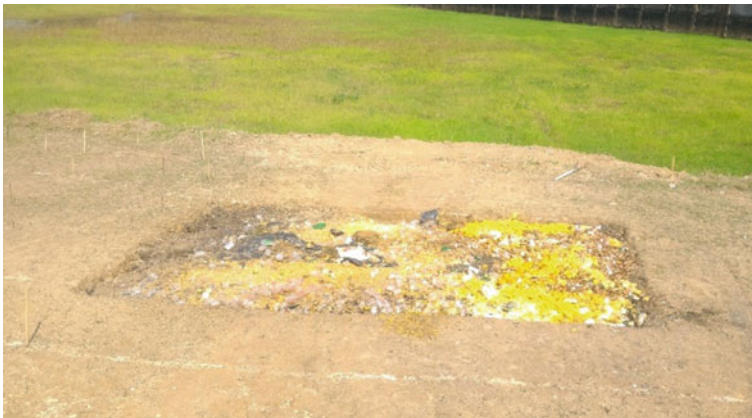
**Fig. 8** Model landfill at the site

The trench was filled with discarded paper, food waste, cow dung, disposable plastics which were used to replicate the original MSW dumps. Cow dung was used as a waste material as it contains some minerals which cause groundwater contamination. Food waste attributes 40% of the total municipal solid waste in a

landfill for which these were considered as the governing reasons for groundwater contamination at a landfill site. The model landfill was kept open to allow the rainfall and run-off to pass through wastes in the landfill followed by production of leachate from the model landfill. In the absence of rainfall, the landfill was watered on regular basis so as to produce leachate out of the landfill. It was observed that the top surface of the filled waste has been settled for an average depth of 16 cm which is due to the result of decomposition of organic waste in the dump.

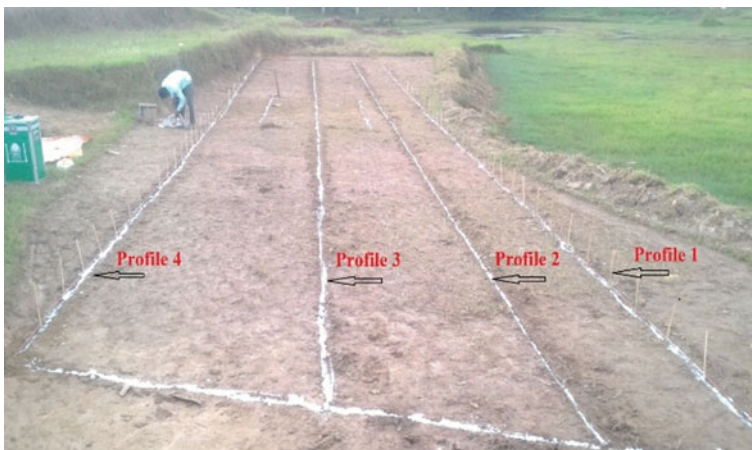
Fig. 9 Model landfill at the site

Two ERT profiles on the downstream side, one on the upstream side and one on the landfill itself, were marked to conduct the resistivity survey along these profiles throughout the research period. The two downstream profiles were at a perpendicular distance of 0.5 and 1.5 m from the landfill, respectively, for profiles 2 and 3. A total of 48 electrodes were used at a spacing of 0.5 m resulting in a 23.5-m-long profile. Two- and three-dimensional resistivity tests were performed at every month to predict the groundwater contamination and visualize the flow of leachate from the model landfill. Positions of the ERT profiles near the model landfill are shown in Fig. 9.

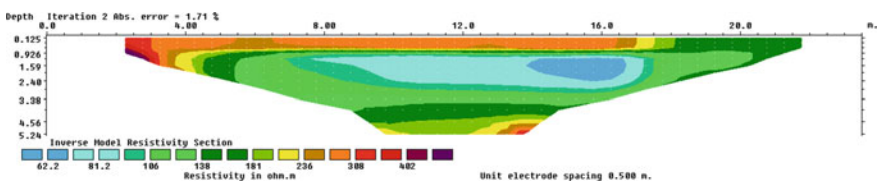
Fig. 10 Resistivity profile before filling the waste

**Resistivity and Water Quality Data for Profile 1.** Resistivity survey was carried out for a period of five months from November 2017 to March 2018, and water quality parameters were also determined for each of the investigated months for profile 1. The resistivity profiles for each of the investigated months are presented in Figs. 10, 11, 12, 13 and 14, and the test results for water quality parameters are shown in Table 1.

After one month of dumping and watering the waste in the landfill, resistivity profile 1 which is 1.5 m away from the landfill at downstream side of landfill showed reduced value of resistivity from about 80 to 70  $\Omega$ -m which was suspected as a result of leachate intrusion. As there was no significant decrease in resistivity value in the subsoil, therefore it was suspected as very negligible intrusion of the leachate

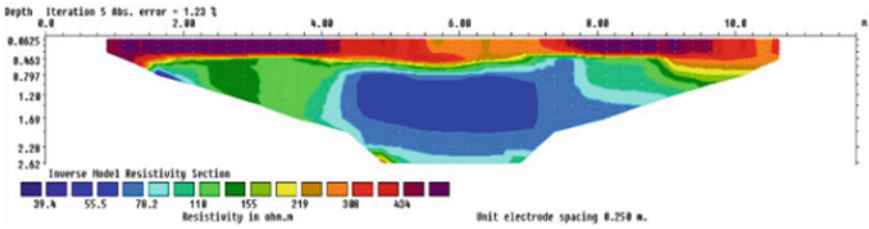
Fig. 12 Resistivity profile after two months of filling

To detect the contaminated zone very minutely, the electrode spacing in the second month has been reduced to 0.25 m. The maximum depth of investigation is up to 2.62 m. ERT profile 1 conducted during the month of December has shown a drastic reduction in resistivity values. The resistivity of the contaminated zone is ranging between 50 and 55  $\Omega$ -m, much lower than the resistivity before contamination. Physicochemical analysis has also shown increase in contaminant concentration. The width of contaminated zone is around 1.5 m, and the contaminated zone was about from depth 0.8 to 1.7 m. In third month, the resistivity value of the contaminated portion value decreased from the second month and was in the range of 40–45  $\Omega$ -m. The wide contaminated zone was 3.13 m, and contaminated zone started from the depth of 0.84 to 2.28 m. There was some precipitation during the fourth month, which affected the changes in contaminant concentration in groundwater along with the leachate. It was observed that the contaminant concentration somehow reduced in the groundwater due to the precipitation. The resistivity survey also witnessed some similar effect due to precipitation. Most of the resistivity data were observed to follow the changes in the concentration of the physicochemical parameters of the groundwater. The area of the contaminated zone increases largely. There is rise in water table following the precipitation. The contamination zone started from a depth of 0.6 m and spread up to a depth of 3.1 m. The maximum depth of flow of leachate increased at subsequent months as predicted from electrical resistivity tomography. The variation of depth of groundwater table noted from observatory well 1 is also tabulated below. The variation of maximum depth of flow and the width of flow are presented in Table 2.

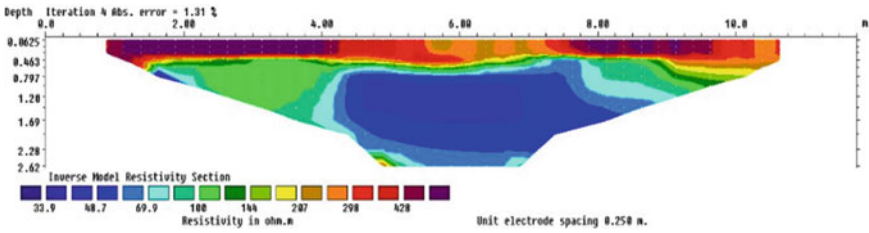
Fig. 13 Resistivity profile after three months of filling

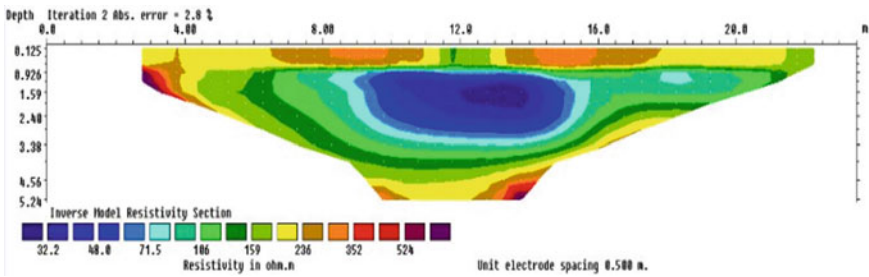
Fig. 14 Resistivity profile after four months of filling

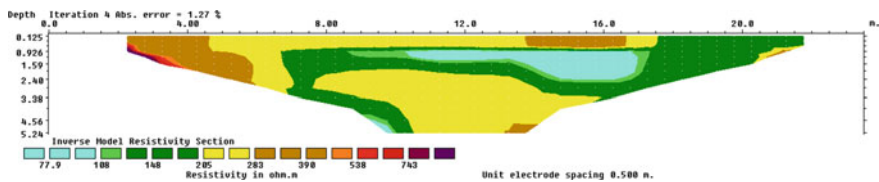
Fig. 15 Resistivity profile before filling the waste

**Resistivity and Water Quality Data for Profile 2.** Along profile 2, the resistivity survey was also carried out which is nearer to the landfill and the corresponding water quality parameters were also determined in the laboratory. Two-dimensional resistivity profiles along the profile 2 are presented in Figs. 15, 16, 17 and 18, and the test results for water quality parameters are presented in Table 3.

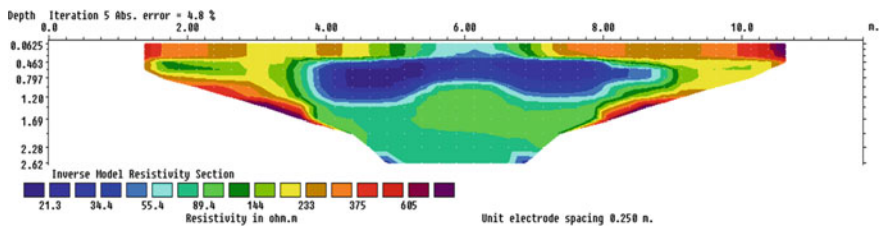
Fig. 16 Resistivity profile after two months of filling

The physicochemical analysis of water samples witnessed more fluctuations in borehole 2 which was nearer to the landfill rather in the borehole which was away from the landfill. The parameters which were more affected by the contamination in borehole 2 include pH, acidity, alkalinity, chlorides, sulphate, nitrate, turbidity, hardness and iron. The pH value indicated the acidic nature of the groundwater where the value was reduced from 6.0 before contamination to nearer 5.5 after contamination. The parameter which was most influenced by the contamination was iron concentration. Iron concentration was increased from 0.042 mg/l before contamination to 0.959 mg/l after contamination, which informed about the sensitivity of iron contamination in the groundwater at the investigated site. Even within one month of waste filling, iron concentration exceeded its standard value of 0.300 mg/l recommended by the Indian standard code of practice for drinking water. Similarly, sulphate concentration was also more pronounced after the leachate being introduced in the groundwater.

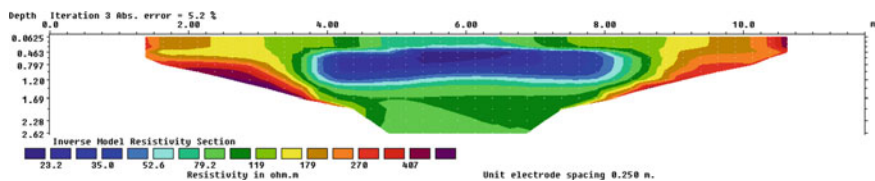
Fig. 17 Resistivity profile after three months of filling

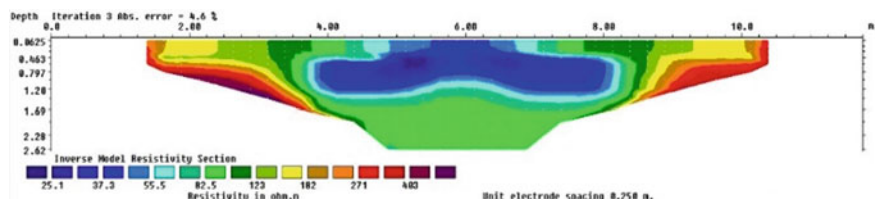
Fig. 18 Resistivity profile after four months of filling

After the precipitation during March 2018, changes occurred in contaminant concentration in groundwater along with the leachate. It was observed that the contaminant concentration somehow reduced in the groundwater due to the precipitation. The resistivity survey also witnessed some similar effect due to precipitation. Most of the resistivity data were observed to follow the changes in the concentration of the physicochemical parameters of the groundwater. Resistivity survey also showed very less flow of leachate below the profile which was representative for the

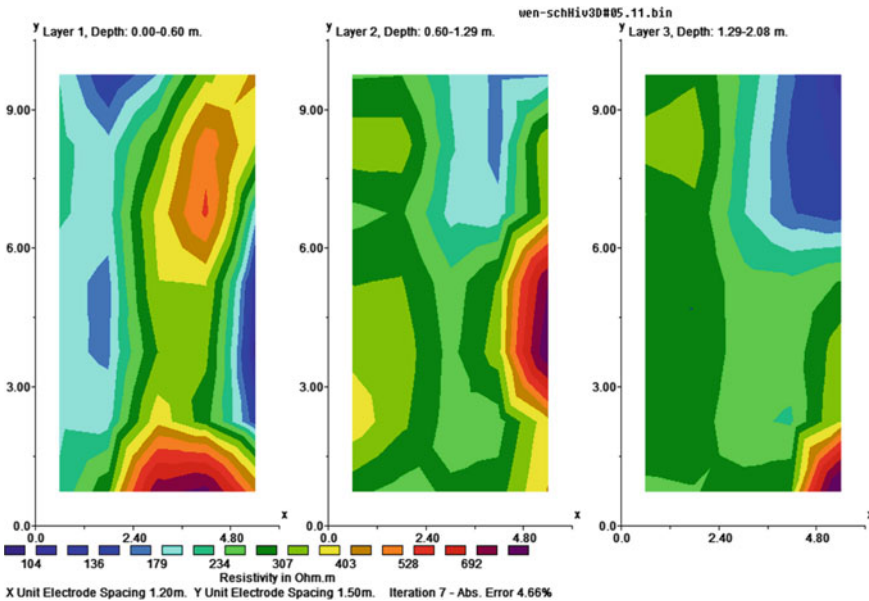
**Fig. 19** 3D resistivity profile before contamination

**Three-Dimensional Resistivity Survey.** Two three-dimensional resistivity profiles were performed, one before the construction of landfill and another after one month of construction of landfill. The three-dimensional resistivity profile clearly showed the position of waste filled trench within 0.6-m depth. The waste has a resistivity

of 20–25  $\Omega$ -m. The flow path of leachate was clearly visible which was indicated by the reduced resistivity value within the depth of 0.6–1.29 m in Fig. 19. In this resistivity profile, it was also seen that the flow of leachate was towards the lake which was present at the downstream of the landfill. A little flow of leachate was observed beyond the depth of 0.6 m after one month of construction of landfill.

Three-dimensional resistivity data showed the resistivity values in three horizontal layers along the depth at the site. The resistivity data reflected to a great extent a similar type of soil and groundwater flow zones as in case of two-dimensional resistivity profiles at the same site. The groundwater zones were interpreted to be

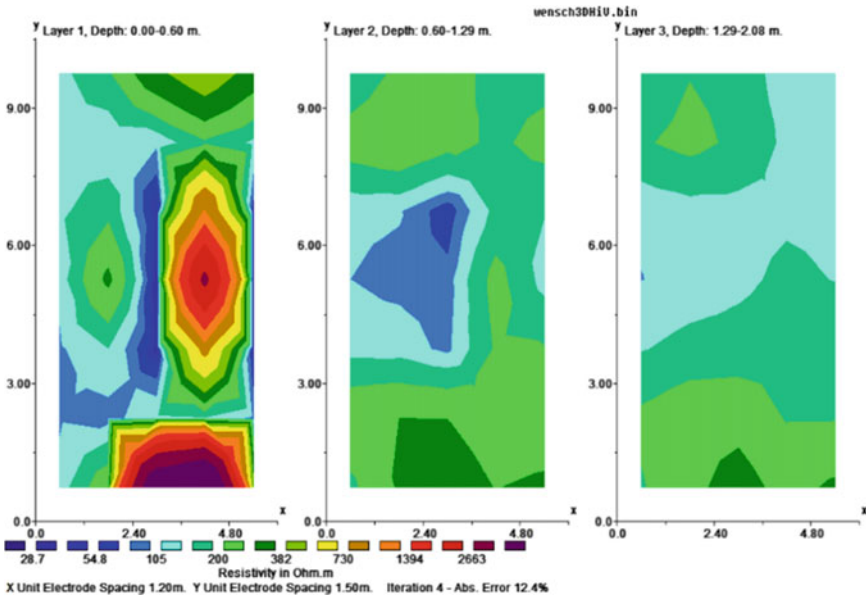
**Fig. 20** 3D resistivity profile after one month of filling

below 0.6-m depth which the two-dimensional resistivity data have shown earlier. The slope of the groundwater flow was found towards the lake, and the same data were observed during the investigation using piezometric analysis. From this profile, it was observed that a high resistive zone conforming the presence of gravelly area was present at the site which was also evidenced during the boring of the test wells (Fig. 20).

The three-dimensional resistivity profile after one month of contamination clearly showed the flow of leachate from the landfill to its downstream side towards the lake present at the site. The low resistive zone at the middle of the profile in second layer of the resistivity profiles is interpreted as the landfill, and the low resistivity zone surrounding the landfill was observed as the flow of low resistive liquid known as leachate originated from the landfill. The absence of low resistivity zone in the third layer of the resistivity profiles indicated that the flow of leachate from the landfill is limited to a depth of about 1.3 m in vertical direction. But the contaminated zone in the third layer was observed to be extended in horizontal lateral directions. Some high resistivity zones were also observed at the site from this resistivity profiles in case of the earlier resistivity profile.

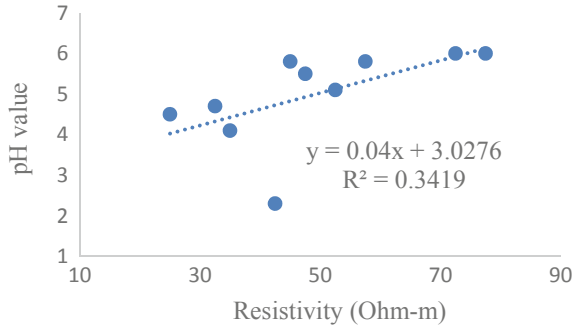
**Fig. 21** Correlation of resistivity with pH values

**Correlation of Resistivity Data with Water Quality Parameters.** Efforts were made to analyse the physicochemical parameters of each water sample collected from the boreholes over a period of five months and to correlate each parameter with the resistivity values corresponding to each observed month. Correlation charts are being prepared with electrical resistivity and the water quality parameters including pH,

chloride concentration, iron concentration, nitrate concentration, sulphate concentration and hardness concentration. The correlations of resistivity value with the water quality parameters are presented in Figs. 21, 22, 23, 24, 25 and 26.

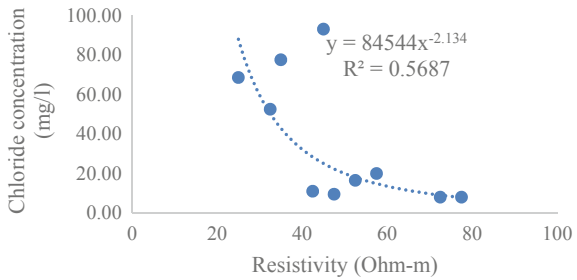
**Fig. 22** Correlation of resistivity with chloride

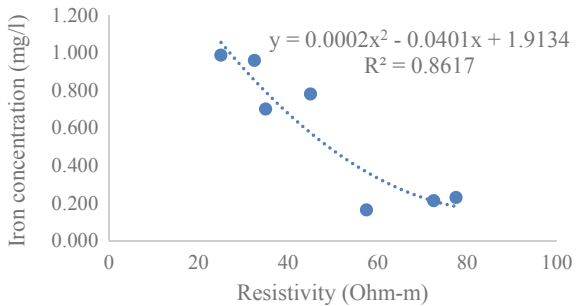
**Fig. 23** Correlation of resistivity with iron

2. The regression coefficient value of 0.87, 0.90 and 0.86 resulted from the correlation of resistivity value, respectively, with nitrate, sulphate and iron concentrations indicates the accuracy of the resistivity survey in determining the contaminant concentrations in polluted groundwater at a landfill site.
3. Non-engineered landfills have a great potential in contaminating the immediate environment within a very short period of time if no remedial measure is adopted.

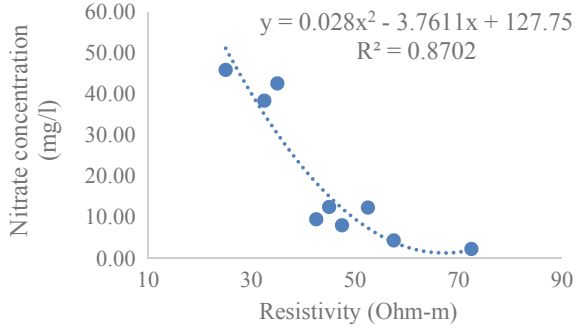
**Fig. 24** Correlation of resistivity with nitrate

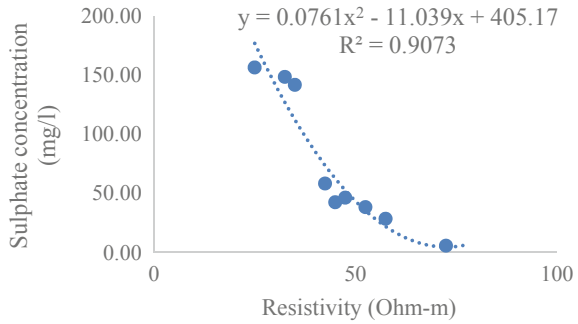
**Fig. 25** Correlation of resistivity with sulphate

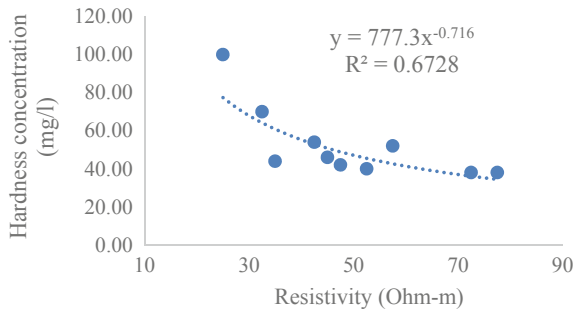
**Fig. 26** Correlation of resistivity with hardness
