# FMECA Analysis and Condition Monitoring of Kneader in Green Anode Plant of an Aluminium Smelter

**Abstract** In large plants like aluminium smelters, integrated condition monitoring techniques play an important role as break down of any critical equipment can lead to shut down of the entire plant, which in turn leads to loss of productivity and profits. From economical and operational point of view, it is desirable to ensure optimum level of system availability and reliability. Condition monitoring is implementation of the diagnostic techniques to detect the fault and forthcoming fault in the system. It helps to reduce downtime, increase efficiency and reliability of the system. Nowadays, most of the industries adopted condition monitoring techniques as a part of support system to the basic maintenance strategies. Major techniques that they follow are vibration analysis which can detect faults at a very early stage. But implementation of other techniques like oil analysis or ferrography, thermography, non-destructive testing like ultrasonic tests, magnetic particle testing, etc. can further enhance the data interpretation as they would detect the source of abnormality at much ea

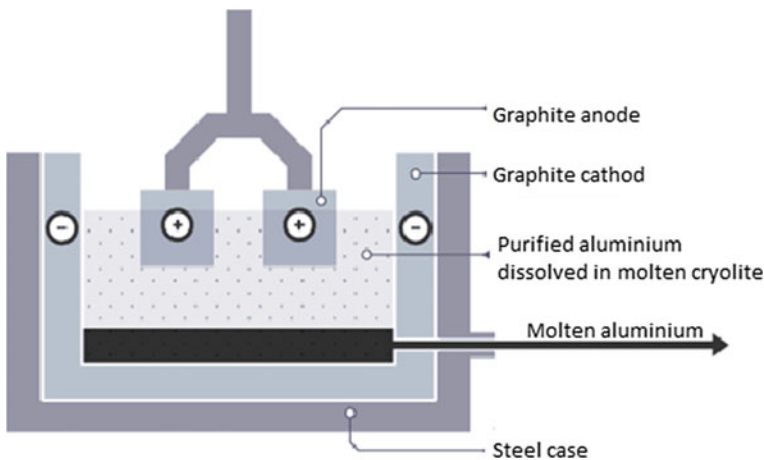
**Fig. 1** Sectional view of pot for extraction

The diagram (Fig. 1) shows an aluminium oxide electrolysis cell. The negative electrodes (cathodes) and the positive electrodes (anodes) are made of graphite, a form of carbon. During electrolysis, (i) positively charged aluminium ions gain electrons from the cathode and form molten aluminium and (ii) oxide ions lose electrons at the anode and form oxygen molecules. The oxygen reacts with the carbon in the anodes, forming carbon dioxide which bubbles off. Carbon is therefore lost from the positive electrodes, so they must be replaced frequently. This adds to the cost of the process.

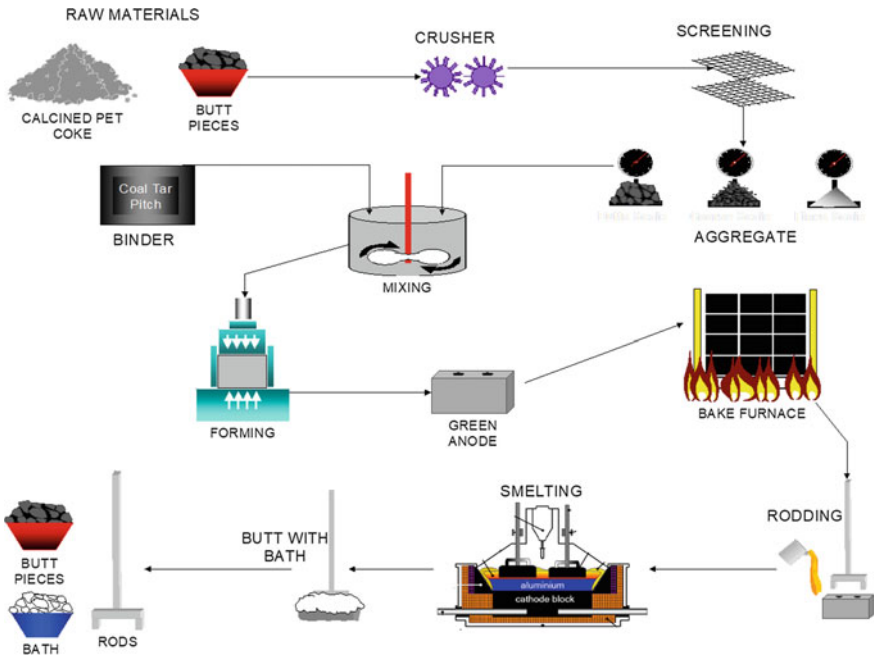
Fig. 2 Overall view of anode production process

The current study is based on Green Anode Plant in Carbon Area of Smelter-1 in Vedanta Limited, Jharsuguda, India, where anodes are produced for use in pot cells for electrolysis process. Carbon area is basically consists of three plants, namely Green Anode Plant (GAP), Bake Oven and Rodding Shop. The anode production process is shown in Fig. 2. In Green Anode Plant, a raw anode is made using coke and pitch. After crushing and screening calcined petroleum coke is mixed with coal tar pitch (as binder) inside Kneader to form semi-solid paste. The paste is filled up in the mould of a vibro compactor to get a solid carbon block (Green Anode) of required density and height. After cooling, it is transferred to storage area and then to Bake Oven for baking. In Bake Oven, the green anodes are baked to release the volatiles to get the required qualities of electrical conductivity, corrosion resistance and mechanical strength suitable for electrolysis process. The Baked anodes are then transferred to Rodding Shop to fuse with aluminium rods, so that they can be connected to the bus bars of pot cells.

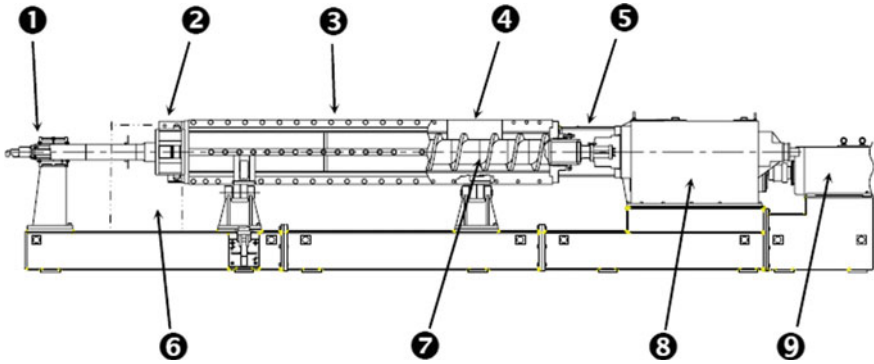
**Fig. 3** Kneader and its major components (1) outboard bearing support stand, (2) discharge gate, (3) split barrel, (4) feed inlet, (5) thrust yoke, (6) optional discharge chute, (7) kneading screw, (8) gear box and (9) drive motors

3. The general arrangements of different parts a Kneader are shown in Fig. 3.
4. Kneader specifications: Inner diameter: 600 mm, barrel length: 7232 mm, heating jackets (designed pressure: 6 bar, designed temperature: 300 °C); inlet: 800 × 530 mm; outlet: 1200 × 1200 mm; screw outer diameter: 572 mm; core diameter: 338 mm. It is designed for a rated capacity of 35 tons/hour with minimum and maximum capacities of 21 tons/hour and 40 tons/hour, respectively. Average mixing time takes 120 s with estimated inlet temperature of dry mix coke is

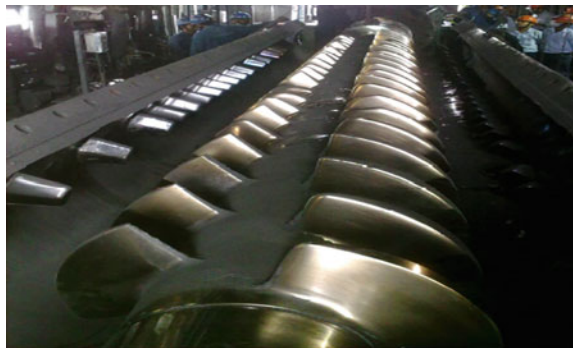
8. Mixing chamber (as shown in Fig. 5) is fabricated of carbon steel utilizing a replaceable abrasion-resistant segmented liner extending the full chamber length. The chamber is constructed of segmented barrels, split along the vertical centre-line and hinged for opening allowing access to the kneading screw, liner sections and replaceable hardened steel kneading teeth. The chamber sections are opened and closed by means of hydraulic cylinders powered by a hydraulic power unit that is complete with a totally enclosed fan cooled electric motor. The chamber halves are bolted together along the top and bottom split lines to ensure a positive seal during operation. The accurate machining tolerances between mixing chamber inner diameter and liner outer diameter provide efficient heat exchange without requiring the use of heat-transfer paste. Barrel sections are jacketed for circulating heat-transfer oil.

Fig. 5 Kneader mixer screw

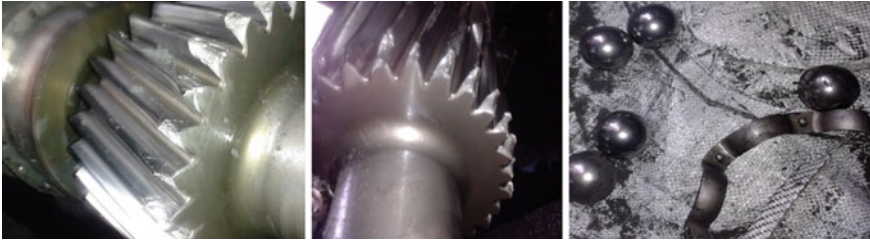
3. On 5 February 2018 vibration analysis shows that amplitude of vibration (RMS) increased up to 8.34 mm/s in the intermediate shaft and PeakVue readings were high at 1.25  $G_E$ . Kneader was stopped and gearbox was opened for inspection and it was found that intermediate shaft gear teeth and its drive end bearing were damaged (as shown in Fig. 6). As per recommendation, both the shaft (with integrated gear) and bearing were replaced.

**Fig. 6** Damaged intermediate gear and roller bearing

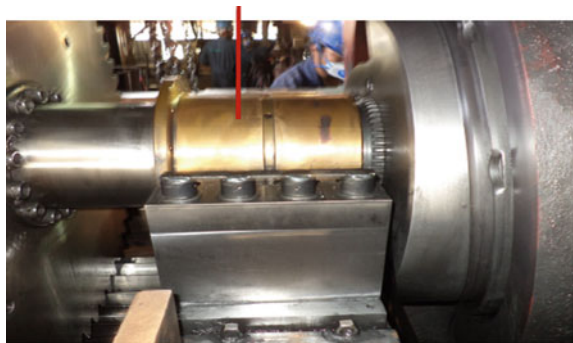
found that intermediate bush clearance was increased (as shown in Fig. 7) due to which abnormal sound was observed. After giving shim packing of 3 mm, clearance was adjusted and sound was reduced.

**Fig. 7** Kneader intermediate bush

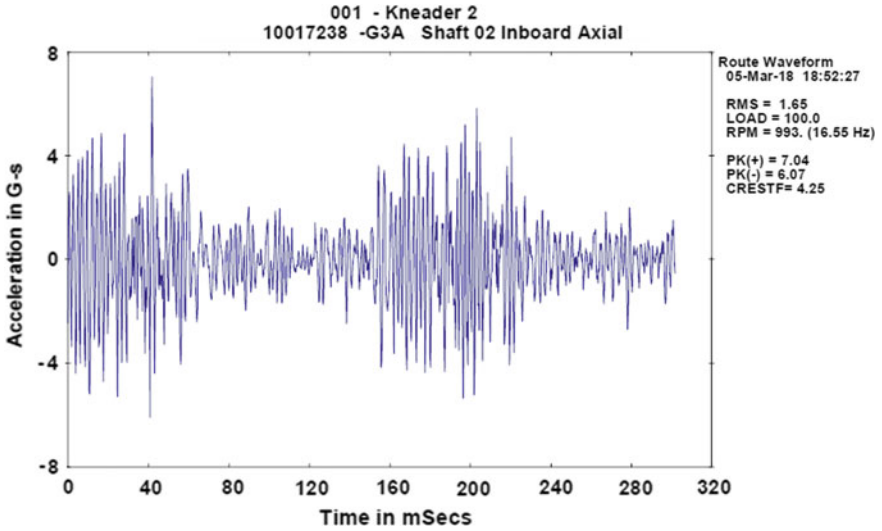
5. On 5 March 2018, vibration amplitude was still high on intermediate shaft (5.12 mm/s). The time waveform (as shown in Figs. 8 and 9) indicates the irregular impacts, which happens mainly due to bearing looseness, high bearing clearance or other bearing related abnormalities. The impact waves were ranging from +7 to  $-6 G_s$  indicating a high alert. The crest factor (peak to RMS) is also as high as 4.25 (against a normal value of 2 to  $-2$  for a good bearing) indicating high impact. Same was being transmitted to input shaft also which showed similar pattern of time waveform.

Fig. 8 Time waveform of intermediate shaft during faulty condition

6. Since already the bearing was replaced along with adjustment of bush, so intermediate bearing housing was removed for checking. After inspection, it was found that housing diameter has increased leading to looseness of bearing in the housing. Bearing housing was repaired with in situ welding and machining to maintain the accurate tolerances.

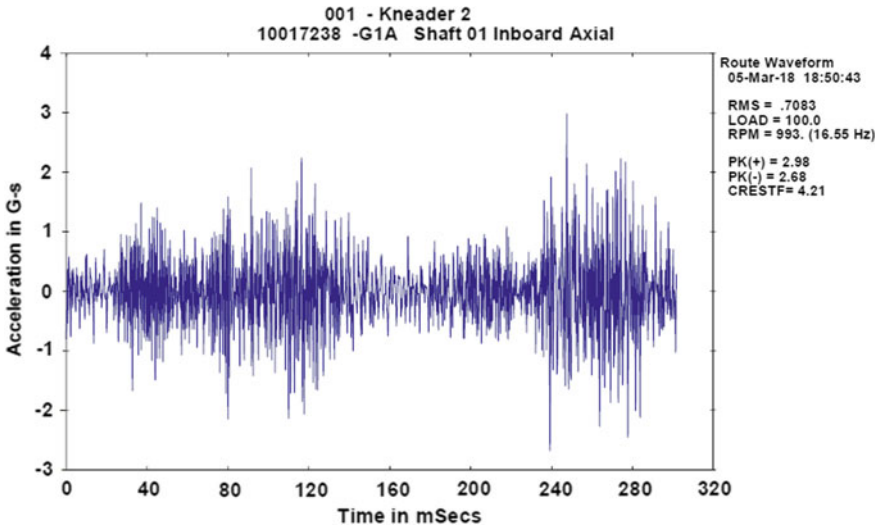
Fig. 9 Time waveform of input shaft during faulty condition

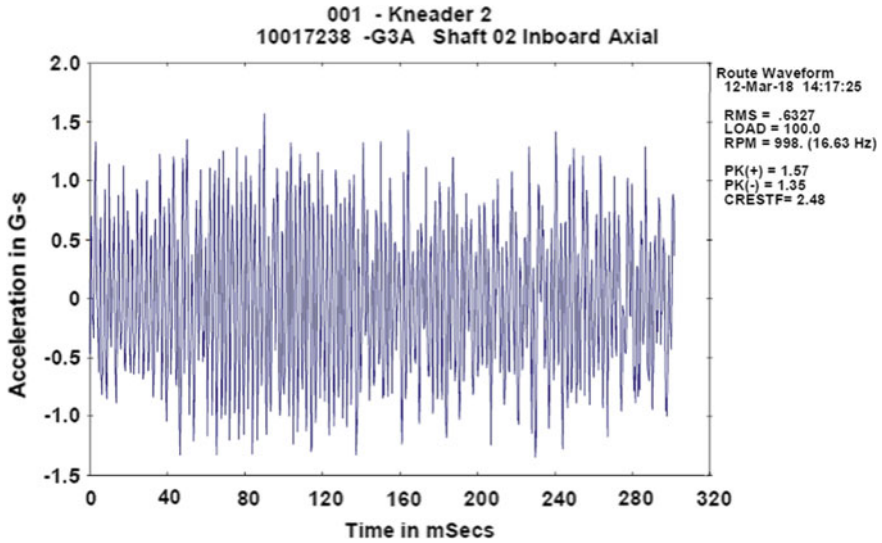
8. The time waveform analysis also showed an excellent improvement in the health of the intermediate and input bearing. There were no fault patterns and impact

wave ranged from 1.6  $G_s$  to  $-1.3 G_s$  indicating normal conditions. The crest factor has also decreased to 2.4 (as shown in Fig. 10).

**Fig. 10** Time waveform of intermediate shaft after correction

7. After that on 12 March 2018, vibration readings were found normal, i.e. 2.76 mm/s maximum, which was well within acceptable limits and there is no abnormal sound.
