August, 2019 Landslide Events in Kinnaur, H.P.—An Assessment of Earthquake and Landslide Consequences Using Satellite Data

Abstract On August 18, 2019, the Kinnaur region in the Indian state of Himachal Pradesh experienced many landslides due to heavy rains. In H.P.'s Kinnaur district, National Highway 5 was blocked, heavy rainfall triggered many landslides in isolated regions of Himachal Pradesh, blocking large number of roads, it was blocked near Ribba village of Kinnaur district causing heavy traffic jam. According to reports, this event resulted in the death of 22 people and a significant loss of property. This study presents the results of the Kinnaur landslide damage assessment derived from the analysis of very high-resolution images (VHR) received from different satellites. These datasets were obtained through a coordinated effort by the government organisation major disasters. The damage is mainly attributed to rock slides from the area of the slope that later became debris flows by sanding the material along the exit zone.

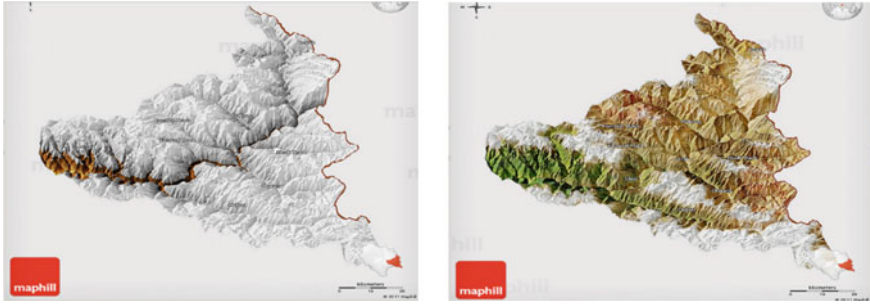
Fig. 1 Physical and satellite map of Kinnaur district [8]

Kinnaur is a Trans-Himalayan region which is located in the bank of Sutlej and tributary of Baspa. It is the east frontier district of Himachal Pradesh. The total area of Kinnaur is about 6401 km². Ribba is a village panchayat located in Kinnaur district, Himachal Pradesh, India. The coordinates of Ribba are longitude 78.364 and latitude 31.584. In eastern part of Kinnaur lies Ngari region located in Tibet. In southern region, Douladhar ranges which separates Shimla district of Himachal Pradesh and Uttarkashi district of Uttar Pradesh. Srikhand Dhar makes boundary between Kuku and Kinnaur in the western region. In norther region Spiti is located which shares Indo-Tibetan border (2017) (Fig. 1).

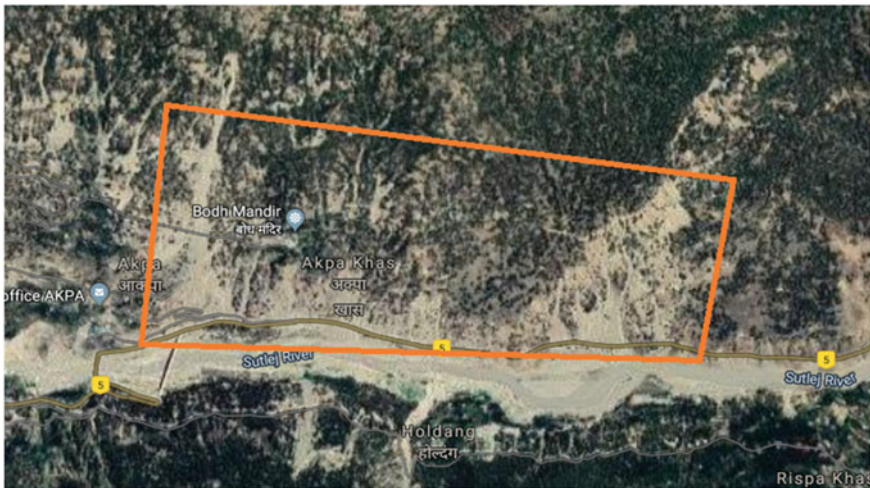
Fig. 2 Ribba village landslide zone [9]

The landslide of Ribba village is located at $31^{\circ}59'20''N$ and $78^{\circ}36'49''E$, along which another landslide zone is located called Pawari landslide zone where the landslides are common. These two zones are located near the bank of Sutlej River. Recently on August 18, 2019 due to heavy rainfall a massive landslide was occurred in Ribba landslide zone due to which National Highway 5 was blocked. The width and length of landslide zone are 2.58 km and 859 m, respectively, and has an area of about 2.21 km^2 . [9] (Fig. 2).

The landslide occurred at MSL of 1993 m and at an altitude of 2850 m. The surrounding villages are Rarang, Akpa, Panah and Purbani. In this landslide zone the northern part is a cliff with debris flow and rock boulders. In the southern zone there is a valley of Sutlej river. By geomorphic characteristics, this zone has steep angle of slope with a difference of 50° and 65° in the northern region and 40° and 55° in the southern region [1].

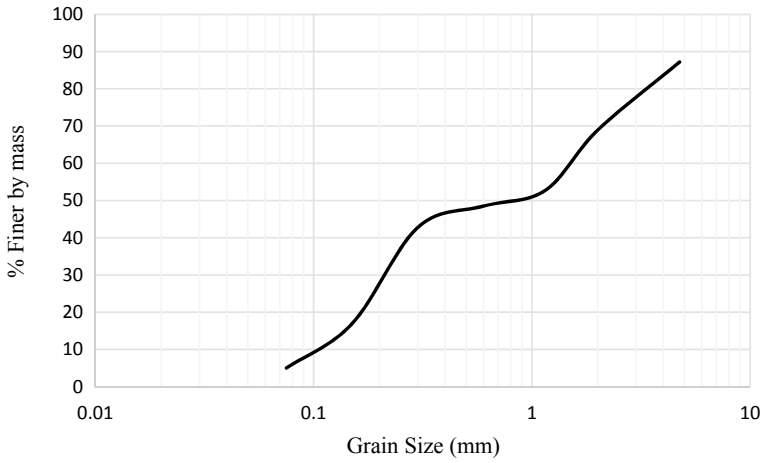
Fig. 3 Particle size distribution

- The average specific gravity of the soil is 2.47.
- By performing sieve analysis, the following graph is plotted in which the value of coefficient of uniformity is 16.84 and coefficient of curvature is 0.31.
- In Atterberg limits, Liquid Limit (LL) is 23.339%, Plastic Limit (PL) is 19.67% and shrinkage limit (SL) is 17.05%.
- From standard proctor test, a compaction curve is plotted to obtained optimum moisture content (OMC) of 25.1% and maximum dry density (MDD) of 1.744 gm/cc (Figs. 3, 4 and 5).

By performing soil experiments on the soil sample collected from the Ribba landslide it is found that the soil is poorly graded with coarse and very fine grade category.

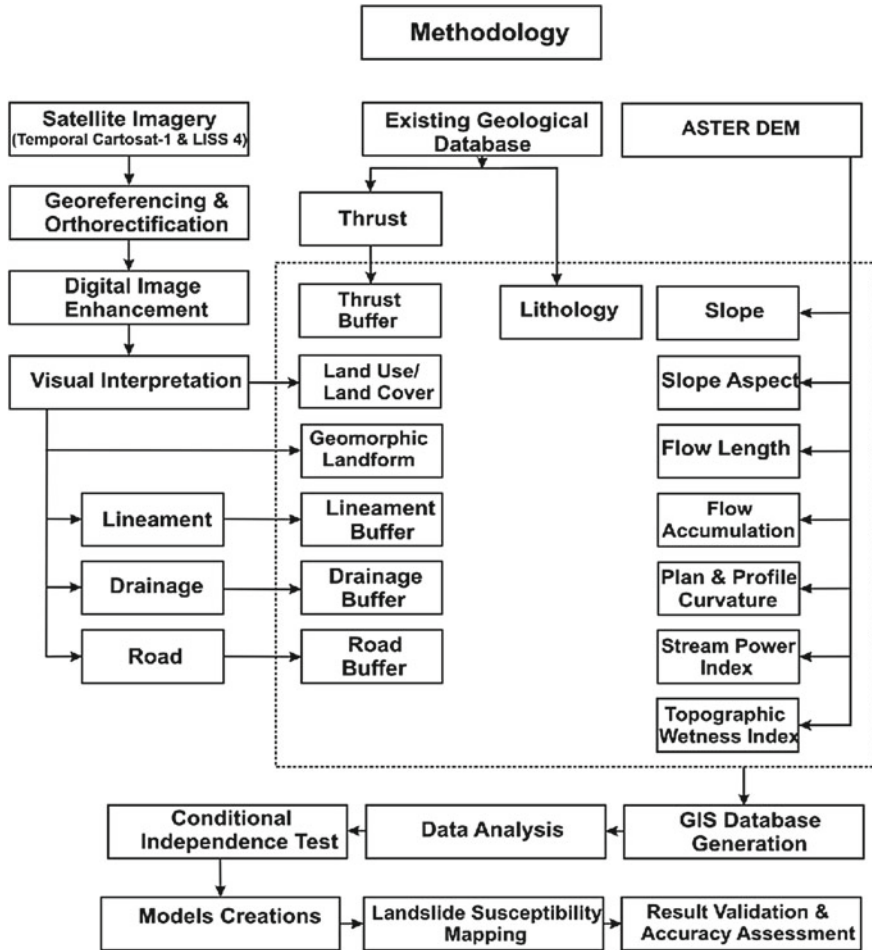
Fig. 6 Landslide susceptibility mapping

to perform further investigation in those regions. Thematic layers of these map are prepared by overlaying the different factors showing geological, morphological and land use conditions [5]. Finally, a model is prepared on the landslide susceptibility for assessment which can be qualitative or quantitative approach. Landslide vulnerability includes different aspects based on physical, land use and land cover, people perception, comprehensive vulnerability (Fig. 6).

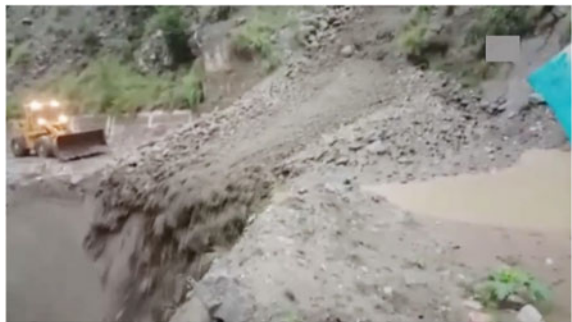
Fig. 7 Flow of rainwater along with debris and soil blocking NH 5

Due to heavy rainfall in this region, a high amount of volume of water is discharged with greater velocity which leads to erosion of soil. As the slope has steeper gradient the flow of water along with debris is high and this flow washes away the pavement constructed and finally into the Sutlej river. The bifurcation ratio is defined as the ratio of number of streams of given order to number of streams to next order. The bifurcation ratio gives us the physical loss of the soil mass (Fig. 7).

Here the Sutlej River has a low bifurcation value which says that it has a controlled bedrock. Many streams are formed from higher ridge, and due to continuous flow, the boulders and soil gets washed away into Sutlej basin.

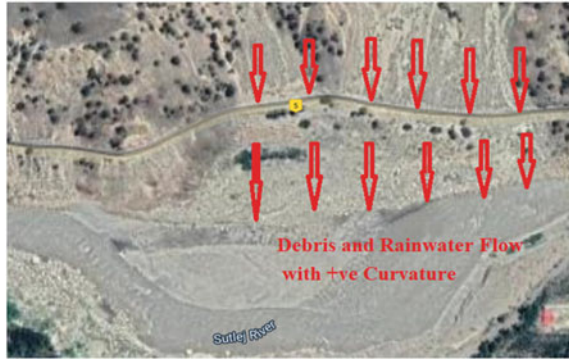
Fig. 8 Positive curvature of landslide

The deceleration and acceleration of the flow due to profile curvature affect the nature of the landslide. If the curvature has a negative value then it shows that the surface is upward convex and the flow will be decelerated. If positive then the surface is upward concave with accelerated flow (Fig. 8).

Here the landslide occurred at Ribba has a positive curvature due to which high amount of movement of soil mass, boulders and debris took place.

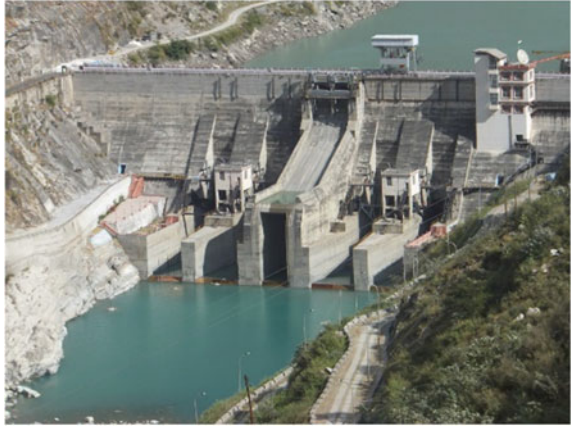
Fig. 9 Hydroelectric project [10]

Construction of hydroelectric project is a major issue which finally leads to slope failures and landslides. If surrounding of the Sutlej is considered it is observed that slope instability is common causing sliding of soil mass and boulders. There are four hydroelectric projects constructed in Sutlej basin and are different in type which were under investigation, clearance, one was commissioned and another was under construction. It was found that the maximum number of landslides were occurred due to under construction type and were causing risk. As the continuity of construction

activities, the chances of landslides in the surrounding region are increasing. The wildlife sanctuary, forestland and topsoil and many villages were threatened under hydroelectric projects [2] (Fig. 9).

When these hydroelectric projects are constructed blasting technique and tunnelling is done which will cause ground disturbances and finally causing landslides.

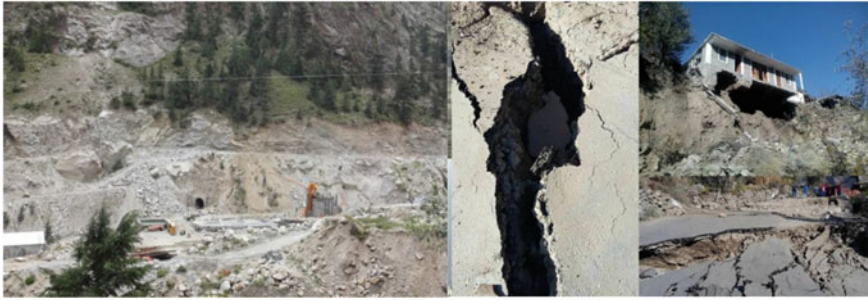
Fig. 10 Small range seismic waves due to blasting and tunnelling operations

Land movements due to earthquake in Kinnaur region have an intensity between 4.0 and 6.1. The average magnitude recorded is 4.5 and low intensity earthquakes commonly occur in this region. By comparing with the Mercalli intensity scale Kinnaur district falls under IV to V. Every time when a low intensity earthquake is occurred, the tremors can be felt in the surrounding region, with cracks developed in buildings, pavement failure, spalling, settlement, utility disturbances. People living in the surrounding also explained about how they experienced those tremors (Fig. 10).

Even due to blasting operations and tunnelling construction they felt those vibrations. Due to these conditions every village in Kinnaur district comes under earthquake vulnerability zone.
